This **Summary Report** is meant to organize any **Moderate Recommendations** and **Significant and/or Safety Concerns** into a shorter, straight to-the-point format. It does not, however, include **Minor/Maintenance/Monitor** issues or Informational data that can be found in the Full Report.

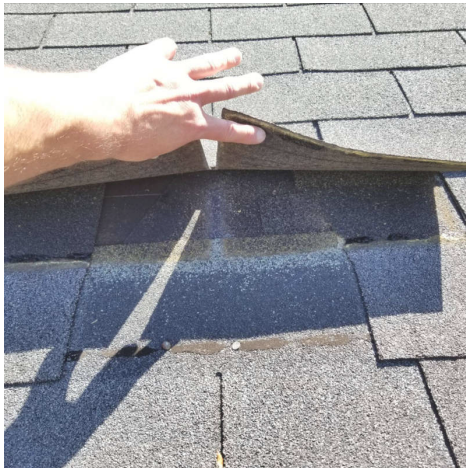
Northwest

2.2.1 Shingles

SHINGLES DAMAGED

One or more composition shingles were Damaged. Recommend that a qualified roofing professional make needed repairs as necessary.

Contact a qualified roofing professional.

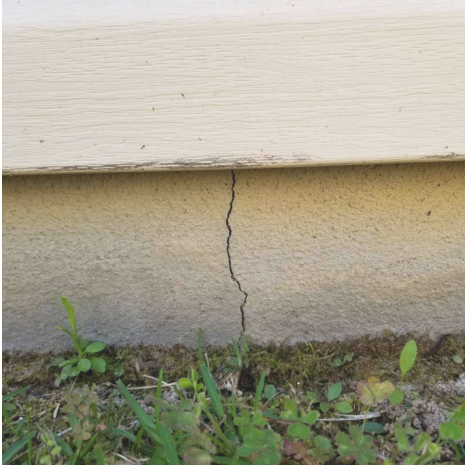
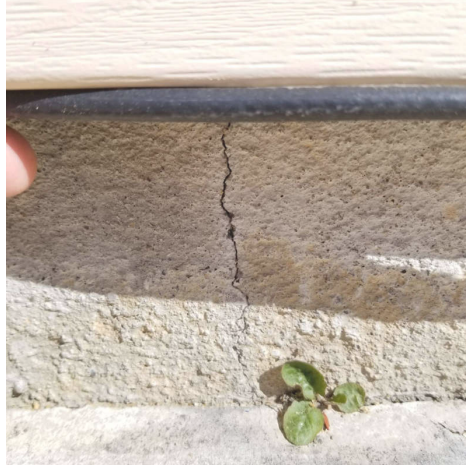
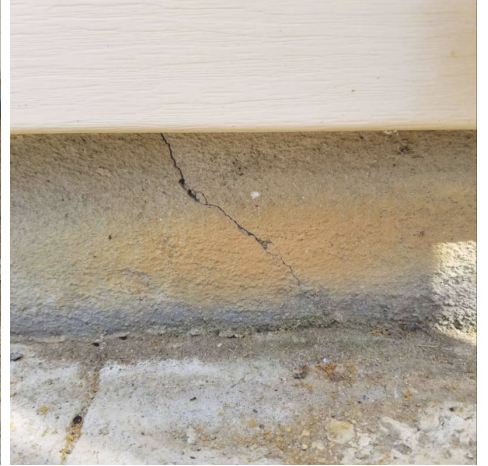
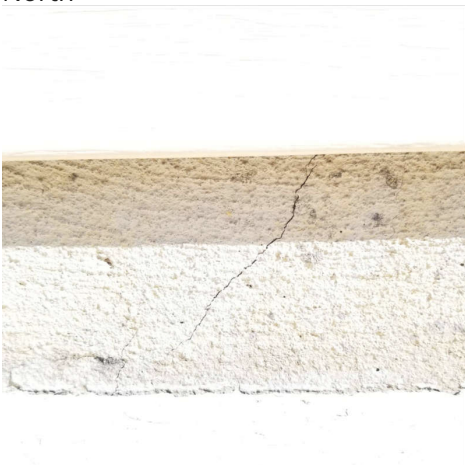
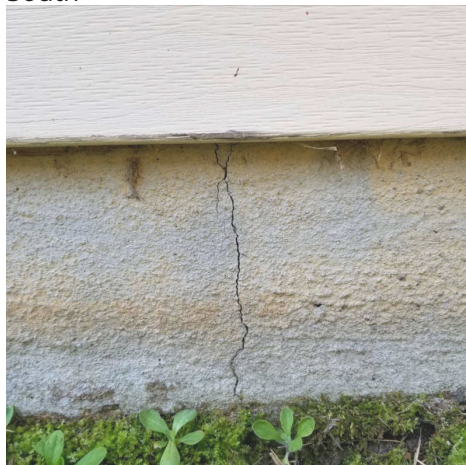
3.2.1 Exterior issues

COMMON CRACKING

Common cracks were visible in the floor slab. This type of cracking can have several causes:

- Concrete shrinkage, which is a normal part of the concrete curing process and not a structural concern:
- Post-construction settling due to inadequate compaction of the soil beneath the slab during construction. This also is not an unusual condition and this type of cracking ceases after the first few years after original construction as the soil beneath the slab becomes stable: or
- Heaving of the soil due to the presence of expansive soils.

Recommend monitoring.

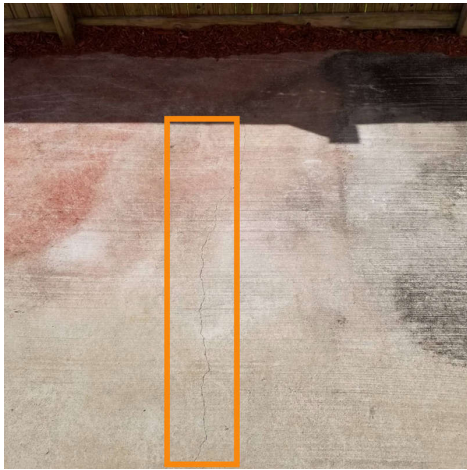
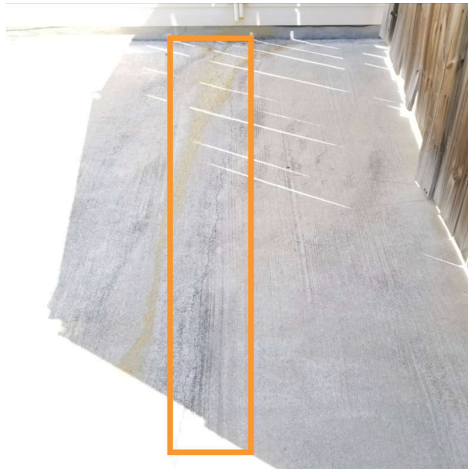
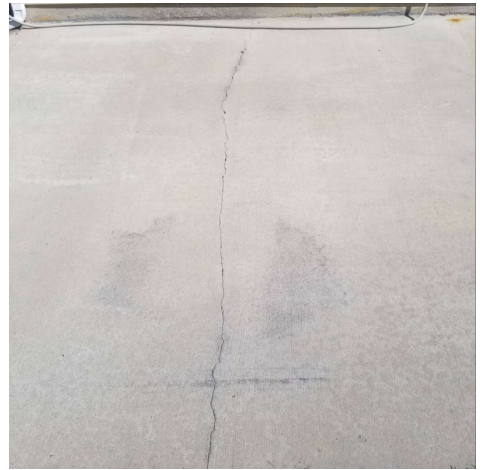
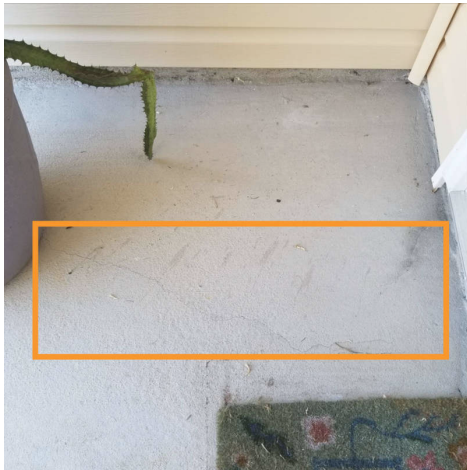
3.3.1 Driveway, Walkway, Patio

MINOR DAMAGE-DRIVEWAY,SIDEWALK,PATIO

Minor deterioration (cracks, chips, holes, settlement, heaving) was found in driveways, sidewalks or patios, but no trip hazards were found. The client may wish to have repairs made for cosmetic reasons.

Contact a qualified professional.

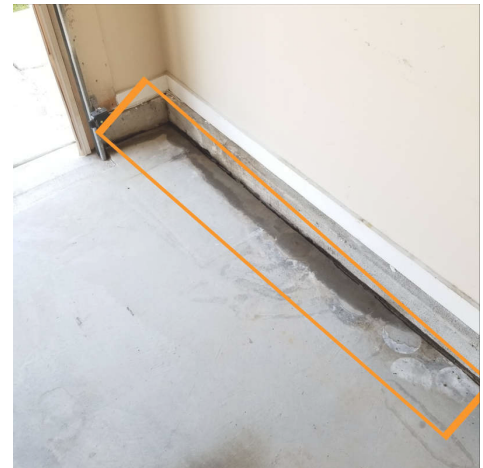
4.3.1 Floors, walls, Ceiling **MOISTURE INTRUSION**

Garage floor showed signs of moisture intrusion. Recommend a qualified contractor evaluate and find source of moisture to prevent further damage and/or mold.

Recommendation
Contact a qualified professional.

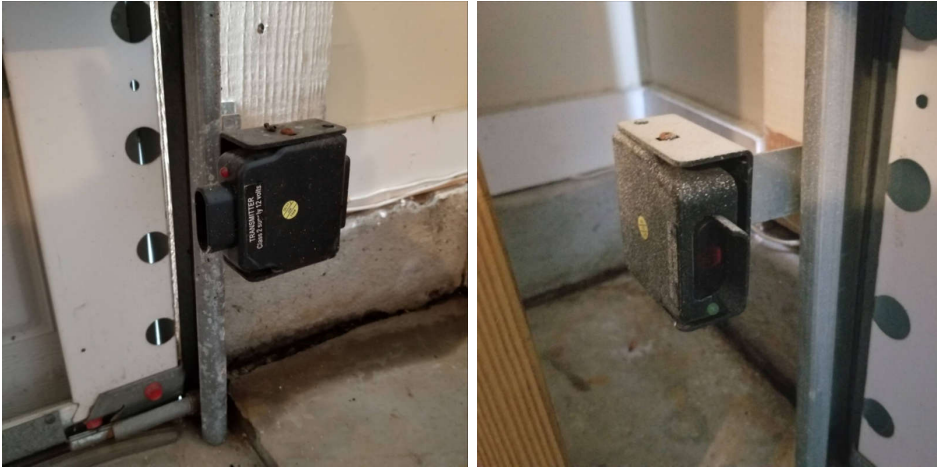
4.4.1 Vehicle door **PHOTO-EYES INOPERABLE**

The infrared "photo eye" devices that trigger the vehicle door opener's auto-reverse feature were inoperable during the inspection. This is a safety hazard, especially for small children. A qualified contractor should evaluate and make repairs or replace components as necessary.

Recommendation
Contact a qualified garage door contractor.

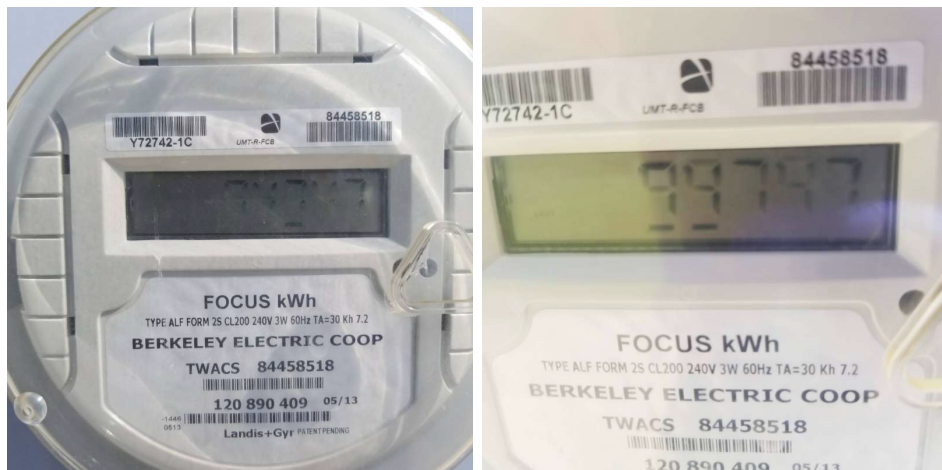
8.5.1 Meter

COVER FADED

The meter cover plate is damaged or faded and not readable. Recommended asking the utility company if this is something they are to repair.

Contact your local utility company

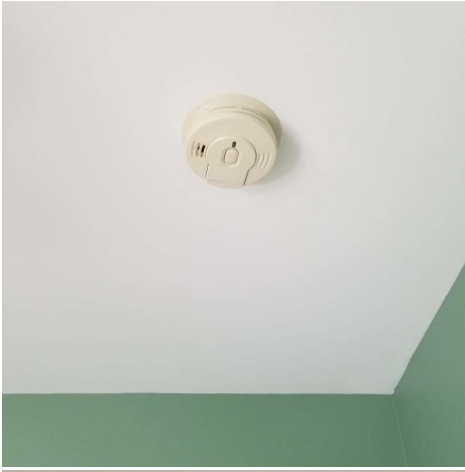
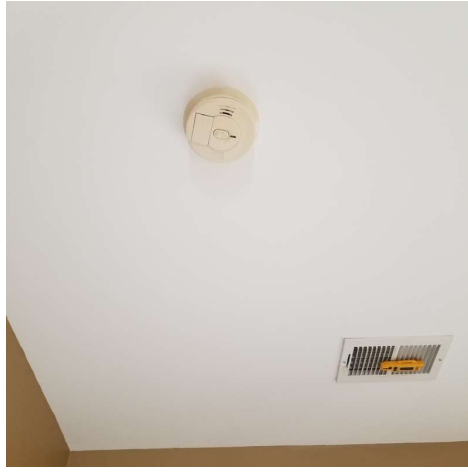
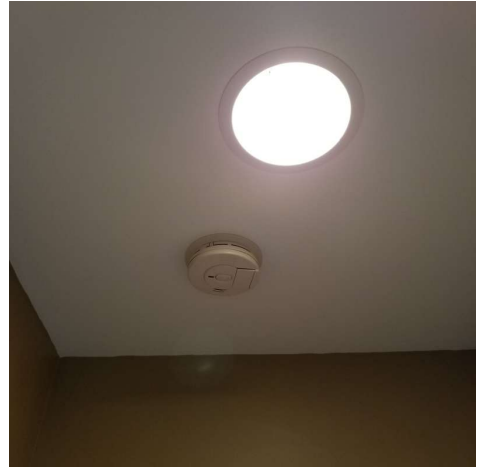
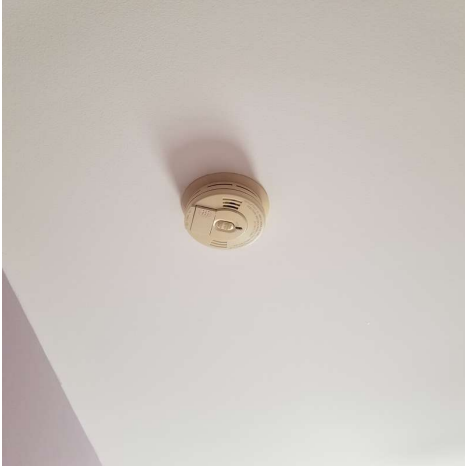
11.4.2 Smoke and CO alarms

SMOKE ALARM >10 YRS

Based on the age of this structure and the appearance of existing smoke alarms, the alarms may have been installed more than 10 years ago. According to National Fire Protection Association, aging smoke alarms don't operate as efficiently and often are the source for nuisance alarms. Older smoke alarms are estimated to have a 30% probability of failure within the first 10 years. Newer smoke alarms do better, but should be replaced after 10 years. Unless you know that the smoke alarms are new, replacing them when moving into a new residence is also recommended by NFPA.

Contact a qualified electrical contractor.

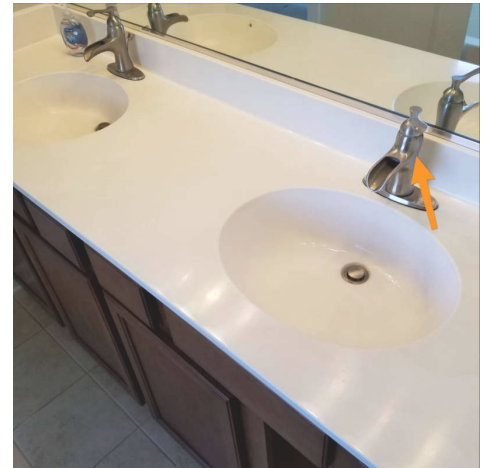
Master Bathroom

12.7.1 Sink/countertop

STOPPER ISSUE

One or more sink stopper(s) mechanisms are missing, or need adjustment or repair. Stopper mechanisms should be installed where missing and/or repairs should be made so sink stoppers open and close easily.

Contact a qualified plumbing contractor.
