SUMMARY

1234 Main St. Mountain Home AR 72653

Buyer Name
01/14/2018 9:00AM

Chris Cochran
Arkansas License HI-1886
Cochran Home Inspections, LLC
(870) 656-8735
chris@cochranhomeinspections.com

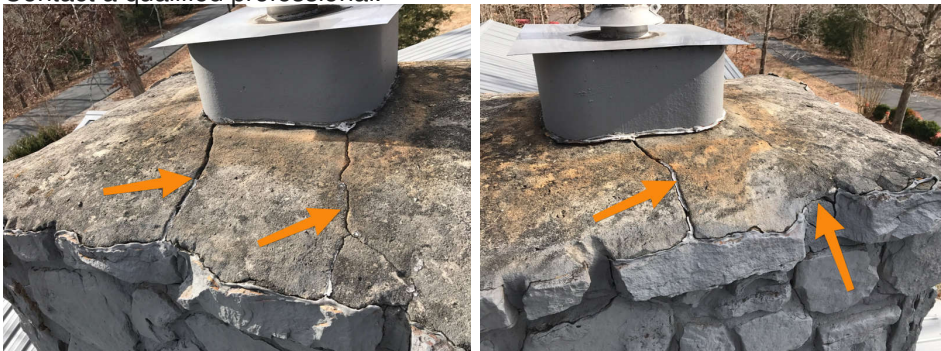
2.5.1 Chimney (above roof)

CHIMNEY CROWN CRACKING - MINOR

Minor cracking noted in the chimney crown which could allow water/moisture intrusion down chimney. Recommend reseal cracks and monitor.

Recommendation
Contact a qualified professional.

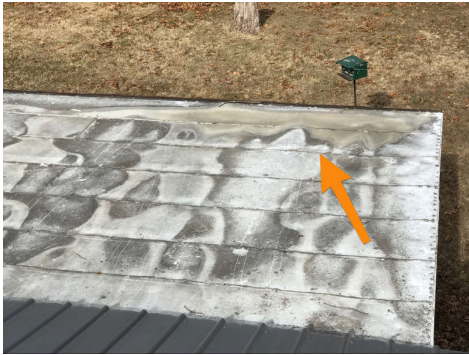
North

PONDING

Observed indications of ponding in one or more areas of roof. Ponding can lead to accelerated erosion and deterioration. Recommend a qualified roofing contractor evaluate and repair.

Recommendation
Contact a qualified roofing professional.

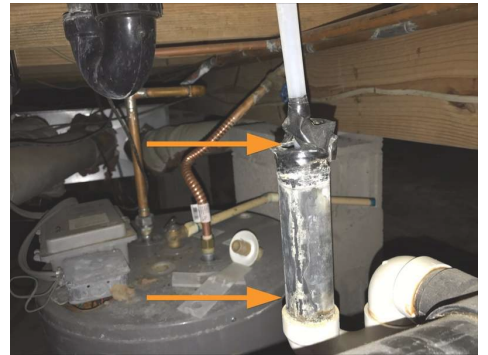
East Crawspace

8.2.1 Drain, Waste, & Vent Systems
**IMPROPER CONNECTION -
CONDITIONER DISCHARGE**

An improper connection from a whole house conditioner line was observed at a drain pipe. Indications of overflow were noted which will cause moisture problems in crawspace. Recommend further evaluation and repair by installing a proper discharge connection fitting.

Contact a qualified plumbing contractor.

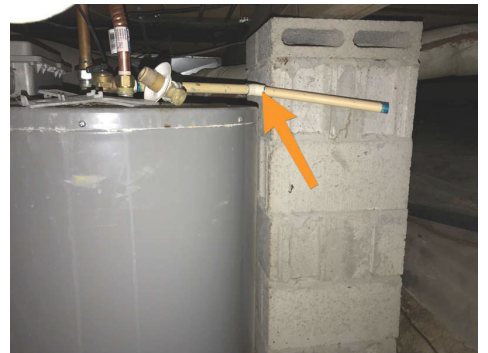
East Crawspace

**TPR DISCHARGE PIPE
IMPROPERLY INSTALLED**

The temperature/pressure relief (TPR) valve had a discharge pipe that was not properly installed in a crawspace area. Discharge pipe should be facing down towards the ground preferably over a drip pan and approx. 6 inches off of the ground. Recommend TPR discharge pipe is installed correctly.

Contact a qualified professional.

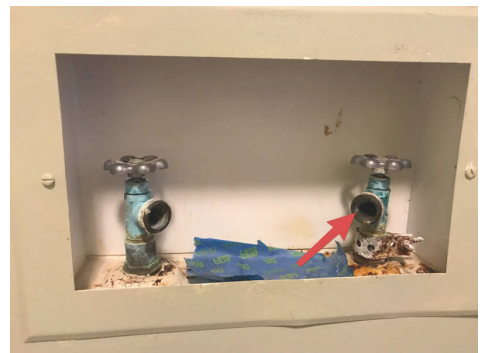
Laundry Room

8.5.1 Washer Connections / Drain Pipe
LEAKING NOZZLE

One or more of the washer nozzles were leaking at the time of the inspection. Recommend further evaluation and repair/replacement.

Contact a qualified plumbing contractor.

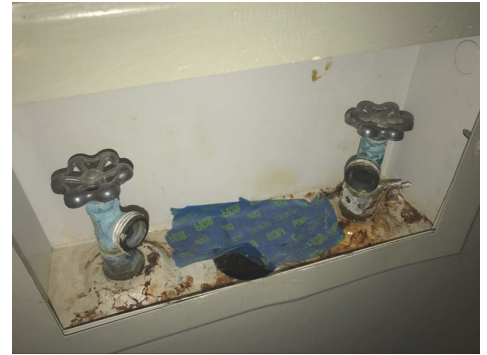
Laundry Room

RUSTY/DEGRADED BOX

Laundry box was noted as degraded with visible rust which could lead to leaking into wall. Recommend laundry box is replaced.

Contact a handyman or DIY project

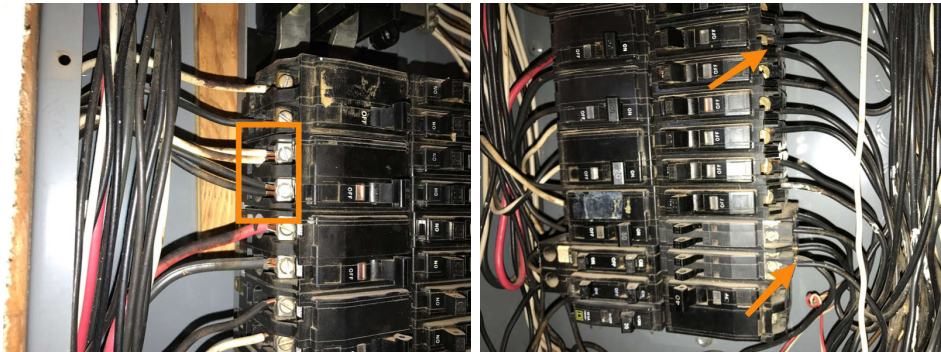
9.2.1 Main Service Panel, Service & Grounding, Main Overcurrent Device

BREAKER DOUBLE TAPPED

Breaker was double tapped which means two different circuits are connected to one breaker. Recommend electrician further inspect and repair.

Contact a qualified electrical contractor.

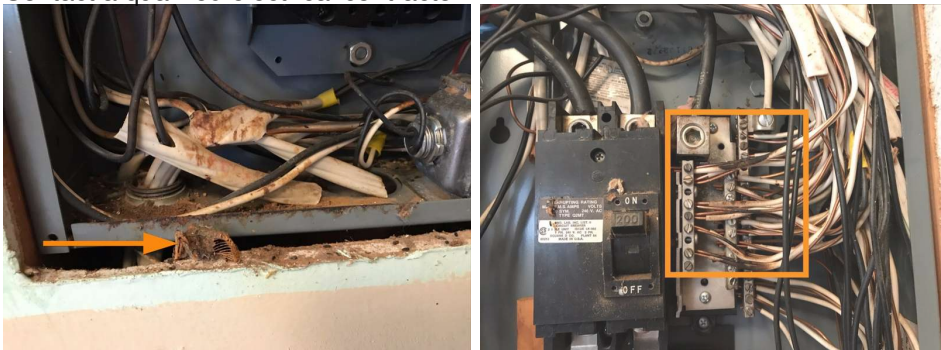
MSP

BURNT WIRES

Burnt wires were noted inside and connected to the main service panel. A dead rodent was noted at bottom of panel and may have been the cause of the damage. Recommend further evaluation and repair if needed.

Contact a qualified electrical contractor.

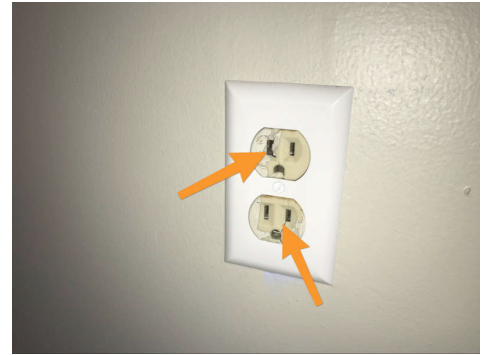
Master Bedroom

RECEPTACLE DAMAGED

One or more of the receptacles was damaged at the time of inspection. Recommend further evaluation and replace.

Contact a qualified electrical contractor.

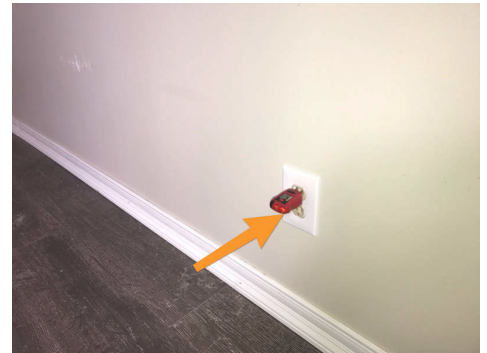
Master Bedroom

RECEPTACLE LOOSE

One or more receptacle was loose which could become a shock hazard. Recommend properly securing receptacle.

Contact a qualified electrical contractor.

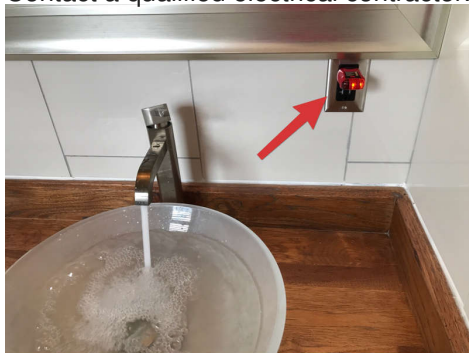
Master Bathroom

NO GFCI PROTECTION INSTALLED - INTERIOR

One or more area inside home did not have ground fault circuit interrupter (GFCI) for electrical receptacles located within 6 feet of a plumbing fixture; potential shock or electrocution hazard. Recommend installation by qualified professional.

Contact a qualified electrical contractor.

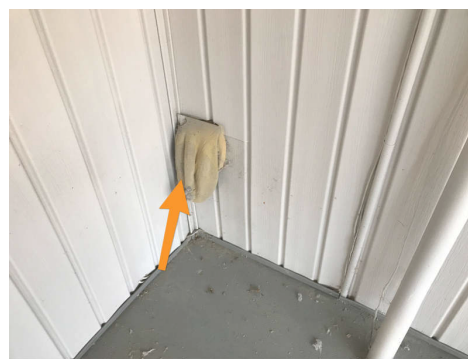
North

DRYER EXHAUST CLOGGED

Dryer exhaust had a generic catcher installed which will not allow the vent to discharge properly. Recommend further evaluation and change in discharge location if possible. Recommend removal of catcher, cleaning of the entire exhaust line and monitor for proper function.

Recommendation
Recommended DIY Project

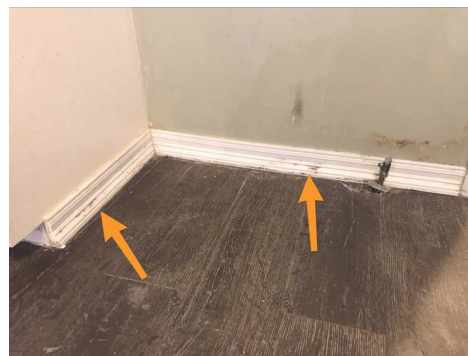
Kitchen

MICROBIAL GROWTH - ISOLATED

One or more areas of the home had visual microbial growth noted; isolated. Recommend cleaning using a microbial killing/inhibiting product and monitoring.

Recommendation
Contact a qualified mold inspection professional.

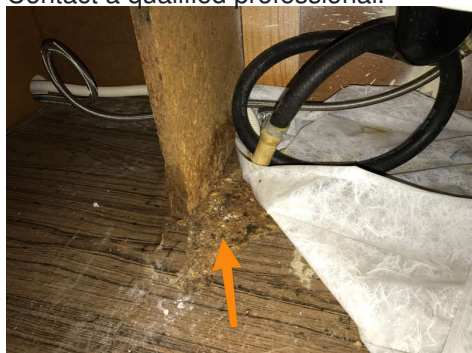
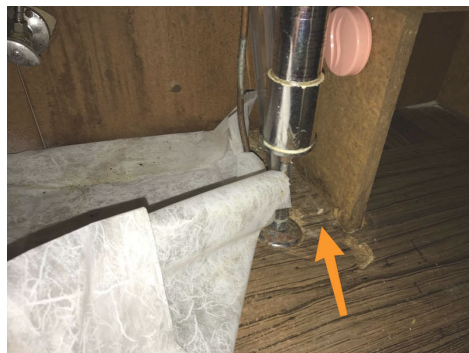
SINK BASE MOISTURE DAMAGE

Moisture damage to sink base cabinet noted; active leak at countertop is causing left side damage; cause of right side damage unknown. Recommend surface is kept dry from further deterioration.

Recommendation
Contact a qualified professional.

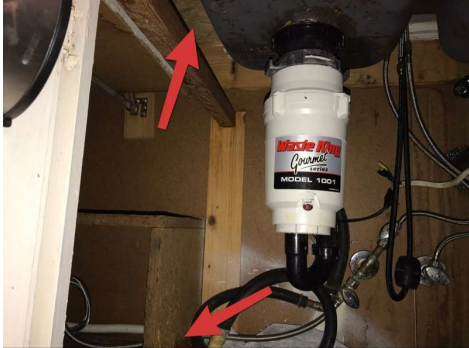
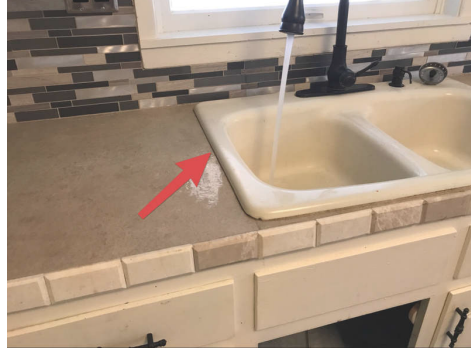
SINK LEAKING

Sink at countertop was noted leaking into the sink base. Recommend sealing sink at countertop to stop leaking into base.

Recommendation
Contact a handyman or DIY project

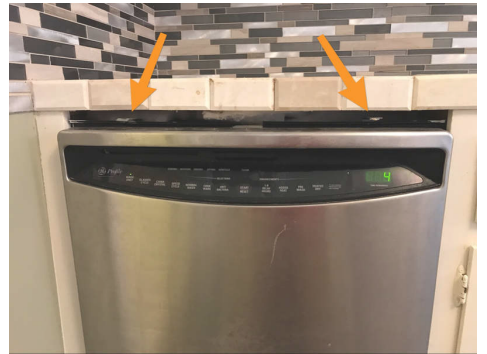
Kitchen

NOT SECURED

Dishwasher was not properly secured to countertops/cabinets. Recommend properly fastening unit.

Recommendation
Contact a qualified handyman.

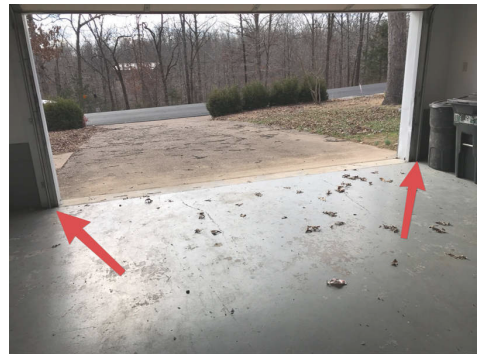
Garage

PHOTO SENSOR NOT INSTALLED

The overhead garage door was not equipped with a photoelectric sensor. Photoelectric sensors are devices installed to prevent injury by raising the vehicle door if the sensor detects a person on a position in which they may be injured by the descending door. Installation of photo sensors in new homes has been required by generally-accepted safety standards since 1993. The Inspector recommends installation of a photo sensor by a qualified contractor or technician for safety reasons.

Recommendation
Contact a qualified professional.
