SUMMARY

1234 Main St. Nashua NH 03060

Brian C. Burlison, CMI
Certified Master Inspector®
Gate City Home Inspections, LLC
603-508-9458
brian@gatecityinspection.com

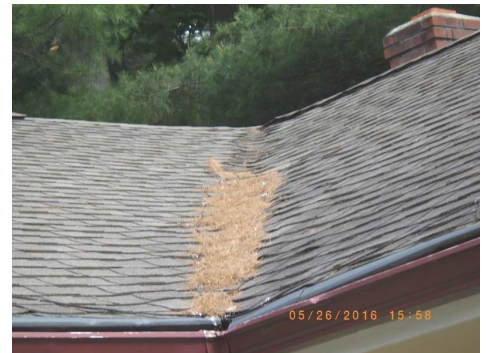
2.1.1 Coverings

DEBRIS ACCUMULATION

Tree debris was observed to be accumulating on the roof. This will hold moisture against the roof shingles and could lead to premature wear. Recommend clearing the debris off the roof.

Contact a handyman or DIY project

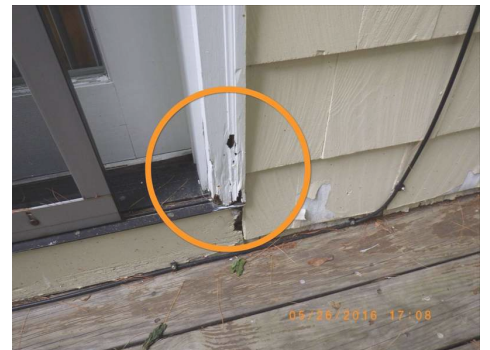
3.1.1 Siding, Flashing & Trim

WOOD ROT DAMAGE

Wood rot damage was observed on exterior surfaces (see photos). Repair by a qualified contractor is recommended. It is recommended that all wood exterior surfaces be kept well painted/sealed to avoid this issue.

Please Note: Area(s) of wood rot were observed on the exterior of the home. While this damage is often limited to the visible areas noted, it is possible that sheathing and/or framing components of the building that cannot be visually inspected are affected. Any work done to repair wood rot on finished surfaces should include a thorough examination of the underlying building components.

Contact a qualified professional.

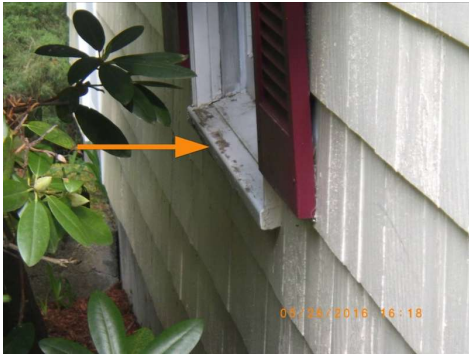
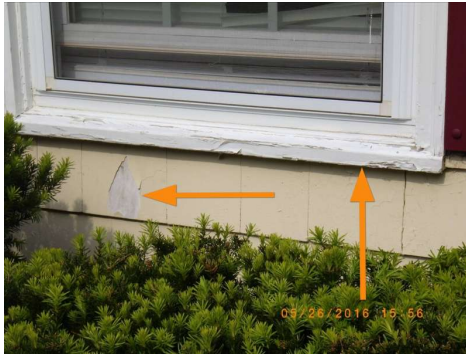
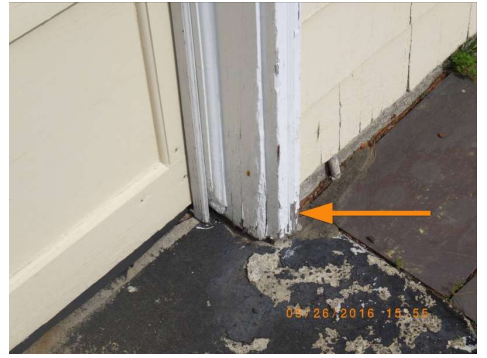
3.1.2 Siding, Flashing & Trim

PEELING PAINT

Peeling paint was observed on exterior surfaces (see photos). It is recommended that all wood exterior surfaces be kept well painted/sealed to avoid wood rot issues.

Contact a qualified painter.

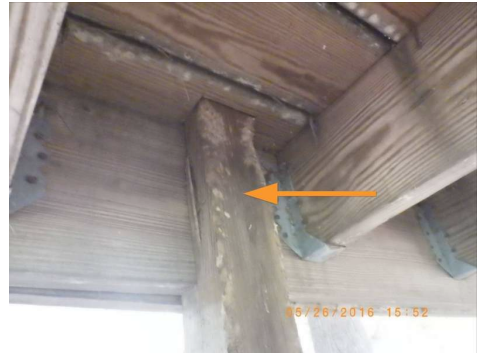
3.3.1 Decks, Balconies, Porches & Steps

DECK BEAM - IMPROPERLY SUPPORTED

Deck beam was observed to be improperly/inadequately supported. Recommend evaluation by a qualified deck contractor.

Needs bolts.

Recommendation
Contact a qualified deck contractor.

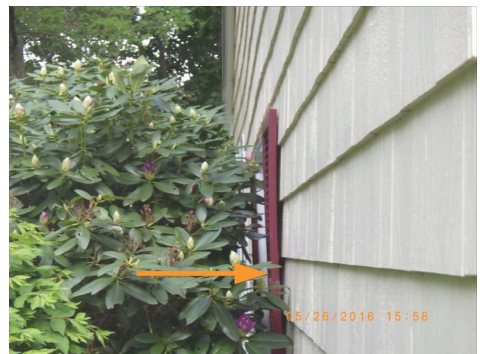
3.4.1 Vegetation, Grading, Drainage & Retaining Walls

SHRUBS TOO CLOSE/IN CONTACT

Shrub(s) were observed to be too close or in contact with the building. It is recommended that shrubs be maintained a minimum of one foot from the building to prevent wear and pest issues.

Recommendation
Contact a qualified landscaper or gardener.

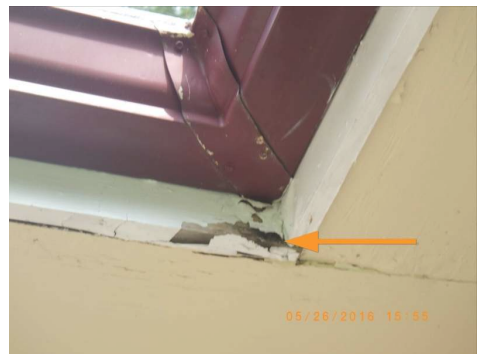
3.6.1 Eaves, Soffits & Fascia

PAINT/FINISH FAILING

The paint or finish is failing. This can lead to deterioration and rot of the material. Recommend that the areas be properly prepared and painted / finished.

Recommendation
Contact a qualified painter.

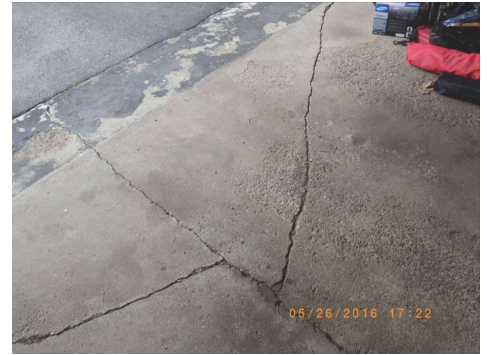
4.3.1 Floor

LARGE/DISPLACED CRACKS

Large cracks or cracks with movement of the floor slab sections were observed. Further evaluation by a qualified contractor is recommended.

Contact a qualified general contractor.

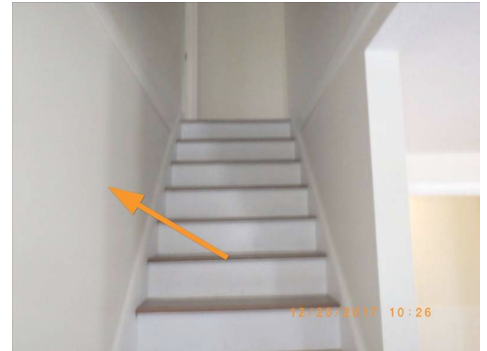
5.4.1 Steps, Stairways & Railings

NO HANDRAIL

Staircase had no handrail(s). This is a safety hazard. Recommend a qualified handyman/contractor install a graspable handrail.

Contact a qualified handyman.

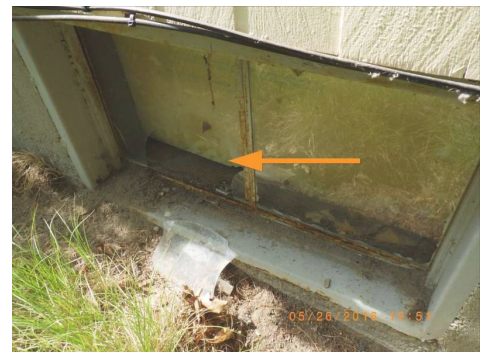
SOUTH BASEMENT

BROKEN/CRACKED WINDOWPANE

Broken/cracked windowpane(s) observed. Recommend repair by a glass professional or handyman.

Contact a qualified handyman.

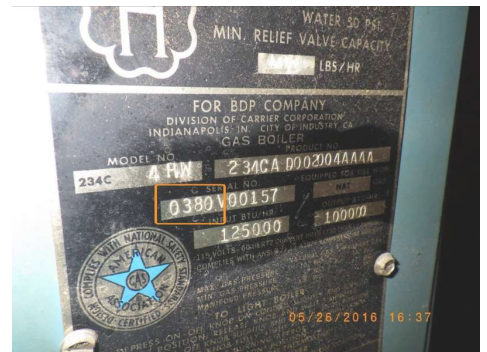
7.1.1 Equipment

AGING SYSTEM

It was noted that the heating system is at an advanced age, at or near the end of the average service life of furnaces/boilers in this region. While the system was functional at the time of the inspection, budgeting for eventual replacement should be considered. Annual servicing of the heating system is important to keep it operating efficiently and safely.

Manufactured 3rd week of 1980

Recommend monitoring.

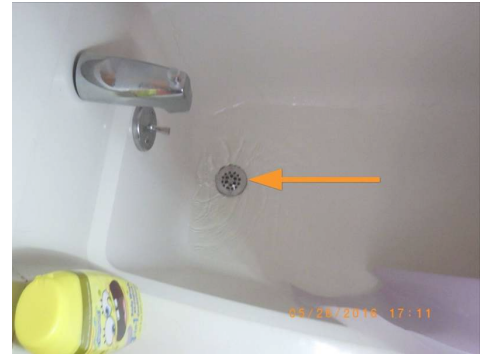
9.1.1 Drain, Waste, & Vent Systems

BATHTUB - SLOW DRAIN

Bathtub was slow to drain. This partial clog appeared to be isolated to this one fixture. Recommend the drain be cleared.

Contact a qualified plumbing contractor.

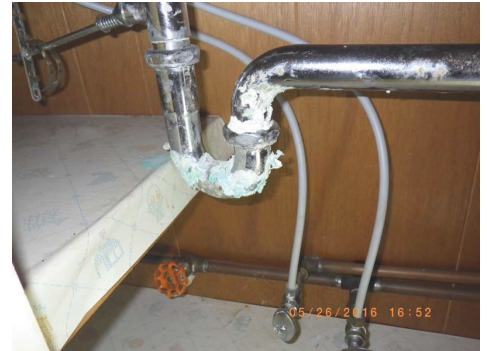
BASEMENT BATHROOM

CORROSION

Corrosion was observed on drain pipes. Recommend repair.

Contact a qualified plumbing contractor.

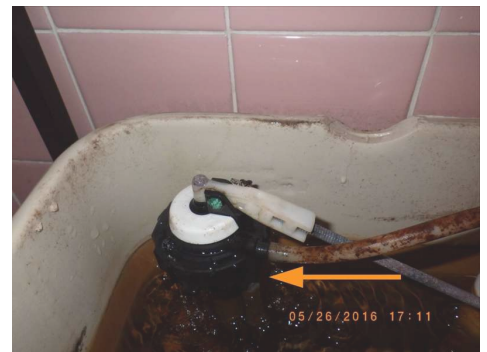
9.2.1 Water Supply, Distribution Systems & Fixtures

TOILET - FILL VALVE MALFUNCTION

Toilet tank fill valve is malfunctioning. Recommend a qualified plumber evaluate and repair/replace.

Contact a qualified plumbing contractor.

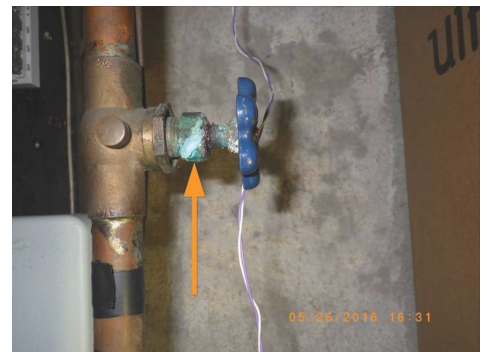
9.2.2 Water Supply, Distribution Systems & Fixtures

MAIN WATER SUPPLY VALVE LEAKING

Main water supply shut-off valve was leaking. Recommend a qualified plumber evaluate and repair.

Contact a qualified plumbing contractor.

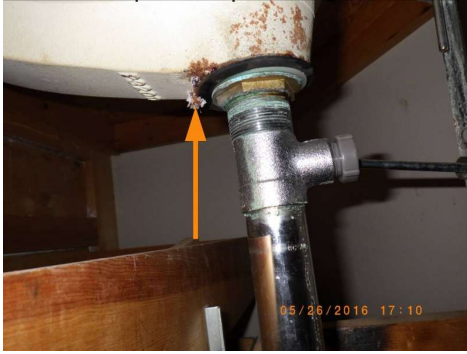
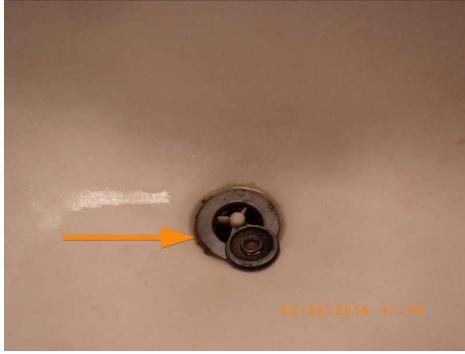
1ST FLOOR BATHROOM

CORROSION - FIXTURE

Corrosion was observed around the drain. Recommend repair/replacement by a plumbing professional.

Contact a qualified plumbing contractor.

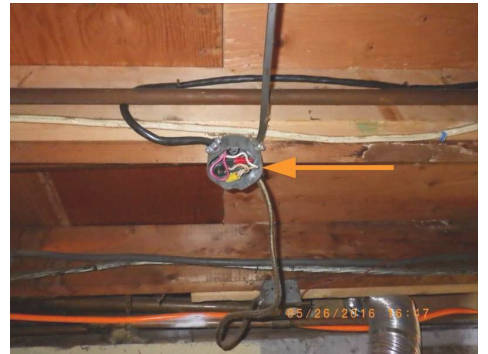
LAUNDRY

COVER PLATES MISSING

Junction box(es) missing a cover plate. This causes short and shock risk. Recommend installation of cover plates.

Contact a qualified electrical contractor.

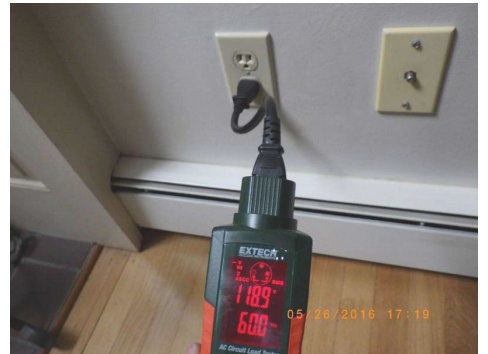
LIVING ROOM

REVERSE POLARITY

One or more receptacles have been wired with reverse polarity. This can create a shock hazard. Recommend licensed electrician evaluate & correct.

Contact a qualified electrical contractor.

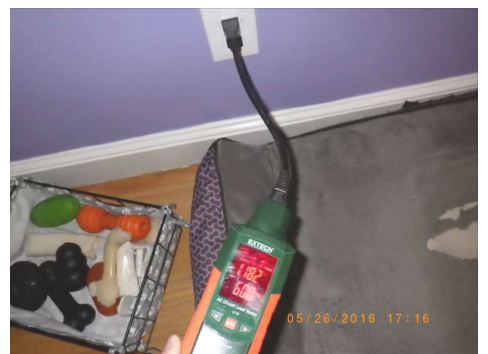
10.4.2 Lighting Fixtures, Switches & Receptacles

UNGROUND 3-WIRE RECEPTACLE

3-wire receptacle(s) were observed to be ungrounded (see photos). These receptacles should only be installed where an equipment grounding conductor is available. It is recommended that these receptacles be provided with a ground wire or changed-out with two-wire receptacles, or GFCI receptacles where appliances with three-prong power cords will be used.

Contact a qualified electrical contractor.

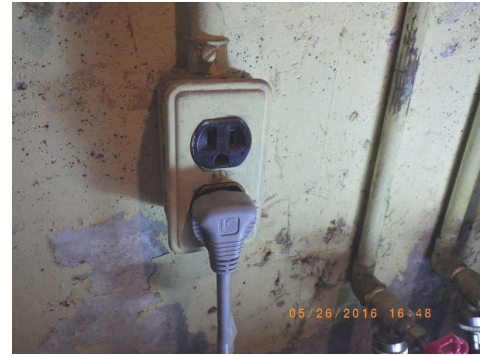
LAUNDRY

LOOSE-FITTING RECEPTACLE

Receptacle(s) found to be very loose-fitting around plug. This could allow arcing to occur. Recommend replacement.

Contact a qualified electrical contractor.

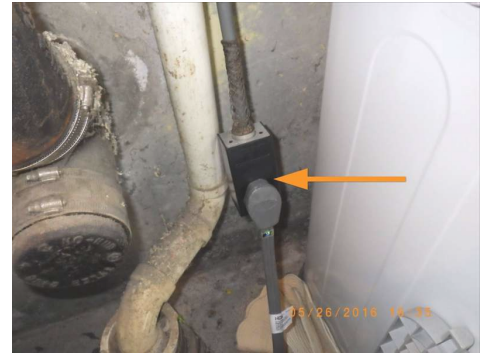
10.4.4 Lighting Fixtures, Switches & Receptacles

UNSECURED FIXTURES/WIRES

Electrical fixture(s) observed to be unsecured. Recommend correction by a licensed electrical contractor.

Contact a qualified electrical contractor.

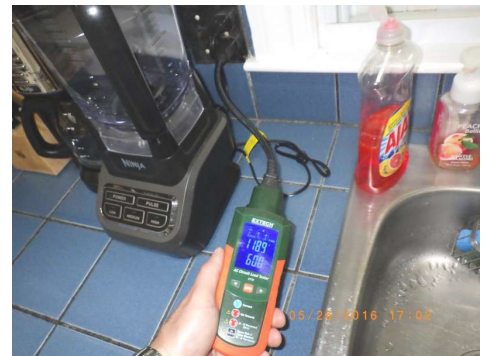
KITCHEN

NO GFCI PROTECTION INSTALLED

GFCI (Ground Fault Circuit Interrupter) protection was not present in all "wet" locations. Although not necessarily required when the home was built, today's safety standards require that receptacles installed at potentially wet locations (within six feet of plumbing fixtures, in garages, unfinished basements and outside) be GFCI-protected. Recommend upgrading where necessary by a licensed electrical contractor.

Contact a qualified electrical contractor.

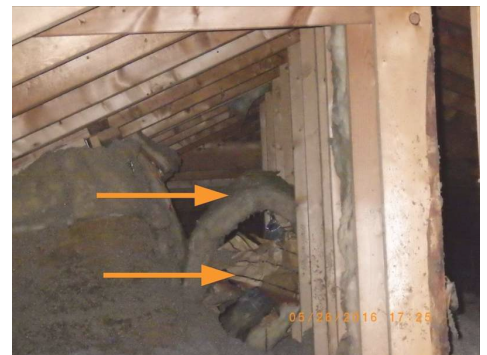
11.1.1 Attic Insulation

DISPLACED

Insulation appears to have been pulled out and/or damaged by pests. Recommend a qualified insulation contractor evaluate and restore.

Contact a qualified insulation contractor.

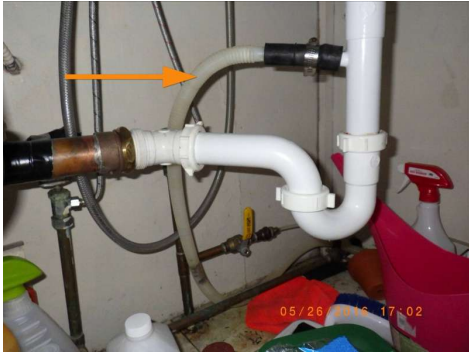
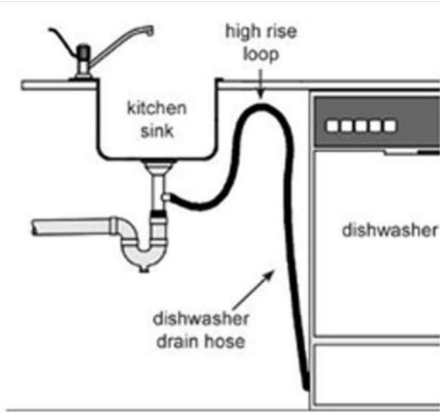
DISHWASHER DRAIN HOSE - NO HIGH LOOP/AIR GAP

No high loop or air gap was provided in the dishwasher discharge hose before connecting to the drain. This could allow waste from the sink to enter the hose. Recommend the hose be re-routed to provide a high loop.
