SUMMARY
1234 Main St. Virginia Beach VIRGINIA
23453
Buyer Name
04/06/2019 9:00AM

Clay Somers
VA HI# 3380001331, NRS
A Premier Home Inspection, LLC
989.413.6905
clay@premierinspects.com

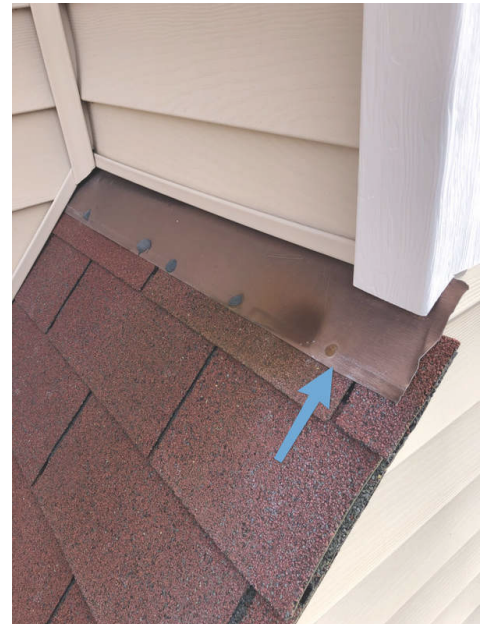
Chimney chase

NEED SEALANT(DISH, MAST, ETC)

For rooftop items such as dish antennas, guy wires or masts were missing sealant or had substandard sealant. Leaks can occur as a result. This is a conducive condition for wood-destroying organisms. Recommend that a qualified person apply approved sealant where necessary.

Contact a qualified roofing professional.

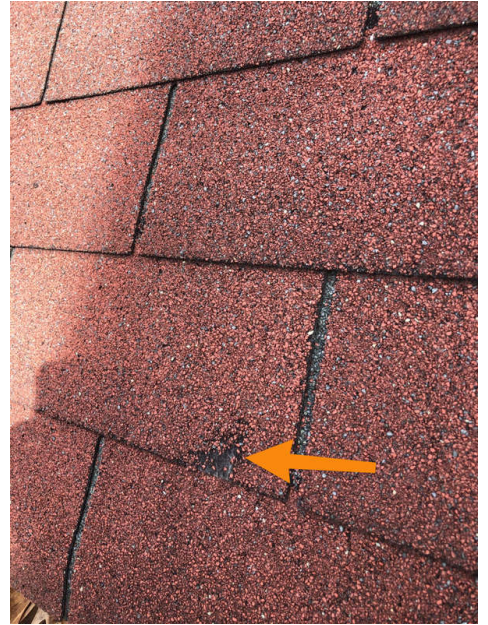
Rear garage near gutter edge

SHINGLES DAMAGED

One or more composition shingles were Damaged. Recommend that a qualified contractor repair as necessary. For example, by repairing or replacing shingles. This can reduce the life expectancy of the roofing material.

Contact a qualified roofing professional.

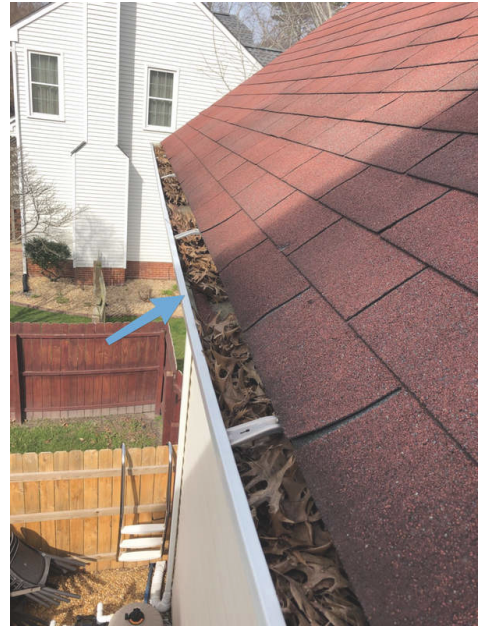
CLOGGED GUTTERS/DOWNSPOUTS

Significant amounts of debris have accumulated in one or more gutters or downspouts. Gutters can overflow and cause water to come in contact with the building exterior, or water can accumulate around the foundation. This is a conducive condition for wood-destroying organisms. Recommend cleaning gutters and downspouts now and as necessary in the future.

Recommendation
Recommended DIY Project

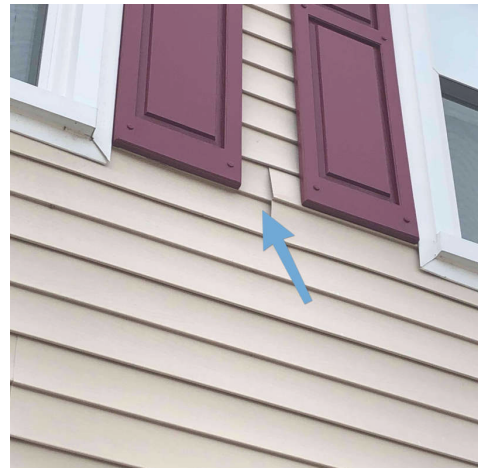
SIDING BUCKLED

The siding is buckled in one or more areas. It could be due to sun reflections or a grill that was used too closely.

Recommendation
Contact a qualified professional.

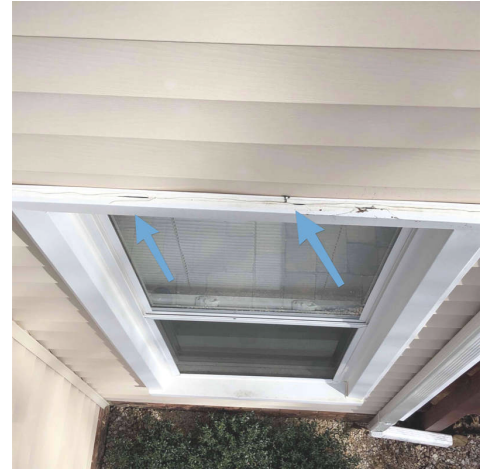
Left Rear

CAULKING

Caulk was *missing / deteriorated / substandard* in some areas. For example, *around windows / around doors / at siding butt joints / at siding-trim junctions / at wall penetrations*. Recommend that a qualified person renew or install caulk as necessary. Where gaps are wider than 1/4 inch, an appropriate material other than caulk should be used.

Recommendation
Contact a qualified handyman.

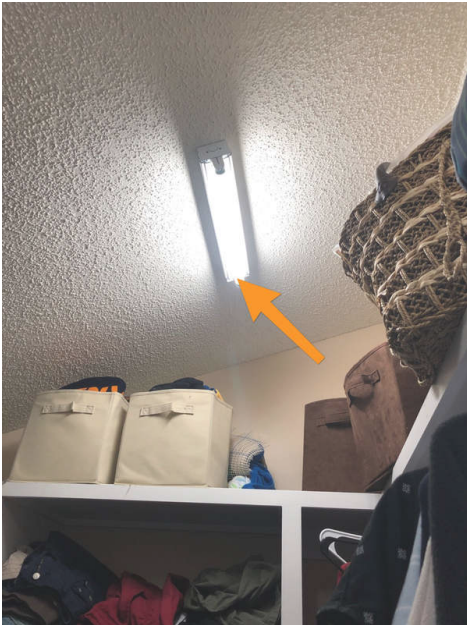
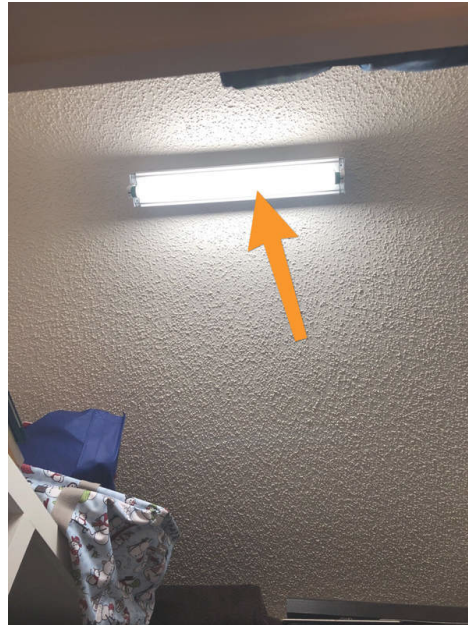
LIGHT FIXTURE-OPEN LAMP

Lamp holders or light fixtures with fully or partially exposed bulbs are installed in one or more closets. This is a safety hazard due to the risk of fire. Flammable stored items may come into contact with hot bulbs, and hot fragments from broken bulbs may fall on combustible materials. Standard building practices require closet lighting to use fluorescent light fixtures, or to use fully enclosed incandescent fixtures. Installing a compact fluorescent lamp in a lamp holder is not an acceptable practice. A qualified electrician should replace closet lights as necessary and as per standard building practices.

Recommendation
Contact a qualified electrical contractor.

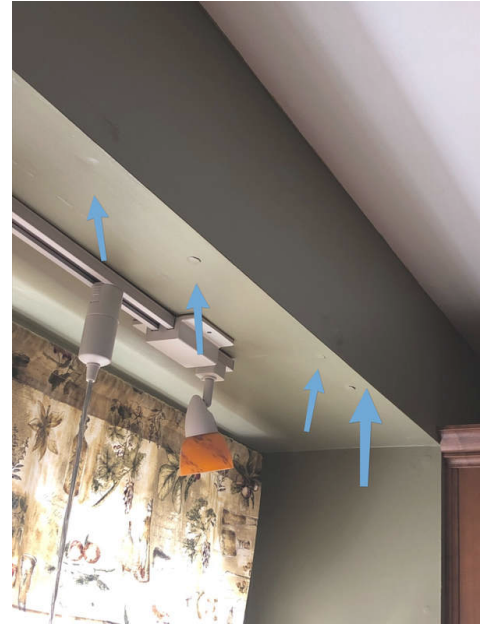
Kitchen

CEILING-MINOR CRACKS

Minor cracks were found in ceilings in one or more areas. They do not appear to be a structural concern, but the client(s) may wish to repair these for aesthetic reasons.

Recommendation
Contact a qualified drywall contractor.

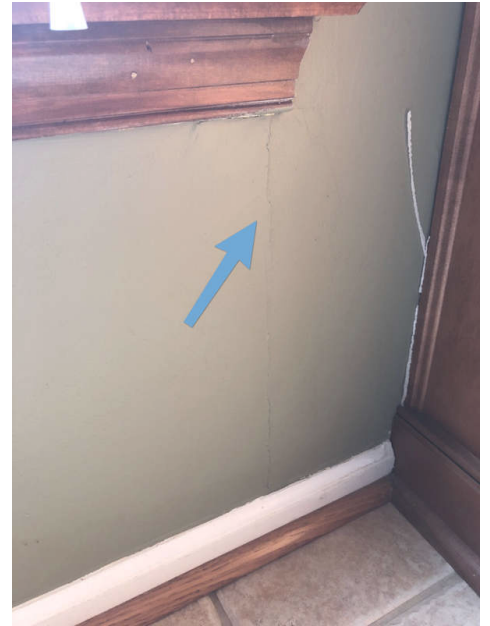
Dining Room

WALLS-MINOR CRACK

Minor cracks were found in walls in one or more areas. They do not appear to be a structural concern, but the client(s) may wish to repair these for aesthetic reasons.

Recommendation
Contact a qualified drywall contractor.

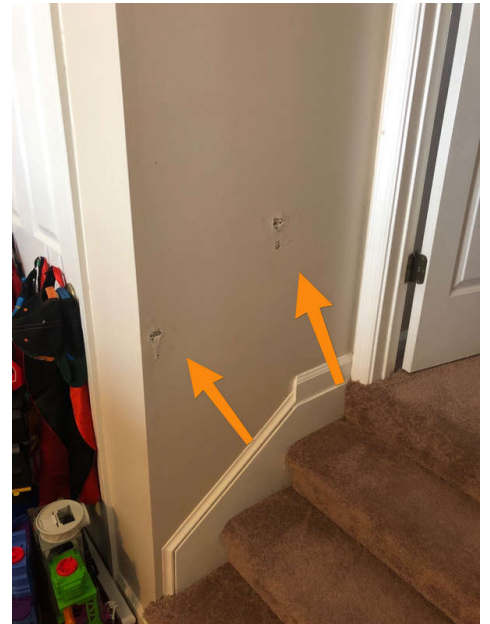
2nd floor above garage

HANDRAIL MISSING 3 STEPS

Handrails at one or more flights of stairs were missing. This is a potential fall hazard. Handrails should be installed at stairs with four or more risers or where stairs are greater than 30 inches high. Recommend that a qualified contractor install handrails where missing and per standard building practices.

Recommendation
Contact a qualified professional.

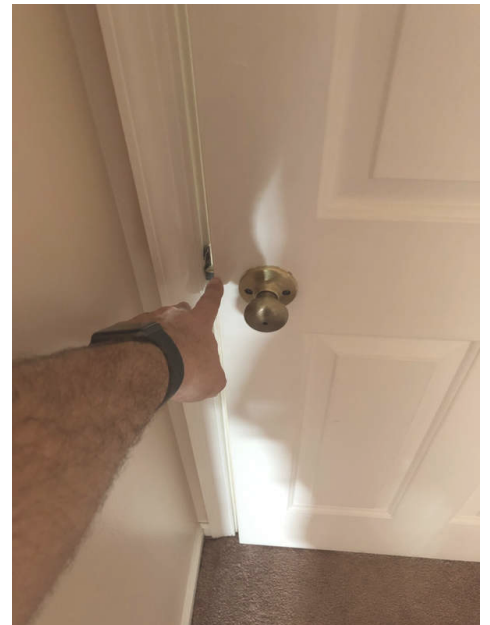
2nd floor to room over garage

DOOR-WON'T LATCH

One or more doors will not latch when closed. Repairs should be made as necessary, and by a qualified contractor if necessary. For example, aligning strike plates with latch bolts and/or replacing locksets.

Contact a qualified door repair/installation contractor.

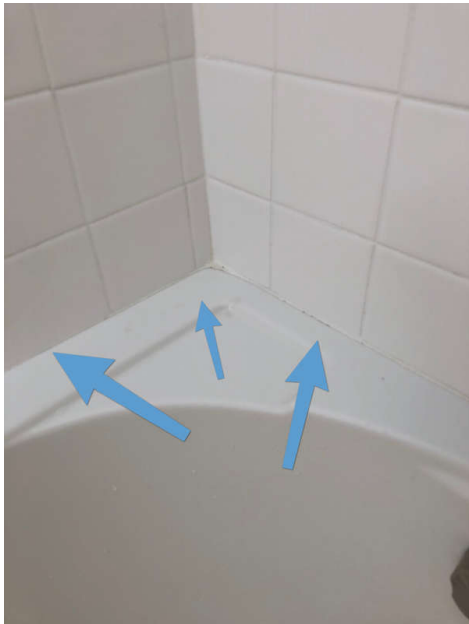
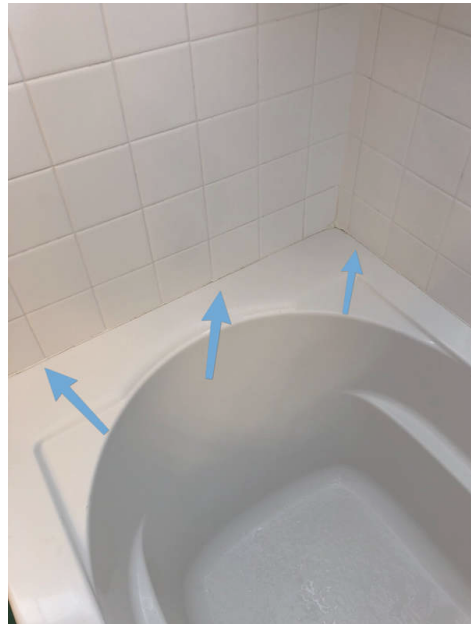
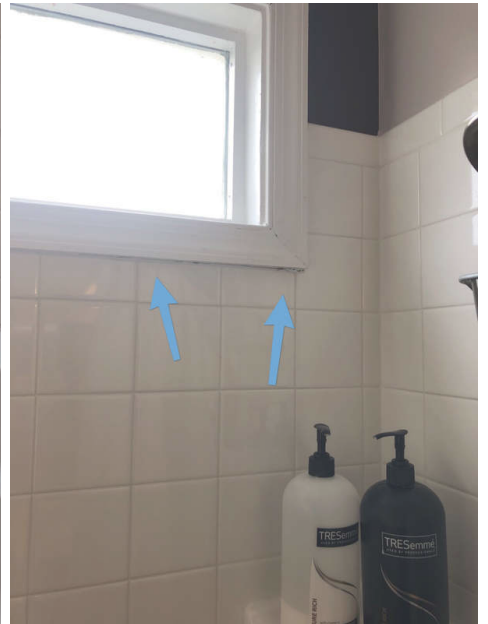
CAULKING AT SURROUND

Caulk is missing or deteriorated above one or more bathtubs, where the tub surround meets the tub. It should be replaced where deteriorated and/or applied where missing to prevent water intrusion and damage to the wall structure.

Recommended DIY Project

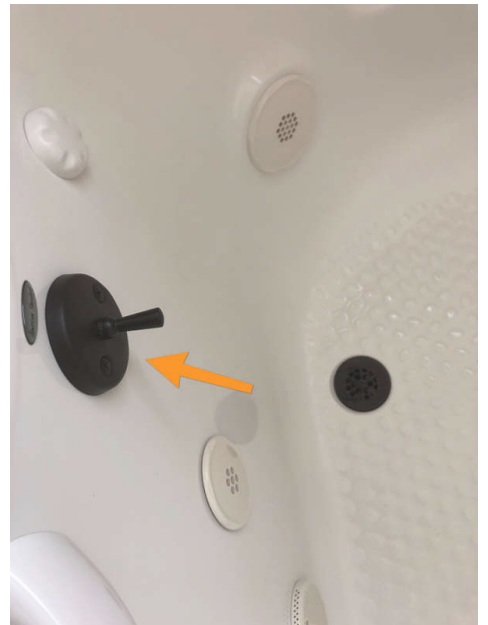
Master Bathroom

STOPPER ISSUE

The bath tub stopper mechanisms are missing, or need adjustment or repair. Stopper mechanisms should be installed where missing and/or repairs should be made so sink stoppers open and close easily.

Contact a qualified plumbing contractor.

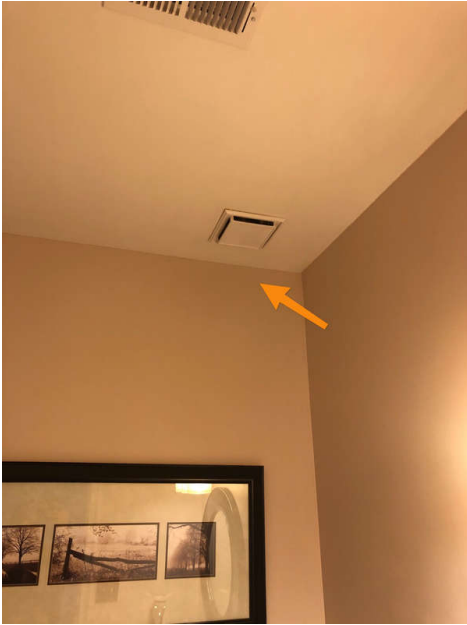
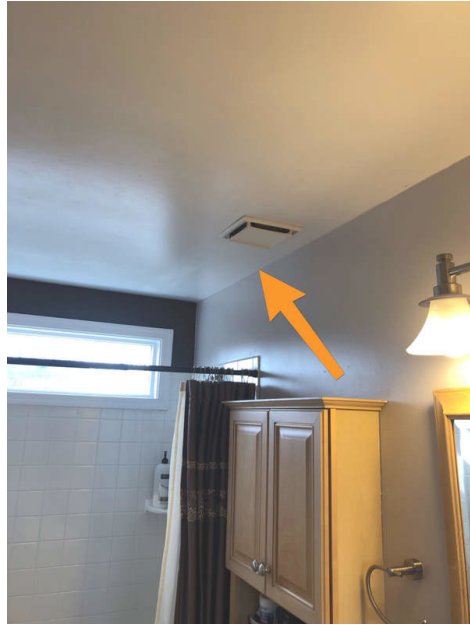
NOISY

One or more exhaust fans are noisy or vibrate excessively. A qualified contractor should evaluate and replace the fan(s) or make repairs as necessary.

Contact a qualified electrical contractor.

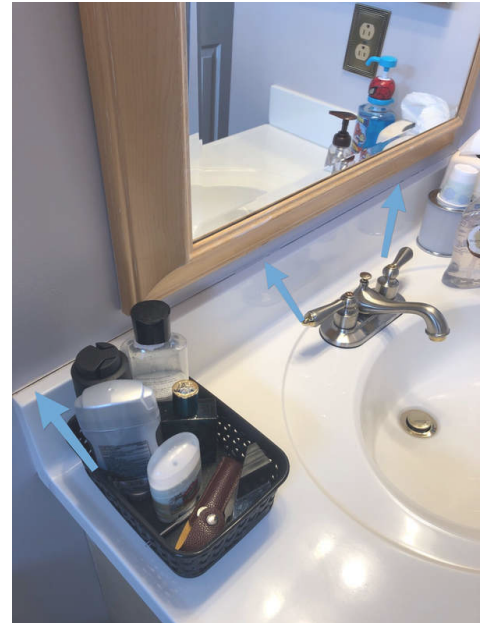
2nd floor Bathroom

BACKSPLASH SEALANT

Caulk is missing and/or deteriorated where counter tops meet back splashes in wet areas, such as around sinks. Caulk should be replaced where deteriorated and/or applied where missing to prevent water damage.

Recommended DIY Project

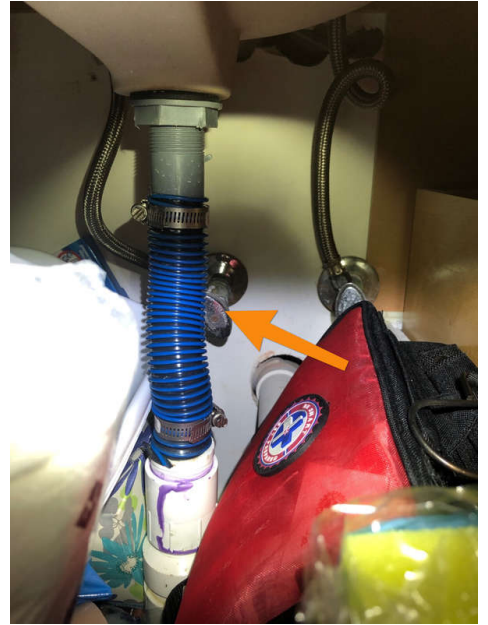
1st Floor Bathroom

SINK DRAIN FLEX PIPE

One or more sink drains use flexible drain pipe. This type of drain pipe is more likely to clog than smooth wall pipe. Recommend having a qualified plumber replace this pipe with standard plumbing components (smooth wall pipe) to prevent clogged drains.

Contact a qualified plumbing contractor.

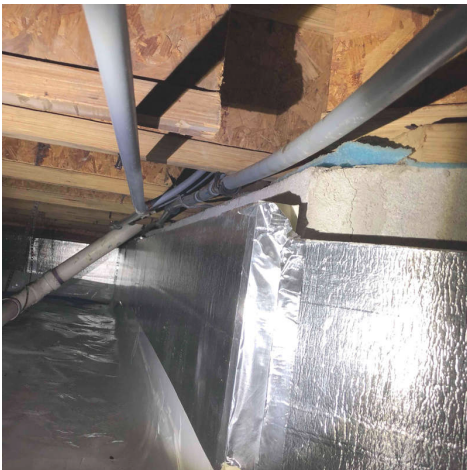
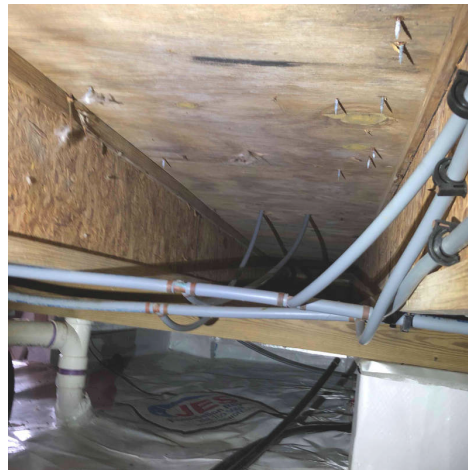
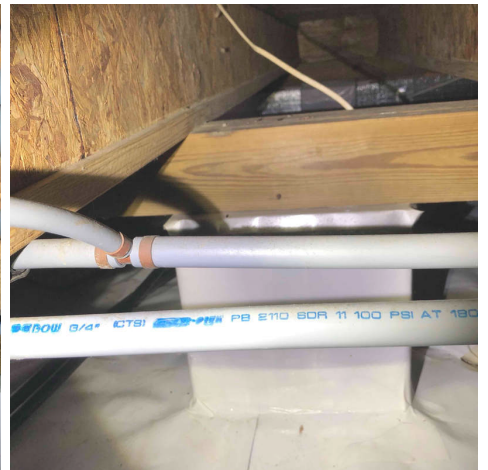
POLYBUTYLENE

What appears to be Polybutylene plastic water supply piping was found. This was commonly used in manufactured homes from the 1980s through 1995. Other plastics such as PEX or CPVC have been used since then. Some fittings with polybutylene piping have a history of failure that results in leaks. Recommend reviewing any available disclosure statements for comments on leaks in the water supply system. Much of the water supply piping is typically concealed in walls, floors and/or ceilings, and the inspector does not guarantee that leaks don't exist as part of this inspection. If concerned, have a qualified plumber review this system and make repairs if necessary.

Contact a qualified plumbing contractor.

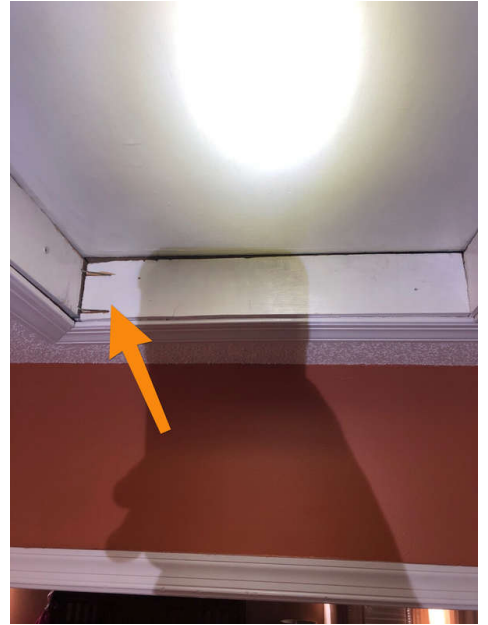
ACCESS COVER DAMAGE

The drywall access cover is damaged. The exit to cover should be replaced as a repair is not adequate. The cover was repaired once before.

Contact a qualified professional.

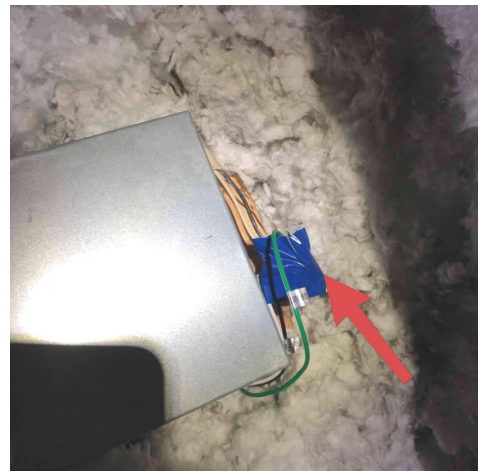
SPLICES NOT IN BOX

Wire splices are exposed due to not being contained in a covered junction box. This is a safety hazard due to the risk of shock and fire. A qualified electrician should evaluate and make repairs as necessary. For example, install securely mounted junction boxes with cover plates where needed to contain wiring splices.

Contact a qualified electrical contractor.

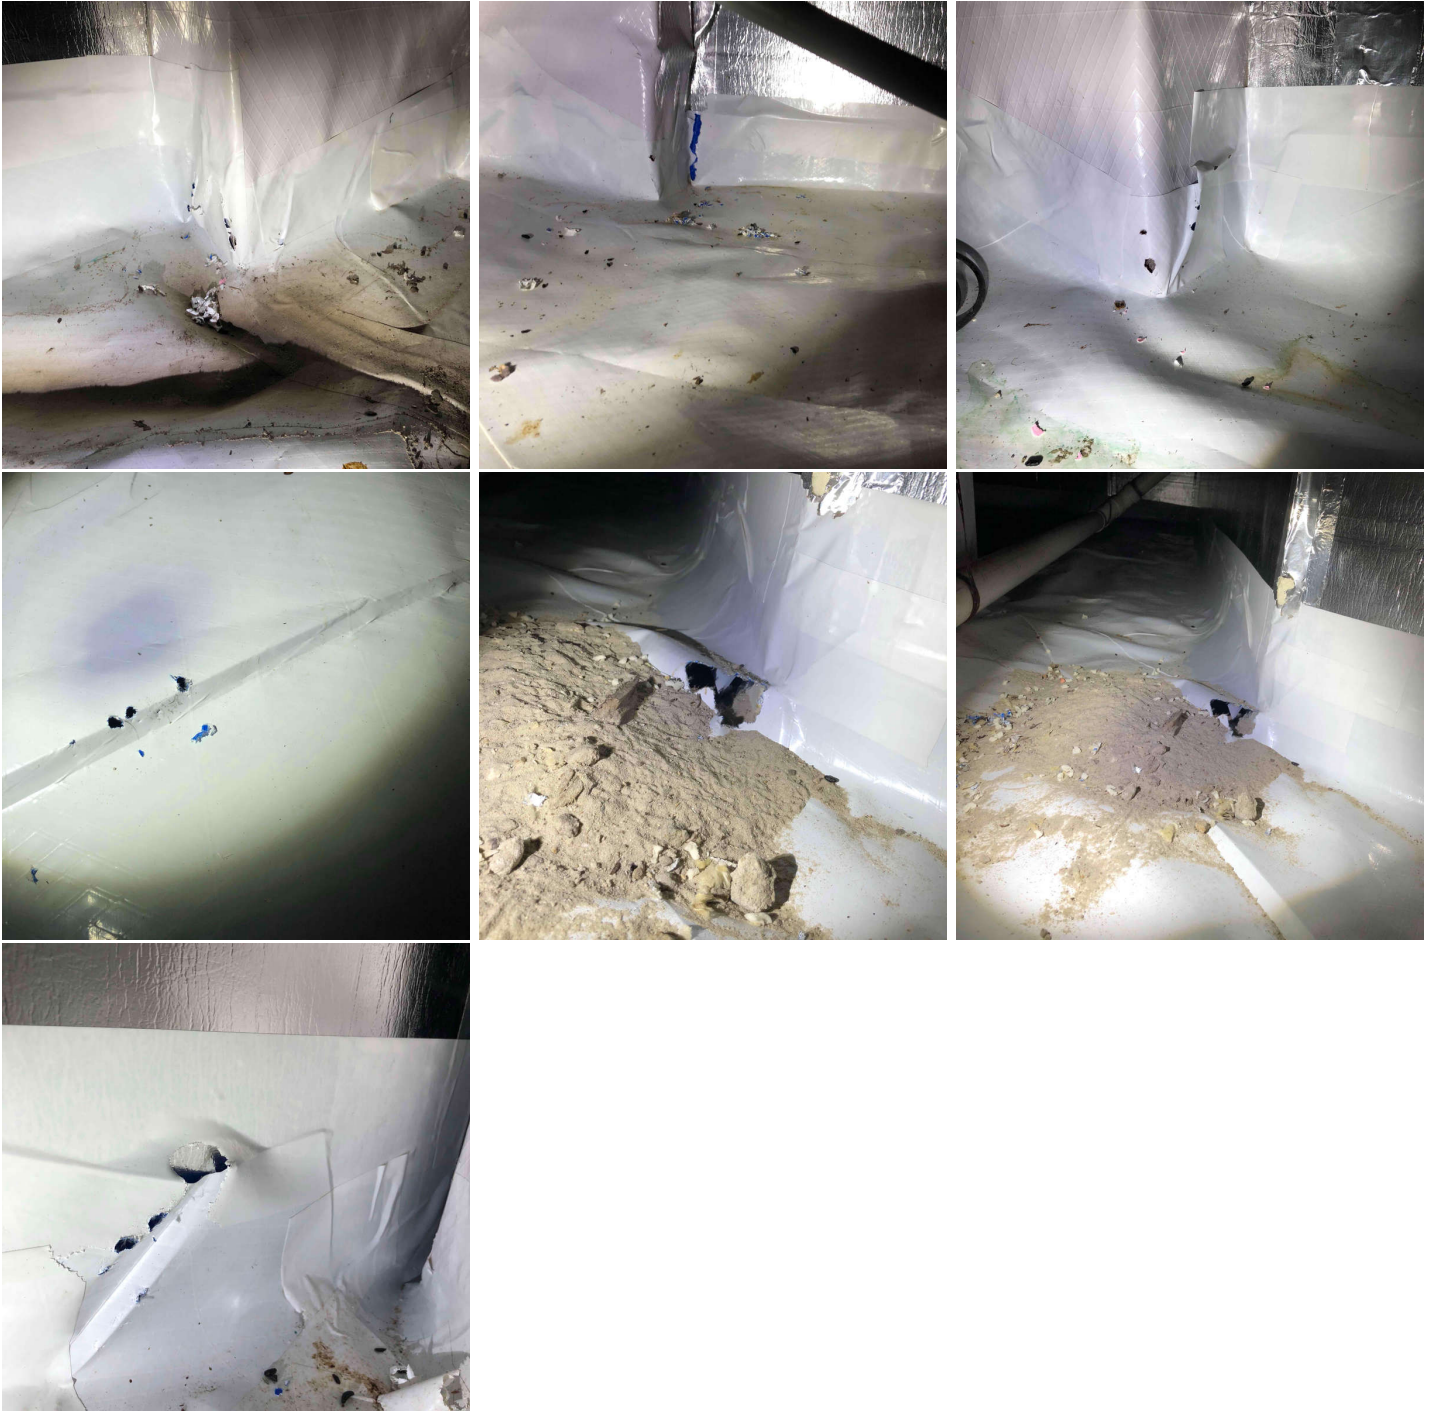
PEST EVIDENCE

Evidence of rodent infestation was found in the form of *feces / urine stains / traps / poison / dead rodents / damaged insulation* in the *attic / crawl space / basement / garage / interior rooms* . Consult with the property owner about this. A qualified person should make repairs to seal openings in the structure, set traps, and clean rodent waste as necessary.

Contact a qualified professional.

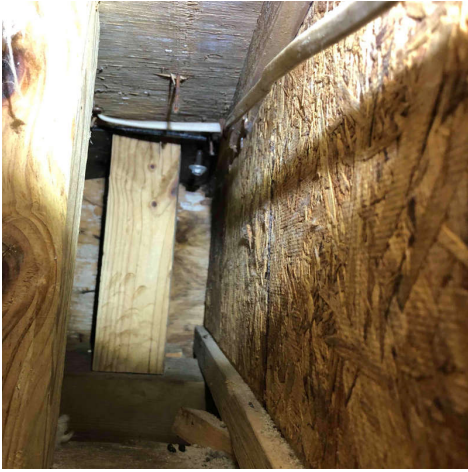
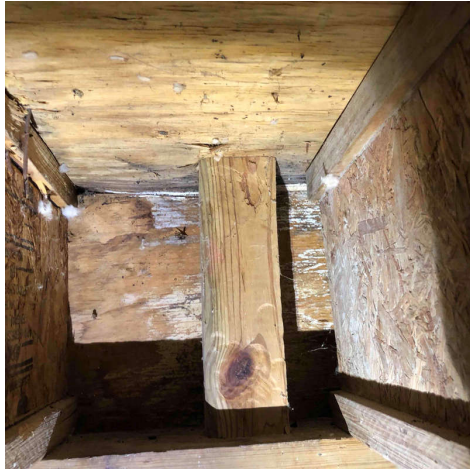
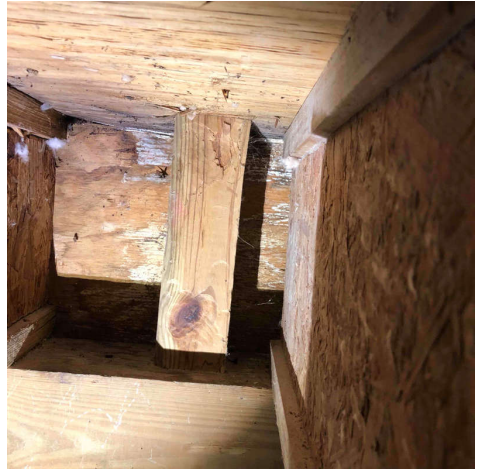
PRIOR MOISTURE ON JOISTS

There is staining/film/fungal growth/ microbial growth on a number of floor joists throughout the crawlspace. Areas of minor wood rot have been noted in separate comment. Recommend treatment to crawlspace wood structures to prevent further deterioration of floor/subfloor/ substructure.

Contact a qualified professional.
