SUMMARY

1234 Main St. Raynham MA 02767

Buyer Name
06/03/2019 9:00AM

Chuck Striler
Massachusetts License 726-1HI
Striler Home Inspections, Inc.
508-813-4636
chuck@strilerhi.com

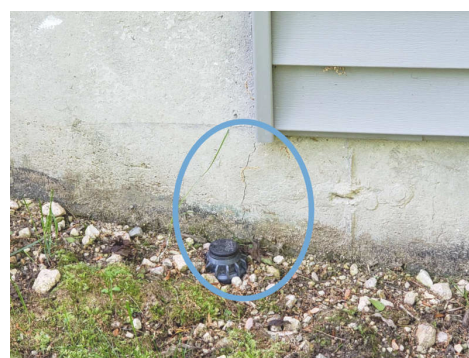
Right

5.15.1 Foundation (Exterior)

SHRINKAGE CRACK

One or more walls have hairline cracks. They appear to be shrinkage cracks. Shrinkage cracks are caused by the evaporation of water in the mix. This is a normal condition. As the concrete cures and dries it "shrinks" leaving hairline cracks. Seventy-five percent of all shrinkage cracks appear in the first year. Monitor and repair if needed.

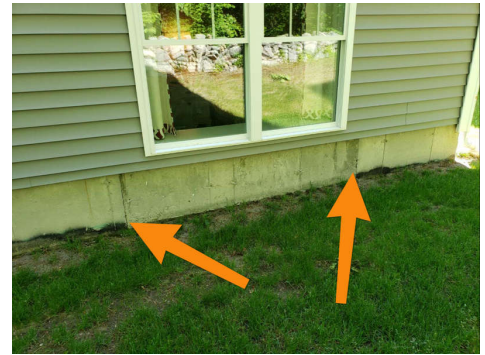
Rear

5.15.2 Foundation (Exterior)

COLD POUR SEAM

A cold pour joint was noted. Cold pour joints occur because of the time delay between subsequent "pours" into the foundation forms.

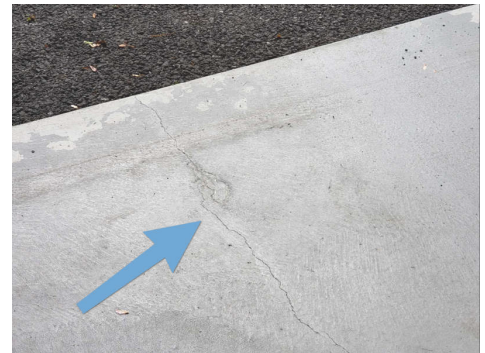
7.2.1 Floor

CRACKS (TYPICAL)

Typical cracks were noted. Seal as needed.

Contact a handyman or DIY project

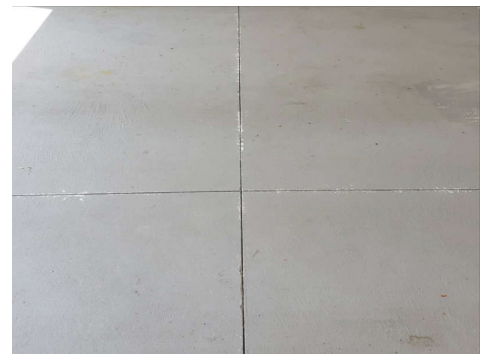
7.2.2 Floor

EXPANSION CRACKS

"Expansion Cracks" were noted in the floor. This is an intentional building method designed to limit the anticipated cracking that occurs in concrete floors and is not a structural concern.

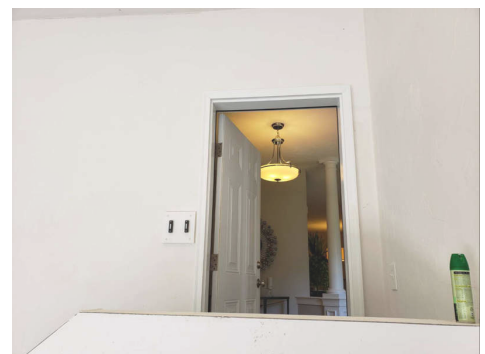
7.8.1 Occupant Door (From Garage To Home)

NOT SELF-CLOSING

The door from the garage to the home should have self-closing hinges to help prevent the spread of a fire to living space. Recommend installing self-closing hinges.

Contact a qualified handyman.

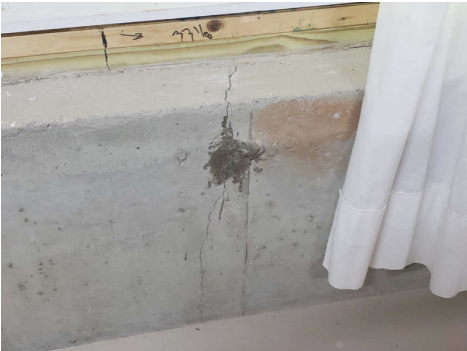
Rear

8.2.1 Interior Foundation

POURED CONCRETE (-1/4 INCH CRACK)

One or more cracks less than 1/4 inch were noted in the foundation walls. Consider sealing and monitoring for future cracking.

Recommendation
Contact a handyman or DIY project

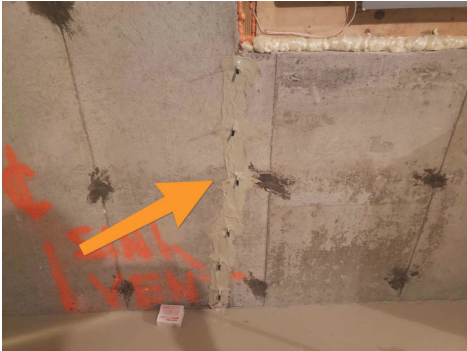
8.2.2 Interior Foundation
FOUNDATION (CRACKS REPAIRED)

Epoxy repairs have been made, consult owner for warranty.

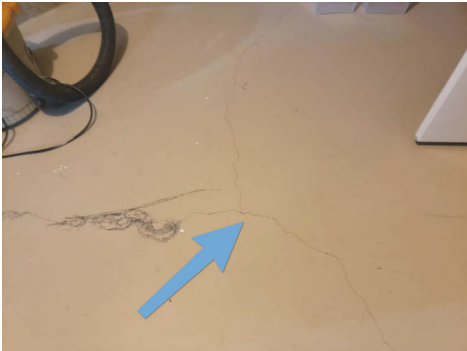
8.4.1 Floor
COMMON CRACKS

Common cracks were visible in the basement floor. This type of cracking can have several causes

- concrete shrinkage, which is a normal part of the concrete curing process and not a structural concern
- post-construction settling due to incomplete compaction of the soil beneath the slab during construction. This also is not an unusual condition and typically would not continue.
- heaving of the soil due to the presence of expansive soils.

Determining the cause of cracking lies beyond the scope of the General Home Inspection. Consider repairing cracks as needed and monitor.

Contact a handyman or DIY project

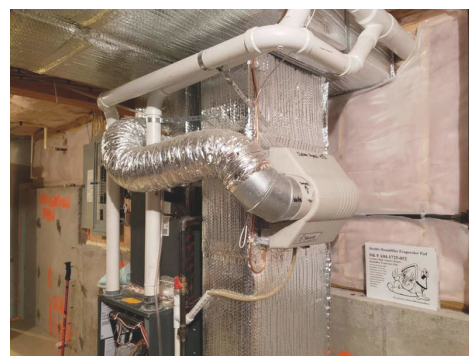
10.10.1 Duct System

SHEET METAL (HUMIDIFIER INSTALLED)

The ductwork has a humidifier installed in the plenum. Humidifiers can increase interior home comfort in the winter if maintained properly. If no maintenance information is available from the homeowner, then we recommend checking online for information about your particular model and it's operation.

Recommended DIY Project

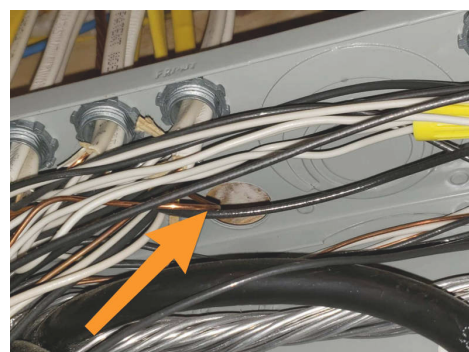
12.3.1 Panel Enclosure & Cover

PANEL ENCLOSURE (MISSING KO)

Unfilled holes or knockouts in the main electrical service panel were noted. A knockout seal is recommended.

Contact a qualified electrical contractor.

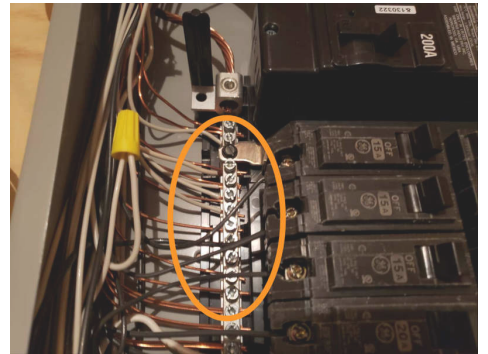
12.4.2 Interior Wiring In Panel

NEUTRAL BAR (NEUTRAL AND GROUND, SAME SCREW)

Older wiring technique. One or more neutral (white) wires and ground (bare copper) wires were attached under the same screw in the panel. This is not up to current standards. Consider updating.

Contact a qualified electrical contractor.

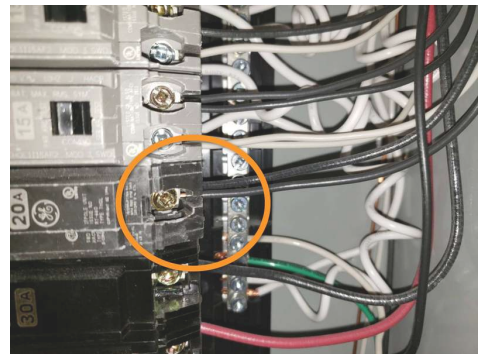
12.4.3 Interior Wiring In Panel

BREAKER (MULTI TAP)

Two or more wires were connected to a breaker designed for only one wire. This is known as a "multi-tap" and is a defective condition. Further evaluation and or repair is recommended.

Contact a qualified electrical contractor.

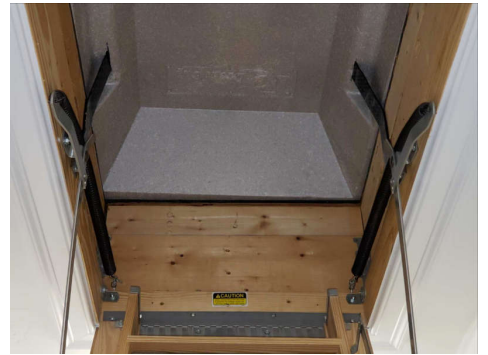
13.1.1 Access

SEALED

The cover to the attic hatch was physically sealed and we were unable to remove it without causing damage. No comment on any items related to the attic or ventilation is possible.

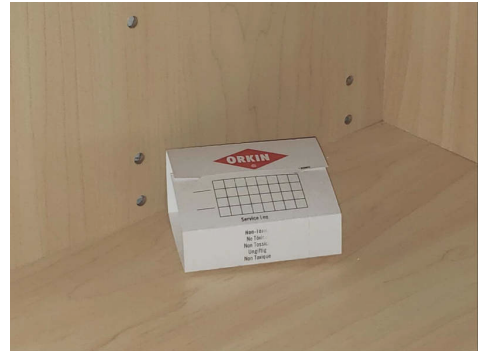
18.1.1 Visual Signs

TRAPS

One or more "mouse traps" were noted.

Check with the current owner regarding the history of rodents and treatment.

Contact a qualified pest control specialist.
