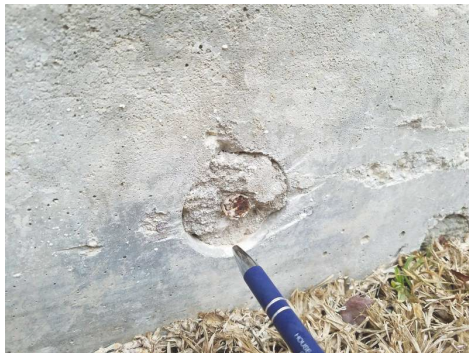
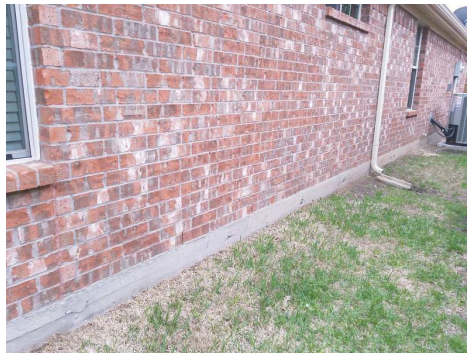
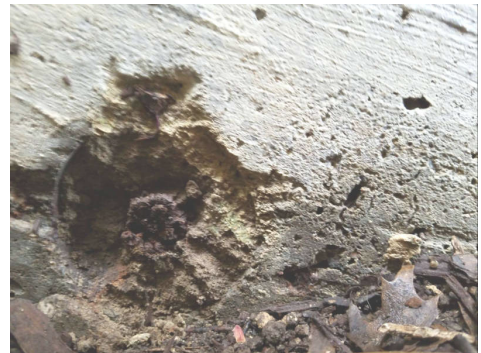
EXPOSED CABLE ENDS

MULTIPLE PLACES ALONG THE FOUNDATION INCLUDING - RIGHT FRONT WALL BEHIND BUSHES IN FLOWER BED.; RIGHT

One or more of the post tension cable ends are exposed and need to be properly sealed.

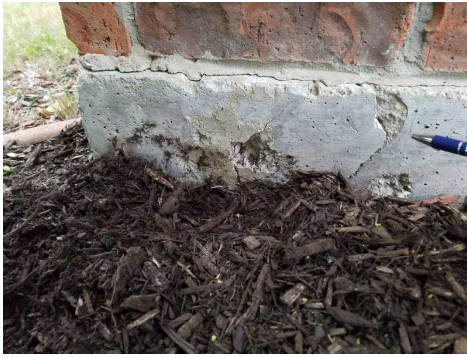
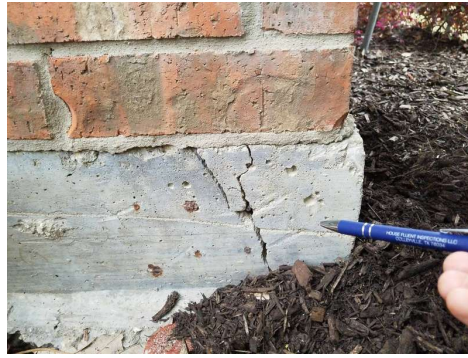
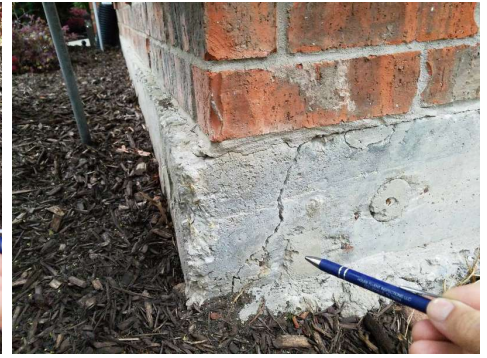
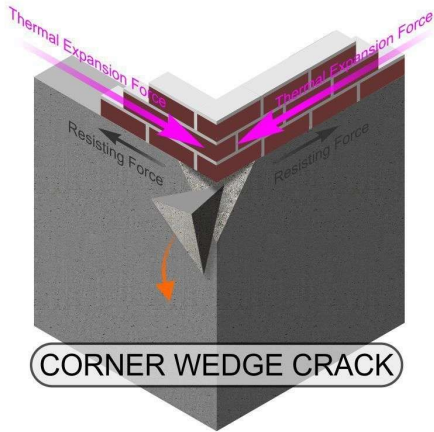
CORNER WEDGE CRACK

RIGHT FRONT WALL IN FLOWER BED

Corner Popping (A.K.A. Corner Wedge Cracking) is extremely common and is almost always cosmetic in nature. This is typically an easily correctable condition and should be remedied.

Brick, especially in the Texas summers, expands due to thermal expansion and water absorption. A slab foundation, is less porous than the brick, is mostly underground and has much less exposure. The stress develops is between the brick mortar below the bottom bricks and the top of the concrete. This puts the brick in compression and the concrete foundation in tension. Concrete is very weak in tension but brick is very strong in compression, the concrete loses and the corner cracks.

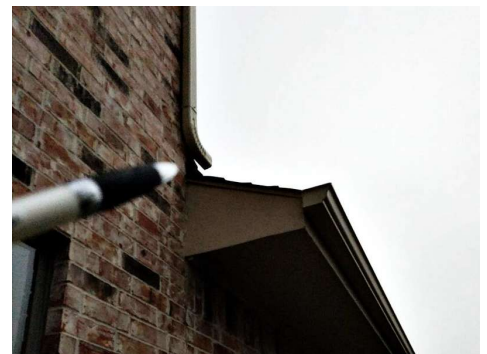
DOWNSPOUT DISCHARGE ONTO ROOF

MULTIPLE

Downspout(s) that discharge onto the roof should be extended to discharge directly into the gutters below. This condition, if left unattended, can result in premature deterioration of the roofing under the end of the downspout.

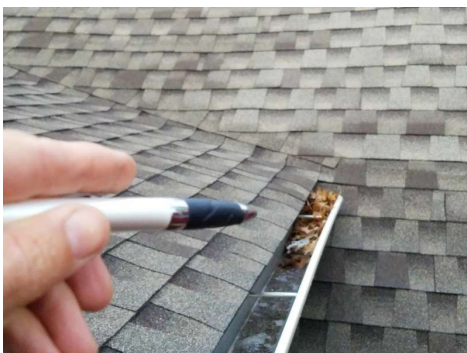
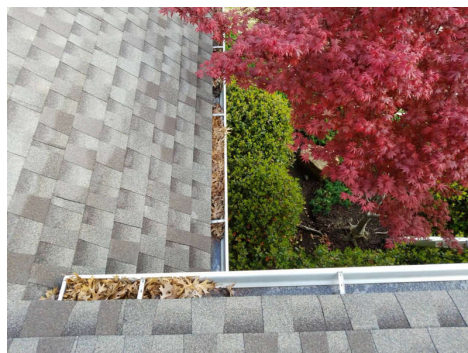
GUTTERS CLOGGED

The gutters are clogged and require a simple cleaning to avoid spilling roof runoff around the building. This is a common maintenance concern, which if not corrected, has potential to become a source of water entry or water damage. In addition, gutters that overflow can allow water to pool or pond near the foundation which could lead to result in structural issues over time.

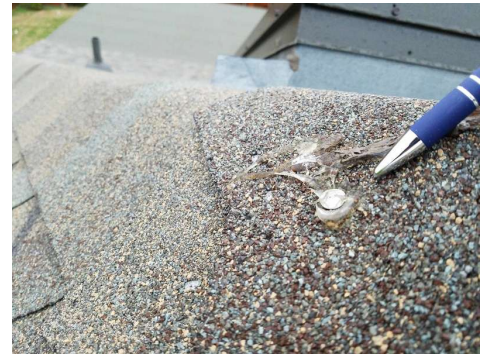
NAIL HEADS EXPOSED

Under-driven or exposed nails were found in one or more roof coverings. While this is often not an immediate threat for water penetration, it can lead to further, more rapid degradation to the roof covering material at these locations. Under-driven or exposed nails should be sealed or otherwise repaired..

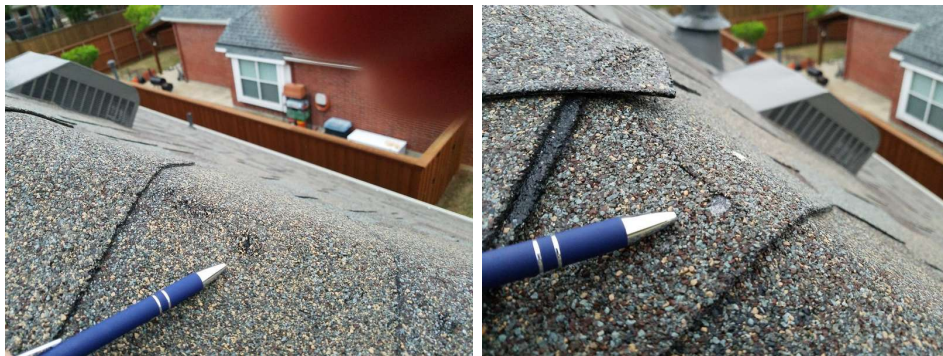
GENERAL DAMAGE TO COVERINGS

Roof coverings exhibited minor general damage that could affect performance over time.

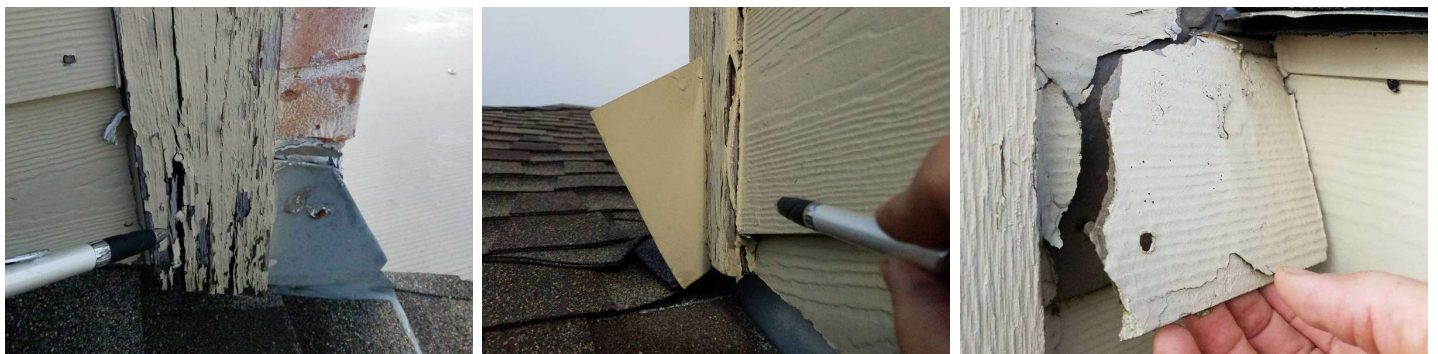
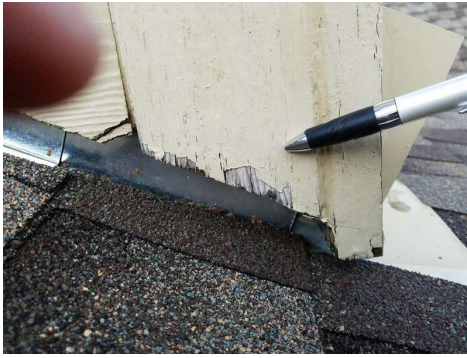
EXTERIOR WALLS - SIDING DETERIORATION

LEFT WALL OF DORMER

Deterioration of the siding was observed. Improved roof flashing and guttering to properly shed water from the roof surface can reduce the impact of this type of deterioration. Once repaired, monitoring and regular maintenance are recommended to maintain the integrity of the siding. When the roof covering material is due for replacement it is recommended that the roofers understand where these vulnerable points are and install flashing to help protect them.

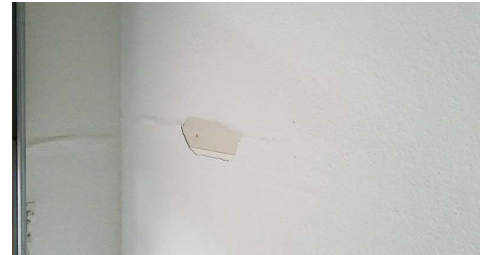
WALLS TAPE AND BED JOINT CRACK

A joint crack was observed on the wall. Temperature swings in the summer and winter months can cause expansion and contraction of building materials which at times can be observed as a crack in the joint between two pieces of sheetrock.

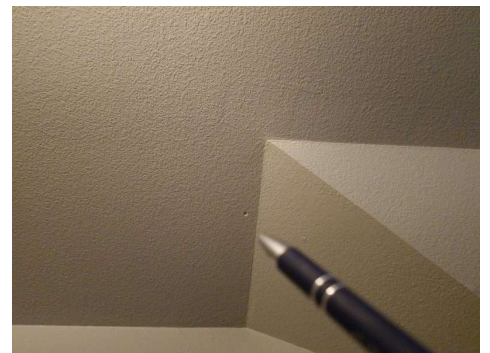
CEILING NAIL POP

As the wood framing members such as ceiling joists shrink and pull away from the drywall, at times, the nail will not be pulled with it. The nail head instead will remain flush with the drywall surface. Because this occurs on a ceiling, the remainder of the sheetrock moves, however the nail will remain stationary. The head of the nail will appear to **pop** out, although, in fact, its not moving, its the wallboard being pushed back against the framing members in the ceiling, which creates the nail pop effect.

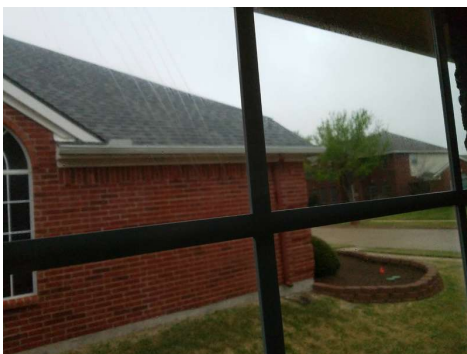
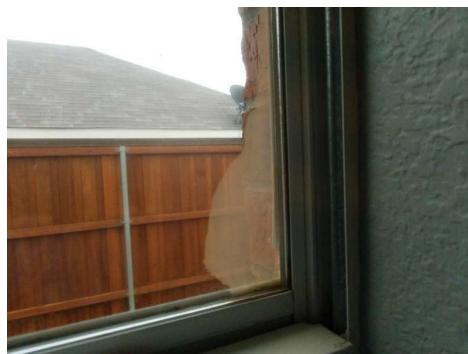
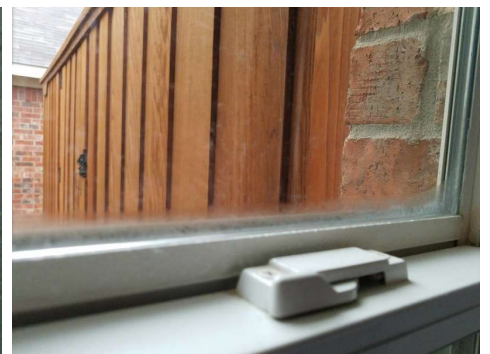
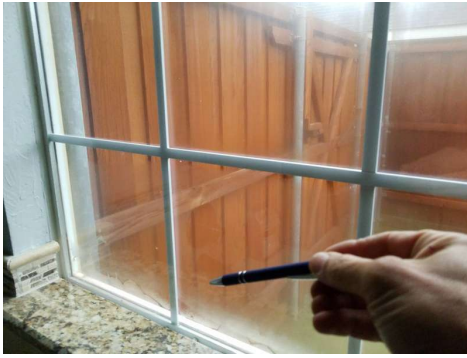
LOST SEAL

The window(s) have lost their seal. This has resulted in condensation developing between the panes of glass and can cause the glass to loose its insulating properties. The glass should be repaired or replaced.

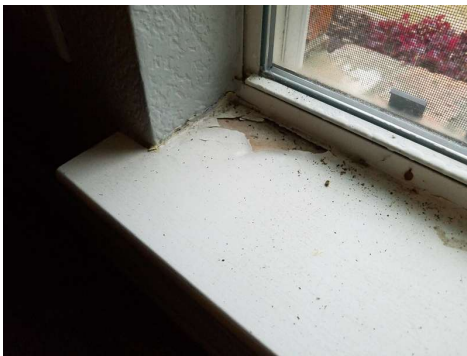
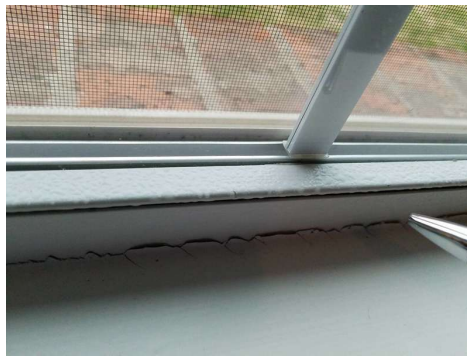
WINDOW CONDENSATION

The windows show evidence of condensation. This is not a major concern. Controlling indoor humidity levels and/or improving window efficiency (if needed) would help to control this condition.

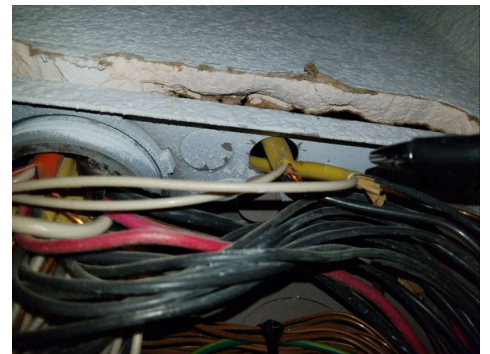
CABLE CLAMPS NEEDED

Cable clamps (sometimes referred to as bushings or grommets) are required where wiring passes into the main distribution panel. Cable clamps serve to protect the wiring from the metal edges of the panel openings.

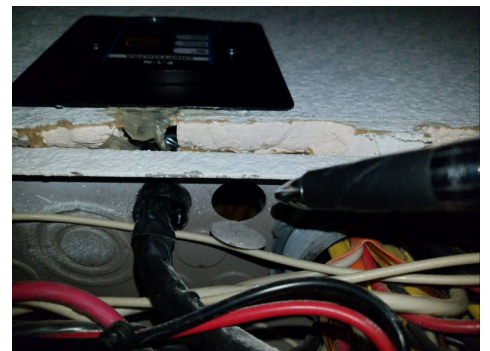
OPENINGS IN PANEL

Any openings in the main panel should be covered.

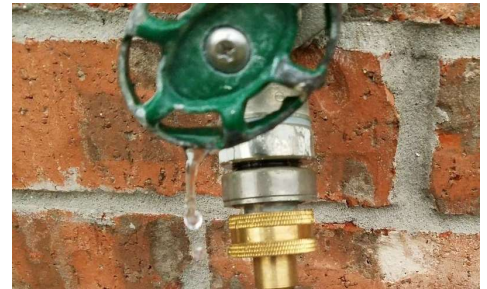
HOSE BIB LEAKS

The hose bib is leaking at the handle when turned on and should be repaired.

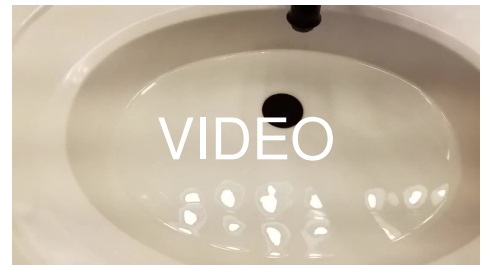
POOR/SLOW DRAINAGE

DOWNSTAIRS MASTER BATHROOM. VANITY SINK ON THE LEFT

Poor/slow drainage was observed at time of inspection. Recommend a qualified plumber evaluate and repair.

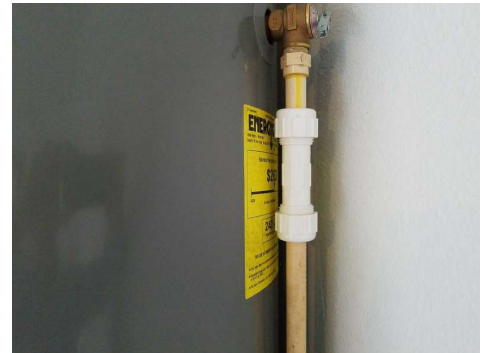
DISCHARGE TUBE NEEDS IMPROVEMENT

The discharge piping serving the Temperature and Pressure Relief (TPR) Valve for the water heater has a questionable fitting, this should be replaced with an appropriate fitting.

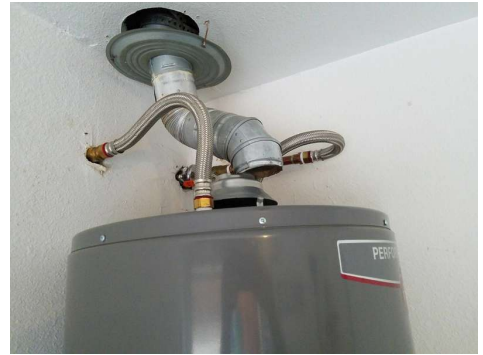
VENT PIPE CONNECTIONS

For enhanced safety, it is recommended that the connections of the water heater venting system be improved.

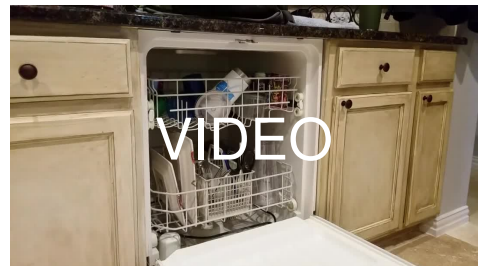
DISHWASHER POORLY ATTACHED

The dishwasher should be properly secured.

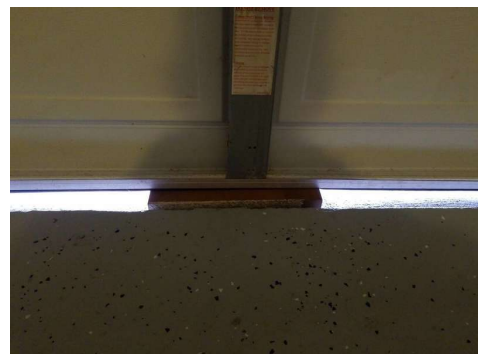
OPENER AUTO REVERSE DEFECTIVE

The garage door opener did not automatically reverse under resistance to closing. There is a serious risk of injury, particularly to children, under this condition. Improvement may be as simple as adjusting the sensitivity control on the opener. This should be repaired immediately.
