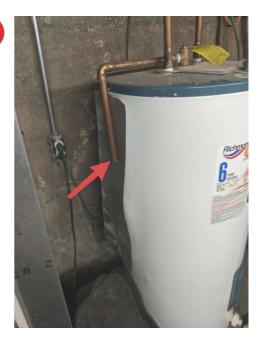
TPR DISCHARGE PIPE

The TPR discharge pipe was missing or had an improper installation. This is a potential safety hazard due to the risk of scalding if someone is standing next to the water heater when the valve opens. A qualified plumber should install a drain line as per standard building practices.

Recommendation Contact a handyman or DIY project

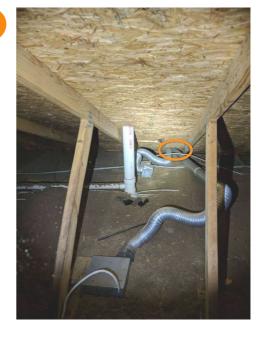
BATHROOM VENTS INTO ATTIC

Bathroom fan vented into the attic, which can cause moisture and mold. Recommend a qualified contractor property install exhaust to terminate to the exterior.

Contact a qualified professional.
