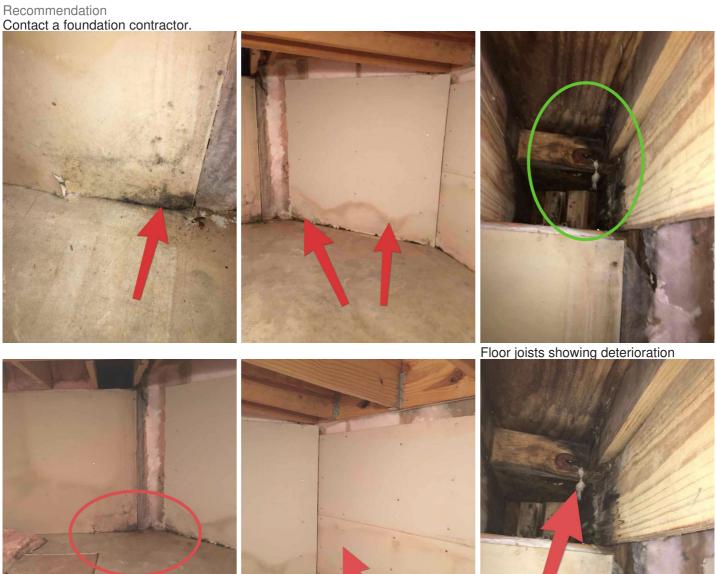
UNDER STAIRS STORAGE AREA

WATER PENETRATION

Crawl/storage space under the interior staircase show signs of water penetration.
