2.1.1 Siding, Flashing & Trim

DAMAGED SIDING

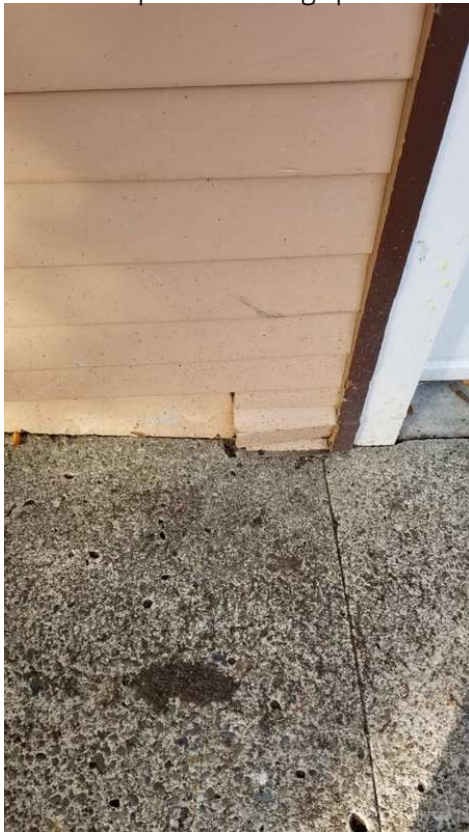
Front

Siding appears to be damaged numerous locations budget for repairs. I recommend evaluation and repair as needed.

Recommendation
Contact a qualified siding specialist.

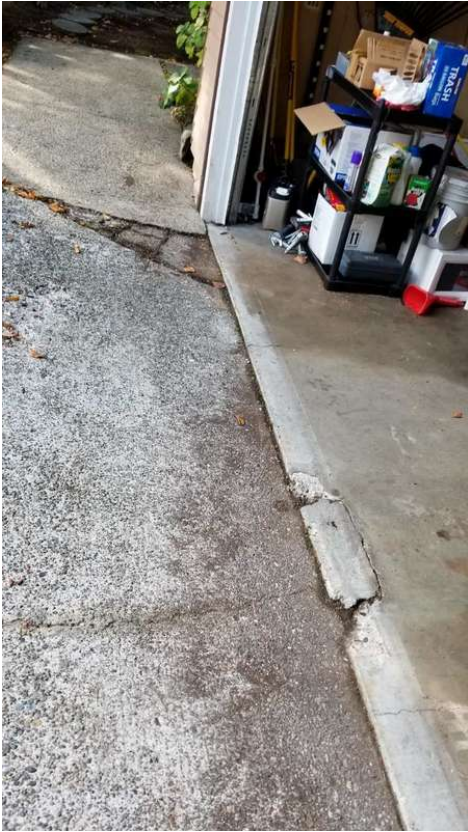
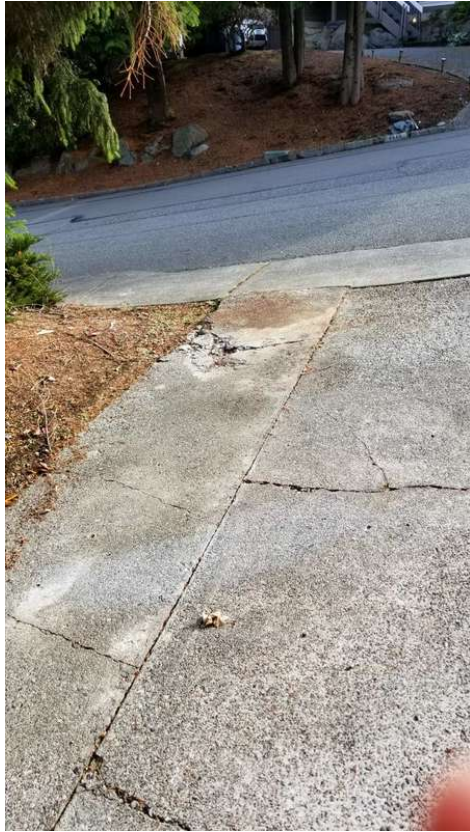
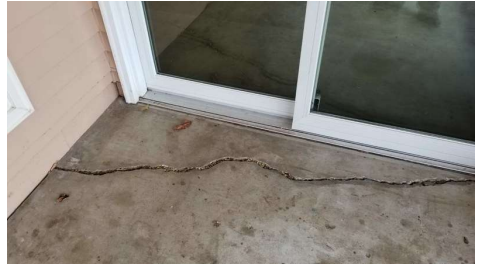
DRIVEWAY TRIP HAZARD

Trip hazards observed. Patch or repair recommended.

Recommendation
Recommended DIY Project

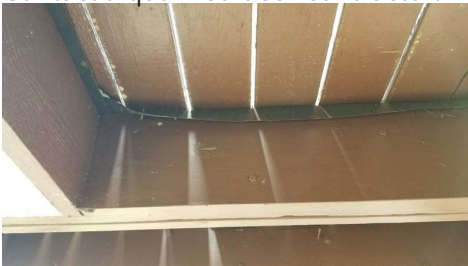
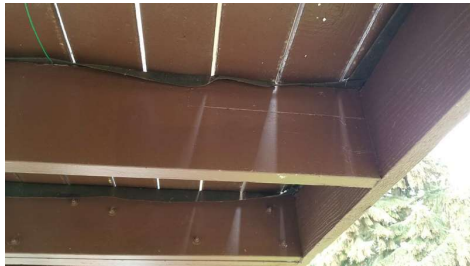
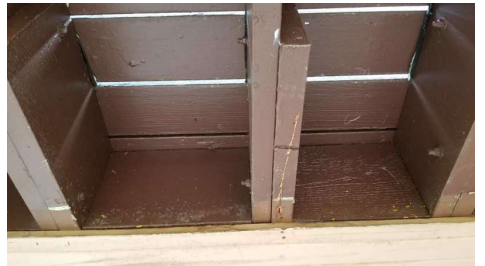
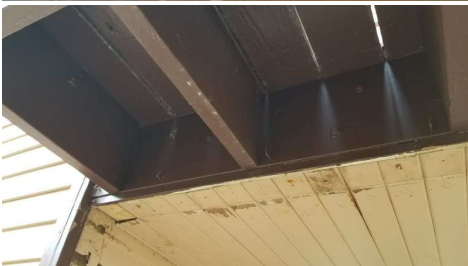
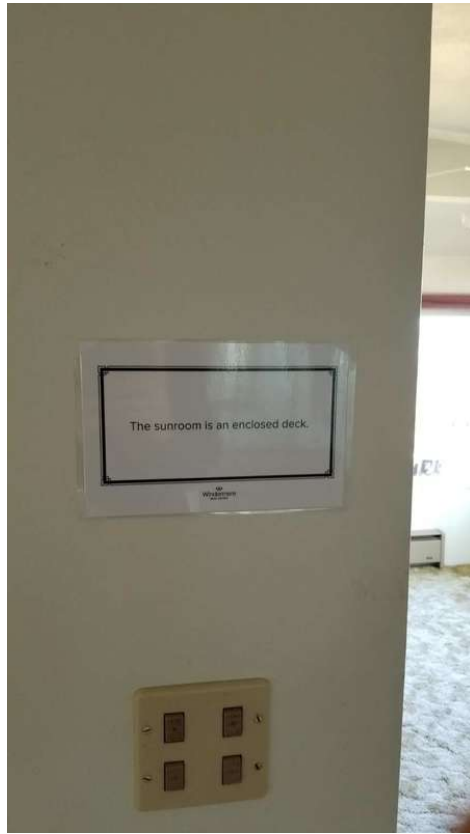
2.4.1 Decks, Balconies, Porches & Steps
NON-STANDARD INSTALLATION

Cantilever decking improper installation with sistered joists this can trap moisture and cause rot. Appears a structure was built on top of a deck. Recommend a 2nd story decking contractor evaluate for repair/replacement.

Recommendation
Contact a qualified deck contractor.

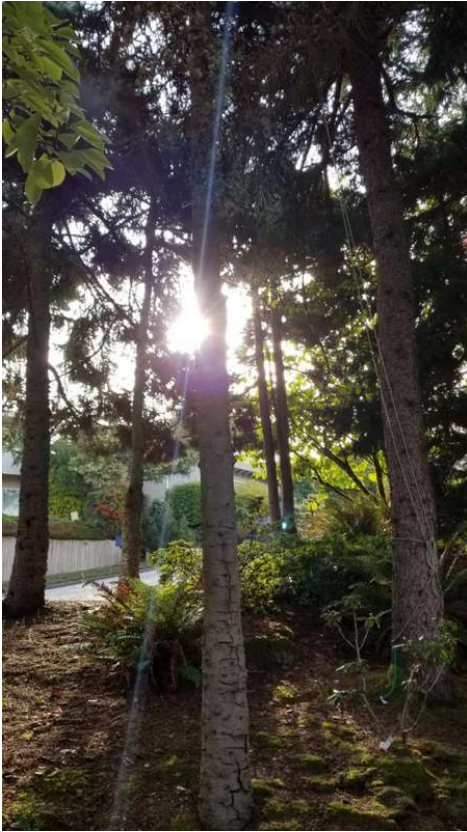
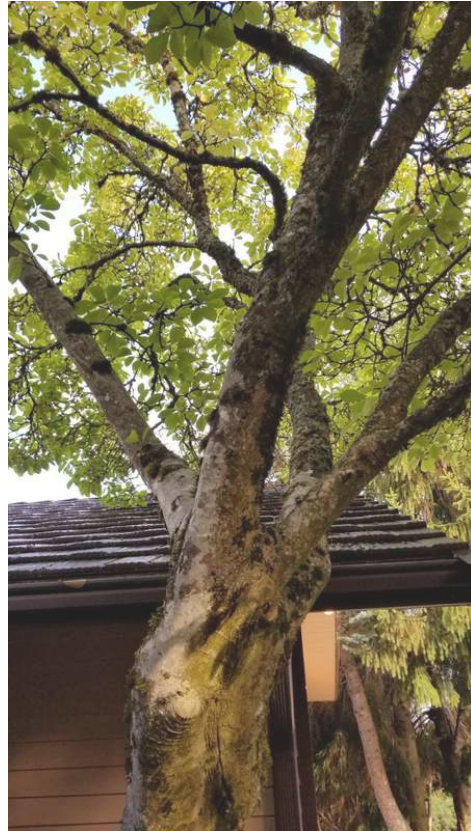
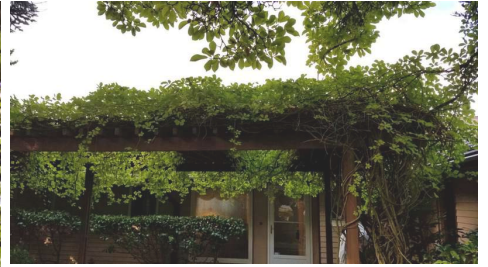
There were a large amount of trees removed at the rear of the property. Unknown if this has compromised the soil stability and/or if these were permitted to be removed. For an accurate evaluation of the trees I recommend contacting a qualified arborist or tree expert. Inquire with seller regarding permits and the proper tree removal process.

Appears to be a dead tree front of house. A lot of trees appear topped.

Contact a qualified landscaping contractor

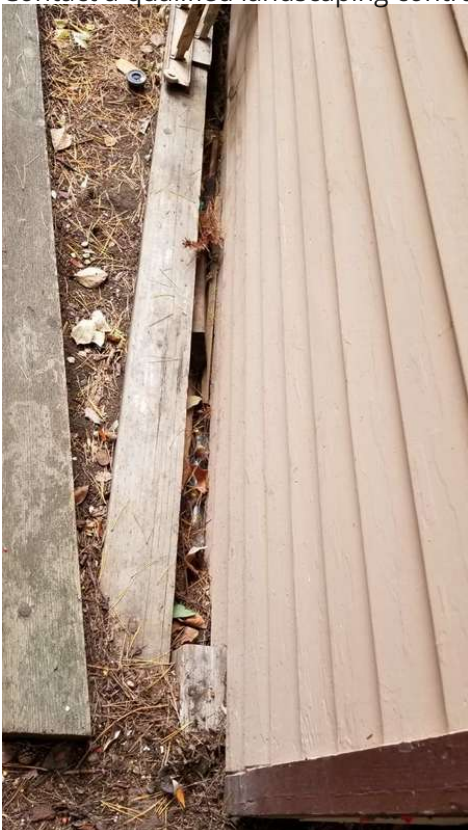
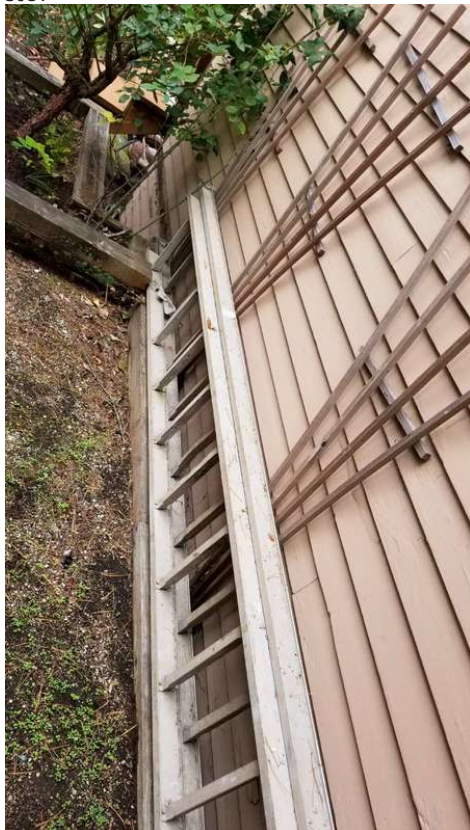
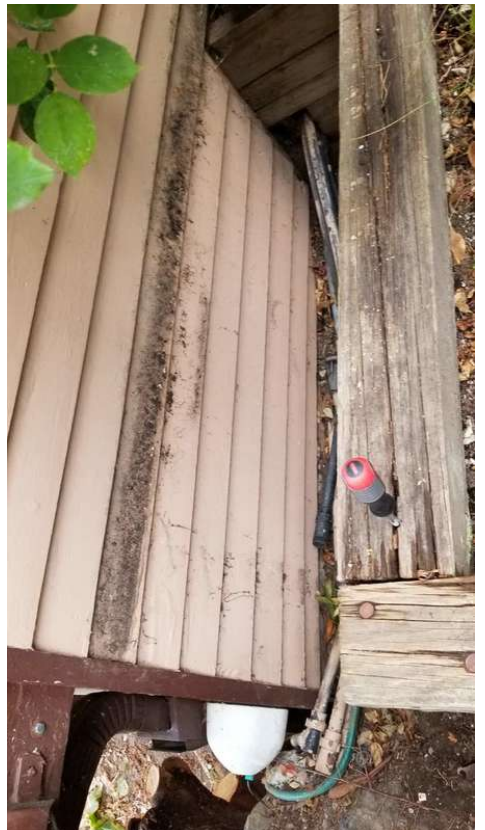
SOIL TO WOOD CONTACT

There appears to be soil to wood contact. This is a conducive condition to potential rot. I recommend a qualified landscape professional to repair or replace as necessary.

Contact a qualified landscaping contractor

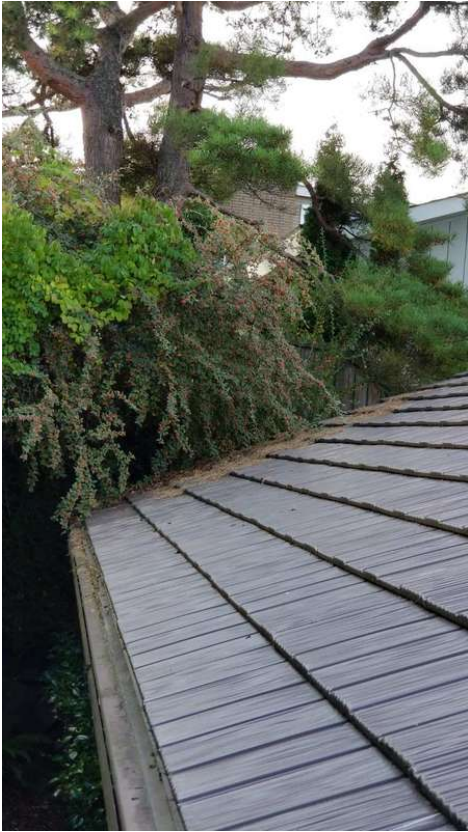
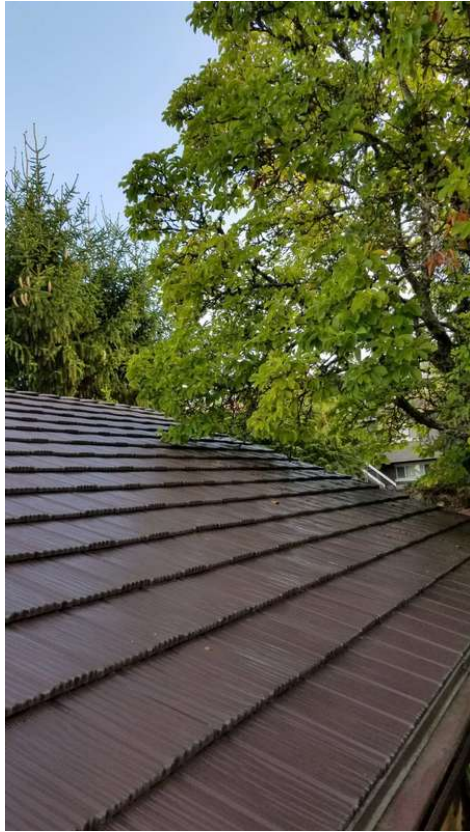
TREE

Trees hanging over roof need to be cut back to prevent damage to the structure.

Recommendation
Contact a qualified professional.

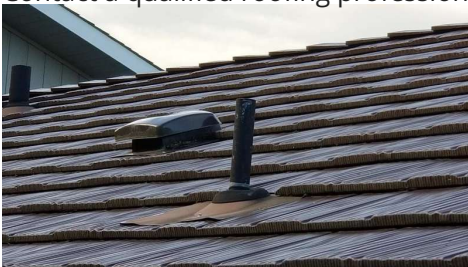
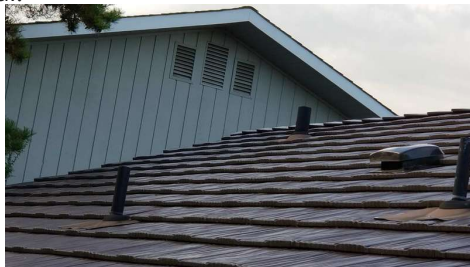
IMPROPER FLASHING SYSTEM

Poor flashing system installed on rubber boots for plumbing. Signs of inverted flashing system budget for repairs.

Contact a qualified roofing professional.

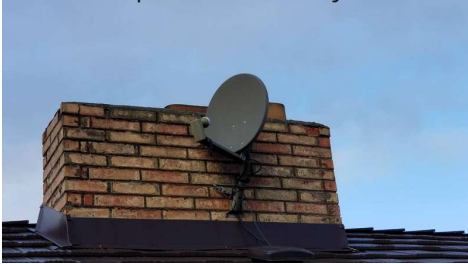
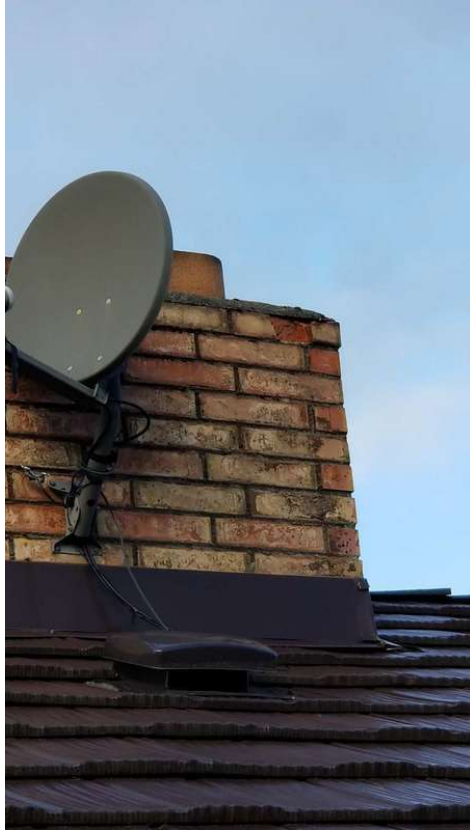
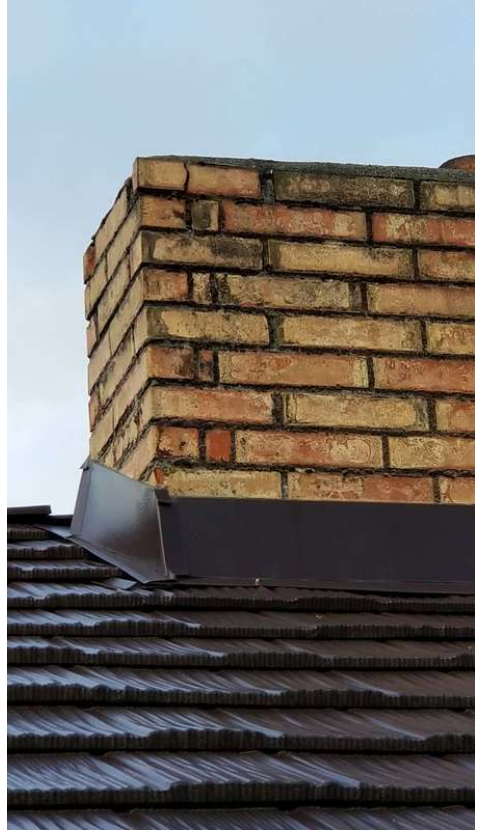
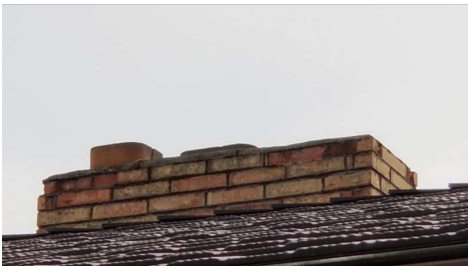
MISSING SPARK ARRESTOR

Missing spark arrestor on top of chimney. A missing spark arrestor can allow pest entry into the chimney, allow water to enter the chimney and freeze, potentially damaging the firebox/damper/chimney/etc., as well as allowing fire embers to exit the home, potentially leading to fire hazards. Recommend a qualified chimney sweep evaluate for cleaning and repairs.

Cracked bricks recommend further review.

Cracked bricks

Contact a qualified chimney contractor.

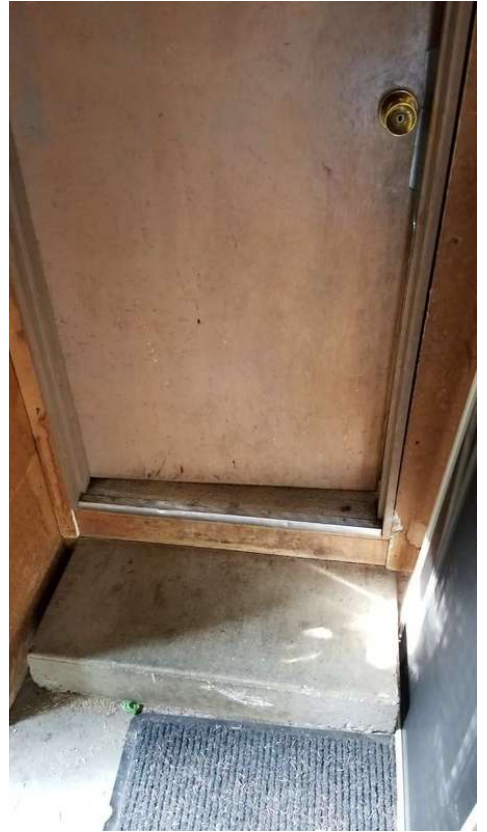
DOOR DOES NOT MEET SEPARATION REQUIREMENTS

Door separating garage and home does not meet safety standards. Doors in firewalls must be at least 1 3/8-inch thick, metal/steel, or a 20-minute fire-rated door.

Contact a qualified door repair/installation contractor.

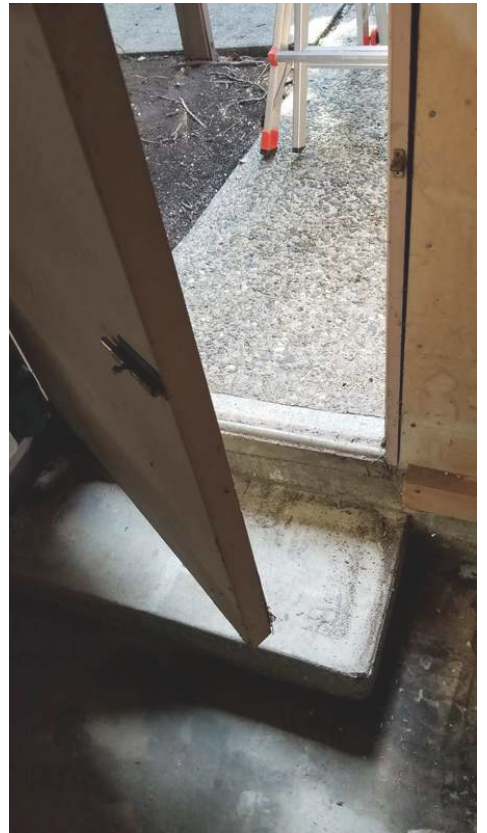
DOOR OPENS OVER A STEP DOWN

The garage door opens over a step down. This is a potential safety hazard due to the possibility of a person entering without knowing a step is there. I recommend repair for increased safety.

Contact a qualified door repair/installation contractor.

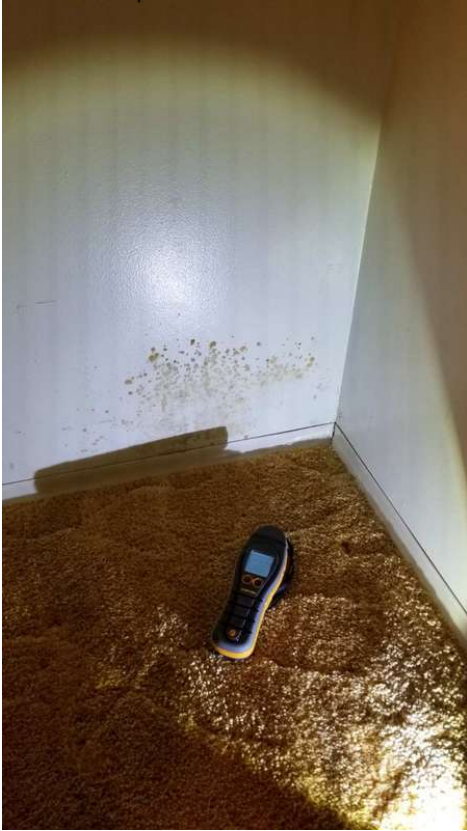
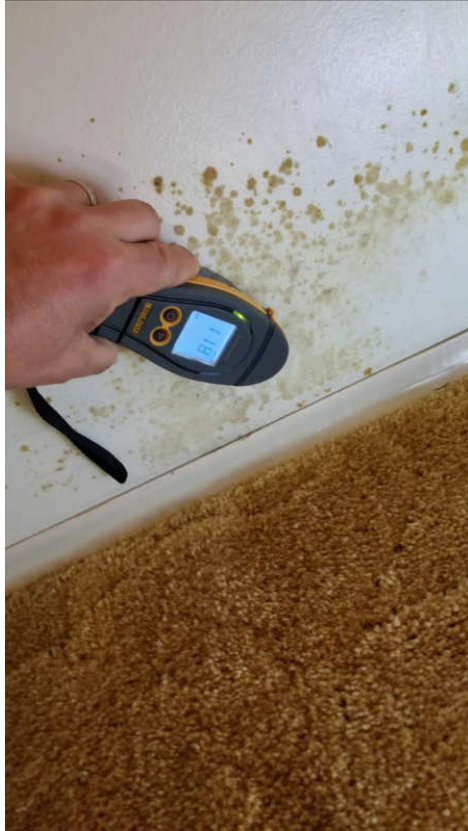
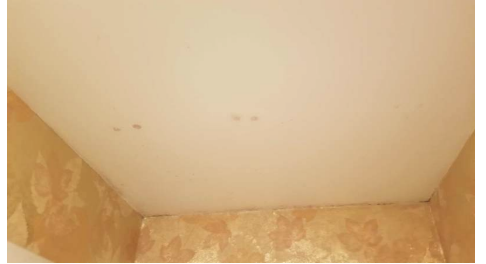
Master closet

FUNGAL GROWTH

Residue appears fungal in nature on ceiling. I did not inspect, test or determine if this growth is or is not a health hazard. This type of testing is beyond the scope of a standard home inspection. The underlying cause is moisture or dampness. No obvious elevated moisture at time of inspection. Fungus noted numerous locations. Dry at time of inspection.

Contact a qualified environmental contractor

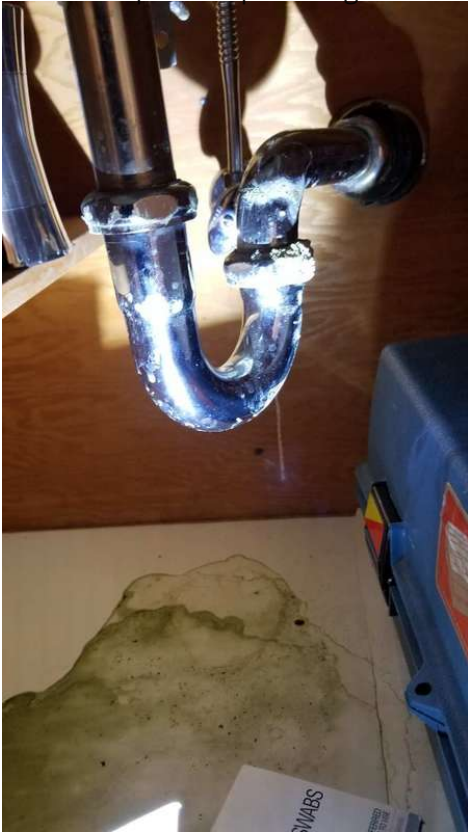
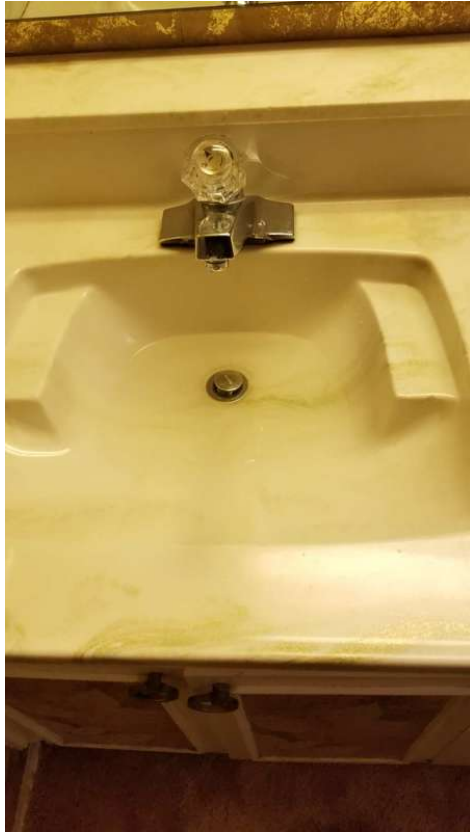
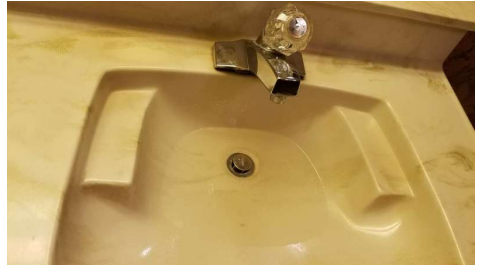
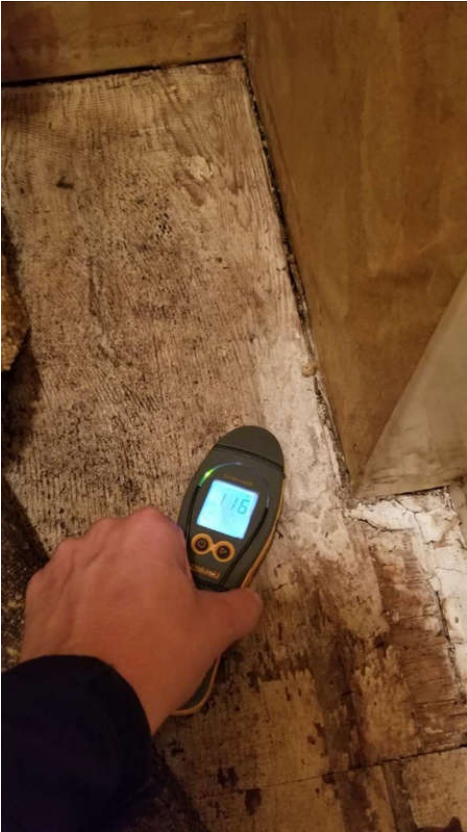
Master bathroom

DRAIN LEAKS

Leak noticed in the drain lines in the bathroom sinks. We recommend a qualified plumbing contractor evaluate and repair/replace as needed.

Rotting floor master

Recommendation
Contact a qualified plumbing contractor.

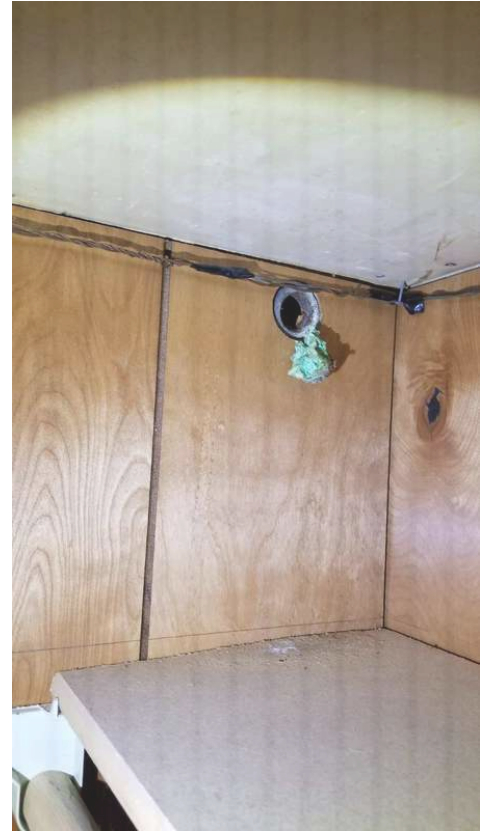
UNKNOWN PLUMBING

Unknown plumbing-venting room in the front right of the basement. This is not a proper living space as there is not proper ingress-egress due to fire safety standards. Inquire with seller for further details on history of repairs.

Contact a qualified professional.

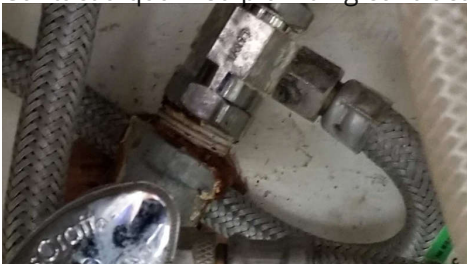
Kitchen

DISTRIBUTION PIPE LEAKING

Distribution pipe appeared to be leaking. Recommend a qualified plumber evaluate and repair. Aged galvanized plumbing with signs of corrosion and leakage throughout the home. Recommend budgeting for complete replacement.

Contact a qualified plumbing contractor.

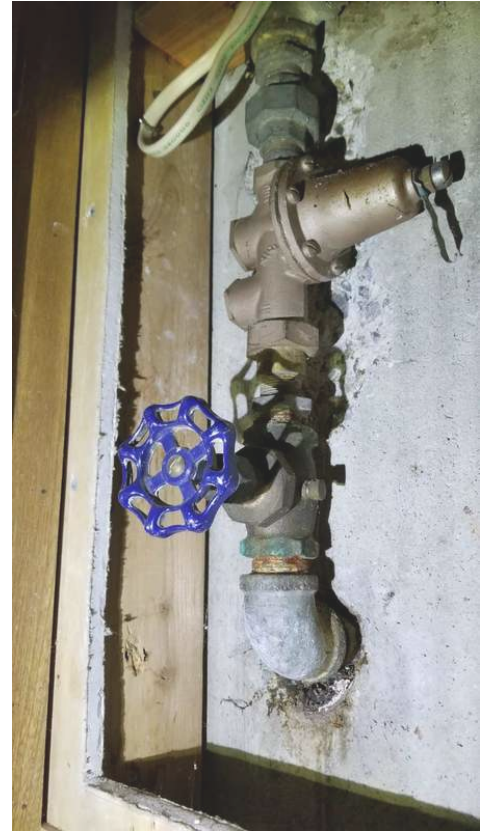
MAIN WATER SUPPLY PIPE CORRODED

Main water supply pipe was heavily corroded. This can lead to shortened lifespan of the pipe. Recommend a qualified plumber repair.

Contact a qualified plumbing contractor.

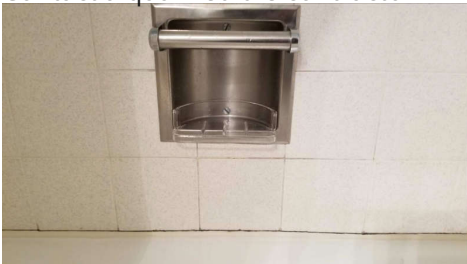
Guest bath tile movement

SHOWER TILE MOVEMENT

Shower showing signs of moisture intrusion. High likelihood of rot damage behind the wall due to the construction methods of the time period (i.e. sheetrock only). We recommend budget for rebuilding the shower surrounds.

Contact a qualified tile contractor

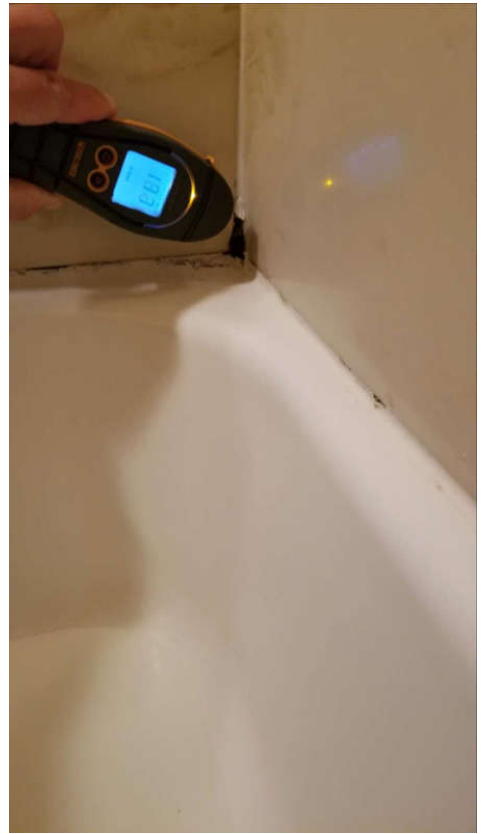
Moisture in master shower

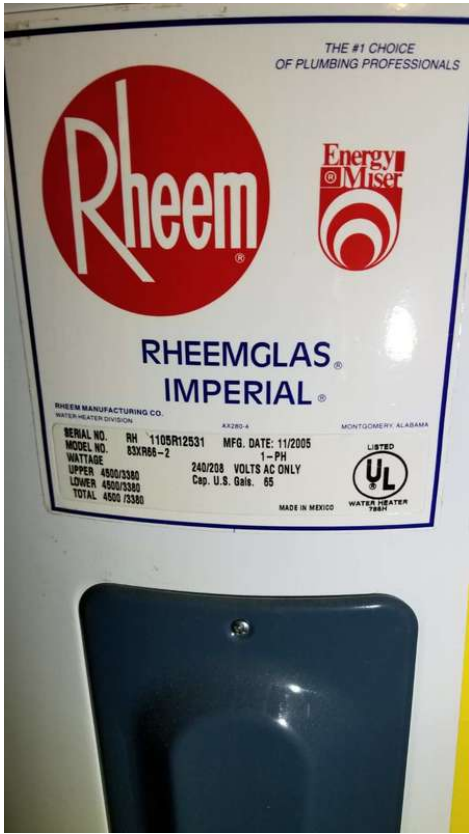
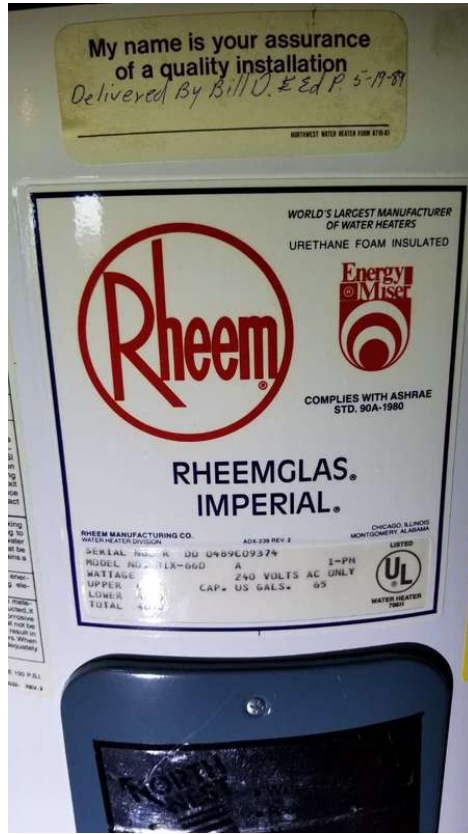
AGED UNIT

The water heater is nearing the end of its design life. Standard life is 8-12 years this water heater appears to be 12 & 19 years old. No obvious leaks or rust at time of inspection. I recommend budgeting for repair/replacement.

Contact a qualified plumbing contractor.

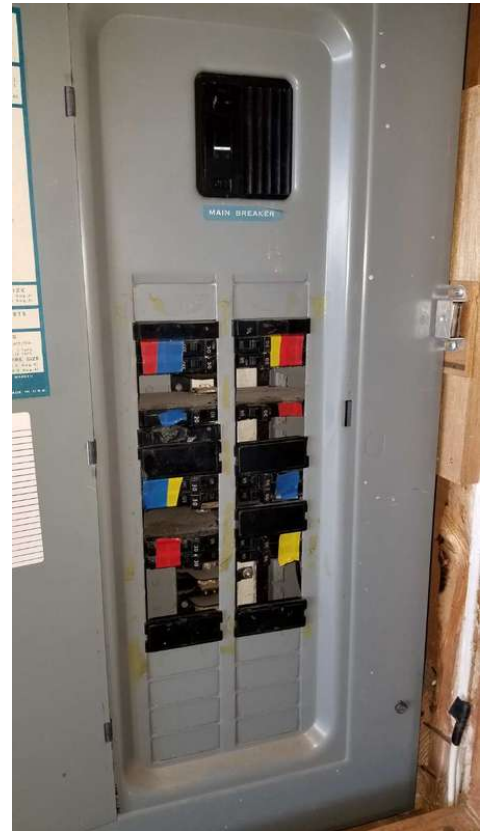
TWIST OUTS MISSING

Twist-outs/knock-outs missing at electrical panel. This has a potential for improper human contact. Generally, a simple fix by a qualified professional but does pose a safety hazard. Immediate correction is recommended.

Contact a qualified electrical contractor.

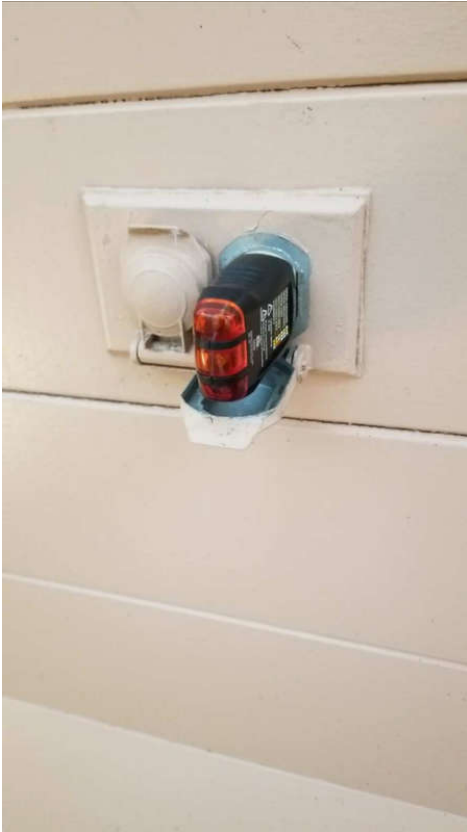
Entryway non-operable

Contact a qualified electrical contractor.

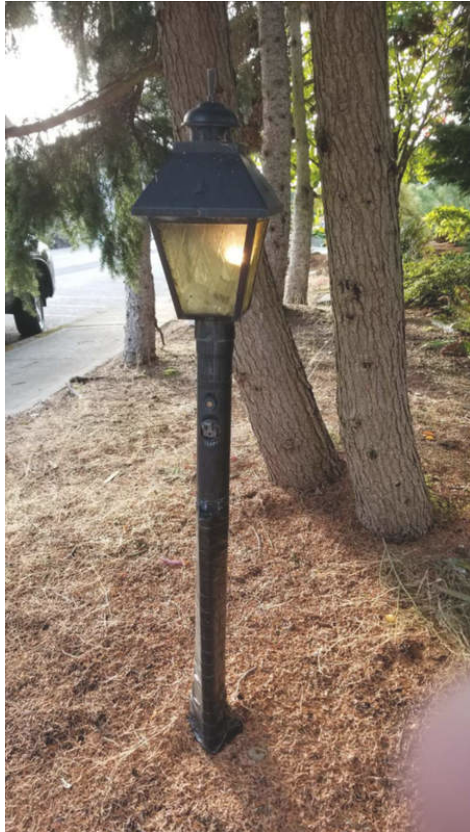
Broken driveway safety hazard

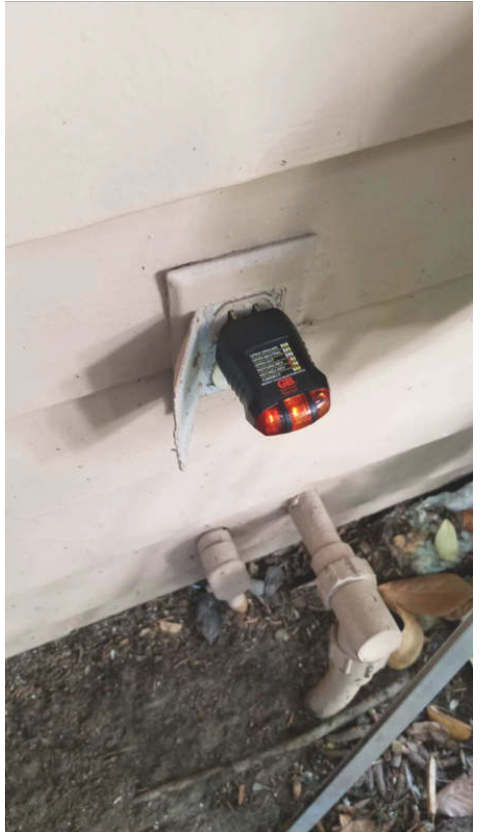
Front reverse polarity

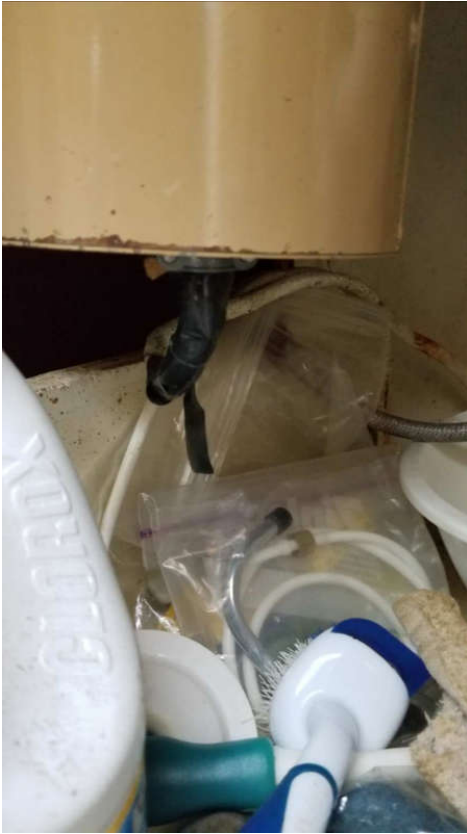
Kitchen

EXPOSED WIRE IN CABINET

All exposed wiring for the lights in the cabinets should be properly protected with conduit. I recommend a qualified electrical contractor repair/replace as needed for increased safety.

Contact a qualified electrical contractor.

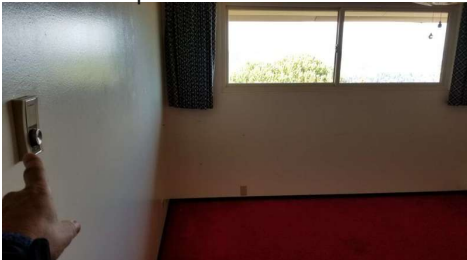
NO HEAT

The room appears to be missing any heat source at the time of inspection. I recommend a qualified electrician to repair replace as necessary. Unable to verify operation of electric heat, in ceiling, floors or walls. The aged baseboard heating system was detached from the wall numerous location and not tested due to safety hazard potential. Recommend a qualified HVAC contractor reevaluate the entire heating system for repair/replacement. Hydronic heating may be a great upgrade.

Contact a qualified electrical contractor.

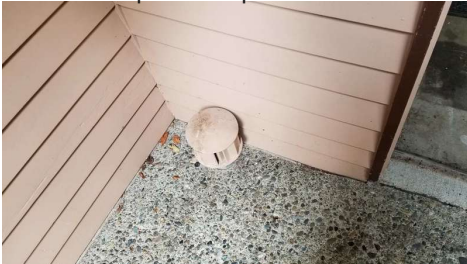
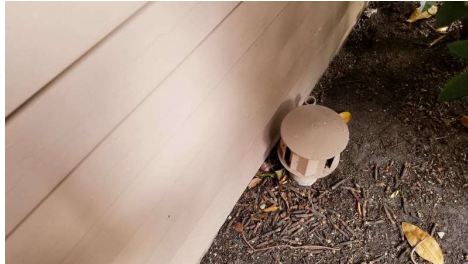
NONSTANDARD LOCATION

Unknown venting for basement wine cellar. Inquire with seller for further details.

Contact a qualified professional.

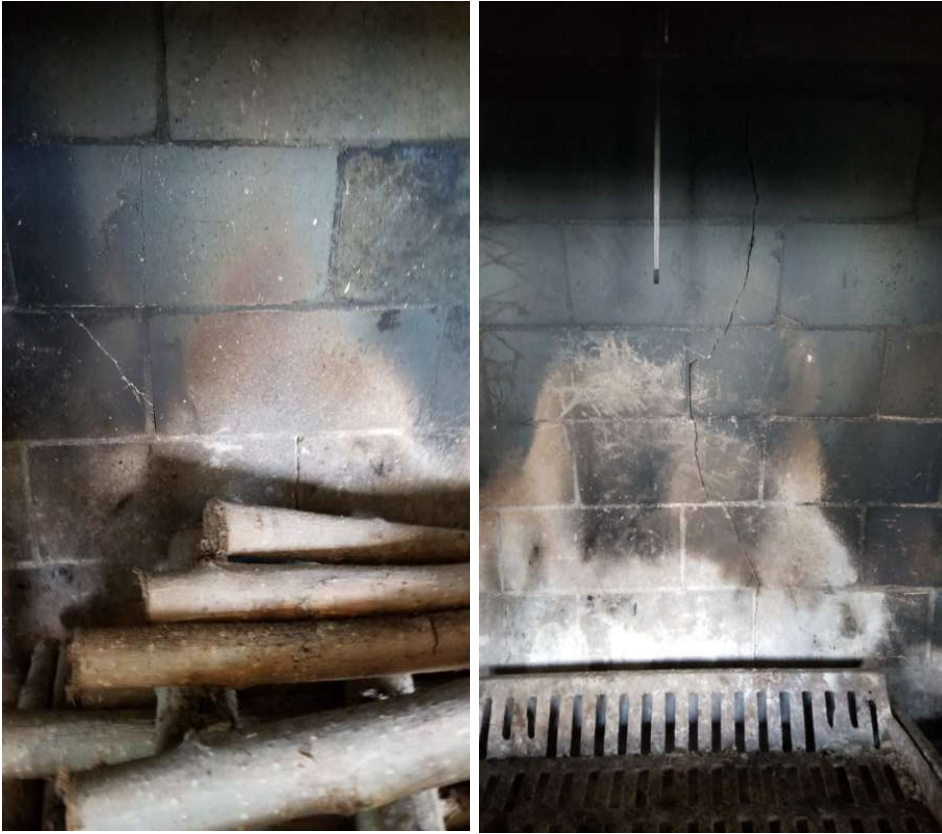
CRACKED WARPED BRICKS IN FIREBOX

Bricks in Fire box appear to be cracked/warped. I recommend evaluation and repair as needed by a qualified chimney sweep prior to use.

Contact a qualified chimney contractor.

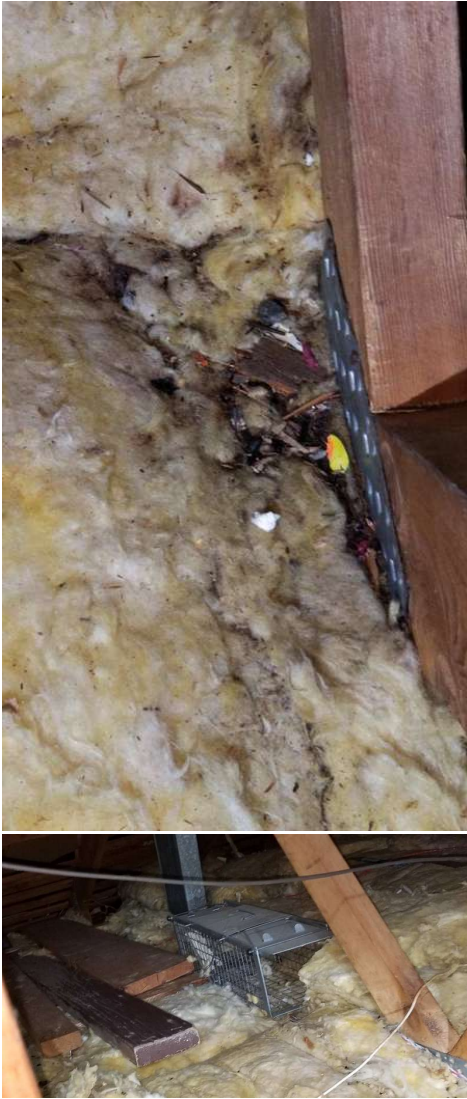
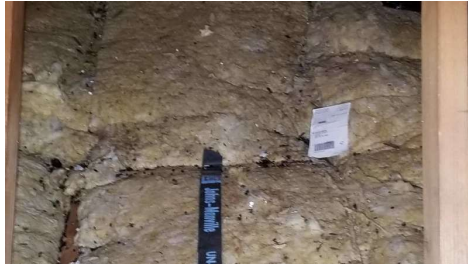
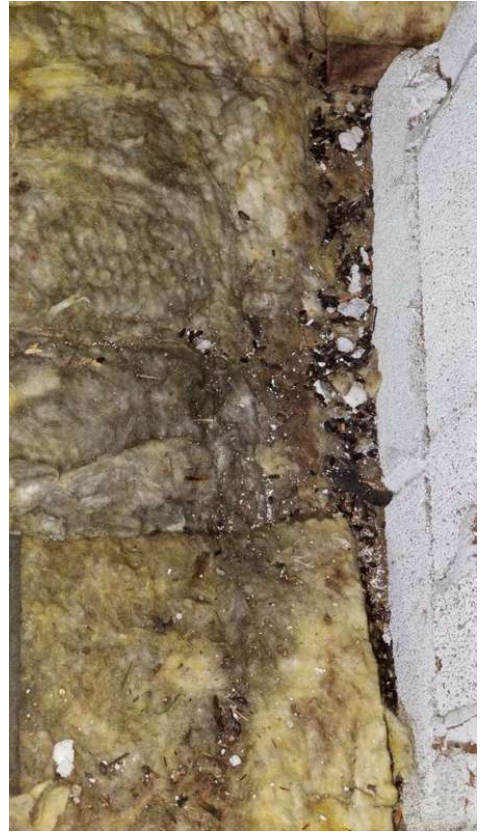
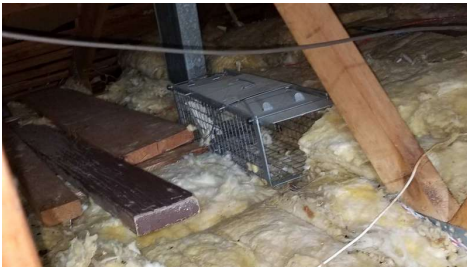
RODENT ACTIVITY ATTIC

Rodent activity noted in the attic area. I recommend contacting a qualified Pest Control Operator to remedy the situation and re-inspect the area. This will include but not limited to removing all rodents, rodent droppings, repairing/replacing, all damaged materials <i.e. insulation, electrical, etc.>, inquiring with the sellers on the history of rodent activity/infestation. Followed by taking the proper steps to ensure no future infestation will occur. Due to the common nature of rodent accessing different areas of the home I recommend these steps also be taken in any other areas where pest activity/infestation has occurred.

Contact a qualified pest control specialist.

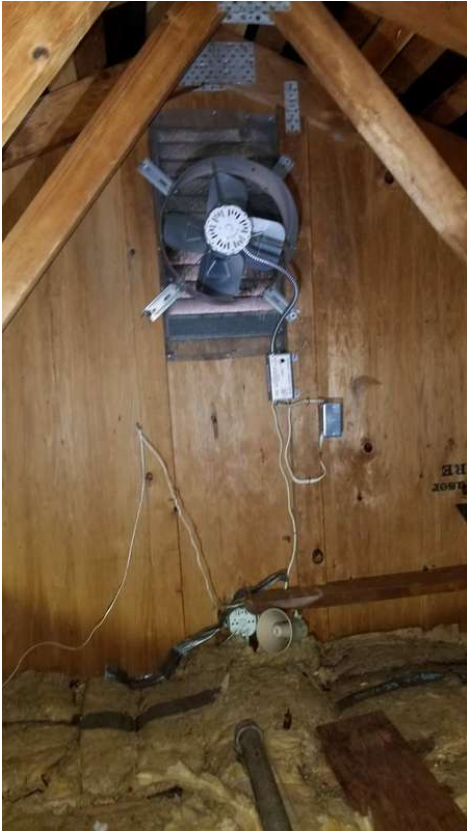
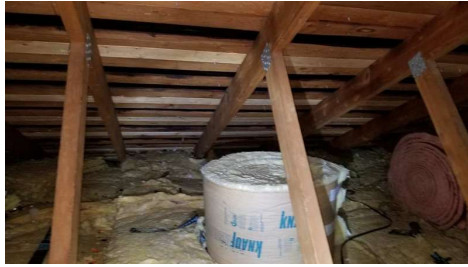
NON-OPERABLE FAN

The fan appeared to be non-operable at the time of Inspection. I recommend a qualified HVAC technician to repair/replace.

Soffit vents not installed. Non-standard electrical installation in attic. Refer to electrician for repair/replacement.

Contact a qualified HVAC professional.

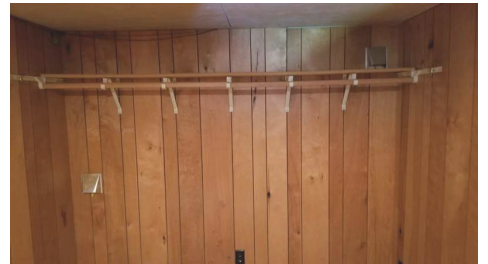
STRANGE VENTS

Unknown vents in storage area. Inquire with seller for further details.

Recommendation
Contact a qualified professional.

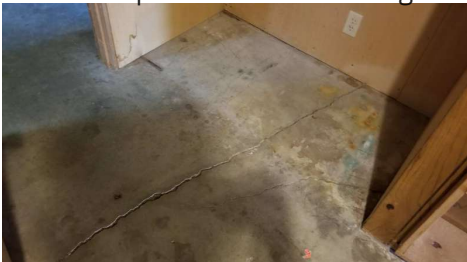
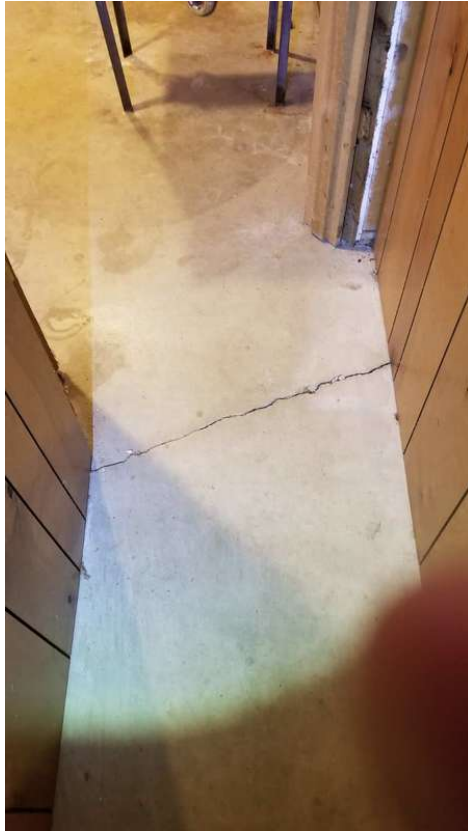
FOUNDATION CRACKS - MINOR

Larger than normal cracks in the basement floor. Common for the age of the home budget for additional repairs when completing construction on the basement area.

Recommendation
Contact a qualified structural engineer.

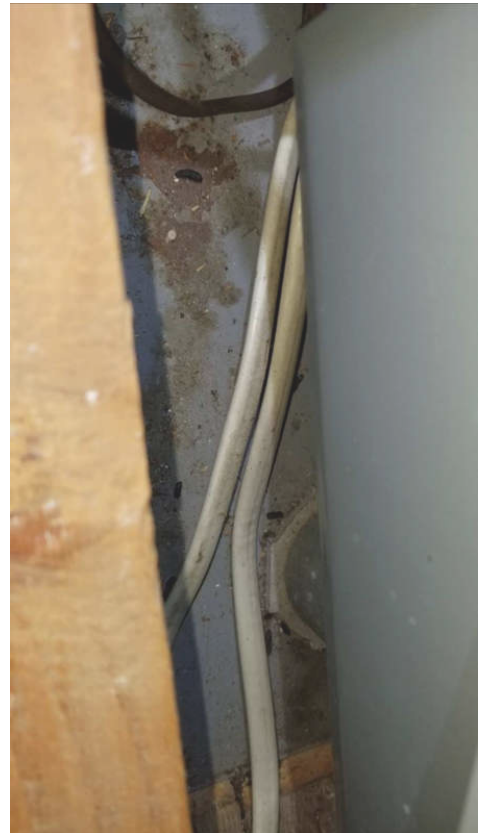
Near electrical panels

RODENT ACTIVITY

Rodent activity noted next to electrical panels in basement. Refer to a pest control operator for remediation.

Contact a qualified pest control specialist.

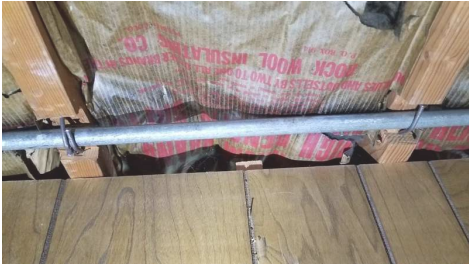
FLOOR JOIST NOTCHED

A floor joist in the basement has been notched. The notch appears large enough that reinforcement is recommended. I recommend a qualified contractor proficient in structural framing evaluate and repair/replace as needed.

Recommendation
Contact a qualified general contractor.

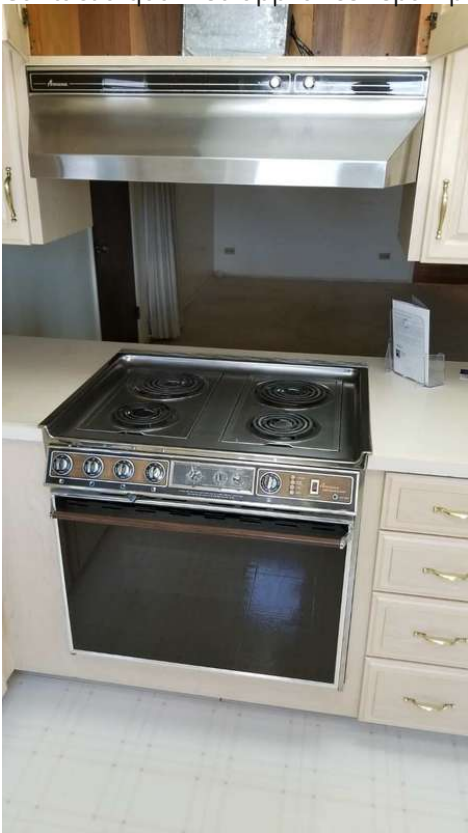
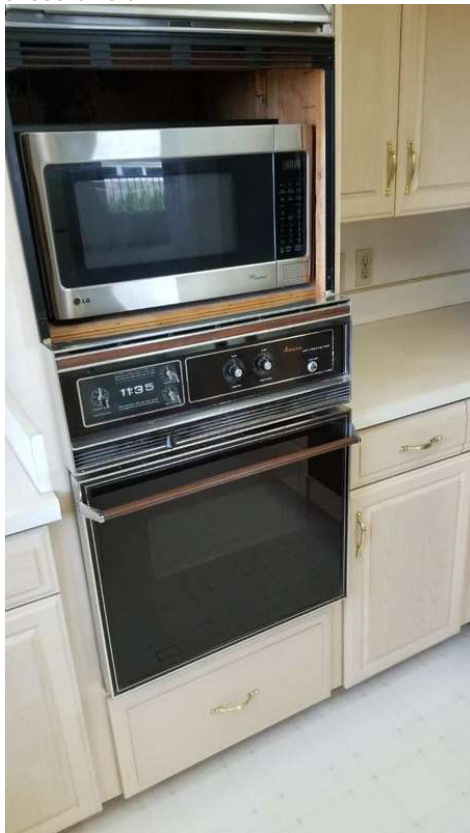
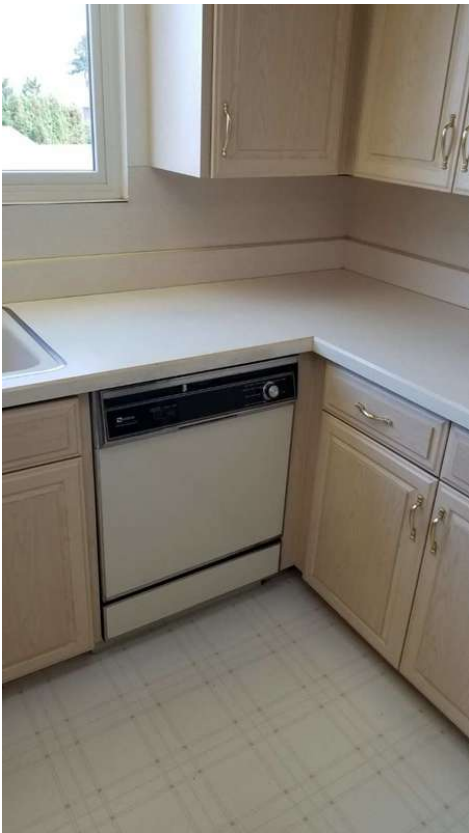
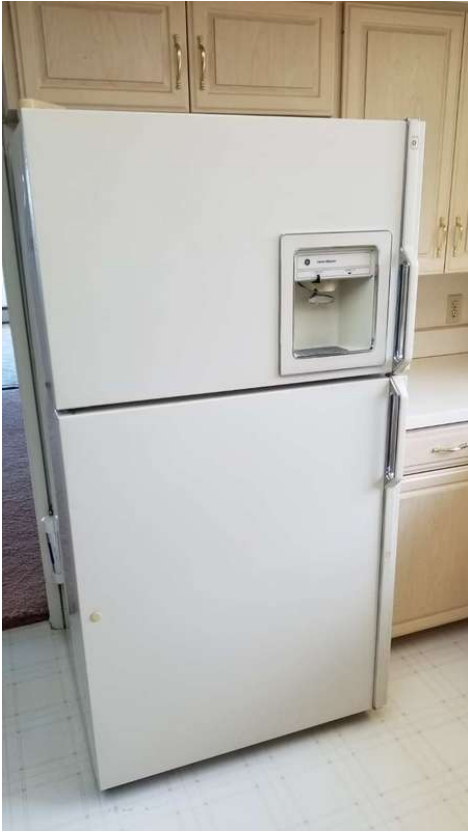
AGED UNIT-BUDGET FOR REPLACEMENT

The appliances are aged and in need of replacement. Although operable at time of inspection they have exceeded their design and have an unknown failure date in the future.

Recommendation
Contact a qualified appliance repair professional.
