SUMMARY

1234 Main St. Raeford NC 28376

Jerry Brown
NC-4198/NACHI18110815
NEST Check Home Inspection
910-973-5660
jerry@nestcheckhomeinspection.com

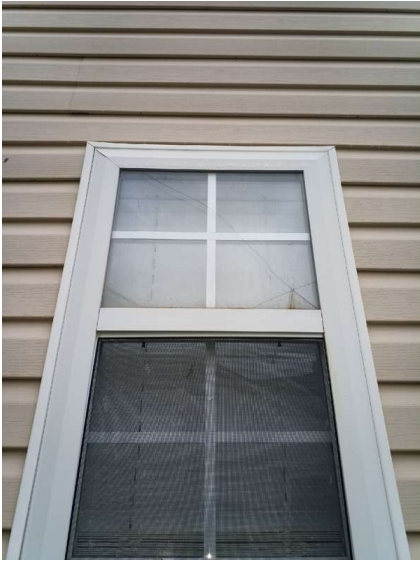
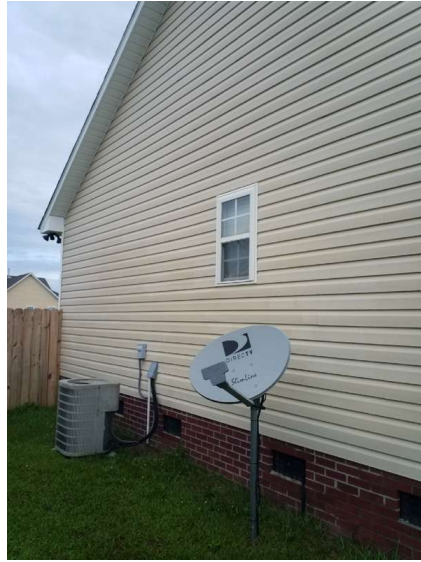
2.7.1 Windows

BROKEN/CRACKED GLASS

LEFT EXTERIOR

Some windows showed signs of damage in the form of cracked or broken glass panes. This poses a potential safety hazard to anyone using the windows or in the event of a need for egress. Also this reduces the efficiency of the windows. Recommend contacting window specialist for repair and replace as required.

Contact a qualified window repair/installation contractor.

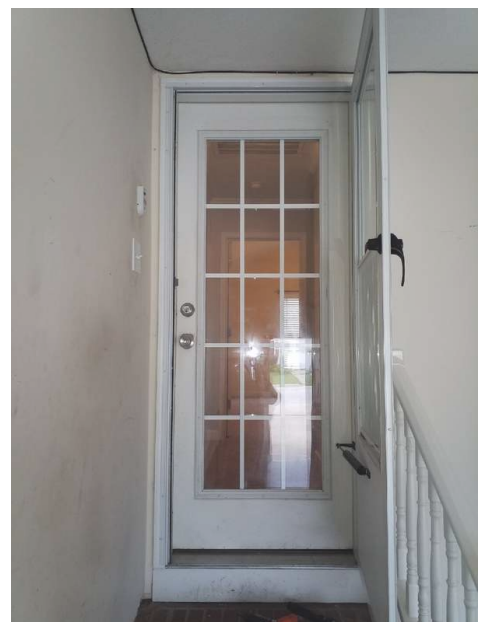
7.2.1 Occupant Door (From garage to inside of home)

DOOR DOES NOT MEET SEPARATION REQUIREMENTS

Safety Though not required at the time of building, the door separating the garage and home does not meet current safety standards. Doors in firewalls must be at least 1 3/8-inch thick, metal/steel or solid core wood, or a 20-minute fire-rated door, and sealed to keep vehicle gases from home. Recommend correction by installing a fire separation approved door with proper weather seals to keep garage environment out of home.

Recommendation
Contact a qualified door repair/installation contractor.

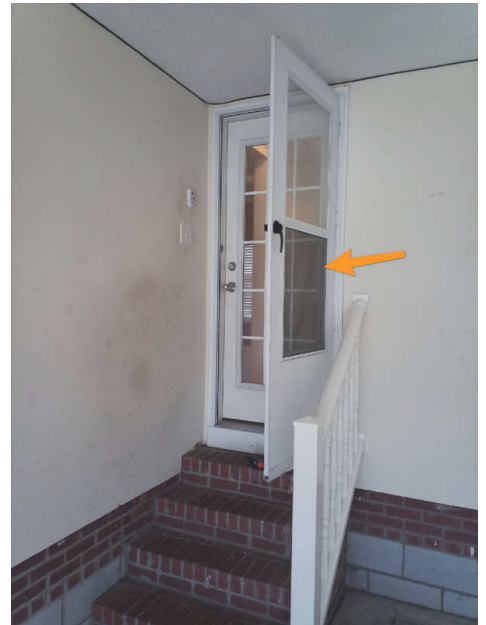
7.2.2 Occupant Door (From garage to inside of home)

DOOR SWINGS OUTWARD

GARAGE

Outward swinging door with no landing was noted at the garage steps leading to the home. This could pose a penitential safety hazard if the door is opened while someone is on the steps. Recommend removing outward screen door as a minimum and or have steps reconstructed to add appropriate landing to enhance safety.

Outward swinging door

Contact a qualified general contractor.

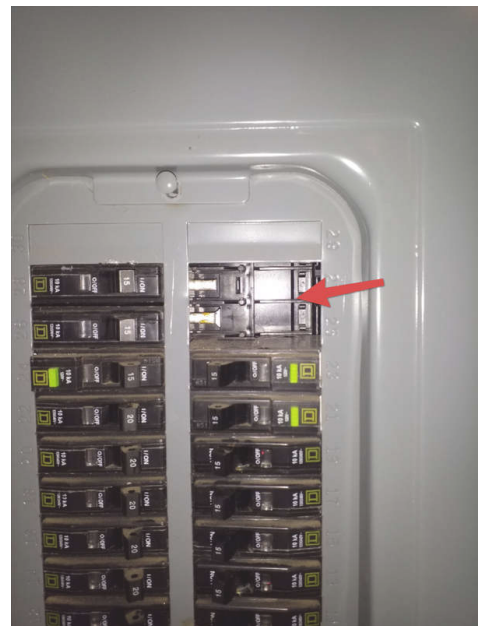
8.2.1 Service and Grounding Equipment, Main Overcurrent Device, Main and Distribution Panels

KNOCK COVER MISSING

Knockout cover on main panel is missing exposing the interior parts of the electrical panel. This poses a serious potential shock hazard to anyone working in or around the electrical panel. Recommend qualified electrician for repair as required.

Contact a qualified electrical contractor.

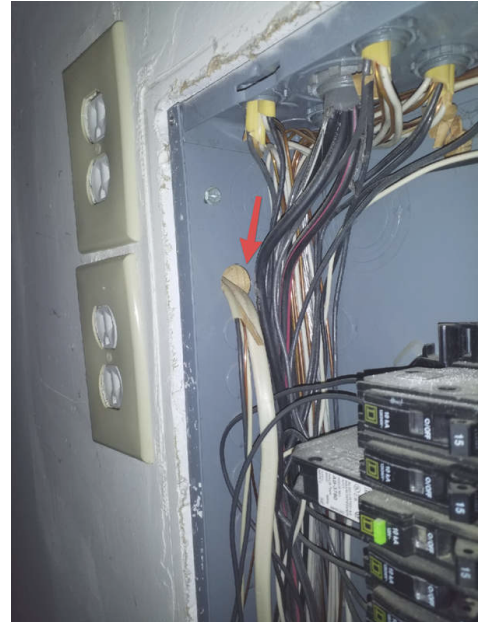
MISSING BUSHINGS

One or more bushings within the panel were noted as missing at the time of the inspection. These bushings are installed to protect conductors from being damaged as they pass through the metal panel. If left in the current condition could pose a shock hazard if conductors are damaged. This also exposes combustible material within the wall to sparks if components were to malfunction. Recommend qualified electrician install appropriate bushing to ensure safety and increase protection.

Missing bushing

Contact a qualified electrical contractor.

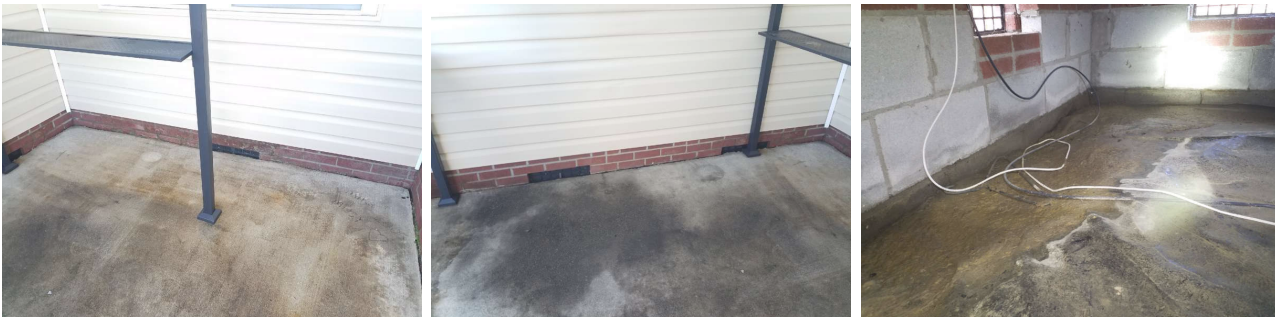
CRAWLSPACE VENTS BELOW GRADE

It was noted that one or more crawlspace vents were located below grade. Crawlspace vents located below grade will be susceptible to water intrusion during wet weather. This will allow water to collect within the crawlspace creating higher-than-normal moisture levels. Recommend a qualified contractor for further evaluation and set appropriate course of action to alleviate any further issues

Contact a qualified general contractor.

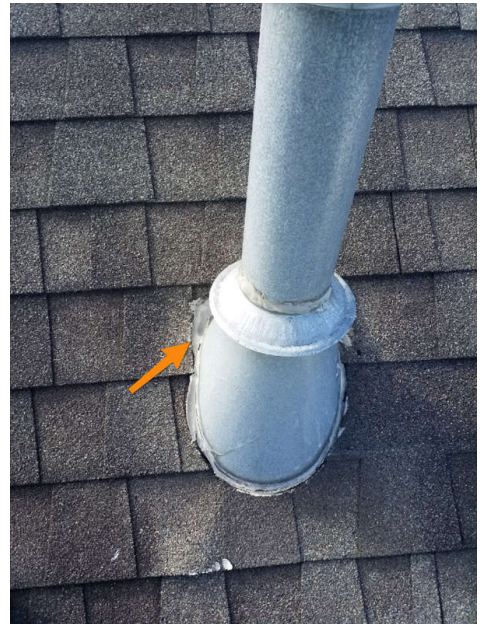
ROOF PENETRATION SEALANT

Deteriorated sealant around penetration flashing. If left in the current condition water will be allowed to run into the interior roof structure causing damage to interior structure. Recommend consulting with qualified roofer for further evaluation and repair as required.

Deteriorated sealant

Contact a handyman or DIY project

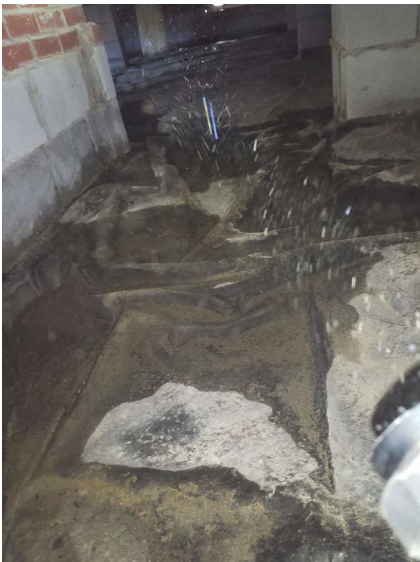
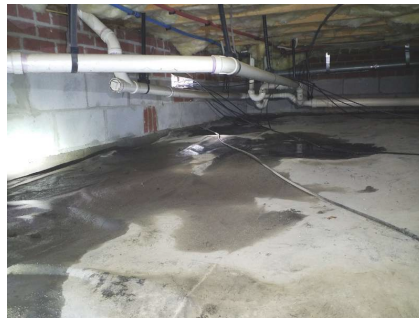
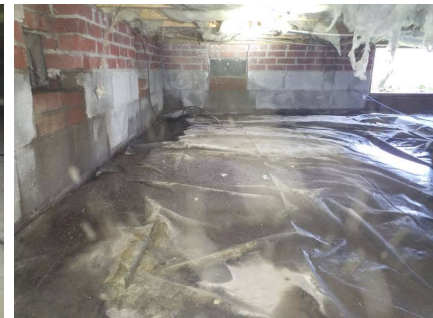
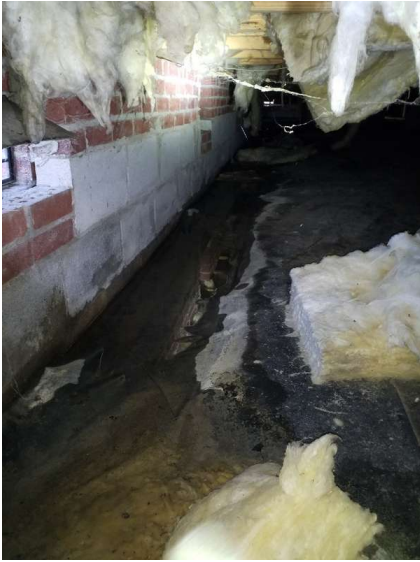
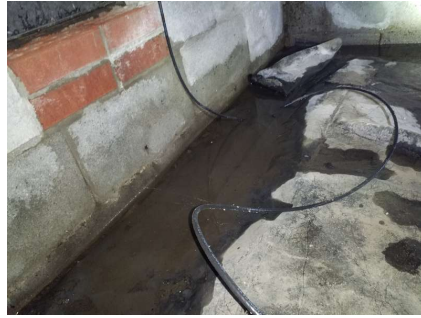
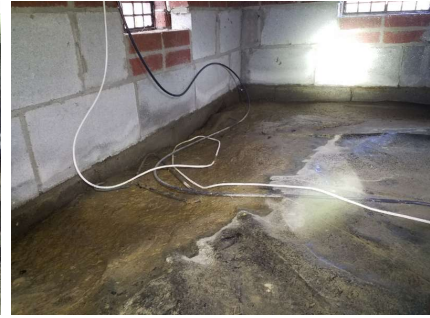
12.2.1 Foundation, Basement & Crawspaces

WATER INTRUSION

CRAWLSPACE

Water intrusion was evident on the surface of the crawspace. It appears water is entering through vents and pooling around the perimeter of the crawspace. This can compromise the soil's ability to stabilize the structure and could cause damage if left un-corrected as well as create an environment conducive to fungal growth. Recommend a qualified contractor to identify the source of moisture and remedy as required.

Contact a qualified general contractor.

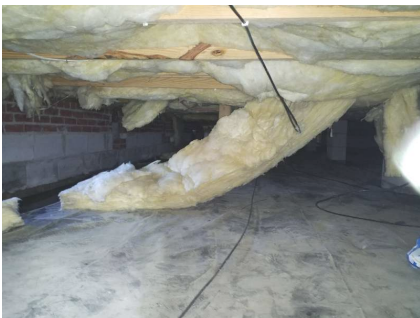
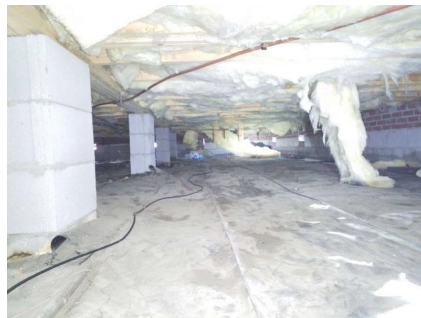
12.2.2 Foundation, Basement & Crawlspaces

INSULATION FALLING

Insulation was noted falling from joists in various locations in crawlspace. left in the current condition it will reduce the the homes efficiency and expose wood components to moisture. This is sometimes attributed to higher than normal moisture levels and failure to correct that will result in reoccurring issue. Recommend installing appropriate vapor barrier/control moisture levels and reattach/replace affected insulation by qualified professional.

Contact a handyman or DIY project
