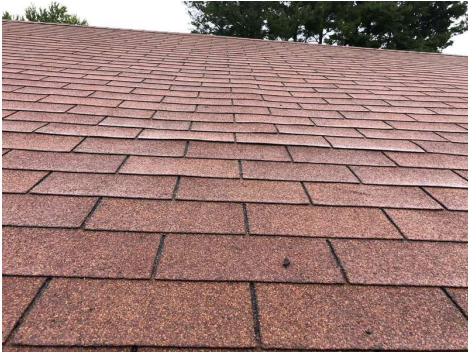
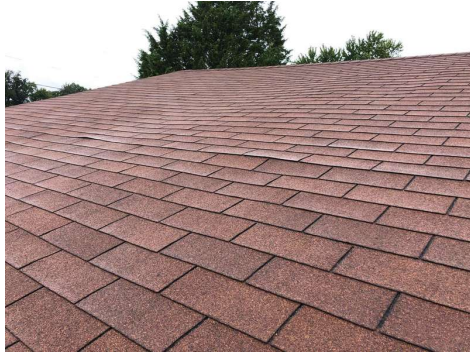
### NAILS EXPOSED / RAISED SHINGLES

There were some locations where the nails have either pushed up or were face nailed and they needed to be sealed. There are a couple of different options out there. [Here is an example](#). If neglected, they could develop into a leak or blown off shingle. Any observed leaks will be noted elsewhere.

Contact a qualified roofing professional.

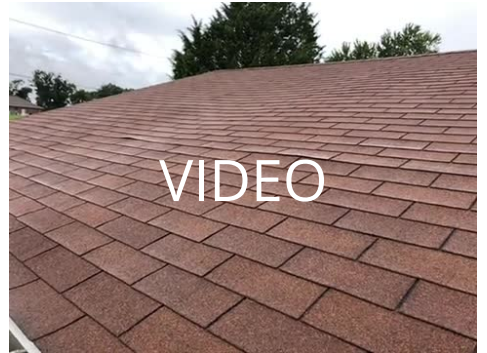
#### **SOFT SPOT(S) NOTED**

MINOR CONCERN

In localized areas of the roof, when it was walked on, sheathing deflected to a greater degree than on the rest of the roof. This can be the result of a number of conditions, including wood decay, and sheathing panels with damaged or defective sections. Roof sheathing was not directly visible from the exterior.

Contact a qualified carpenter.

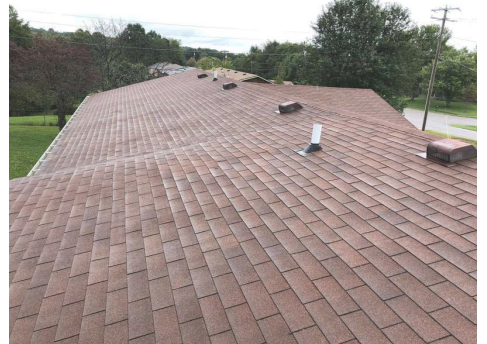
#### **SAGGING RAFTERS**

MINOR CONCERN

The rafters were sagging in one or more locations. This could indicate that they are either undersized or damaged. No damage observed from the attic.

Contact a qualified carpenter.

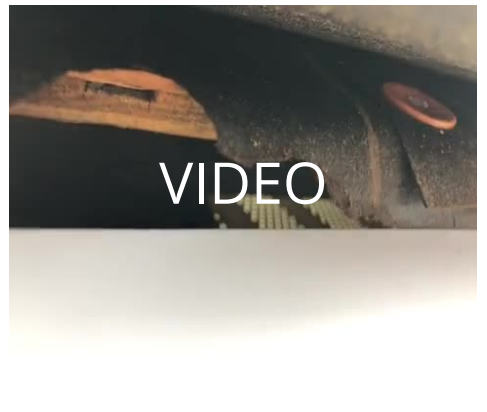
#### **DECKING STOPS SHORT**

MINOR CONCERN

The roof decking stops short of the fascia. This would be considered poor building practice but no major issues were observed.

Contact a qualified professional.

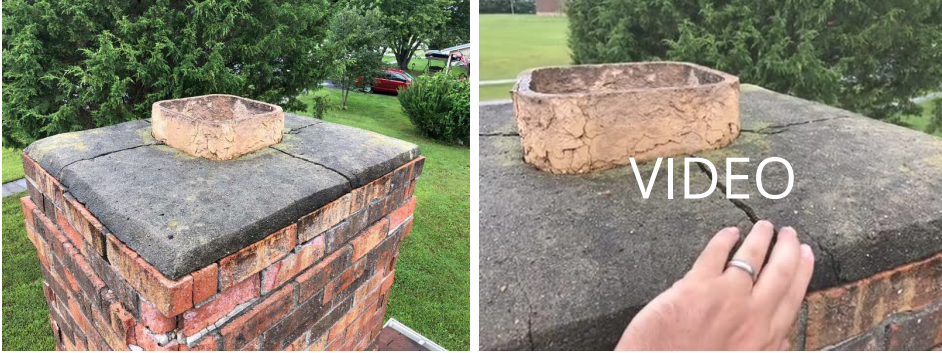
#### **CHIMNEY CROWN - CRACKED**

MODERATE CONCERN

Cracking visible in the chimney crown, and mortar joints, should be filled with an appropriate sealant to prevent continued damage from the freeze/thaw cycle. This can also be a source of moisture intrusion at the interior. Recommend further review. [Here is some more information about moisture intrusion and chimneys.](#)

Contact a qualified chimney contractor.

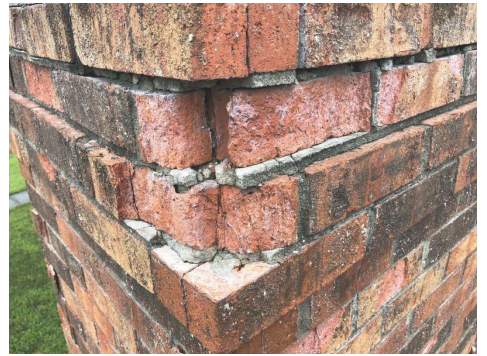
#### CHIMNEY REPOINT NEEDED

MODERATE CONCERN

Joints in the masonry have deteriorated and should be repointed. Repointing is the restoration of the mortar joints in the masonry. Moisture intrusion at chimneys can be problematic. [Here is some more information about moisture intrusion and chimneys.](#)

Contact a qualified chimney contractor.

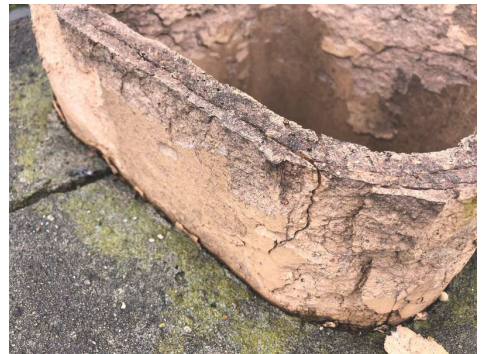
#### CHIMNEY FLUE CRACKED

MINOR CONCERN

The chimney flue had one or more cracks, which can lead to further damage to the chimney structure. Recommend a qualified contractor repair.

Contact a qualified roofing professional.

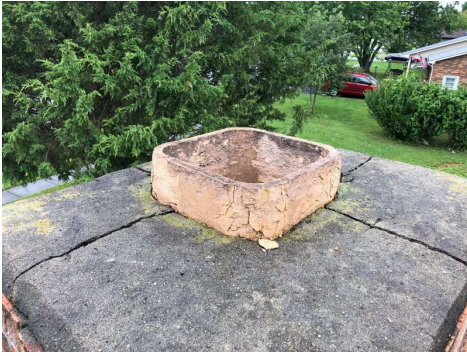
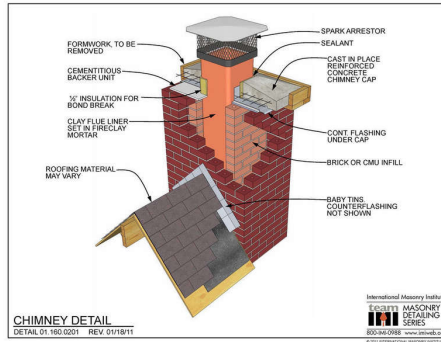
#### SPARK ARRESTOR

MINOR CONCERN

Consider installing a spark arrestor to mitigate the moisture intrusion, the potential for sparks, and nesting. [See here for more information.](#)

Contact a qualified chimney contractor.

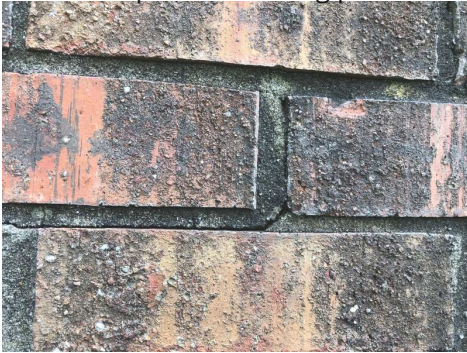
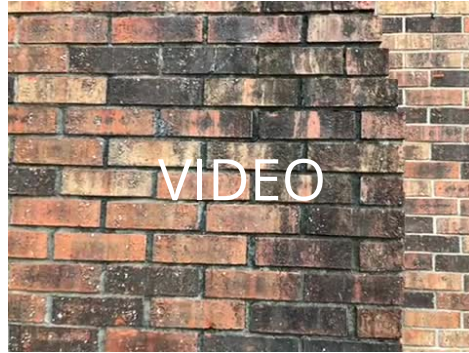
### 2.6.5 Chimney CRACKS - MINOR

**MODERATE CONCERN**

There were some visible cracks noted in the masonry. Recommend measures to seal any gaps to mitigate the risk of moisture intrusion.

Recommendation  
Contact a qualified roofing professional.

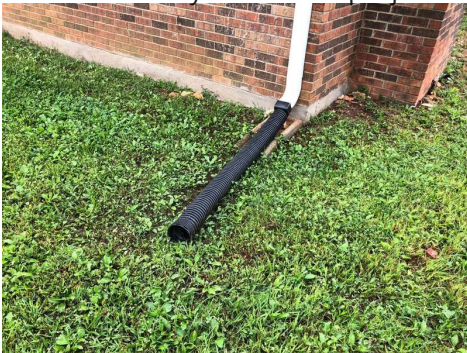
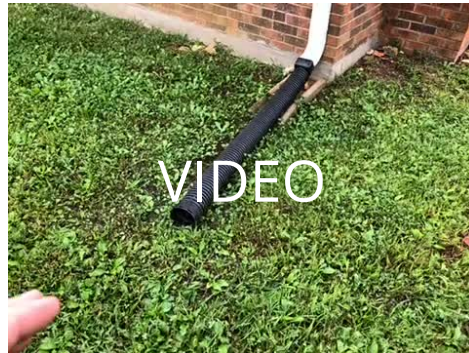
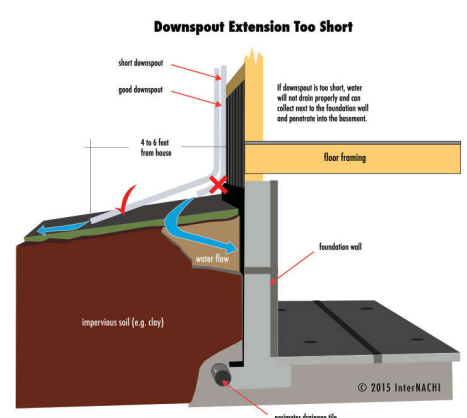
### 3.3.1 Vegetation, Grading, & Drainage DOWNSPOUTS - DRAIN NEAR HOUSE

**MODERATE CONCERN**

One or more downspouts drain too close to the home's foundation. This can result in excessive moisture in the soil at the foundation, which can lead to foundation/structural movement. Recommend a qualified contractor adjust downspout extensions to drain at least 6 feet from the foundation.

Recommendation  
Contact a handyman or DIY project

Recommend extending the downspouts further away from the

foundation.

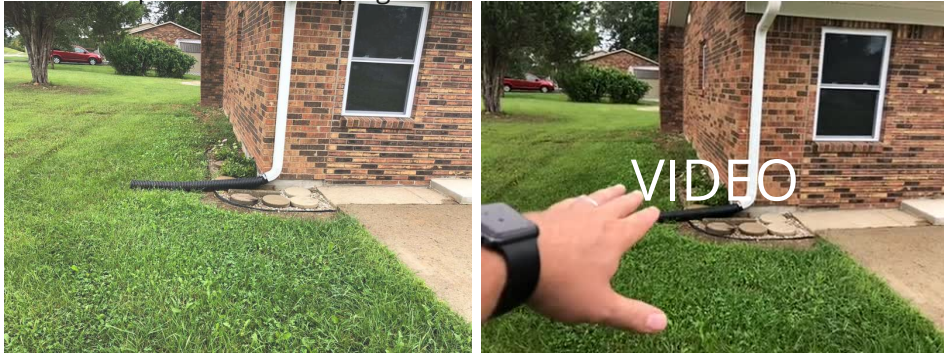
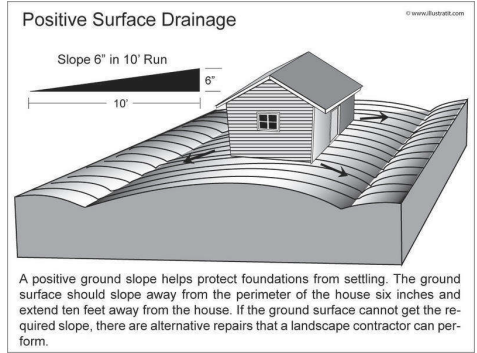
#### NEGATIVE GRADING

MINOR CONCERN

Grading is sloping towards the home in some areas. This could lead to water intrusion and foundation issues. Recommend qualified landscaper or foundation contractor regrade so water flows away from home.

Contact a qualified landscaping contractor

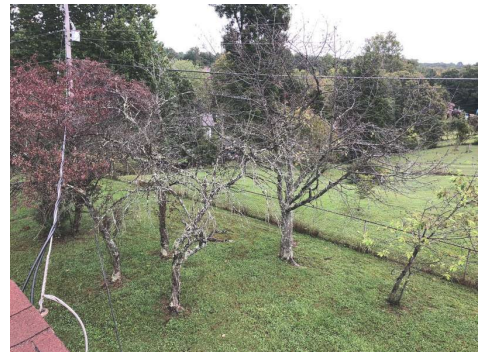
#### DEAD TREE/LIMBS

MINOR CONCERN

There was a dead tree or limb noted during the inspection. It could cause damage or injuries if not addressed.

Contact a qualified tree service company.

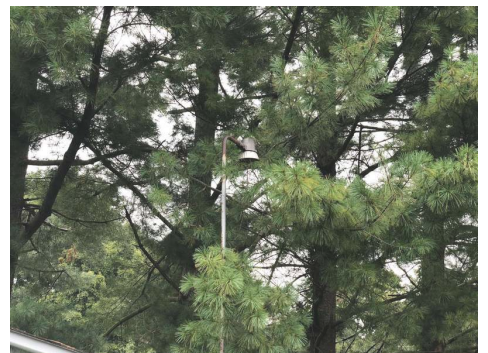
#### FIXTURE DAMAGED

MINOR CONCERN

EXTERIOR NORTH

One or more of the exterior fixtures were damaged or missing. Repair as needed.

Contact a qualified professional.

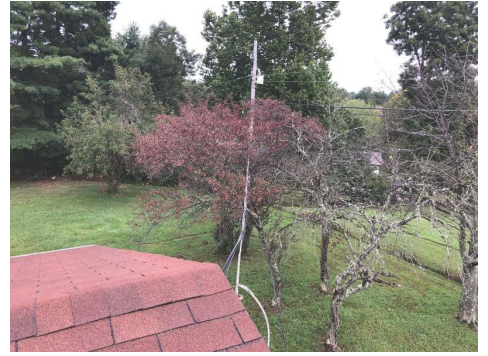
#### BRANCHES

MINOR CONCERN

Branches around the service entrance may cause damage.

Recommendation  
Contact a qualified professional.

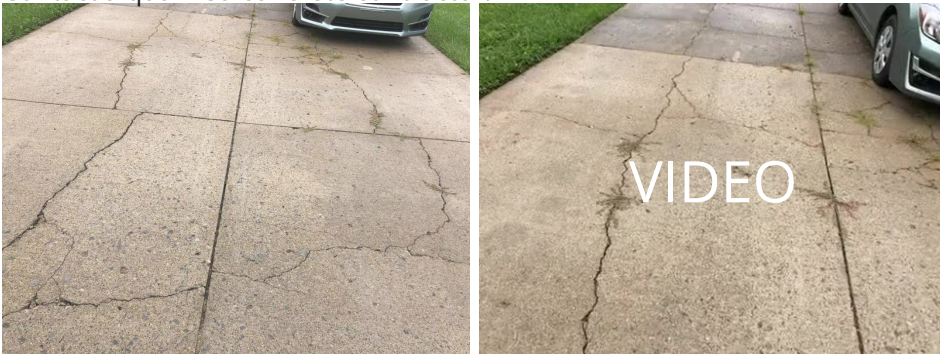
3.7.1 Driveways & Walkways  
**CRACKING/SETTLING**

MODERATE CONCERN

Major cracks and/or settling observed. This may indicate inadequate soil prep or erosion. It may be a lack of reinforcing bar. Some trip hazards may exist. Further review by a concrete contractor is recommended.

Recommendation  
Contact a qualified concrete contractor.

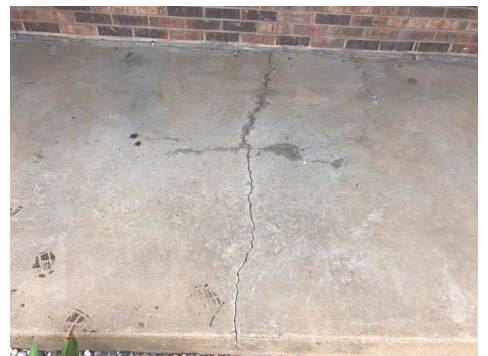
3.9.1 Porches & Patios  
**TYPICAL CRACKING**

MINOR CONCERN

There was some typical cracking/settling noted at the concrete. I observed no significant concerns.

Recommendation  
Recommend monitoring.

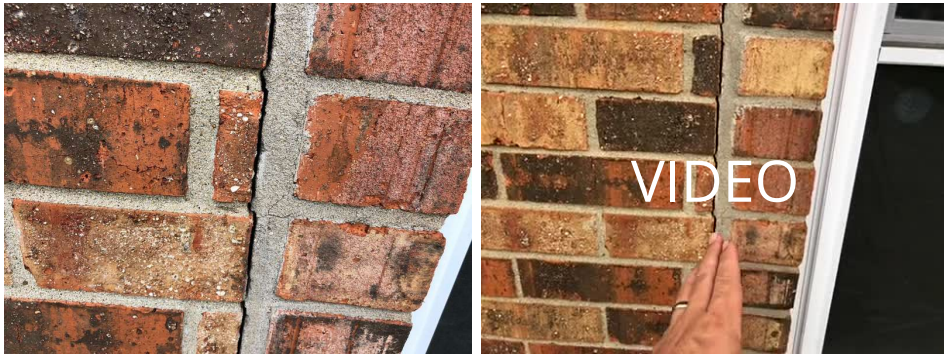
3.11.1 Masonry  
**GAPS**

MINOR CONCERN

Recommend that any gaps or penetrations in the masonry exterior be sealed to mitigate moisture intrusion.

Recommendation  
Contact a handyman or DIY project

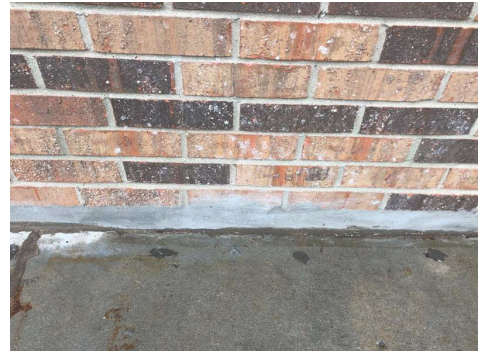
### 3.11.2 Masonry **WEEP HOLES**

**MINOR CONCERN**

No means was provided for ventilating the air space behind the brick (weep holes). Good building practice requires ventilating the air space behind the brick to help prevent moisture problems. Under certain circumstances, this condition can create moisture problems resulting from condensation and excessive moisture levels in wall assembly materials. This condition may also trap any moisture which finds its way into this space from roof or plumbing leaks. Excessive moisture levels in wall materials can also encourage the growth of microbes such as mold fungi. There is not typically a way to correct this condition because it requires flashing that can not be installed after the fact. Recommend monitoring the area.

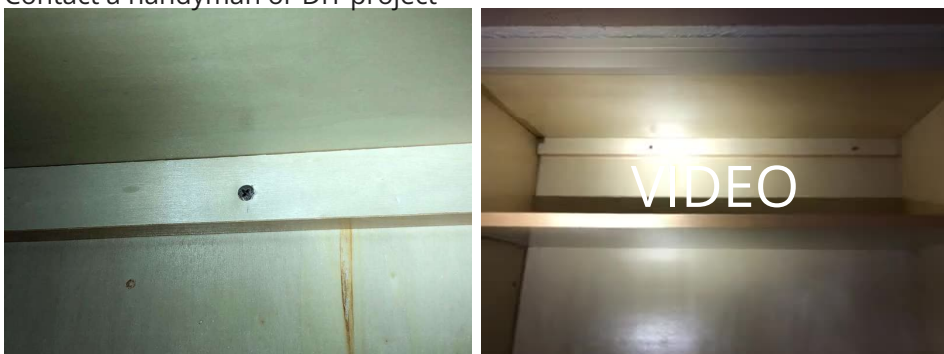
### 4.7.1 Countertops & Cabinets **CABINET SCREWS**

**MINOR CONCERN**

One or more cabinet screws are missing or the wrong type of screws were used. Recommend further review and installing as needed.

Recommendation  
Contact a handyman or DIY project

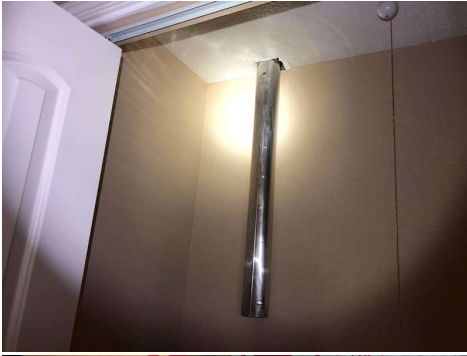
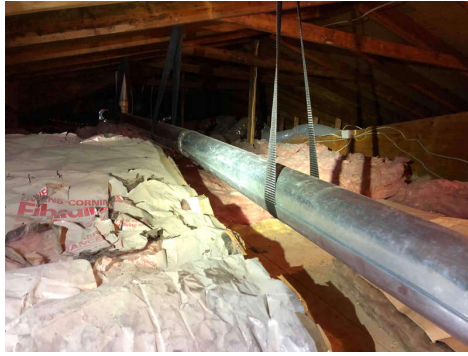
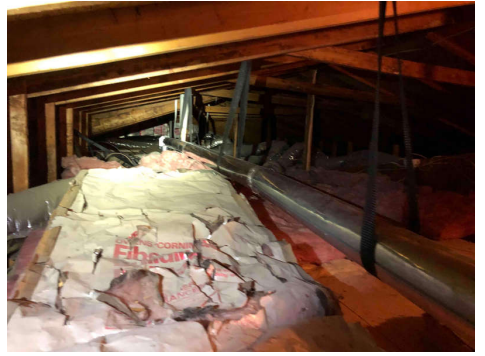
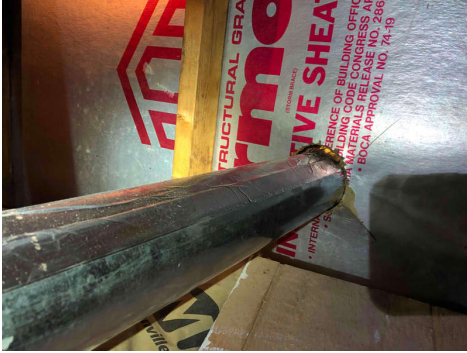
### 4.8.1 Laundry **DRYER VENT IN ATTIC**

**MODERATE CONCERN**

The metal dryer vent should be insulated. They are prone to clogging when the hot moist air hits the colder metal vent. Recommend making improvements.

Recommendation  
Contact a qualified professional.

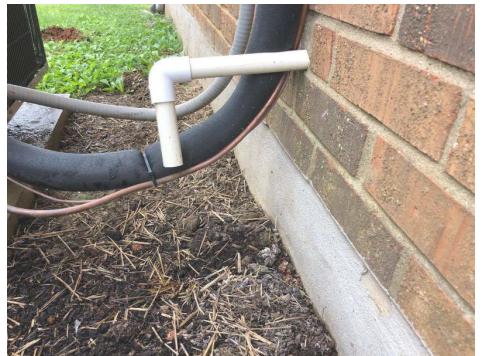
#### **DRAIN**

**MINOR CONCERN**

The condensation drain should extend further away from the foundation.

Contact a handyman or DIY project

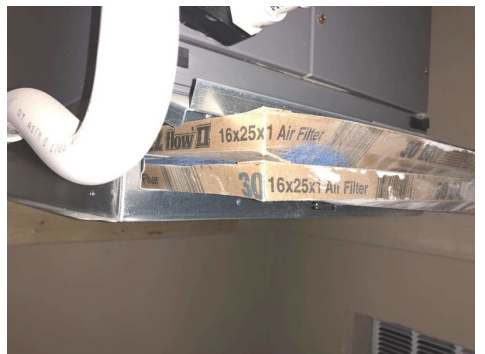
#### **WRONG SIZE**

**MINOR CONCERN**

The filter installed was the wrong size or improperly fit. Replace with proper filter or size. There should not be two installed.

Recommended DIY Project

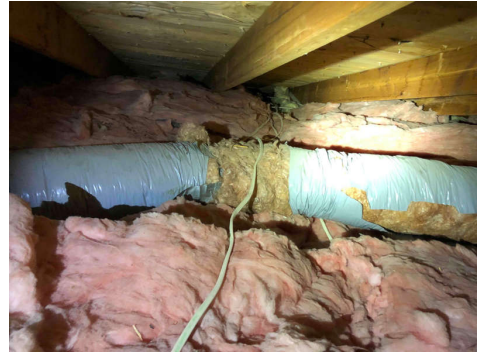
#### **DUCT DAMAGED**

**MODERATE CONCERN**

Air supply duct was damaged. This can impact the efficiency of the system.

Contact a qualified HVAC professional.

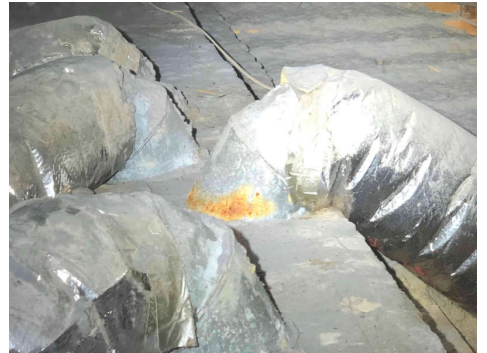
### 6.5.2 Distribution Systems **BOOT NOT INSULATED**

**MINOR CONCERN**

Sometimes when the boot is not insulated in an attic, the cold metal boot will cause condensation to form and some staining is the result. As seen here.

Recommendation  
Contact a qualified HVAC professional.

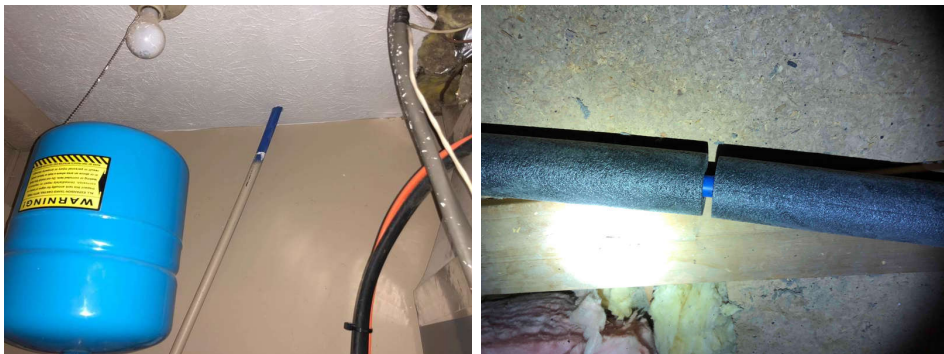
### 7.3.1 Water Supply **WATER LINES IN ATTIC**

**MODERATE CONCERN**

Some water lines run thru the attic. These appeared to be somewhat insulated but I could not confirm it was adequate to prevent the lines from freezing.

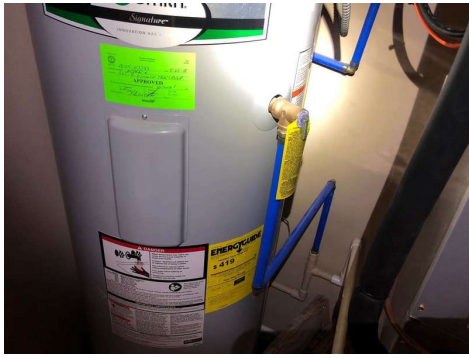
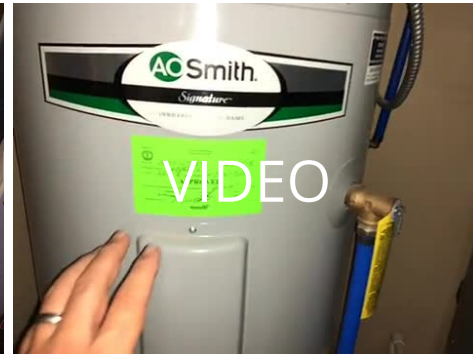
### 7.4.1 Hot Water - Tank **FAULTY T&P DISCHARGE**

**MINOR CONCERN**

**\*SAFETY\*** Faulty T&P drain. Recommend further review and repair. Here are the guidelines. The drain pipe must be as short as possible and be the same size as the valve discharge connection throughout its entire length. Excessive length, over 15 long, or the use of more than two elbows can cause a restriction and reduce the discharge capacity of the valve. The drain pipe must pitch down from the valve and terminate a maximum of 6 above the floor drain, or outside ground level where any discharge will be clearly visible. The drain line shall terminate plain, not threaded, with a material serviceable for temperatures up to 250F or greater.

Recommendation  
Contact a qualified plumbing contractor.

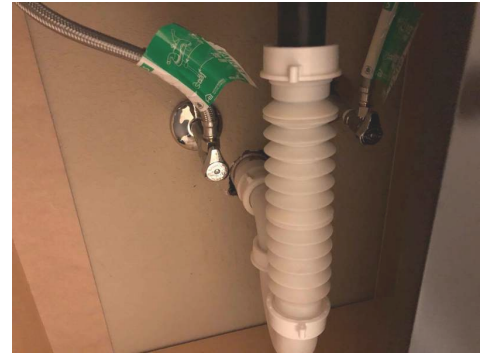
#### **FLEXIBLE DRAIN**

The use of flexible drain is not recommended as they are prone to clogging.

Recommendation  
Recommend monitoring.

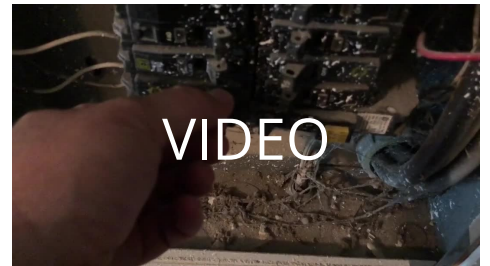
#### **LOOSE**

One or more of the breakers were loose.

Recommendation  
Contact a qualified electrical contractor.

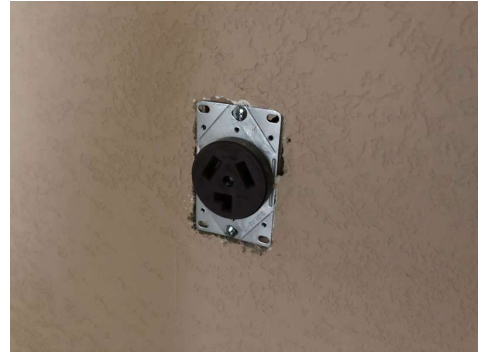
#### **COVER PLATES MISSING**

**\*SAFETY\*** One or more receptacles are missing a cover plate or the cover was damaged/loose. This causes short and shock risk. Recommend installation of plates.

Recommendation  
Contact a handyman or DIY project

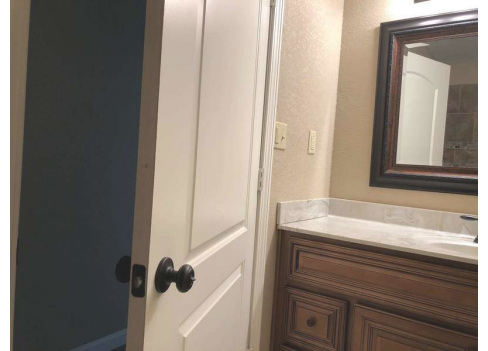
### SWITCH BEHIND DOOR

Switch to was located behind the door.

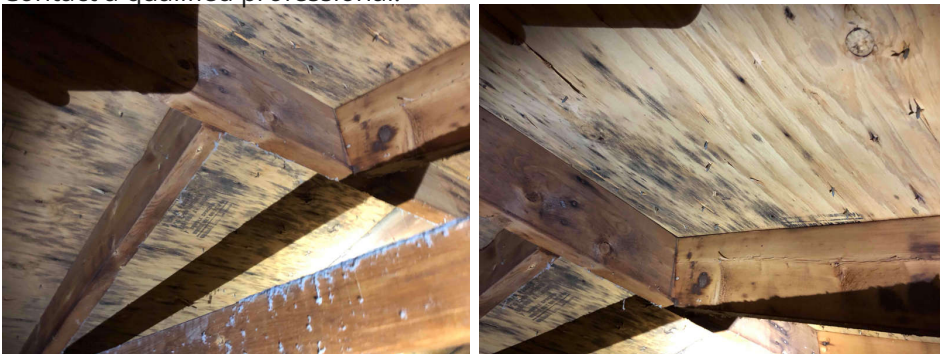
### MICROBIAL GROWTH

There was a substance noted in the attic that appeared to be microbial growth. Many times this is resulted from inadequate venting of the attic. It appeared as though the dryer vent had been terminated into the attic. Confirming the presence of mold lies beyond the scope of a home inspection.

Recommendation  
Contact a qualified professional.

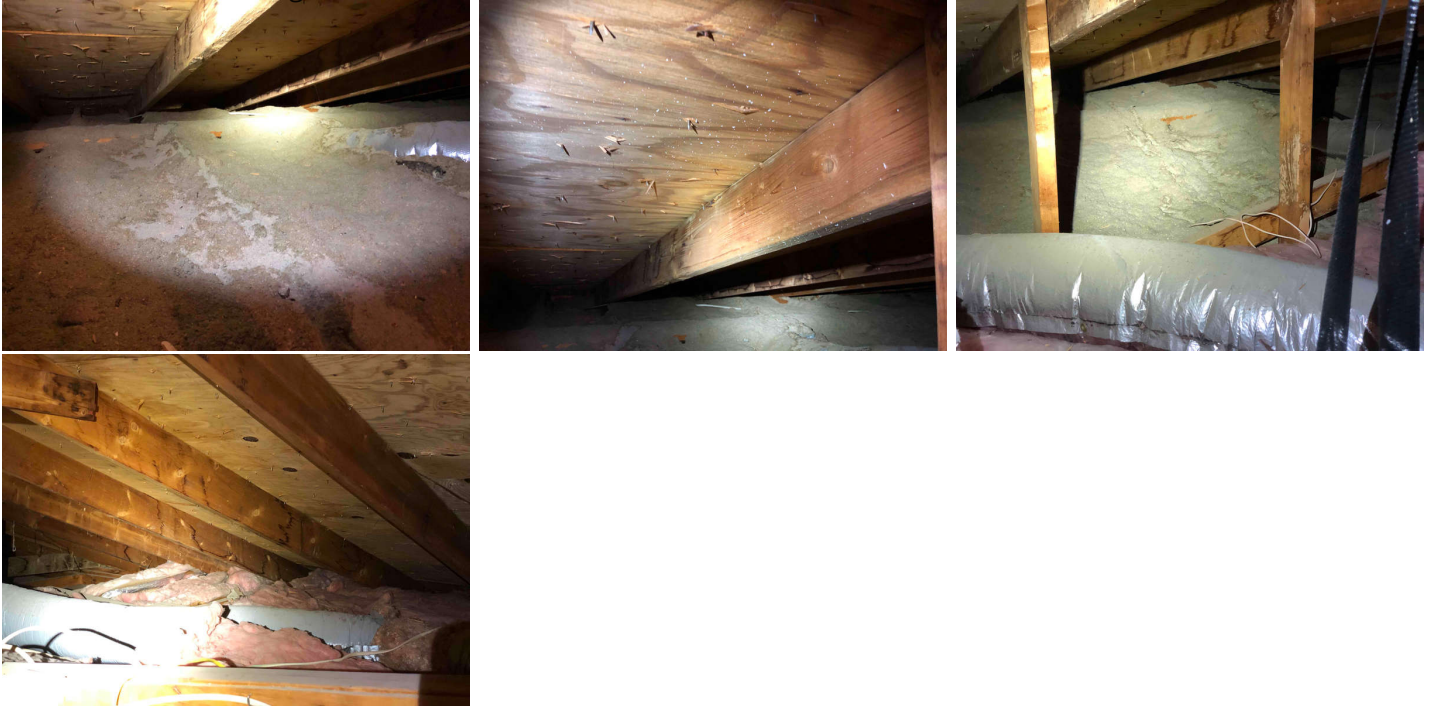
**PREVIOUS LEAKS**

**MINOR CONCERN**

There was some water staining indicating previous water leaks. There were some signs of moisture intrusion at the insulation. No active moisture was observed however.

Recommendation  
Recommend monitoring.

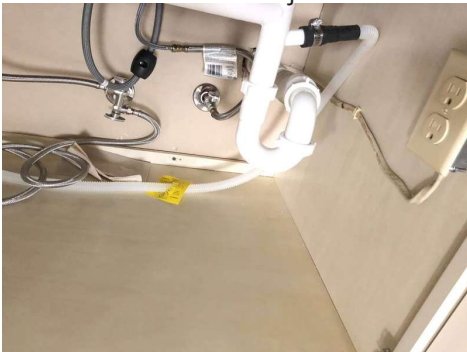
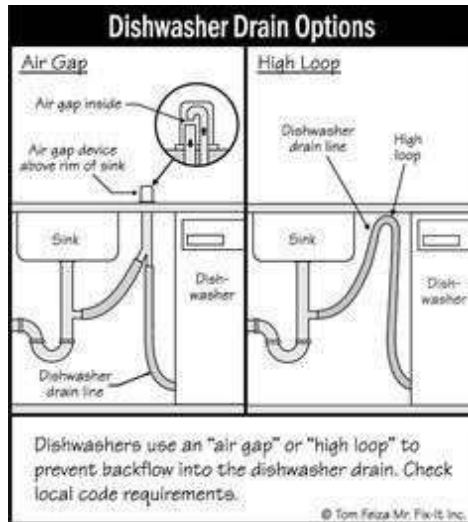
**HIGH LOOP MISSING**

**MINOR CONCERN**

Dishwasher drain pipe was installed improperly. Recommend a qualified plumber evaluate and repair.

Recommendation  
Recommended DIY Project

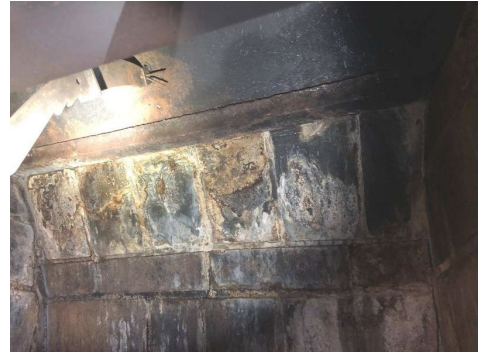
**RUST/CORROSION**

**MODERATE CONCERN**

There was some evidence the chimney needs to be cleaned. Signs of corrosion or buildup were noted in the attic. Recommend having a chimney sweep evaluate.

Recommendation  
Contact a qualified chimney sweep.
