## SUMMARY

1234 Main St. Fort Worth Texas 76126

Kent Keith  
TREC Professional Inspector #7413  
Green Tag Inspection Services  
8177053200  
[kent@fortworthinspector.com](mailto:kent@fortworthinspector.com)

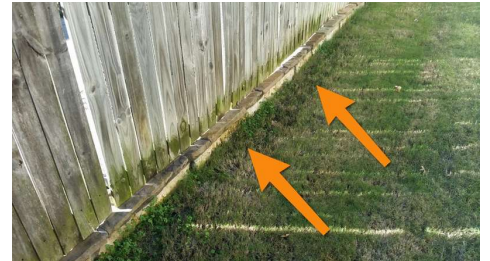
#### SWALE GRADING

The swale grading at the left side is poor and can allow excessive water to collect and not drain properly. Installing a surface or French drainage system is recommended.

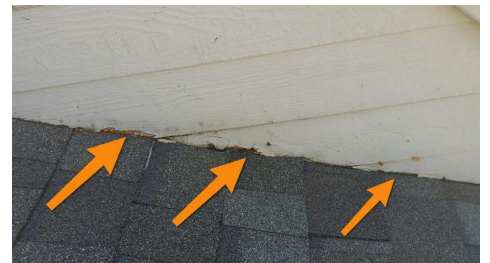
#### INADEQUATE SIDING CLEARANCE

There should be a one inch clearance between the upper rear siding and the roof shingles to prevent water from wicking into and damaging the siding.

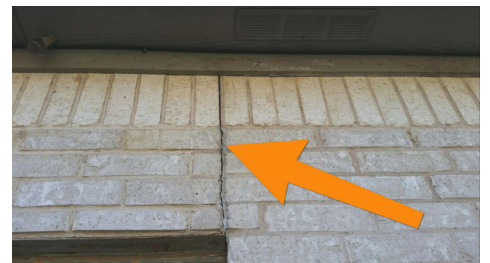
#### CAULK EXPANSION JOINTS

The expansion control joints to the right side exterior brick veneer walls should be caulked and sealed.

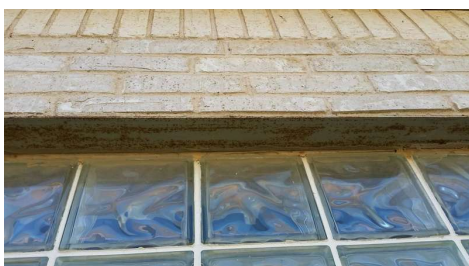
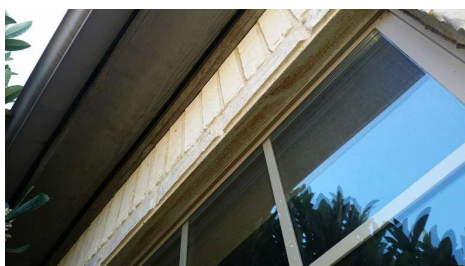
#### RUSTING LINTELS

The metal lintels above windows are starting to rust and should be painted with a rust inhibitor paint.

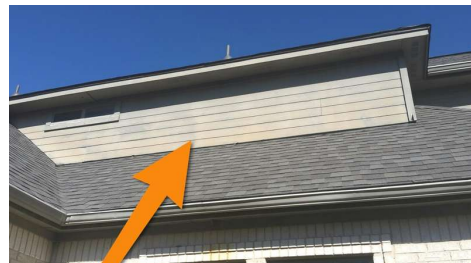
### SIDING

The left side siding is sun faded and needs maintenance painting.

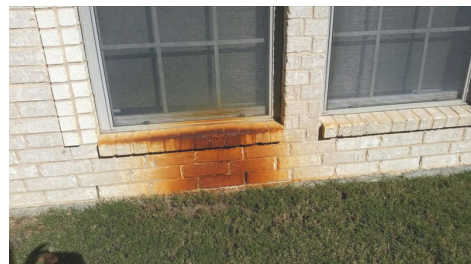
### BRICK

There is brick on the left side of the house that is stained with rust.

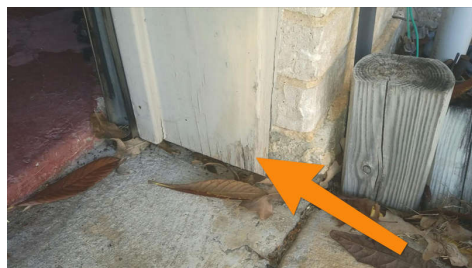
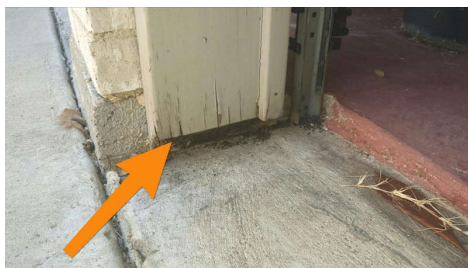
### WOOD ROT - GARAGE DOOR JAMBS

The bottoms of the overhead garage door jambs have minor wood rot and needs repairs or replacements.

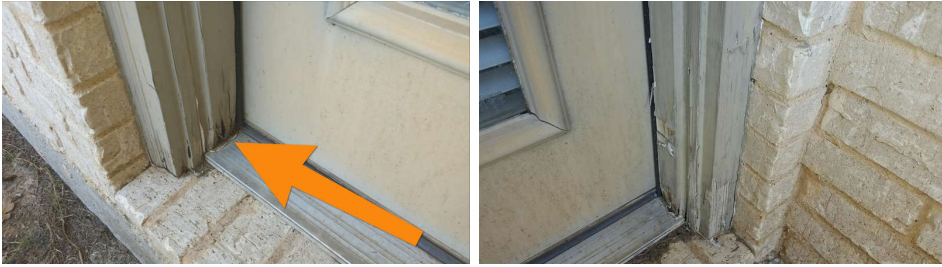
### DOOR TRIM AND JAMB

The door jamb and trims to the exterior door in the master bedroom has wood rot and chipping paint.

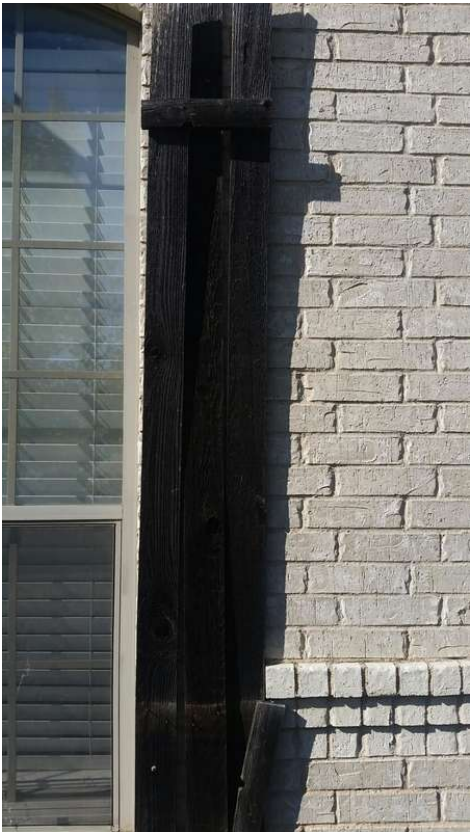
**SHUTTER**

There is a broke window shutter at the front right side of the house.

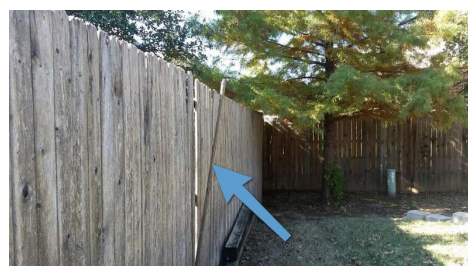
### FENCE PICKET

A loose fence picket was noted in the back yard.

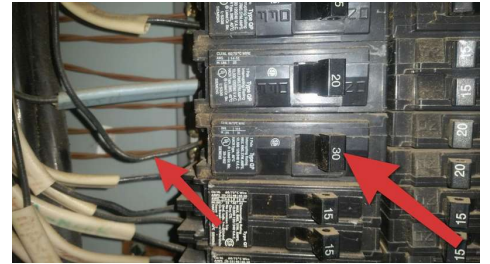
### OVERSIZED BREAKER

There is a circuit with 14 gauge wire that has a 30 amp breaker that needs to be changed to a 15 amp breaker.

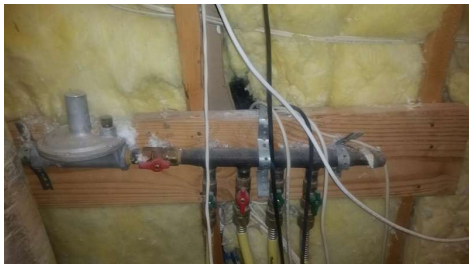
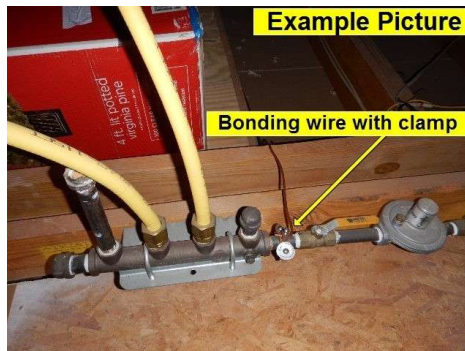
### CSST NOT GROUNDED

The CSST (Corrugated Stainless Steel Tubing) gas manifold in the attic needs to be properly bonded to be main electrical grounding system.

TREC Standards of Practice require the reporting of corrugated stainless steel tubing (CSST) that lacks electrical bonding and grounding.

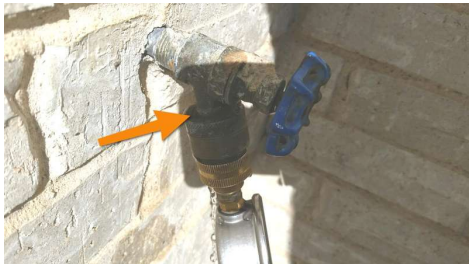
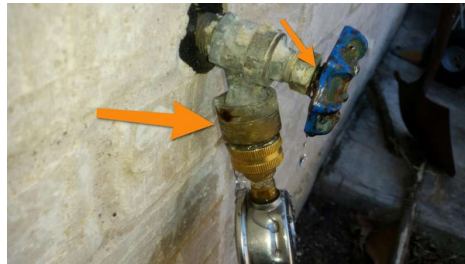
### HOSE FAUCET LEAKS WHEN PRESSURIZED

The left and right side hose faucets leak when pressurized and needs repairs.

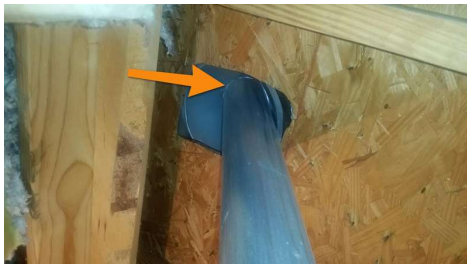
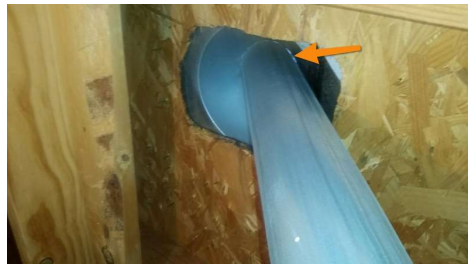
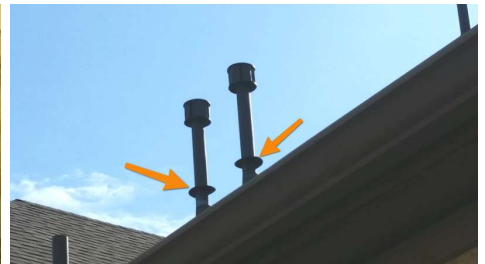
#### **WATER HEATER FLUE PIPE DIVERTER HOOD NEEDS SEALING**

The rain diverter hoods for the water heater's flue pipes needs to be sealed to prevent water intrusion.

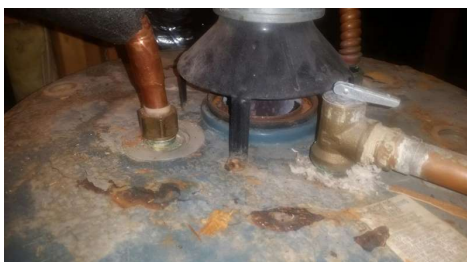
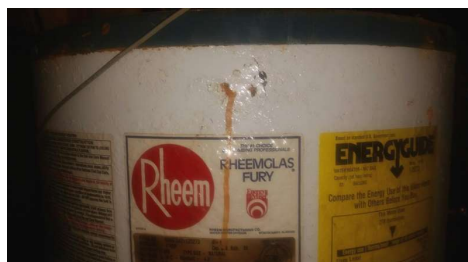
#### **CORRODED TANK**

The 2000 model water heater has a very rusted tank and should be replaced.

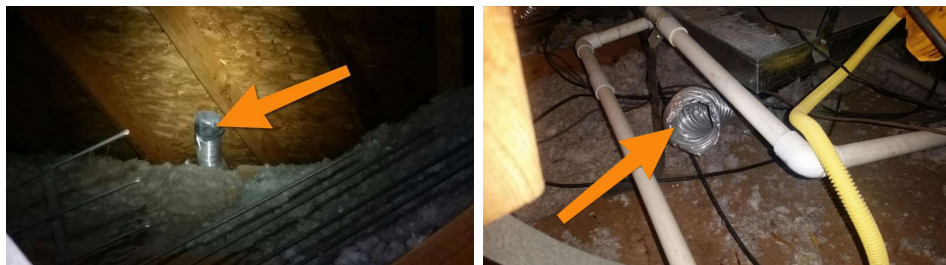
**EXHAUST FAN(S) TERMINATE TO ATTIC**

**The bath exhaust fans are venting into the attic and should vent to the exterior of the house.**

**TREC standards of practice require the reporting as deficient ducts that do not terminate outside the home.**

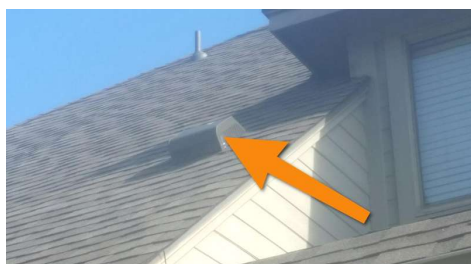
**IMPROPER DRYER VENT HOOD TYPE**

**The dryer vent hood on the roof is an improper type and can cause lint to collect. It should be replaced with a vent hood with a self-closing backdraft damper.**
