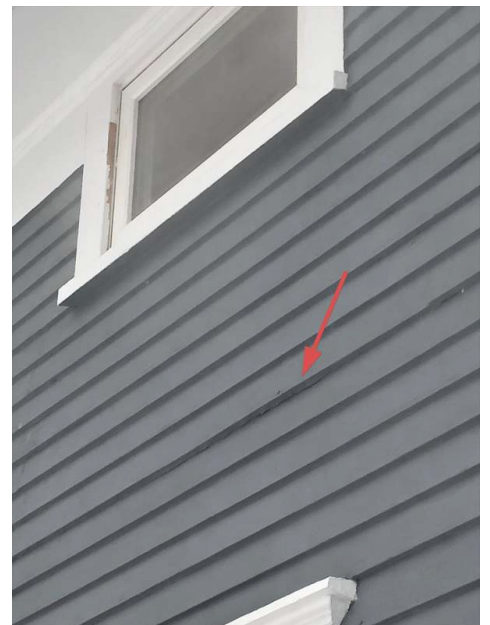
3.2.1 Siding, Flashing & Trim

CRACKING - MINOR

Siding showed cracking in one or more places. This is a result of temperature changes, and typical as homes with stucco age. Recommend monitoring.

Recommended DIY Project

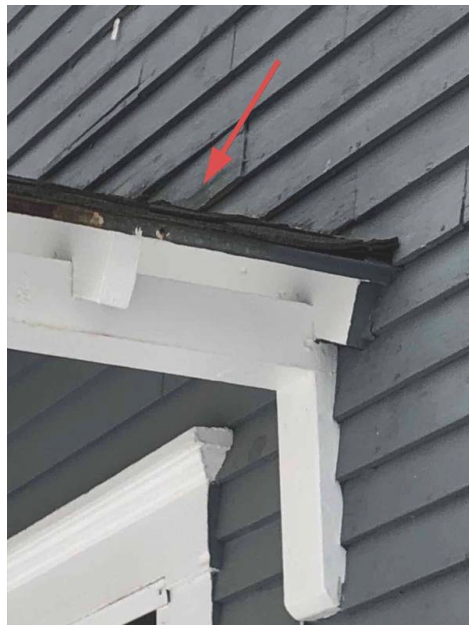
BACK ENTRANCE

3.2.2 Siding, Flashing & Trim

FLASHING/TRIM IMPROPERLY INSTALLED

Flashing & trim pieces were improperly installed or missing, which could result in moisture intrusion and damaging leaks. Recommend a qualified siding contractor evaluate and repair.

Contact a qualified professional.

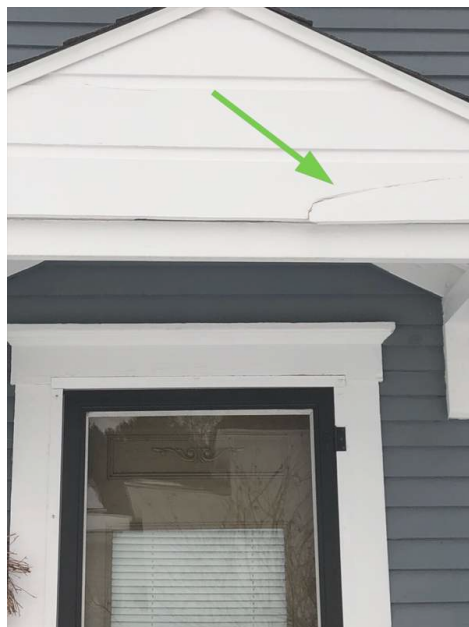
3.9.1 Porch Over Stoop

CRACKING OF FACIA BOARD

Possible entrance for water and decay. Recommend repair.

Contact a qualified carpenter.

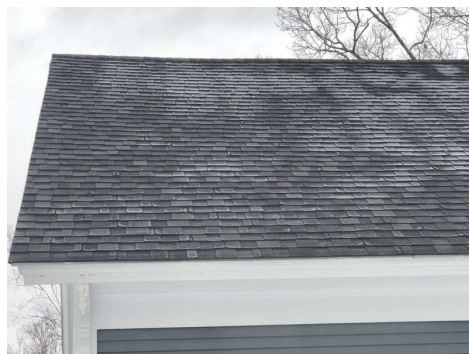
6.2.1 Ventilation

ATTIC VENTILATION INSUFFICIENT

Attic venting was insufficient at time of inspection. Modern standards recommend 1.5 square feet of venting area for every 300 square feet of attic floor space. Recommend an attic contractor evaluate and remedy.

Contact a qualified professional.

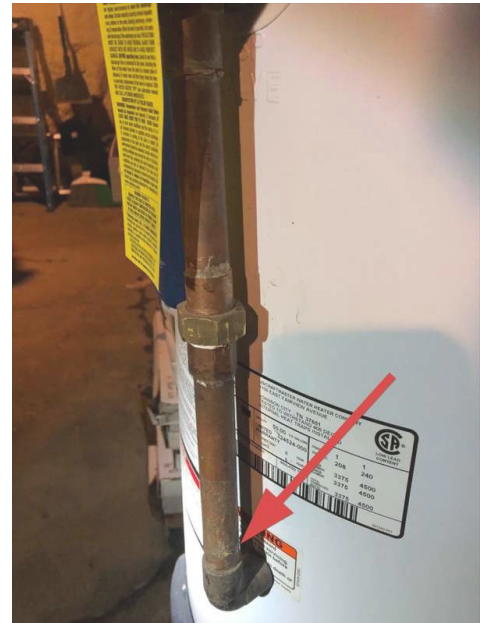
BASEMENT

11.4.2 Hot Water Systems, Controls, Flues & Vents

TPR DISCHARGE INCORRECTLY INSTALLED

Safety Hazard

Discharge pipe to the Pressure Temp Relief Valve is installed incorrectly. should be 3/4" ID, non-threaded, 6" above floor surface.

Contact a qualified plumbing contractor.

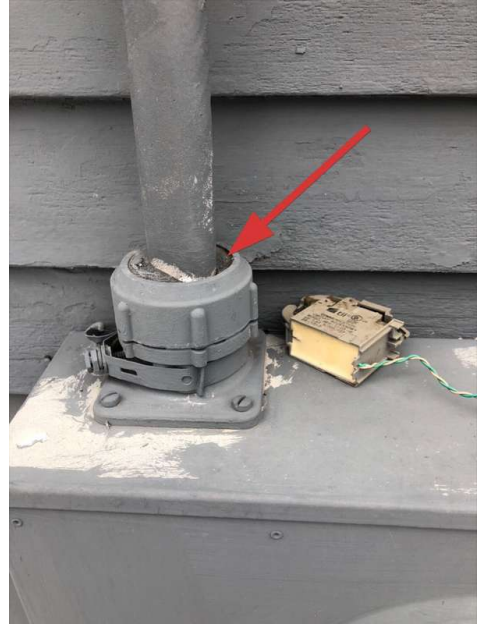
SOUTH

15.1.1 Service Entrance Conductors

WATER INTRUSION

There is possible water intrusion and the meter / service entrance. Additional chalk recommended. Moisture can deteriorate the electrical equipment. Recommend that a licensed electrician repair / replace as needed.

Contact a qualified electrical contractor.
