SAVIOR
INSPECTION SERVICES

SUMMARY

1234 Main St. Melissa TX 75454

Buyer Name
09/17/2018 9:00AM

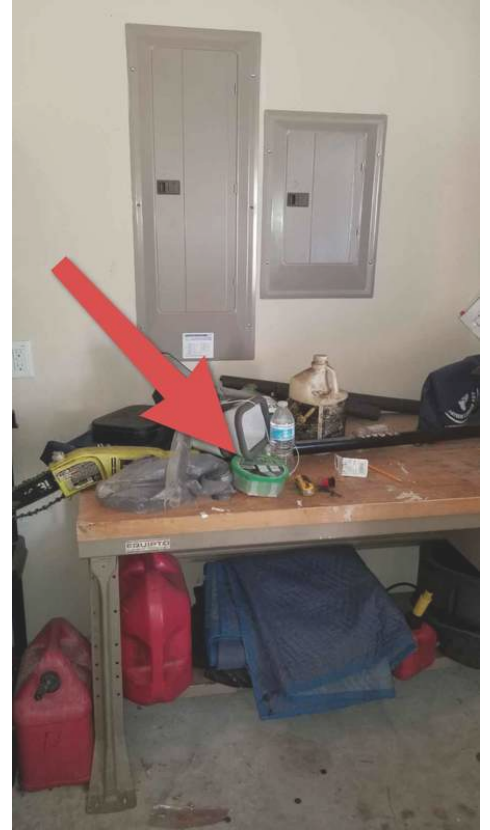
Garage

NOT ENOUGH CLEARANCE

The service panel did not have proper clearances to provide quick access for an emergency disconnect. The clear working space required in front of a panel is 30" wide by 36" deep with a minimum headroom clearance of 6 feet-6 inches. Recommend moving the work bench from in front of the panel to satisfy these requirements.

Contact a handyman or DIY project

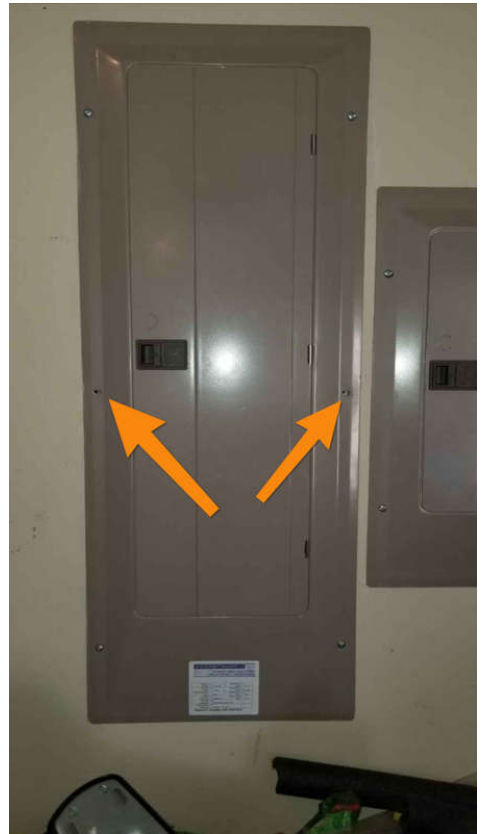
Garage

MISSING SCREWS

Service panel was missing 2 screws at time of inspection.

Contact a qualified electrical contractor.

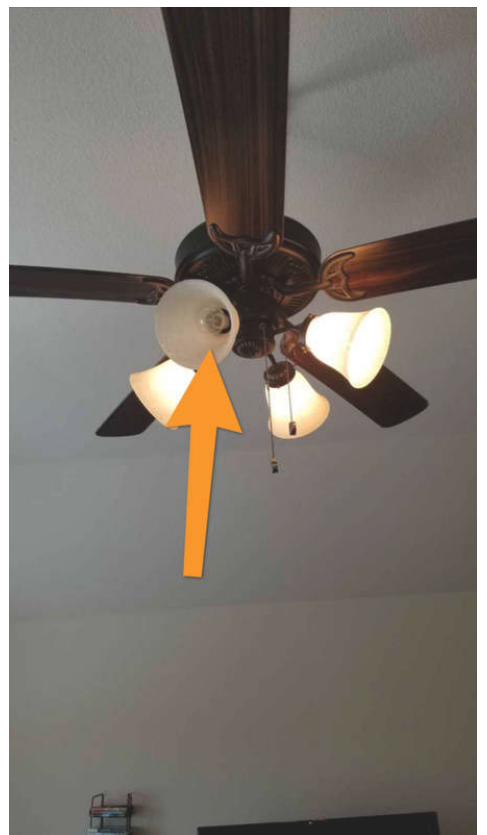
2nd Floor Gameroom

LIGHT DID NOT RESPOND

One or more lights did not respond to the switch. The bulb may need to be replaced or there may be a problem with the switch, wiring or light fixture. If after the bulb is replaced this light still fails to respond to the switch, the Inspector recommends that an evaluation and any necessary repairs be made by a qualified electrical contractor.

Contact a qualified electrical contractor.

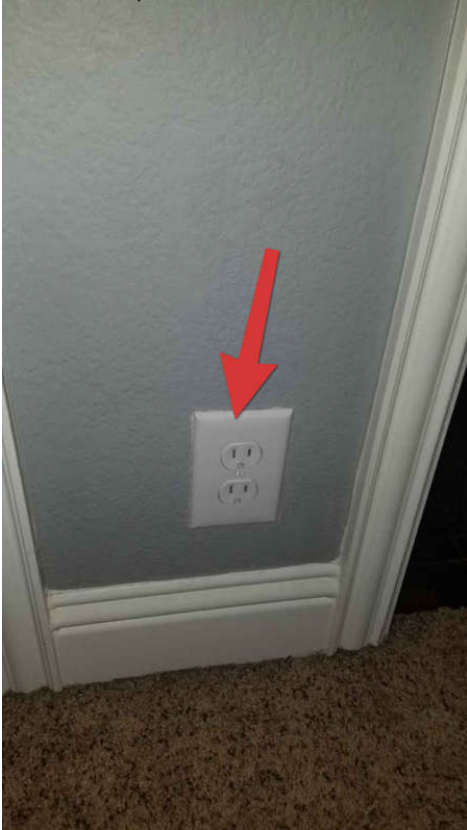
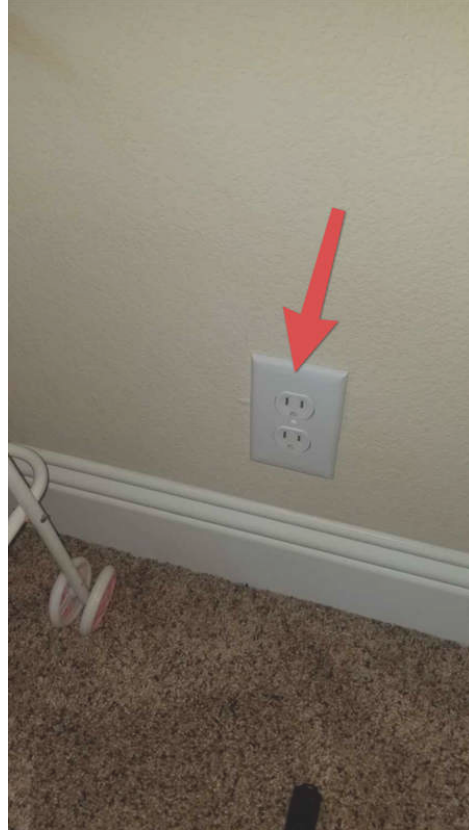
LOOSE OUTLET

One or more electrical receptacles in the home were improperly secured and moved when plugs were inserted. Receptacles should be securely installed to prevent fire, shock and/or electrocution hazard.

Contact a qualified electrical contractor.

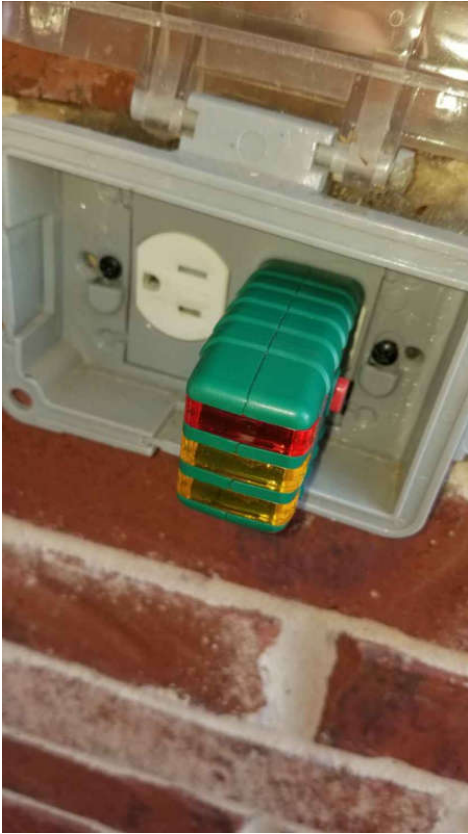
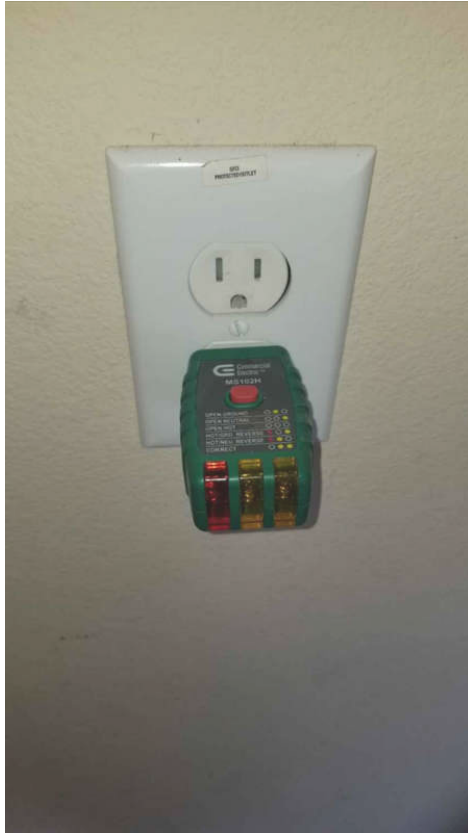
RECEPTACLE - INOPERABLE

Two receptacles were inoperable at the time of the inspection. There was a breaker that was in the OFF position at time of inspection. These receptacles may be on that particular circuit, however, since the breaker was already off at the time of inspection, it was not turned to the on position. Also, these are GFCI receptacles, so there may be a tripped GFCI outlet that needs to be reset, however one could not be located. The Inspector recommends service by a qualified electrical contractor if the OFF breaker or GFCI reset is not the reason why they are inoperable.

Contact a qualified electrical contractor.

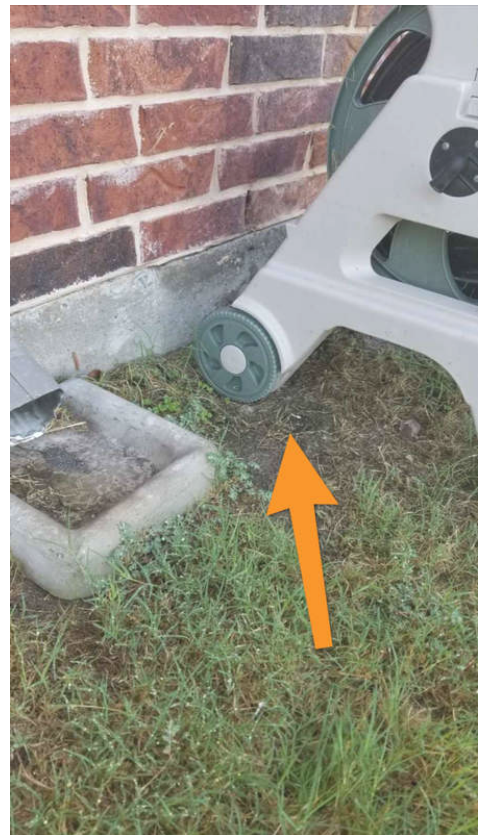
West

EROSION DUE TO DOWNSPOUT

In one or more locations, gutter downspouts causing minor erosion near foundation. Recommend installing downspout extensions to channel moisture away from foundation.

Contact a handyman or DIY project

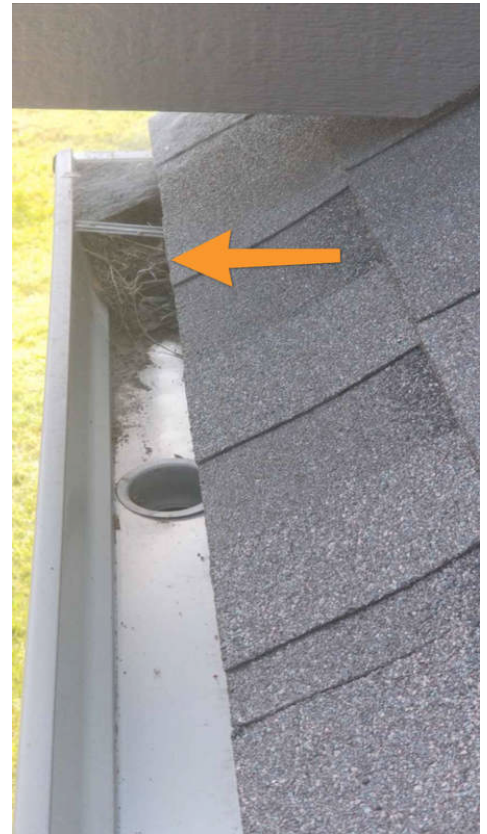
North

DEBRIS IN GUTTERS

Debris found in gutters which could adversely gutter performance. Recommend having gutters cleaned to ensure proper drainage.

Contact a handyman or DIY project

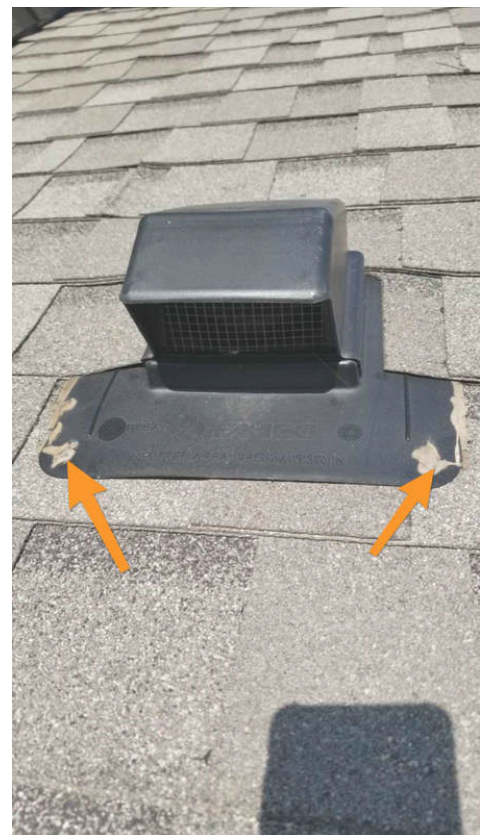
East

EXPOSED NAILS

Under-driven or exposed nails were found in one or more roof coverings. Recommend a qualified roofer evaluate and correct.

Contact a qualified roofing professional.

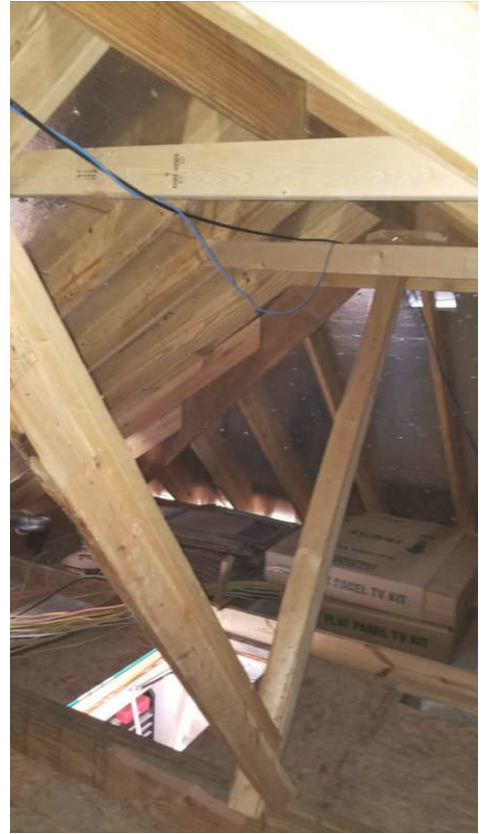
NO LIGHT IN THE ATTIC

The attic space above garage was not provided with a light.

Contact a qualified electrical contractor.

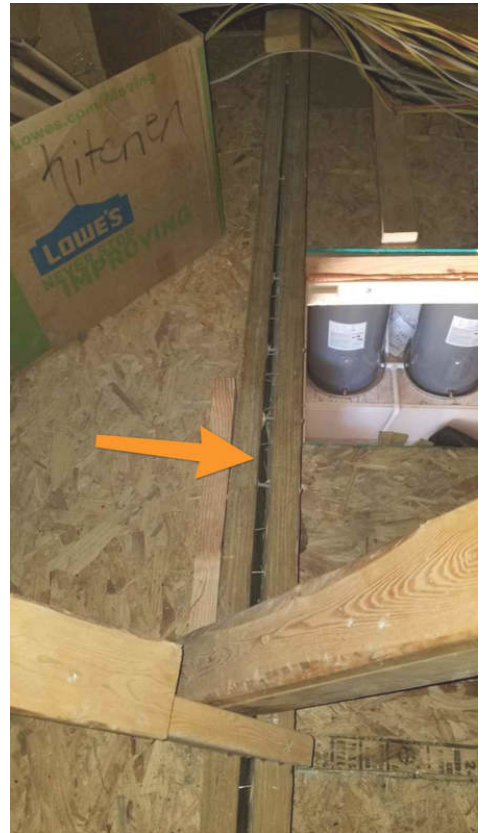
Attic Above Garage

TWISTED ENGINEERED BEAM

In attic above the garage, there are two engineered beams that parallel each other. One of those beams appear to have rotated or twisted and is separating from the other. There also appears to be a failed attempt at attaching these beams together.

Contact a qualified structural engineer.

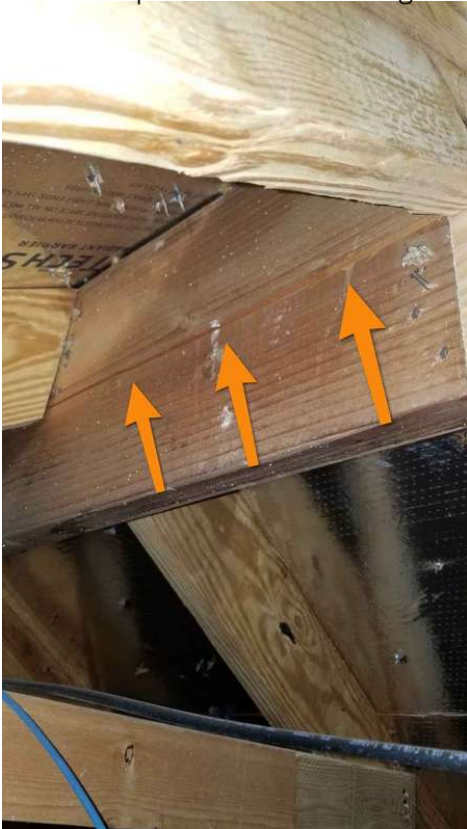
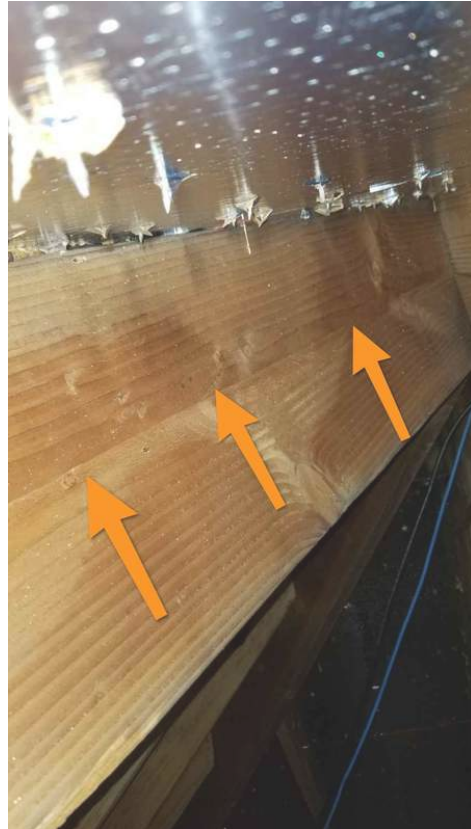
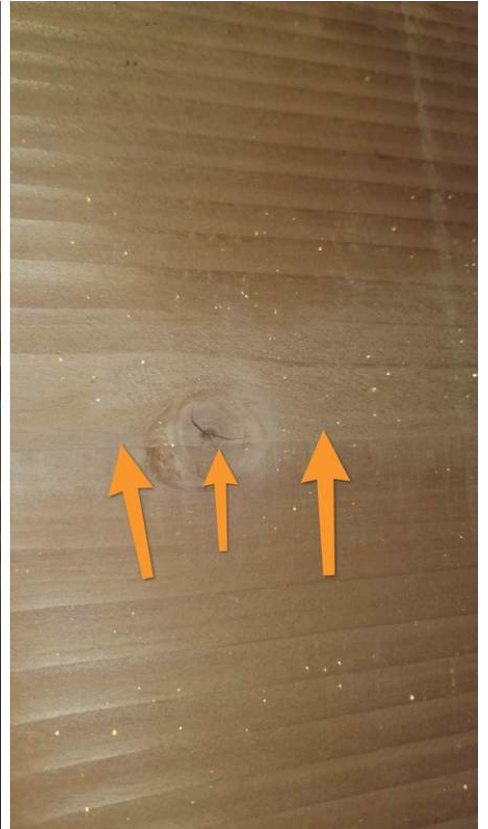
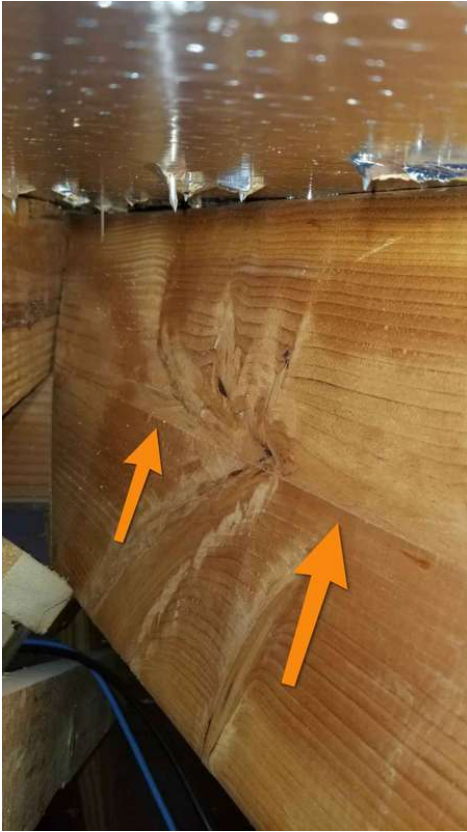
SPLIT FRAMING

In the attic above the garage, above the access hatch, there were three framing members that are split. These appear to be a combination of hip rafters and ridge beams. All of these are 2x12 boards and come together at the peak. Although difficult to see in photos, the split continues almost the entire length of a couple of the boards.

The Inspector highly recommends that a Structural Engineer evaluate the safety and integrity of the roof structure.

Contact a qualified structural engineer.

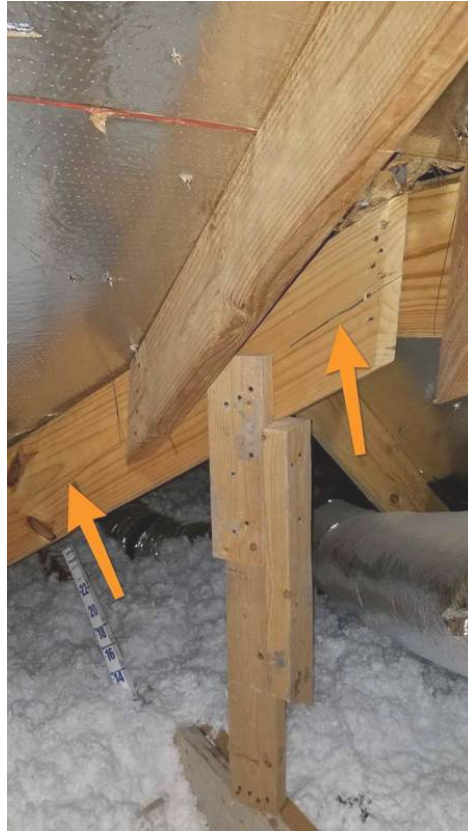
Attic Above Master Bedroom

In addition, in the portion of the attic above the master bedroom/bath, there was another split framing member.

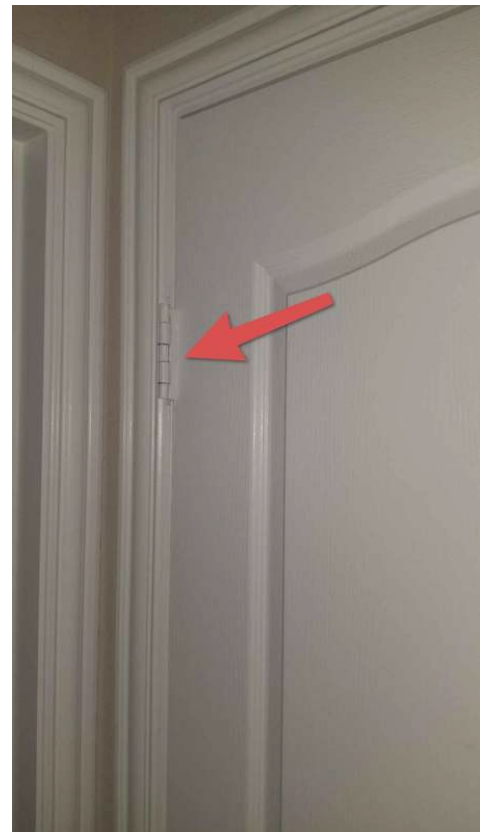
FIREWALL NOT COMPLIANT TO CURRENT SAFETY STANDARDS

The walls separating the garage from the home living space did not meet generally-accepted current safety standards firewall requirements. Firewalls are designed to resist the spread of a fire which starts in the garage for a certain length of time in order to give the home's occupants adequate time to escape.

This home failed to meet requirement number (5).

Door Leading to Garage Needs Self-closing Hinge

Contact a handyman or DIY project

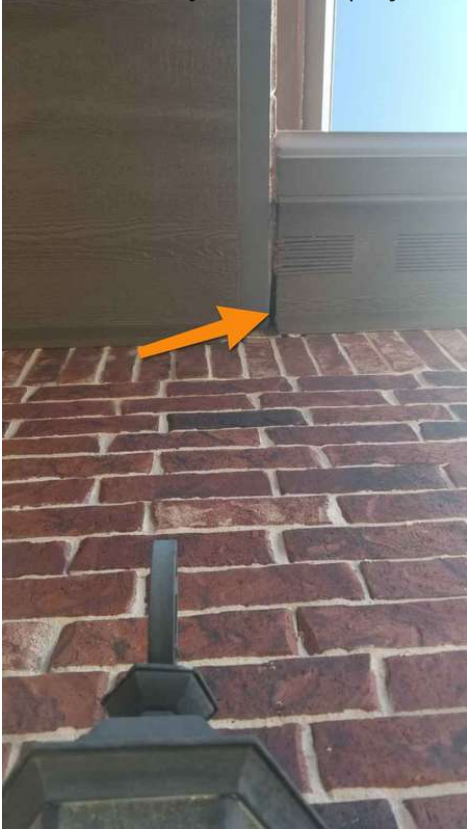
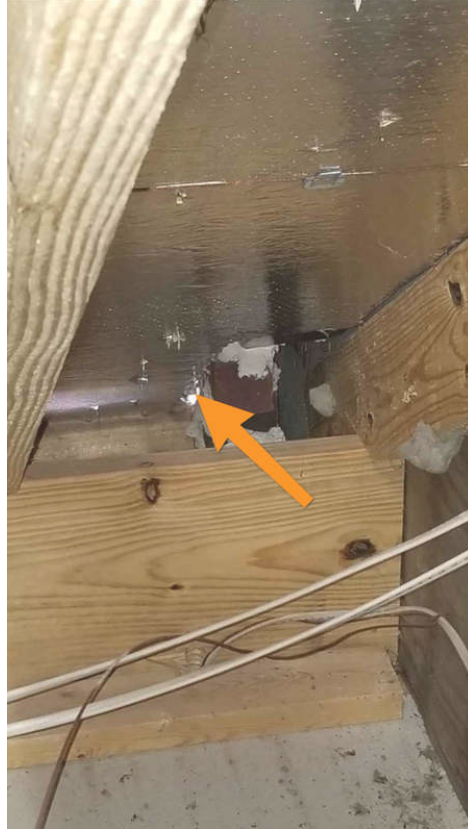
EXTERIOR GAP NEEDS SEALED

In one or more locations, gaps/holes were observed that are big enough for vermin intrusion. Recommend sealing gaps/holes to prevent vermin from entering attic space.

Contact a handyman or DIY project

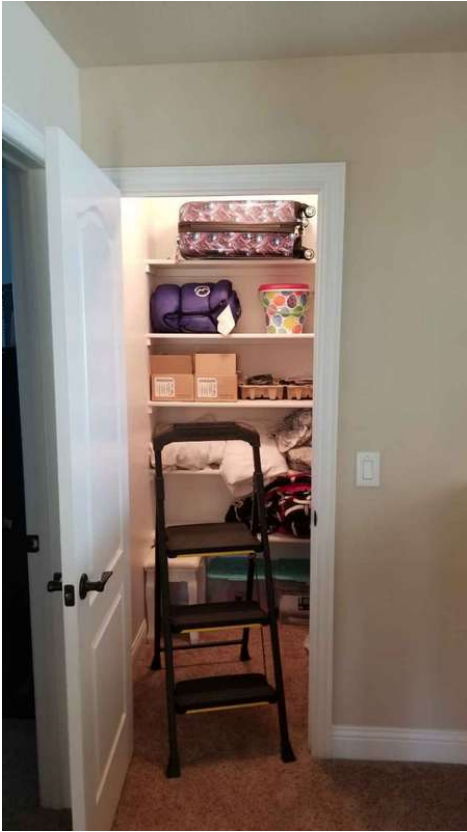
The ceiling in the 2nd floor closet showed signs of water intrusion, which could lead to more serious structural damage. In the ceiling area and wall area near the ceiling, there were very high levels of moisture present. This closet is directly underneath the air handler, which is leaking onto the attic floor. Once the leaking air handler is repaired, the Inspector recommends a qualified professional evaluate and repair the area of high moisture.

2nd Floor Closet Where Moisture is Present

Contact a qualified professional.

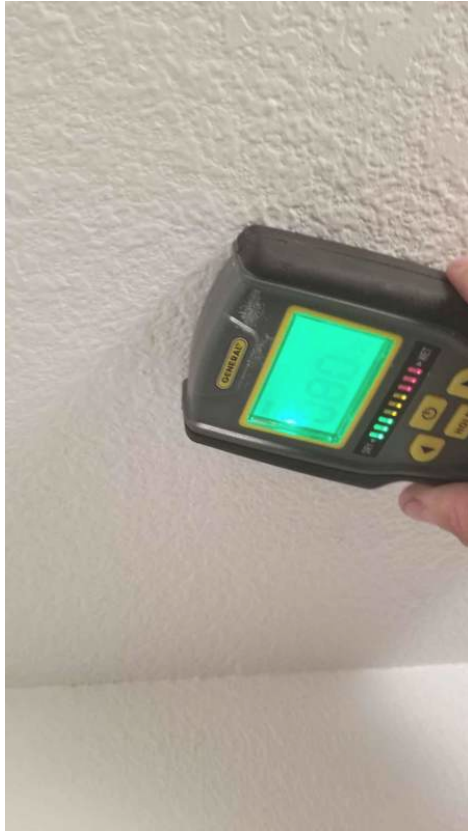
High Moisture, 2nd Floor Closet Ceiling

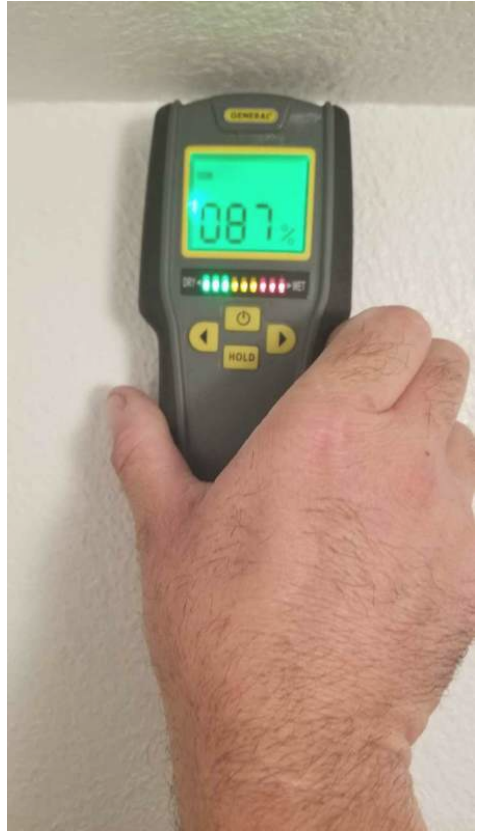
High Moisture Level , 2nd Floor Closet Wall

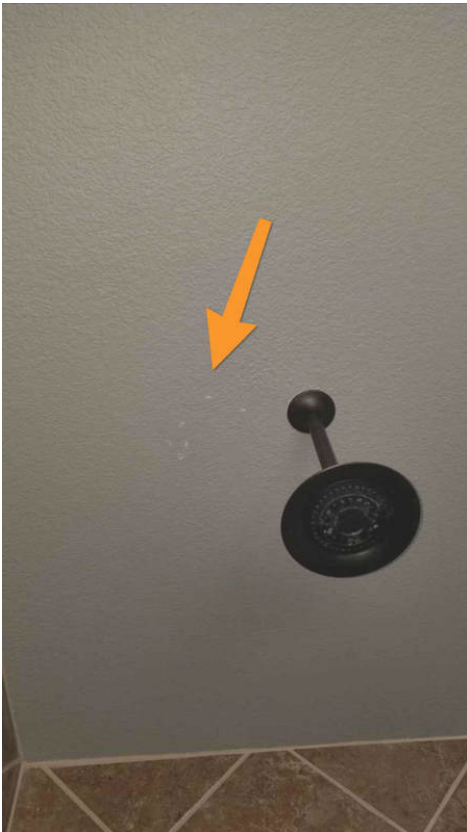
Master Bathroom

In the master bathroom shower, there is a small area right beside the overhead shower head that may be the result of water intrusion. However, the moisture meter showed very low levels of moisture in this area. The Inspector was unable to positively confirm the presence of moisture in this area and recommends monitoring the area to see if it worsens. Contact a qualified plumbing contractor to evaluate and repair if needed.

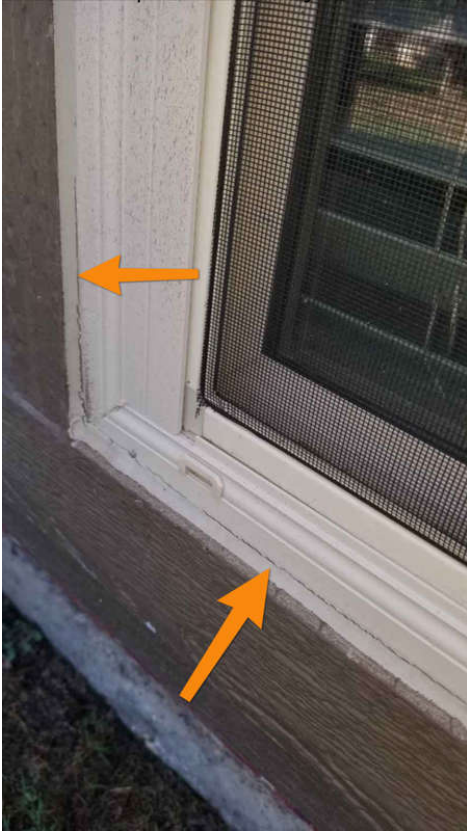
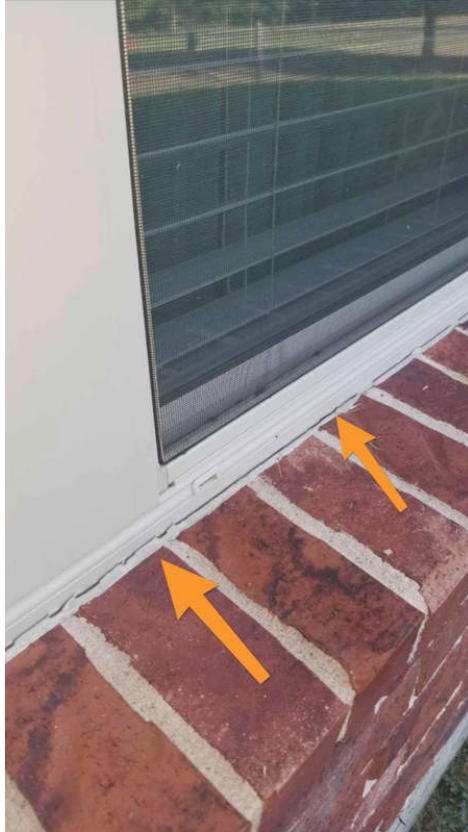
CAULKING

One or more windows need new exterior caulking to prevent moisture intrusion.

Recommendation
Contact a qualified handyman.

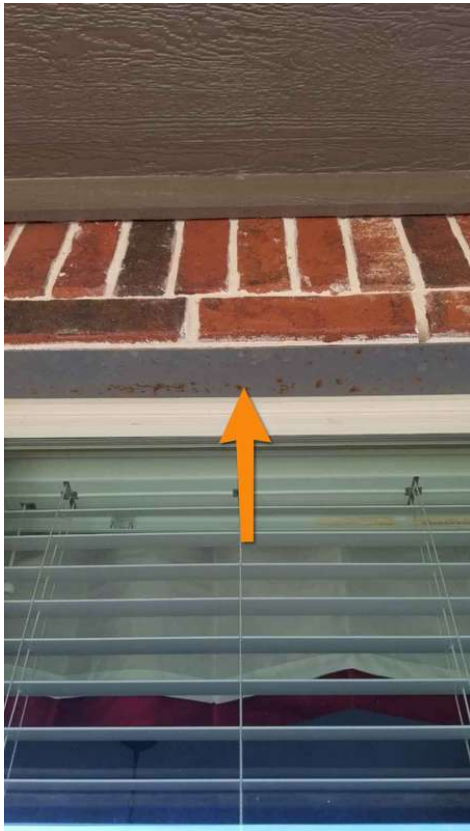
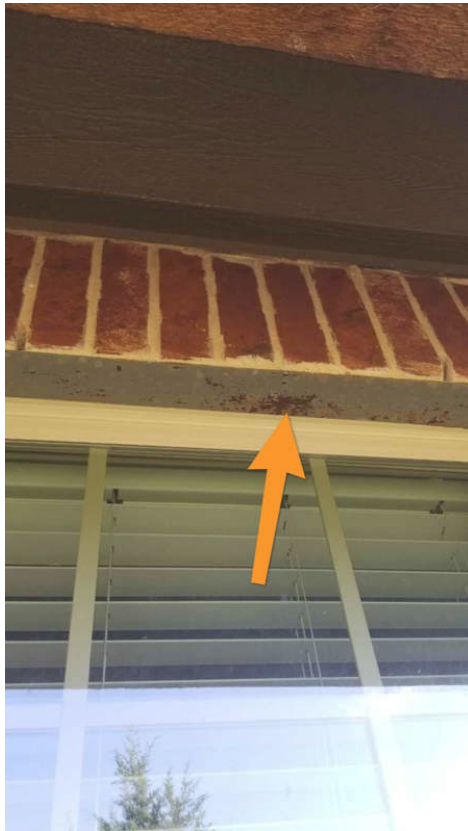
LINTLE RUSTED

In one or more location, lintels are rusted. Recommend having lintels painted to help prevent corrosion, which can damage the brick around it.

Recommendation
Contact a qualified professional.

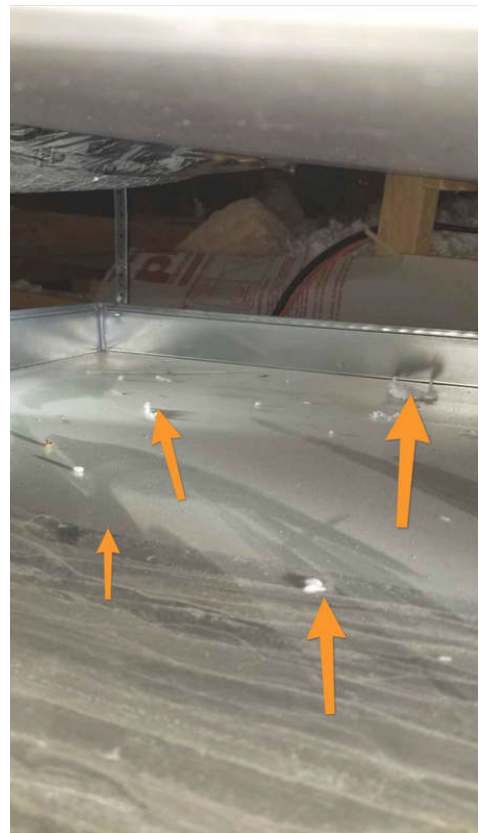
DRIP PAN DEBRI

Both secondary drip pan contain debri which can clog the drain line. If drain gets clogged it can result in overflowing the pan which will cause moisture damage to surrounding area. Recommend cleaning drip pan.

Recommended DIY Project

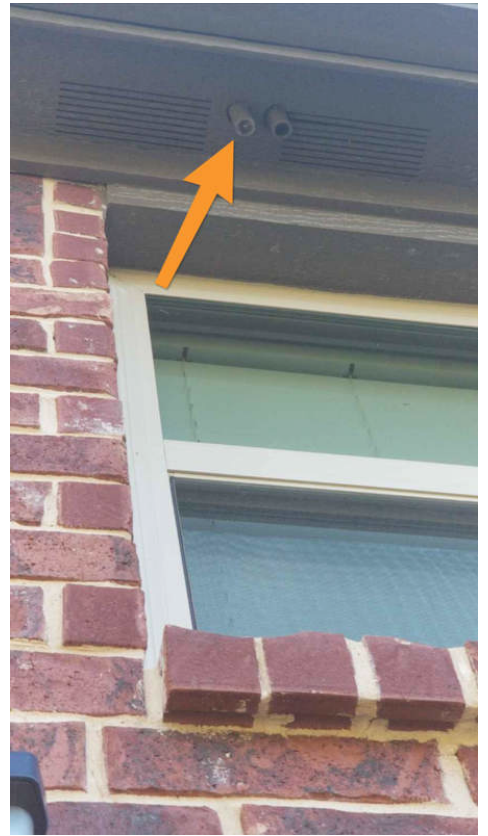
Northeast

CLOGGED SECONDARY DRAIN LINE

One of the secondary condensation drain lines appear to be clogged. This can result in moisture intrusion in the attic and the structure below the air handler.

Recommendation
Contact a qualified HVAC professional.

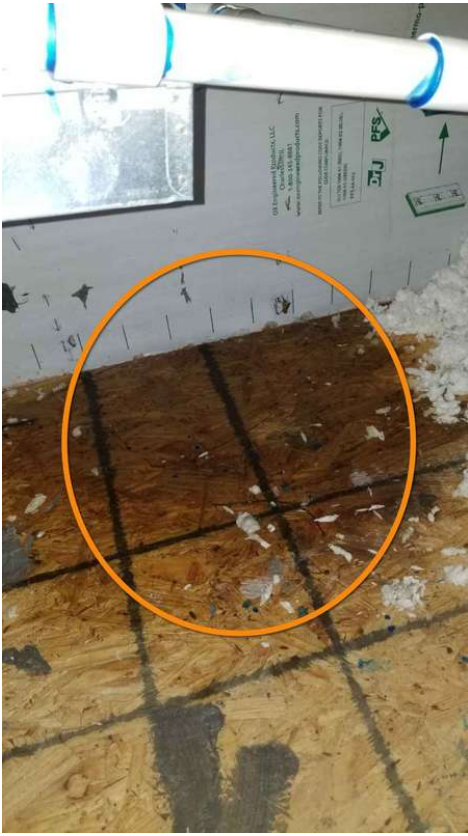
MOISTURE DRIPPING

Return side of air handler is leaking condensate onto the attic floor and running down the wall to the structure below. Water intrusion can cause mold and structural damage if not corrected.

Area of Moisture

Recommendation
Contact a qualified heating and cooling contractor

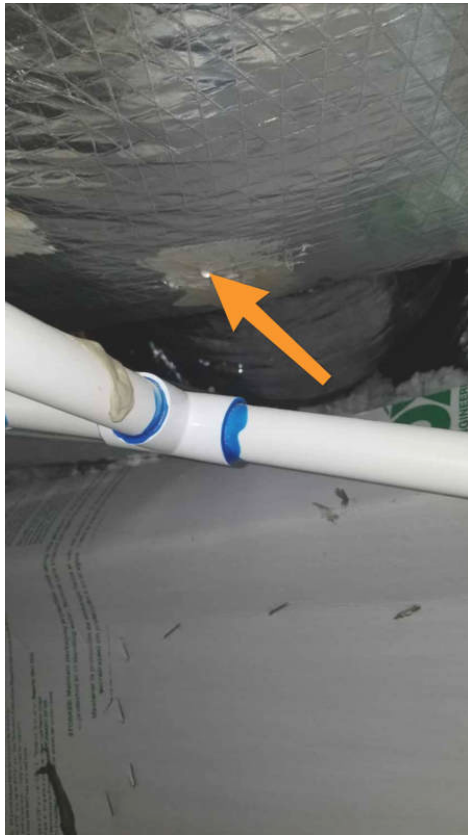
Dripping From Here
