**SUMMARY**  
1234 Main St. Windham NH 03087  
Buyer Name  
04/19/2019 9:00AM

Jenna Roberts-Weeks, CPI  
AHIT & InterNACHI Certified (CPI)  
Summit Home Inspection, LLC  
6039529101  
[contact@summit-homeinspection.com](mailto:contact@summit-homeinspection.com)

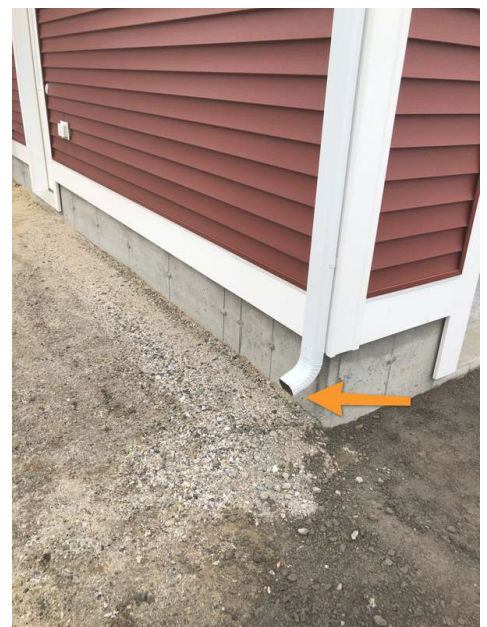
### **DOWNSPOUT-IMPROPER DRAIN CLEARANCE**

One or more downspouts drain too close to the home's foundation. This can result in excessive moisture in the soil at the foundation, which can lead to foundation/structural movement. Recommend a qualified contractor adjust downspout extensions to drain at least 6 feet from the foundation.

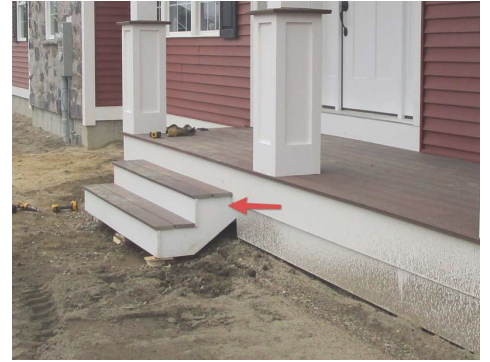
### **STEPS-MISSING**

Front porch is missing steps. Contractors were actively pouring the cement during the inspection. Please ensure steps are complete prior to moving into home.

Steps were removed during inspection. Front Steps

Recommendation  
Contact a qualified professional.

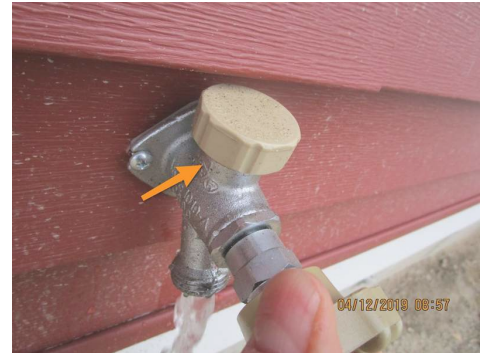
WEST

### 3.7.1 Exterior Hose Bibs **HOSE BIB-LEAKING**

Leak observed at exterior hose bib. This could be caused by dirt/debris inside vacuum breaker (top plastic portion) or a failed gasket/poppet preventing proper seating for vacuum breaker.

Leak observed at hose bib

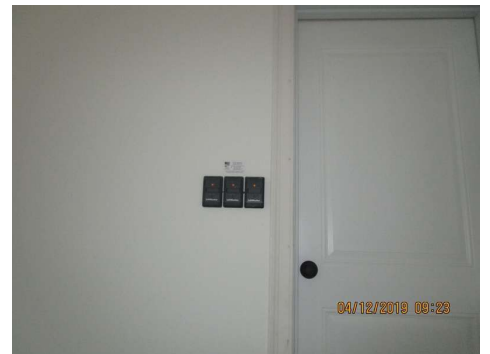
Garage Entry Door

### 5.1.1 Garage Structure **FIRE CODE-DOOR NOT SELF-CLOSING**

Door from garage to home should have self-closing hinges to help prevent spread of a fire to living space. Recommend a qualified contractor install self-closing hinges.

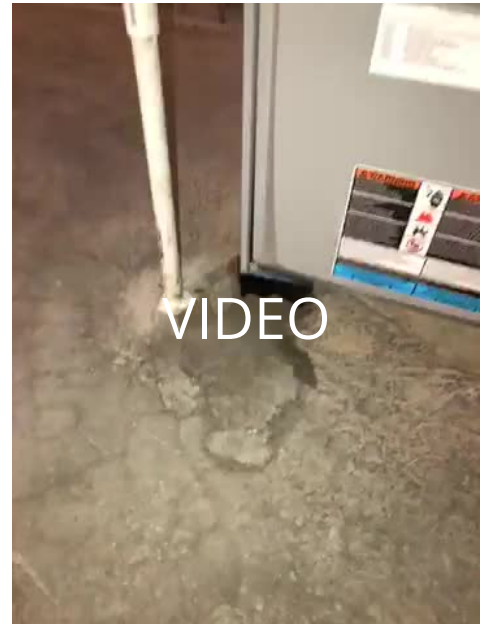
BASEMENT

### 7.1.1 Equipment **CONDENSATE DRAIN LINE LEAKING**

Observed an active leak at the condensate drain line. Condensate line appears to have standing water in the line. Recommend adjusting the pitch to allow proper drainage.

Recommendation  
Contact a qualified HVAC professional.

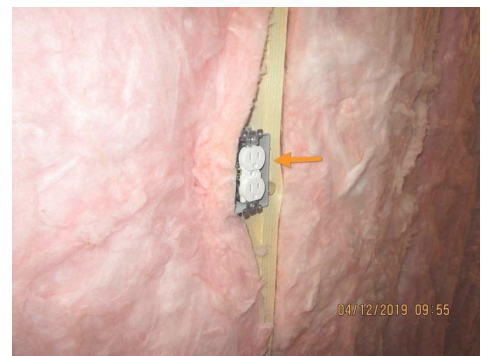
EAST DORMER

**COVER PLATES MISSING**

Cover plate missing on receptacle (outlet) in east dormer access. Recommend installation of plates.

Contact a handyman or DIY project

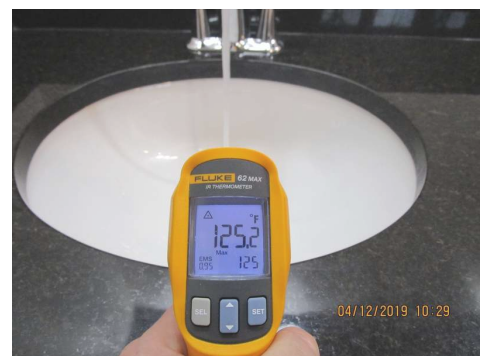
FIXTURES

**WATER TEMPERATURES ABOVE RECOMMENDED**

Water temperatures at faucet are above recommended 110-120 degrees. Temperatures in excess of 120 degrees have the potential to burn or scald a person. Recommend adjusting water heater to prevent injuries.

Contact a qualified professional.

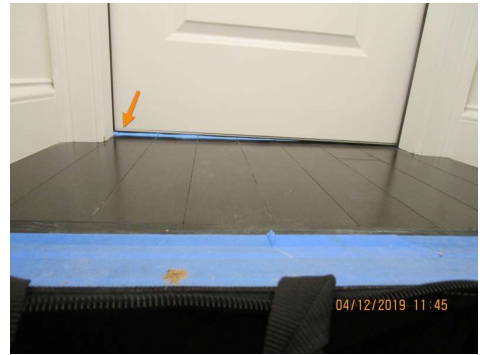
BASEMENT DOOR

**DOOR-OPENING/GAP OBSERVED**

Interior door appears to have a gap or opening at the bottom.

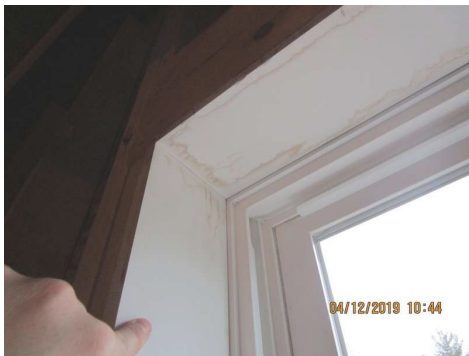
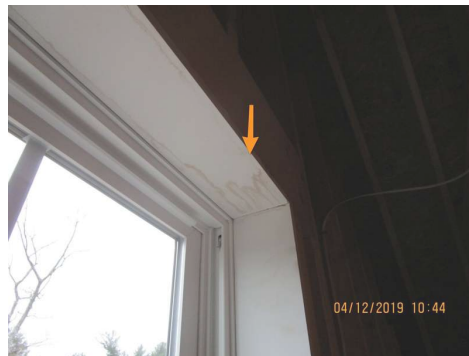
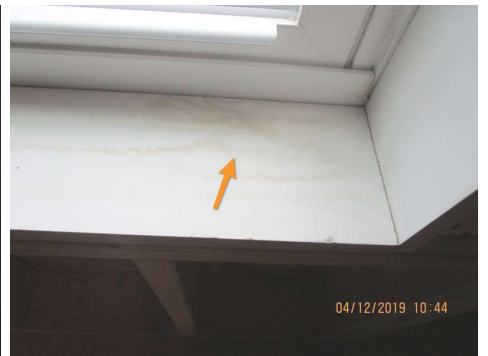
Attic window (South) Master Bedroom walkup

**WINDOW SILL-STAINS**

Observed staining on the window sill/trim. Stains appeared dry at time of inspection. Recommend monitoring location during heavy rainfall.

Material may have been stained prior to installation and require paint.

Contact a qualified professional.

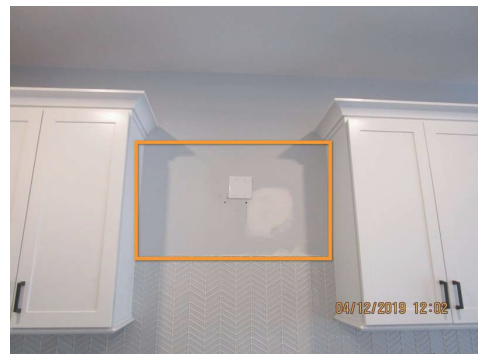
**EXHAUST SYSTEM MISSING**

Exhaust system was not installed at time of inspection. Confirm proper installation and operation prior to closing.

Kitchen-Exhaust hood missing

Contact your builder.
