## SUMMARY

1234 Main St. Anamosa IA 52205

Royal Home Inspections, LLC  
ASHI, InterNACHI Certified...

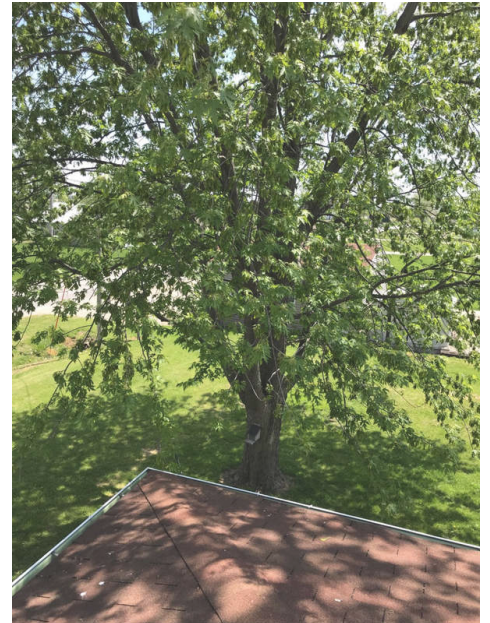
### 2.1.2 Roof Structure/Covering

#### ASPHALT SHINGLE, TREE OVERHANG

Tree limbs overhanging the roof of the home can shorten the life of your roof covering by up to 50%. The increase in debris can also cause increased gutter damming which slows or stops water drainage away from home. Recommend contacting a tree service to cut back branches to alleviate these possible issues.

Contact a qualified tree service company.

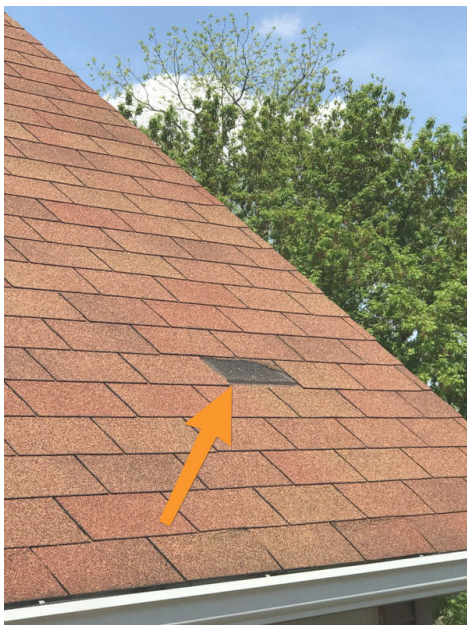
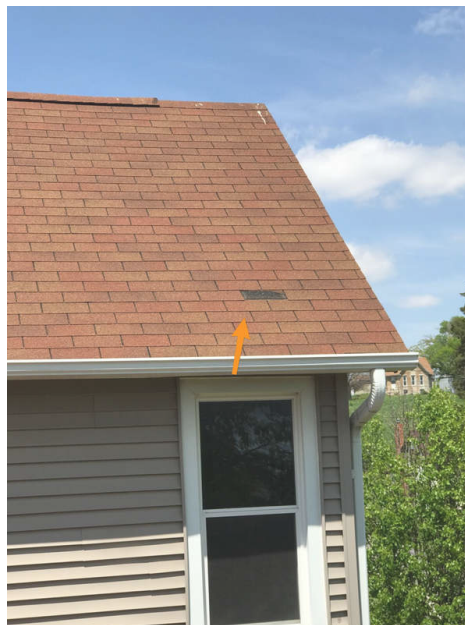
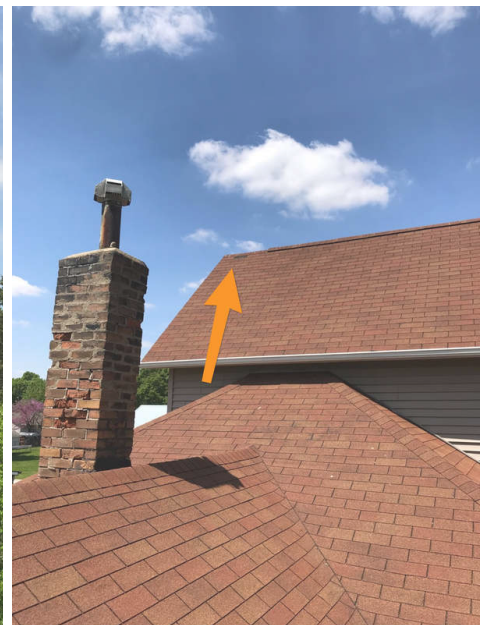
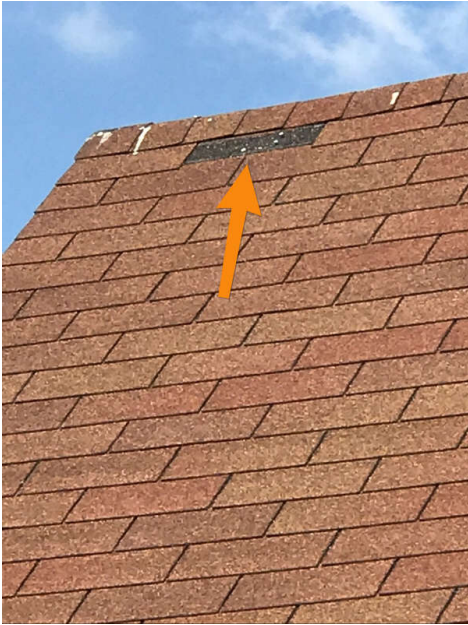
### 2.1.3 Roof Structure/Covering

#### MISSING SHINGLE.

Missing shingles observed at the time inspection. Recommend repair or replacement as a missing shingle could allow water penetration into structure

Contact a qualified roofing professional.

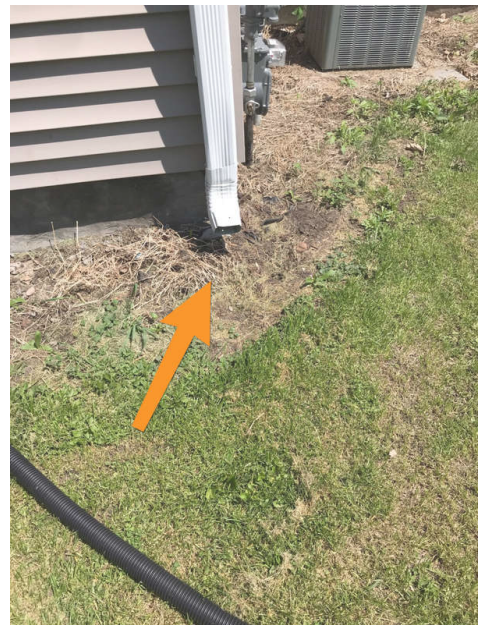
#### 2.4.1 Roof Drainage System

##### **GUTTERS, DISCHARGE TO FOUNDATION OR SLAB**

One or more downspouts discharged roof drainage next to the foundation or slab. This condition can effect the ability of the soil to support the weight of the structure above and can cause damage related to soil/foundation movement. The Inspector recommends the installation of downspout extensions to discharge roof drainage 4 to 6 feet from the foundation.

Contact a qualified gutter contractor

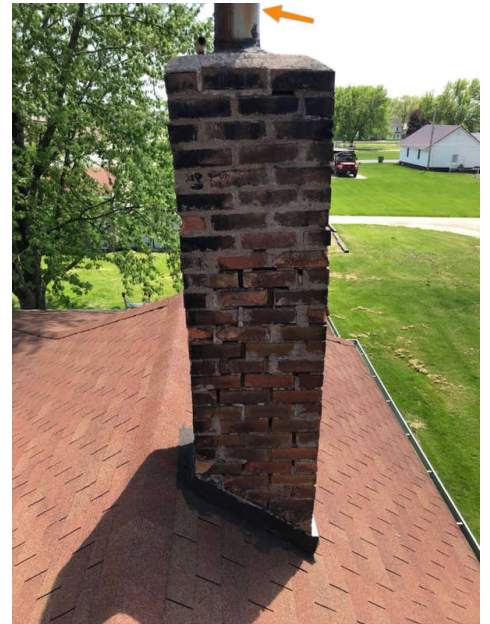
#### 2.5.1 Chimney at Roof

##### **ADD SPARK ARRESTOR**

The chimney(s) had no spark arrestor. The Inspector recommends that all chimneys have an approved spark arrestor installed by a qualified contractor to prevent pest entry and to help protect the roof-covering materials from potential chimney-source ignition.

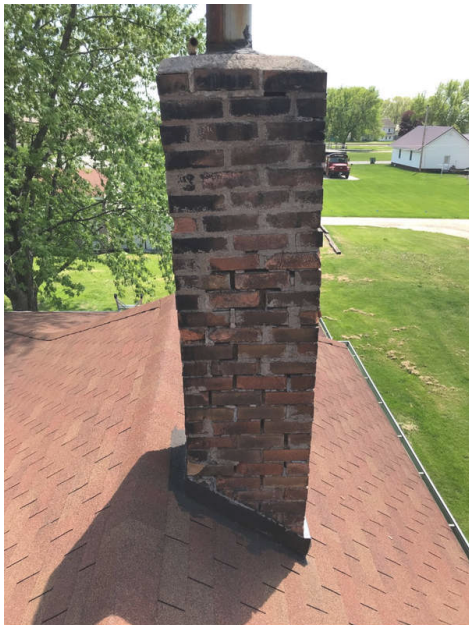
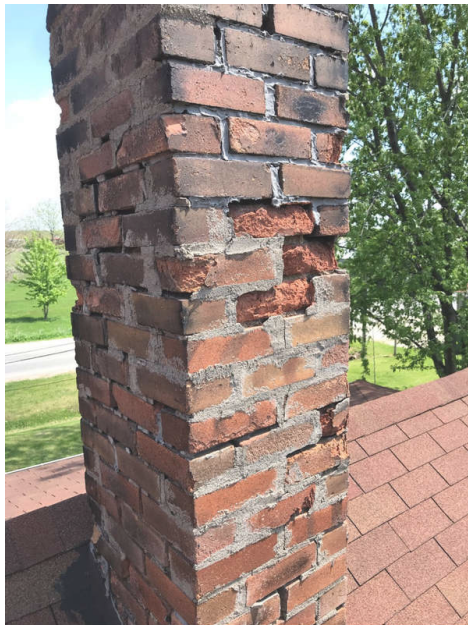
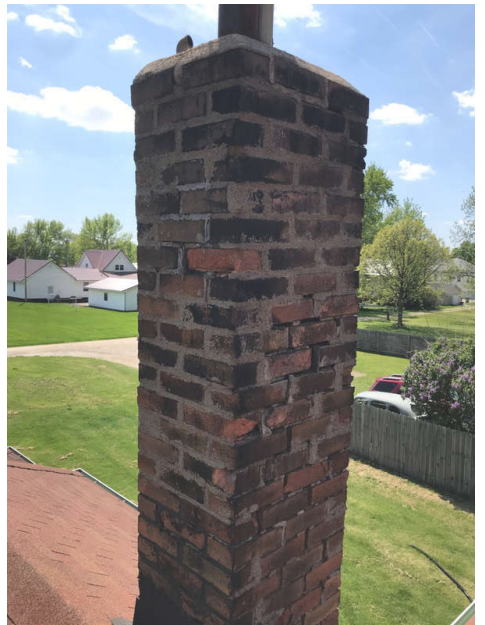
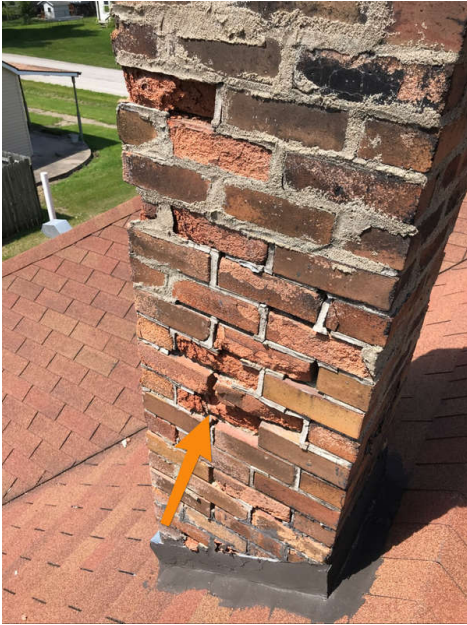
#### 2.5.2 Chimney at Roof

### SEVERELY DETERIORATED BRICK/MORTAR

The brick chimney had severely deteriorated brick and mortar. The Inspector recommends that an evaluation and any necessary work be performed by a qualified masonry contractor.

Contact a qualified chimney contractor.

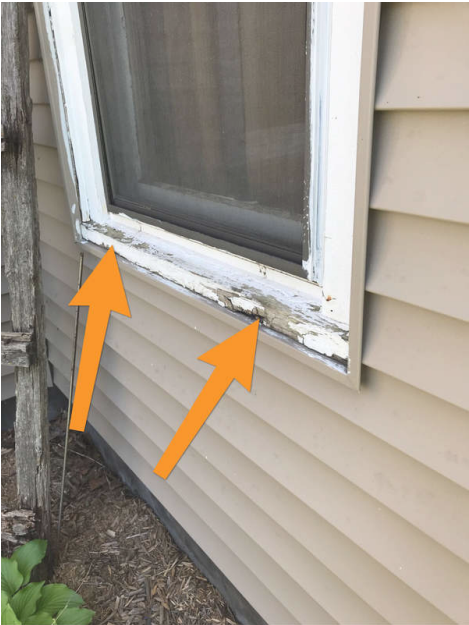
**WINDOW FRAMING, MOISTURE DAMAGE PEELING PAINT.**

Moisture damage/peeling paint. shown on window framing at the time of inspection. Moderate deterioration of wooden components. Recommend replacement of damaged areas and sealed to prevent future damage.

Recommendation  
Contact a qualified professional.

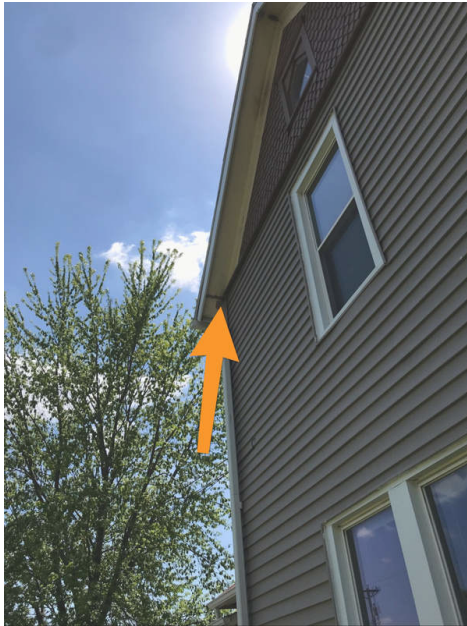
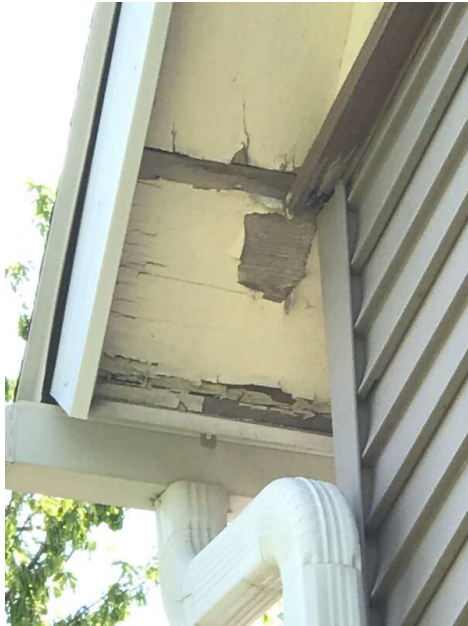
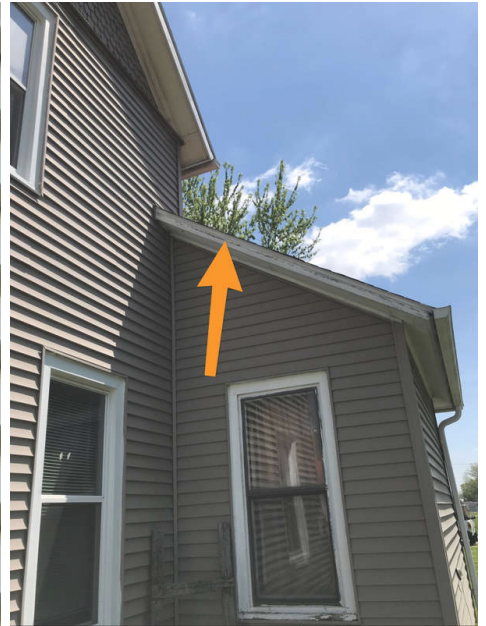
3.3.1 4 Soffits Facia and Trim

**PEELING PAINT, BARE WOOD**

Trim had peeling paint and bare wood exposed to weather. Dry, cracked wood was visible in areas. To avoid the need for replacement, repair and paint this trim soon. All work should be performed by a qualified contractor.

Contact a qualified painting contractor.

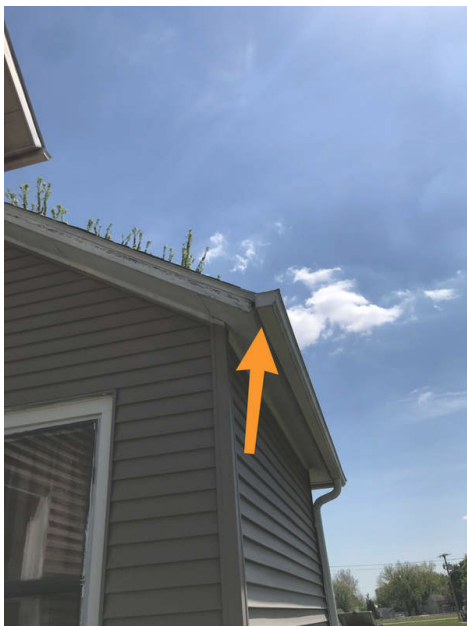
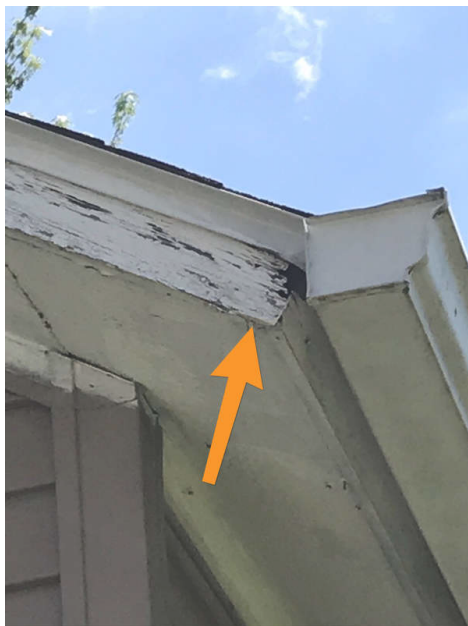
#### 3.3.2 4 Soffits Facia and Trim

### FACIA DETERIORATION

Facia deterioration Was observed at the time inspection. This deterioration can allow for waters, or birds/pest to enter the home. Recommend sealing exposed and Bare wood.

Contact a qualified professional.

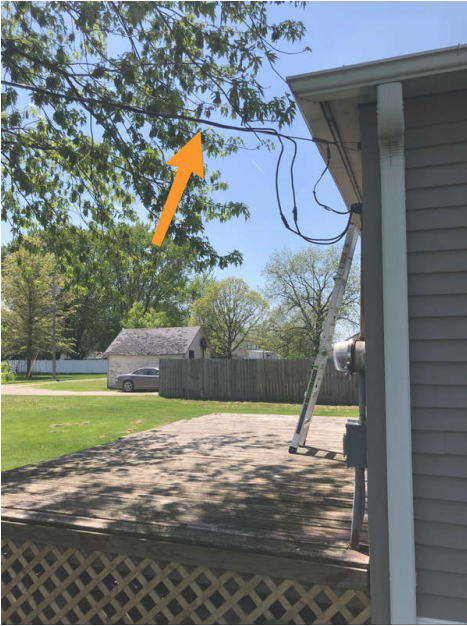
#### 3.7.1 9 Electrical Service to property

### CLEARANCE <10' ABOVE WALKING SURFACE

The overhead service-drop conductors have inadequate height clearance above a walking surface. Safe building practices require 10 feet (3m) clearance above walking surfaces (including decks , stairs, and balconies). The Inspector recommends that before the expiration of your Inspection Objection Deadline, you consult with your electrical service provider to discuss options and costs for correction. Any work on the service conductors should be performed by a qualified personnel only.

Recommendation  
Contact a qualified electrical contractor.

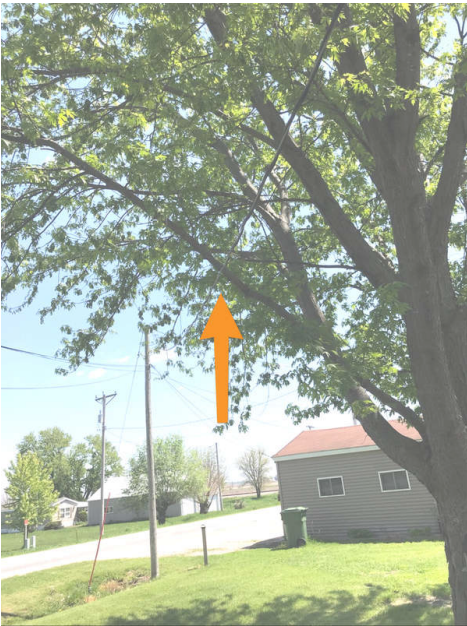
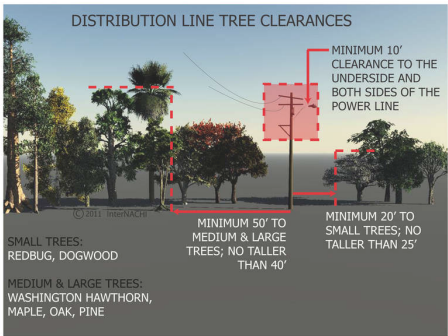
3.7.2 9 Electrical Service to property

**CLEARANCE FROM TREES**

The overhead service-drop conductors had inadequate clearance from tree branches. This condition should be corrected by a qualified contractor or the utility service provider to avoid abrasion and damage to the conductors. Work around the service conductors should be performed by a qualified personnel only. Injury or death may result from attempts at correction by those without proper qualifications.

Recommendation  
Contact a qualified tree service company.

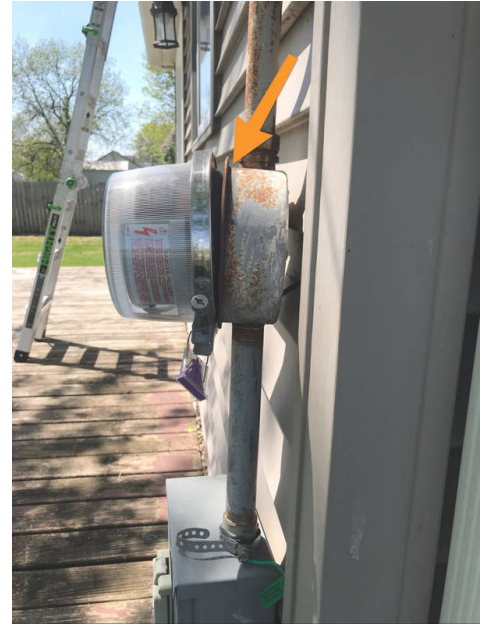
3.7.3 9 Electrical Service to property

**METER LOOSE**

The electric meter was loose and should be securely fastened. The Inspector recommends correction by the electric utility provider.

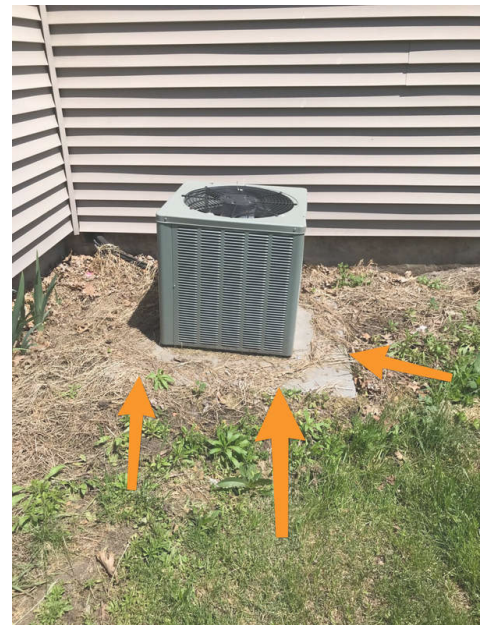
3.8.1 10 Central Air Conditioner

**A/C PAD OUT OF LEVEL**

The pad supporting the air-conditioner compressor housing was not level. Over time, this may result in damage to the fan bearings and a shortened fan lifespan, or it may result in movement of the compressor housing which can stress the refrigerant lines resulting in e, damage and expensive service. The Inspector recommends that the compressor housing be leveled by a qualified HVAC contractor.

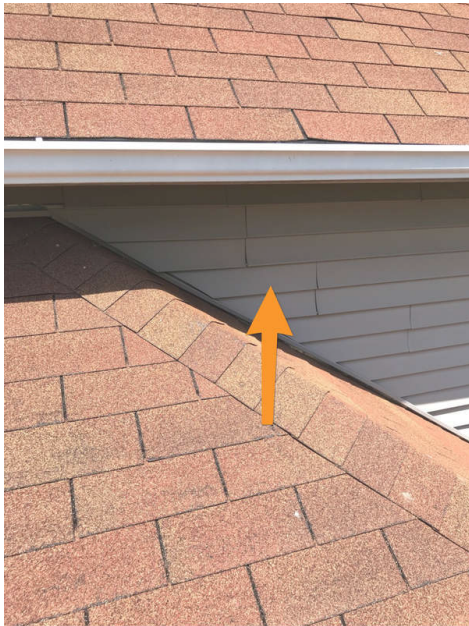
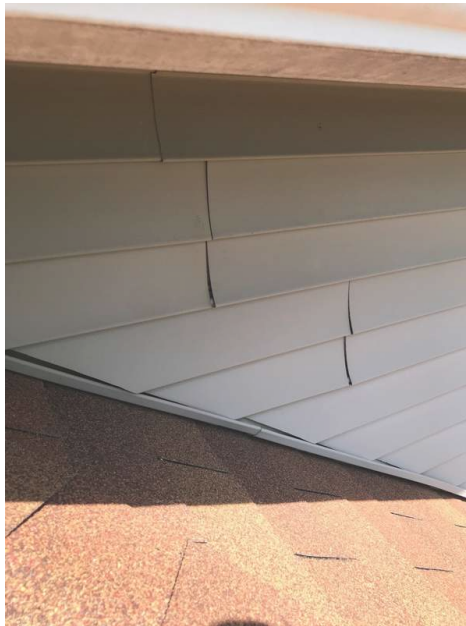
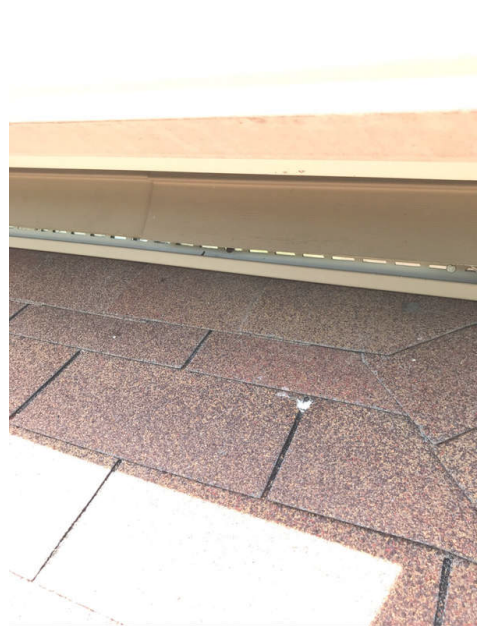
**LOOSE OR SAGGING VINYL**

Areas of loose or sagging vinyl siding covering exterior walls indicated failure of the fastening method. Vinyl siding in these areas should be re-fastened or replaced to prevent damage to the siding and to prevent potential damage from moisture intrusion to the home materials, the exterior wall structure and to prevent development of microbial growth such as mold. All work should be performed by a qualified contractor.

Contact a qualified siding specialist.

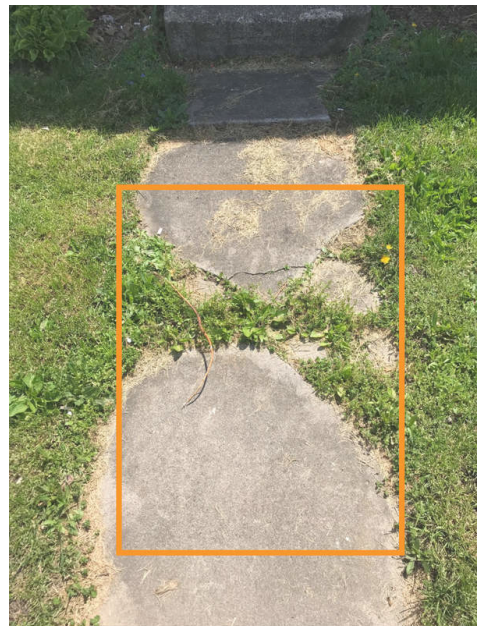
#### 4.2.1 Walkways

### CRACKING HAS CAUSED TRIPPING HAZZARD

One or more trip hazards were found in sidewalk and/or patio sections due to cracks, settlement and/or heaving. A qualified contractor should evaluate and repair or replace sidewalk and/or patio sections as necessary to eliminate trip hazards.

Contact a qualified concrete contractor.

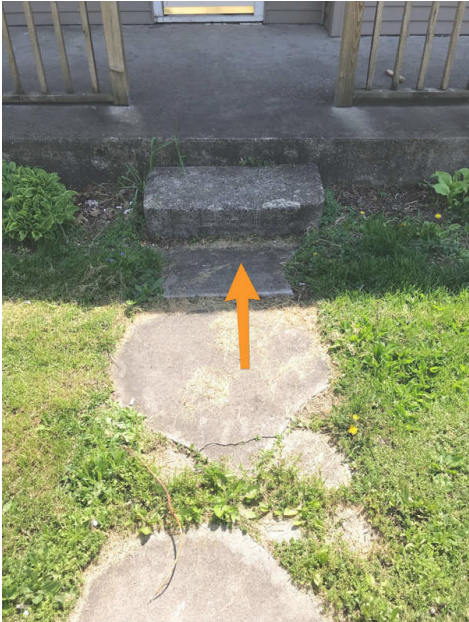
#### 4.2.2 Walkways

### MODERATE SETTLING

At the time of the inspection, the walkways had areas of areas of moderate settling visible. This condition is typically the result of poor compaction practices during original construction. As time passes, settling continues until soil beneath the affected area reaches equal density with the surrounding soil and the affected portions of the walkway become stable. Chances that settling will continue are low.

Recommendation  
Contact a qualified concrete contractor.

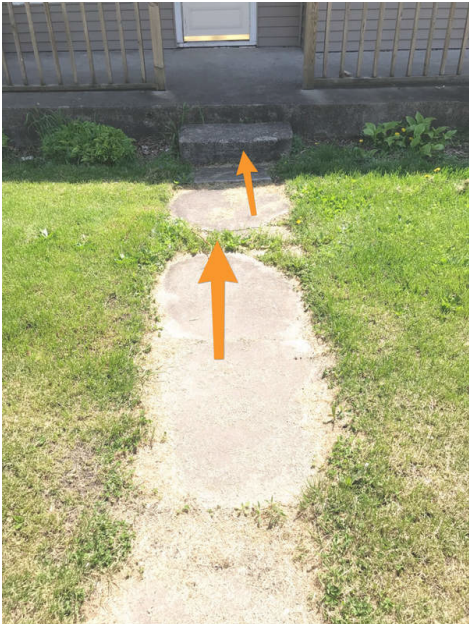
4.2.3 Walkways  
**SIGNIFICANT CRACKS**

Significant cracks visible in the walkways at the time of the inspection should be patched with an appropriate sealant to avoid continued damage from freezing moisture.  
Recommendation  
Contact a qualified concrete contractor.

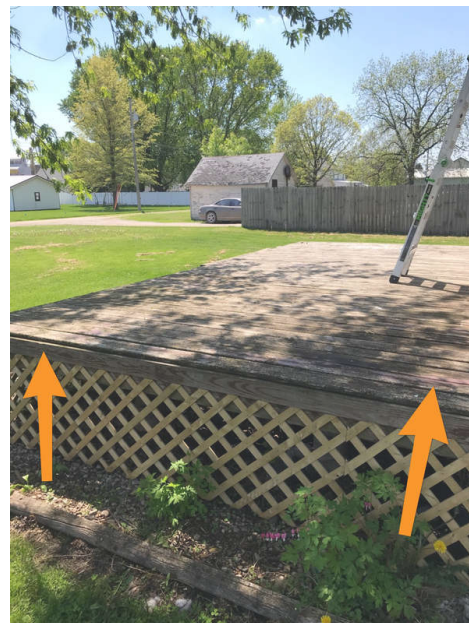
4.4.1 Deck, Balcony, Bridge and Porch,  
**GUARDRAIL, MODERN STANDARDS**

Although the deck guardrails may have complied with the building safety standards in effect at the time of original construction, they do not meet generally-accepted current standards and may be hazardous to small children. Current standards include the following:

1. A 4 inch sphere may not pass through the guardrail at any point
2. The guardrail should not be climbable (especially by children).
3. Minimum guardrail height is 36 inches
4. Any walking surface 30 inches or more above grade should have a guardrail.

The deck failed to meet safety standard number \*Safety Numbers\*. The Inspector recommends that before the expiration of your Inspection Objection Deadline you consult with a qualified contractor to gain an idea of options and costs for updating this condition to comply with modern safety standards.

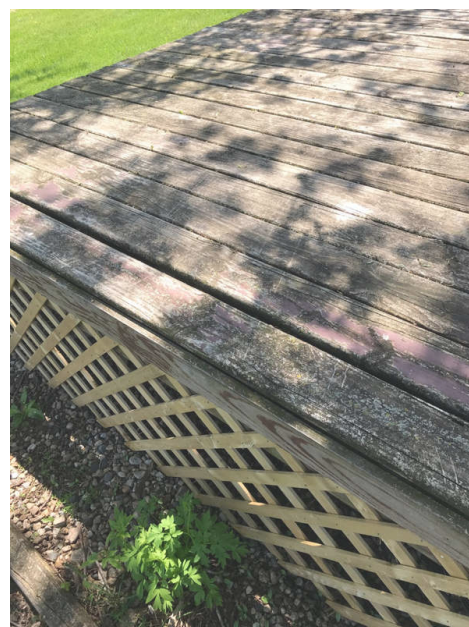
#### 4.4.2 Deck, Balcony, Bridge and Porch, **SEALANT, FAILING**

The finish coating was protecting the porch in places where it was protected from weather and wear but had failed where exposed to weather and wear. Failure to maintain the finish coating will allow Ultra Violet (UV) radiation from sunlight, heat, moisture and freezing moisture to reduce the lifespan of bare wood exposed to weather. The Inspector recommends maintenance of the finish coating as necessary by a qualified contractor.

Contact a qualified deck contractor.

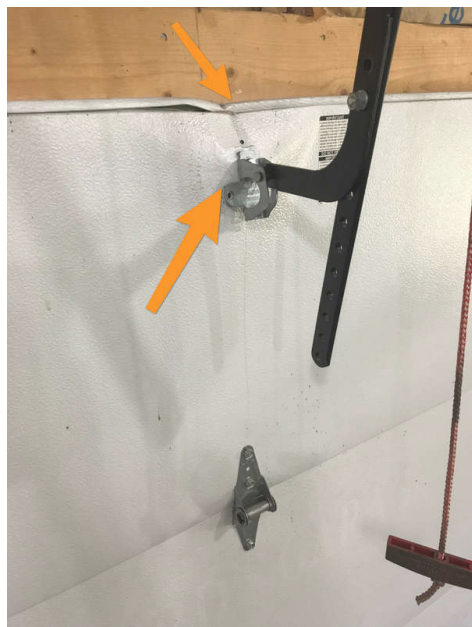
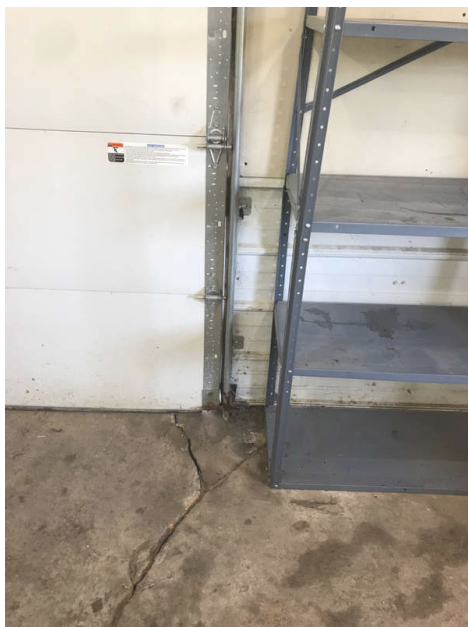
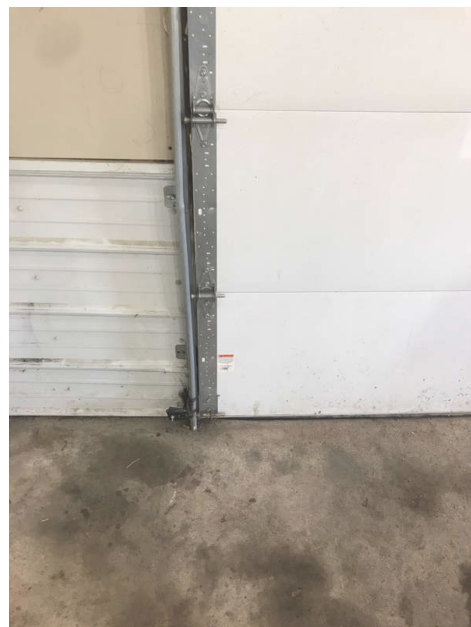
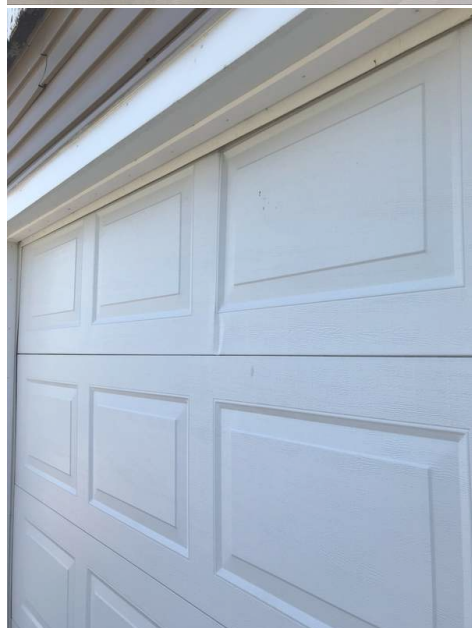
##### **FAILED ANSI 2X4 REVERSE REQUIREMENTS**

With testing it damaged the door. It appeared to have some alignment issues prior. As the bottom track is tight. Also Bolts were not installed correctly.

Contact a qualified garage door contractor.

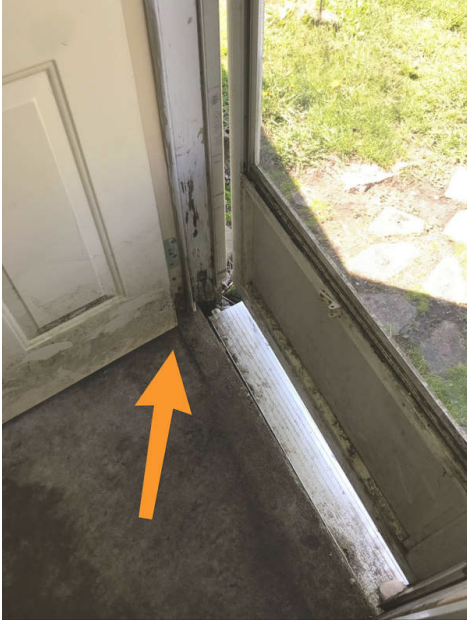
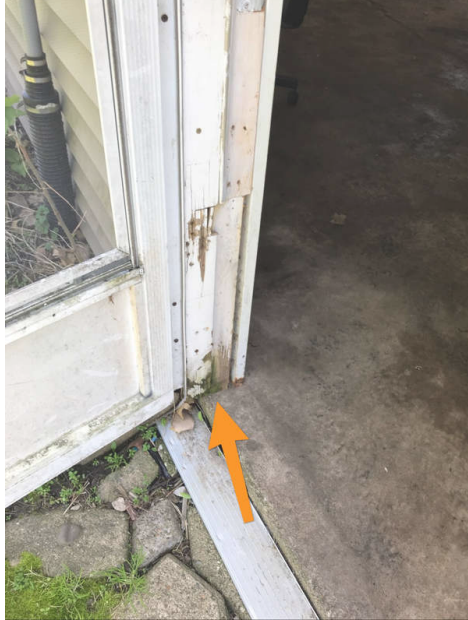
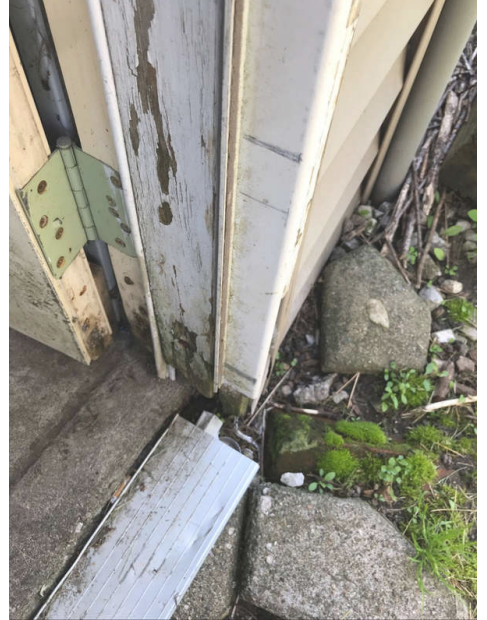
#### DOOR JAMB, MOISTURE ENTRY

Door jamb showed signs of moisture entry due to unsealed joint between jamb and threshold. Recommend repair by licensed general contractor.

Contact a qualified professional.

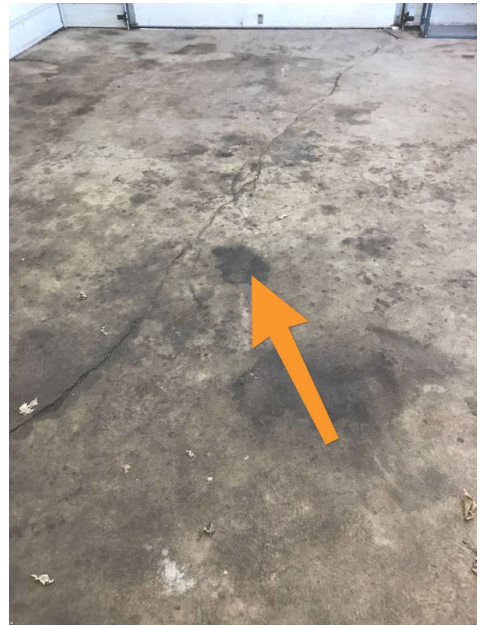
### 5.3.1 Floors

#### HEAVING- EXPANSIVE SOILS

The garage floor showed signs of heaving. It was not level or flat and had raised areas. This condition appeared to be the result of expansive soil beneath the slab. Expansive soils are those that expand to many times their original volume with increases in soil content. If expansive soils are the cause of this heaving, it may continue in the future.

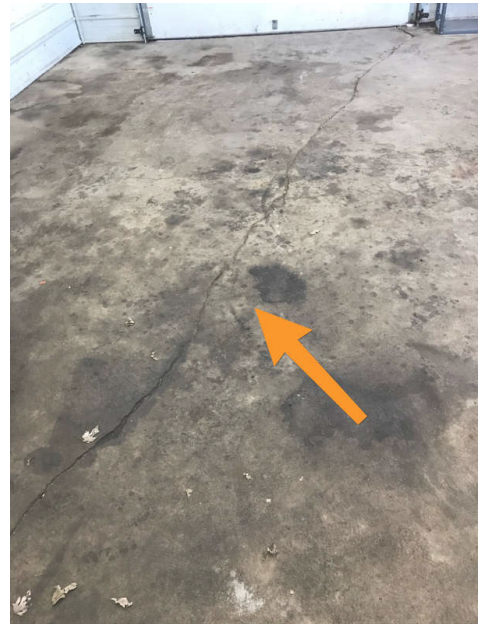
### 5.3.2 Floors

#### RANDOM CRACKING- NO CONTROL JOINTS

Random shrinkage cracking was visible in the garage floor slab. No control joints were installed in the concrete floor. Control joints are grooves or cuts in the floor designed to control the location of cracking taking place as part of the curing process.

Contact a qualified concrete contractor.

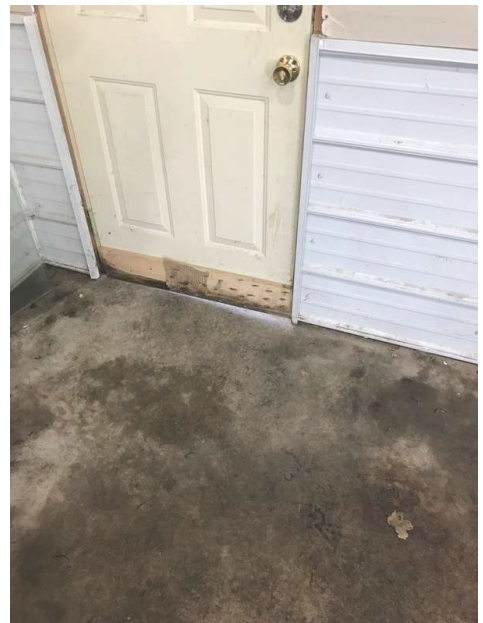
5.3.3 Floors

**STAINING- MOISTURE INTRUSION-  
MOISTURE VISIBLE**

Staining of the garage floor appeared to be the result of moisture intrusion. Moisture was visible in this area at the time of the inspection.

Contact a qualified general contractor.

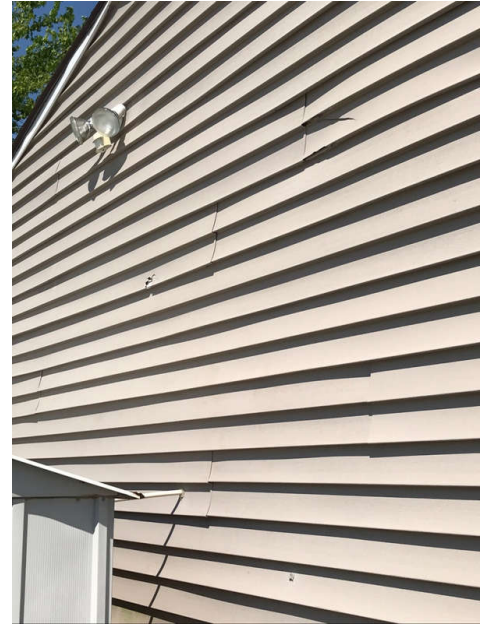
5.4.1 Walls

**DAMAGE SIDING**

Damage siding was observed at the time inspection on the exterior of the garage. Recommend repair or replacement has these holes could allow for moisture intrusion.

Contact a qualified professional.

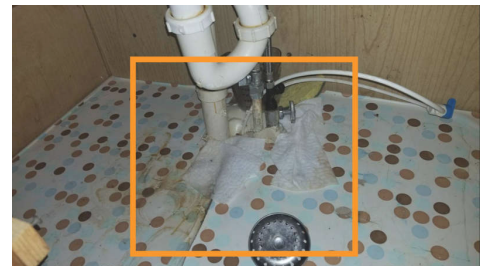
#### 6.1.1 Cabinets

### UNDER SINK MOISTURE DAMAGE

There was moisture damage and staining under the kitchen sink at the time of inspection. This damage is from a leaking drain pipe that was observed at the time of inspection.

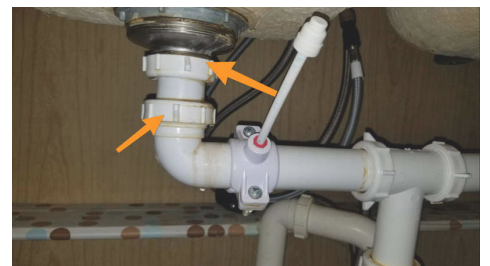
#### 6.3.1 Kitchen Plumbing / Sink

### LEAKING CONNECTIONS

Leaking connections at the drain assembly beneath the kitchen sink should be repaired to avoid future/additional damage to the cabinet floor and possibly the wall/floor structures below. The Inspector recommends repair by a qualified plumbing contractor.

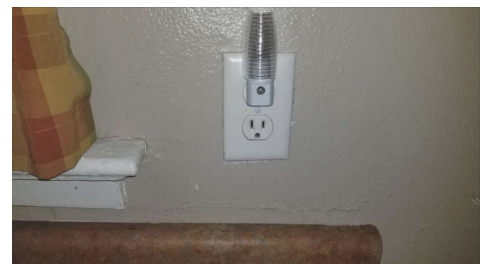
#### 6.4.1 Receptacles and Switches

Electrical receptacles in the kitchen had no Ground Fault Circuit Interrupter (GFCI) protection. Although this condition may have been considered acceptable at the time the home was originally constructed, as knowledge of safe building practices has improved with the passage of time, building standards have changed to reflect current understanding. Consider having GFCI protection installed as a safety precaution for receptacles within 6 feet of a plumbing fixture. This can be achieved by: 1. Replacing the current standard electrical receptacles with GFCI outlets; 2. Replacing the electrical receptacle nearest the overcurrent protection devices (breakers or fuses) protecting laundry room circuits with a GFCI receptacle; or 3. Replacing the breakers currently protecting the electrical circuits in the Laundry room with GFCI breakers.

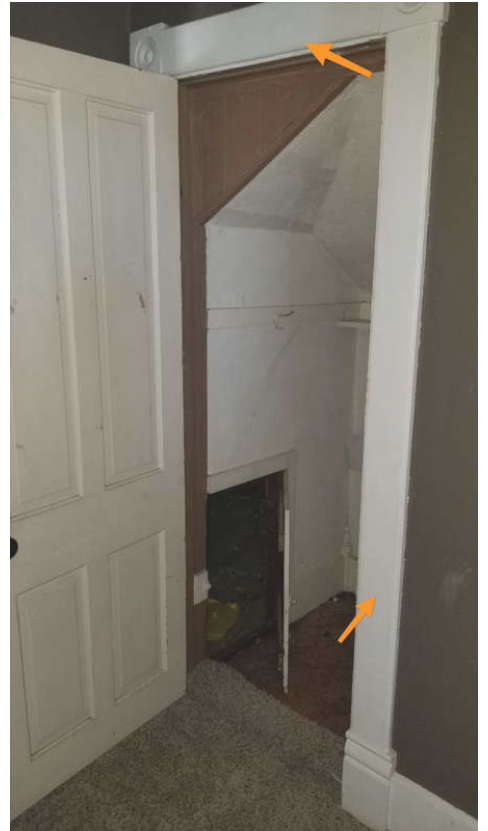
2nd Floor Hall

Interior door binds and will not operate correctly. Recommend repairs by licensed general contractor.

Recommendation  
Contact a qualified professional.

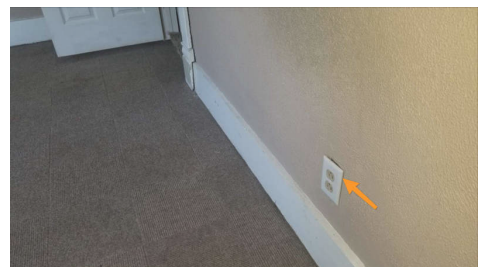
2nd Floor Bedroom

**RECEPTACLE, LOOSE IN WALL**

An electrical receptacle was improperly secured and moved when a plug were inserted. Receptacles should be securely installed to prevent fire, shock and/or electrocution hazard. The Inspector recommends correction by a qualified electrical contractor.

Recommendation  
Contact a qualified electrical contractor.

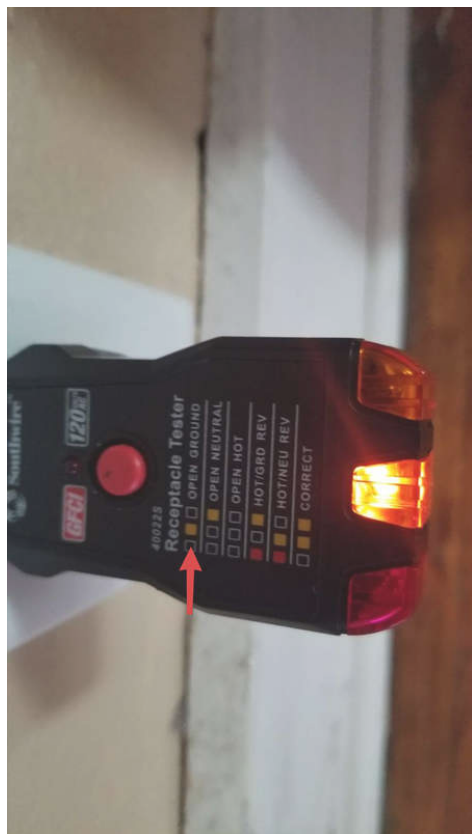
1st Floor Bedroom

**RECEPTACLE, OPEN GROUNDS**

The ground in an electrical circuit is a safe way for electricity to return to the panel if the hot/neutral circuit is compromised. If a failure occurs within the circuit then the ground carries the current back to the panel and causes the fuse or breaker to blow, disconnecting the circuit. An open ground means that the additional path does not exist. It could mean that there is no wire running to that outlet, or that the wire is broken or disconnected somewhere in the circuit. Open grounds are especially dangerous if grounded (3-prong) outlets are installed. If an open ground is present and a failure in the circuit occurs then the current has nowhere to go and could potentially use your body to ground out and complete the circuit, resulting in electrocution.

In conclusion, reverse polarity and open grounds can be dangerous and are considered safety hazards when inspecting the home. We recommend that these problems be fixed immediately as they can result in a fire or electrocution if an electrical system fails.

Contact a qualified electrical contractor.

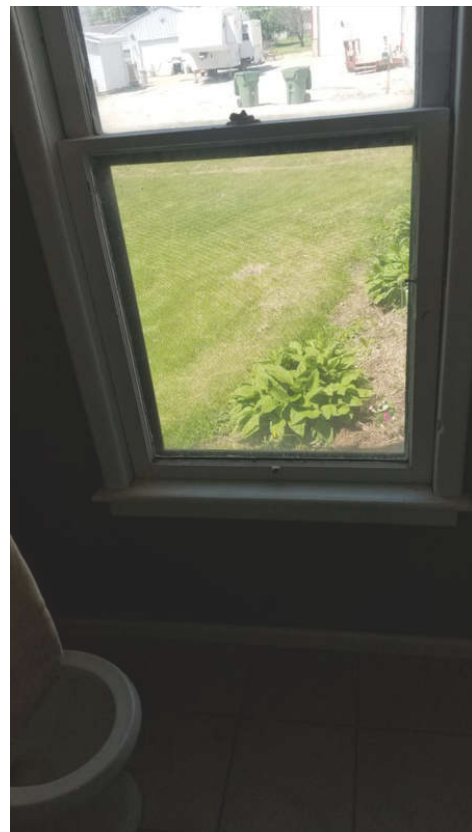
1st Floor Bathroom

A window(s) was difficult to operate and needed maintenance. The Inspector recommends service by a qualified contractor.

Contact a qualified window repair/installation contractor.

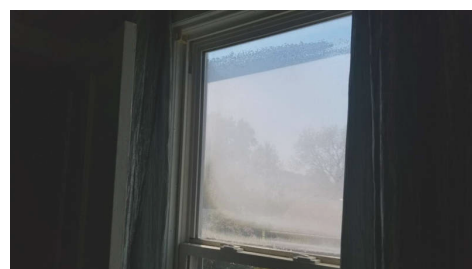
2nd Floor Bedroom top of the stairs

### **FAILED SEALS, CONDENSATION, REPLACE**

A window had double-pane glazing in which condensation and staining was visible at the time of the inspection. This is an indication that the skylight has lost its thermal integrity. The glass was damaged beyond repair. The Inspector recommends that before the expiration of your Inspection Objection Deadline you consult with a qualified contractor to discuss options and costs for replacement.

Contact a qualified window repair/installation contractor.

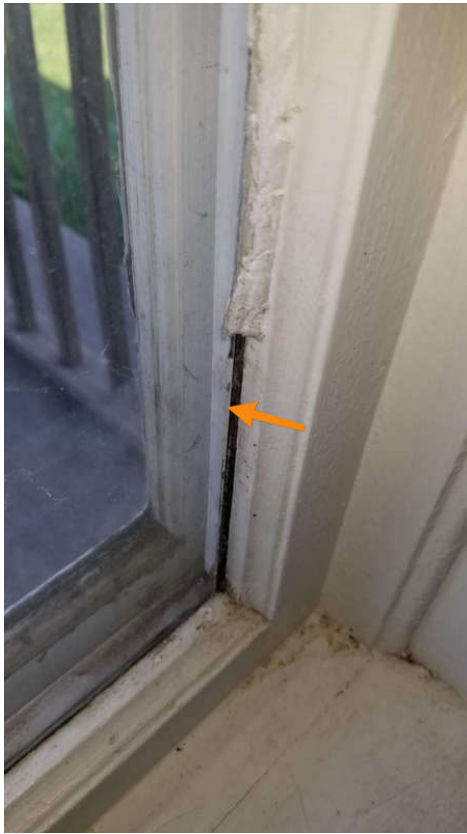
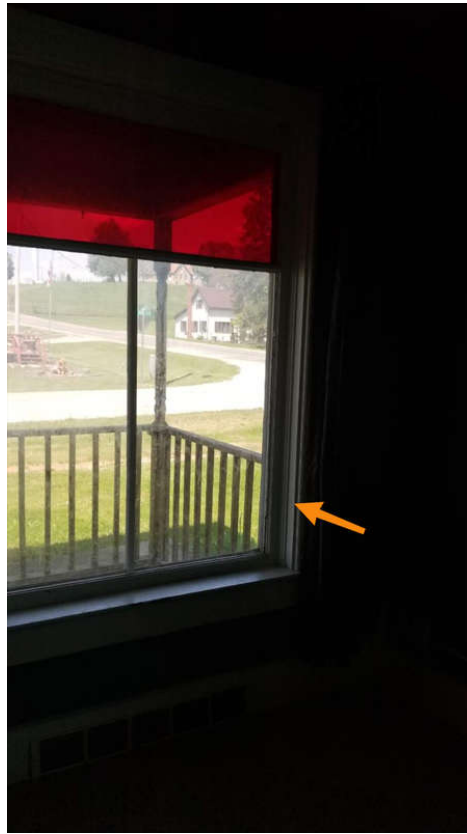
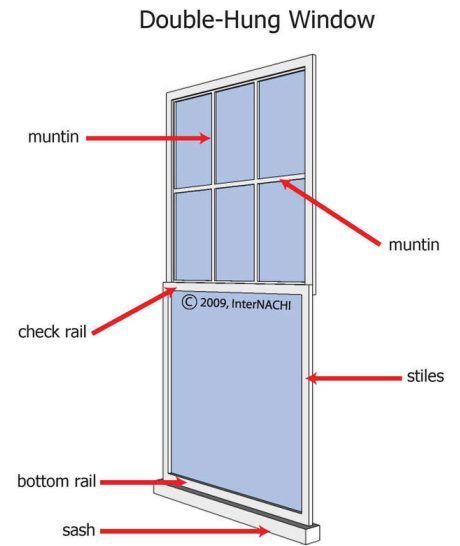
Glazing compound at window sashes in the home needed maintenance at the time of the inspection. The Inspector recommends maintenance by a qualified painting contractor.

Contact a qualified window repair/installation contractor.

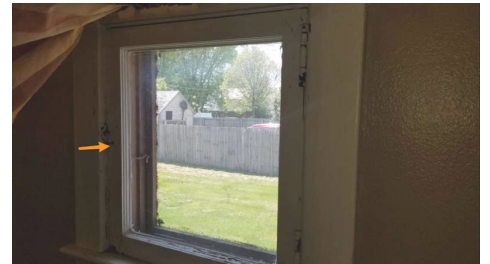
Kitchen behind fridge location

### INOPERABLE WINDOW

Window(s) was inoperable at the time of the inspection. The Inspector recommends service by a qualified contractor.

Contact a qualified window repair/installation contractor.

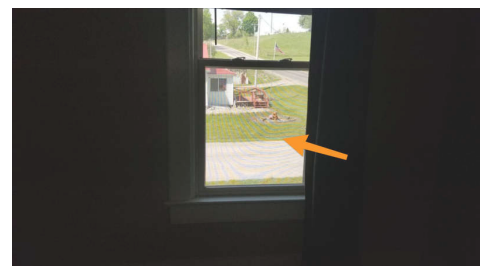
2nd Floor Bedroom

Some double-hung windows in the home had lower sashes that would not stay in place when raised. The Inspector recommends service by a qualified contractor.

Contact a qualified window repair/installation contractor.

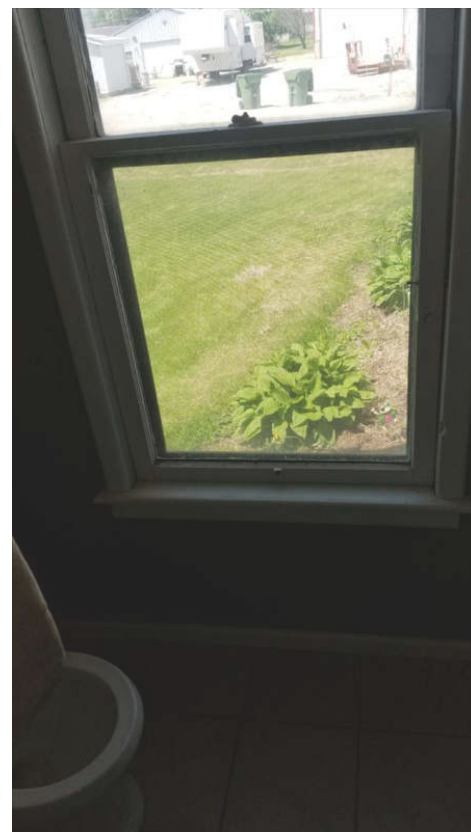
## 1st Floor Bathroom

Windows in the home had peeling paint. The Inspector recommends that before the expiration of your Inspection Objection Deadline you consult with a qualified contractor to discuss options and costs for repair.

Recommendation  
Contact a qualified window repair/installation contractor.

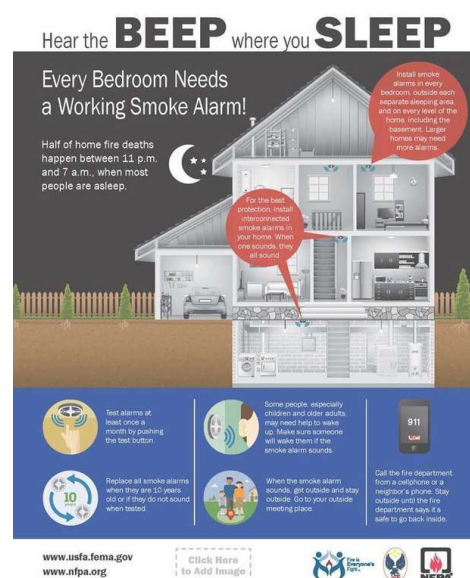
The Inspector recommends installing a smoke detector to provide improved fire protection for sleeping areas. Generally-accepted current safety standards recommend smoke detectors be installed in the following locations: 1. In the immediate vicinity of the bedrooms 2. In all bedrooms 3. In each story of a dwelling unit, including basements and cellars, but not including crawl spaces and uninhabitable attics. 4. In residential units of 1,200 square feet or more, automatic fire detectors, in the form of smoke detectors shall be provided for each 1,200 square feet of area or part thereof. Any smoke detector located within 20 feet of a kitchen or bathroom containing a tub or shower must be a photoelectric type. The 1996 edition of the National Fire Protection Association (NFPA) 72 gives further guidance on the placement of smoke detectors, when required. Here are some examples from Chapter 2 of NFPA 72: 5. Smoke detectors in a bedroom with a ceiling sloped greater than one foot in eight feet horizontally should be located on the high side of the ceiling. 6. Smoke detectors should not be located within three (3) feet of a door to a bathroom containing a tub or a shower or the supply registers of a forced air HVAC system. Smoke detectors can be located on the ceiling with the side of the detector greater than four (4) inches from the wall or on the wall of a bedroom with the top of the detector located four (4) to twelve (12) inches down from the ceiling. All smoke detectors should be installed in accordance with the manufacturer's recommendation and be UL listed.

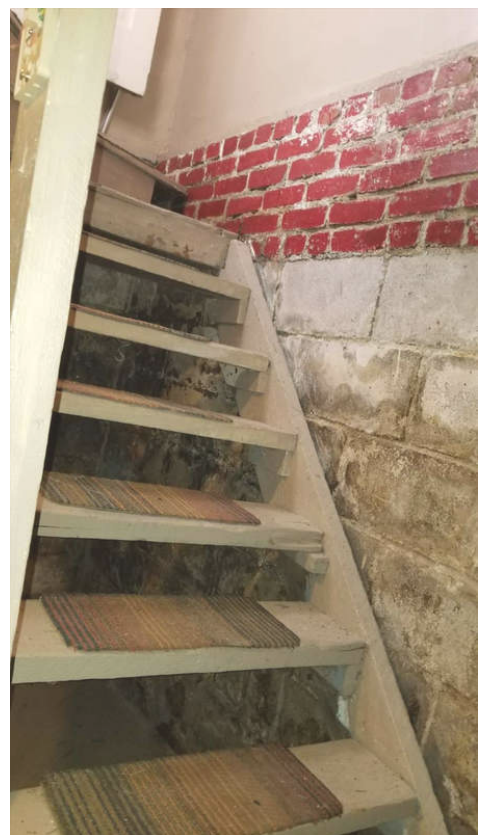
Although it had 4 or more risers, this staircase had no handrail installed. This condition is a potential fall hazard. In order to comply with generally-accepted current standards which require a handrail at stairways with 4 or more risers, this stairway would need a handrail installed. The Inspector recommends that a handrail be installed that complies with modern safety standards. All work should be performed by a qualified contractor.

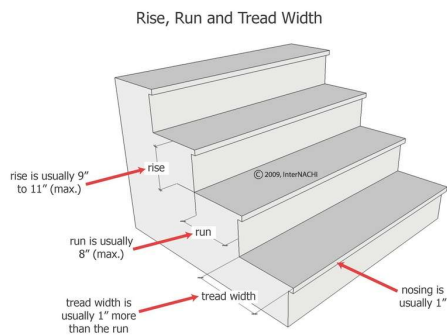
Basement

### TREAD DEPTH EXCESSIVE DIFFERENCE

At the interior staircase, the greatest tread depth exceeded the shallowest tread depth by more than the 3/8 of an inch recommended by generally-accepted current standards. This condition is a potential trip hazard. All corrections should be made by a qualified contractor.

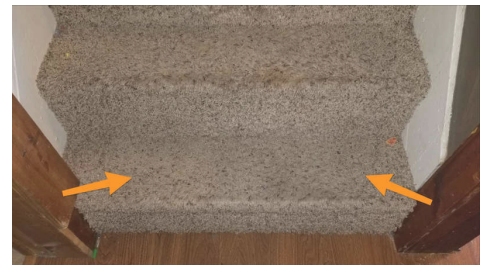
#### TREAD, LOOSE

Tread section of step was loose at the time of inspection. Recommend repairs to ensure safe use of interior stairs. All work should be performed by a licensed general contractor.

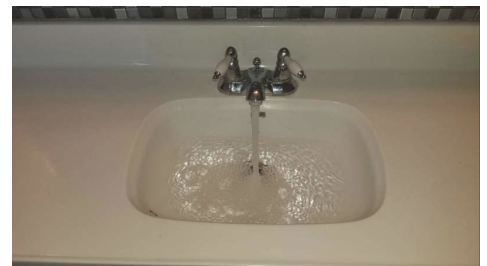
### 9.1.1 2 Sink

#### SLOW DRAIN

Bathroom sink was slow to drain. Recommend drain cleaning by license plumbing contractor.

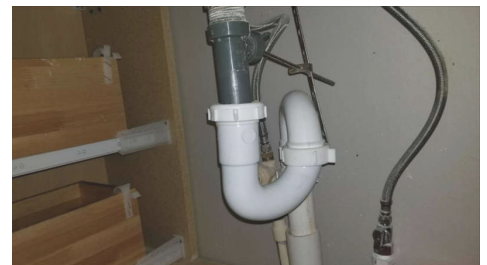
### 9.1.2 2 Sink

#### S-TRAP OBSOLETE

A trap beneath a sink in the kitchen was of a type called an "S-trap". S-traps are no longer allowed to be installed in new construction for safety reasons. A siphon can develop which empties the trap of water; a condition with the potential to allow toxic sewer gas to enter the living space. Although this type of trap may have been commonly considered safe at the time the home was originally constructed, as general knowledge of safe building practices has improved with the passage of time, building standards have changed to reflect current understanding. The Inspector recommends replacement of all such traps in the home by a qualified plumbing contractor.

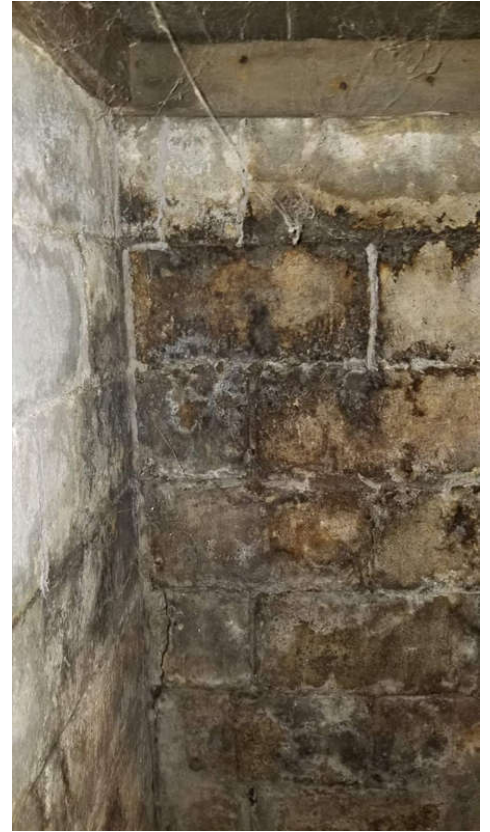
### 10.2.1 Foundation

#### **FOUNDATION INTERIOR BIOLOGICAL GROWTH PRESENT**

Biological growth signs are indicated on interior of foundation wall. Recommend mold testing to verify if mold is present and if it could be toxic.

Contact a qualified mold inspection professional.

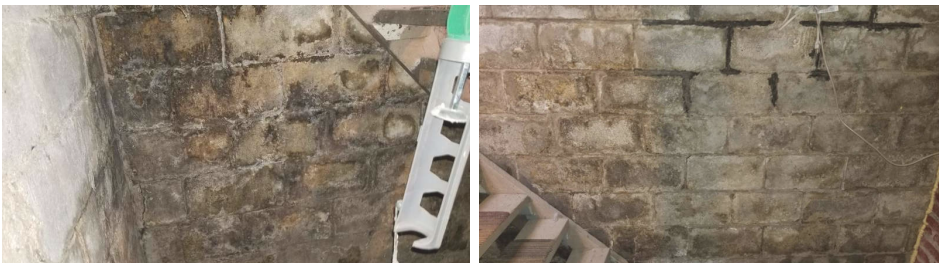
#### 10.2.2 Foundation

### FOUNDATION WALL, EFFLORESCENCE, HEAVY DEPOSITS

In the basement, heavy deposits of efflorescence were visible at some of the interior surfaces of the foundation walls. Efflorescence is a white, powdery residue left by moisture seeping through the foundation wall and its presence indicates high moisture levels in soil near the foundation. Excessively high moisture levels in soil supporting the foundation can cause various structural problems related to soil movement. Long-term exposure to this condition can cause foundation damage. The Inspector recommends that the source of moisture be identified and the condition corrected.

Recommend tuck pointing done by licensed masonry contractor to help prevent moisture deterioration an entry into home.
