## SUMMARY

1234 Main St. Anamosa IA 52205

Royal Home Inspections, LLC  
ASHI, InterNACHI Certified...

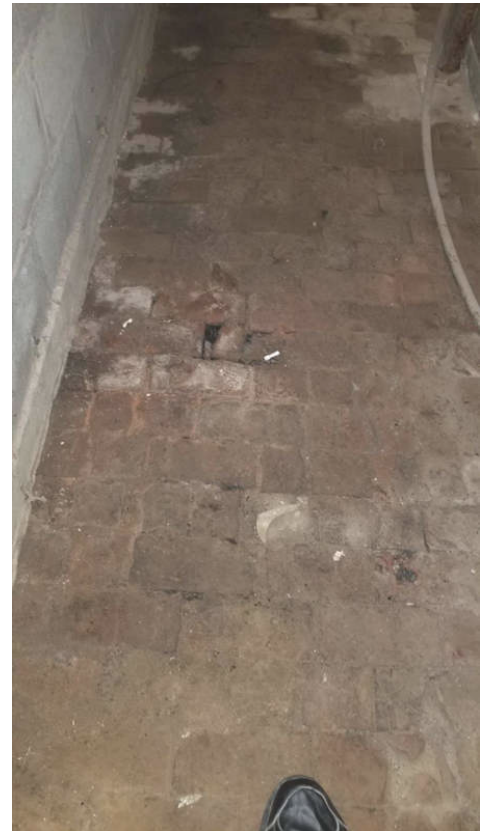
#### 10.3.1 Slab

### BASEMENT FLOOR, STAINS, ELEVATED MOISTURE LEVEL INDICATED WITH METER

Stains visible on the interior surfaces of the brick floor slab appear to be the result of active moisture intrusion. The moisture meter showed elevated levels of moisture present in the slab at the time of the inspection. Moisture intrusion can damage materials and encourage the growth of microbes such as mold. The source of moisture should be located and corrected to avoid future moisture intrusion.

Contact a qualified waterproofing contractor

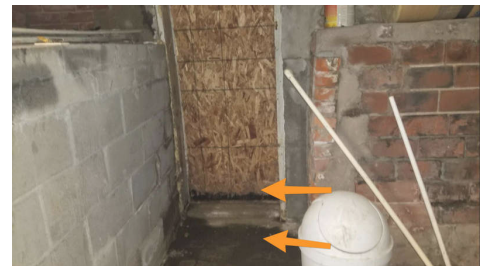
#### 10.3.2 Slab

### EXTERIOR ENTRANCE, MOISTURE ENTRY

Moisture entry from pre-existing exterior entry into basement. This has been crudely sealed off and is allowing moisture entry into basement.

Contact a qualified professional.

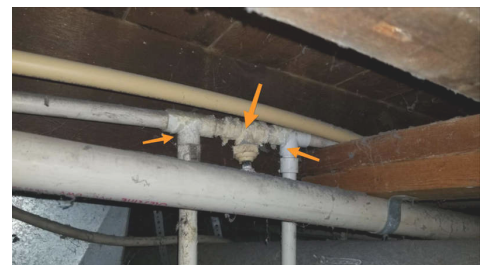
#### 12.1.1 Water Supply and Distribution

### ACTIVE LEAK, HEAVILY CORRODED

Actively leaking, heavily-corroded water distribution pipes visible. Should be repaired by a qualified plumbing contractor to avoid damage to home materials or the development of conditions which encourage the growth of microbes such as mold.

Contact a qualified plumbing contractor.

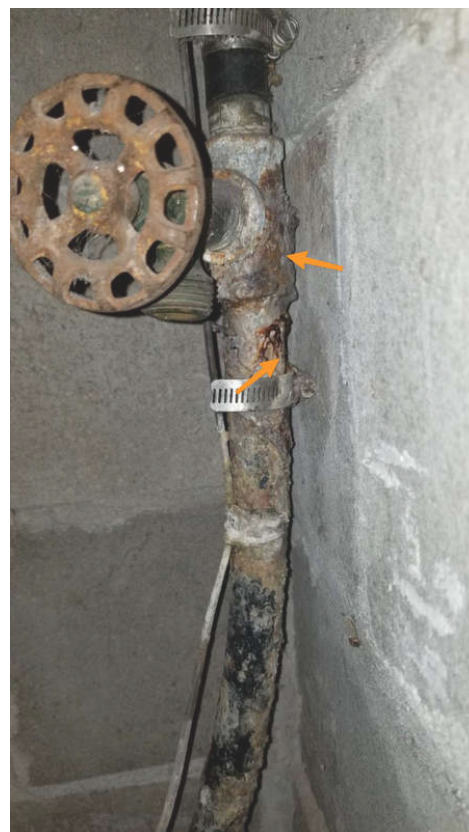
#### 12.1.2 Water Supply and Distribution

### MAIN WATER SUPPLY PIPE HEAVY CORROSION (SHORTENED LIFESPAN)

Contact a qualified plumbing contractor.

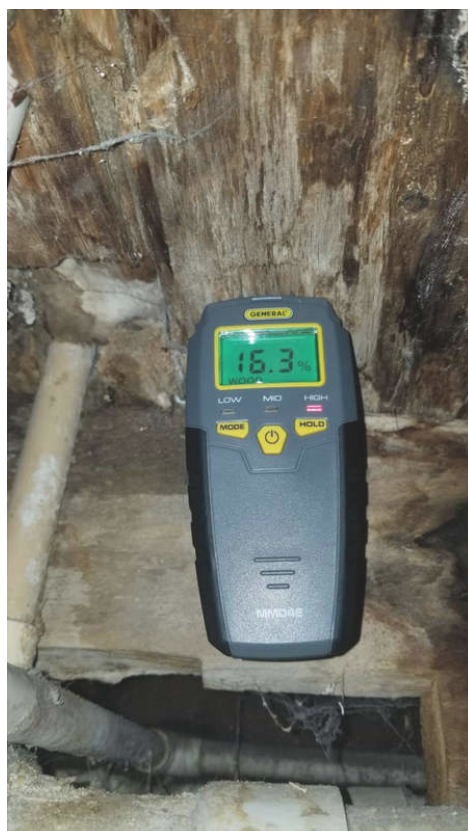
#### 12.2.1 Sewage and DWV Systems

### ACTIVE LEAKE

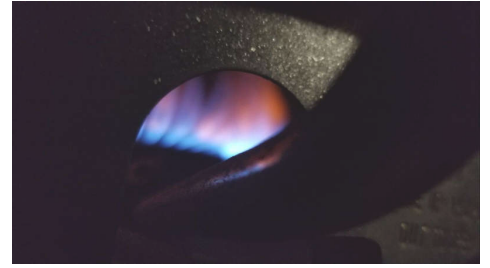
#### 12.4.1 Water Heater

### FLAME COLOR - NEEDS SERVICE

Contact a qualified plumbing contractor.
