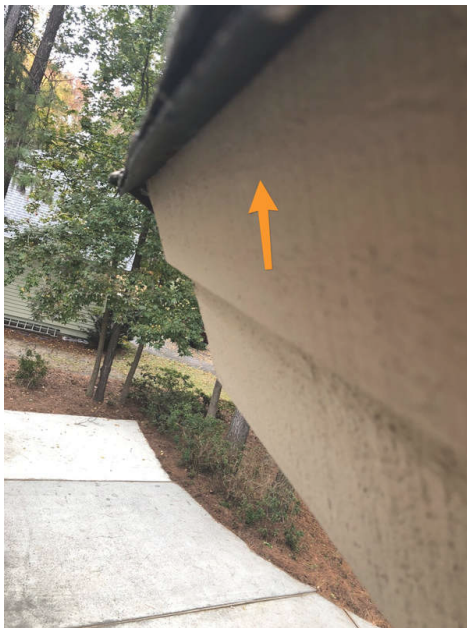
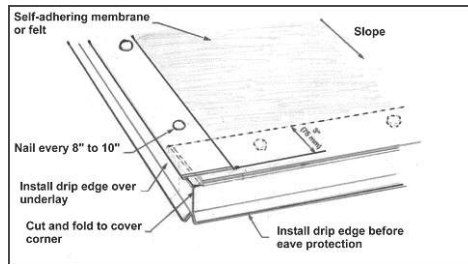
SHINGLES - DRIP EDGE NOT INSTALLED

Moderate / Repair or Replace

Drip edge flashing was not installed. Lack of roof edge flashing leaves the edges of roof sheathing and underlayment exposed to potential moisture damage from wood decay and/or delamination. Recommend a qualified contractor evaluate and repair as needed.

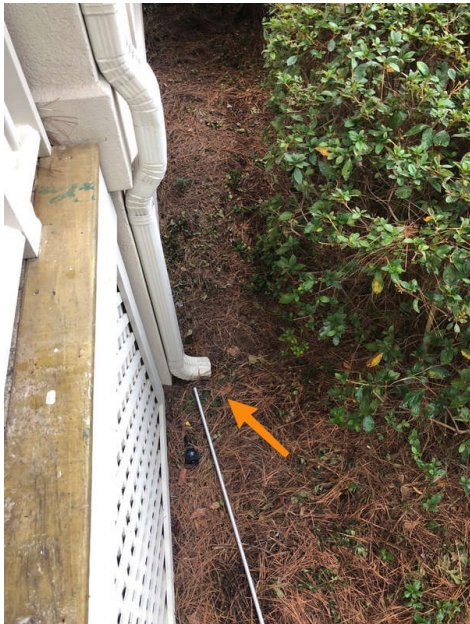
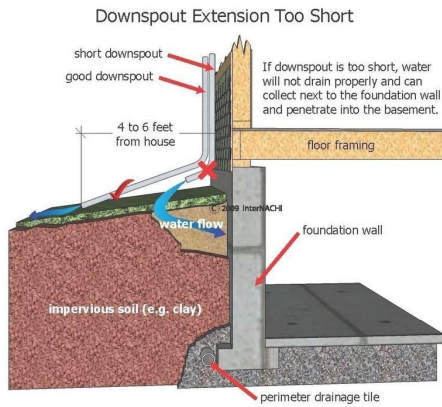
Rear Left Side

DOWNSPOUTS - DRAIN NEAR HOUSE

Moderate / Repair or Replace

One or more downspouts drain to close to the home's foundation. This can result in excessive moisture in the soil at the foundation, which can lead to foundation/structural movement. Recommend a qualified contractor adjust downspout extensions to drain at least 6 feet from the foundation.

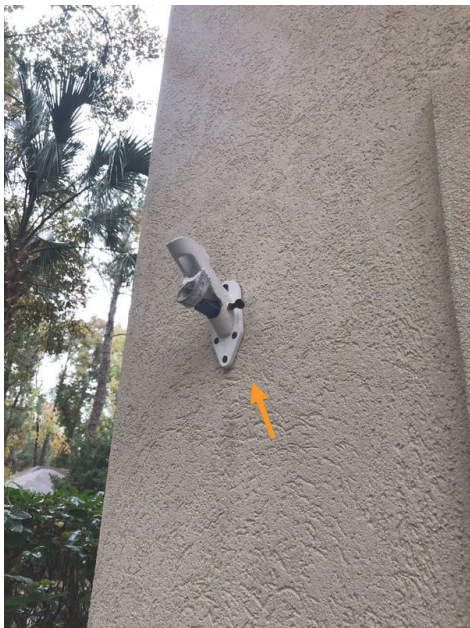
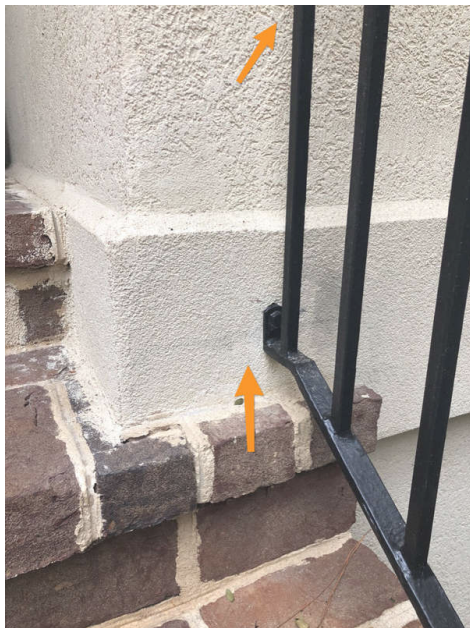
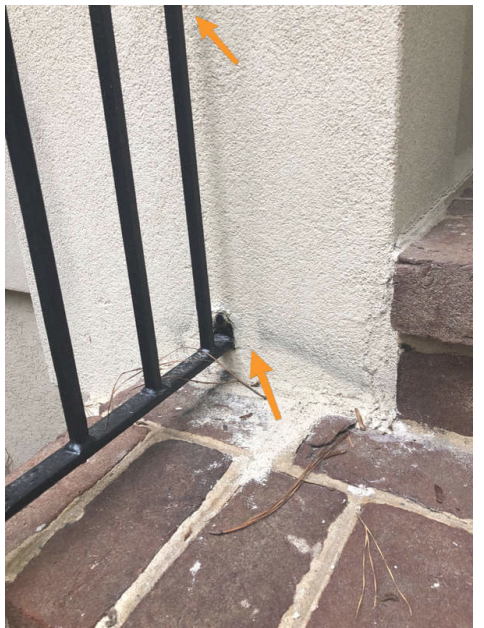
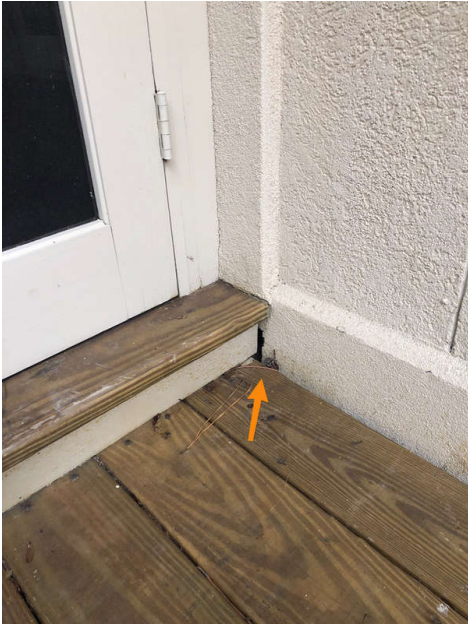
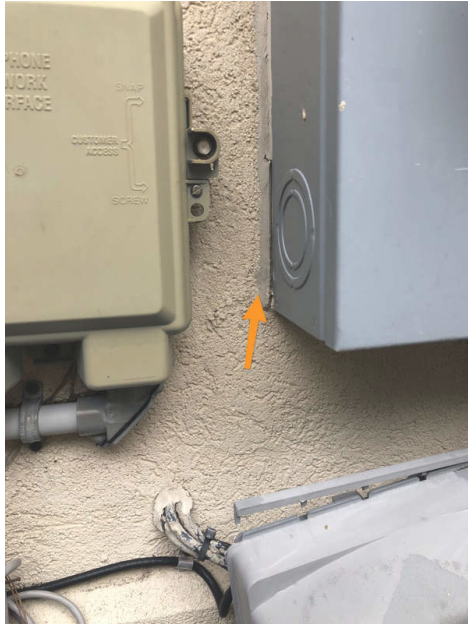
STUCCO / EIFS- SEAL PENETRATION

Moderate / Repair or Replace

A penetration was not properly sealed. There are openings/gaps where water will enter the and get behind the stucco / EIFS causing deterioration. Recommend re-sealing the stucco at all penetrations to keep out moisture.

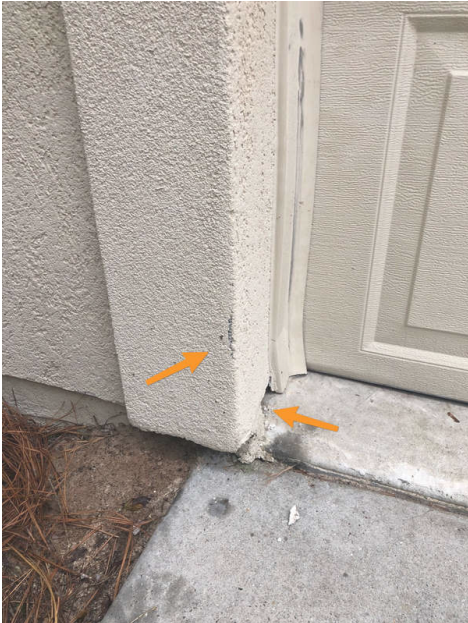
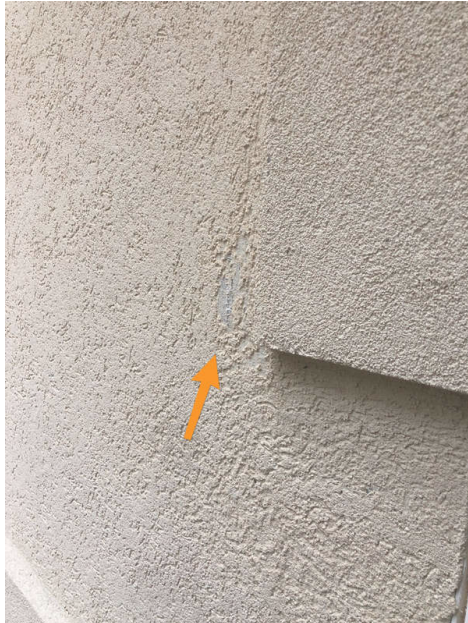
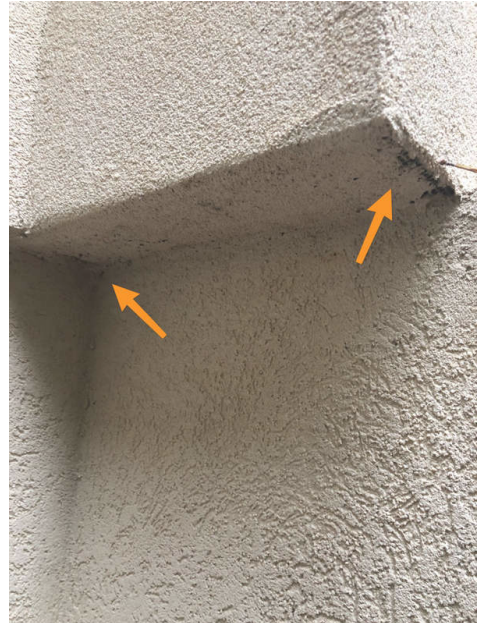
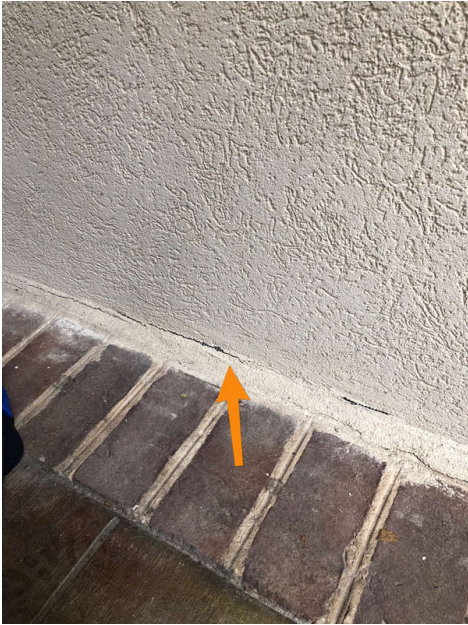
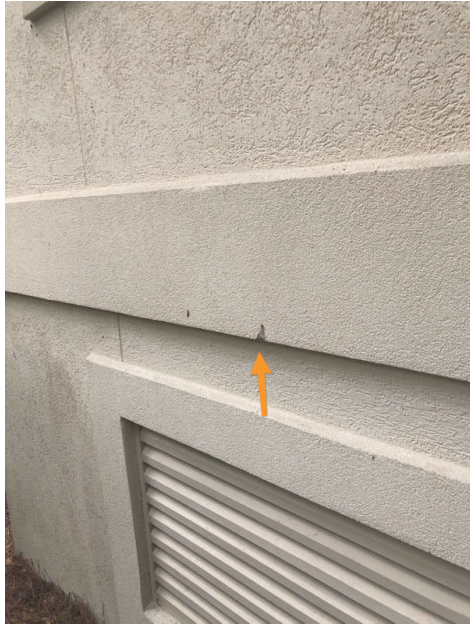
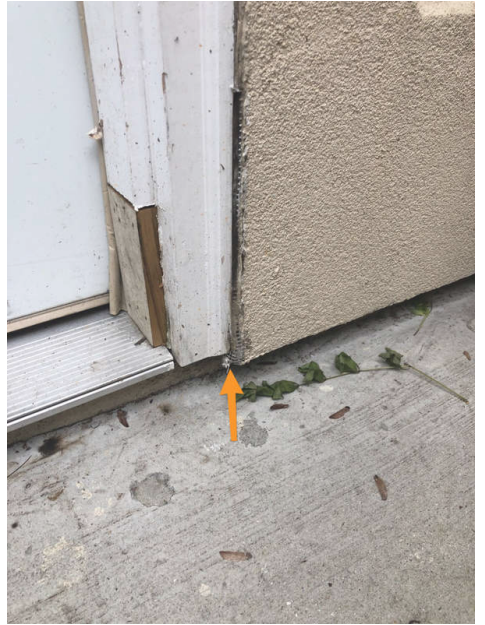
STUCCO / EIFS - DAMAGED

Moderate / Repair or Replace

Stucco / EIFS covering exterior walls of the home had moderate visible damage that should be repaired to prevent possible moisture intrusion. All work should be performed by a qualified contractor.

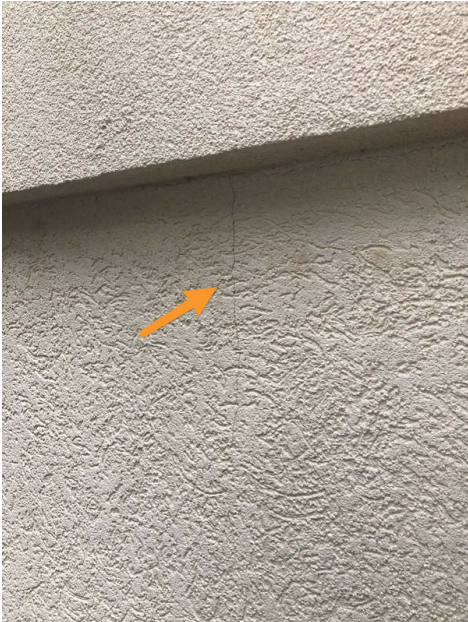
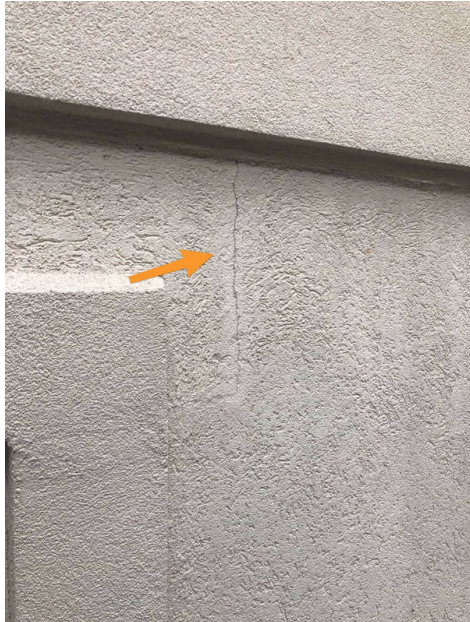
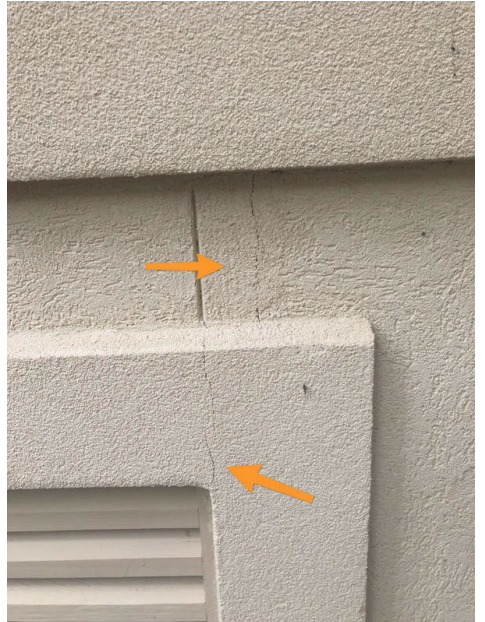
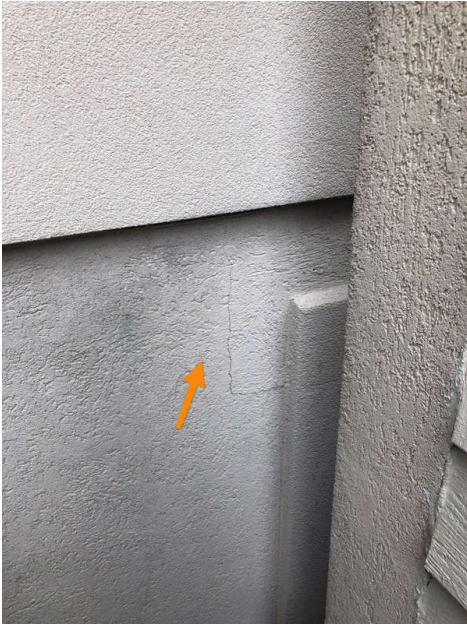
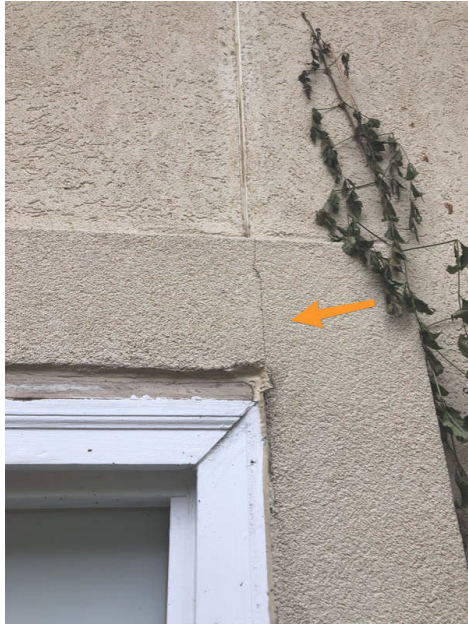
STUCCO / EIFS - MINOR CRACKING

Moderate / Repair or Replace

Moderate localized cracking was observed in stucco / EIFS covering exterior walls of the home. This type of cracking, called "thermal cracking" is typically caused by stucco expansion and contraction that occurs with changes in temperature, made worse over time by exposure to freezing moisture. Cracks exceeding 1/16-inch in width should be filled with an appropriate material to minimize future damage.

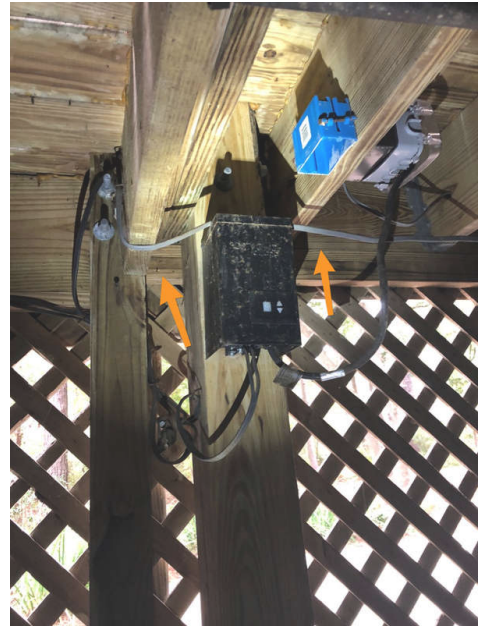
DECK - JOIST NOT SUPPORTED

One of more areas of the deck support appears unsupported. Joists should be fully resting on their joist hanger. Recommend a qualified deck contractor repair as needed.

Moderate / Repair or Replace

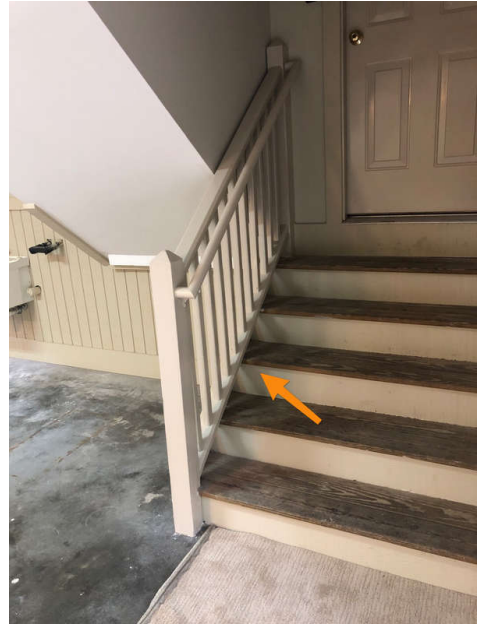
Garage

HANDRAIL - LOOSE

The garage handrail was loose and needed re-fastening. This condition is a potential fall hazard. All corrections should be made by a qualified contractor.

Moderate / Repair or Replace

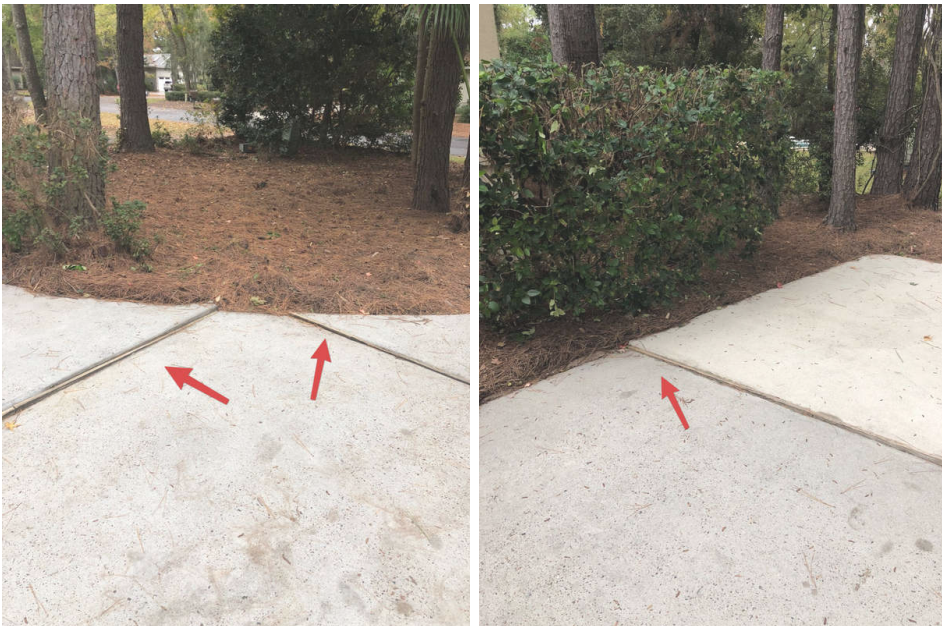
DRIVEWAY - UPHEAVAL

Major / Safety Hazard

Trip hazards in the driveway appeared to be the result of the expansion or contraction (heaving or settling) of underlying soil.

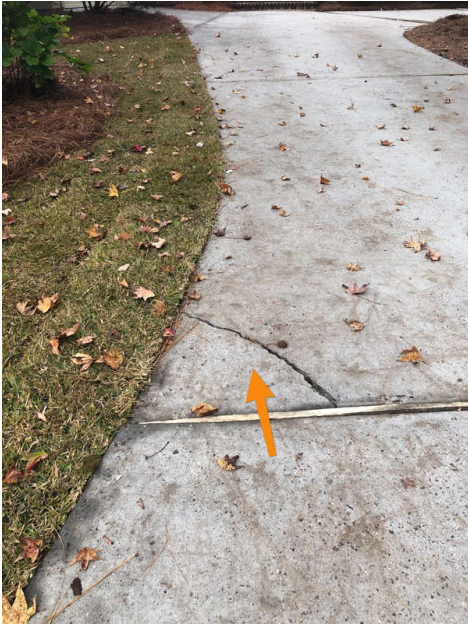
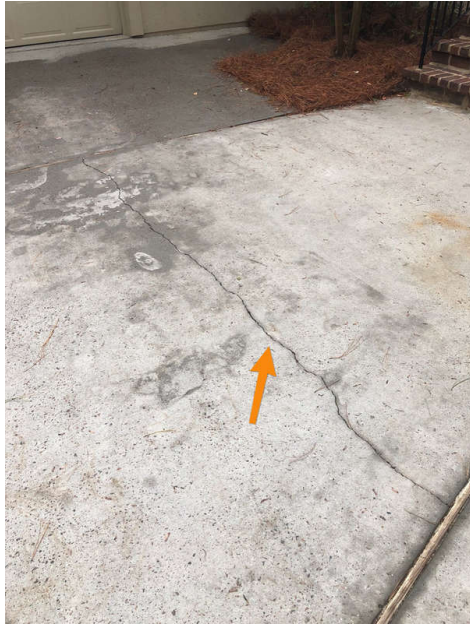
DRIVEWAY - SIGNIFICANT CRACKING

Moderate / Repair or Replace

Significant cracks were observed in the driveway and should be filled with an appropriate material to avoid continued damage to the driveway surface.

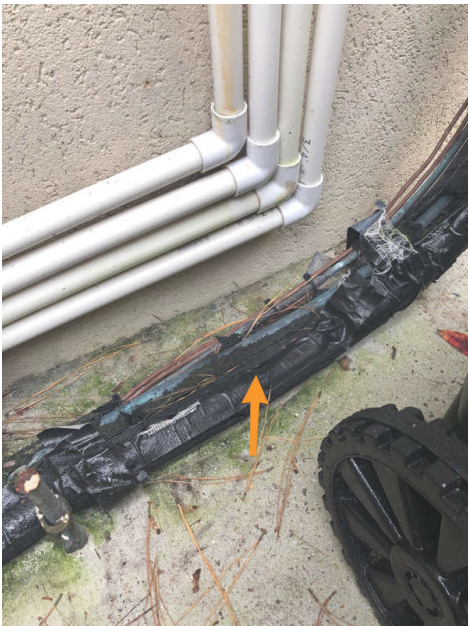
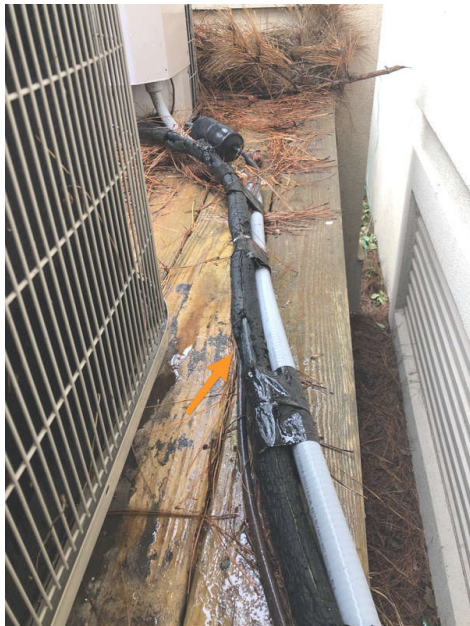
Front Left Side

SUCTION LINE - INSULATION MISSING/ DAMAGED

Moderate / Repair or Replace

Insulation on the air-conditioning suction (large, insulated) line was damaged or missing at areas, which can cause energy loss or condensation. Recommend both suction lines be repaired.

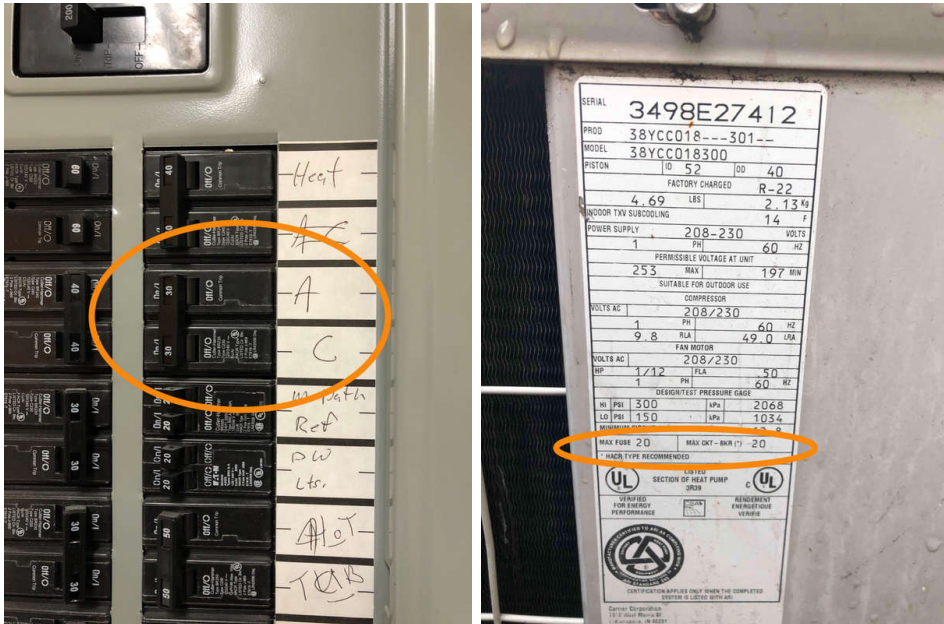
CONDENSING UNIT - OVERSIZED BREAKER

Moderate / Repair or Replace

The breaker servicing the outdoor unit was oversized. This condition is a potential safety hazard and voids the manufactures warranty. Recommend correction by a qualified contractor.

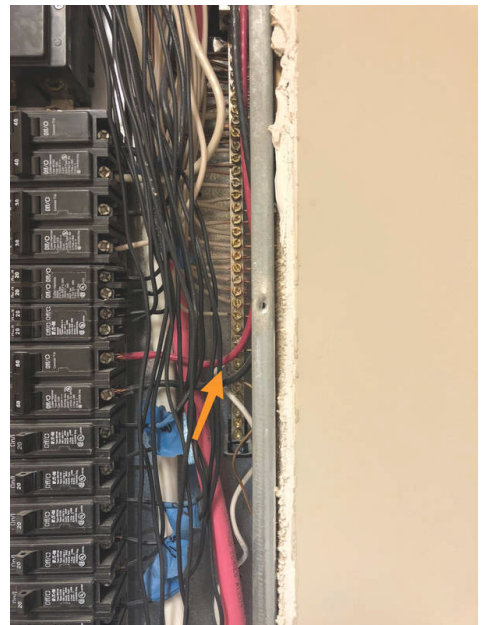
PANEL - BUSBAR NOT BONDED TO PANEL

The grounding bus was not bonded to the distribution panel enclosure. Recommend repair by a qualified contractor.

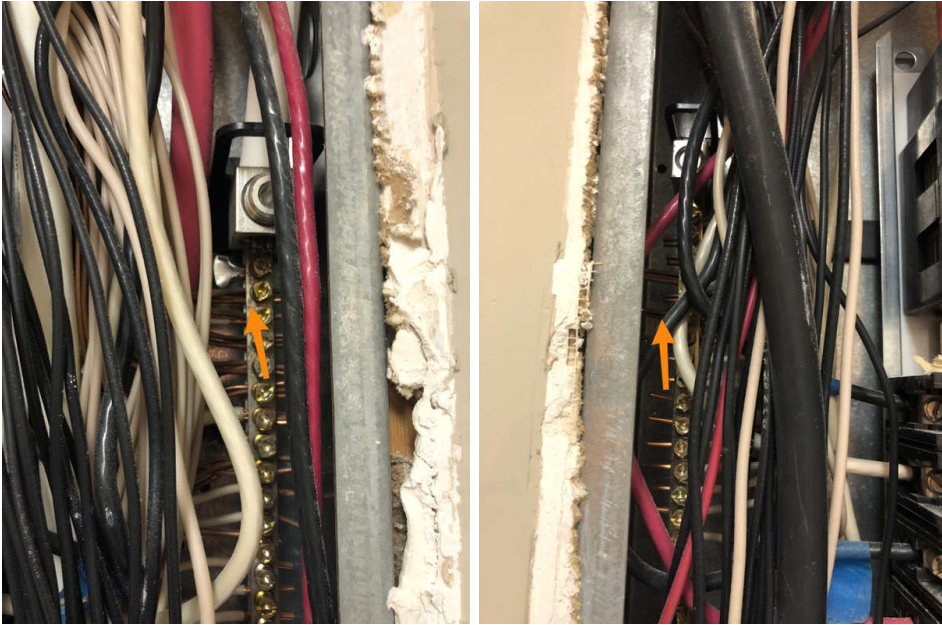
BRANCH CIRCUITS - DOUBLE GROUNDS

Grounding wires were doubled or bundled together on the grounding bus bar. This is unsafe as one of the ground wires could come loose from the lug, allowing the circuit to become ungrounded. A qualified electrician should evaluate and repair as necessary.

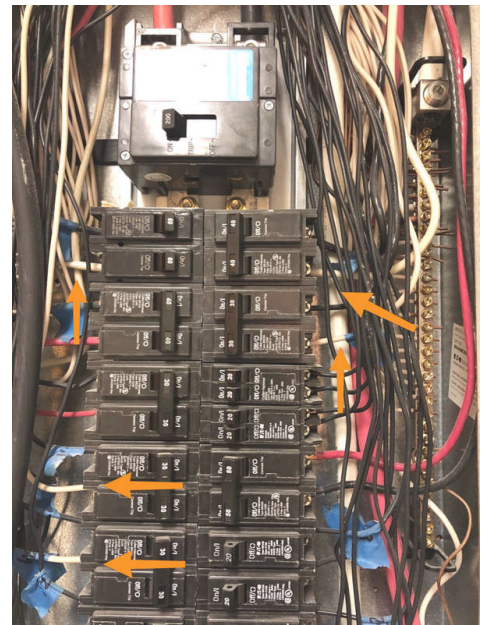
BRANCH CIRCUITS - RE-IDENTIFY NEUTRAL

The neutral conductor was on a 240 volt (two-pole) circuit and was not permanently re-identified to indicate its use as an ungrounded "hot" conductor. It should be taped, typically using red or black tape (anything but white, green, or blue). Recommend correction by a qualified contractor.

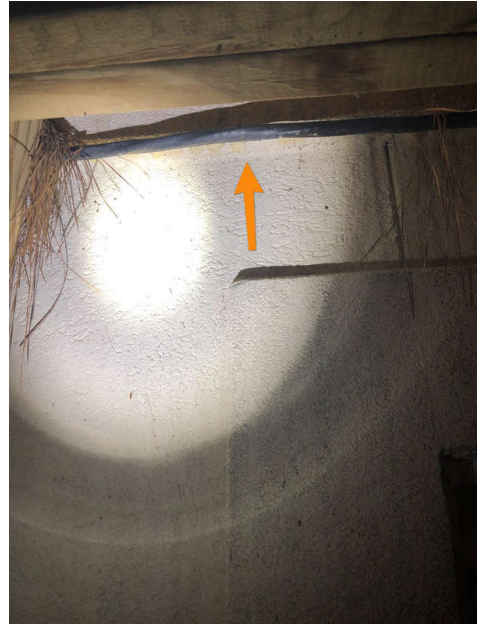
Rear Deck

EXTERIOR WIRE(S) - EXPOSED

One or more sections of outdoor wiring were exposed and not rated for exterior use. This is a potential shock hazard. Recommend that a qualified electrician repair per standard building practices (i.e. installing conduit, re-routing wires or replacing wiring).

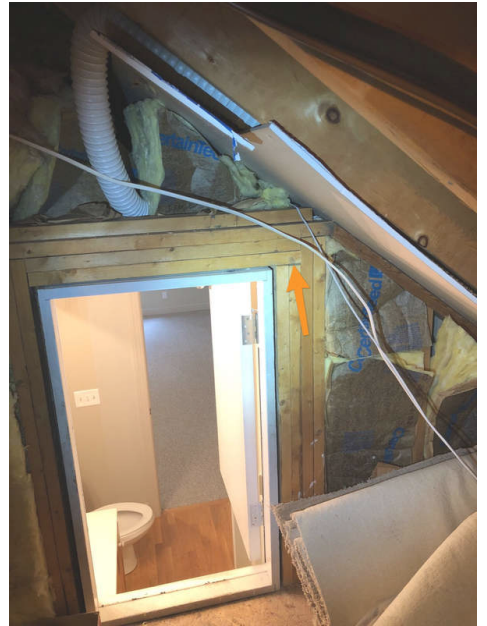
WIRE(S) - UNSECURED

Attic wiring was not secured to joists. Recommend a qualified electrician properly secure all loose wiring to floor joists per standard building practices.

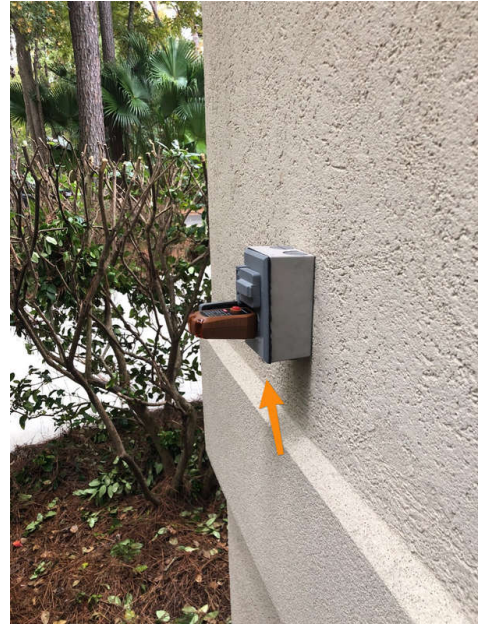
RECEPTACLE(S) - INOPERABLE

An electrical receptacle was inoperable at the time of the inspection. Recommend that an evaluation and any necessary corrections or repairs be performed by a qualified electrical contractor.

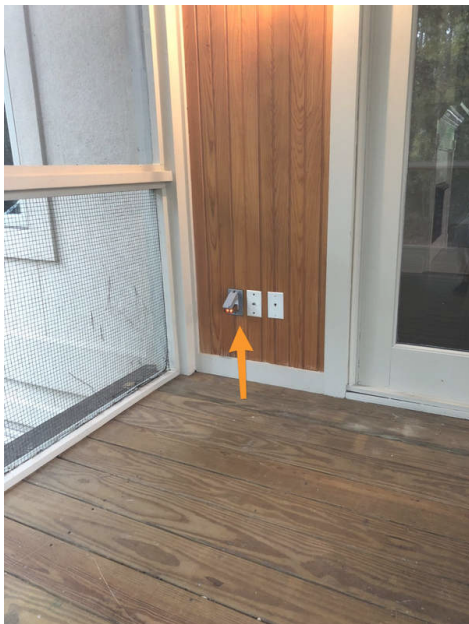
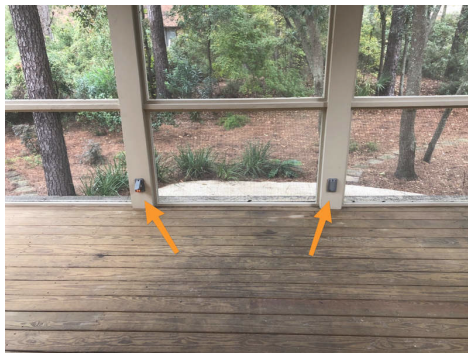
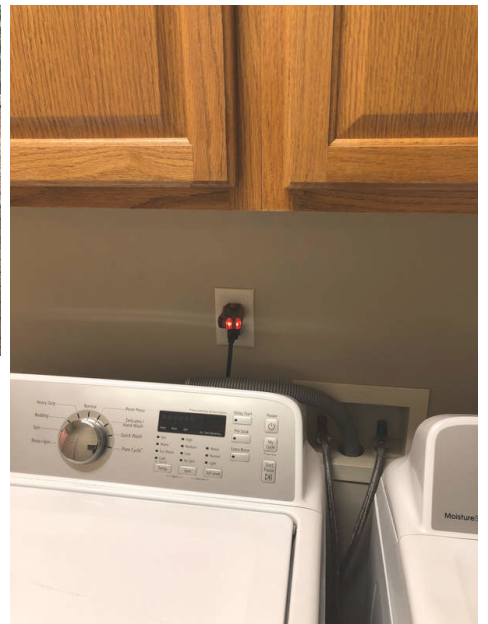
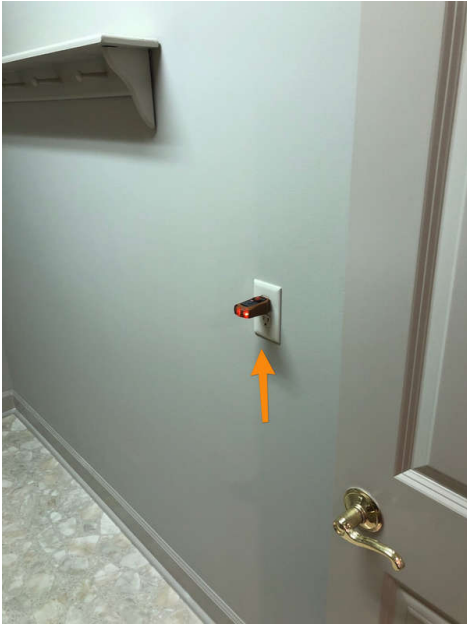
GFCI PROTECTION - NOT INSTALLED

Moderate / Repair or Replace

No ground fault circuit interrupter (GFCI) was present in one or more areas inside and outside of the home. Recommend a licensed electrician upgrade outlets by installing GFCI receptacles located within 6 feet of a water source or in damp locations.

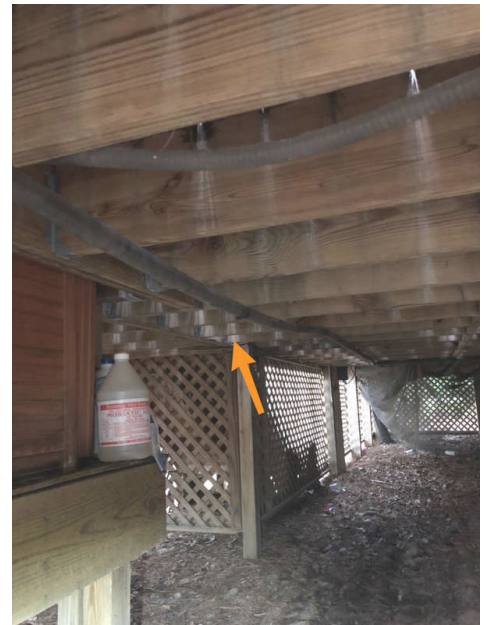
Rear Deck

SUPPLY LINE(S) - SUPPORT NEEDED (CPVC)

Chlorinated Poly Vinyl Chloride (CPVC) water distribution pipes were poorly supported. This condition puts excessive strain on fittings and may result in premature failure. Horizontally-oriented CPVC supply pipes should be supported at least every 3 feet. Recommend installation of additional supports by a qualified contractor.

Moderate / Repair or Replace

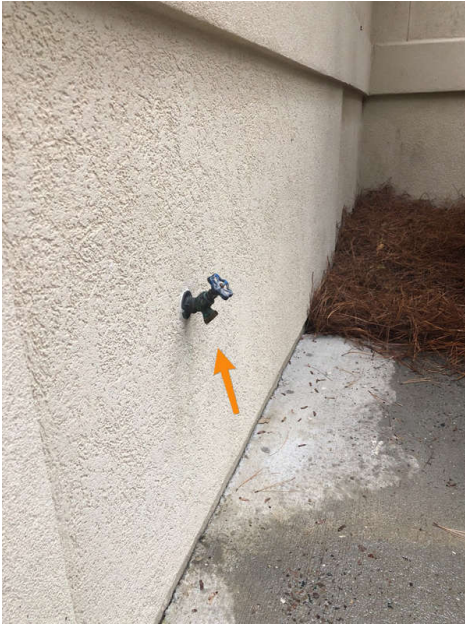
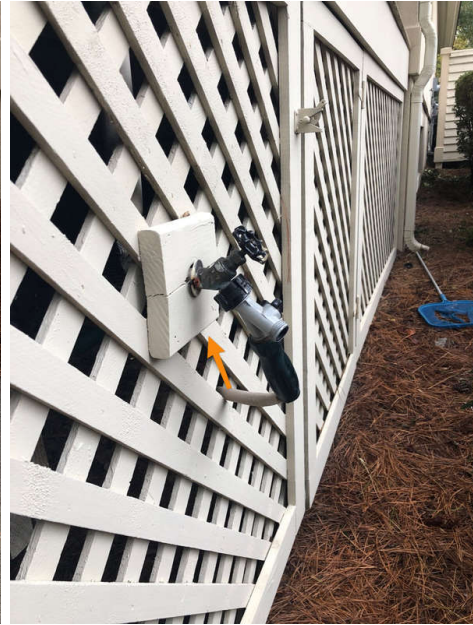
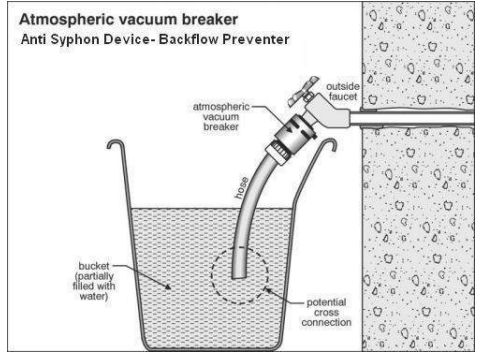
HOSE BIBB - ANTI-SIPHON PROTECTION NOT INSTALLED

Install anti-siphon devices on exterior hose bibbs to prevent cross contamination into the house's drinking water. Recommend installation by a qualified contractor.

Moderate / Repair or Replace

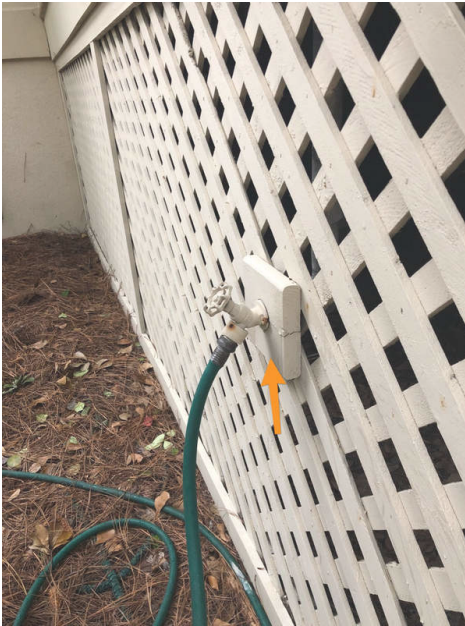
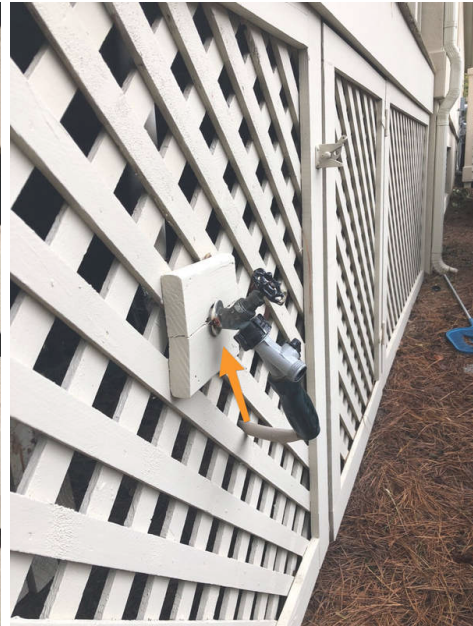
HOSE BIBB - NOT SECURE

Hose bibb was not secured with mounting screws.

Moderate / Repair or Replace

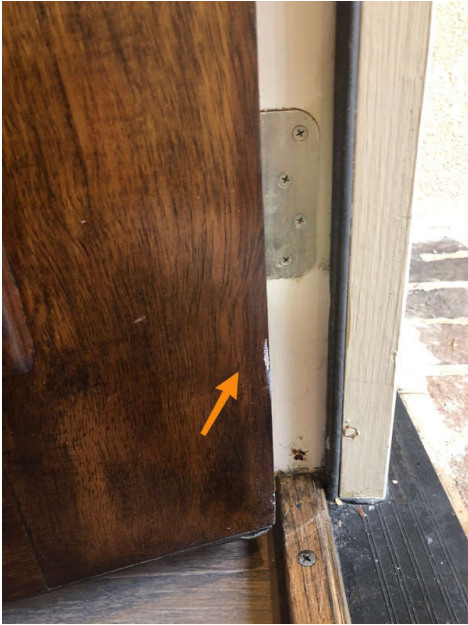
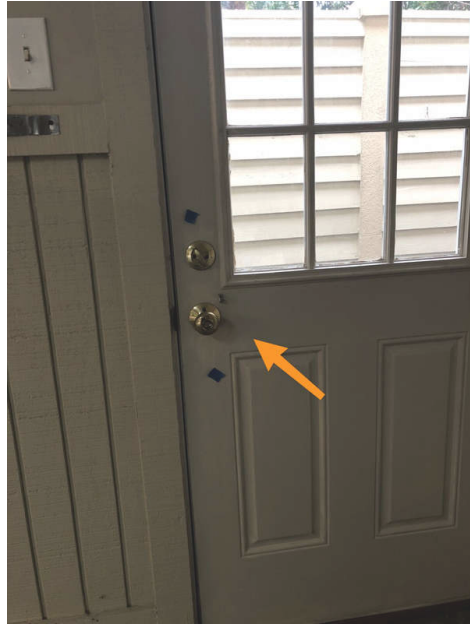
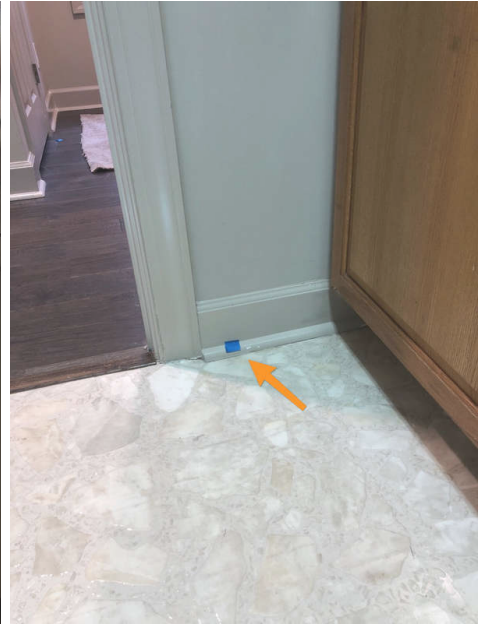
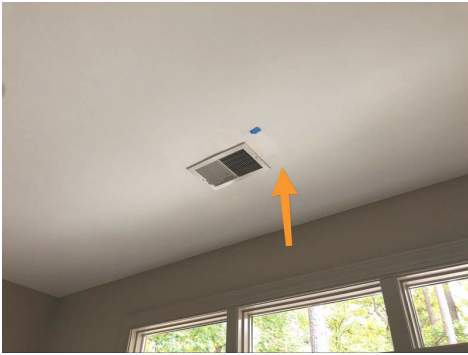
PAINT TOUCH-UP

A few areas of the home was in need of paint touch-ups- not all areas shown and are marked with blue tape.

Moderate / Repair or Replace

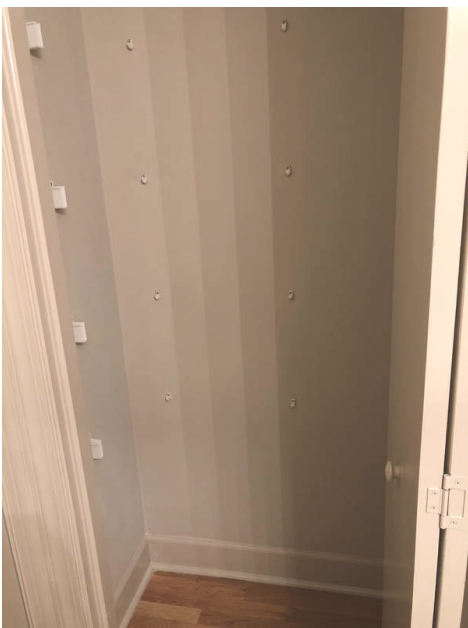
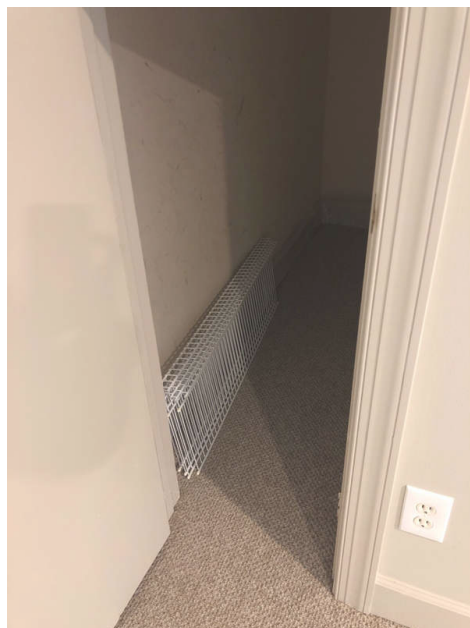
CLOSET SHELF - MISSING

Recommend reinstalling closet shelves.

Moderate / Repair or Replace

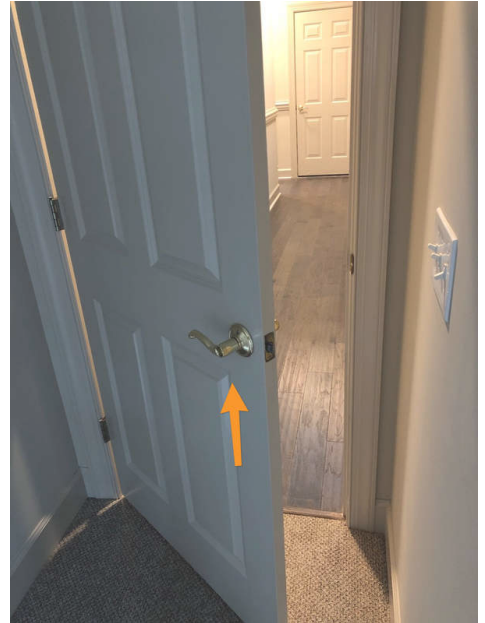
LOCKSETS - ADJUST

Moderate / Repair or Replace

Lockset was not operating properly and should be adjusted or replaced as need.

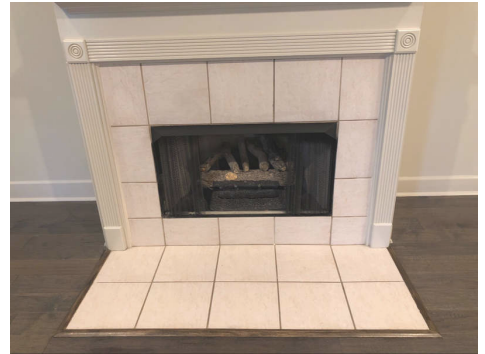
FIREPLACE - INOPERABLE

Moderate / Repair or Replace

The gas fireplace was not functioning at the time of the inspection and should be serviced by a qualified contractor.

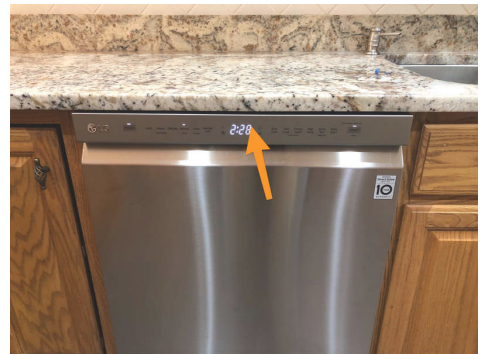
Kitchen

DISHWASHER - DOOR ADJUSTMENT

Moderate / Repair or Replace

The dishwasher door was difficult to open and close, and is need of adjustment.

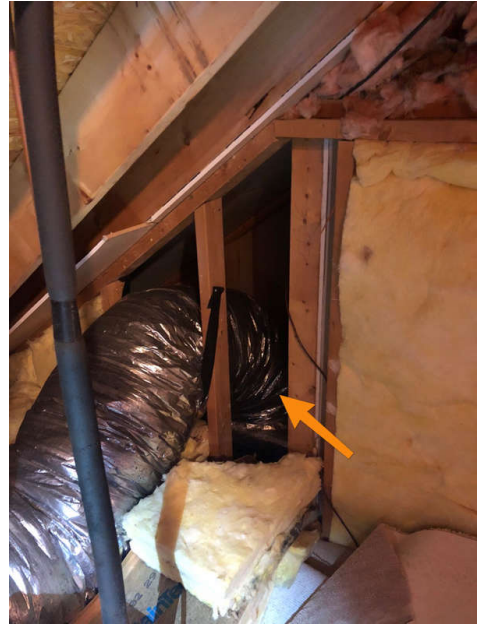
Attic

INSULATION - MISSING

Moderate / Repair or Replace

Insulation was not installed in several places. This condition will result in higher heating and cooling costs and lower comfort levels than would be the case if the walls were insulated. Recommend a qualified contractor install insulation were missing.

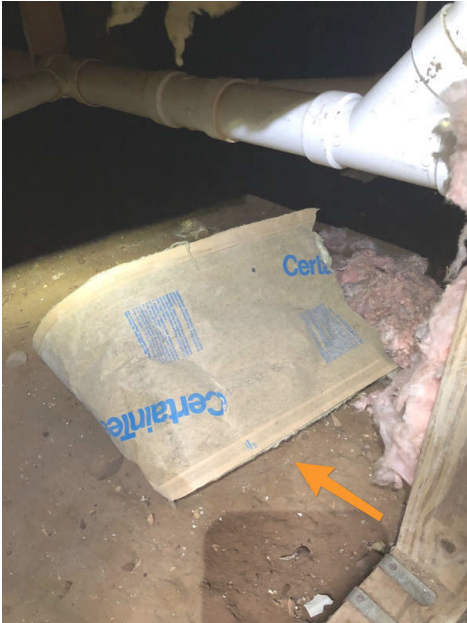
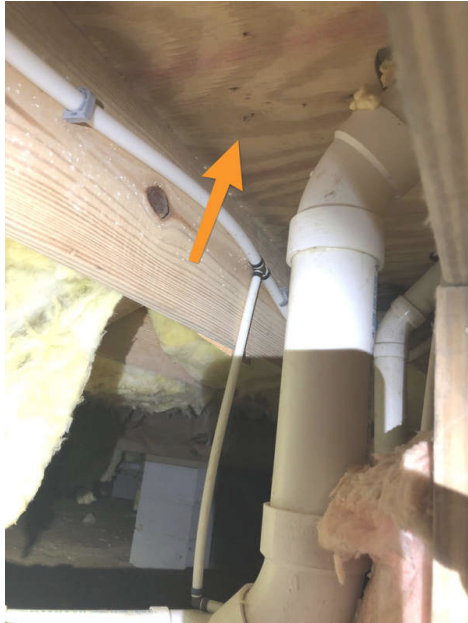
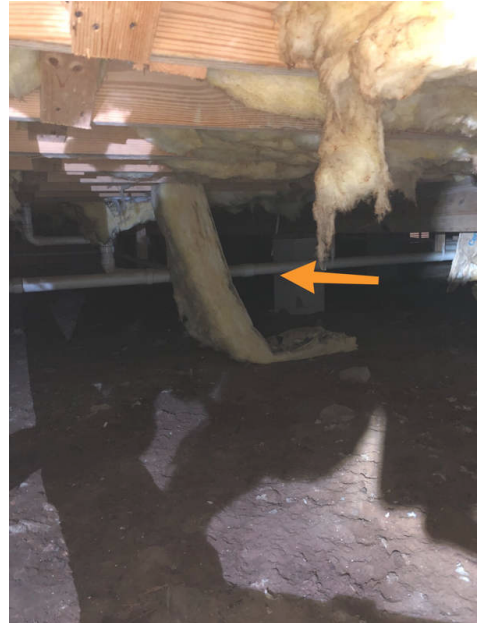
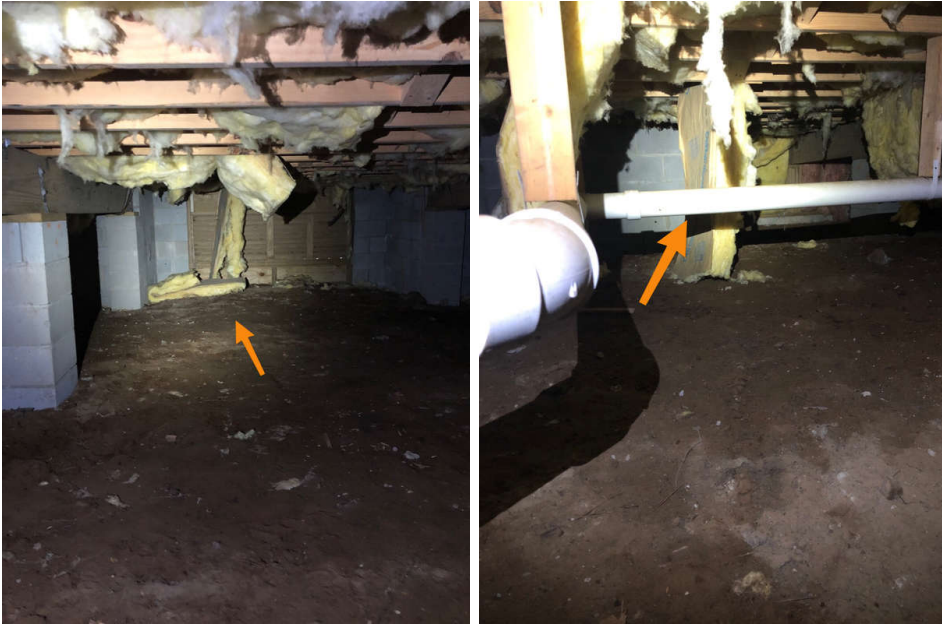
CRAWLSPACE INSULATION - MISSING / LOOSE

Moderate / Repair or Replace

Insulation was loose or missing in the crawlspace. Insulation should be secured properly to help reduce heating costs. Recommend repair by a qualified contractor.

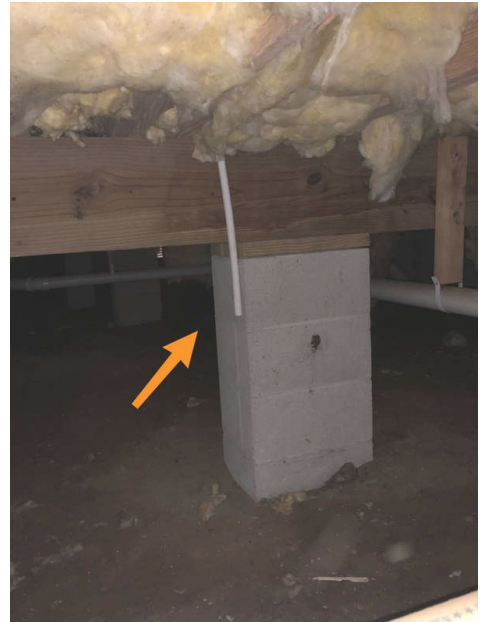
12.4.1 Crawlspace Ventilation
TPR VALVE - IMPROPER DISCHARGE

Moderate / Repair or Replace

The temperature-pressure relief valve was routed to empty into the crawl space. Water may accumulate in the crawlspace if the valve develops a leak. A qualified plumber should re-route the drain to the outside.

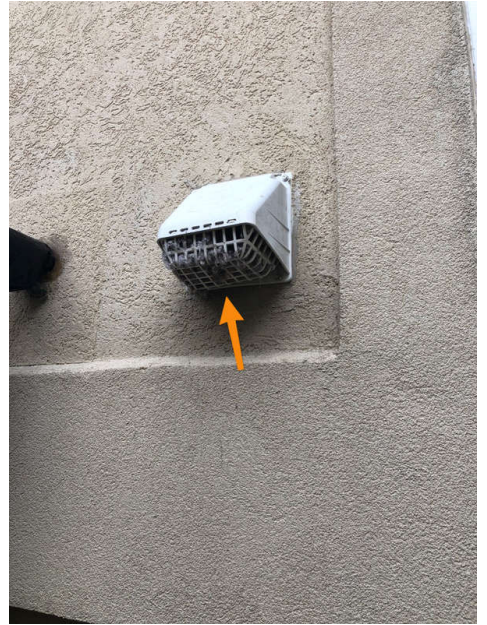
Front Left Side

12.5.1 Exhaust Systems
DRYER VENT - NEEDS CLEANED

Moderate / Repair or Replace

The clothes dryer exhaust duct appears to need cleaning. Significant amounts of lint build up was found. This is a safety hazard due to the risk of fire from decreased air flow. This duct should be cleaned now and at least annually in the future.

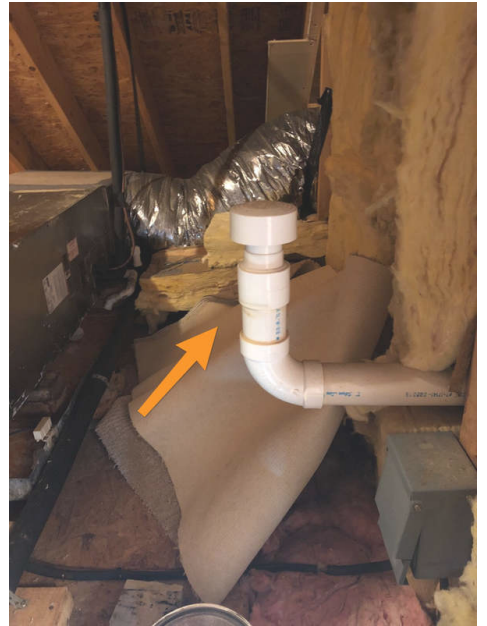
Attic

PLUMBING VENT - EXHAUST INTO ATTIC

Moderate / Repair or Replace

A bathroom plumbing vent terminated in the attic instead of at the home exterior. This condition can raise moisture vapor levels in the attic to the point at which home materials are damaged or unhealthy conditions related to mildew develop. Recommend correction by a qualified contractor.
