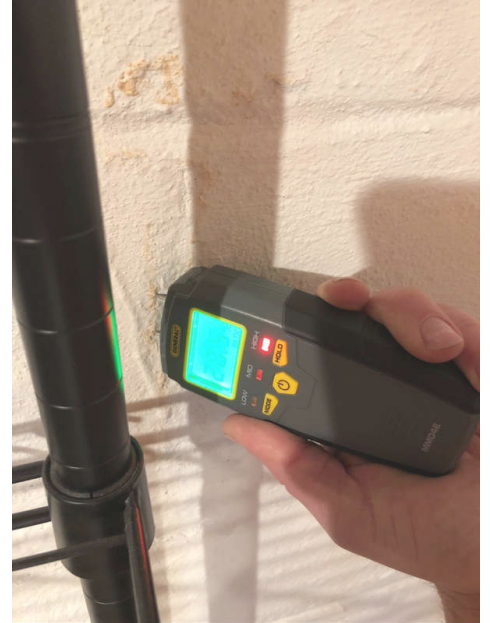
Northeast storage room

HIGH MOISTURE LEVELS

High levels of moisture were noted in areas of the basement. Recommend finding source of moisture intrusion and making necessary repairs to prevent damage or further damage to the structure.

Recommendation
Contact a qualified professional.

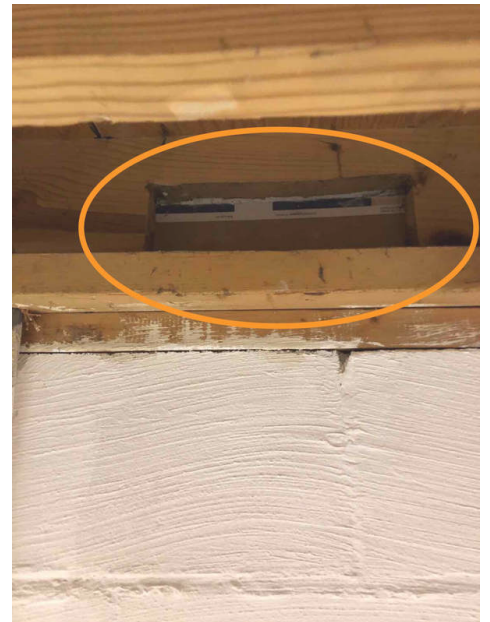
Northwest work room North wall

EXCESSIVE NOTCHING

Excessive notching was noted on a structural member of the floor. This could weaken the floor in this area. Recommend qualified professional to make necessary repairs to ensure stability.

Recommendation
Contact a qualified professional.

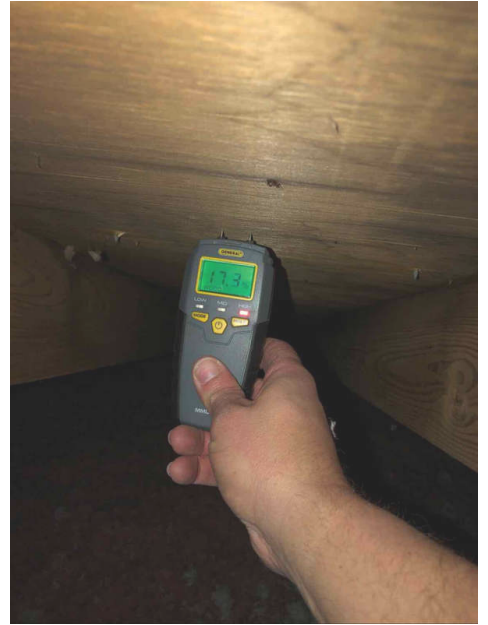
Attic

HIGH MOISTURE LEVELS

High moisture levels were noted in the roof decking. This is potentially due to either a ventilation problem or a failure of the material covering the roof. Recommend qualified roofing professional for evaluation and repair.

Contact a qualified professional.

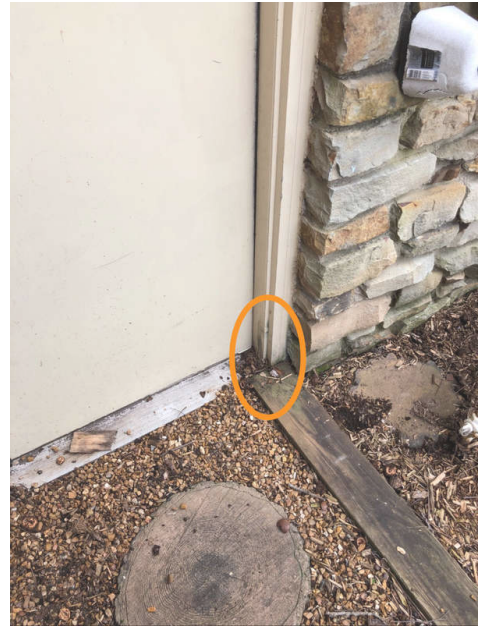
West lower door

WOOD ROT

Wood rot was noted in one or more places. Recommend qualified handyman to repair or replace all affected areas.

Contact a qualified handyman.

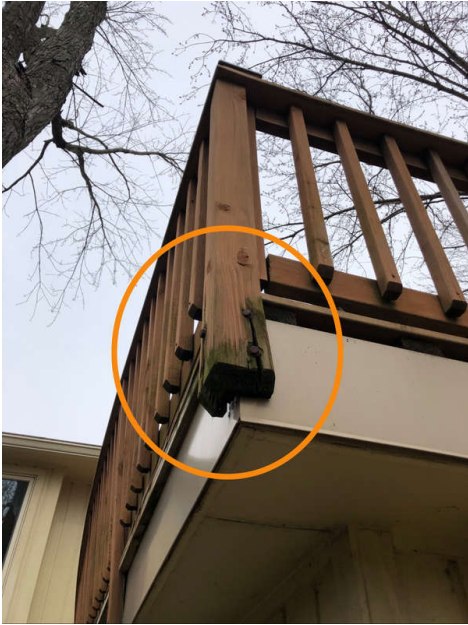
Southwest corner

DECK- WATER DAMAGE ON POSTS

Water damage was noted on the post(s). This could eventually lead to failure of the railing. Recommend qualified professional for repair.

Contact a qualified professional.

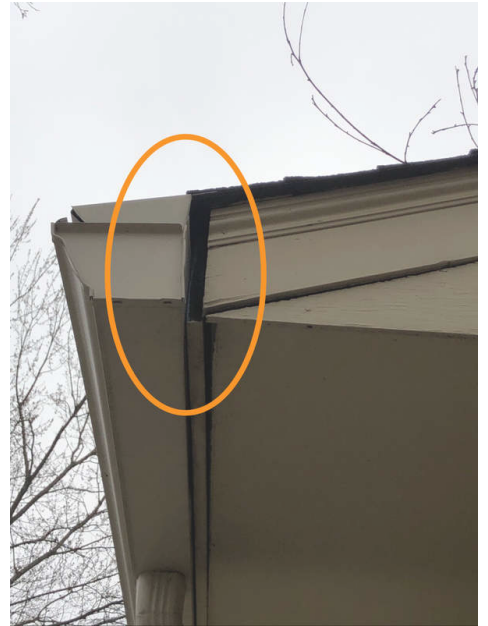
North Garage

FASCIA - LOOSE

One or more sections of the fascia are loose. This could lead to water penetration if not corrected. Recommend qualified professional to evaluate & repair.

Contact a qualified professional.

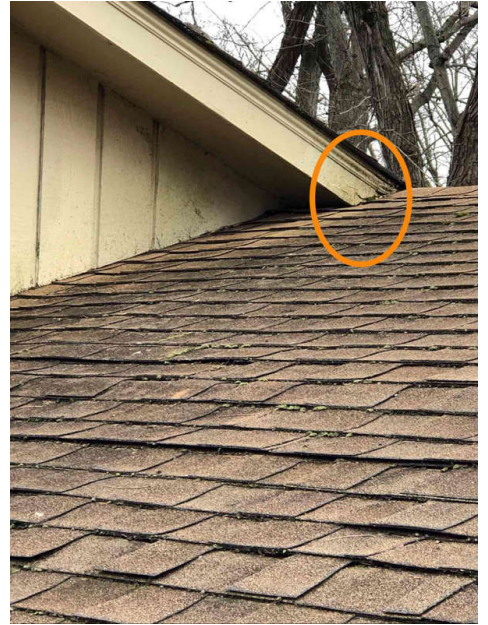
North center

FASCIA - ROTTED

One or more sections of the fascia are rotted. Recommend qualified professional evaluate & repair.

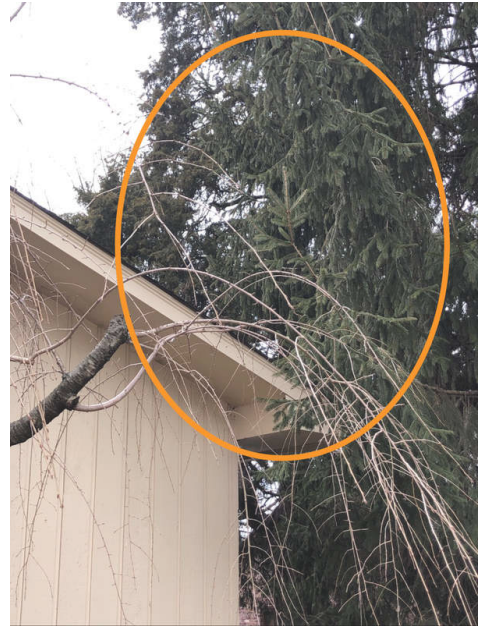
West Garage

TREE OVERHANG

Trees observed overhanging the roof. This can cause damage to the roof and prevent proper drainage. Recommend a qualified tree service trim to allow for proper drainage.

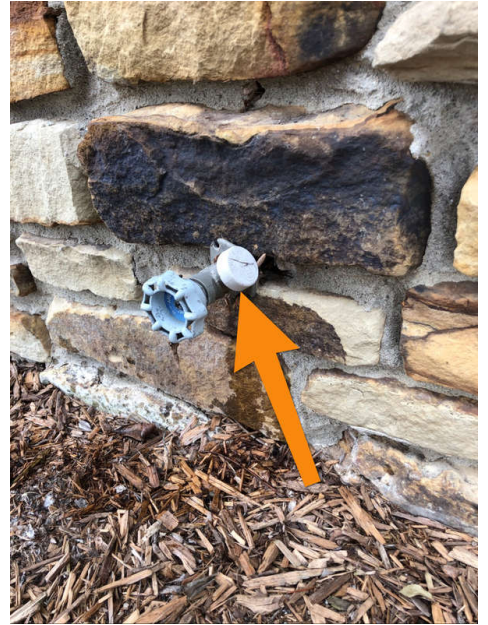
North

FAUCET-LEAKING

Exterior faucet was leaking. Recommend qualified plumber for evaluation and repair.

Contact a qualified plumbing contractor.

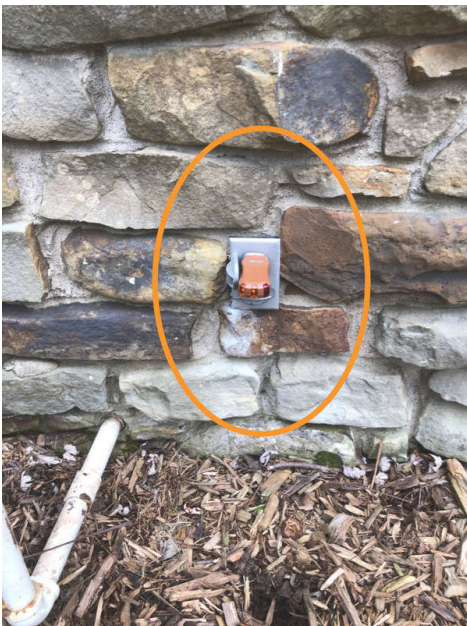
West

NO GFCI PROTECTION

Exterior outlet(s) were not GFCI protected. All exterior outlets should be GFCI protected for safety. Recommend qualified electrician for repair.

Contact a qualified electrical contractor.

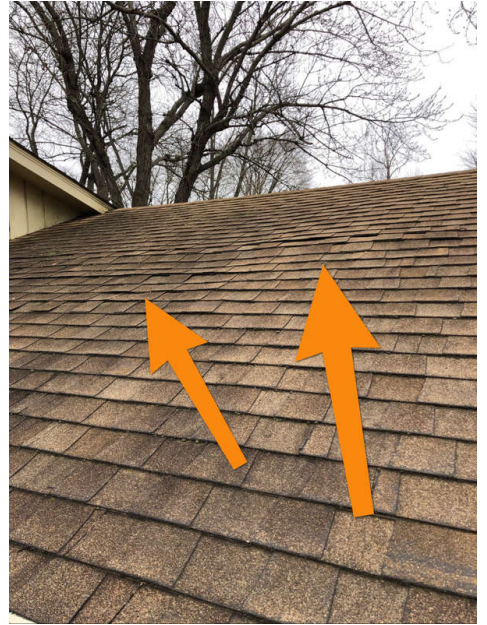
North above front door

DAMAGED COVERINGS

Roof coverings exhibited general damage that could affect performance. Recommend a qualified roofer evaluate and repair.

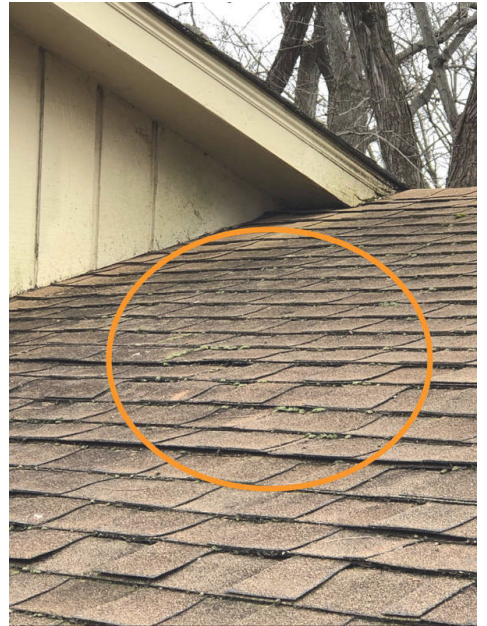
North

VEGETATION GROWTH

The growth of vegetation on the roof covering can lead to premature deterioration and water leaks. Recommend qualified professional to clean and regular maintenance is recommended.

Contact a qualified professional.

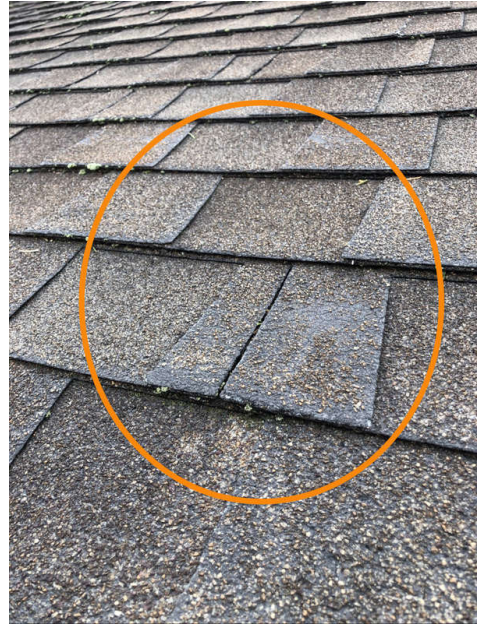
AT OR NEAR DESIGN LIFE

The roof covering is at or near its design life. Recommend monitoring for proper function and budgeting for replacement.

Recommend monitoring.

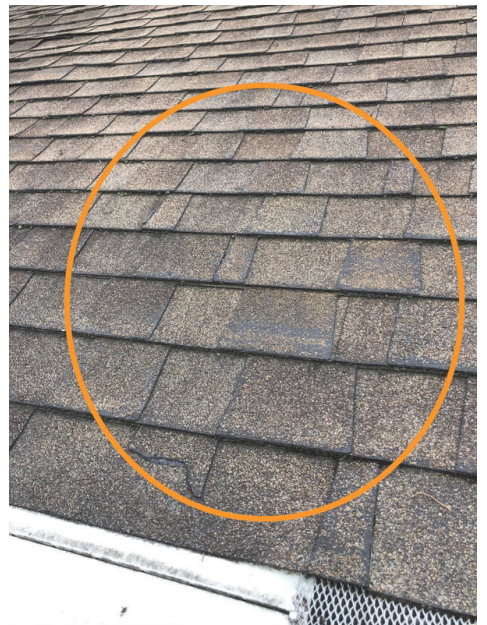
Several places

EXCESSIVE GRANULAR LOSS

There was excessive granular loss noted on the roof covering. This is an indication that the roof is near or at the end of its design life. Recommend qualified roofing professional for evaluation and repair.

Contact a qualified roofing professional.

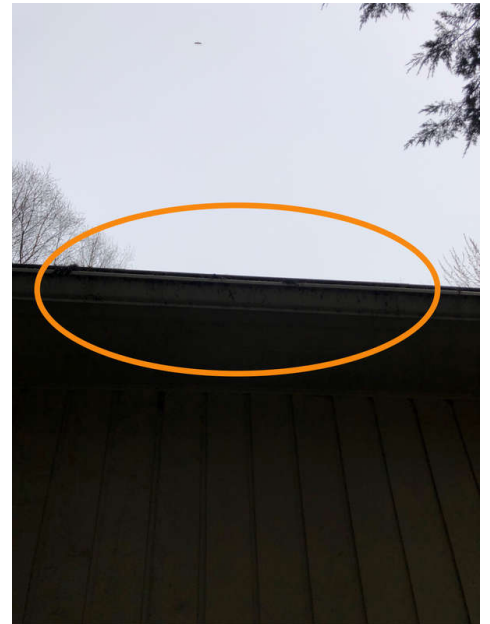
West Garage

DEBRIS

Debris has accumulated in the gutters. Recommend cleaning to facilitate water flow.

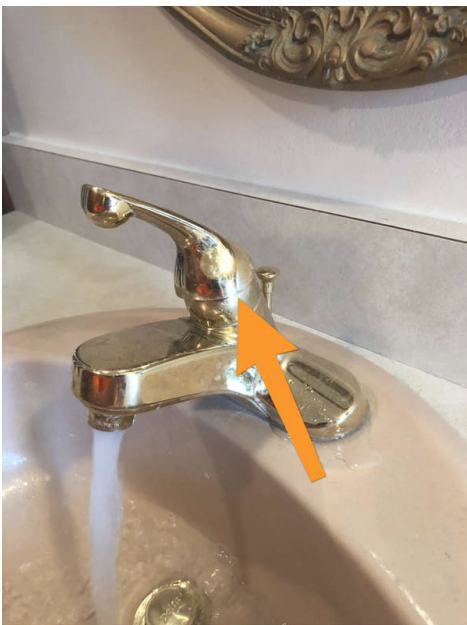
Master Bathroom left sink

FIXTURE LEAKING

A leak was noted coming from the plumbing fixture. Recommend qualified plumber for repair.

Contact a qualified plumbing contractor.

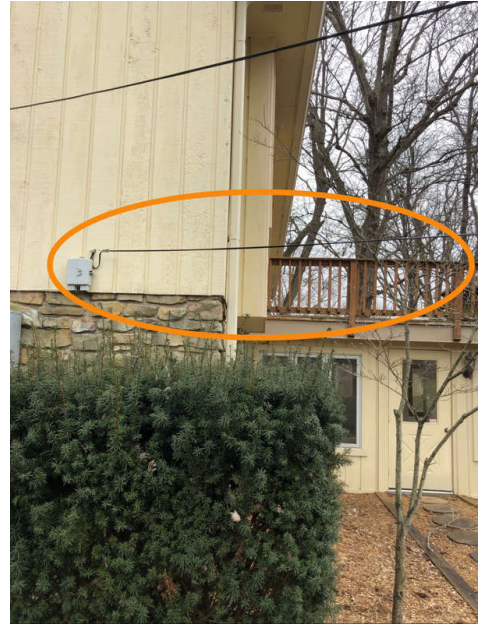
Southwest

CABLE/PHONE WIRE

The cable/phone wire is too low and could easily be grabbed. Recommend relocating the wire.

Contact a qualified professional.

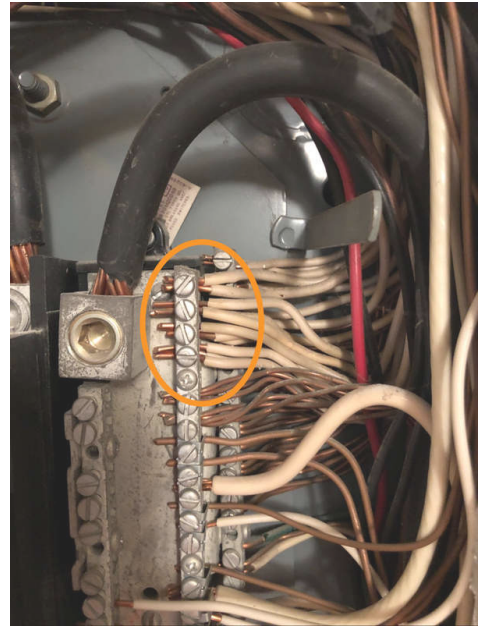
Panel

DOUBLE TAPPED NEUTRAL

Neutral wires should not share the same lug with other neutral wires or ground wires. This can lead to overheating or the inability to isolate a circuit. Recommend qualified electrician for repair.

Contact a qualified professional.

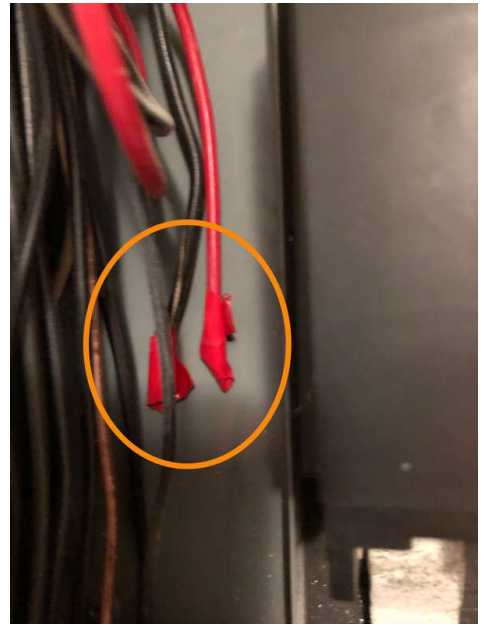
Panel

WIRE NUT

Wire nuts should be used at wire terminations. This ensures that a live wire cannot be touched. Recommend qualified electrician for repair.

Contact a qualified electrical contractor.

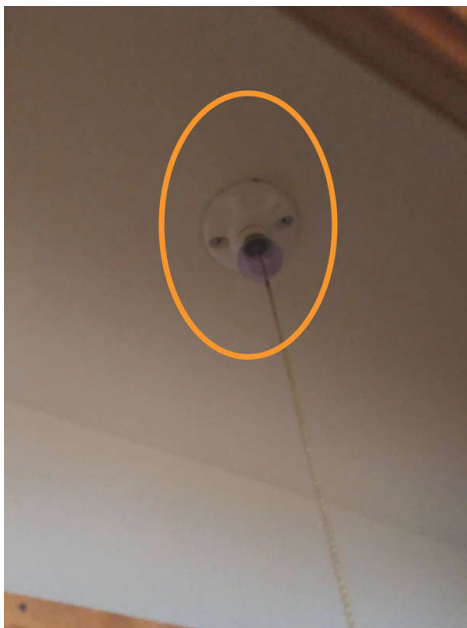
Northeast Bedroom closet

LIGHT INOPERABLE

One or more lights are not operating. New light bulb possibly needed.

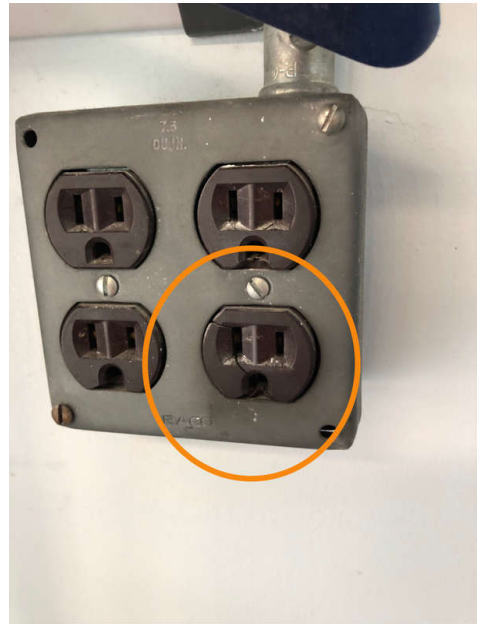
Garage

OUTLET DAMAGED

Outlet was damaged. This could eventually effect the performance of the receptacle. Recommend qualified electrician for replacement.

Contact a qualified electrical contractor.

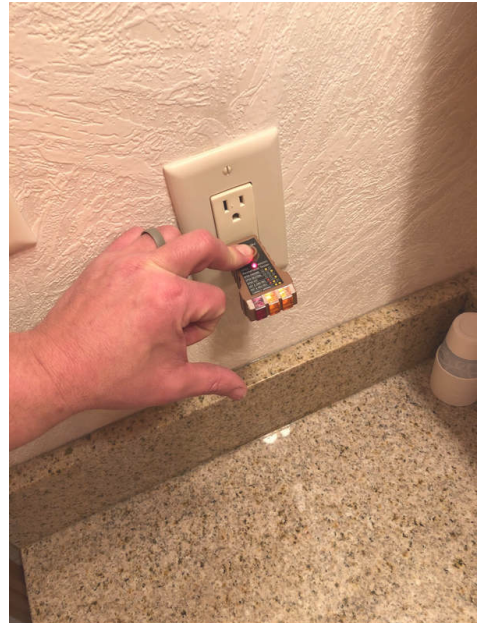
Basement Bathroom

BATHROOM GFCI

Outlet(s) were not GFCI protected. Recommend qualified electrician for repair.

Contact a qualified professional.

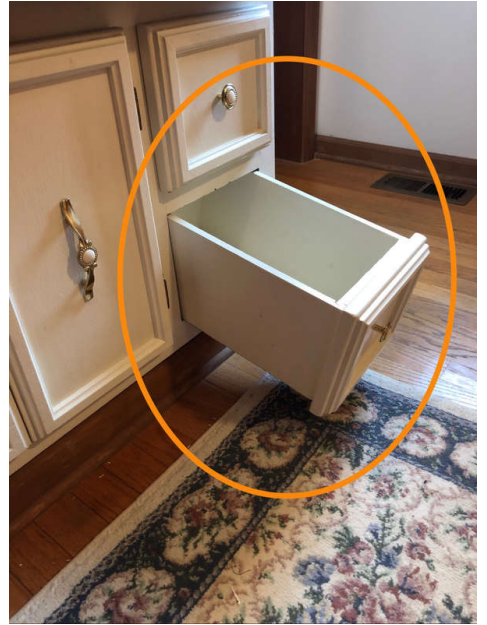
Master Bathroom

DRAWER- BROKEN OR OFF TRACK

A drawer was broken or off of the track. Recommend qualified professional for repair.

Contact a qualified professional.

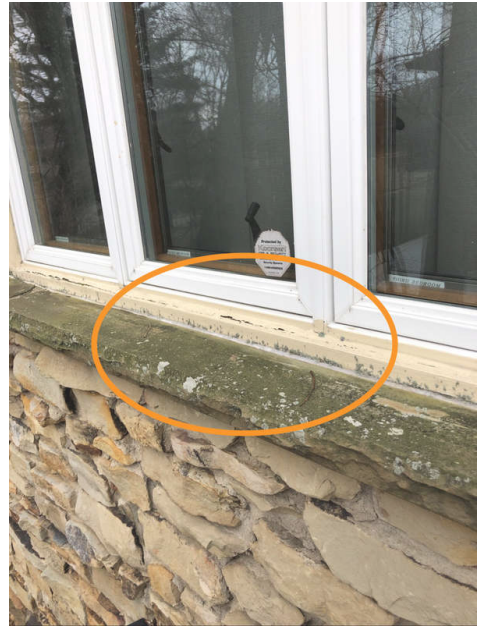
Northeast

WOOD ROT

Wood rot was noted on the exterior trim. Recommend repairing and replacing all affected materials.

Contact a qualified professional.

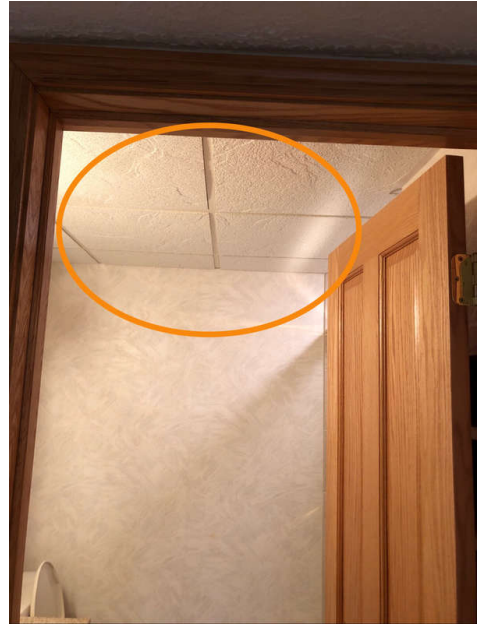
Basement Bathroom

EXHAUST FAN

No exhaust fan. A bathroom needs either an exhaust fan or a window or both.

Contact a qualified professional.

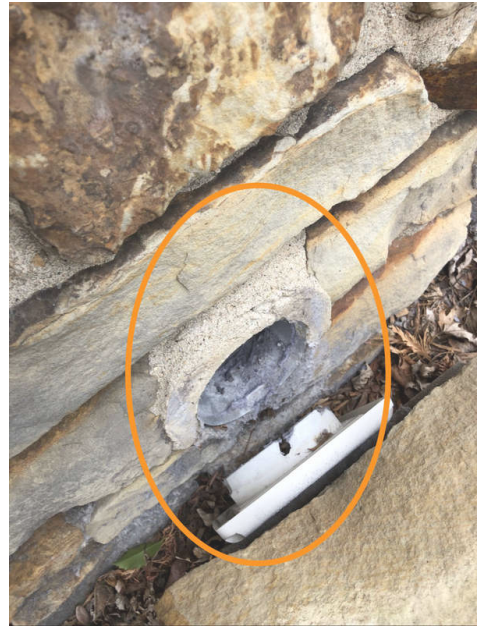
North

COVER-LOOSE

Vent cover is loose. This can lead to insects and varmint intrusion. Recommend qualified handyman for repair.

Contact a qualified professional.

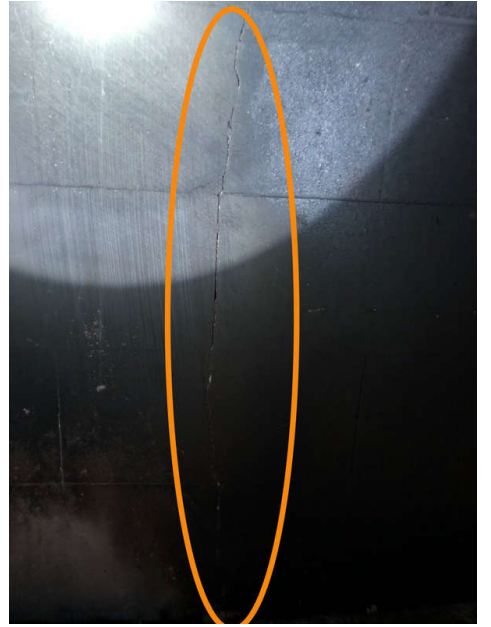
Fireplace

FIREWALL CRACKED

The brick lining of the fireplace was cracked in one or more places, which could lead to chimney damage or toxic fumes entering the home. Recommend a qualified fireplace contractor evaluate and repair.
