SUMMARY

1234 Main St. Moberly MO 65270

Buyer Name
04/15/2018 9:00AM

Jason Butts
InterNACHI, ASHI
Advanced Home Inspection
573-230-2231
jason@advancedinspectionmo.com

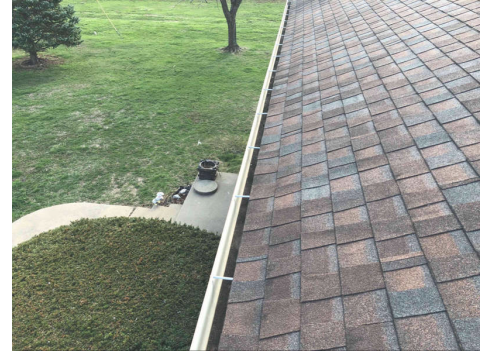
2.2.1 Roof Drainage Systems

DEBRIS

Debris has accumulated in the gutters. Recommend cleaning to facilitate water flow.

Contact a qualified roofing professional.

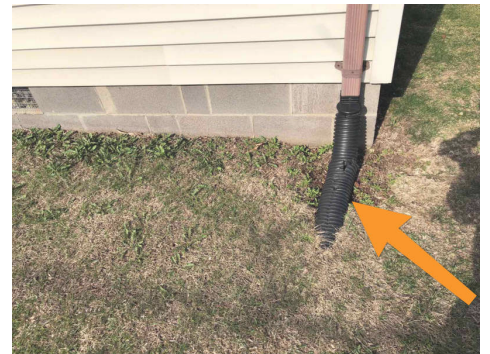
2.2.2 Roof Drainage Systems

DOWNSPOUT DISCHARGE DAMAGED

Black perforated piping is used as sub grade material to discharge the gutters away from the homes foundation. The piping has been damaged and recommend replacement with solid pipe a minimum of 10' away from the homes foundation

Contact a handyman or DIY project

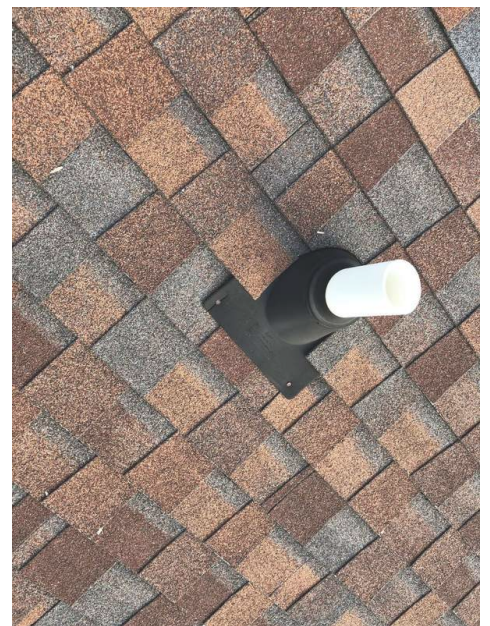
2.4.1 Skylights, Chimneys & Other Roof Penetrations

NAIL HEADS NOT CAULKED

Nail heads on one or more the roof penetrations have not been sealed with a caulk/ or water resistant material.

Contact a handyman or DIY project

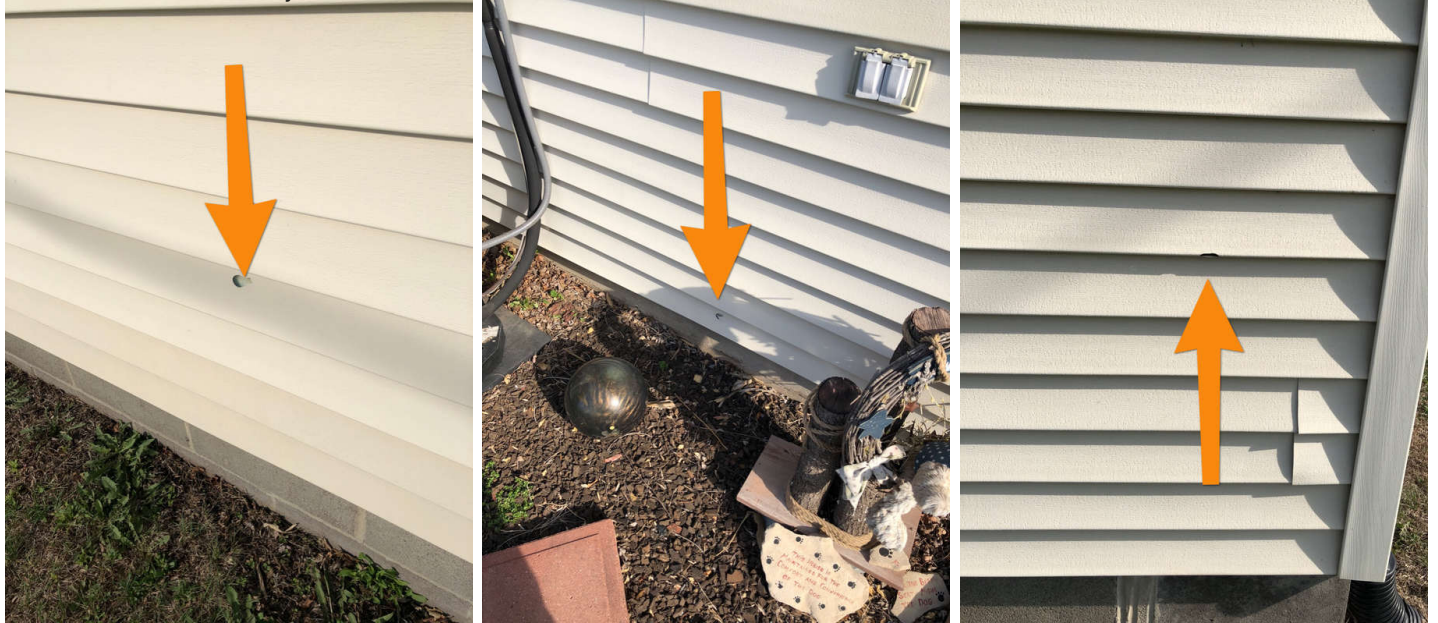
3.1.1 Siding, Flashing & Trim

HOLE IN SIDING IN 3 AREAS

EAST SIDE, BACK SIDE OF GARAGE, SOUTH (BACK) OF EAST SIDE

Recommend to seal the hole or replace the siding as moisture intrusion is possible

Recommended DIY Project

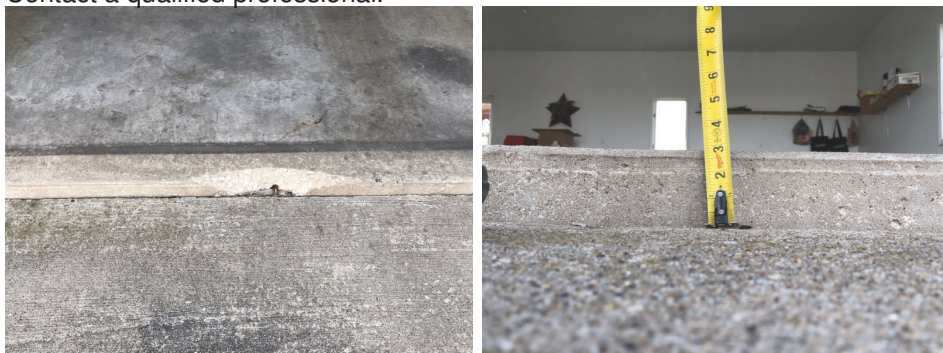
3.3.1 Walkways, Patios & Driveways

APPROACH SETTLEMENT

The approach to the garage has settled and is down approximately 2" from original level. This is due to poor compaction or erosion of the soils after installation. Foam injection is the recommended repair should this ever become an issue or further settlement occurs

Contact a qualified professional.

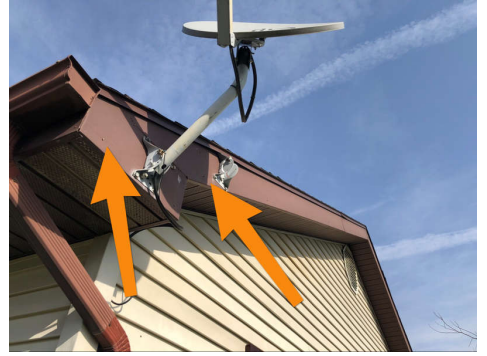
3.5.1 Eaves, Soffits & Fascia

LOOSE NAILS

Recommend hammering nails back

Recommended DIY Project

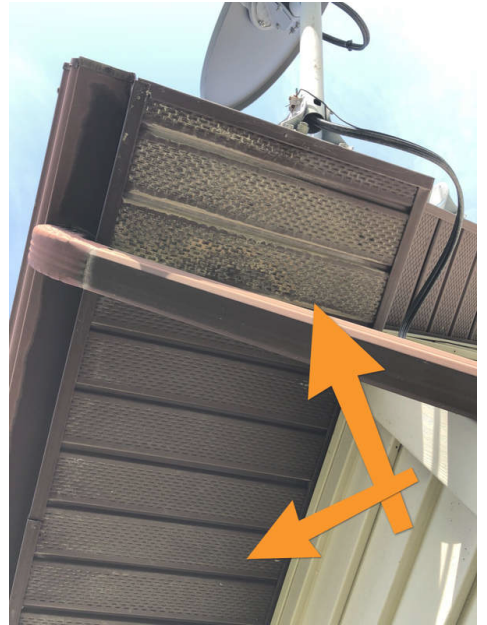
3.5.2 Eaves, Soffits & Fascia

APPEARANCE OF DUST AND DIRT

Due to the close proximity of the Row Crop farming, additional maintenance will be required to ensure the soffit vents are not clogged due to dust and debris. Recommend a good cleaning annually to maintain proper ventilation of the home. The soffit vents play a vital role in the ventilation of the home.

Recommended DIY Project

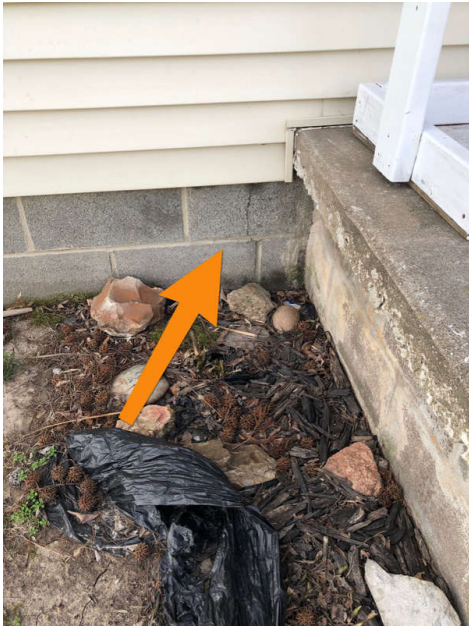
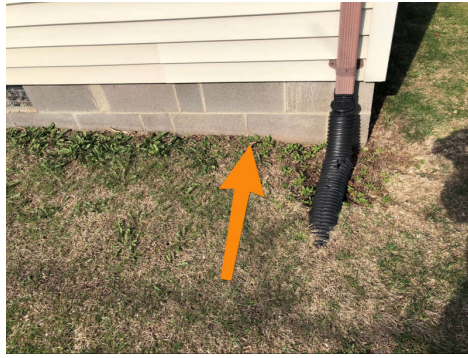
4.1.1 Foundation

MINOR CRACKING IN MORTAR JOINTS AND BLOCK

Minor cracking was observed on the day of inspection. Minor cracking is common as a home settles however continued cracking or larger cracks are a sign of foundation movement and the foundation should be monitored for any future settlement

Recommend monitoring.

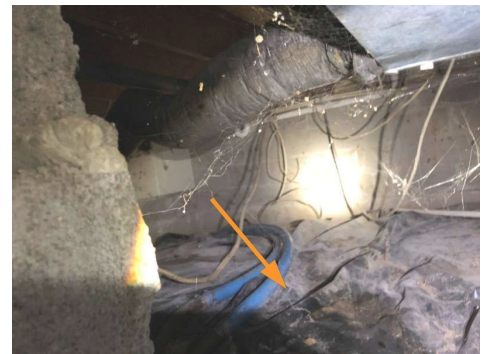
4.2.1 Basements & Crawlspaces

MOISTURE PRESENT

CRAWLSPACE

Moisture was present under the vapor barrier and moisture was noted along all areas where the vapor barrier has degraded or was not installed correctly. A proper vapor barrier is recommended. With moisture present the act of wood rot is accelerated and can cause structural damage. Noted sag in existing beams which have been "Shimmed". Noted in "Floor Structure"

Recommendation
Contact a qualified professional.

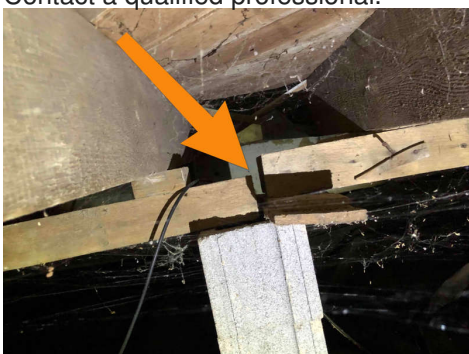
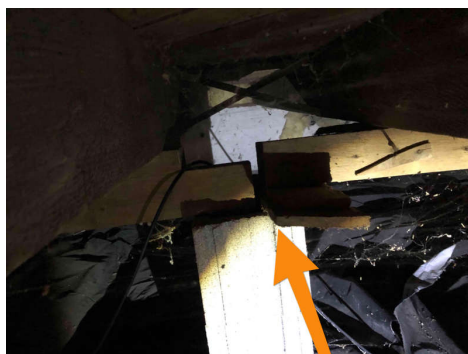
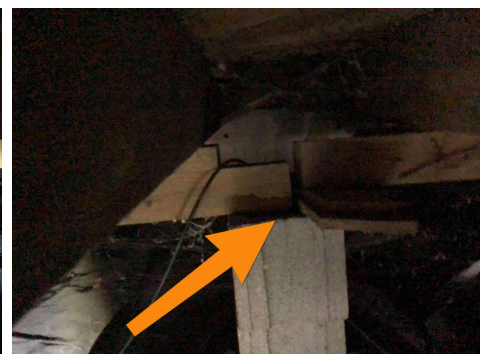
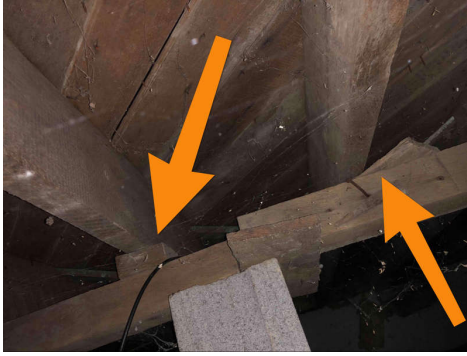
4.3.1 Floor Structure

IMPROPER SPACING OF SUPPORT POSTS

CRAWLSPACE

4x4 beam is supported at too large a span. The beam is sagging and shows signs of sag being improperly repaired using shimming techniques. Recommend proper support of the beam by adding additional support to permanently stabilize the beams in the home. Home should be assessed to determine the load and spacing capacity of the beam and support system. Proper footers should be installed to repair permanently. The shims added sometime after construction indicate the support posts have possibly settled into the soft soil located throughout the crawlspace.

Recommendation
Contact a qualified professional.

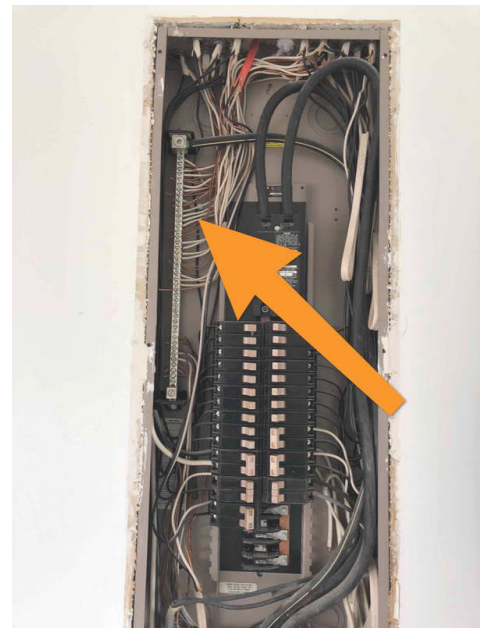
8.2.1 Main & Subpanels, Service & Grounding, Main Overcurrent Device

DOUBLE LUGGED BUS

Contact a qualified electrical contractor.

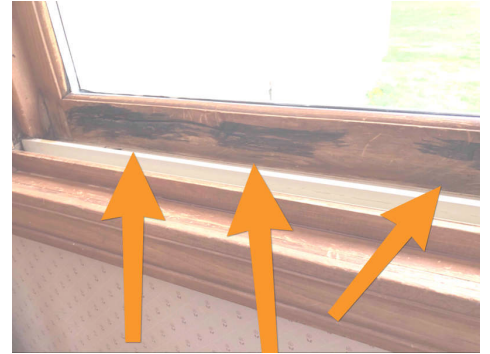
10.2.1 Windows

TERMITE DAMAGE

BACK PORCH AREA

One of the Windows shows signs of termite damage and should be monitored to ensure no further deterioration.

Contact a qualified professional.
