**SUMMARY**  
 1234 Main St.CHARLESTON sc 29412  
 Buyer Name  
 05/25/2018 9:00AM

Preston Clark  
 InterNACHI Certified Home Inspector  
 Clark Inspections LLC  
 843-580-4116  
[preston@spclarkinspections.com](mailto:preston@spclarkinspections.com)

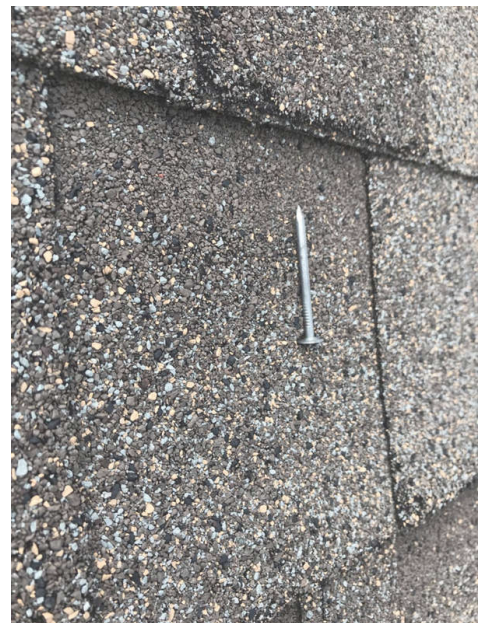
**DEBRIS ON ROOF**

Nail were left on roof from either siding installation or roofing installation. I was able to pick up most nails. This nail had already melted into shingle tab. I recommend having nail removed and area repaired.

Nail on Front Slope 1 story

Contact a qualified roofing professional.

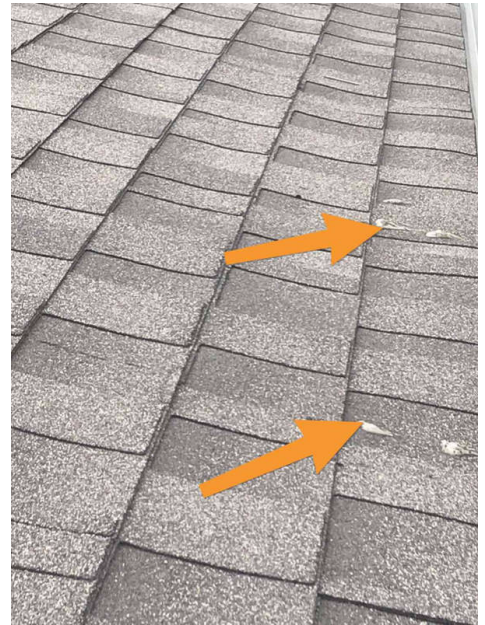
**IMPROPER/INCOMPLETE NAILING**

Roof coverings showed signs of improper installation and fastening. Nail should not be exposed and nailed through the top of the shingle tab. The contractors covered the nails with a silicone sealant. This is a temporary repair. Recommend a qualified roofing contractor evaluate and repair.

These nails probably came from the installation process of the roof.

Silicone sealant covered nails through shingle tabs from installation

Contact a qualified roofing professional.

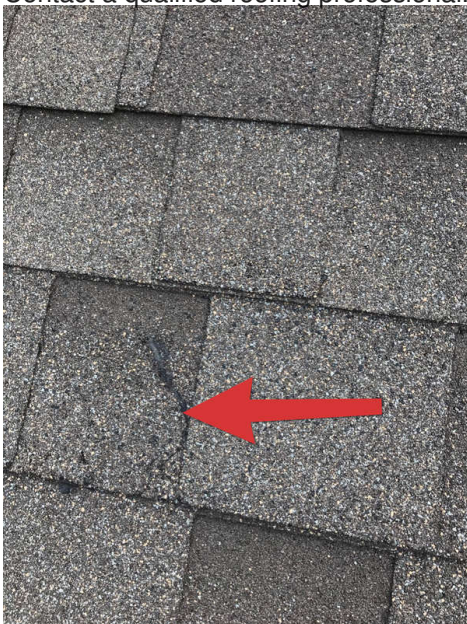
**DAMAGED OR DEFECTIVE SHINGLE**

Cracks from installation for defective shingles found on right slope over the garage. I recommend replacement of shingle shingle by a roofer.

Crack shingle on right elevation towards front of home

Contact a qualified roofing professional.

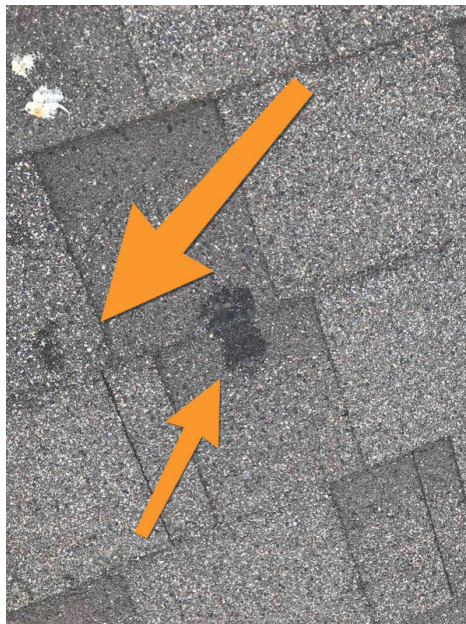
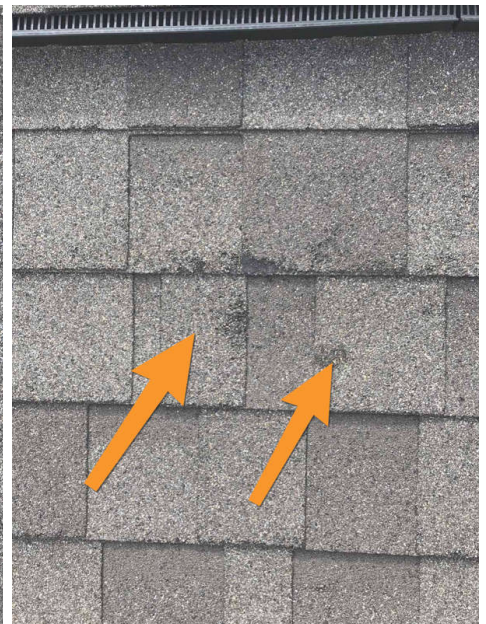
There were some defective shingles found on the roof that showed signs of granules loss. This is a common find on a lot of roofs as some granules are affected when they are shipped in packaging on foot traffic on the roof can cause granule loss.

Missing Granules

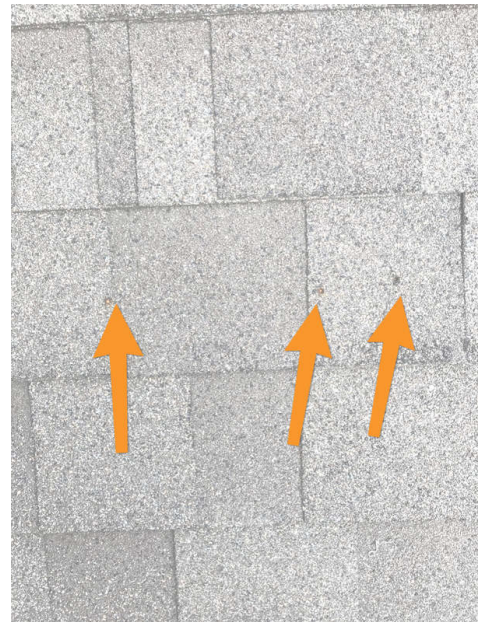
**NAIL HOLES**

Nail hole left in roof from the installation process. Recommend having a roofer repair or replace shingle.

Nail holes left from where roof was being installed.

Contact a qualified roofing professional.

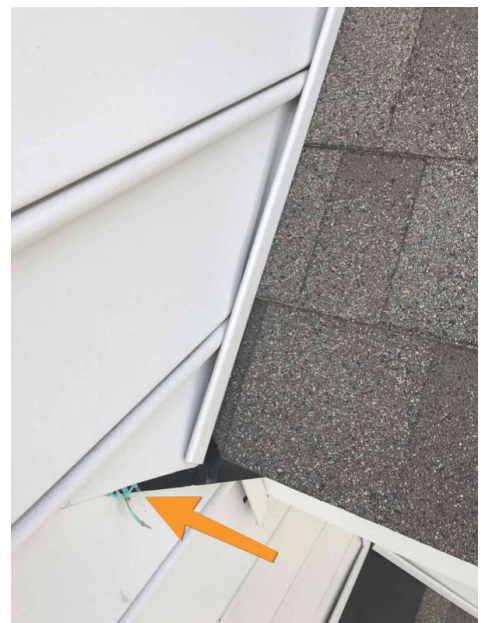
**SEAL PENETRATIONS**

Exterior wall had penetration or gaps that should to be sealed with an appropriate sealant to prevent moisture and insect entry. All work should be performed by a qualified contractor. This penetration is from. Installation of siding and roofing where they intersect due to installation.

Seal Penetration or Flash

Contact a qualified professional.

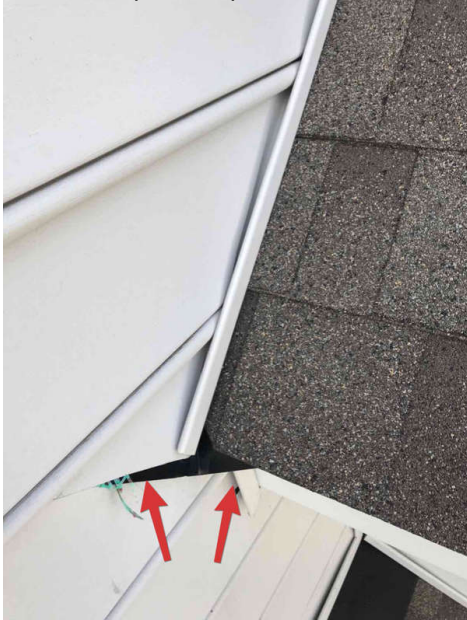
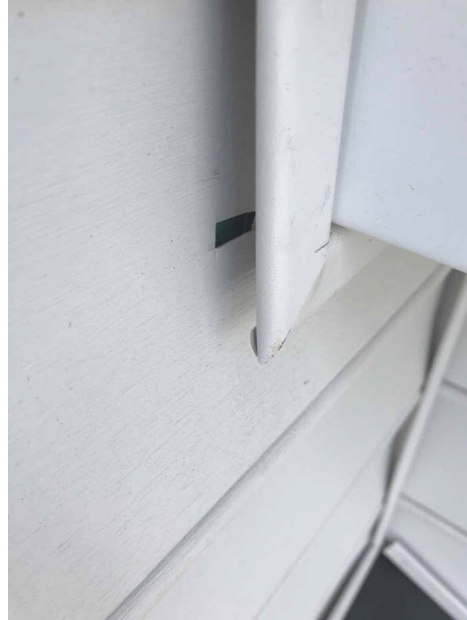
#### GAPS

Gaps between the soffit and exterior walls may allow insect entry and water penetration. I recommend that appropriate measures be taken to prevent insect entry at these areas. I also recommend appropriate measures being taken to prevent water penetration as if water leaks in this area will go unknown until there is rotting pieces of framing around this area.

The siding has a crack in it from the installation.

Cut in siding

Contact a qualified professional.

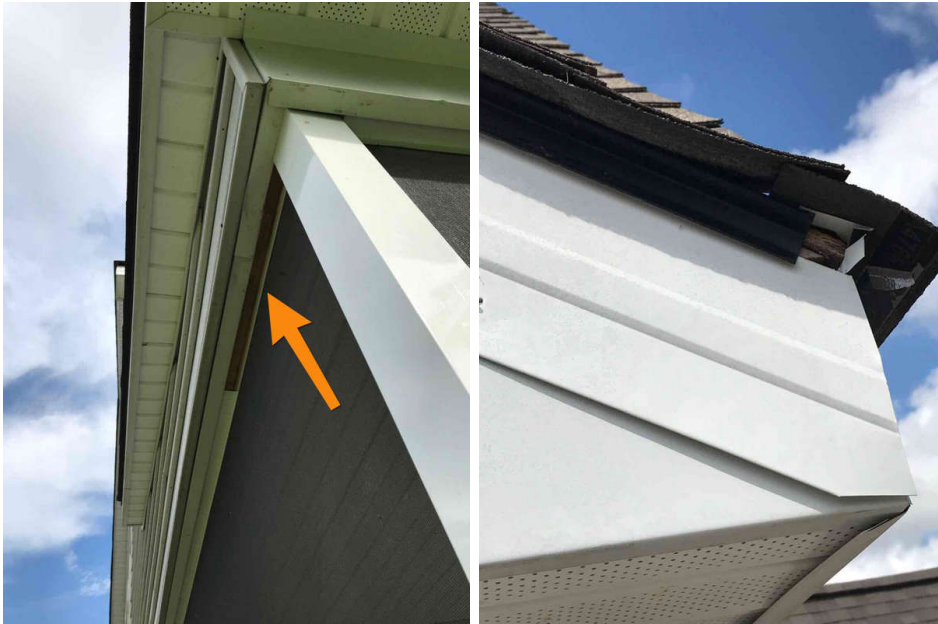
#### BARE WOOD

Barewood was found on both sides of the back porch. The space needs to be sealed and painted. I recommend a painter ceiling and painting all the areas around the perimeter trim that shows bare wood. These areas can show signs of rot at early ages in the tear ration without being sealed.

Bare wood needs to be covered with flashing

Contact a qualified painter.

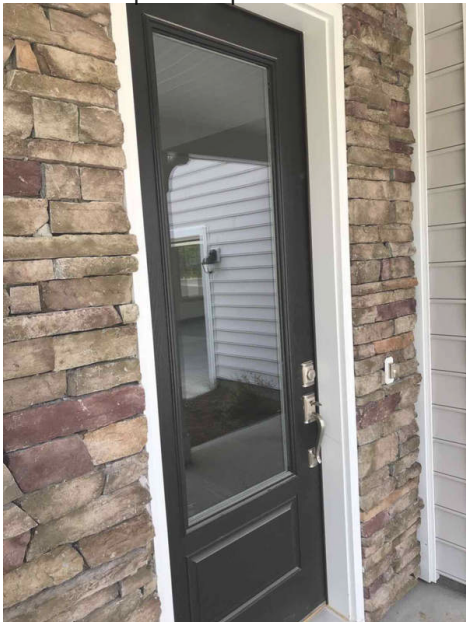
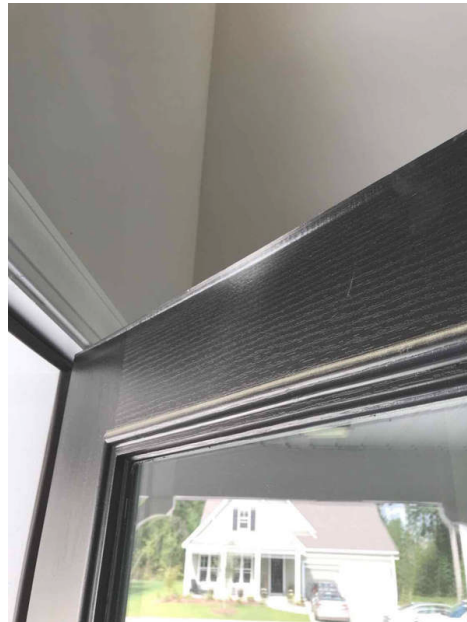
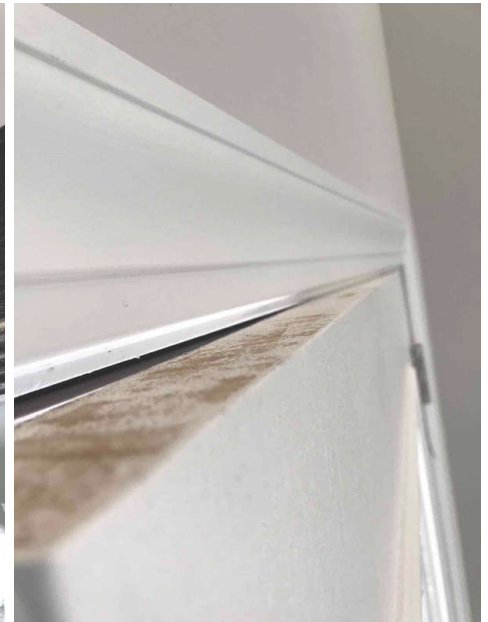
#### **BINDING ON JAMB**

The front exterior door is rubbing on top sill making it difficult to close. I recommend correction by a qualified pro.

Front door had paint on it

The top of the door has been shaved once

Recommendation  
Contact a qualified professional.

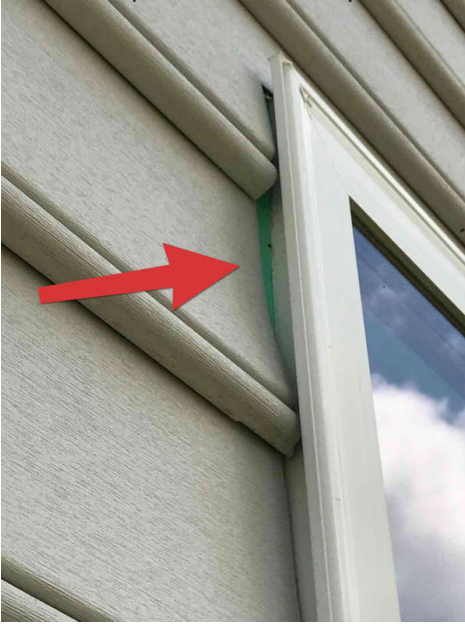
#### **SEALANT NEEDED AT WINDOWS**

It is recommended that window and door openings with vinyl siding be sealed with a high-quality sealant to help prevent moisture intrusion. you can see the vapor barrier. Window may not be properly flashed. I recommend having a window specialist advise.

Sealant needed around exterior if windows or the windows are not properly flashed or trimmed

Recommendation  
Contact a qualified window repair/installation contractor.

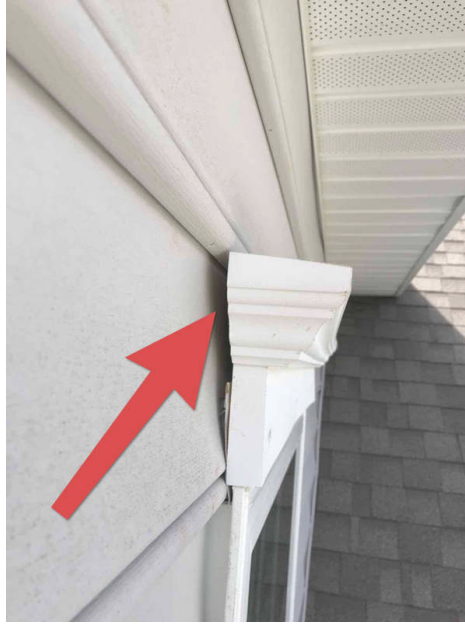
Trim above window in left elevation had an area where water can get trapped. Recommend window repair man review

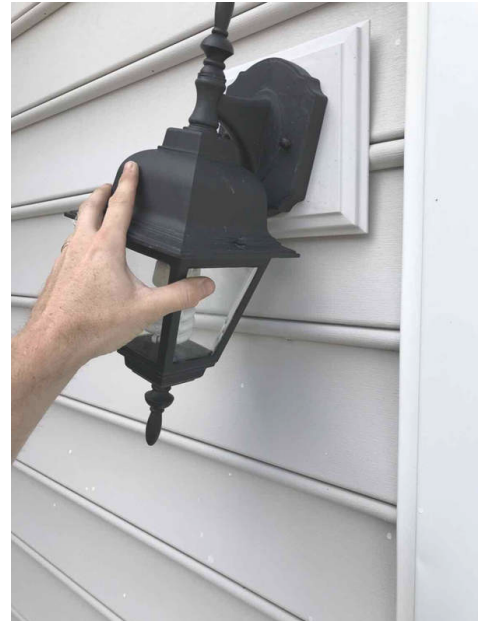
### LOOSE

One or more light fixtures were loose.

Recommendation  
Contact a qualified electrical contractor.

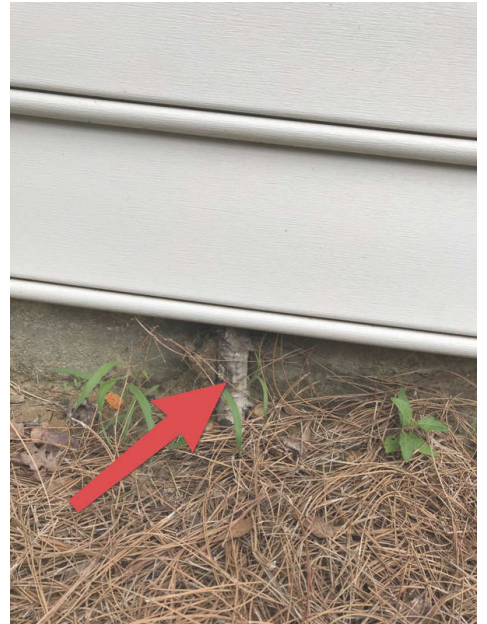
### TREE HAZARD

A new tree had started to grow on the property. It was growing under the siding which can cause significant amount of damages. I recommend cutting the tree and having a siding installer detach and reset the siding in this area to make sure there is no vapor barrier damage under the siding.

The vegetation or beds is also really close to the bottom of the siding. It is recommended that the siding have a 6" clearance to prevent moisture from damaging the wood under the siding. I recommend monitoring the wood beneath the siding for rot every 6 months.

Tree growing under siding

Recommendation  
Contact a qualified professional.

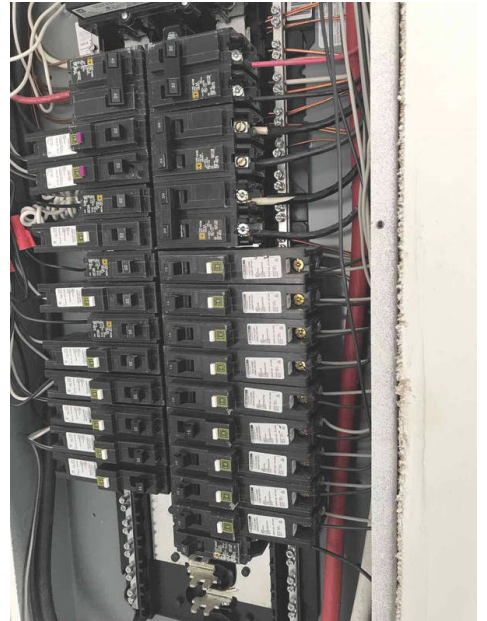
### **BREAKER FLIPPED**

Breaker would flip at panel when kitchen light switches and the related ones in other rooms. This is mention prior in the report.

Recommendation  
Contact a qualified electrical contractor.

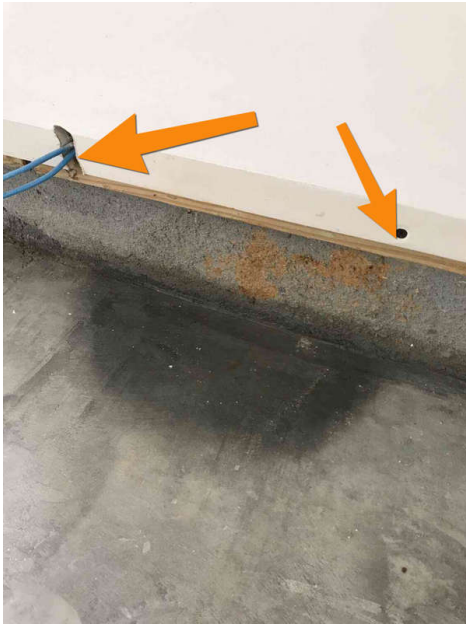
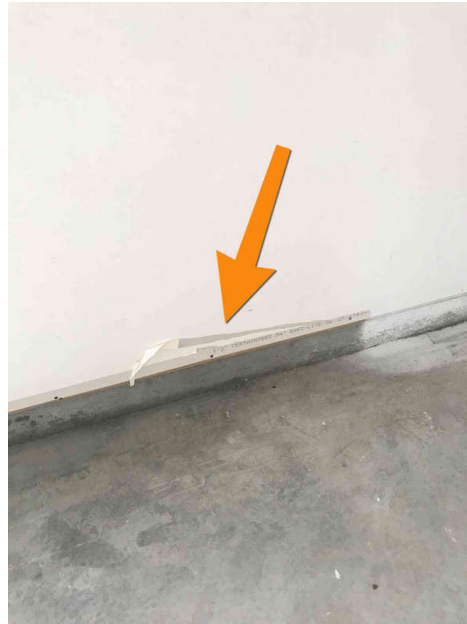
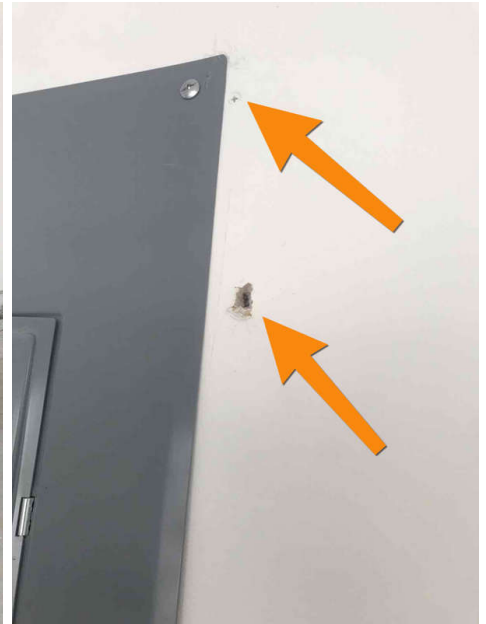
### **SLIGHT INSTALLATION DAMAGE DRYWALL WITH A FEW AREAS UNFINISHED**

Recommendation  
Contact a qualified professional.

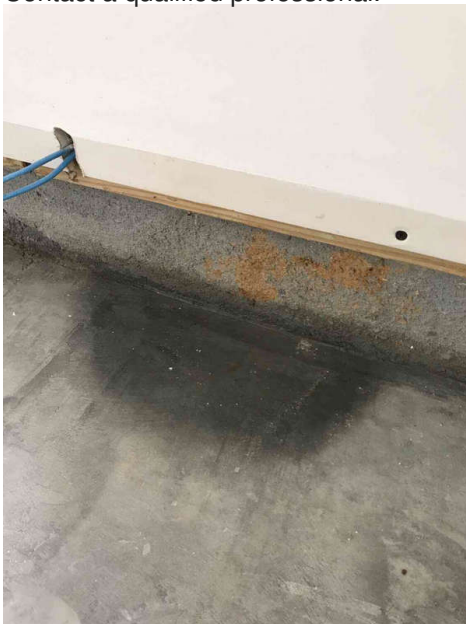
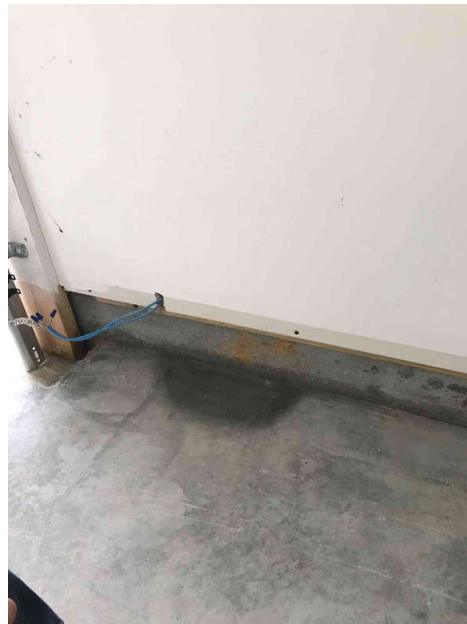
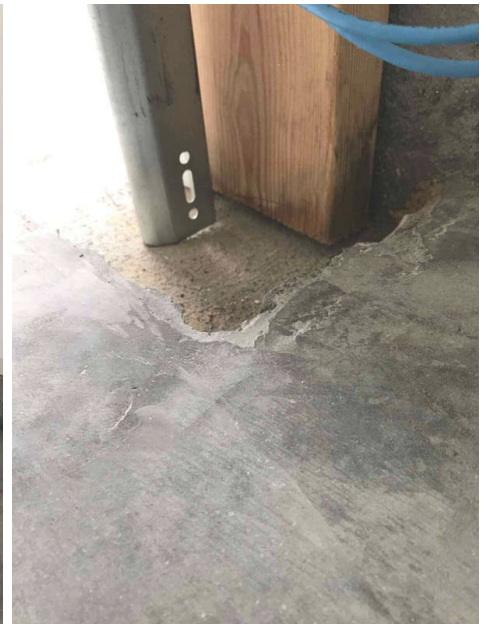
**WATER SEAPAGE PRESENCE**

At the time of the inspection there was some water on the interior of the garage. I advise asking builder if it leaks every time and is it can be repaired.

Water puddle in the garage

Base of wood framing showed light water stain

Contact a qualified professional.

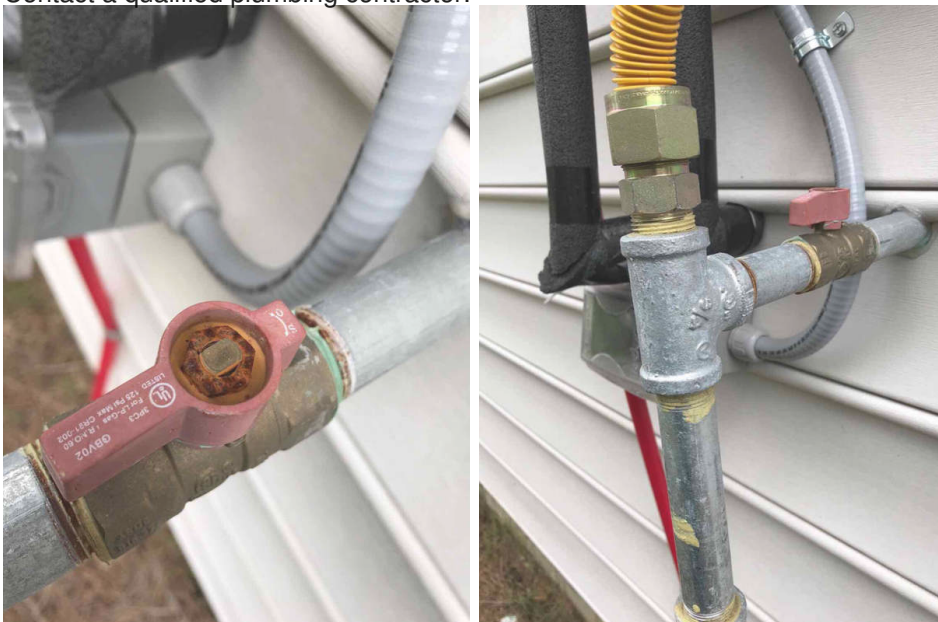
#### **PIPE CORROSION**

Pipe corrosion found on fittings. I recommend monitoring and if problem gets bad call the gas company to evaluate and repair.

If corrosion gets bad it could mean 2 metals like copper and galvanized are connected and causing electrolysis.

Contact a qualified plumbing contractor.

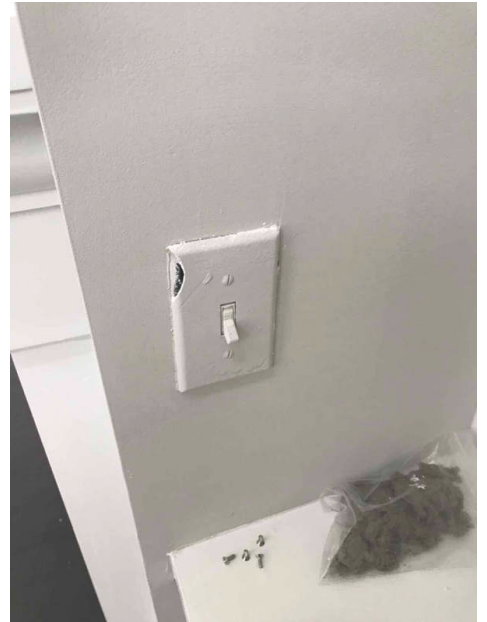
#### **IMPROPER OR DAMAGED COVER PLATE**

An Improper cover plate was noted at the time of the inspection. This safety hazard should be corrected by a qualified electrical contractor.

Recommendation  
Contact a qualified professional.

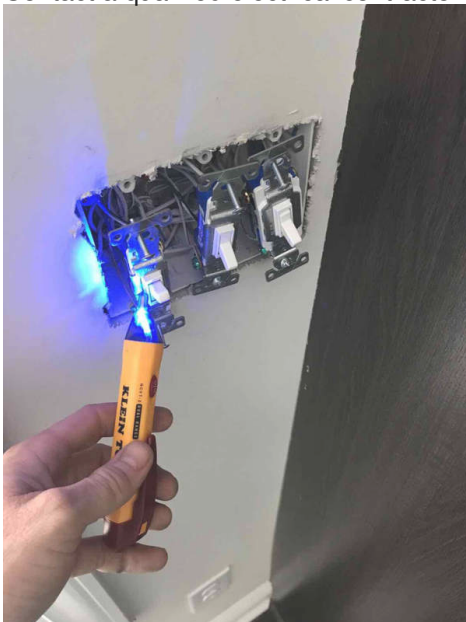
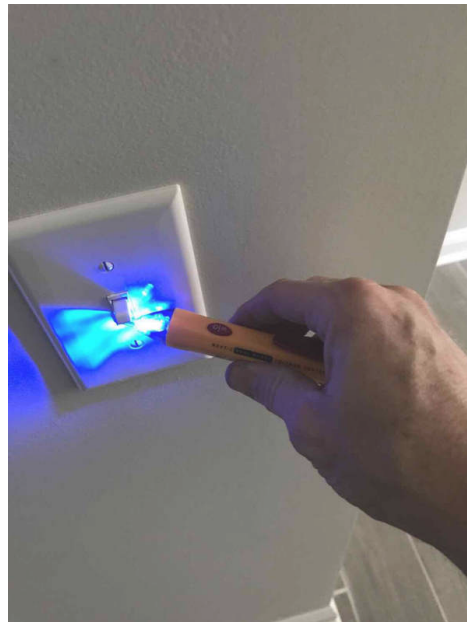
### 11.7.2 Switch Observations **INOPERABLE SWITCH**

A electrical switches next to the oven were Improperly operating at the time of the inspection and this can be a potential fire hazard. You should ask the seller about its operation. If you are unable to accurately confirm its functionality, you should have it examined by a qualified electrical contractor.

The switches on the kitchen half of the home to the laundry room did not work. Electricians are already informed.

Cover needs to be placed over switches and they were not hot at the time of the inspection.

Switches are not hot

Recommendation  
Contact a qualified electrical contractor.

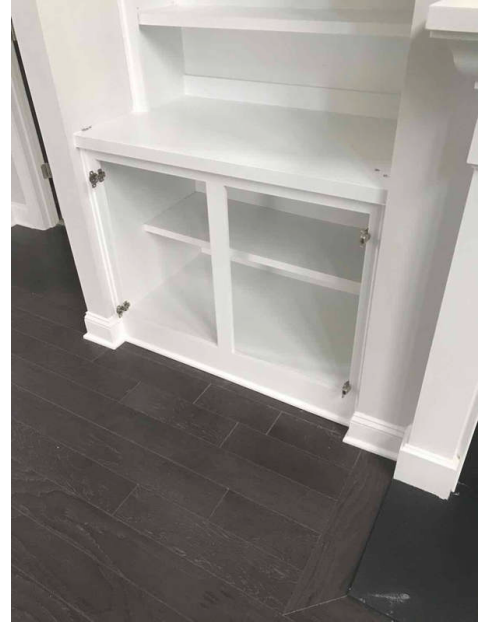
**CABINET DOOR MISSING**

One or more cabinet doors were missing. Recommend replacement.

Cabinet Door are Missing in Living Room

Recommendation  
Contact a qualified cabinet contractor.

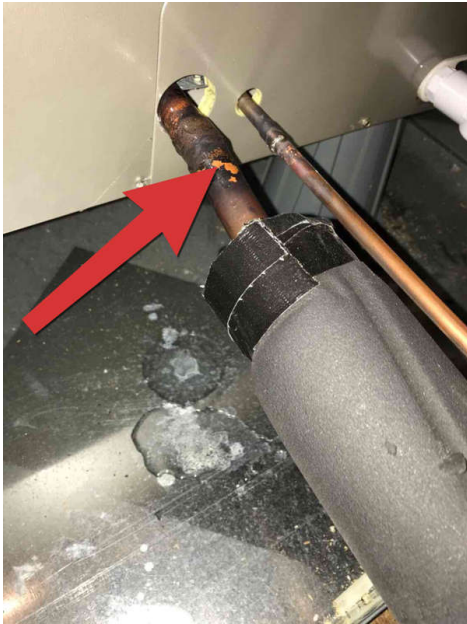
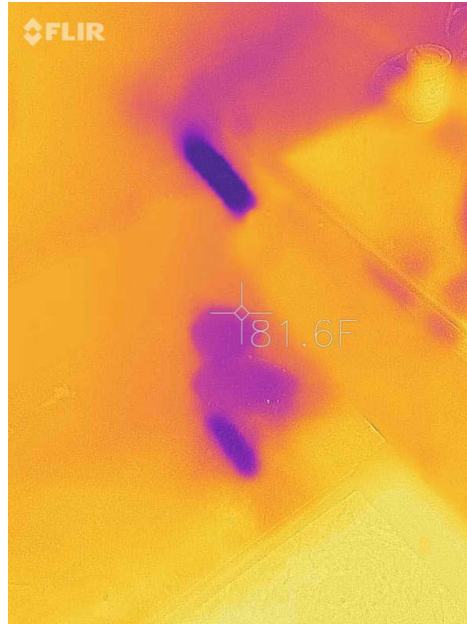
**COPPER LINE FROM AIR HANDLER LEAKING INTO DRIP PAN**

Copper line actively leaking into pan at time of inspection when AC was functioning. Recommend having build review and repair.

Water in pan from leaking copper Piping

Thermal Image of leak

Recommendation  
Contact a qualified HVAC professional.

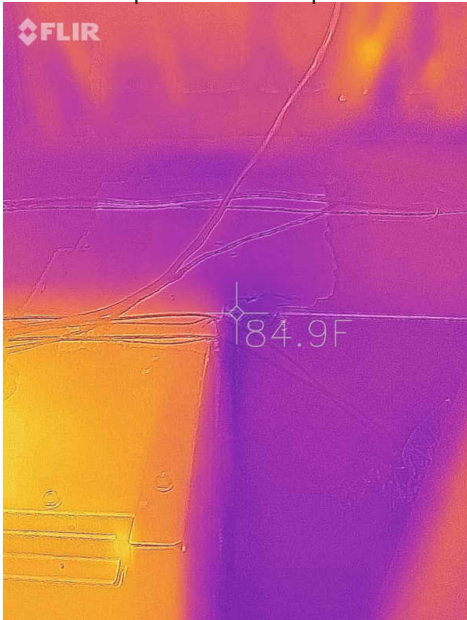
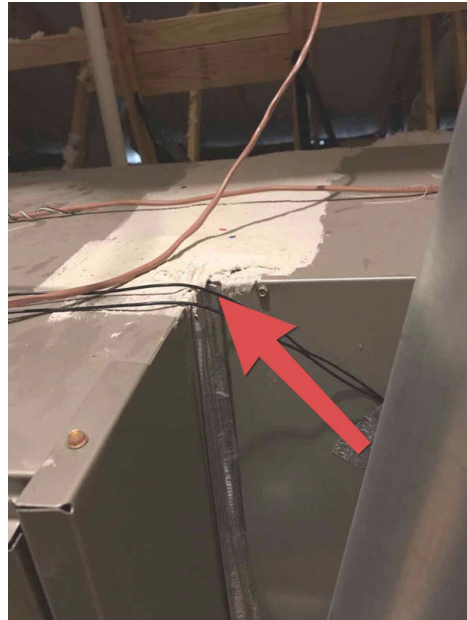
### 15.1.1 Heating & Cooling Distribution **LOOSE CONNECTION**

There is a loose connection on central air handler and cool air was leaking. This can cause rust. Recommend HVAC tech repair.

LEaking air can cause rust

Loose Connection that needs to be sealed due to cold air leaking

Recommendation  
Contact a qualified HVAC professional.
