SUMMARY

1234 Main St. Arvada Colorado 80004

Buyer Name
05/06/2018 9:00AM

Michael Spence
InterNACHI Certified Inspector
Fennario Home Inspections, L.L.C.
720-495-8080
fennarioinspections@gmail.com

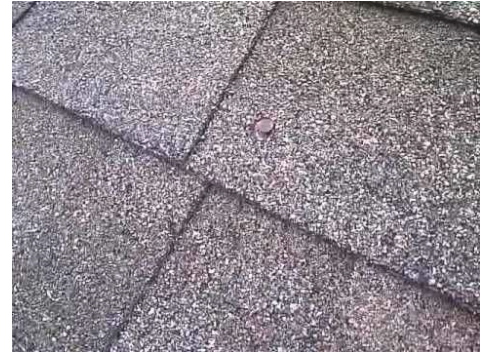
NORTH

2.1.1 Coverings

UNDER-DRIVEN NAILS

Observed one or more under-driven nails/fasteners. Recommend a qualified roofing contractor evaluate and repair.

Contact a qualified roofing professional.

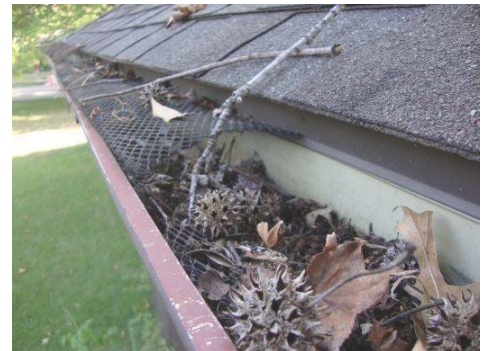
SOUTH

2.2.1 Roof Drainage Systems

DEBRIS

Debris has accumulated in the gutters. Recommend cleaning to facilitate water flow.

Contact a handyman or DIY project

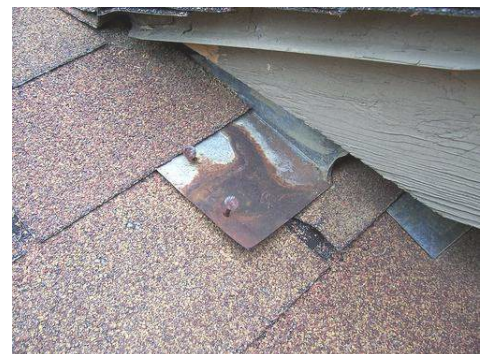
2.3.1 Flashings

CORRODED - MINOR

Roof flashing showed signs of corrosion, but are still in working condition. Flashing should be monitored to prevent severe corrosion leading to moisture intrusion.

Contact a qualified roofing professional.

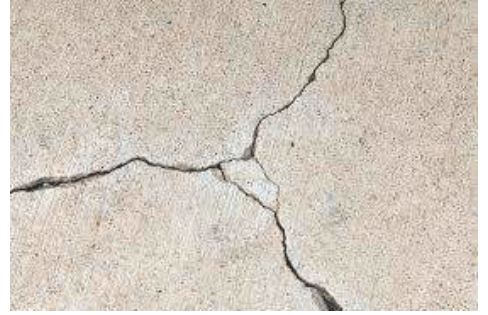
NORTH

3.3.1 Walkways, Patios & Driveways

DRIVEWAY CRACKING - MINOR

Minor cosmetic cracks observed, which may indicate movement in the soil. Recommend monitor and/or have concrete contractor patch/seal.

Recommendation
Contact a handyman or DIY project

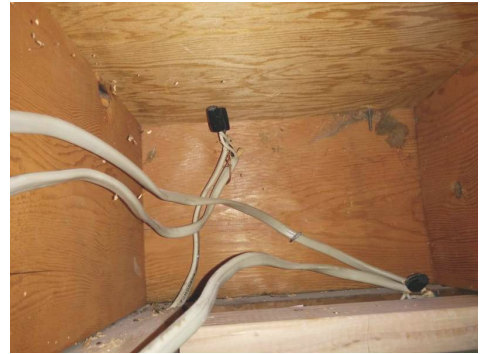
BASEMENT

8.3.1 Branch Wiring Circuits, Breakers & Fuses

IMPROPER WIRING

Improper wiring was observed at the time of inspection. Recommend a licensed electrician evaluate and repair.

Safety Hazard

Contact a qualified electrical contractor.

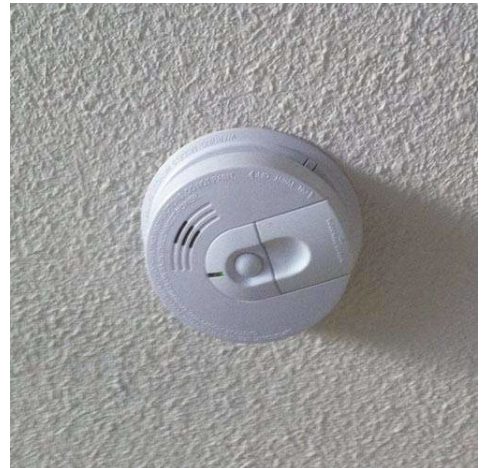
8.7.1 Carbon Monoxide Detectors

LOW BATTERY

CHANGE BATTERIES 2ND FLOOR

Carbon monoxide detector failed to respond when tested. Recommend battery be replaced.

Contact a handyman or DIY project
