SUMMARY
1234 Main St. Lumberton Texas 77657
Buyer Name
10/08/2018 9:00AM

Roger Smith
TREC #: 23254
Tactical Inspections
4099239220
roger@tacticalinspections.com

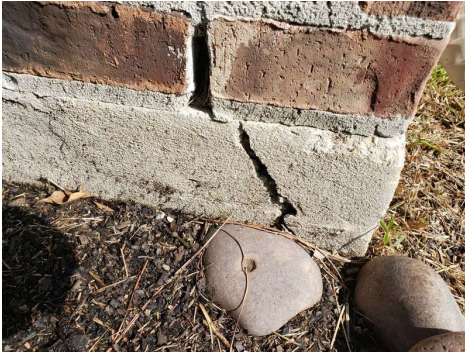
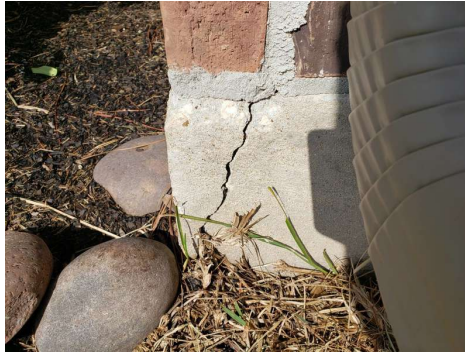
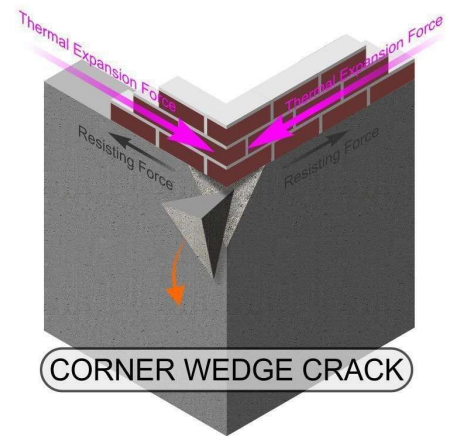
VARIOUS

CORNER WEDGE CRACK

Corner cracks are extremely common and are almost always cosmetic in nature. This is typical and easily correctable condition that should be remedied.

Brick in the Texas summers, expands due to thermal expansion and water absorption. A slab foundation is less porous than brick, is mostly underground and has much less exposure. The stress that develops is between the brick mortar below the bottom bricks and the top of the concrete. This puts the bricks in compression and the concrete foundation in tension. Concrete is weak in tension but brick is very strong in compression, the concrete loses and the corner cracks.

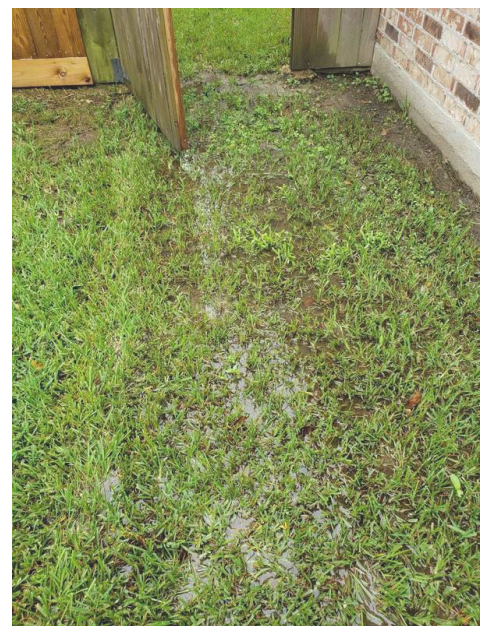
LEFT SIDE OF HOUSE IN FRONT OF GATE.

STANDING WATER

Standing water observed, which could indicate poor drainage and/or grading. Recommend monitor and/or have landscaper correct.

[Here is a resource](#) on dealing with standing water in your yard. Heavy rain was noted the day of inspection.

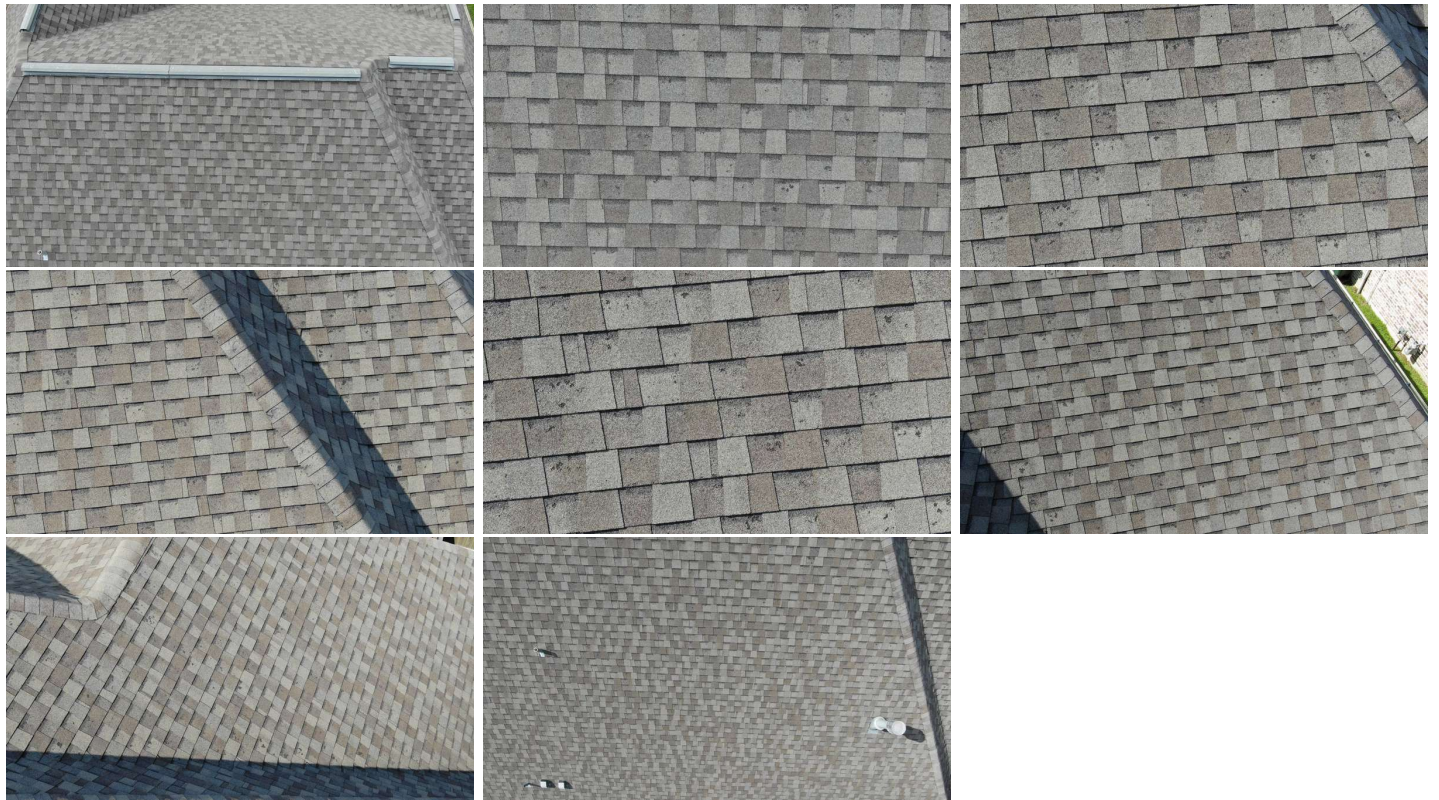
IMPACT DAMAGE

Re-inspection of roof covering material conducted on 09/23/2018 as limitations of a wet roof were observed on date of original inspection. On Re-inspection performed on 09/23/2018 there were visible indications of impact damage on the roof covering. Impact damaged roof covering shingles may allow further deterioration of the roof covering, deterioration of the roof structure, water penetration or other damage. You are strongly encouraged to have your insurance company and a certified, licensed roofing contractor to physically inspect the roof to fully evaluate the insurability and condition of the roofing material.

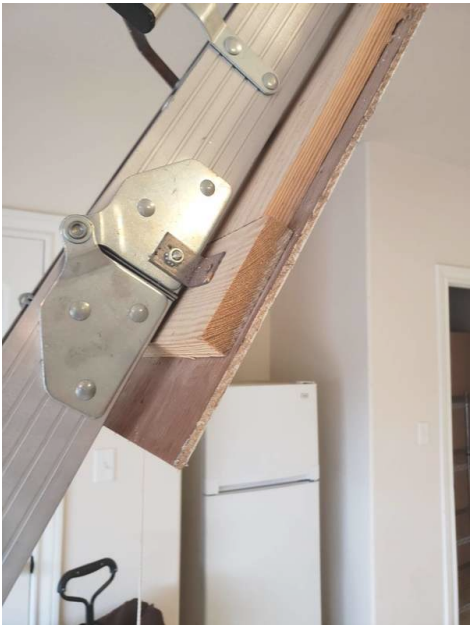
ATTIC LATTER ACCESS NOT FIRE RATED

The attic access stair or attic access port cover installed in the vehicle storage area (garage) was not fire rated and may allow vehicle storage area vapors to penetrate the attic and/or living area. (**SAFETY HAZARD**)

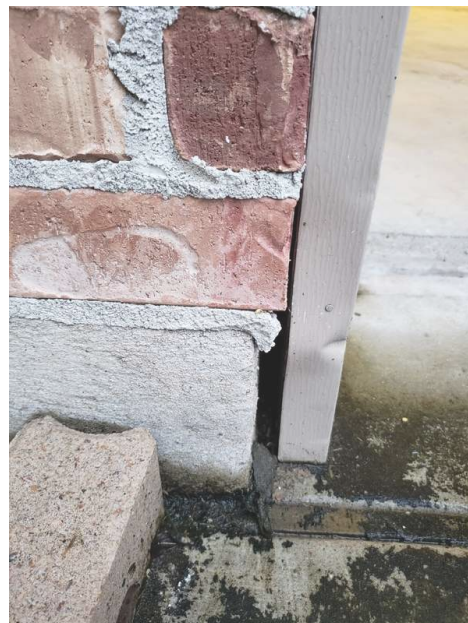
GARAGE TRIM

The garage door trim has some deterioration and/or damage at the bottom.

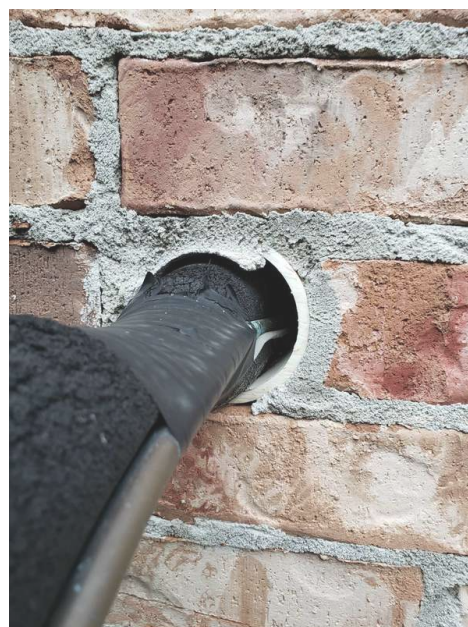
EXTERIOR WALL BEHIND AC UNIT

SEAL PENETRATIONS

The area between the exterior veneer and any wall penetration needs to be properly sealed. Windows, Doors, and all other wall penetrations should be sealed.

It is recommended to use elastomeric caulking.

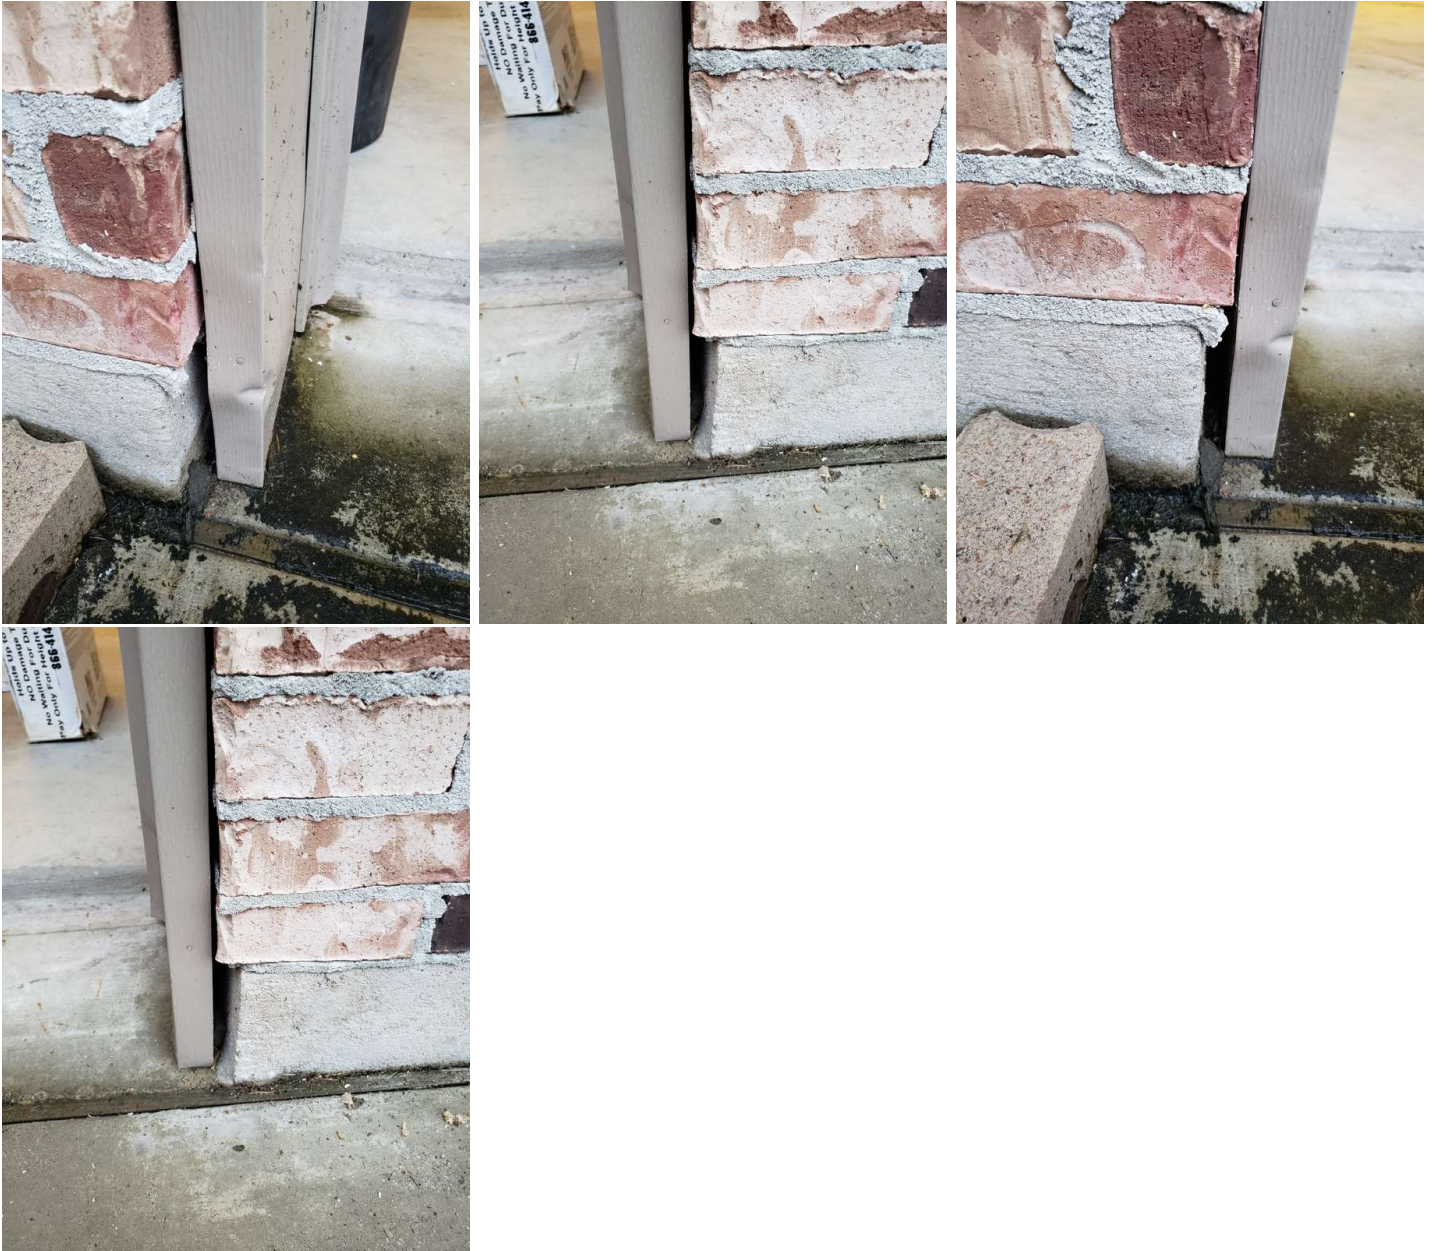
SEAL TRANSITION

The transition from garage door siding to brick veneer needs to be better sealed.

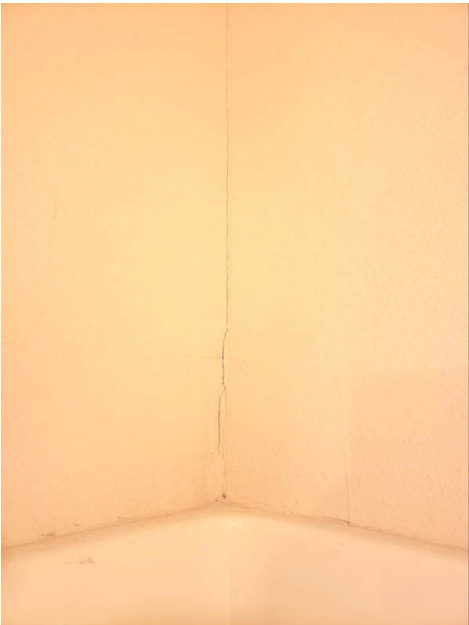
BATHROOM

INTERIOR WALL JOINT CRACK

Interior wall joint cracks were observed

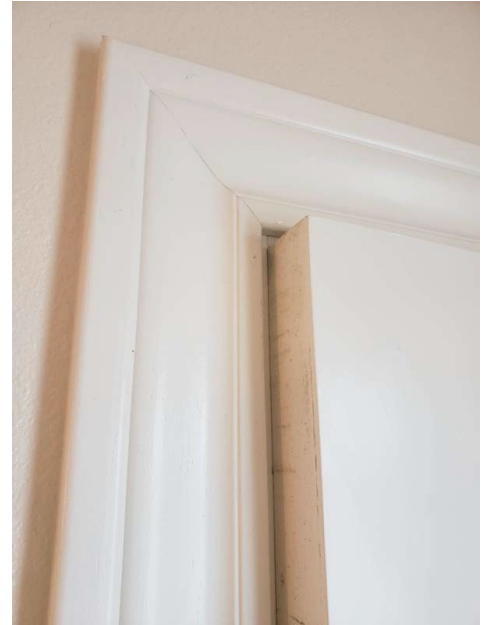
REAR PATIO DOOR

DOOR STICKS

The door is sticking.

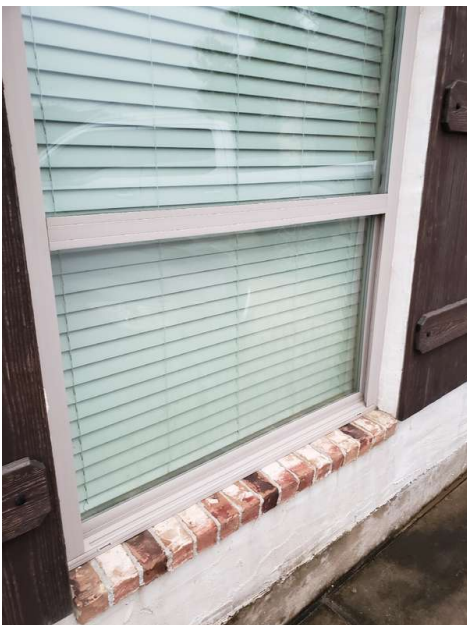
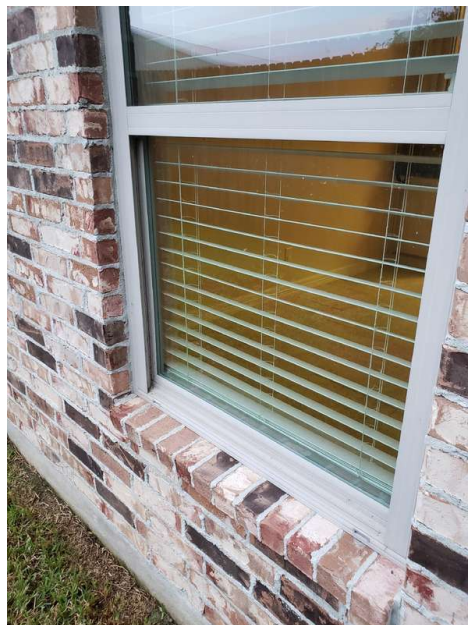
MISSING / DAMAGED SCREEN

One or more of the window screens were observed to be missing or damaged. Per home owner all screens are stored in the attic.

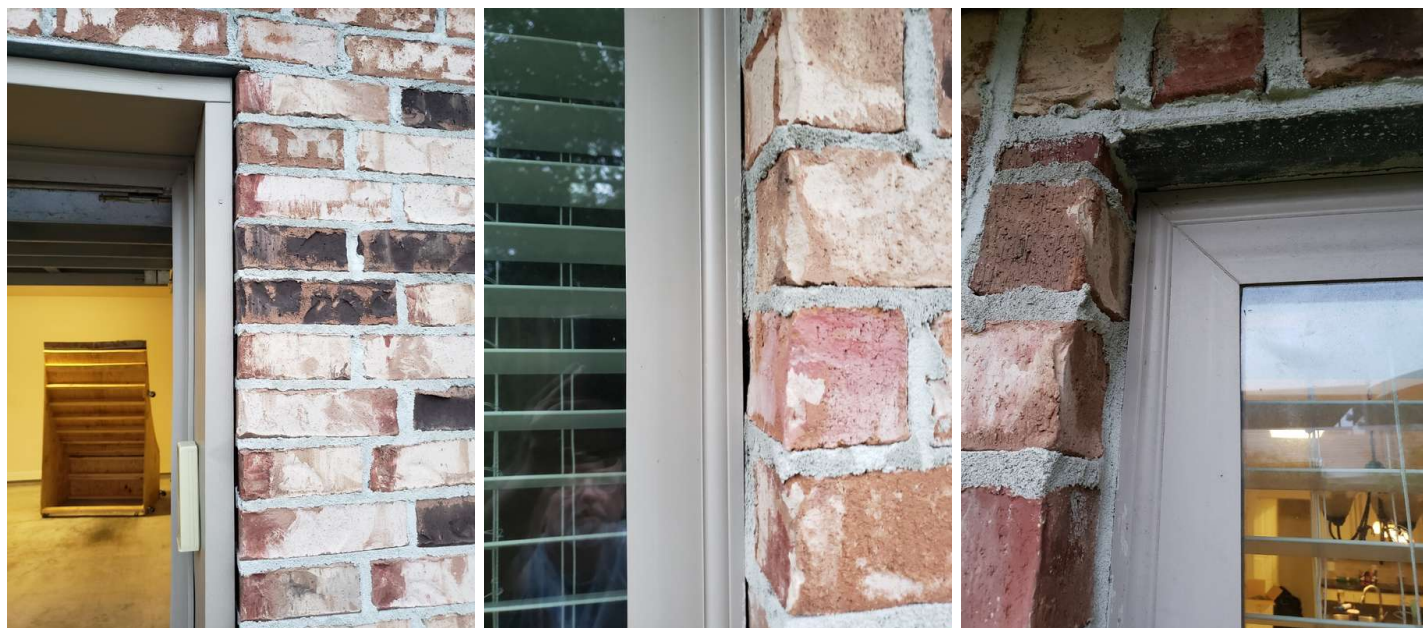
VARIOUS LOCATIONS

EXTERIOR CAULKING NEEDED.

Exterior caulking improvements needed on window seal.

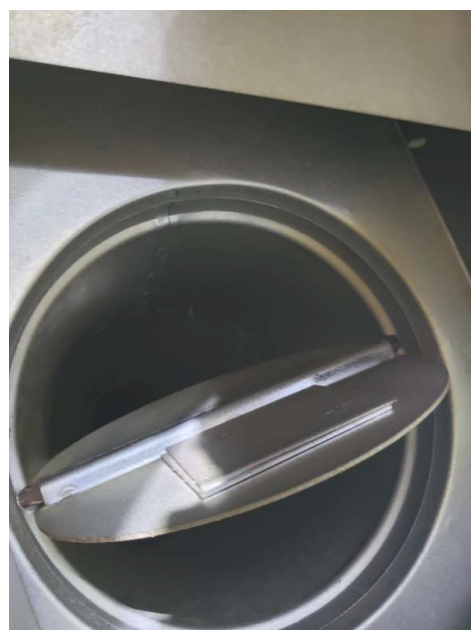
DAMPER CLAMP

When artificial gas logs are installed in a firebox with a damper; the damper should be permanently blocked open with a damper clamp to prevent accidental spillage of carbon monoxide into the living space.

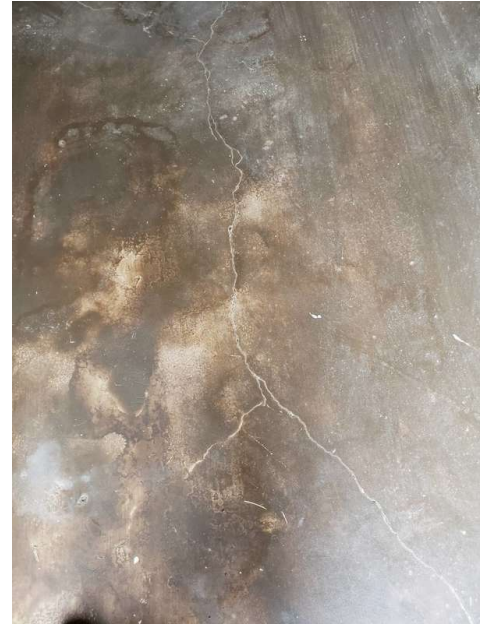
PATIO CRACKS

Some deflection and/or cracking of the patio concrete flatwork was observed.

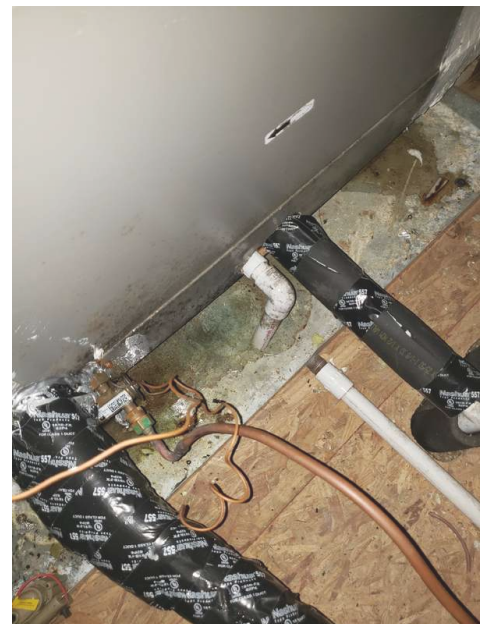
PAN HOLDING WATER

The axiliary/secondary drain pan under the coil housing is holding water at the time of this inspection. The cause and remedy should be further evaluated and corrected as necessary.

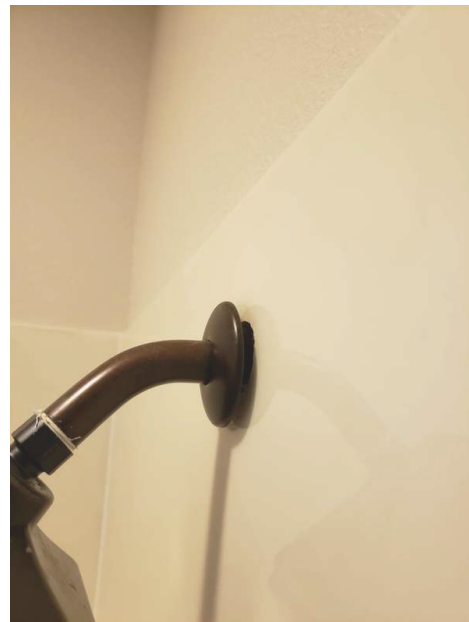
MASTER BATH

SEAL SHOWER SPOUT

The shower spout needs to be sealed to the wall to avoid water intrusion into the wall.

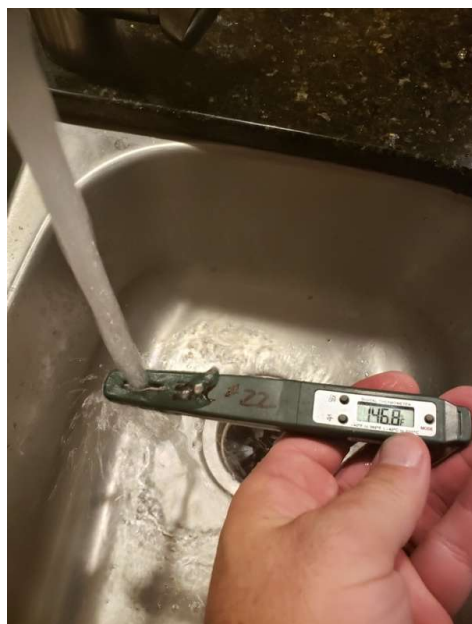
HIGH WATER TEMP > 120 DEGREES

Heated water temperature was observed to be greater than 120 degrees Fahrenheit and is a **SAFETY HAZARD**. Adequate safe heated water temperatures are considered to be between 100 degrees and less than 120 degrees Fahrenheit. The water heater thermostat may be turned up too high or there may be other defects in the water heating equipment.

Temperature reading prior to water heating equipment adjustment made by home owner.

The home owner was present for the inspection and advised of this condition. Home owner adjusted setting on water heater to reduce the temperature output.

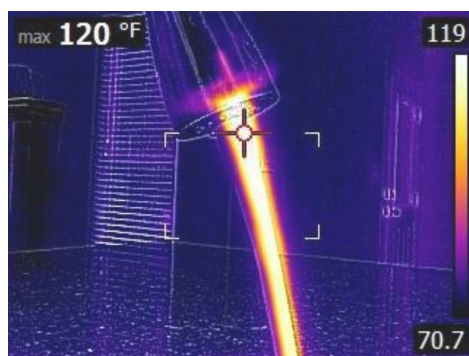
Retested temperature after homeowner adjusted temperature setting of water heating equipment.

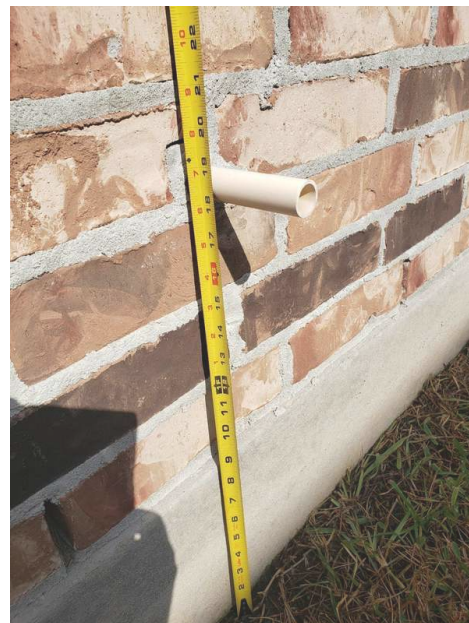
RIGHT EXTERIOR WALL

90 DEGREE

The exterior termination point of the temperature and pressure relief (TPR) valve discharge pipe is missing its 90-degree elbow. The TPR discharge pipe should turn 90-degrees downward and terminate within 6-inches of the ground.

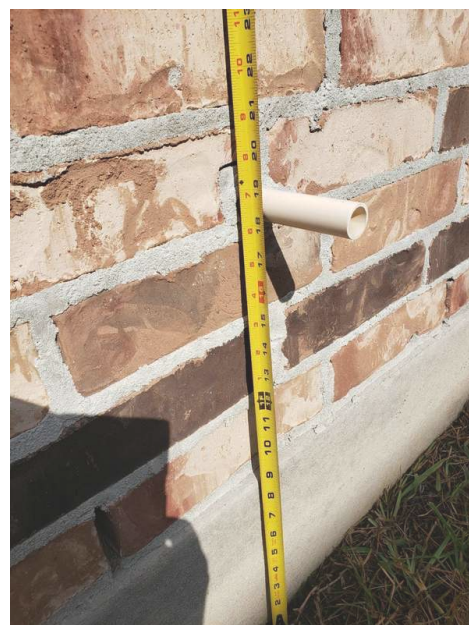
RIGHT EXTERIOR WALL

TERMINATION 6 INCHES

The exterior temperature and pressure relief (TPR) discharge pipe does not terminate at the proper height over the finished grade (ground). The TPR discharge pipe should terminate within 6-inch of the ground.

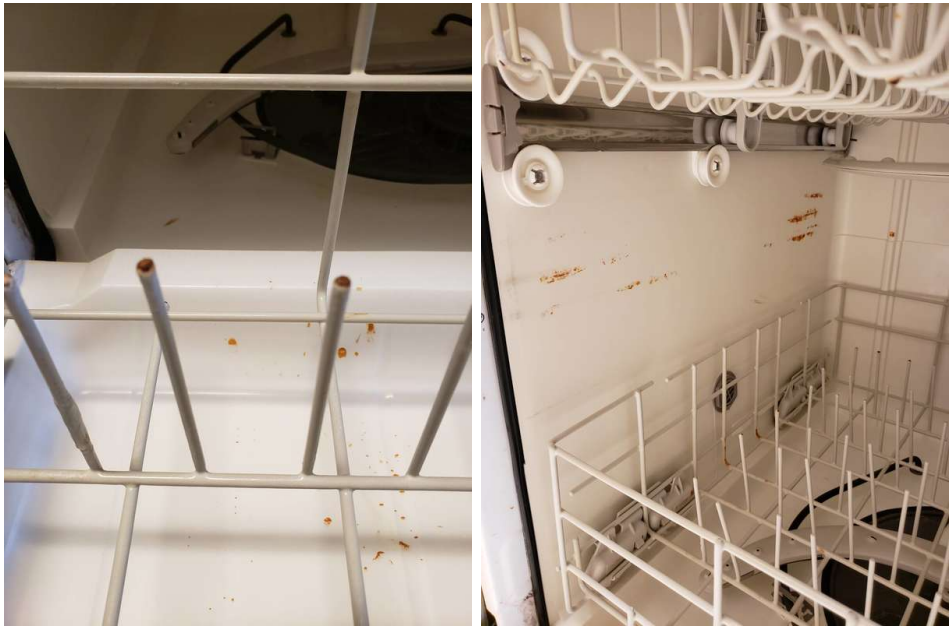
RUST

Some rusting of the dishwasher interior components was observed.

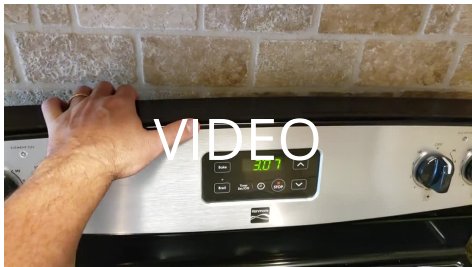
6.4.1 D. Ranges, Cooktops, and Ovens
NO ANTI-TIP

The absence of an anti-tilt device on freestanding ovens/ranges was observed and is a **SAFETY HAZARD**. This may be an as-built condition but Per TREC Standards of Practice we are required to report this condition as a deficiency. An anti-tilt device should be installed prior to use.

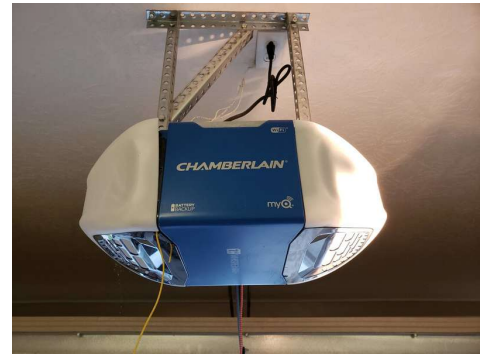
6.7.1 G. Garage Door Operators
LIGHT BULB

Light bulb is out on one side.
