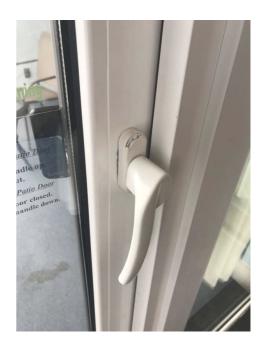
3.2.1 Exterior Doors

HARDWARE DAMAGED

One or more pieces of door hardware are damaged. Recommend repair or replace.

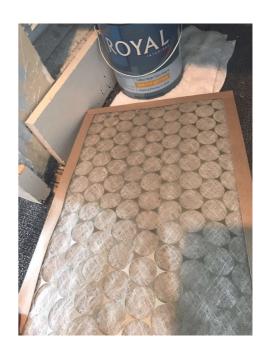
5.1.1 Cooling Equipment MISSING/OLD AIR FILTER

The air unit needs a new air filter size 13" x 21.5" Recommendation Recommended DIY Project

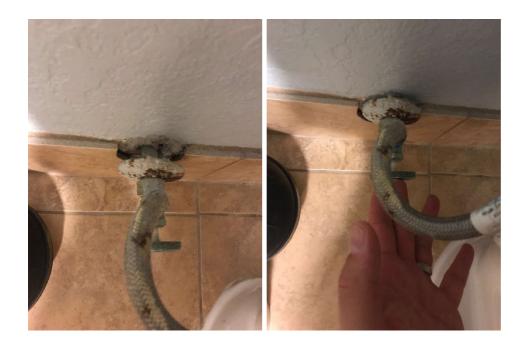
6.2.1 Drain, Waste, & Vent Systems

IMPROPER CONNECTION

An improper connection was observed at the toilet water pipe. Recommend a qualified plumber evaluate and repair.

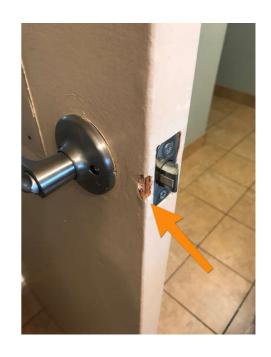
8.1.1 Doors

DOOR DAMAGE

Bathroom northeast door damaged - most likely due to impact with other bathroom door.

Recommendation Contact a qualified professional.

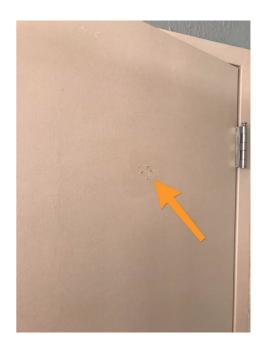
8.1.2 Doors

DOOR DAMAGE

West bathroom door has five holes in it. Recommend sealing and painting.

Recommendation Contact a qualified professional.

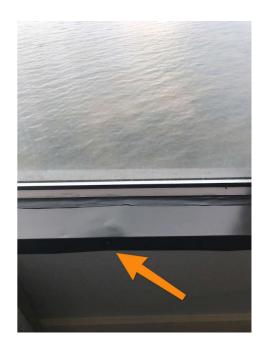
8.2.1 Windows

WINDOW PANE DAMAGED

Appearance of window pane damage, and lack of hardware to secure the pane to the wall, at the time of inspection.

Recommendation Contact a qualified professional.

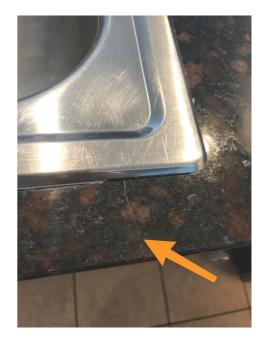
8.6.1 Countertops & Cabinets

COUNTERTOP CRACKED/CHIPPED

Kitchen countertop had one crack near sink. Recommend qualified countertop contractor evaluate and repair.
