SUMMARY

1234 Main St. Katy Tx 77449

Singular Home Inspections

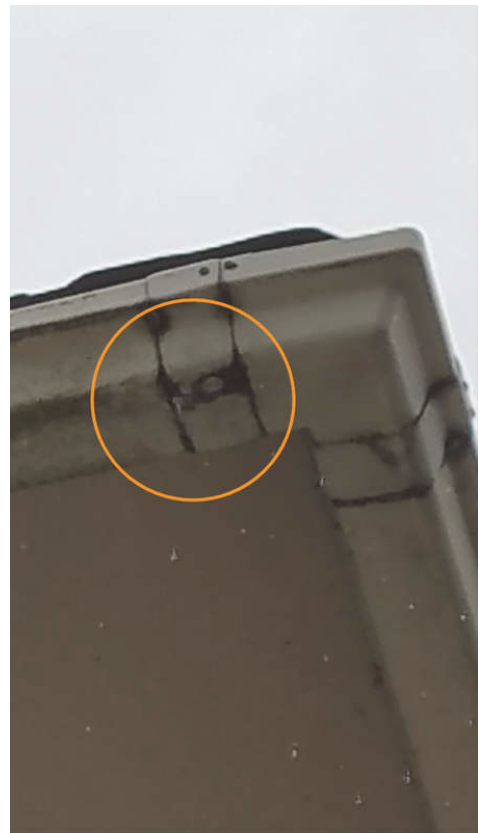
NORTHWEST

GUTTER MINOR LEAKS

Minor leaks in the gutter joints and seams should be repaired.

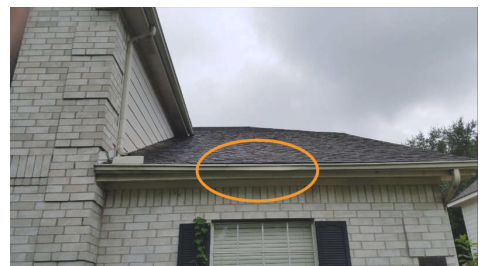
FRONT

GUTTER DAMAGED

Damaged guttering was observed.

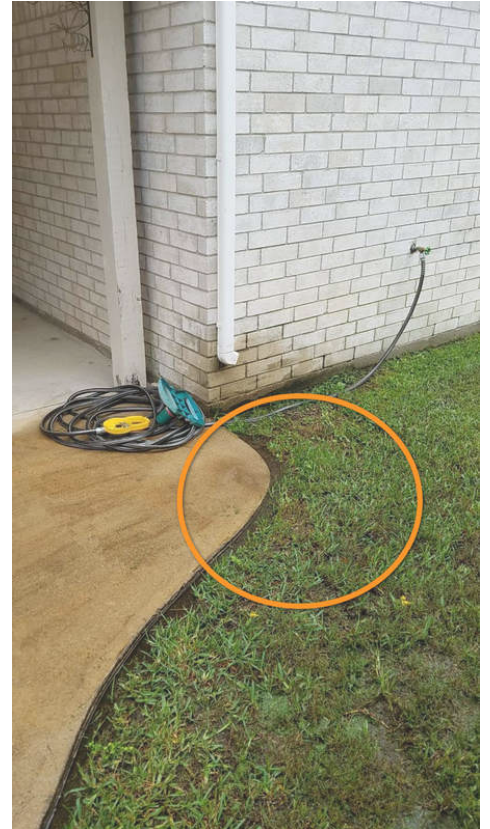
REAR

STANDING WATER

Standing water observed, which could indicate poor drainage and/or grading. Recommend monitor and/or have landscaper correct.

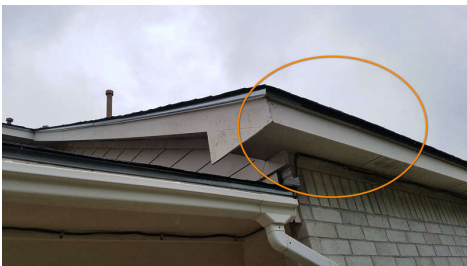
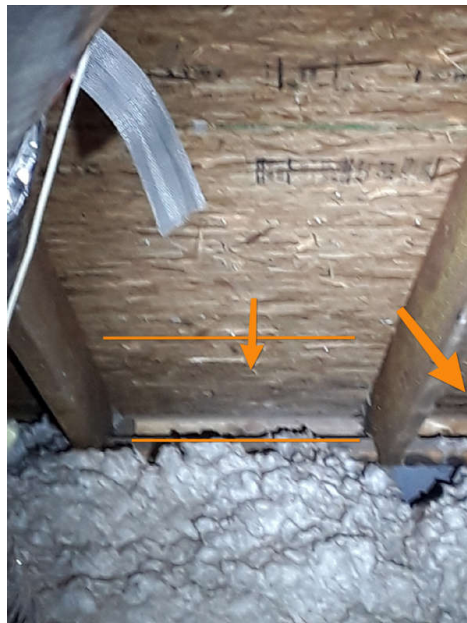
REAR

WATER STAINS ON DECKING

There are visible water stains on the roof sheathing (decking) in one or more locations. This condition should be further evaluated by a qualified roofer and repaired as necessary.

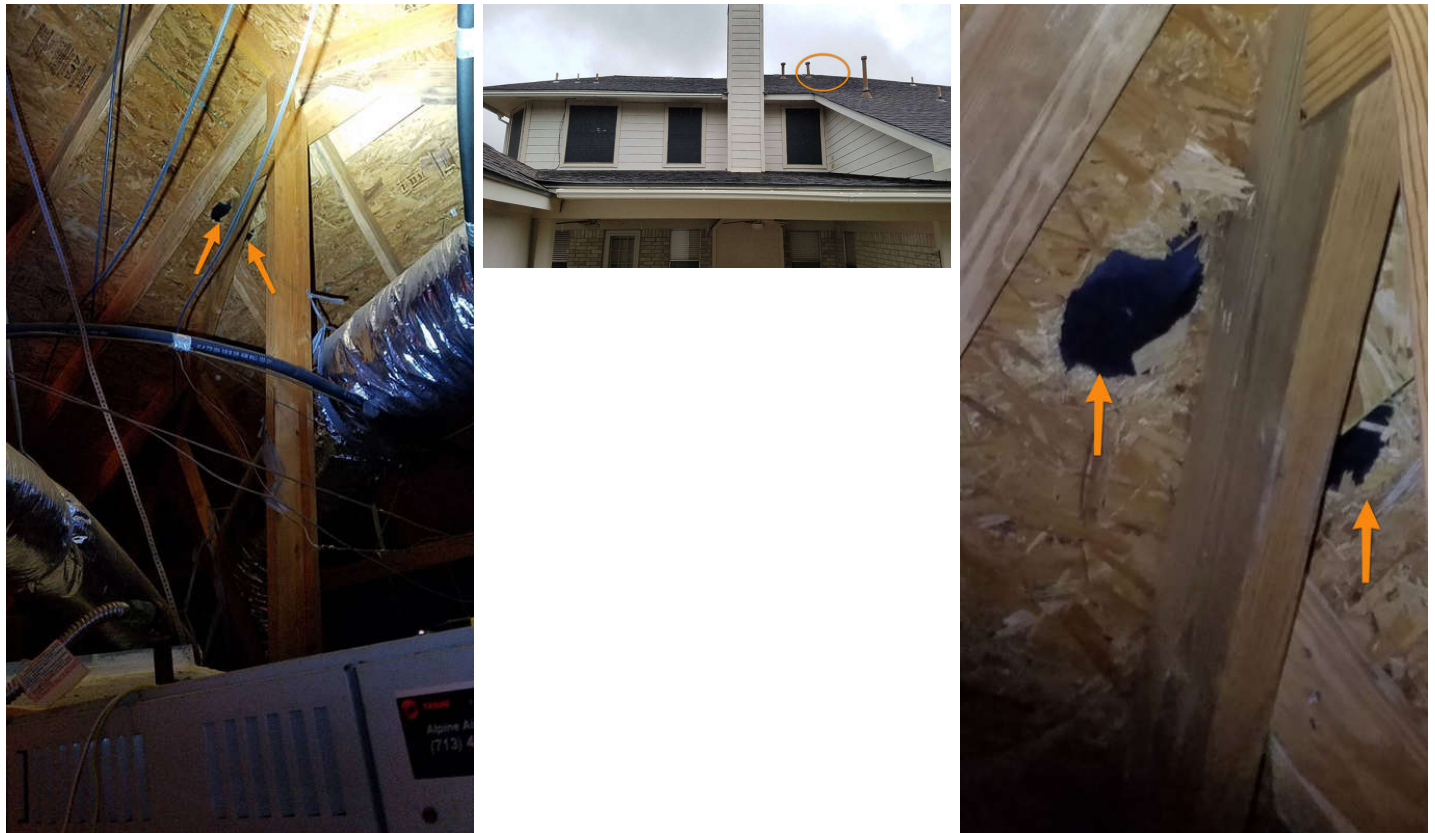
ATTIC

DECKING DAMAGED

Some roof sheathing (decking) deterioration and/or damage was observed in one or more locations. This condition should be further evaluated by a qualified roofer and repaired as necessary

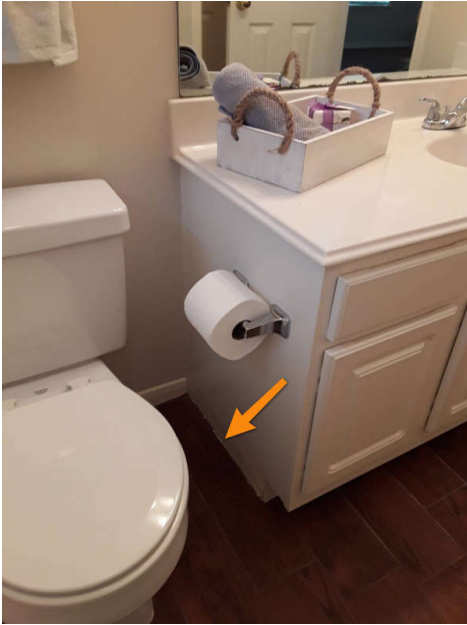
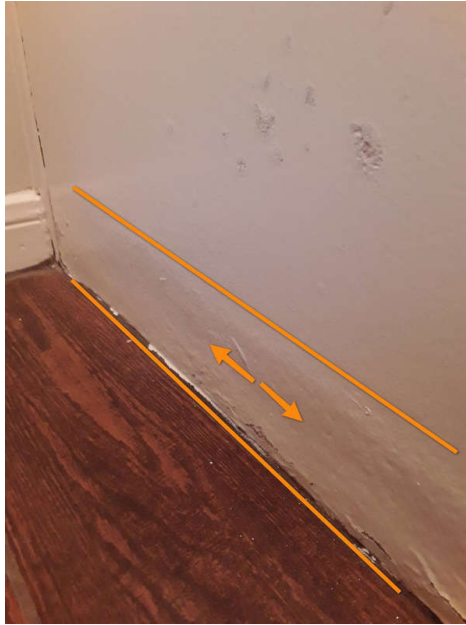
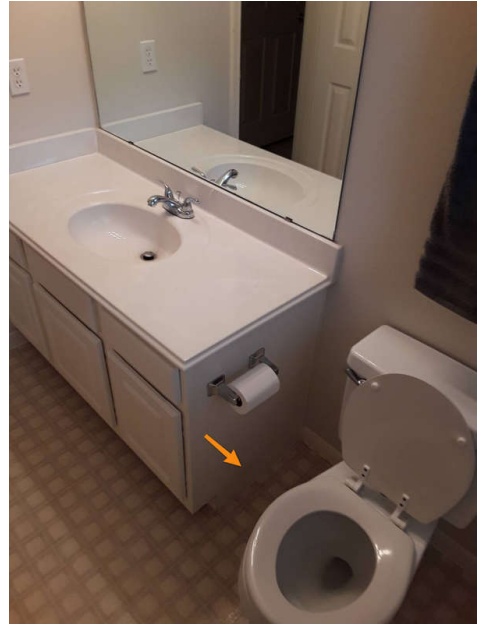
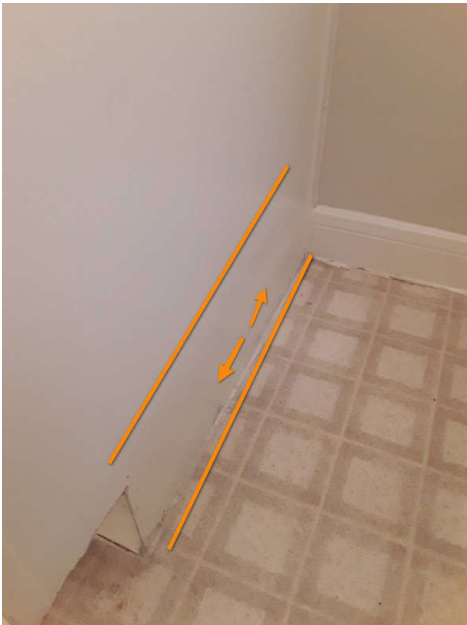
UPSTAIRS NORTH BATHROOM, DOWNSTAIRS SOUTH BATHROOM

OLD WATER STAIN

Water stains were observed on the bathroom cabinetry walls. The cause and remedy should be further evaluated and corrected as necessary. It did not appear to be wet at the time of inspection. It is likely that this is not an active leak, however due diligence should be exercised, and the current owner should be queried about this condition.

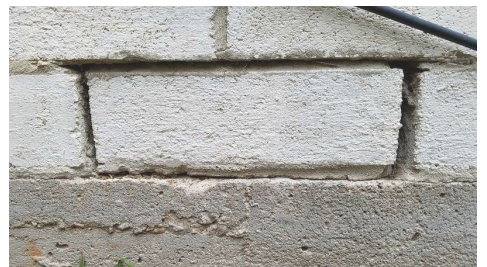
SOUTH

LOOSE BRICK

Loose brick visible at the time of the inspection indicated deterioration of the bond between mortar and brick. This condition should be evaluated by a qualified masonry contractor, and any loose brick should be securely re-installed.

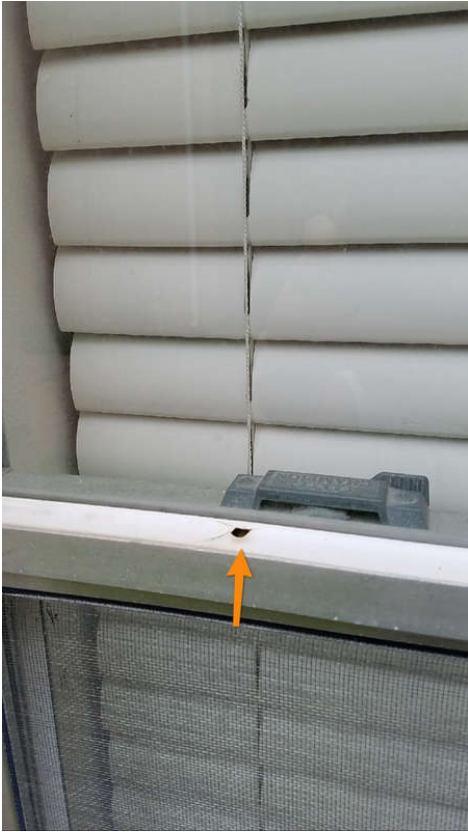
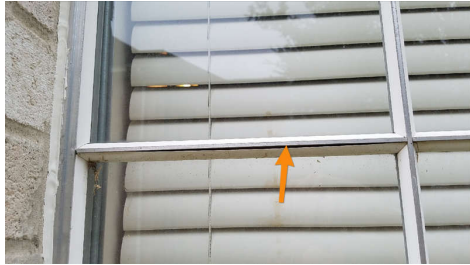
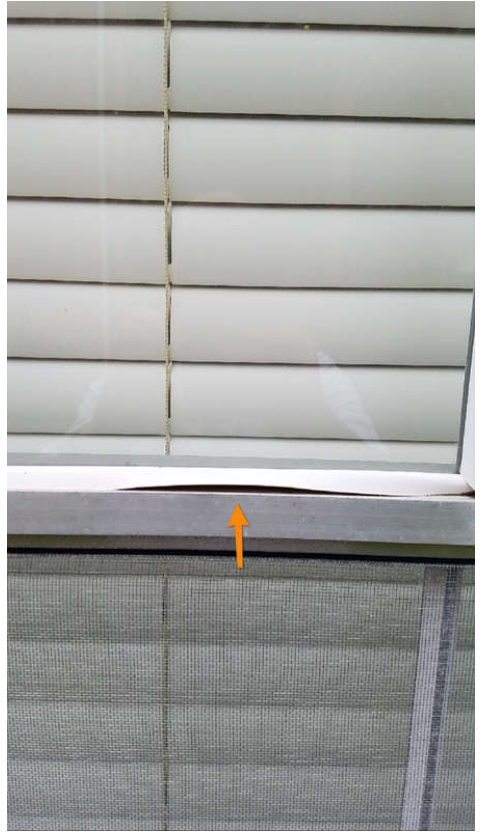
PLASTIC GLAZING ON WINDOWS

The plastic window glass glazing bead is damaged and/or missing at one or more of the windows and improvements are recommended.

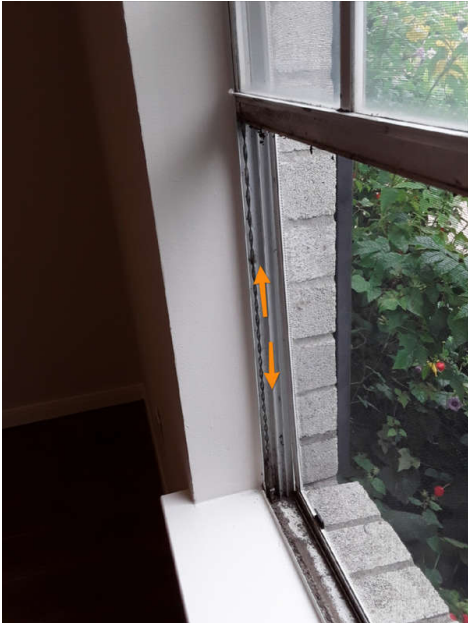
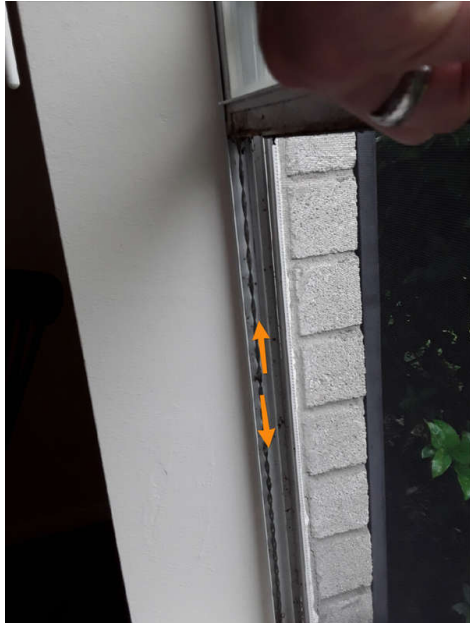
DINING ROOM, LIVING ROOM

WINDOW GUIDE

The window guide in one or more areas was observed to be damaged. The window may not stay in the open position.

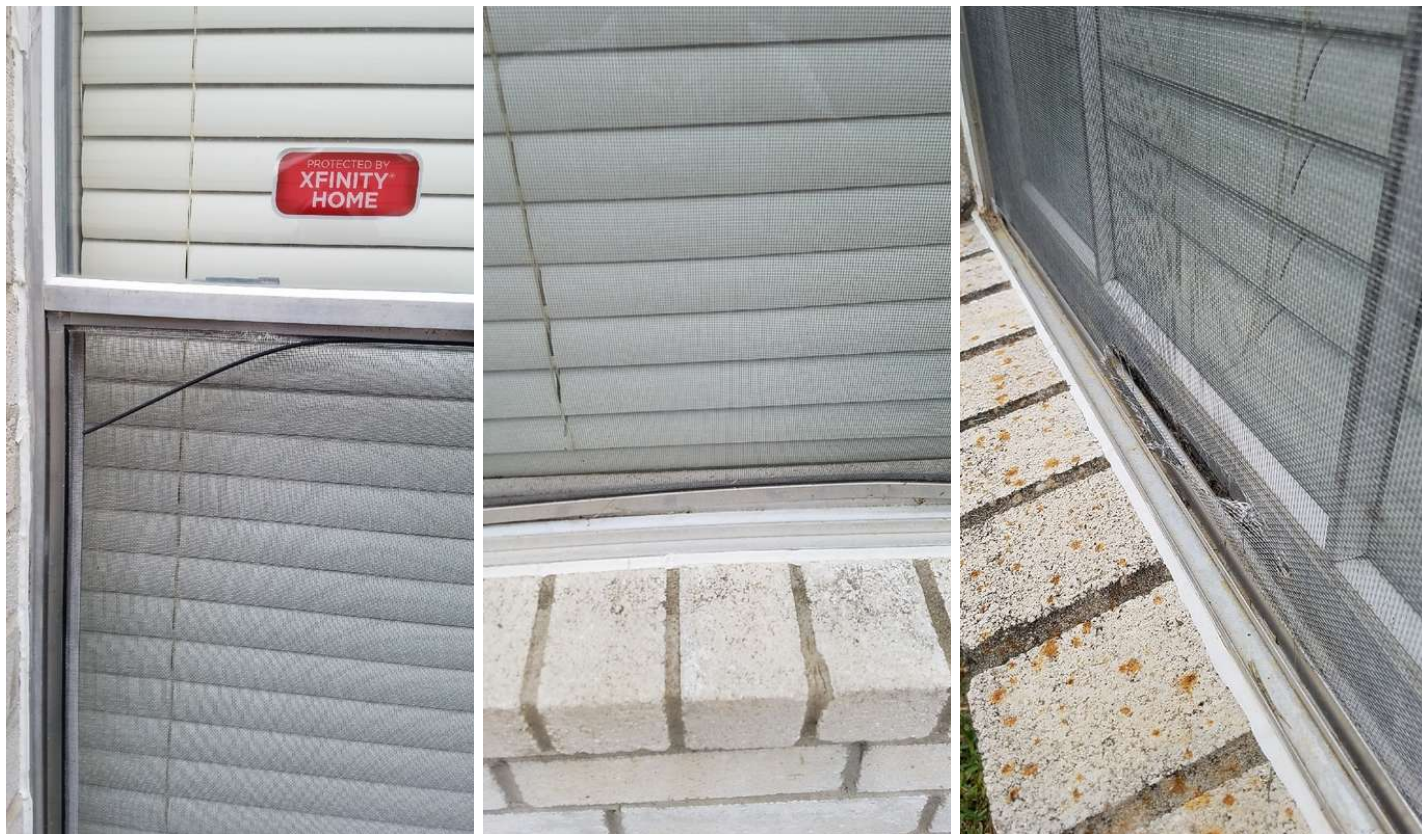
NORTH, SOUTH

MISSING / DAMAGED SCREEN

One or more of the window screens were observed to be missing or damaged.

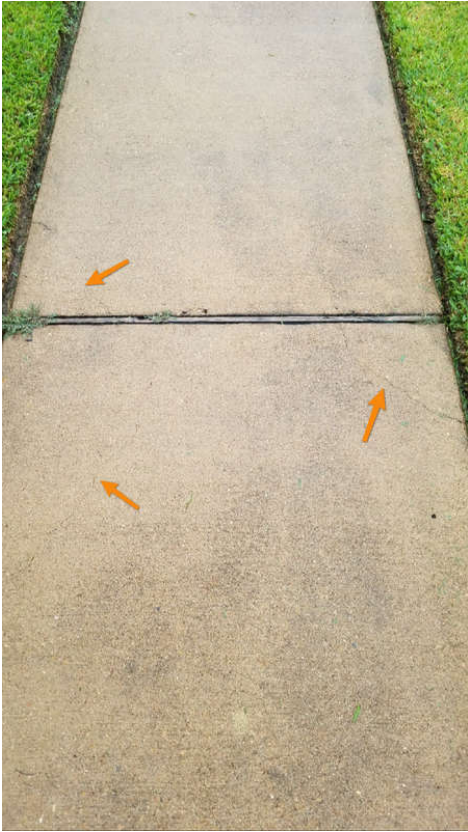
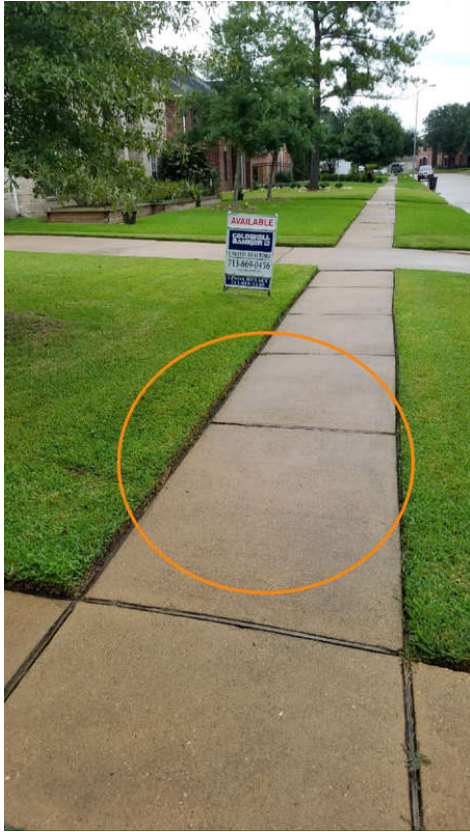
FRONT

MINOR SIDEWALK CRACKS

The sidewalk was observed to have minor cracks and/or deficiencies.

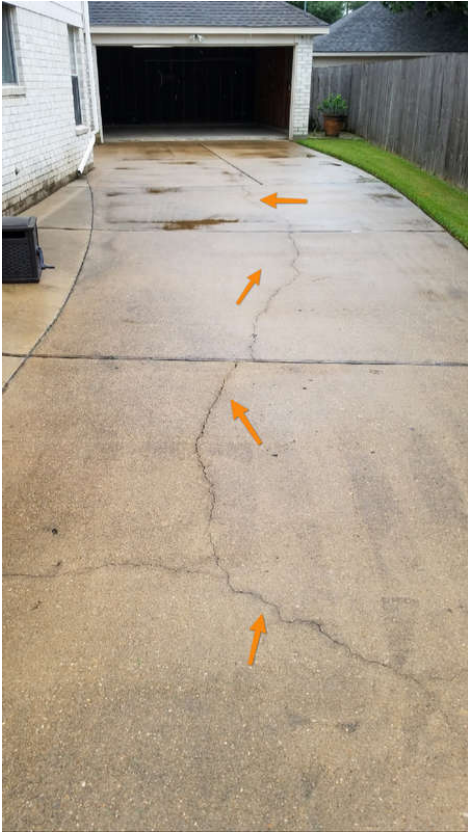
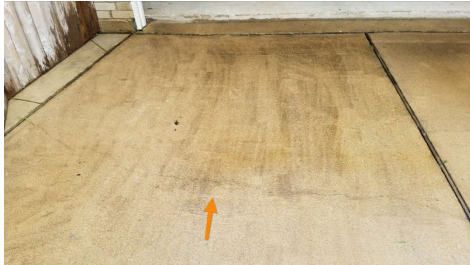
MINOR DRIVEWAY CRACKS

Minor cracks and/or deficiencies were observed in the driveway.

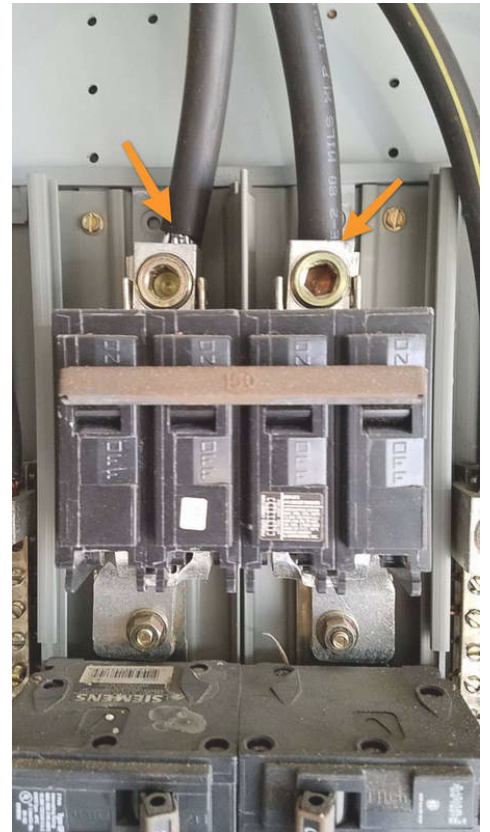
NO ANTI-OXIDANT ALUMINUM

There was no anti-oxidant gel observed on the exposed aluminum conductor terminations.

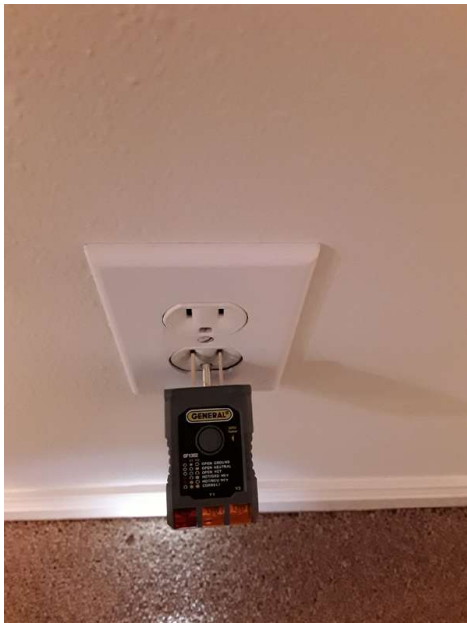
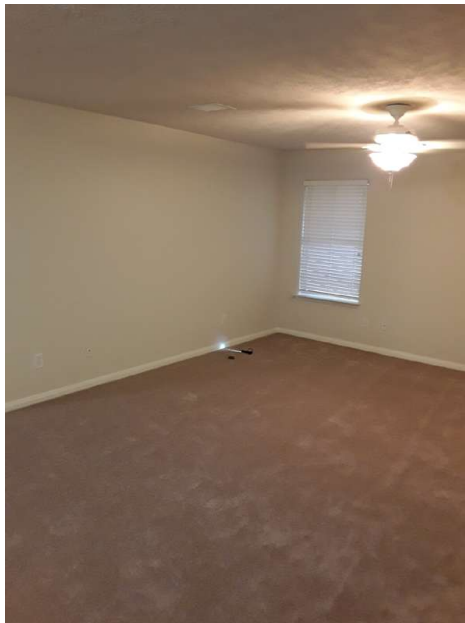
UPSTAIRS GAME ROOM

DAMAGED RECEPTACLE

One or more of the receptacles were observed to be damaged

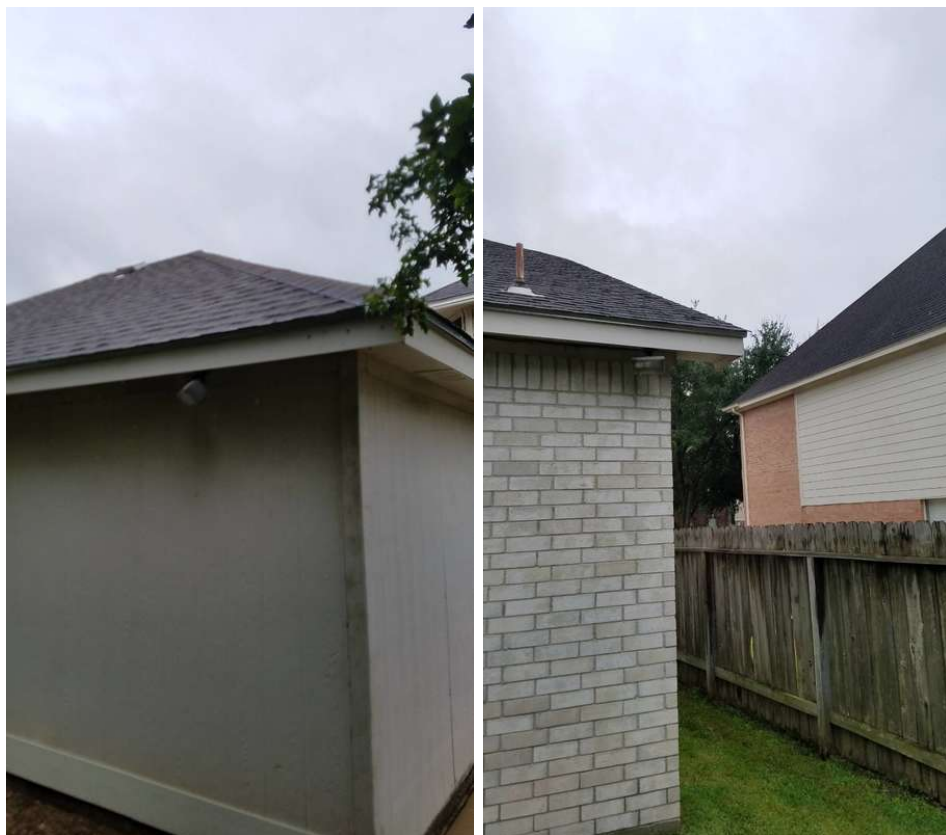
GARAGE, REAR

EXTERIOR LIGHT INOP

Some light fixtures mounted on the exterior walls of the residence were inoperable at the time of the inspection. This condition can be caused by burned out bulbs, the light may be connected to a timer or light-sensitive switch or a problem may exist with the light fixture, wiring or the switch. You should re-test any inoperable light fixtures after replacing the bulbs. If after bulb replacement the lights still fail to respond to the switch, consider evaluation by a qualified electrical contractor. This condition may be a potential fire hazard.

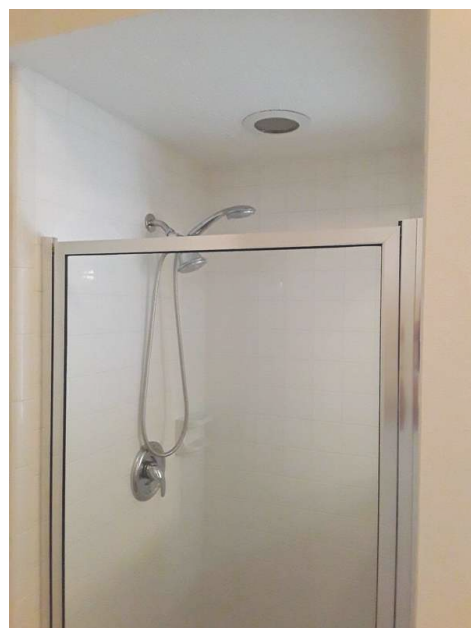
MASTER BATHROOM

BULB?

One or more of the light fixtures appear to be inoperative. This may be due to a bad bulb or some other unknown condition. This condition should be further evaluated and corrected as necessary.

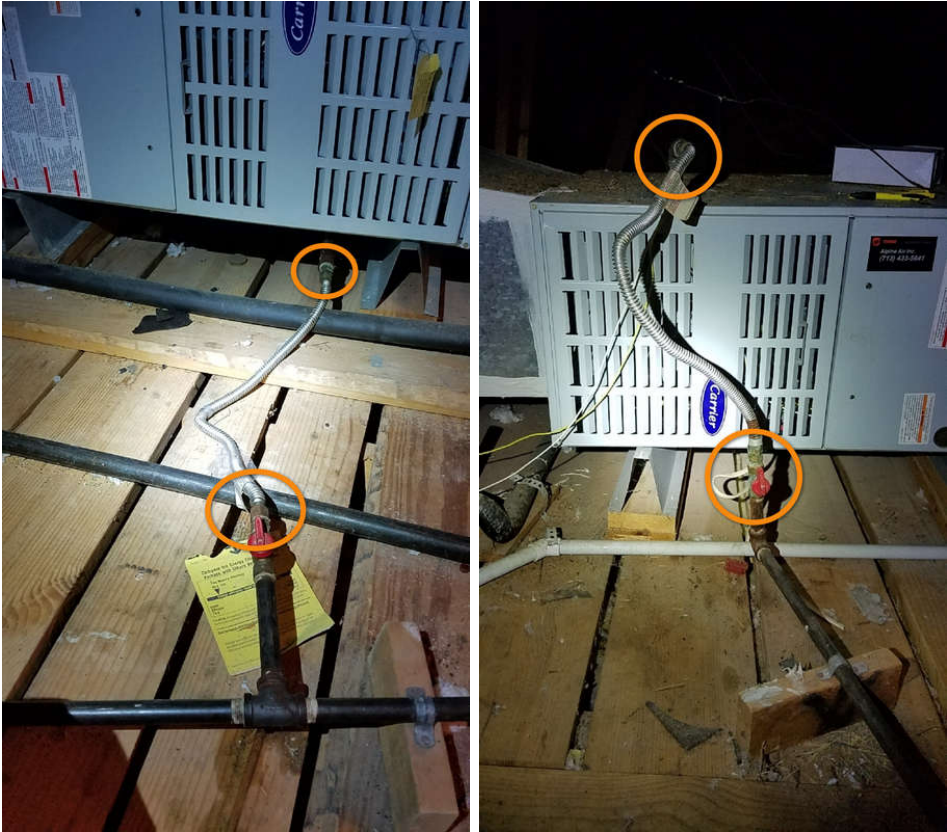
NO SEDIMENT TRAP

The heater gas supply line is not equipped with a sediment trap just before the gas appliance connector. This condition does not meet current installation requirements and should be corrected.

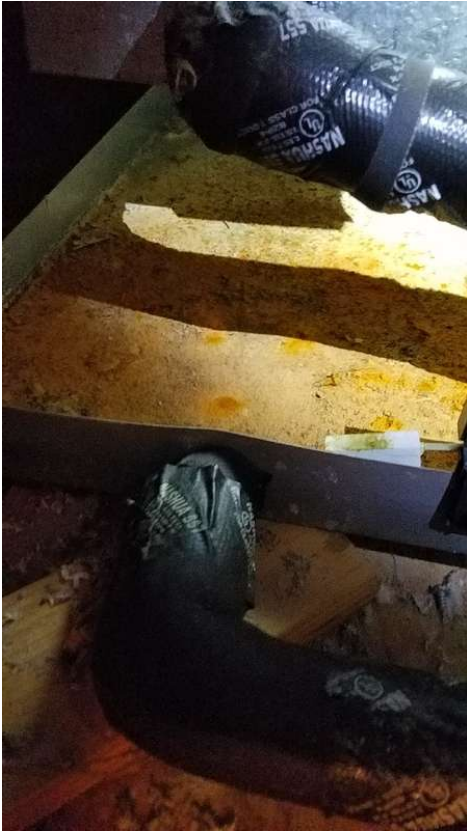
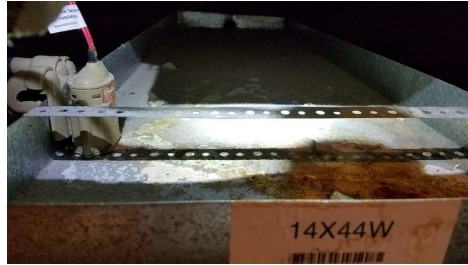
RUST IN PAN

The auxiliary/secondary drain pan under the coil housing has some water staining and/or a rust build-up. This would indicate that the pan has held water in the past and should be closely monitored.

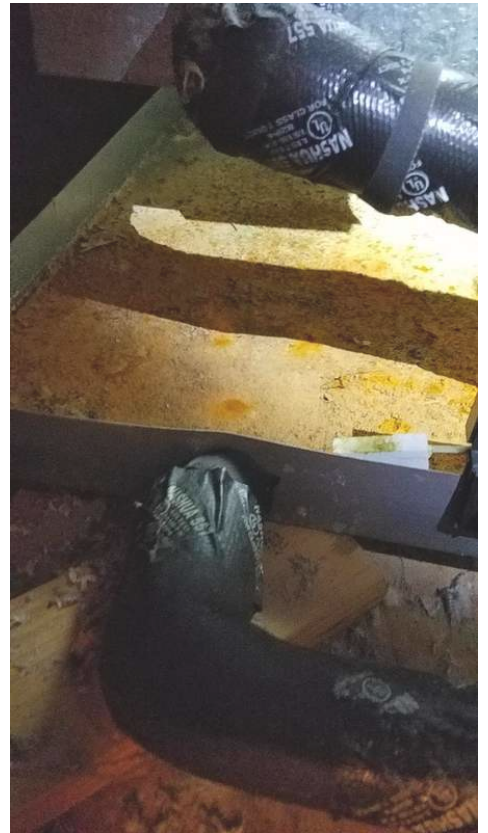
DEBRIS IN PAN

The auxiliary/secondary drain pan under the coil housing should be free of all debris. The debris in the pan could clog the drain line and cause water to leak to the interior of the house.

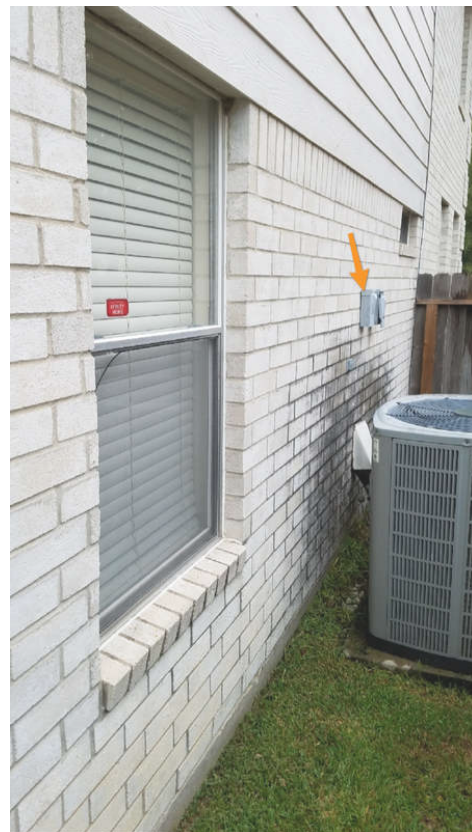
DISCONNECT BEHIND UNIT

The electrical service disconnect is installed behind the outside condenser/coil. This does not meet the clearance requirements of the National Electrical Code or the International Residential Code and should be corrected as necessary.

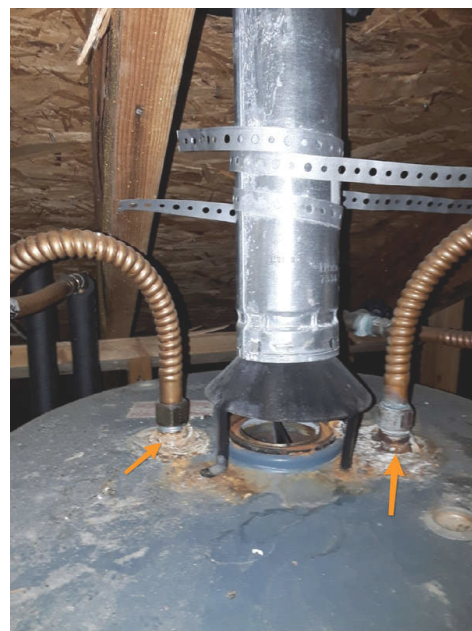
DISSIMILAR METALS

Dissimilar metals observed to be in use in the water supply system in one or more locations. In some cases this will cause electrolysis to occur which will result in water leaks at these connections. It is recommended to install dielectric fitting at any dissimilar metal connection locations.

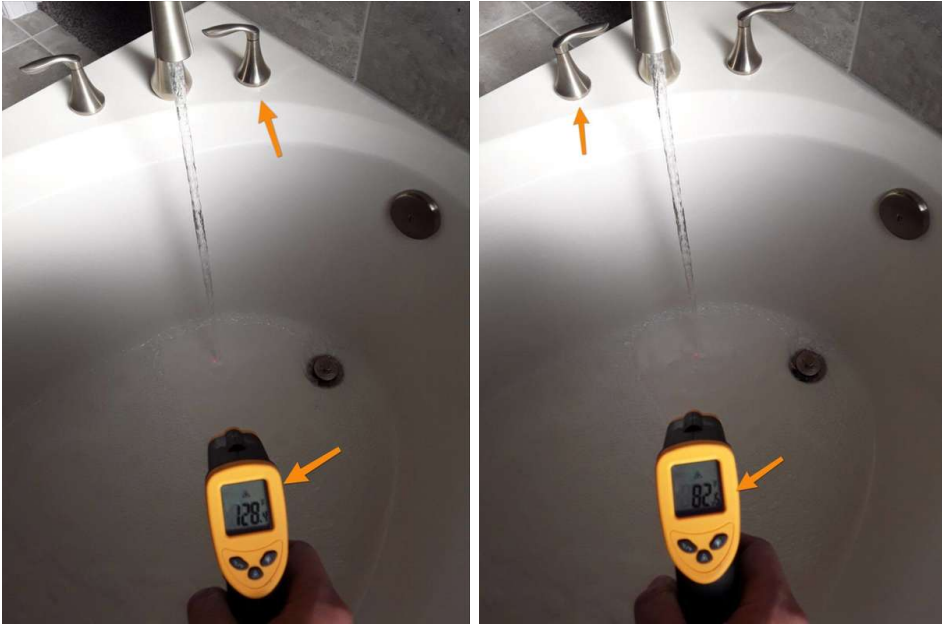
HOT COLD REVERSED

The faucets hot/cold water orientation is reversed.

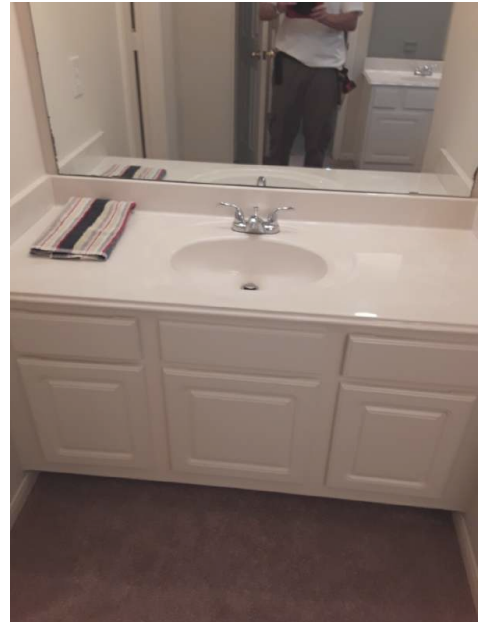
SLOW DRAIN = SINK

The sink was observed to drain slowly, suggesting that an obstruction may exist.

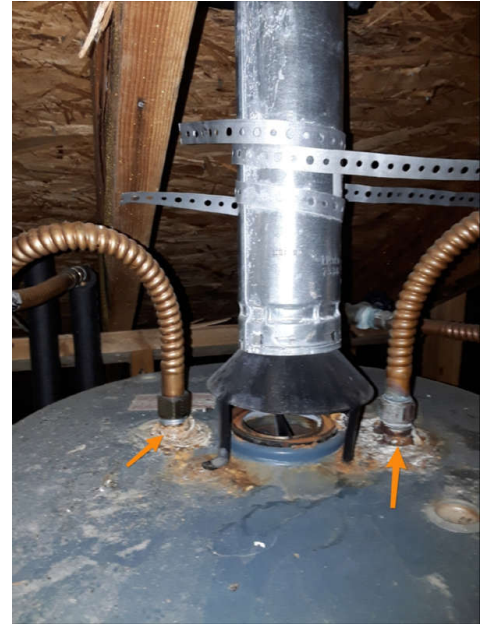
CORROSION

Some corrosion was observed at the water supply connections at the top of the water heater.

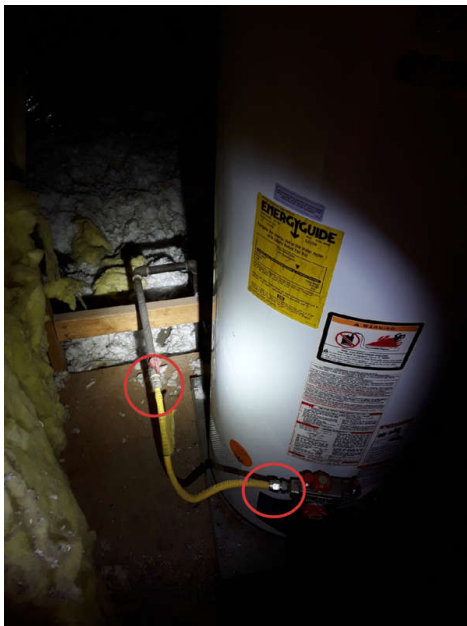
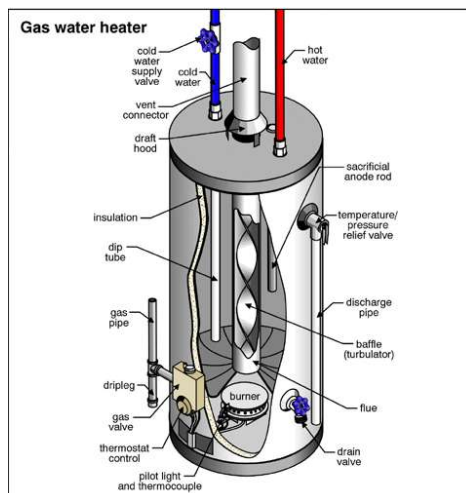
NO DRIP LEG

There is no sediment trap / drip leg present.

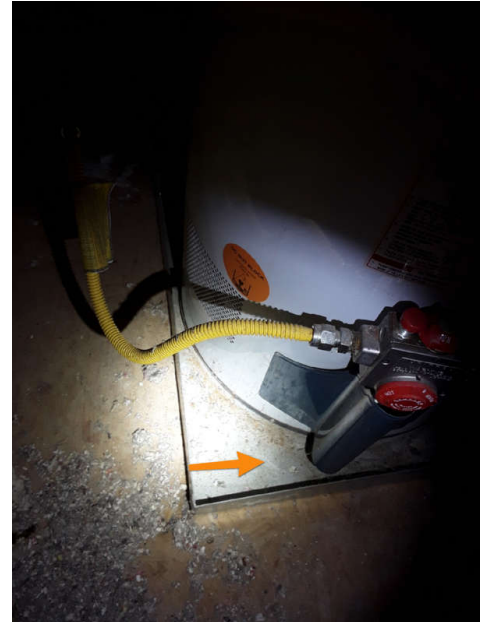
DEBRIS IN PAN

The debris in the water heater pan should be cleaned out to help prevent the pan drain line from being clogged.
