Summary Report outlines **Moderate Concerns** and **Significant and/or Safety Concerns**. It does not include **MINOR/Maintenance or Upgrades**.

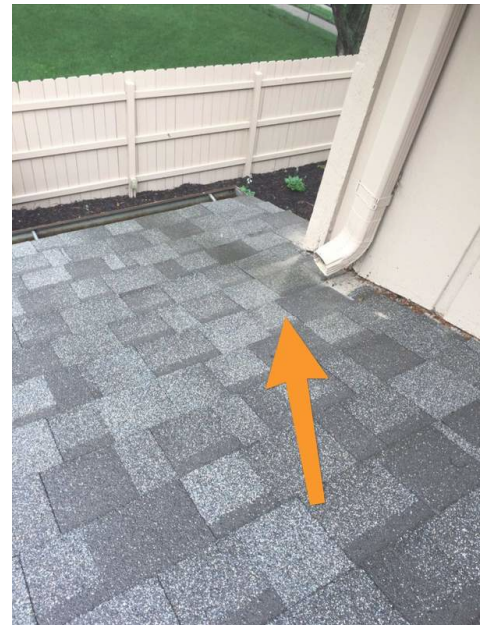
ROOF/REAR OVER DINING ROOM

### **DOWNSPOUT EXTENSIONS OVER ROOF COVERINGS**

Downspout extensions are recommended over roof coverings to extend the life of the roof covering and prevent water intrusion. Prolonged periods of concentrated water travel from downspouts can remove granular coatings and if too close to wall structures can cause leaks. Recommend extending the downspout closer to the nearest downstream gutter.

Contact a handyman or DIY project

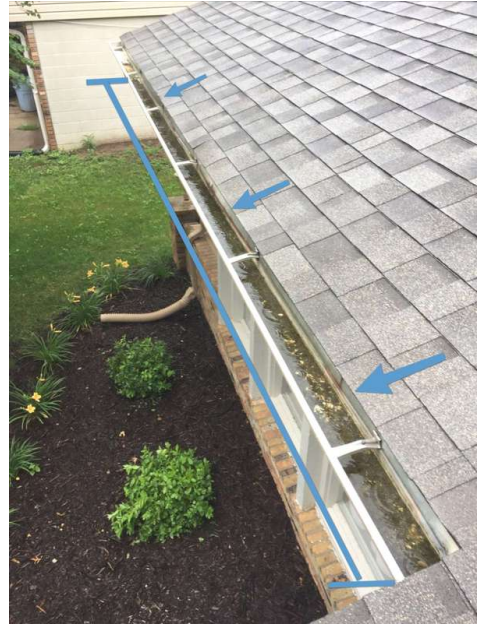
FRONT OF HOME ABOVE LIVING ROOM WINDOWS

### **GUTTER PITCH ADJUSTMENT NEEDED**

One or more gutters are installed with negative pitch. If left in this condition, gutters with negative pitch will hold water limiting their capacity during storms causing overflow which can lead to moisture intrusion in basements, as well as foundation or structural issues. Recommend it be repaired by a qualified gutter contractor.

Approximately two inches of standing water in gutter.

Contact a qualified gutter contractor

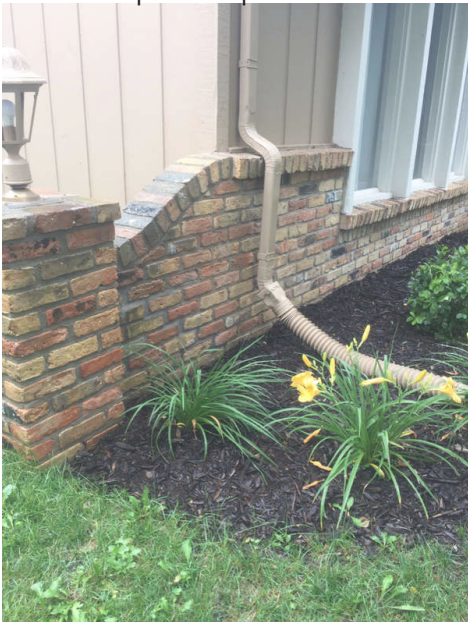
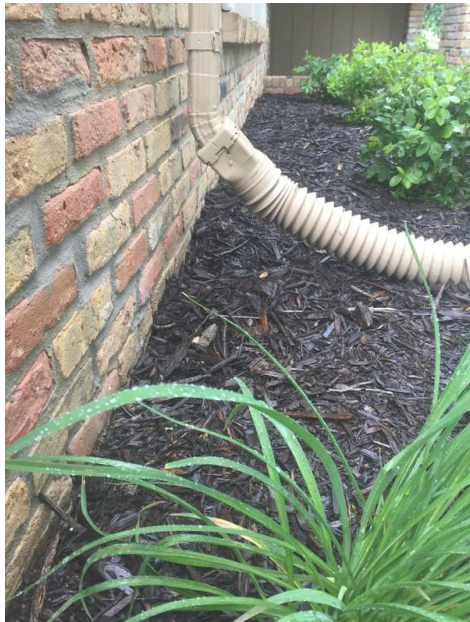
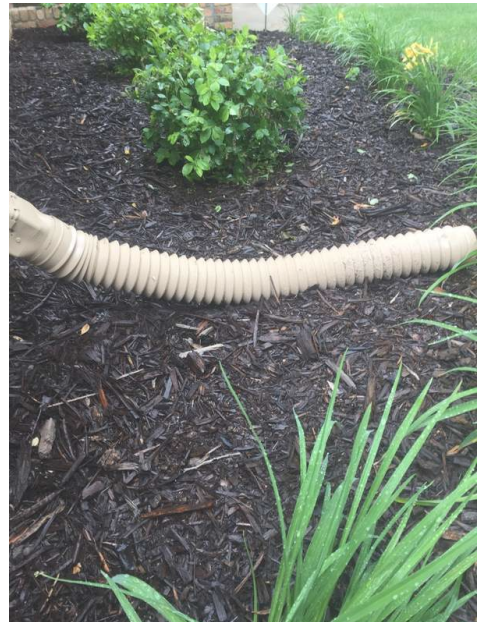
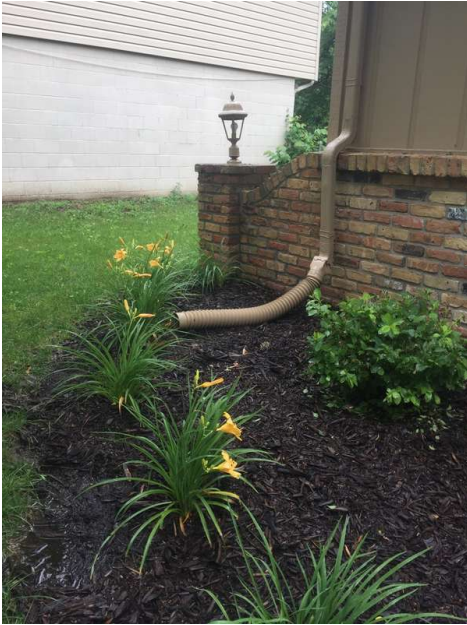
NORTHWEST CORNER FRONT

**REVERSE PERIM SLOPE - SOIL, REPAIR**

The soil or grading sloped down towards building perimeters in one or more areas. This can result in water accumulating around building foundations or underneath buildings. It can be a conducive condition for wood-destroying organisms. Recommend grading soil so it slopes down and away from buildings with a slope of at least 1 inch per horizontal foot for at least 6 feet out from buildings.

Contact a qualified professional.

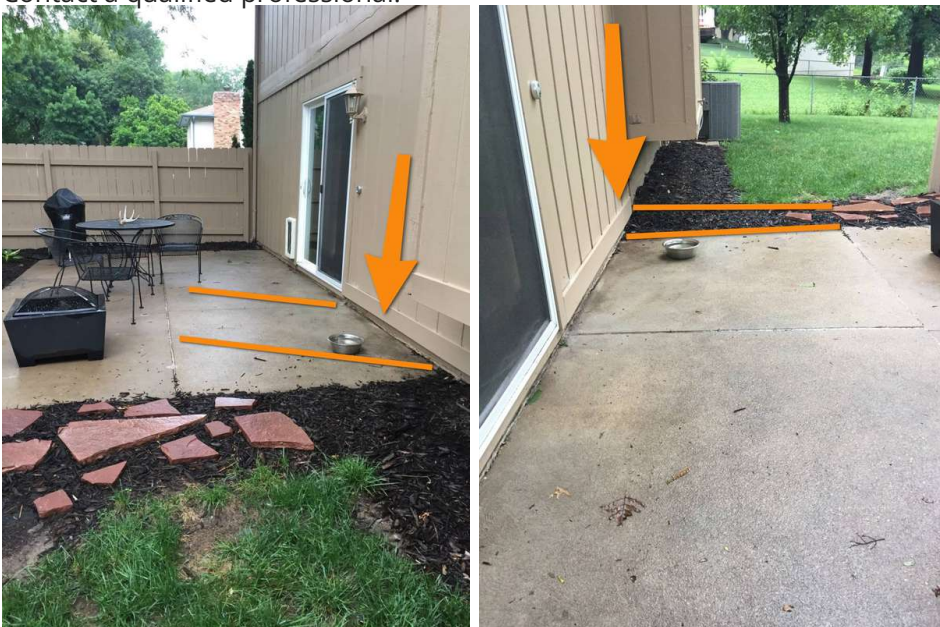
REAR PATIO SECTIONS CLOSEST TO HOME

**REVERSE PERIM SLOPE - PAVEMENT, MONITOR**

Pavement sloped down towards building perimeters in one or more areas. This may result in water accumulating around building foundations or underneath buildings. Monitor these areas in the future, especially during and after periods of rain. If significant amounts of water are found to accumulate, then recommend that a qualified contractor evaluate and repair as necessary. For example, by installing drain(s) or removing old pavement and installing new.

Contact a qualified professional.

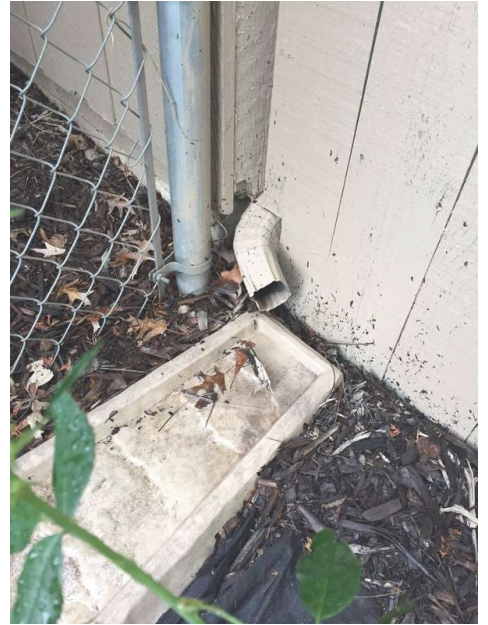
SOUTHEAST

**DOWNSPOUT EXTENSIONS**

Extensions such as splash blocks or drain pipes for one or more downspouts were *missing / poorly sloped / misaligned / clogged / substandard / damaged*. Water can accumulate around the building foundation or inside crawl spaces or basements as a result. Recommend that a qualified person install, replace or repair extensions as necessary so rainwater drains away from the structure.

Contact a qualified professional.

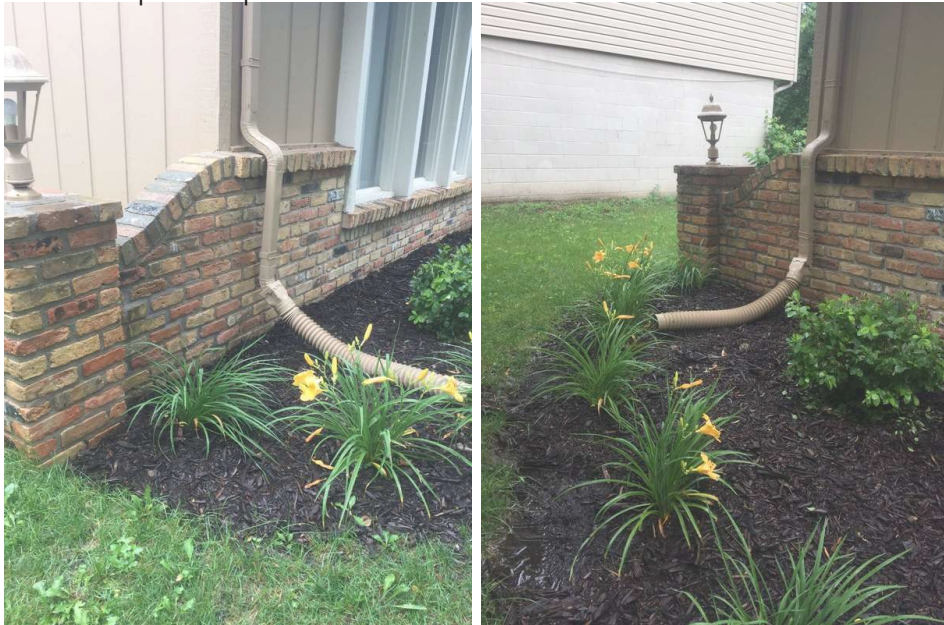
#### **DRAINAGE SYSTEM**

One or more *gutters / downspouts* were *loose / incomplete / missing / leaking / corroded / damaged*. Rainwater can come in contact with the building exterior or accumulate around the building foundation as a result. This is a conducive condition for wood-destroying organisms. Recommend that a qualified person repair as necessary.

Contact a qualified professional.

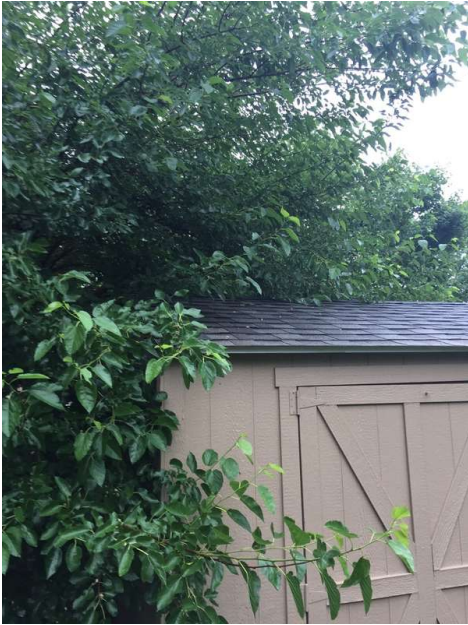
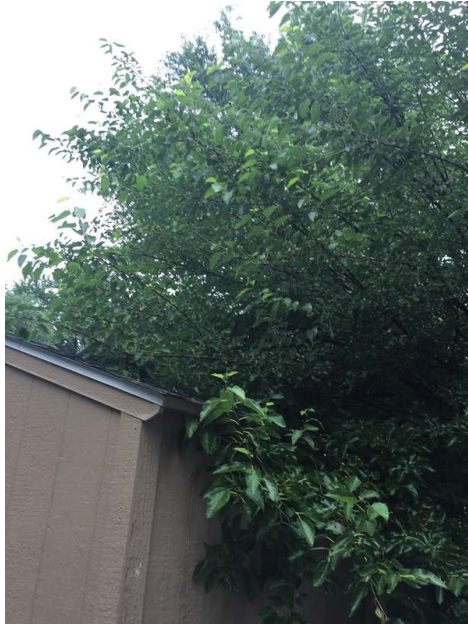
SHED REAR EXTERIOR

#### **VEGETATION CONTACT WITH ROOF/SIDING**

Contact a handyman or DIY project

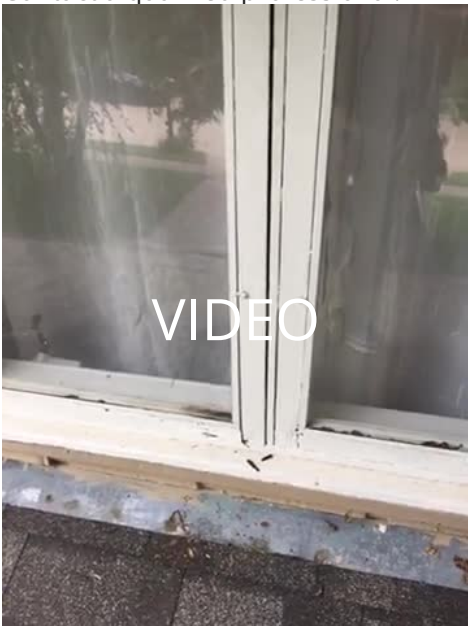
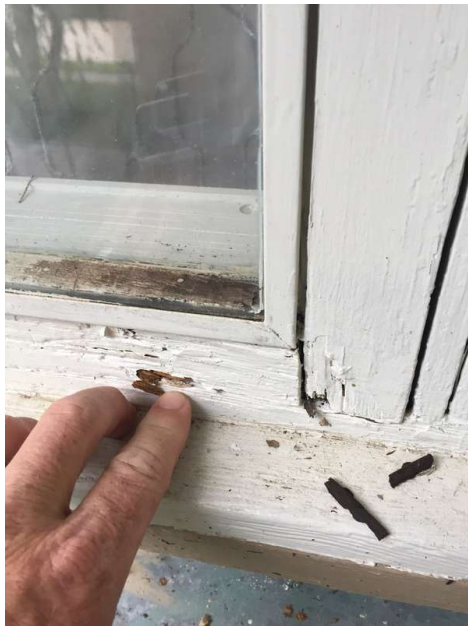
##### FRONT WINDOWS ABOVE GARAGE

Windows above garage have damaged trim. recommend monitoring or repair if necessary.

Contact a qualified professional.

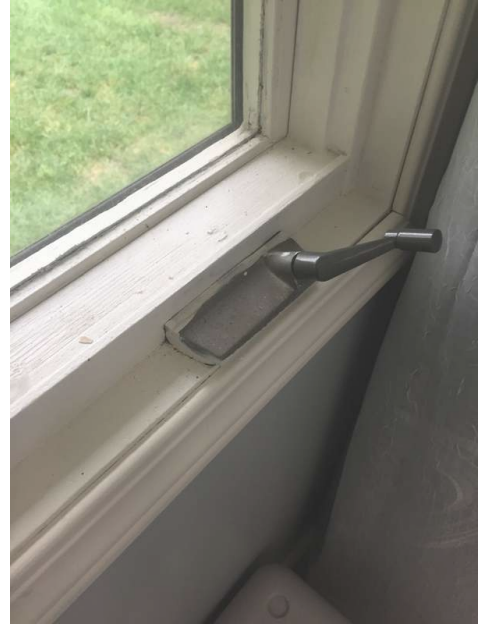
DINING ROOM

#### CRANKS

Crank handles at *some / many* windows were *missing / stripped / loose / broken*. Recommend that a qualified person replace handles or make repairs as necessary.

Recommendation  
Contact a qualified professional.

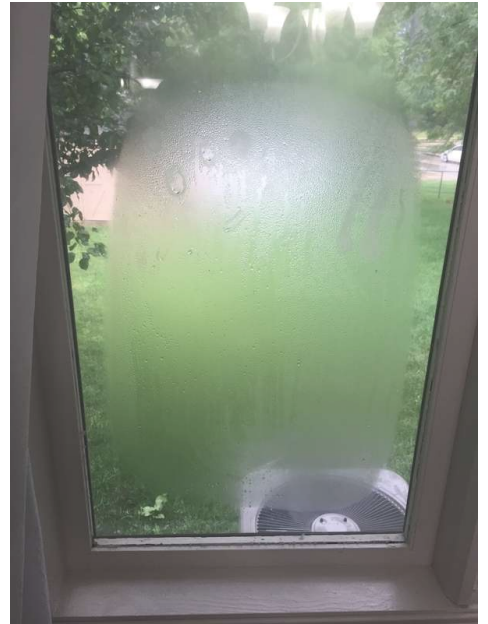
DINING ROOM

#### FOGGING, CONDENSATION BETWEEN GLASS

Condensation or staining was visible between multi-pane glass in *one or more / many* windows / skylights. This usually indicates that the seal between the panes of glass has failed or that the desiccant material that absorbs moisture is saturated. As a result, the view through the window may be obscured, the window's R-value will be reduced, and accumulated condensation may leak into the wall structure below. Recommend that a qualified contractor evaluate and repair windows as necessary. Usually, this means replacing the glass in window frames.

Recommendation  
Contact a qualified professional.

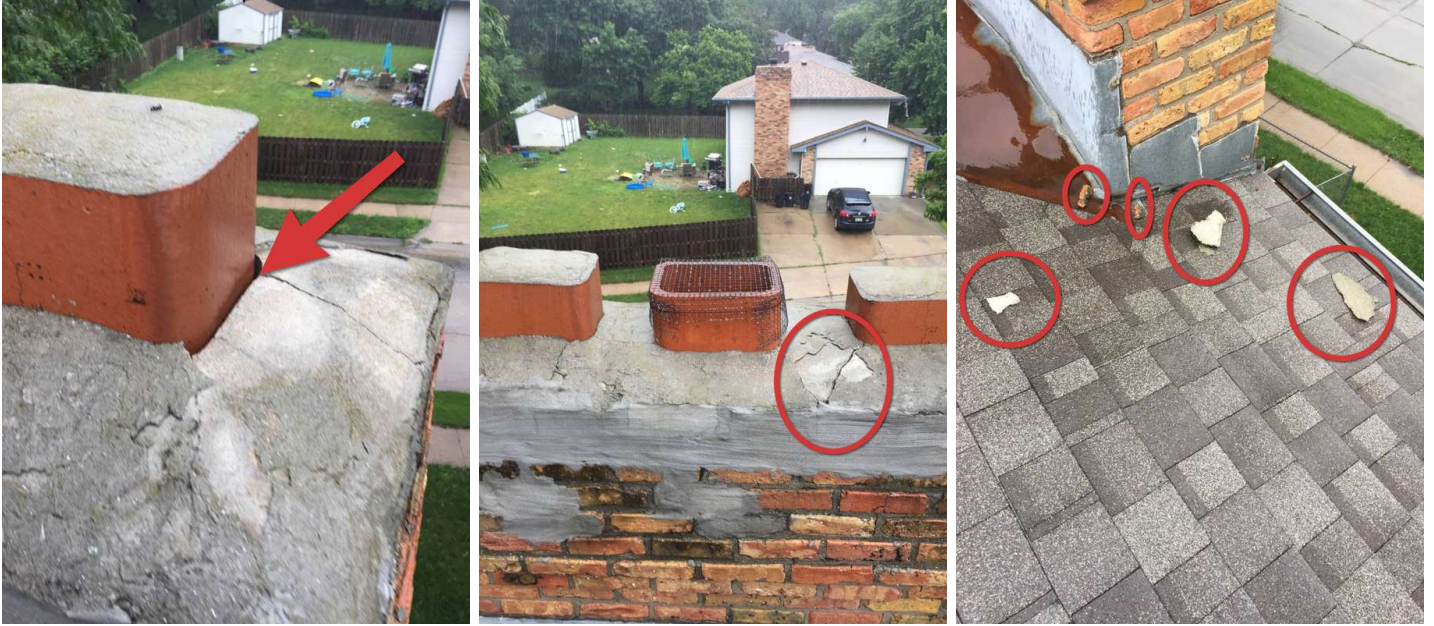
#### CHIMNEY CROWN

Chimney Crown/Mortar Cap appears defective allowing water penetration. This condition can lead to water or ice penetrating mortar joints damaging the brick veneer. Additionally, water intrusion can lead to structural damage as well as the formation and growth of mold. Recommend repair as necessary by qualified professional.

Recommendation  
Contact a qualified professional.

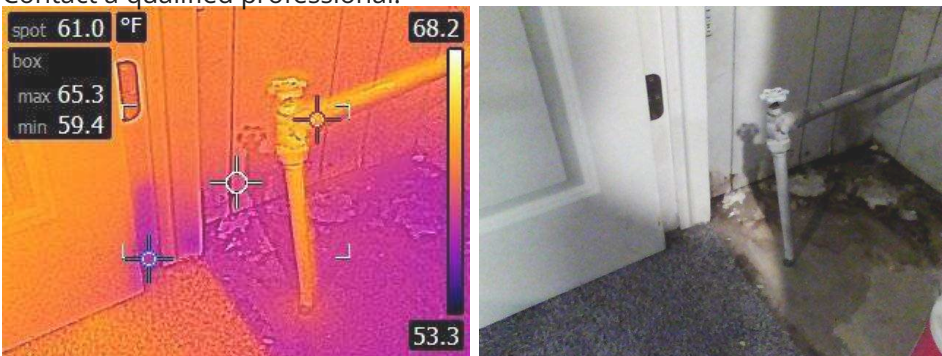
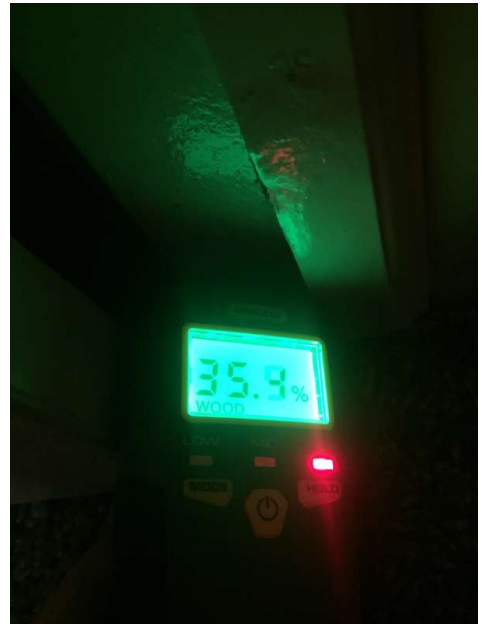
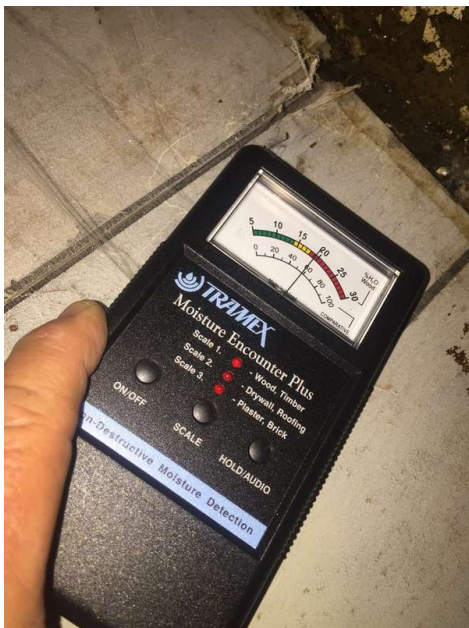
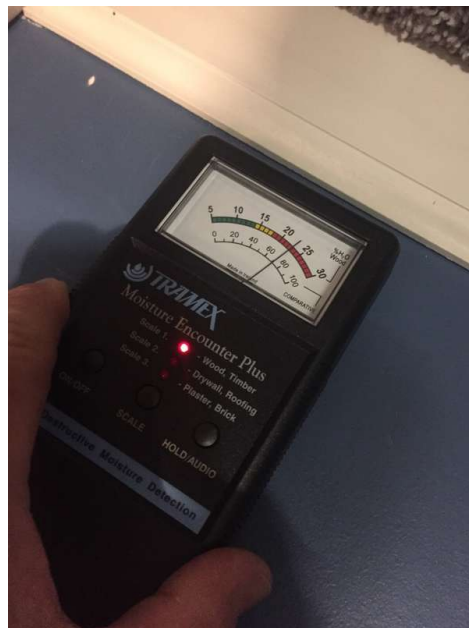
BASEMENT NORTHWEST CORNER

Evidence of water intrusion was found in one or more sections of the basement. For example, water stains or rust at support post bases, efflorescence on the foundation, etc. Accumulated water is a conducive condition for wood-destroying organisms and should not be present in the basement. Recommend reviewing any disclosure statements available and ask the property owner about past accumulation of water in the basement. The basement should be monitored in the future for accumulated water, especially after heavy and/or prolonged periods of rain. If water is found to accumulate, then recommend that a qualified contractor who specializes in drainage issues evaluate and repair as necessary. Typical repairs for preventing water from accumulating in basements include:

- Repairing, installing or improving rain run-off systems (gutters, downspouts and extensions or drain lines)
- Improving perimeter grading
- Repairing, installing or improving underground footing and/or curtain drains

Recommendation  
Contact a qualified professional.

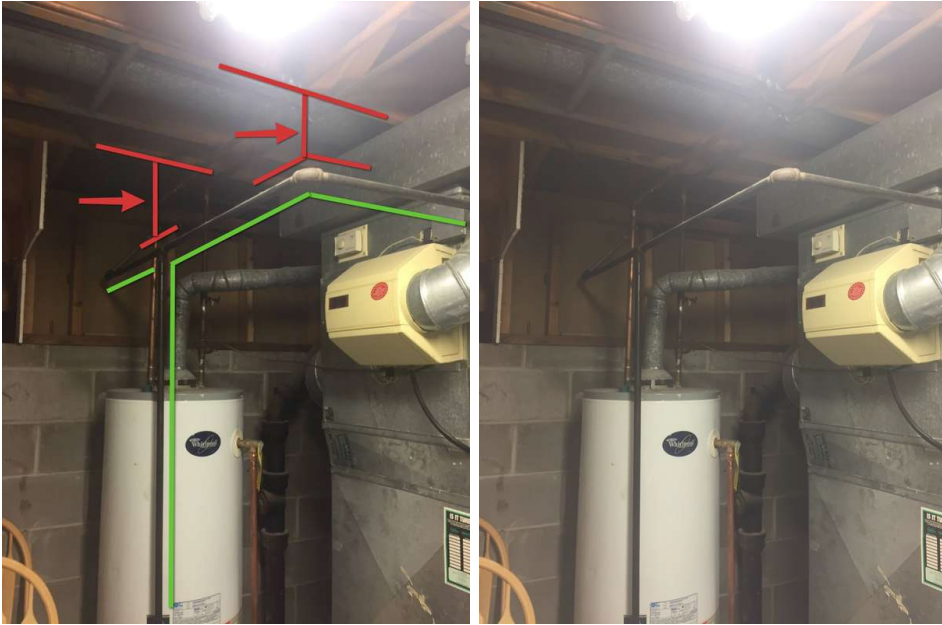
### BASEMENT LAUNDRY ROOM

The gas line above the water heater is installed without support and is vulnerable to being disturbed based on its position relative to open space. This is a potential safety concern and should be addressed by a qualified professional.

Gas line - Green Supports are need in the areas in Red Gas line joint should be protected by supports when suspended.

Contact a qualified professional.

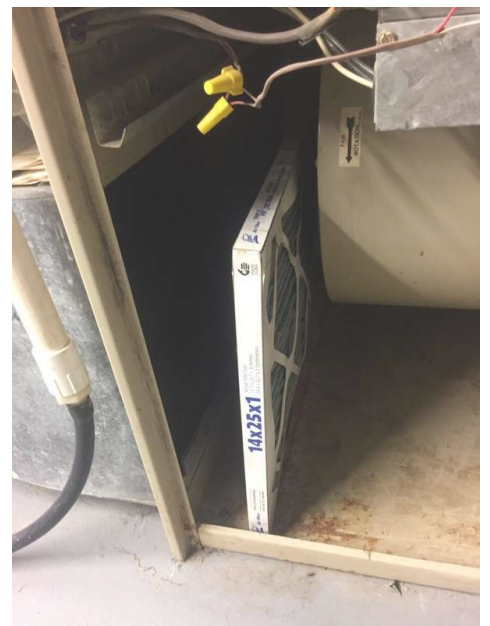
### WRONG FILTER - INCORRECTLY INSTALLED

This filter was sitting inside furnace cabinet blocking the fan. It should be removed and the correct filter installed in correct location, properly secured to insure sufficient air flow mechanics.

Recommendation  
Contact a qualified professional.
