SUMMARY  
1234 Main St. Johnson City Tennessee  
37604  
Buyer Name  
03/05/2019 9:00AM

Michael Ray  
Tennessee Licensed Home...  
Home Check Inspection Services, LLC.  
(423) 791-1264  
homecheckinspect@comcast.net

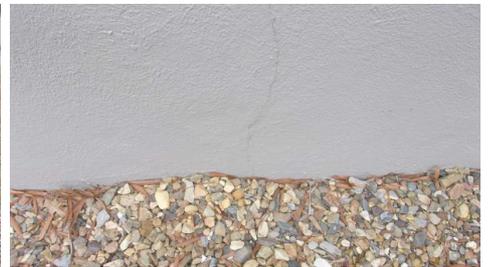
There are areas around the home where the soil grade is flat or negatively sloped toward the home or there are holes in the soil at the base of the home's exterior. Water is not forgiving, some say it is the leading cause of damage to a home. Water infiltration of a foundation wall or structural issues due to hydrostatic pressure or soil heaving or freezing is always possible. To help remove water from the base of the home's foundation the soil around the home should be positively sloped away from the home.

See Grading Overview Information.

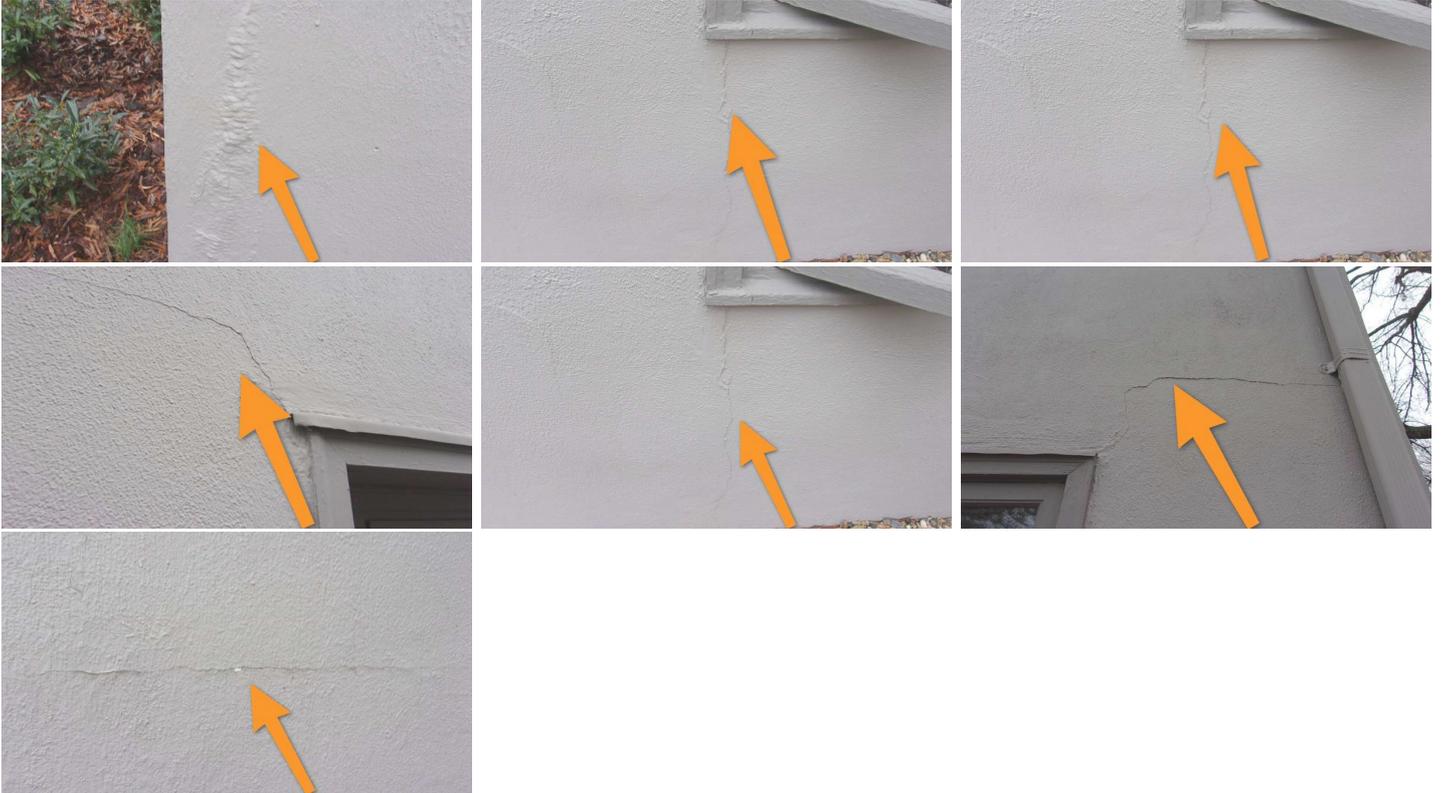
**CRACKING - MINOR**

The home's exterior cladding has minor cracking in places. Some have been painted over and some that were painted have since cracked. There were a few areas where there was some lateral displacement around the cracking. To prevent water entry into the stucco recommend sealing the cracks and periodically monitoring

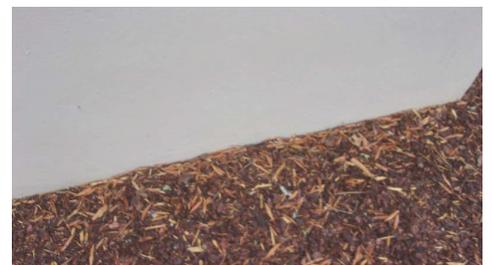
There is inadequate clearance between the home's exterior cladding and the soil grade. The recommended minimum ground clearance between exterior cladding and the soil is 6-8 inches, with 2 inches minimum required between cladding and hardscape. With the soil against the stucco there is always the chance of water wicking up from the soil into the stucco itself. With the soil in the flower beds flat to negatively sloped, at this time, additional soil may be needed or removed to correct the negative grade.

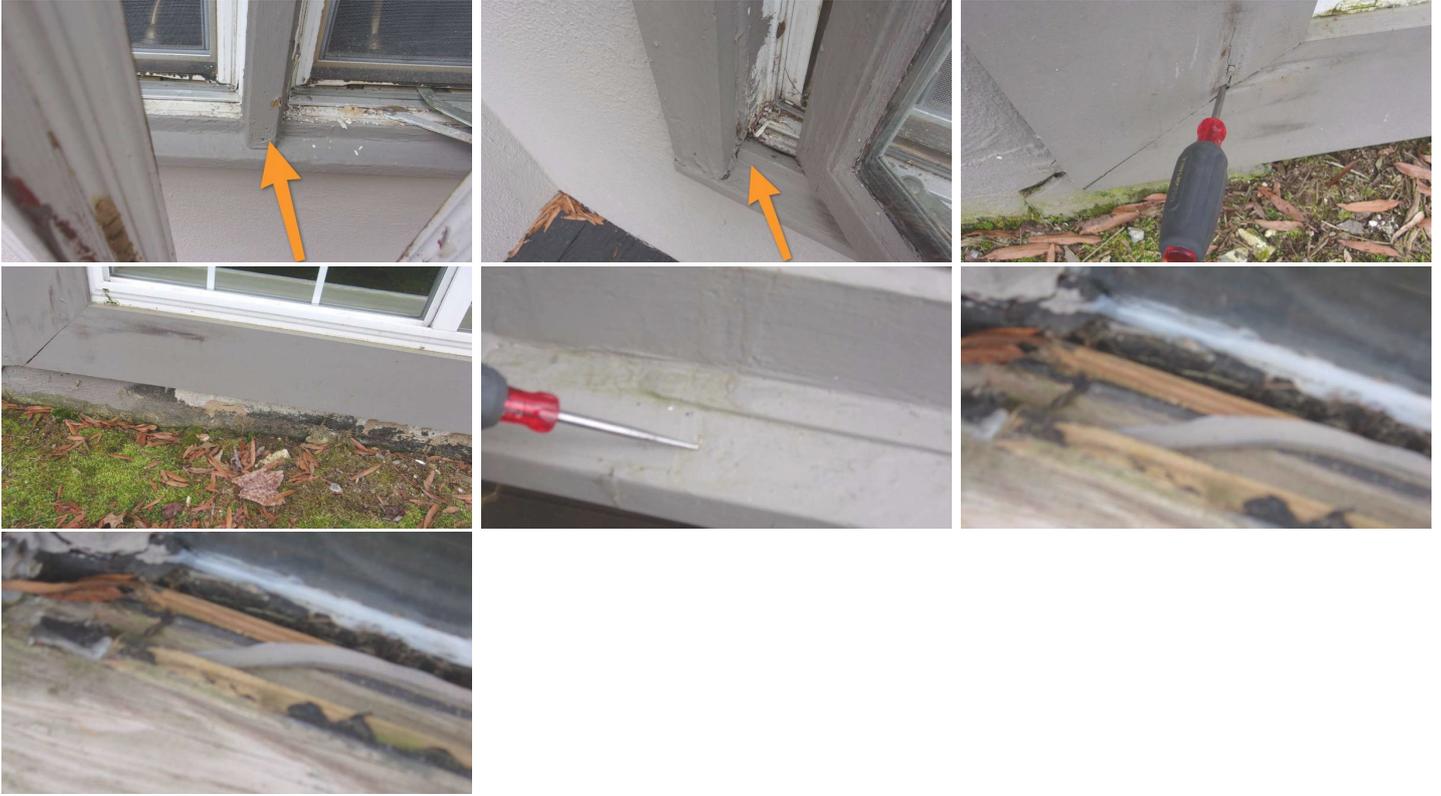
#### ROT / DECAY

There are areas around the home where there is visible wood rot / damage.

1. Exterior window casings and sills.
2. Lower back window trim.

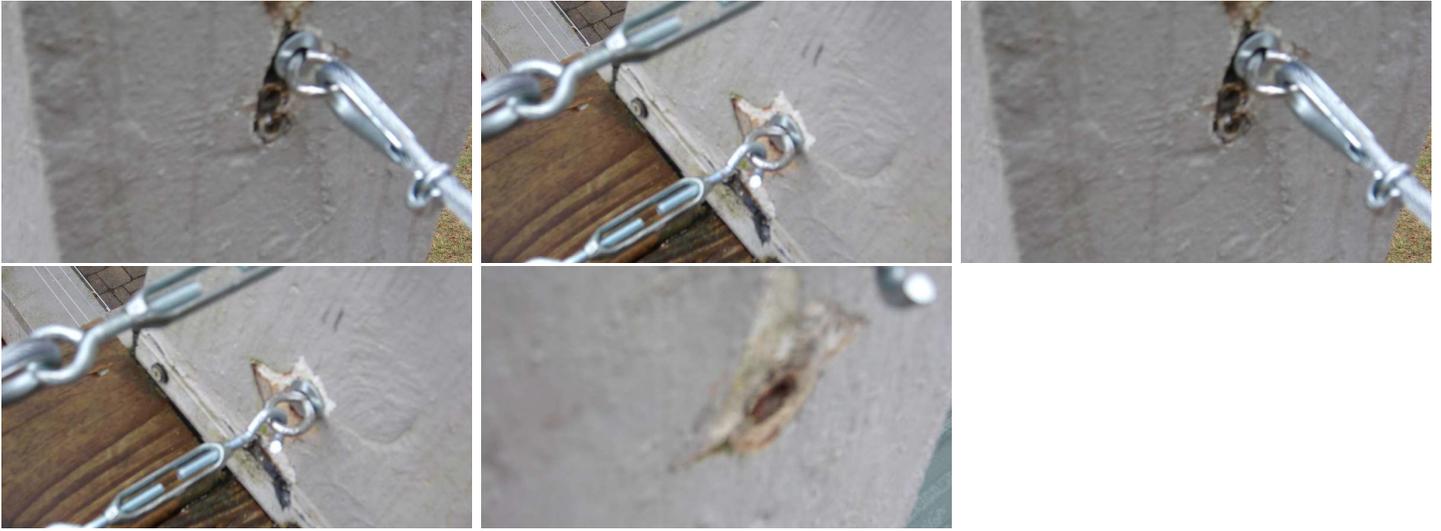
#### DAMAGED AREAS THAT MAY ALLOW WATER ENTRY

There are a few damaged areas or areas where screws or bolts have been removed that will allow water entry into the stucco. Recommend patching, sealing and painting all chipped areas or holes to prevent water entry.

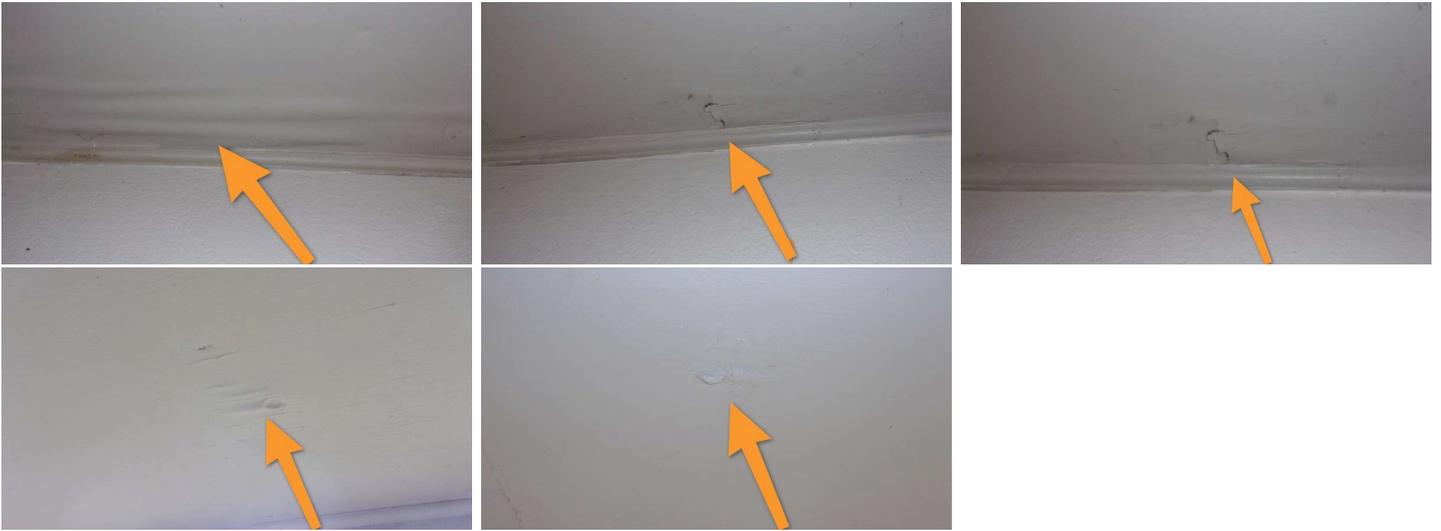
**WATER DAMAGE AREA**

There are a number of areas around the front porch and back patio soffits where there is water damage / wood rot. Most of these areas have been painted over but were probed to be sure.

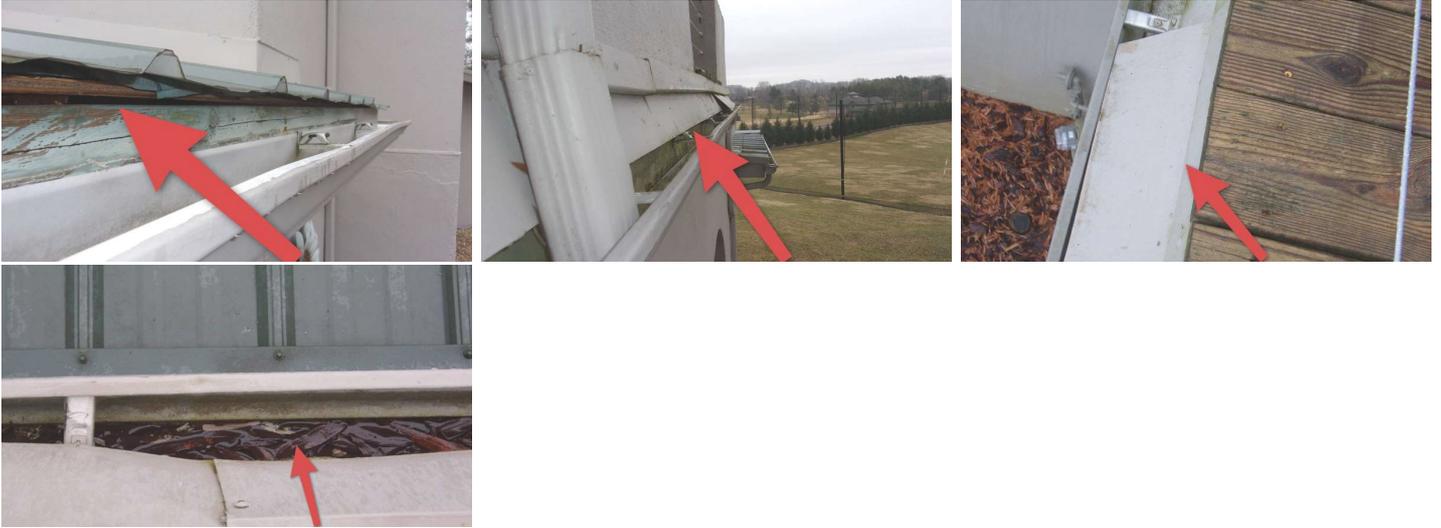
Metal Drip edging is missing or has not been properly installed. There is a flashing like material that has been installed under the metal roofing but it is not the standard drip edge. It is bent over into the gutters and in some areas this metal restricts the guttering space. In some cases the edge of the roof sheathing is void of flashing / drip edge altogether.

Without correct installation the edges of the roof sheathing may be exposed to water and eventually rot.

Recommend evaluation by a Roofing Professional and their recommendation for correction followed.

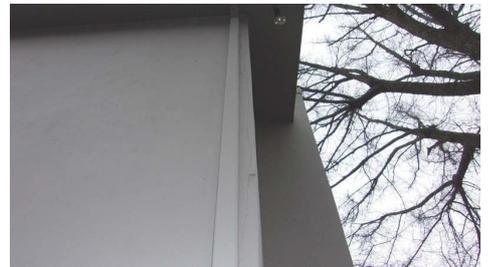
There are tree limbs in close proximity to the roof. It is recommend that limbs be cut back 8-10 feet from the roof and the chimney.

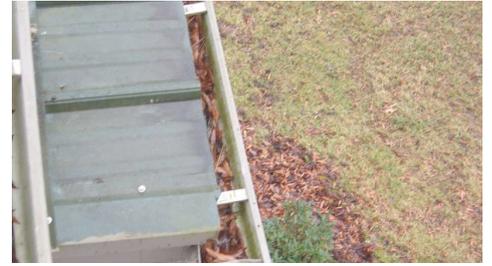
Debris has accumulated in the gutters. Recommend periodically scheduled cleaning to facilitate water flow and / or the installation of gutter guards to prevent the build up of debris.

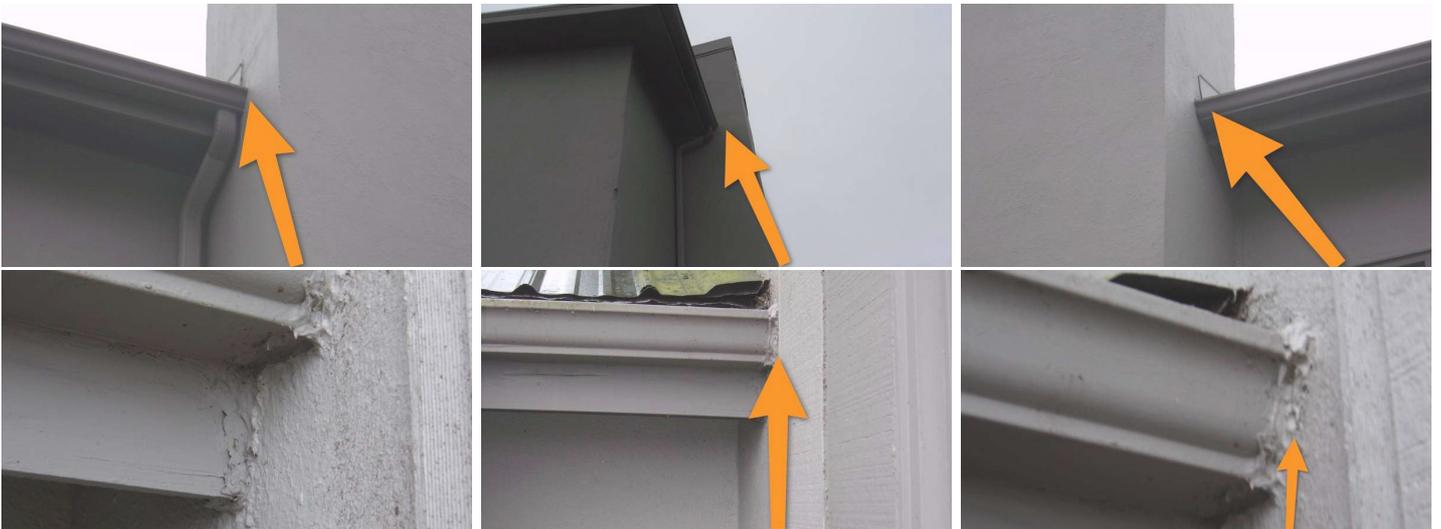
"Kickout" flashing is not present where the gutters meet the house. There is some wall flashing in these areas, but not specifically "kickout" flashing. There is some patching of the stucco and the space between the gutters and the stucco where there has been leaking, possibly due to the lack of this flashing. Specifically above the upper balcony door off the master bedroom.

"Kickout" flashing is an important detail in preventing water damage to a building. It is simply a little piece of metal that directs water out and away from a building where a roof surface ends at a wall. Recommend evaluation and correction by a licensed contractor.

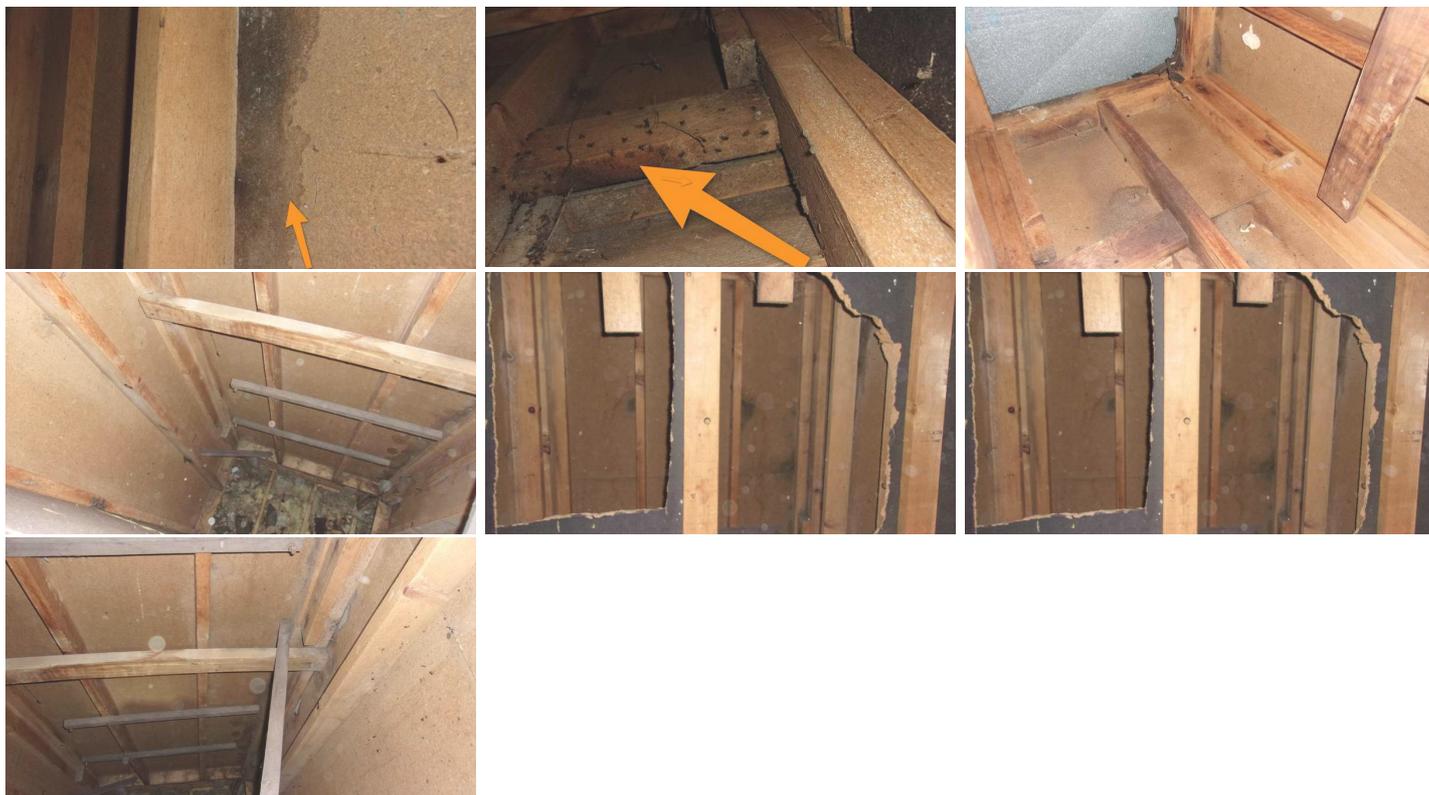
There is an open space or chase in the attic that is considered a fire chase. This area needs to be properly covered and sealed to help prevent the rapid spreading of a fire. These open vertical spaces can act like a chimney providing any fire an easy and rapid pass between floors. This area is at the back right side of the attic area. Recommend the areas noted be properly covered (drywall or OSB) and caulked and then the surface area be insulated in accordance with attic insulation requirements. Or in this case the front wall of the chase can be covered.

Also there was water staining on the interior walls of the chase but no sign of moisture. Also in the upper right side of the chase was a nest of insects. The type of insect is unknown. The inspector is not a professional bug guy.

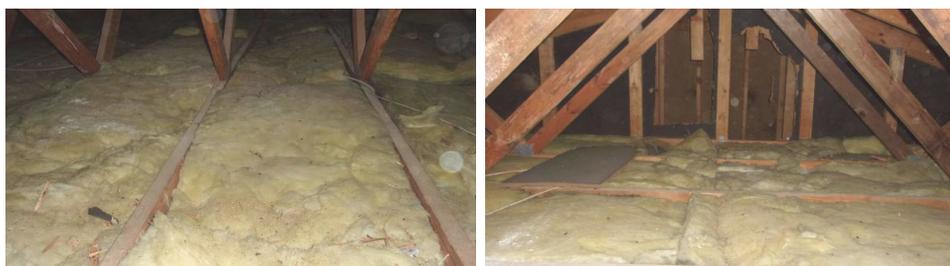
Insulation depth is less than the recommended standard. The insulation appears to be R-19. The minimal insulation R-Value for attics in our region is R-30, while the DOE recommends R-49. Recommend an additional insulation be added. If rolled fiberglass insulation is installed over the current it needs to be unfaced.

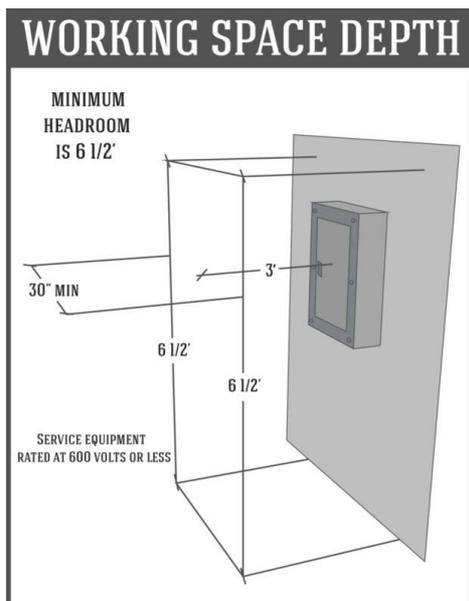
The Main Service Panel is not in unobstructed clear space. The panel should be in clear space (30 inches x 36 inches) that is at least 30 inches wide with 36 inches in front of the panel. The panel does not need to be centered in the 30 inches but the door needs to open a full 90 degrees. Not complying with this is considered a safety issue. I recommend this be corrected. A licensed electrician should address this issue.

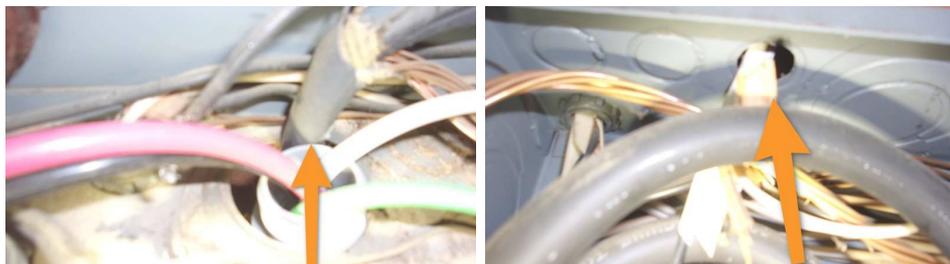
There are conductors entering the service panel that are not protected from the edges of the panel openings with bushings. I recommend a licensed electrician be consulted and their recommendation for correction be followed.

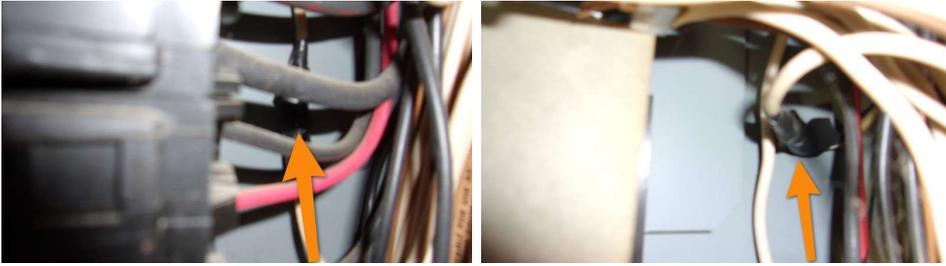
There are two grounded conductor (white wire) splices in the panel. The splices are taped but because of their size do not appear to be capped before tapping.

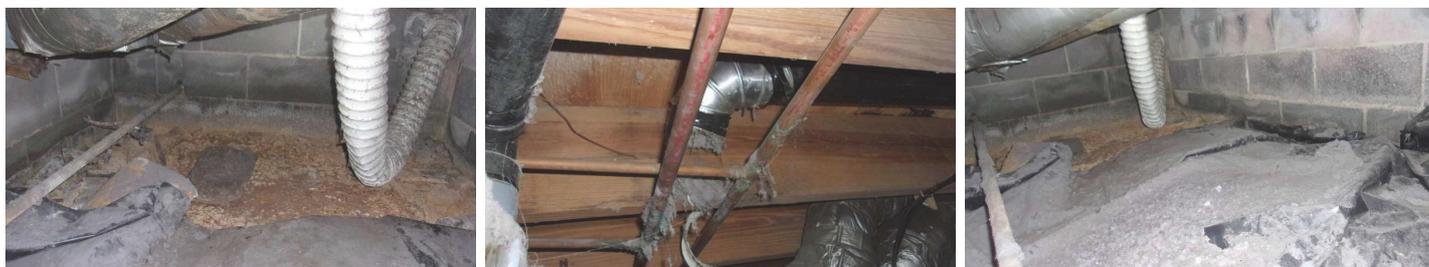
Also the dryer vent is flexible plastic. This type of line tends to trap lint in the line. A solid smooth lined vent pipe is recommended.

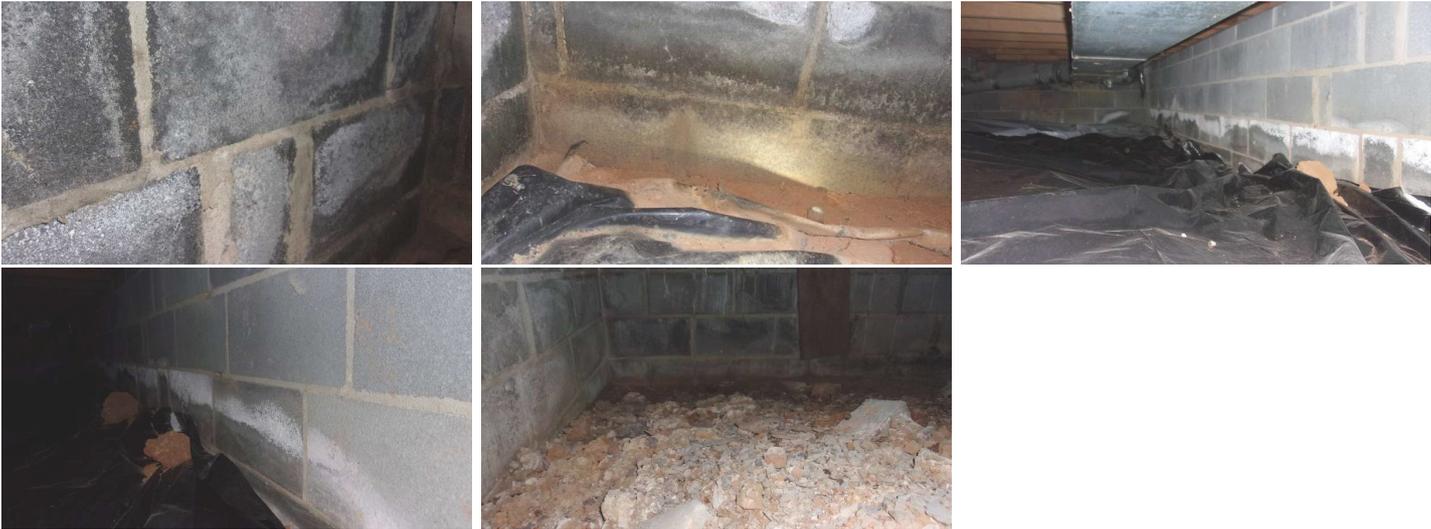
There is efflorescence present on the foundation block in the crawlspace. This is a sign of water penetration of the block presumably from the flat to negatively sloped grading at the exterior of the home. The soil at the base of the block in these areas is wet / muddy indicating current / recent water entry.

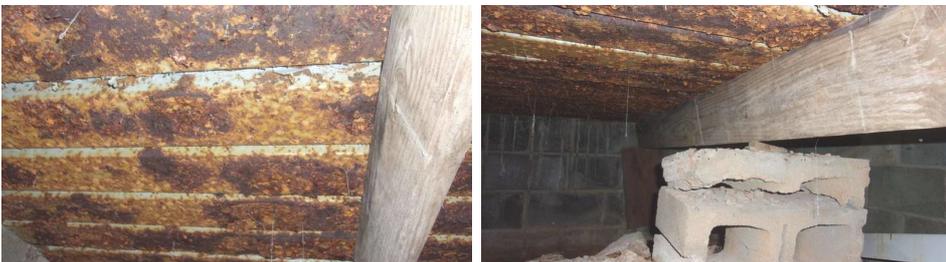
The metal subfloor under the front porch area is heavily rusted and a support beam one a block has been added. The integrity of the support beam and block is in question.

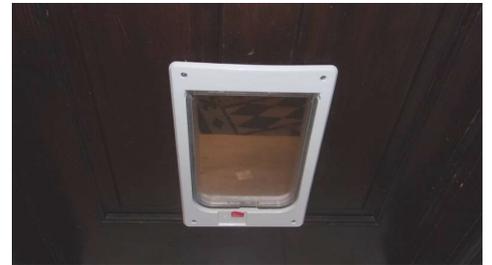
Pet doors in the door between the garage and the living space are not permitted. Having one eliminates the required fire safety standard.

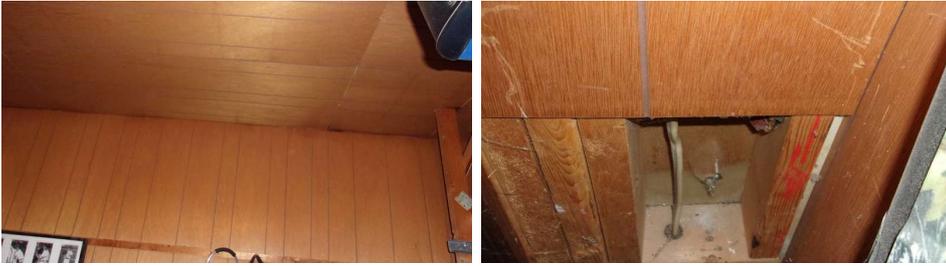
The garage walls are paneling with some loose seams. The floor is painted with common chipped paint. There is hole in the wall to the right of the laundry access (from the garage) around some plumbing lines.

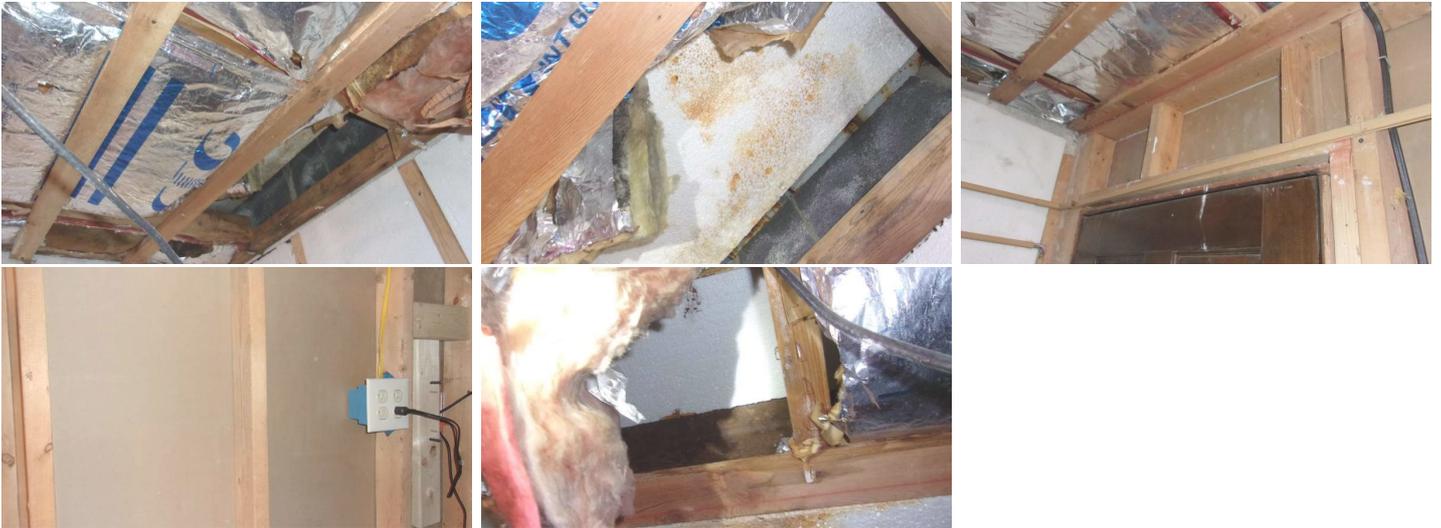
1. This is unconditioned space and the back of the walls between the living area and the closet are not insulated.
2. The ceiling is insulated but the insulation is upside down (paper goes up toward living area) and the insulation is not pressed up against the ceiling. This leaves a gap between the insulation and the flooring that allows air flow thus makes the insulation useless.
3. The door is not weather stripped, has no threshold or sweep to help prevent the movement of air between the two spaces.

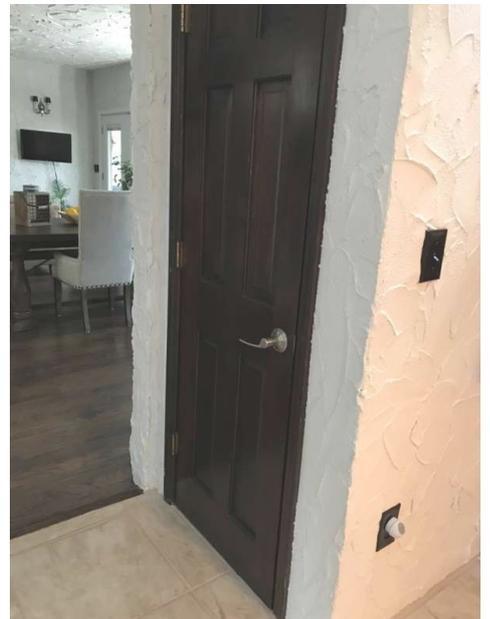
This door doesn't latch. Recommend repair or readjusting the latch and / or strike plate.

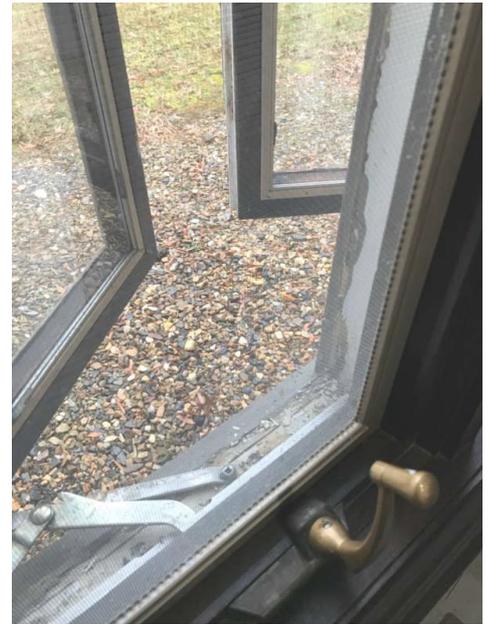
One or more windows appears to have general damage, but are operational.

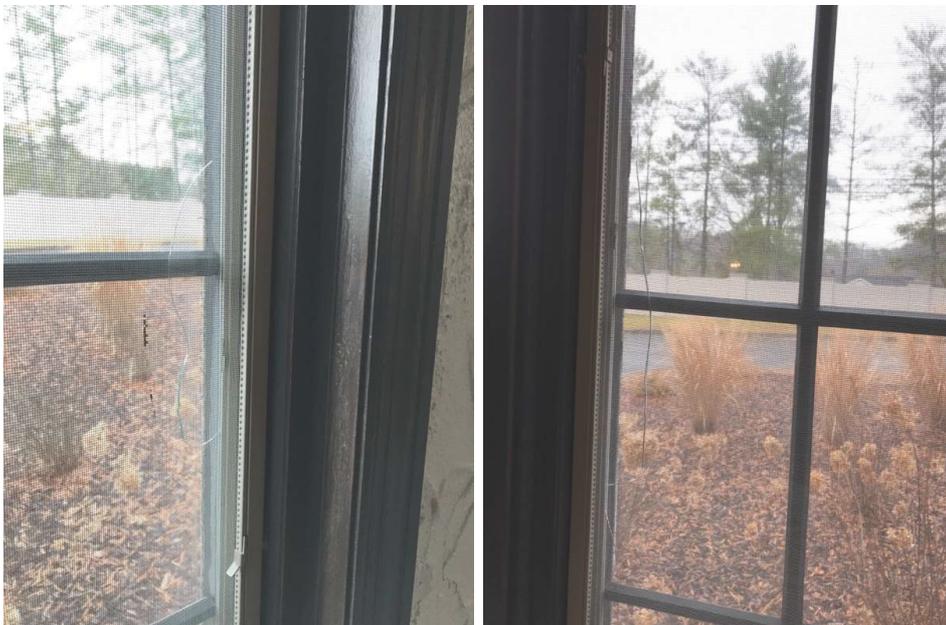
There are windows with cracked or broken window glazing. Recommend repair / replacement of the glazing (glass).

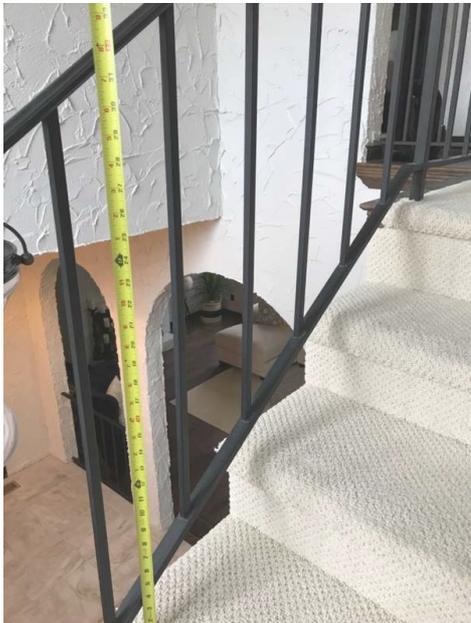
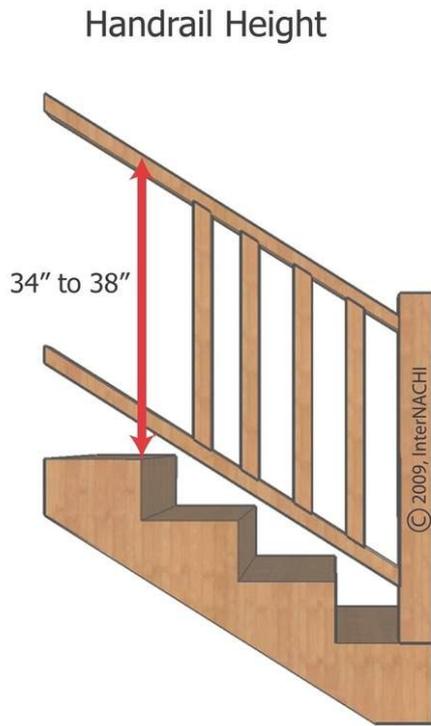
The stair railings are 32 inches high. They do not meet the recommended building standard railing height of 34 to 38 inches. This is considered a safety issue, recommend addressing.

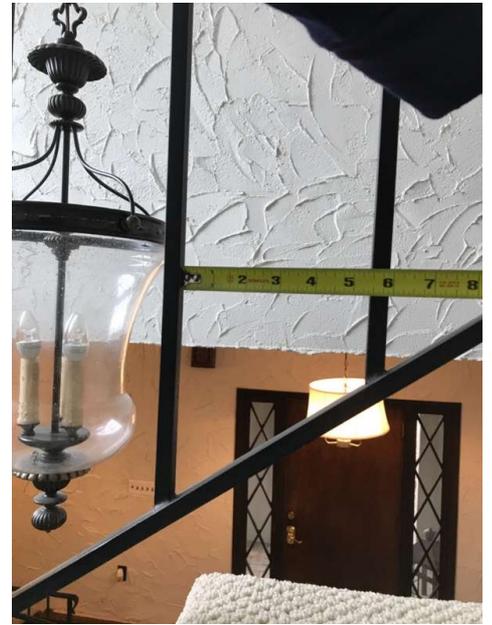
The spacing between the stair railing balusters or fillers is 5.5 inches. There should be no more than 4 3/8 inches of space between stair railing balusters to prevent children heads or other body parts from getting trapped. For safety reasons it is recommended that these steps be brought up to baluster recommended standards.

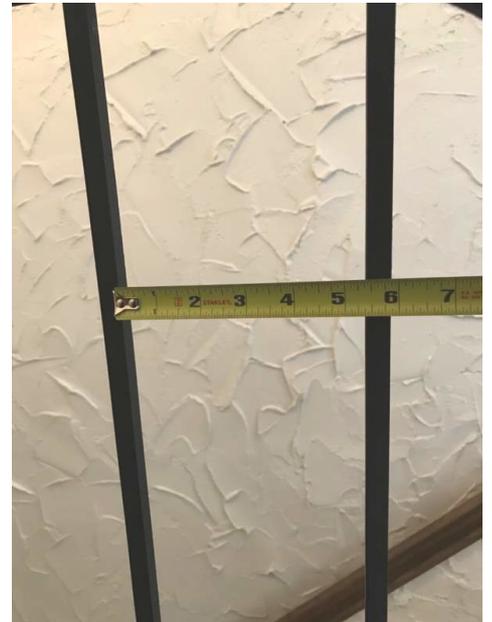
The spacing between the stair railing balusters or fillers is 5.25 inches. There should be no more than 4 3/8 inches of space between stair railing balusters to prevent children heads or other body parts from getting trapped. For safety reasons it is recommended that these steps be brought up to baluster recommended standards.

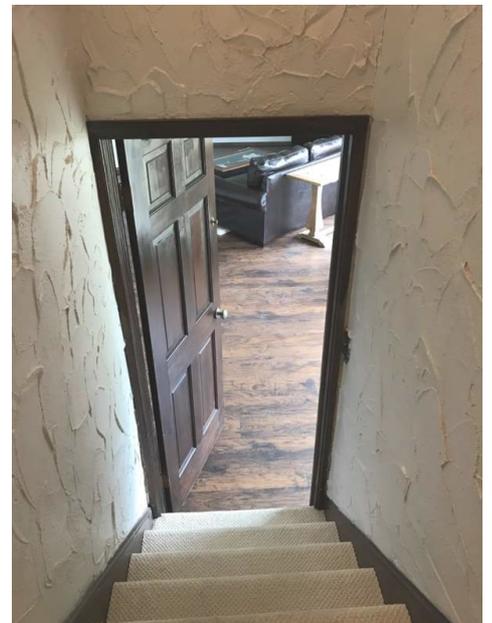
The headroom above these steps is less than the minimum standard of 6 feet 8 inches. Care should be taken so a taller person doesn't smack their head.

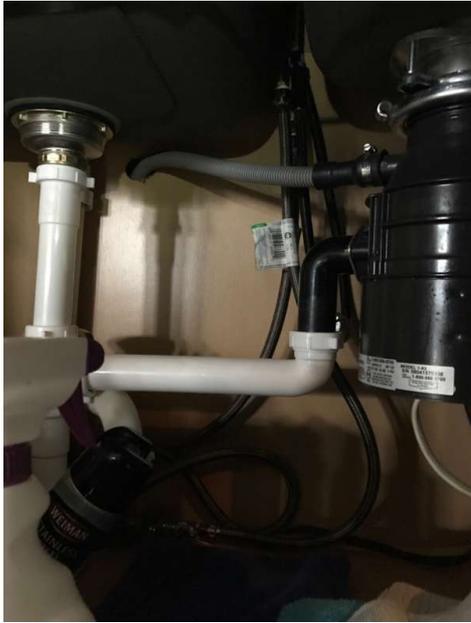
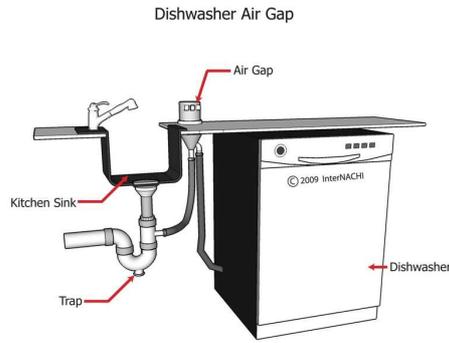
The dishwasher drain line should either connect to an air system at the top of the sink or be installed so it has a loop in the line that touches the under side of the counter top. This air gap system or high loop will help prevent drain water from the sink draining into the dishwasher. Recommend correcting the line positioning to create this high loop.

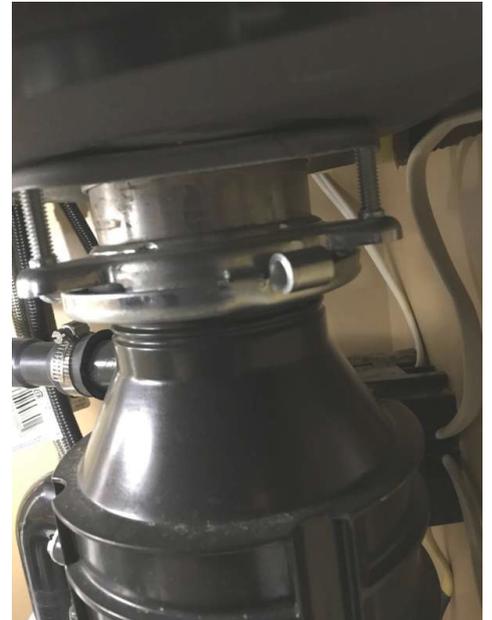
The Romax wiring to the dishwasher and the wiring to the disposal are both unprotected under the sink and both need to be in protective conduit

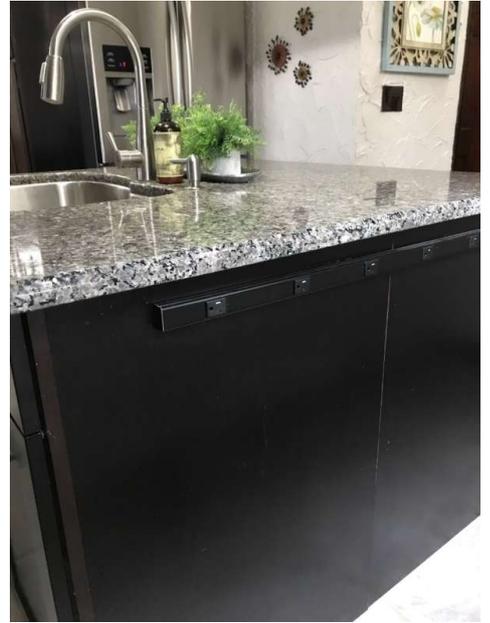
This receptacle strip is within 3 feet of the sink on the island and should be GFCI protected .

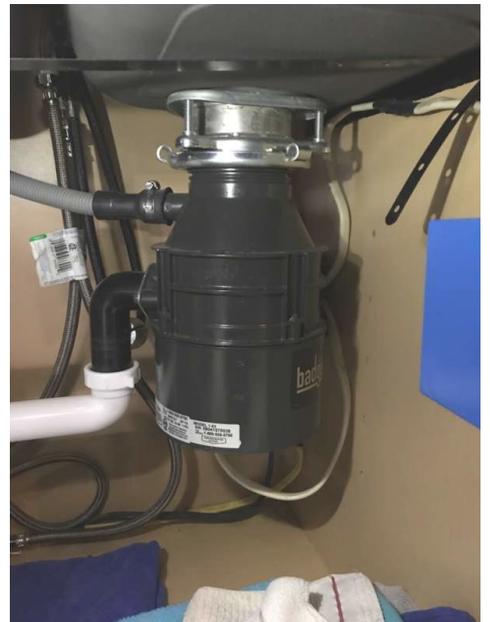
Romex wiring that is connected to the garbage disposal directly should be protected by being placed in conduit. Recommend this be done.

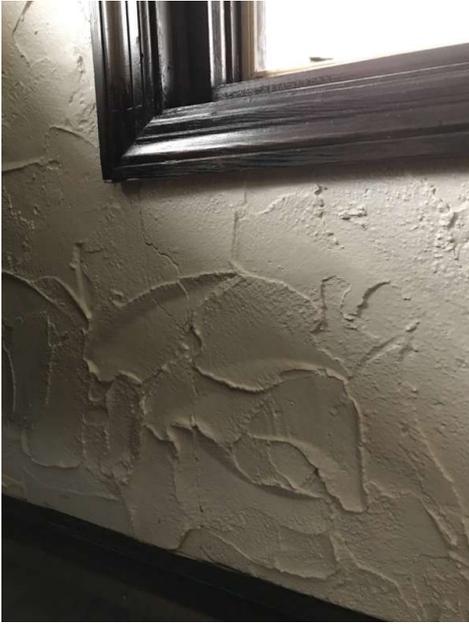
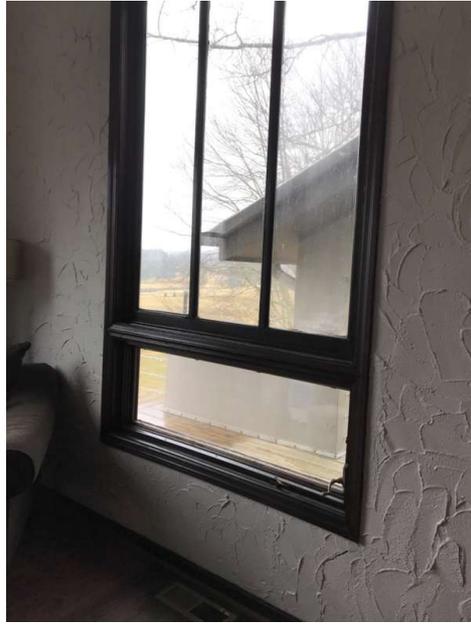
There are minor cracks in the walls /ceiling. Cracks at the corners of doors and windows are not uncommon. They may be due to long-term settlement or from the shifting / shrinking of a door or window header. Joint cracks can be the result of expansion and contraction of framing or structural stress.

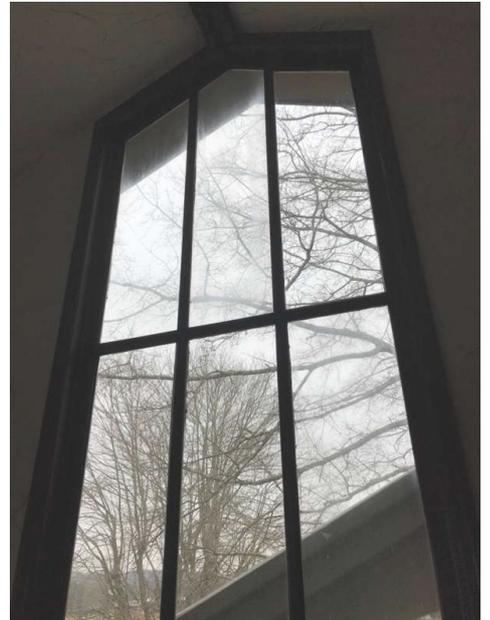
Observed condensation / condensation stains between some window panes, which normally indicates a failed seal. This does not normally reduce the window's efficiency but may negatively impact the windows appearance and the visibility through the glazing.

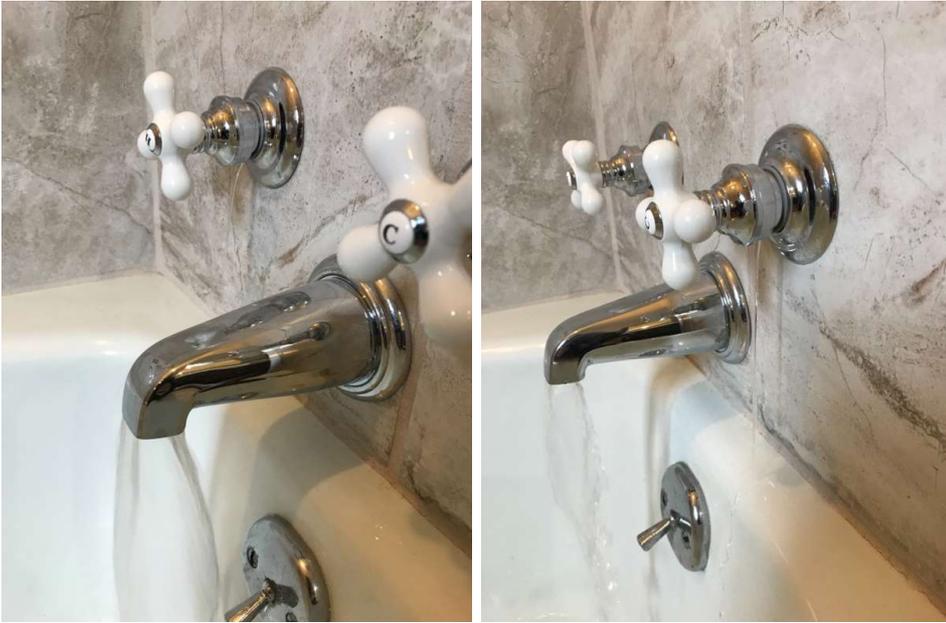
There is water leaking from both the hot and cold faucets. Replacement or repairs are recommended.

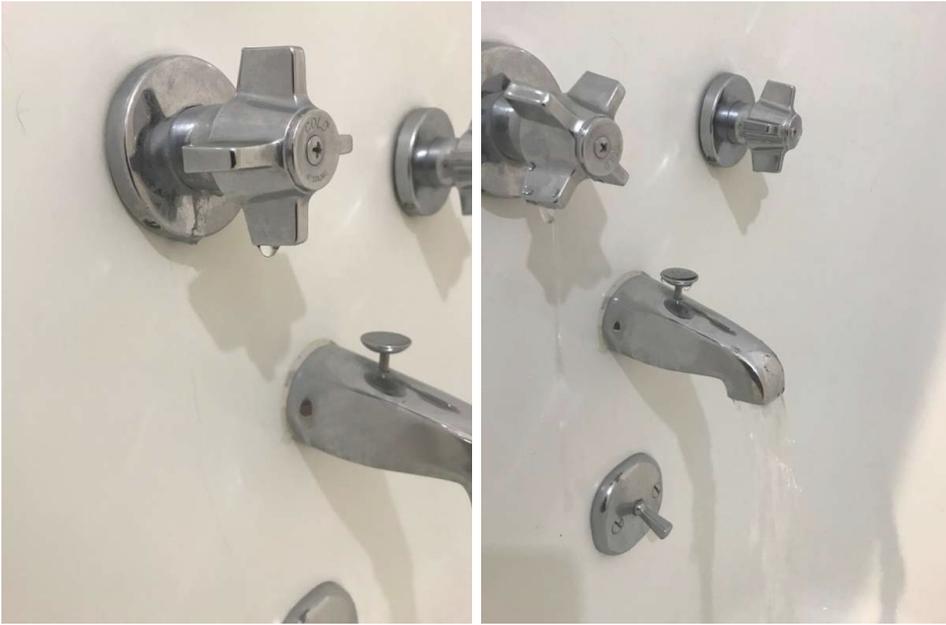
There is water leaking from the shower head assembly / the water faucets. Replacement or repairs are recommended.

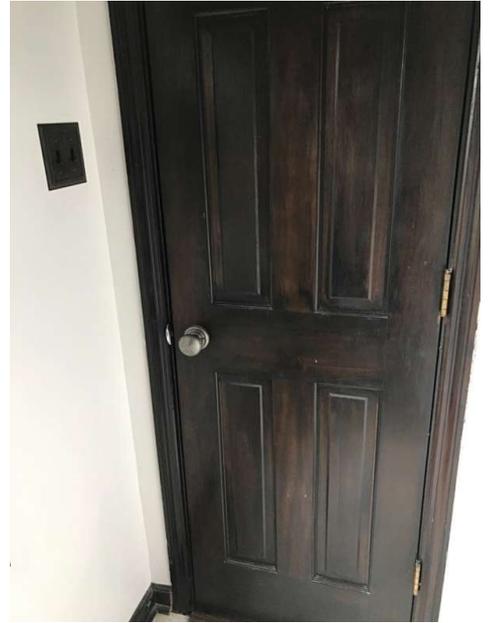
The bathroom door doesn't latch properly. Recommend repair of the latch and / or strike plate.
