SUMMARY

1234 Main St.Saco Maine 04072

11/18/2017 9:00AM

Matthew Blain
InterNACHI ID# NACHI17050108
Blue Lobster Home Inspection INC
207-391-4244
bluelobsterhomeinspection@gmail.com

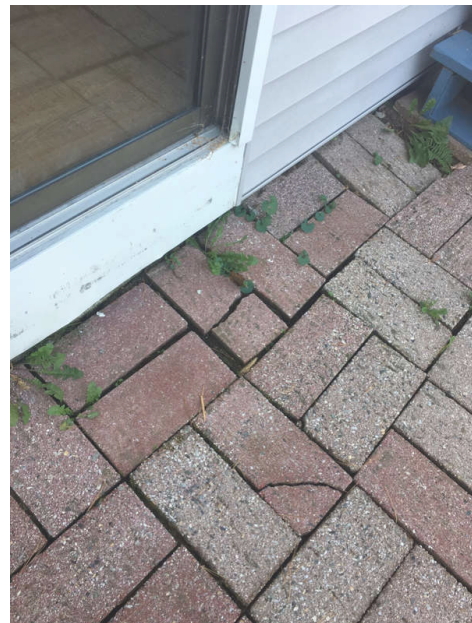
REPAIR - REPLACE

Sidewalks and/or patios have significant cracks and/or deterioration in one or more areas. A qualified contractor should evaluate and repair or replace sidewalk and/or patio sections as necessary.

Recommendation
Contact a qualified concrete contractor.

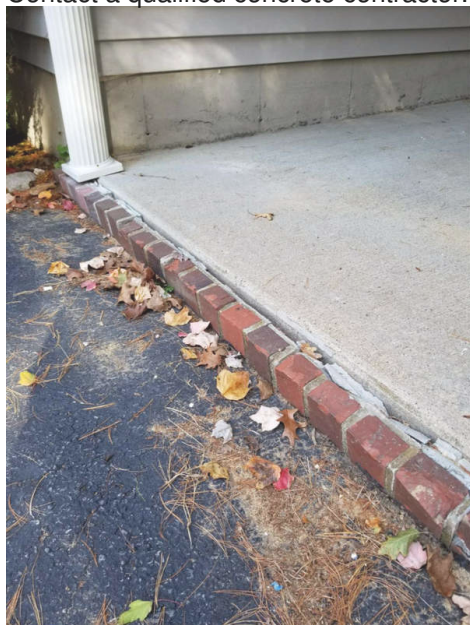
2.4.2 Walkways, Sidewalks, and Patios

TRIP HAZARD

One or more trip hazards were found in sidewalk and/or patio sections due to cracks, settlement and/or heaving. A qualified contractor should evaluate and repair or replace sidewalk and/or patio sections as necessary to eliminate trip hazards.

Recommendation
Contact a qualified concrete contractor.

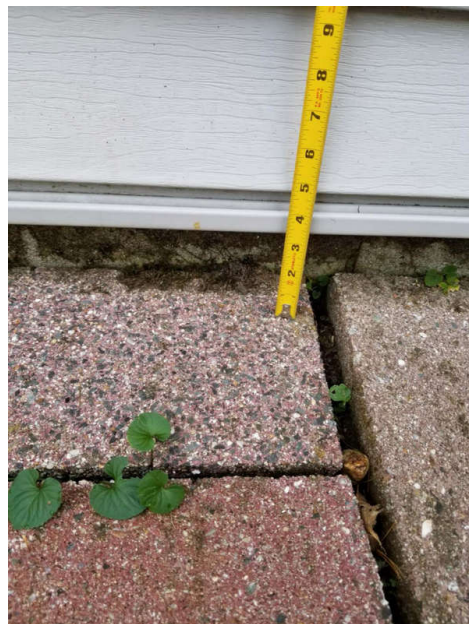
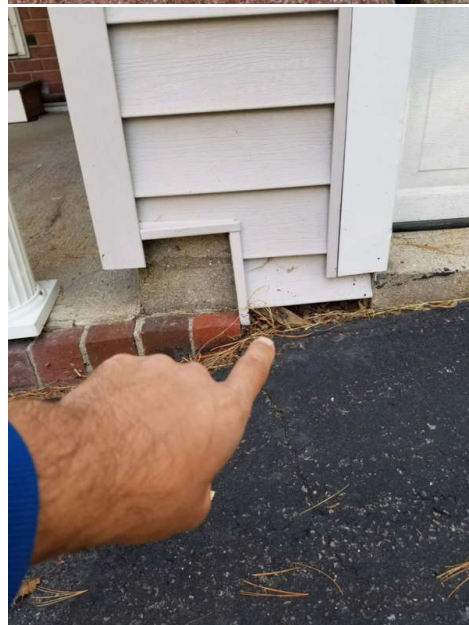
2.5.1 Soil Contact

SOIL WITHIN 6" OF SIDING/TRIM, ROT

Soil is in contact with or less than six inches from siding and/or trim. This is a conducive condition for wood destroying insects and organisms. Wood siding and/or trim is rotten in some areas as a result. A qualified contractor should evaluate and repair as necessary, replacing all rotten wood. Also, the soil should be graded and/or removed as necessary so there

are at least six inches of space between the siding and trim and the soil below.

Recommendation
Contact a qualified professional.

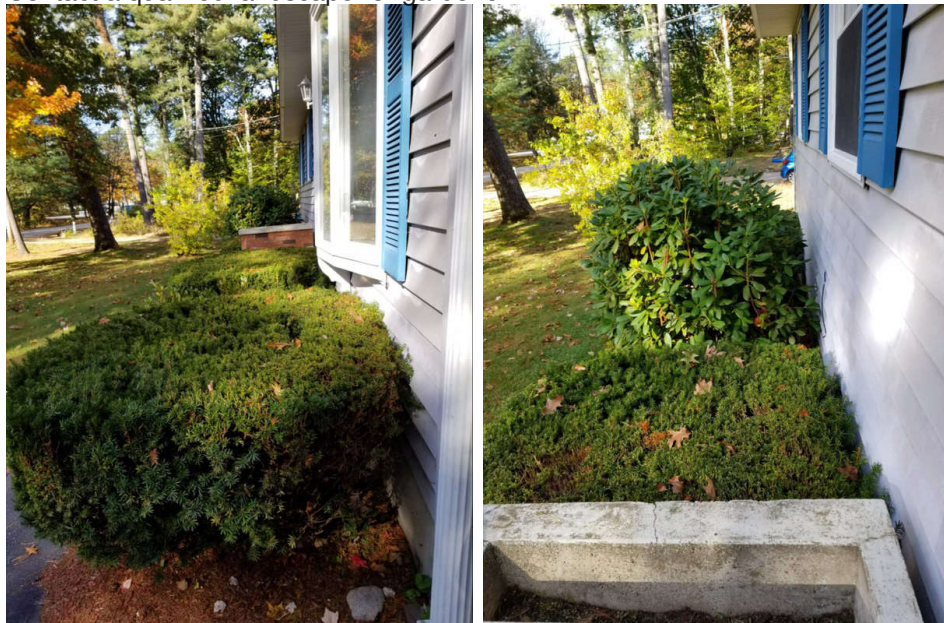
Vegetation such as trees, shrubs and/or vines are in contact with or less than one foot from the structure's exterior. Vegetation can serve as a conduit for wood destroying insects and may retain moisture against the exterior after it rains. Vegetation should be pruned and/or removed as necessary to maintain a one foot clearance between it and the structure's exterior.

Contact a qualified landscaper or gardener.

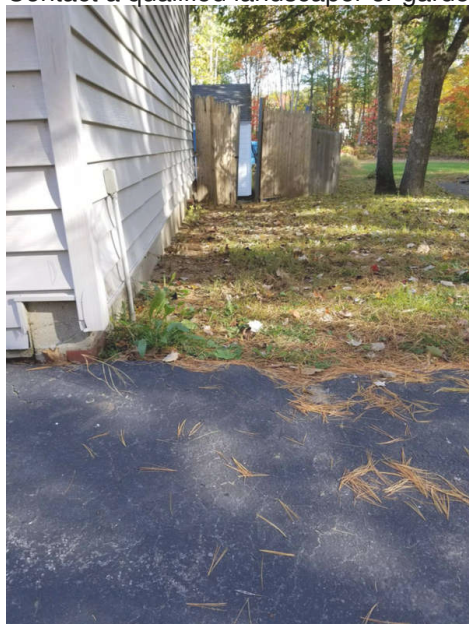
2.7.1 Drainage

NEGATIVE PERIMETER SLOPE - SOIL

The perimeter grading slopes towards the structure in one or more areas. This can result in water accumulating around the structure's foundation, or in basements and crawl spaces if they exist. Accumulated water is a conducive condition to wood destroying insects and organisms. Wet soil may also cause the foundation to settle and possibly fail over time. Recommend grading soil so it slopes down and away from the structure with a slope of at least 5% (10% or better is optimal) for at least 6 feet.

Contact a qualified landscaper or gardener.

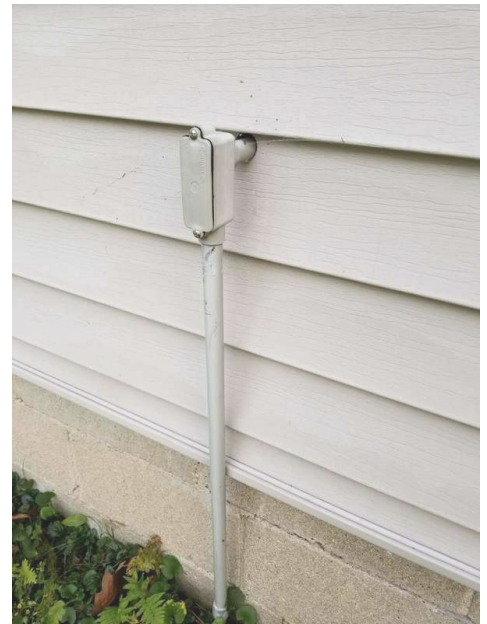
Gaps exist at one or more openings around the exterior, such as those where outside faucets, refrigerant lines, and/or gas supply pipes penetrate the exterior. Gaps should be sealed as necessary to prevent moisture intrusion and entry by vermin.

Contact a qualified handyman.

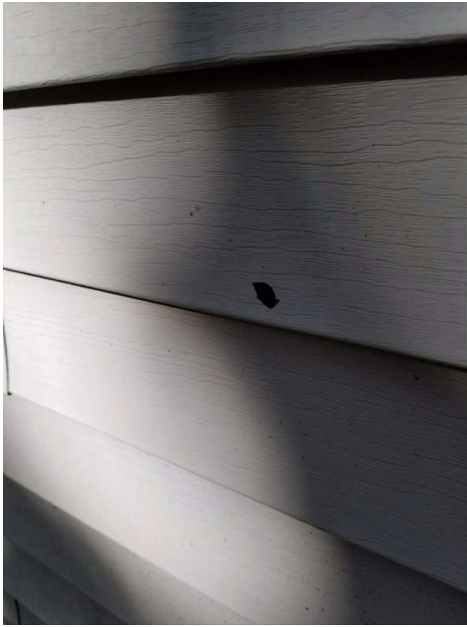
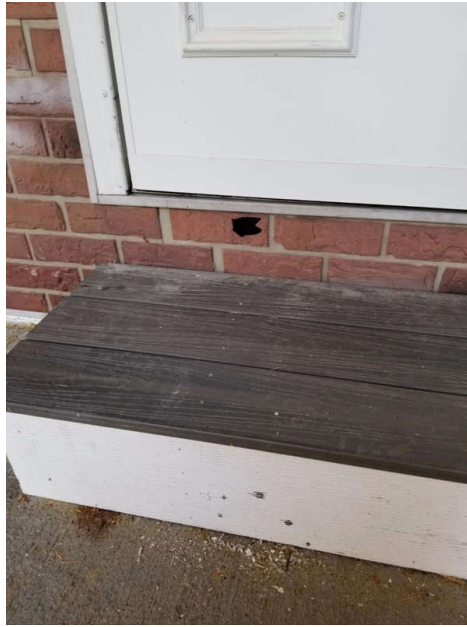
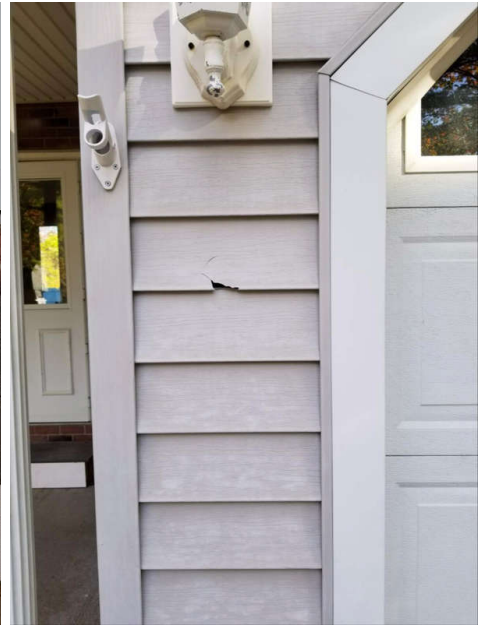
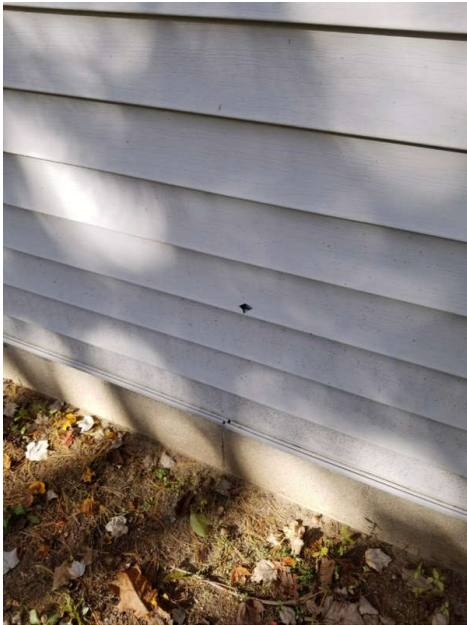
2.10.2 Siding

SIDING BROKEN

There are several places that the siding is broken leading to areas that water can enter the building envelope and cause damage. Recommend replacing the broken sections of siding.

Contact a qualified siding specialist.

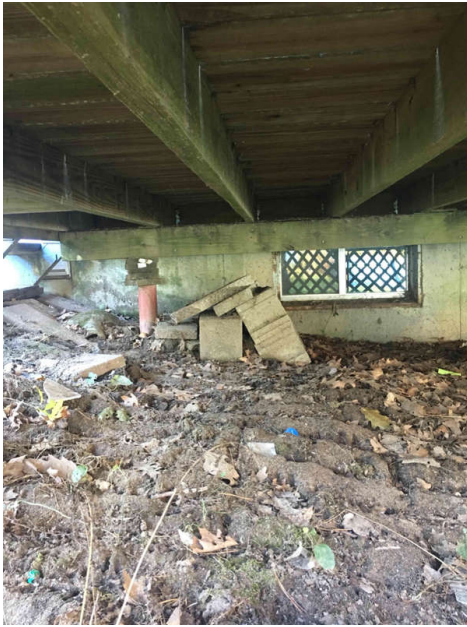
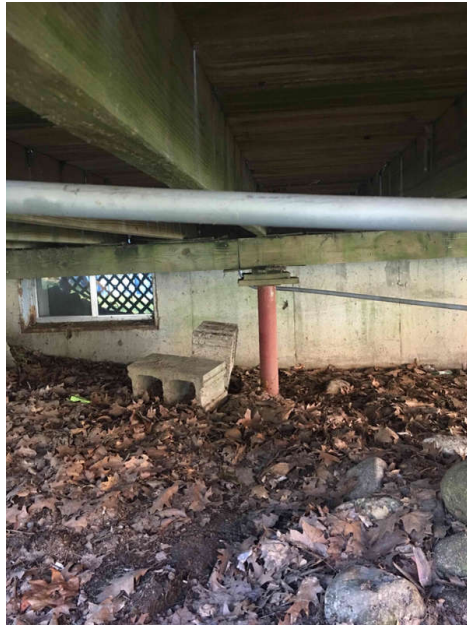
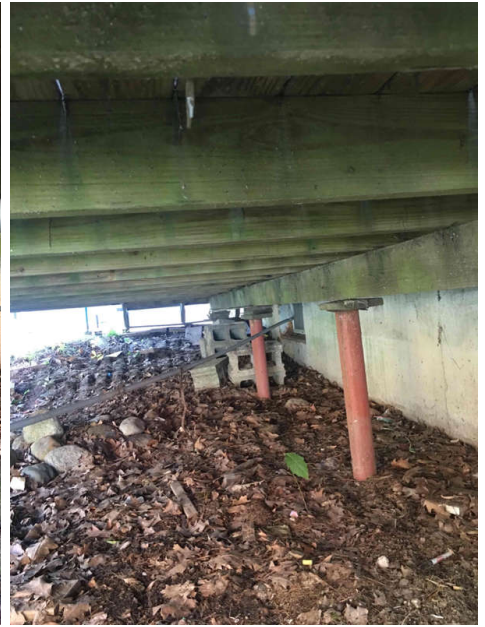
2.13.1 Deck/Patio Cover

DECK/PATIO COVER WRONG

One or more deck, patio and/or porch covers were non-standard. Recommend that a qualified person repair or replace as necessary, and per standard building practices.

Contact a qualified deck contractor.

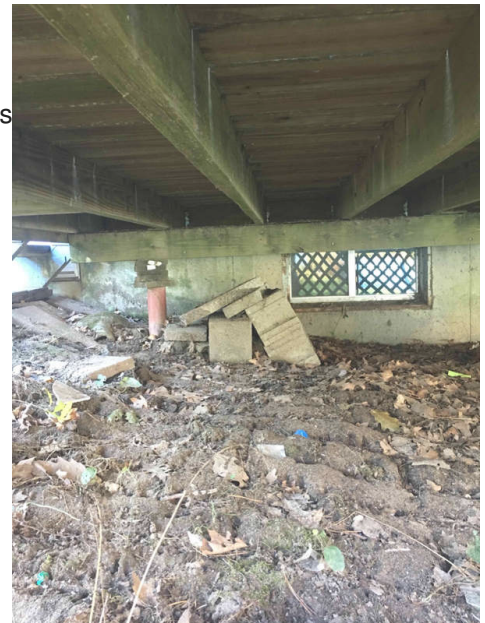
2.13.2 Deck/Patio Cover

SUBSTRUCTURE - NEEDS BRACING

The deck is unstable in one or more areas due to lack of diagonal bracing. This is a safety hazard since severe movement may cause the deck to collapse. A qualified contractor should evaluate and make repairs as necessary.

Contact a qualified deck contractor.

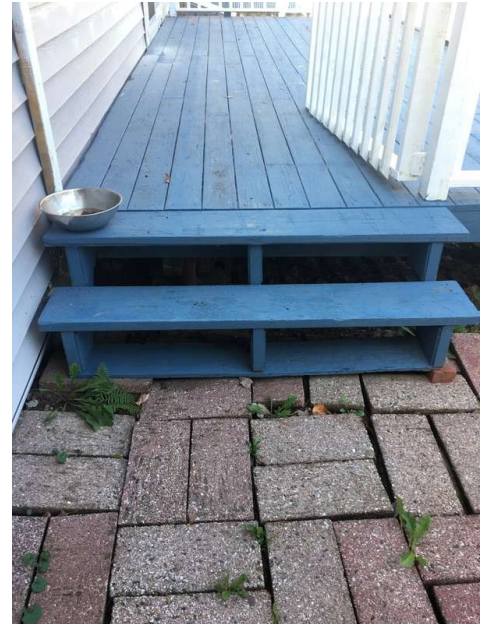
2.14.1 Stairs

NON-STANDARD - WARNING

Stairs are unsafe due to a non-standard configuration, such as too-high riser heights and/or too-narrow tread depths. Standard building practices call for riser heights not to exceed eight inches and tread depths to be at least nine inches but preferably 11 inches. Riser heights should not vary more than 3/8 inch on a flight of stairs. At a minimum, the client(s) should be aware of this hazard, especially when guests who are not familiar with the stairs are present. Ideally a qualified contractor should repair or replace stairs so they conform to standard building practices.

Contact a qualified deck contractor.

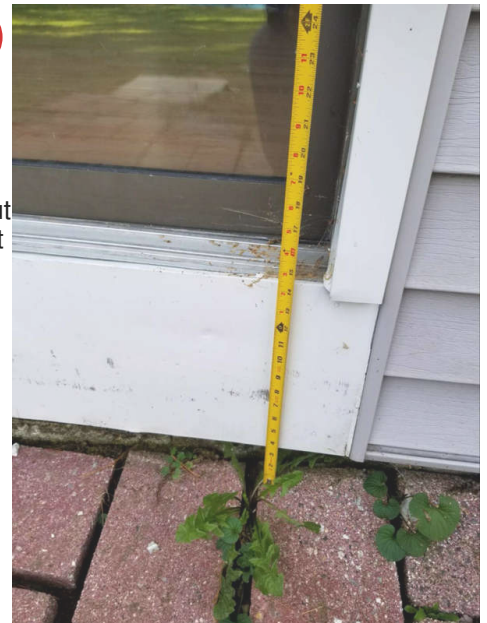
2.14.2 Stairs

NON-STANDARD - REPAIR

Stairs are unsafe due to a non-standard configuration, such as too-high riser heights and/or too-narrow tread depths. Standard building practices call for riser heights not to exceed eight inches and tread depths to be at least nine inches but preferably 11 inches. Riser heights should not vary more than 3/8 inch on a flight of stairs. A qualified contractor should repair or replace stairs so they conform to standard building practices.

Contact a qualified deck contractor.

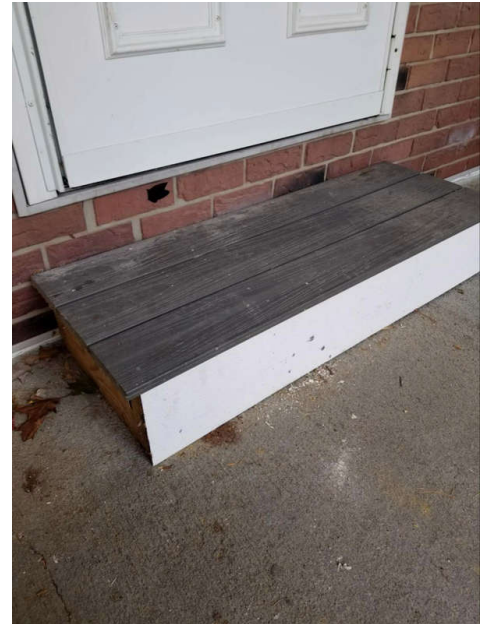
2.14.3 Stairs

NON-UNIFORM RISERS - WARNING

Trip hazard(s) exist at stairs due to non-uniform riser heights. Standard building practices call for riser heights not to vary more than 3/8 inch on a flight of stairs. At a minimum, the client(s) should be aware of this hazard, especially when guests who are not familiar with the stairs are present. Ideally a qualified contractor should evaluate and repair or replace stairs so all riser heights are within 3/8 inch of each other.

Contact a qualified deck contractor.

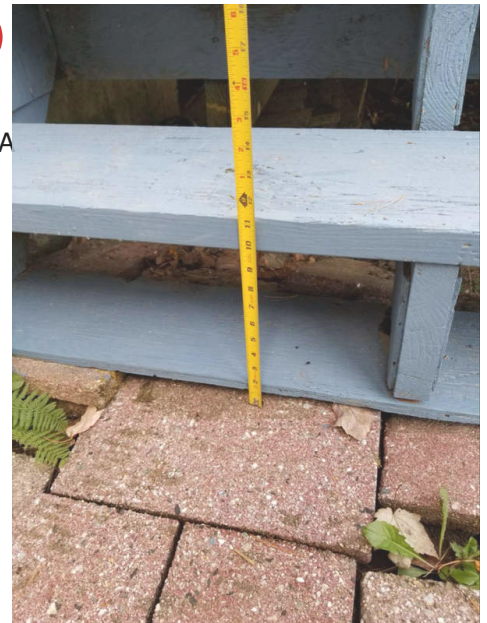
2.14.4 Stairs

NON-UNIFORM RISERS - REPAIR

Trip hazard(s) exist at stairs due to non-uniform riser heights. Standard building practices call for riser heights not to vary more than 3/8 inch on a flight of stairs. A qualified contractor should repair or replace stairs so all riser heights are within 3/8 inch of each other.

Contact a qualified deck contractor.

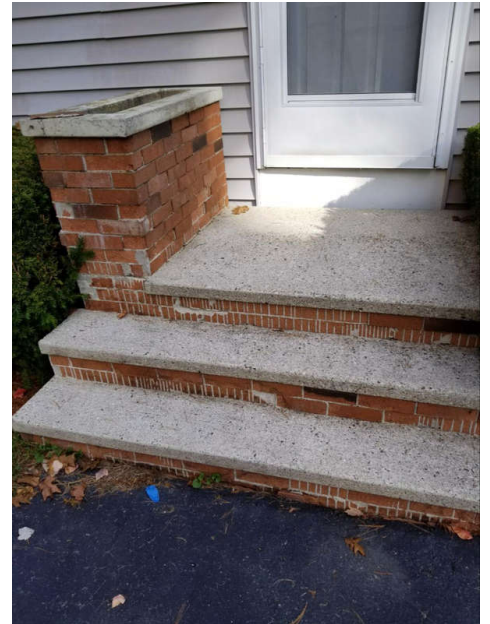
2.15.1 Handrails

MISSING

One or more flights of stairs with more than two risers have no handrail installed. This is a safety hazard. A qualified contractor should install graspable handrails that your hand can completely encircle at stairs where missing, and as per standard building practices.

Contact a qualified professional.

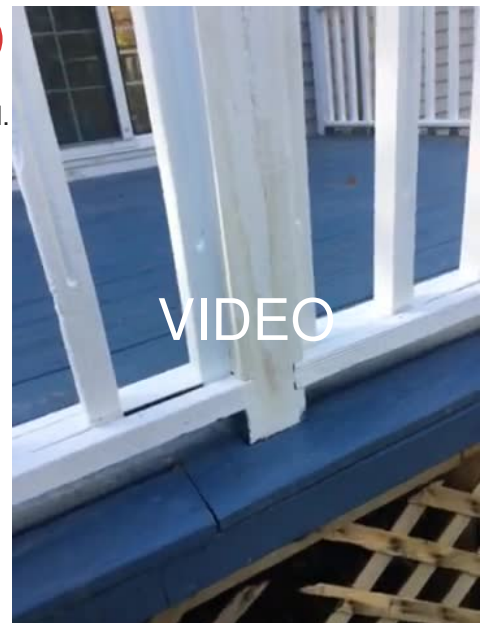
2.16.1 Guardrails

WOBBLY

Guardrails are loose and/or wobbly in one or more areas. This is a safety hazard. A qualified contractor should evaluate and make repairs as necessary, such as installing new fasteners or hardware, installing additional fasteners and/or installing additional railing components as necessary so they are securely attached.

Contact a qualified professional.

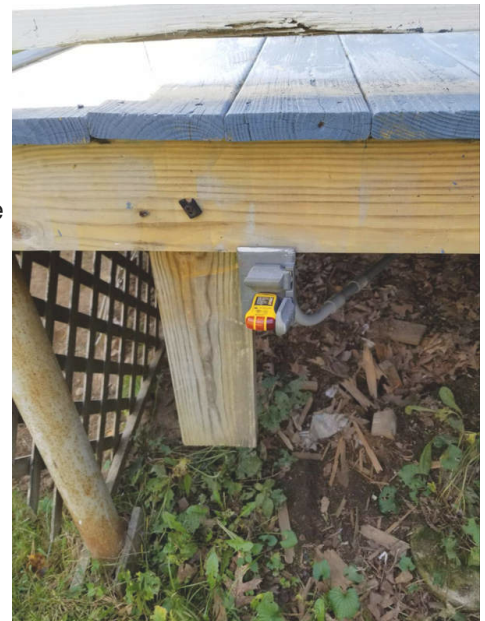
2.17.3 Electrical

RECEPTACLES - NO POWER

One or more electric receptacles appear to have no power. Recommend asking the property owner(s) about this. Switches may need to be operated to make some receptacles energized. If necessary, a qualified electrician should evaluate and make repairs as necessary.

Contact a qualified electrical contractor.

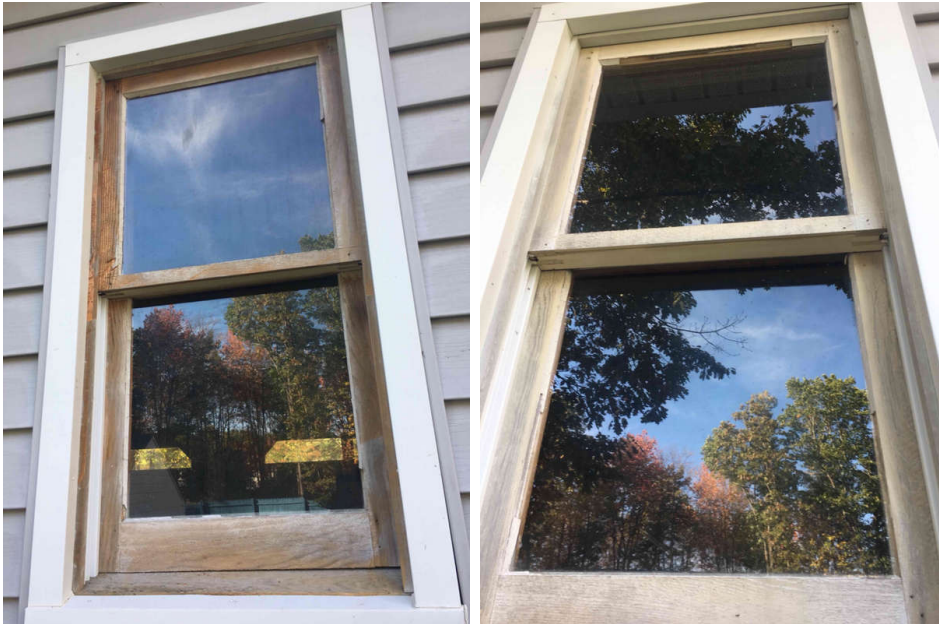
2.18.1 Paint & Caulk

WOOD WINDOW IS MISSING PAINT

One or more wood windows is missing paint. Recommend having a handyman address in order to prevent potential wood rot.

Contact a qualified handyman.

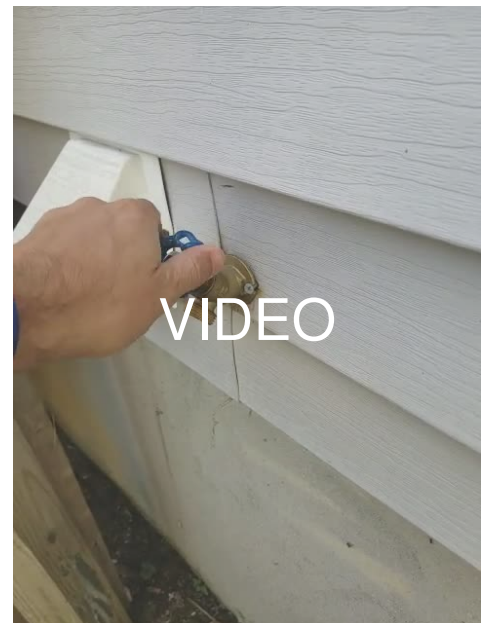
2.19.1 Hose Bibs

NO WATER

One or more outside faucets appeared to be inoperable. No water came out of the faucet(s) when turned on. This may be due to a (winterizing) shut-off valve being turned off. As per the NACHI and ASHI Standards of Practice, the inspector did not attempt to turn on or off any water supply shut-off valves. Recommend that the client(s) ask the seller about outside faucets with no water, and/or have a qualified plumber evaluate and repair faucet(s) as necessary.

Contact a qualified plumbing contractor.

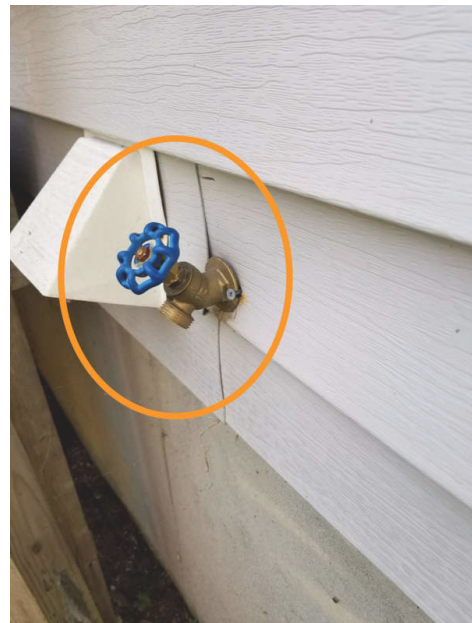
2.19.2 Hose Bibs

NO ANTI-SIPHON

One or more outside faucets are missing backflow prevention devices. These devices reduce the likelihood of polluted or contaminated water entering the potable water supply. This condition can occur when an outside faucet is left in the "on" position with a hose connected and the sprayer head turned off. When pressure in the system fluctuates, water can be drawn back into the water supply pipes from the house. If a chemical sprayer is being used with the hose, those chemicals can enter the water supply pipes.

Recommend installing backflow prevention devices on all exterior hose bibs where missing. They are available at most home improvement stores and are easily installed.

Recommendation
Contact a qualified plumbing contractor.

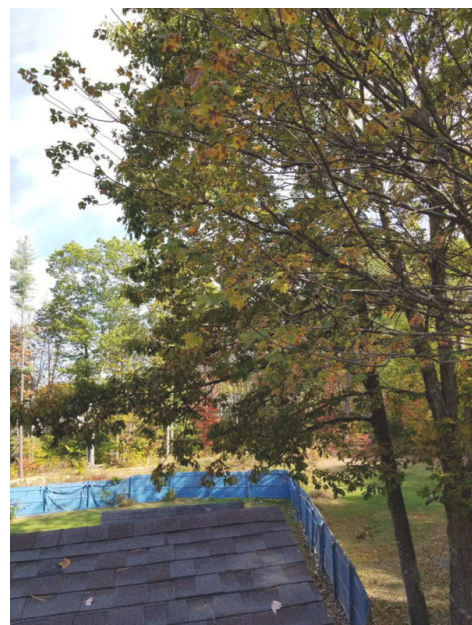
3.2.1 Vegetation and Maintenance

TREES OVERHANGING

Trees are overhanging roof and are within 10 feet of roof vertically. This is a conducive condition for wood destroying insects and organisms since organic debris such as leaves or needles are more likely to accumulate on the roof surface. Accumulated debris may cause water to enter gaps in the roof surface and leak into attic and/or interior spaces. Trees should be pruned so they are at least 10 feet above roof, or don't overhang the roof.

Recommendation
Contact a qualified tree service company.

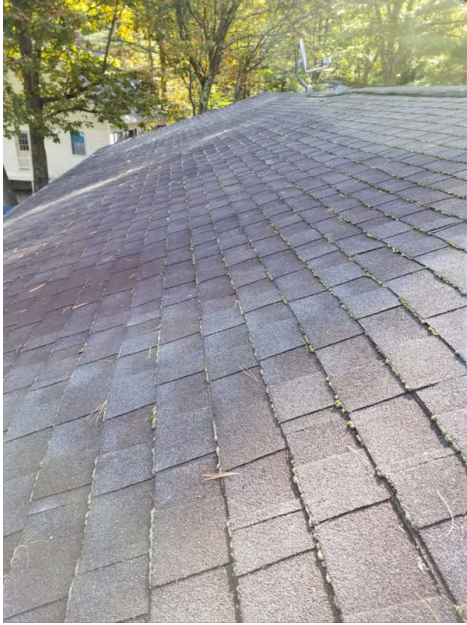
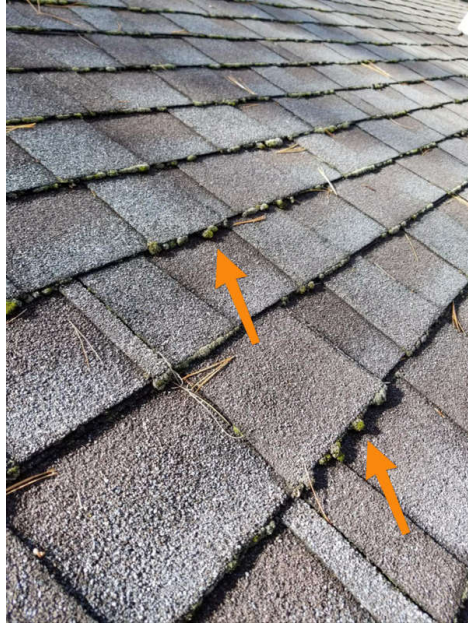
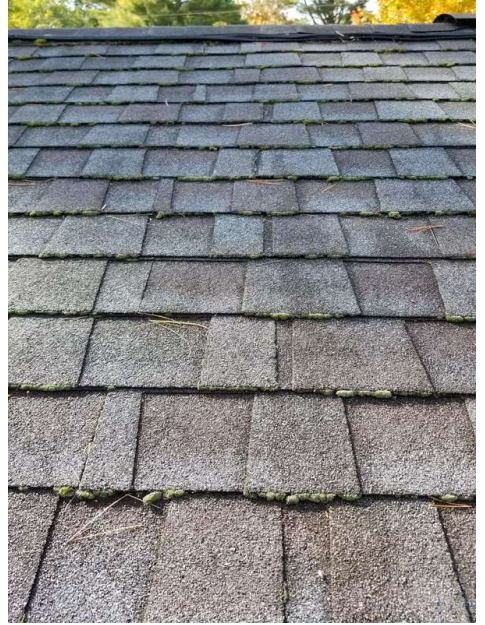
3.2.2 Vegetation and Maintenance

MOSS

Moss is growing on the roof. As a result, shingles may lift or be damaged. Leaks may result and/or the roof surface may fail prematurely. This is a conducive condition for wood destroying insects and organisms. Efforts should be taken to kill the moss during its growing season (wet months). Typically zinc-based chemicals are used for this, and must be applied periodically.

Recommendation
Contact a qualified professional.

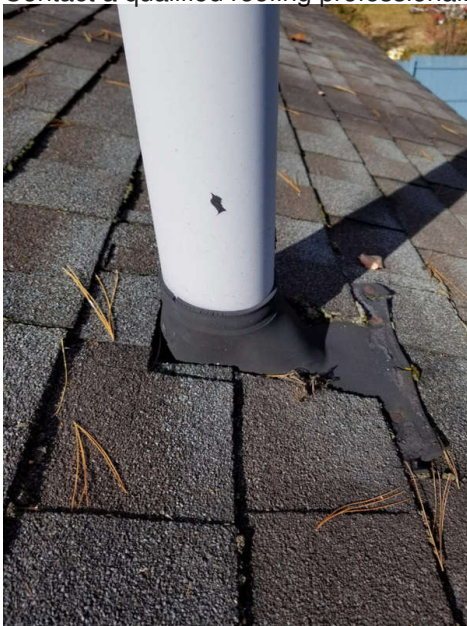
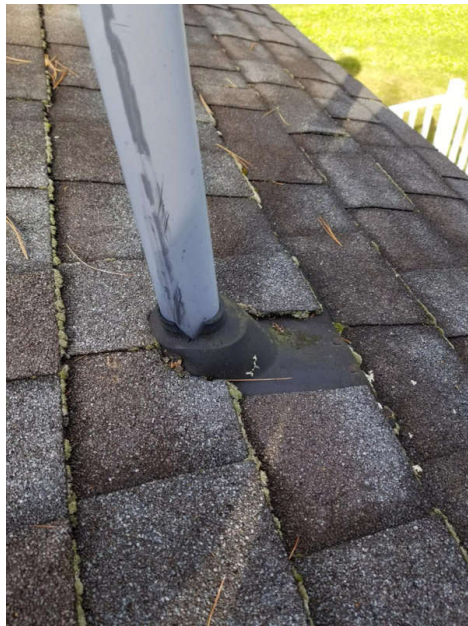
3.4.1 Flashing

DETERIORATED

One or more "rubber boot" flashings are damaged or deteriorated and may result in leaks or vermin intrusion. A qualified contractor should replace flashings where necessary.

Recommendation
Contact a qualified roofing professional.

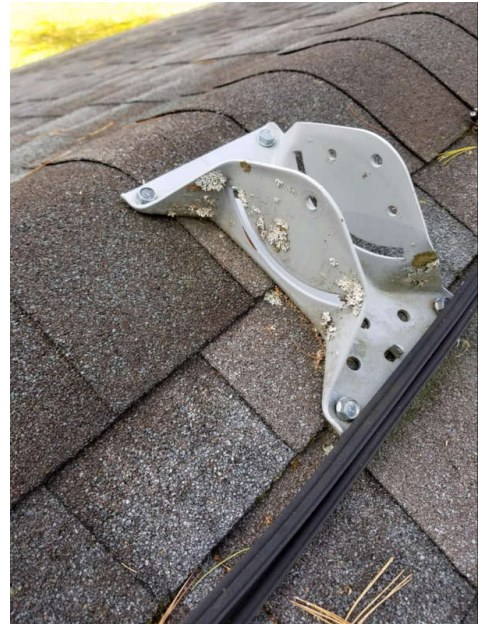
3.4.2 Flashing

NO SEALANT ON FASTENERS

One or more fasteners penetrating the roof covering had no apparent sealant at the time of the inspection. Recommend adding sealant and maintaining to avoid moisture penetration.

Recommendation
Contact a qualified handyman.

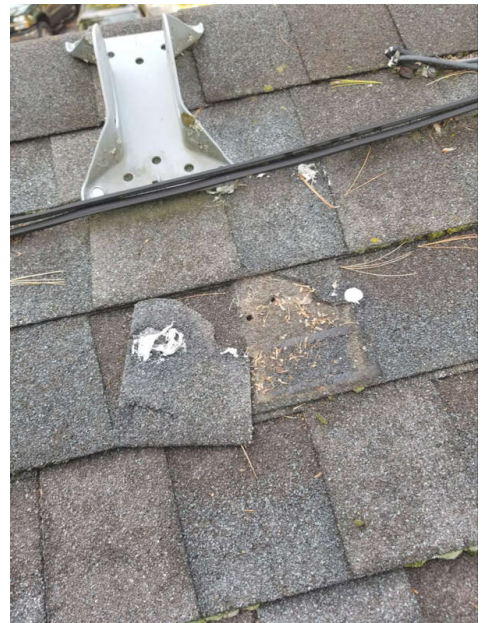
3.6.1 Composition

DETERIORATED OR MISSING

One or more composition shingles are damaged, deteriorated and/or missing, and should be replaced. Leaks may occur as a result. A qualified roofing contractor should evaluate and make repairs as necessary.

Contact a qualified roofing professional.

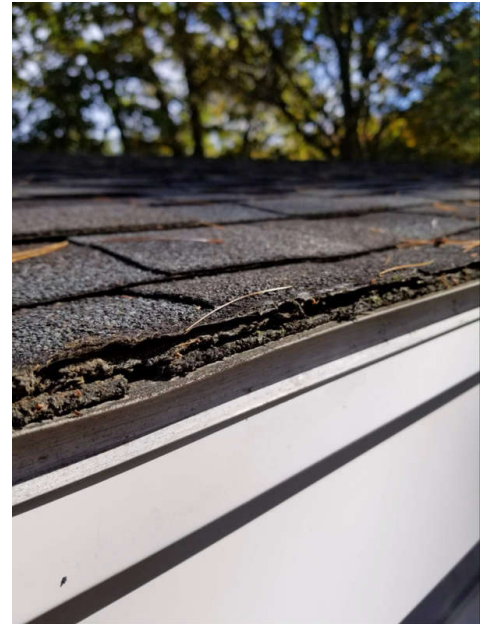
3.6.2 Composition

MULTIPLE LAYERS

Contact a qualified roofing professional.

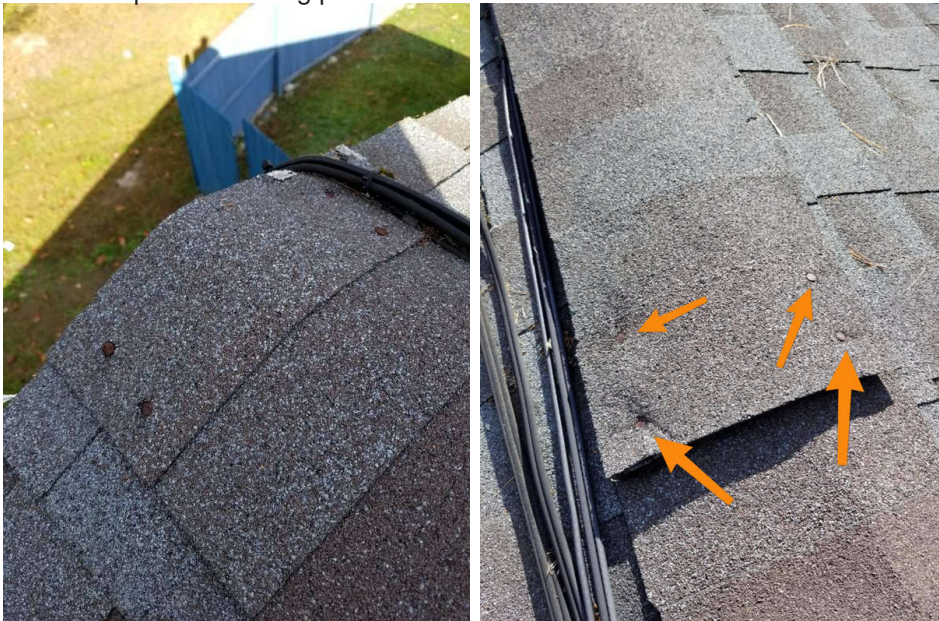
3.6.3 Composition

EXPOSED NAIL HEADS

Nail heads were exposed at one or more shingles. More than just a few exposed nail heads may indicate a substandard roof installation. Recommend applying an approved sealant over exposed nail heads now and as necessary in the future to prevent leaks.

Contact a qualified roofing professional.

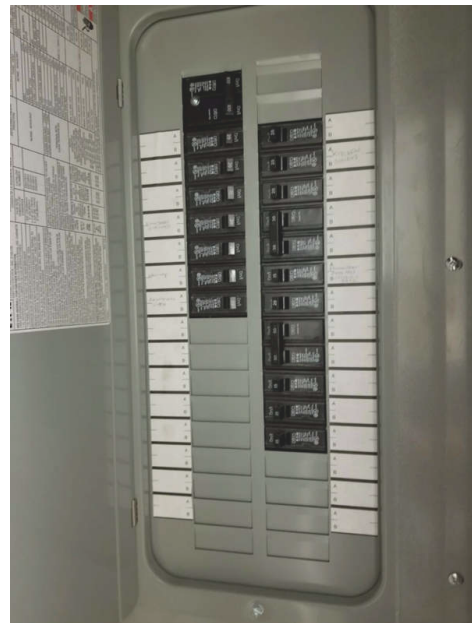
4.8.1 Service and/or Panel

MISSING OR INADEQUATE LEGEND

The legend for overcurrent protection devices (breakers or fuses) in the main service panel is missing, unreadable or incomplete. Recommend installing, updating or correcting the legend as necessary so it's accurate. Evaluation by a qualified electrician may be necessary.

Contact a qualified electrical contractor.

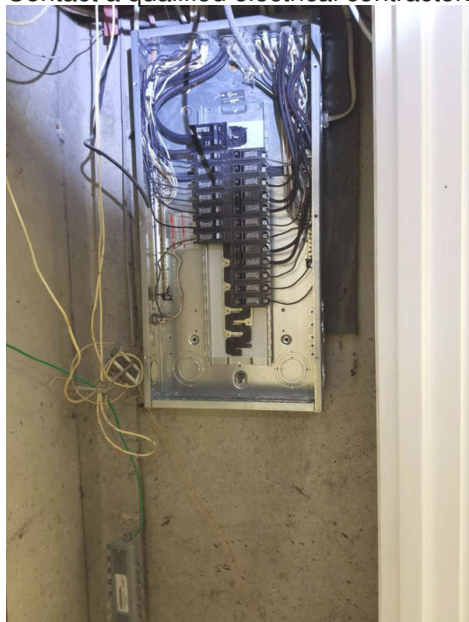
4.8.2 Service and/or Panel

INADEQUATE WORKING SPACE

Inadequate working space exists for the main service panel. Standard building practices require the following clearances:

Contact a qualified electrical contractor.

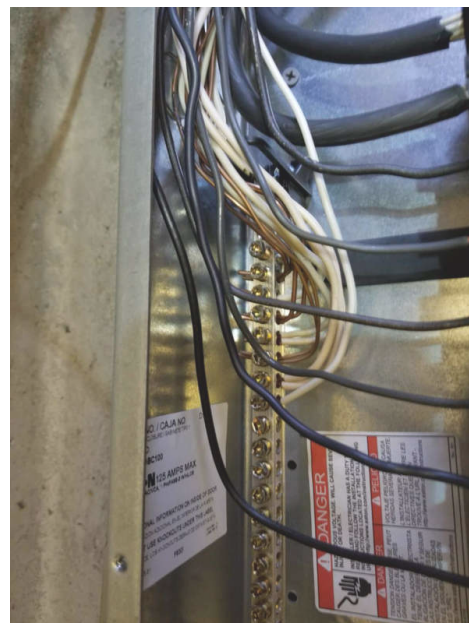
4.8.3 Service and/or Panel

DOUBLED OR BUNDLED NEUTRALS

unsafe due to the need to turn off multiple circuit breakers to work on any of the circuits using these wires. A qualified electrician should evaluate and repair as necessary.

Contact a qualified electrical contractor.

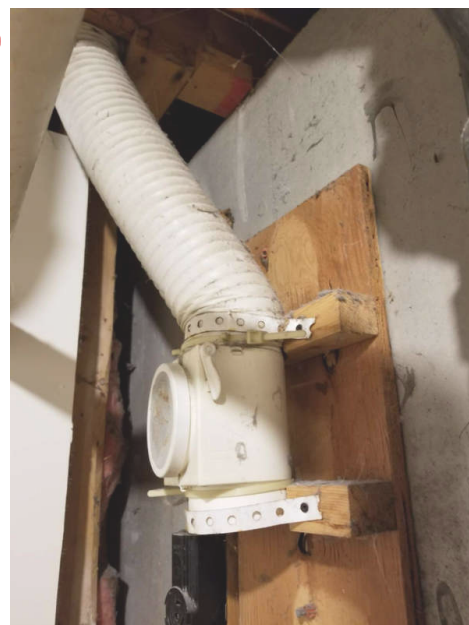
5.5.1 Laundry

DRYER DUCT - PLASTIC OR FOIL

The clothes dryer is equipped with a vinyl or foil, accordion-type, flexible exhaust duct. The U.S. Consumer Product Safety Commission considers these types of ducts to be unsafe, and a fire hazard. These types of ducts can trap lint and are susceptible to kinks or crushing, which can greatly reduce the air flow. This duct should be replaced with a rigid or corrugated semi-rigid metal duct, and by a qualified contractor if necessary. Most clothes dryer manufacturers specify the use of a rigid or corrugated semi-rigid metal duct.

Contact a qualified appliance repair professional.

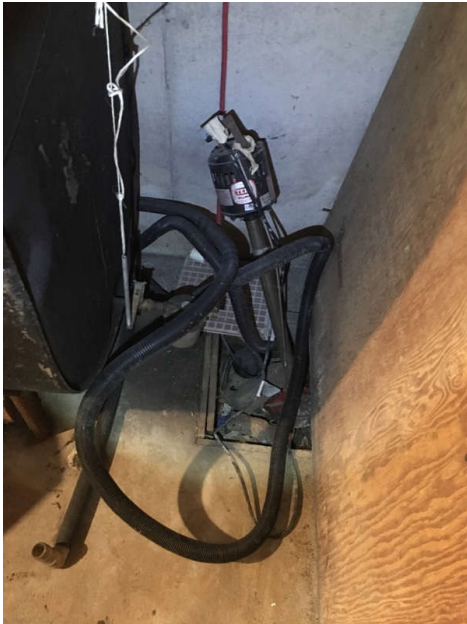
5.7.1 Sump Pump

INOPERABLE

Contact a qualified plumbing contractor.

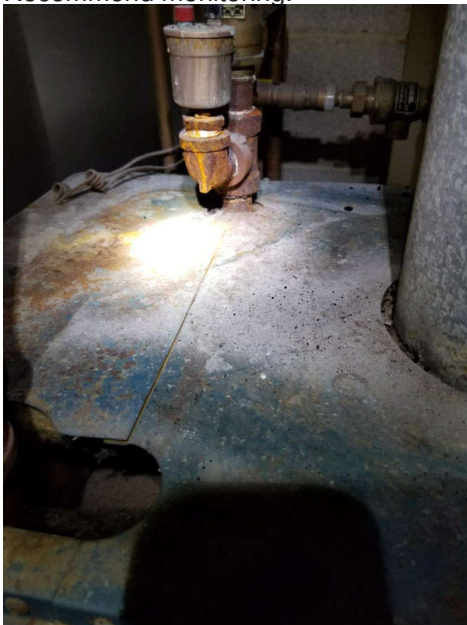
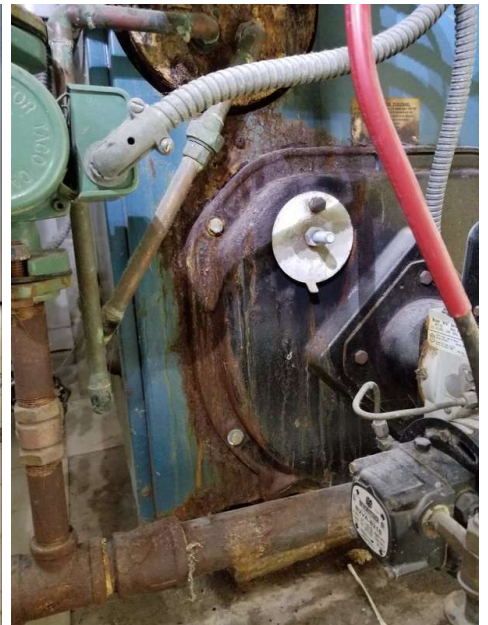
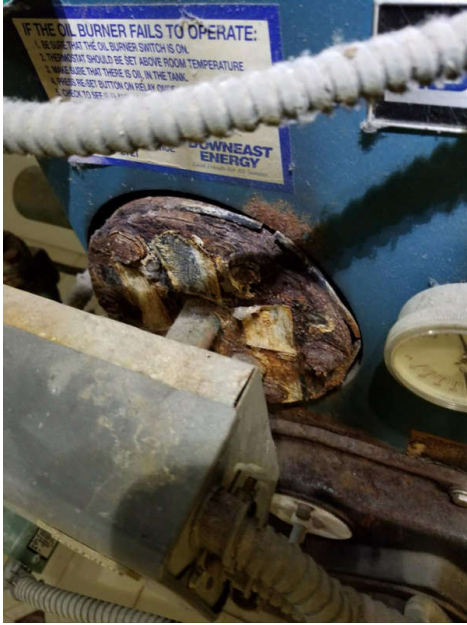
6.2.1 Age

BOILER - 15 TO 20 YEARS OR OLDER

Recommend monitoring.

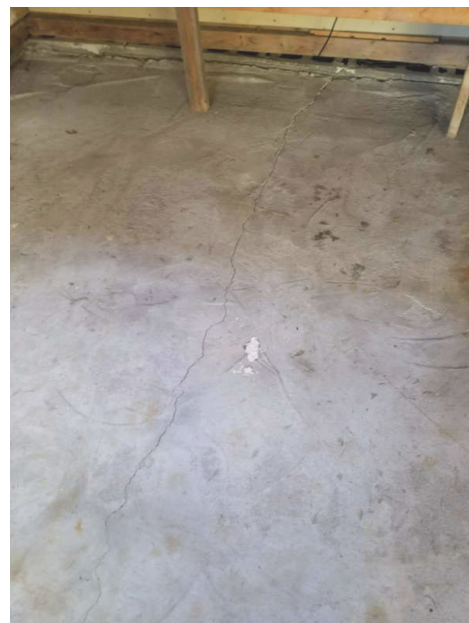
GARAGE FLOOR CRACKS - MINOR

Contact a qualified concrete contractor.

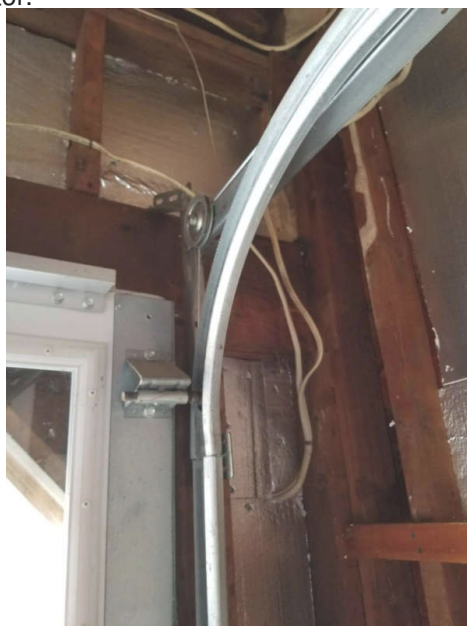
7.4.1 Vehicle Door

DOOR CABLES OFF TRACK

Contact a qualified garage door contractor.

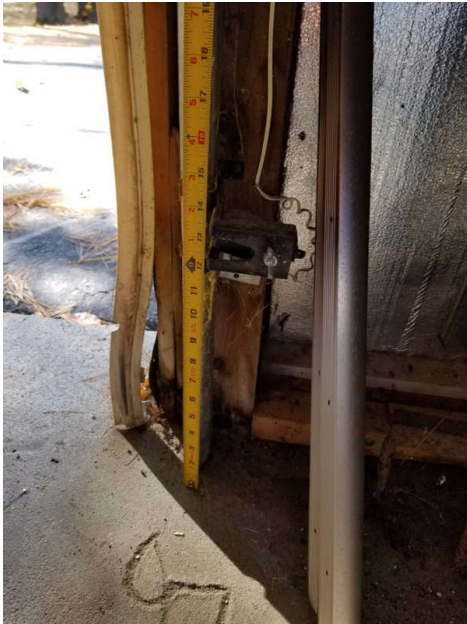
7.5.1 Vehicle Door Opener

INFRARED PHOTO EYES - TOO HIGH

Contact a qualified garage door contractor.

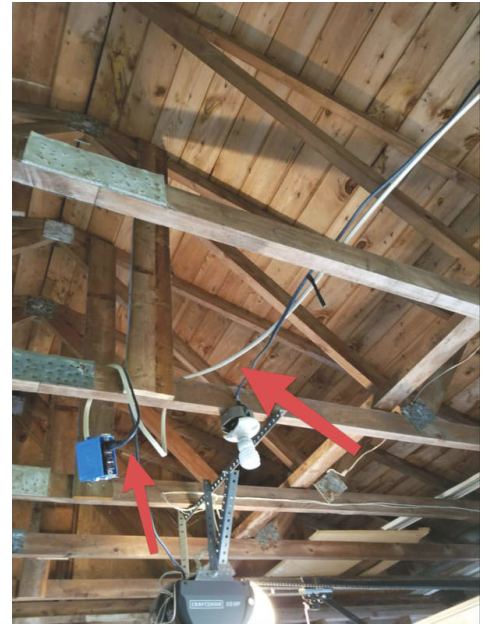
7.11.1 Electrical

COVER PLATES MISSING

Contact a qualified electrical contractor.

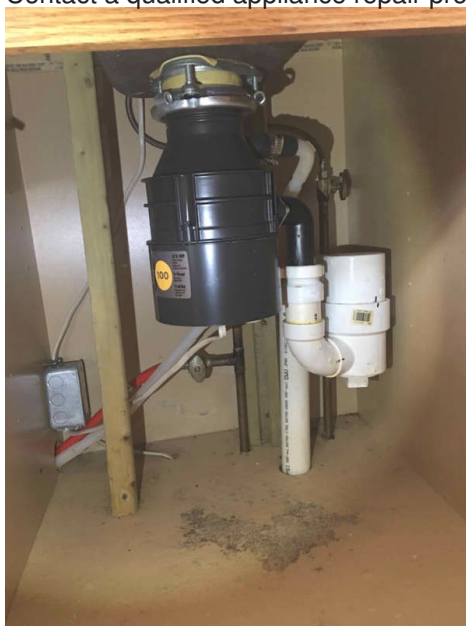
8.2.1 Dishwasher

NO HIGH LOOP OR AIR GAP

Contact a qualified appliance repair professional.

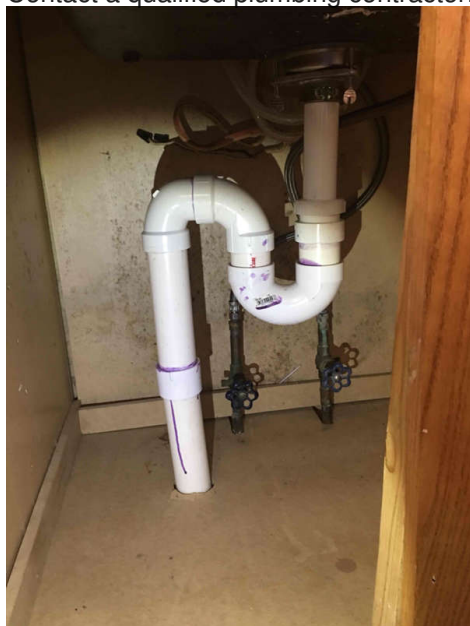
Sink Drains

S-TRAP

Contact a qualified plumbing contractor.

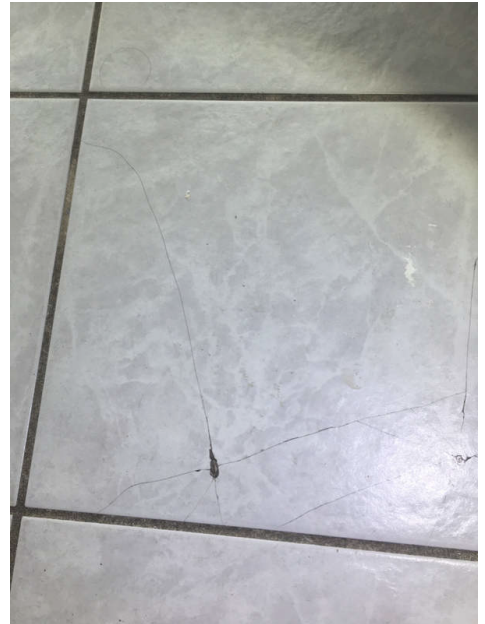
8.19.1 Floors

TILE, STONE AND GROUT - DETERIORATED

Contact a qualified professional.

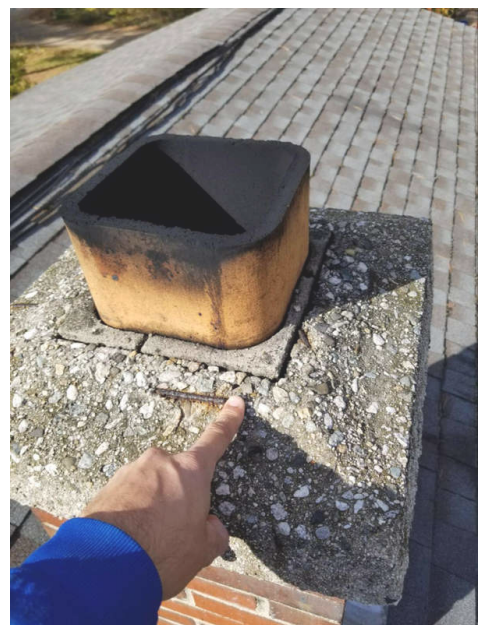
9.2.1 Chimney

MISSING SCREEN & RAINPROOF COVER

Contact a qualified fireplace contractor.

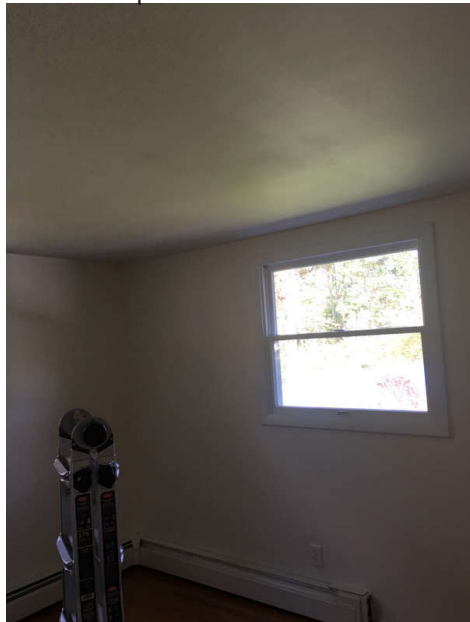
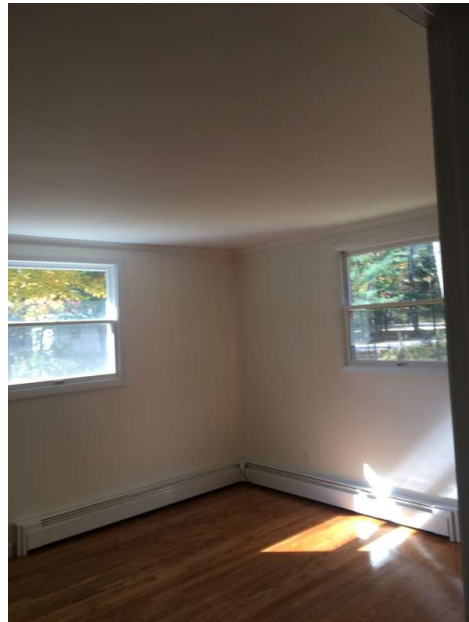
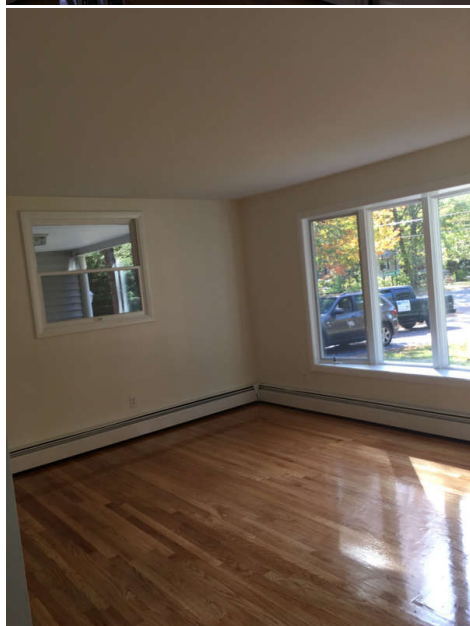
10.2.1 Light Fixtures

NO LIGHT SOURCE OR SWITCHED OUTLETS IN BEDROOMS

Contact a qualified electrical contractor.

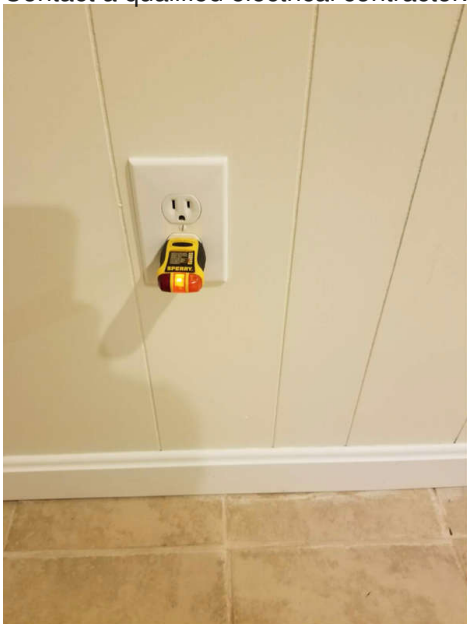
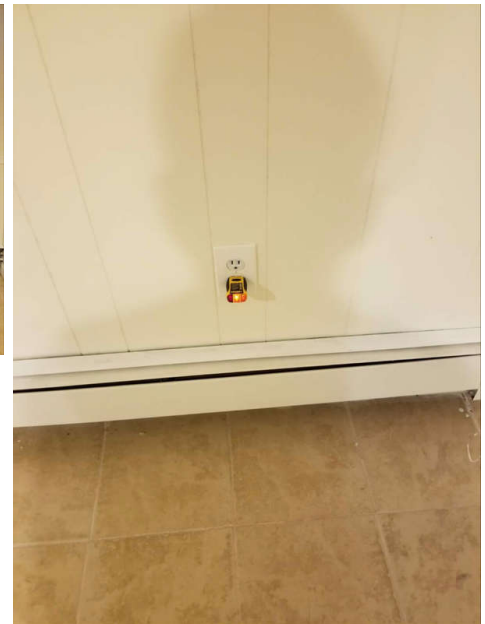
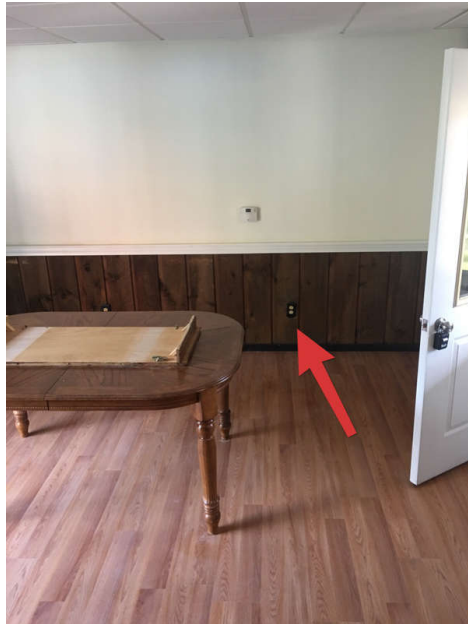
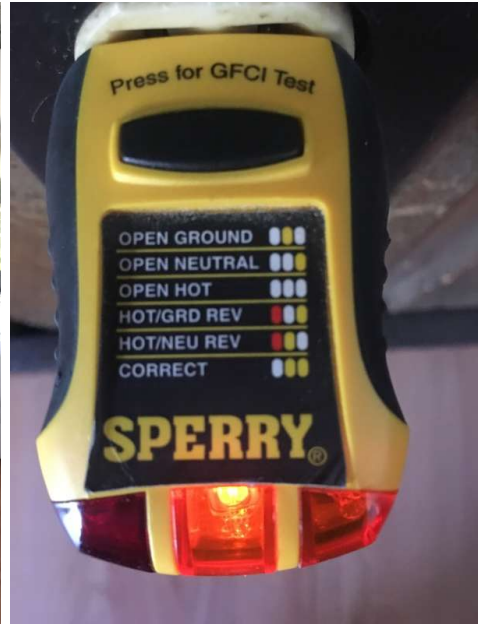
10.3.1 Receptacles

RECEPTACLES - HOT NEUTRAL REVERSE

Contact a qualified electrical contractor.

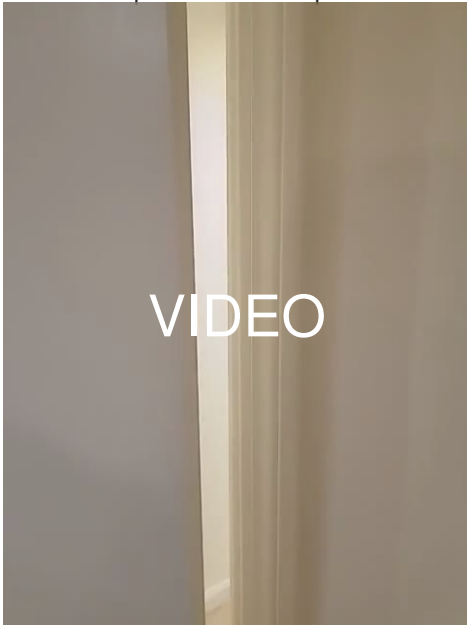
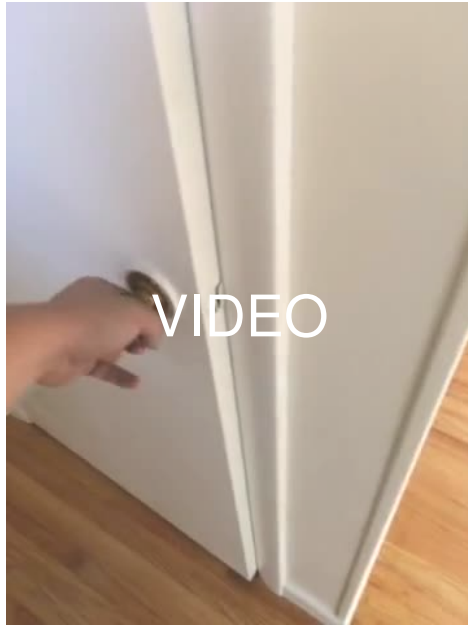
10.14.1 Doors (Representative Number)
BINDS IN JAM

One or more doors bind in their jamb and cannot be closed and latched, or are difficult to open and close. A qualified contractor should evaluate and repair as necessary. For example, adjusting jambs or trimming doors.

Recommendation
Contact a qualified door repair/installation contractor.

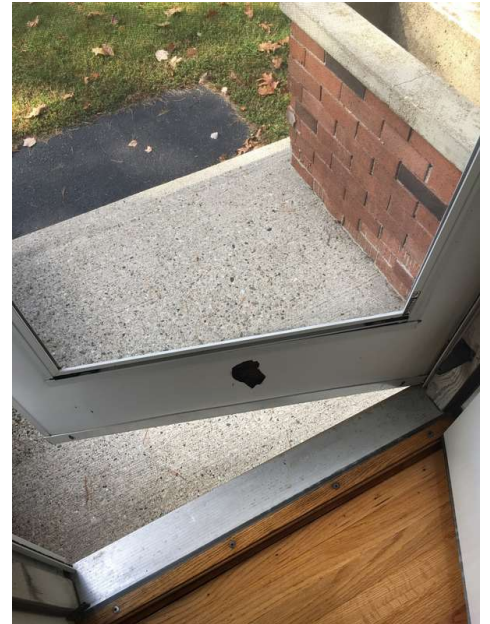
10.14.2 Doors (Representative Number)
DETERIORATED/MISSING

One or more interior doors are missing, damaged and/or deteriorated and should be repaired or replaced by a qualified contractor.

Recommendation
Contact a qualified door repair/installation contractor.
