SUMMARY

1234 Main St.Saco Maine 04072

11/18/2017 9:00AM

Matthew Blain
InterNACHI ID# NACHI17050108
Blue Lobster Home Inspection INC
207-391-4244
bluelobsterhomeinspection@gmail.com

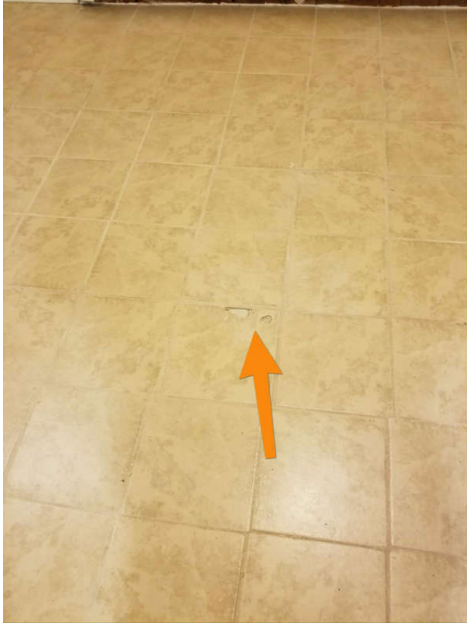
Tile, stone and/or grout flooring is damaged and/or deteriorated in one or more areas. A qualified contractor should evaluate and make repairs as necessary. For example, replacing broken tiles and deteriorated grout, and resealing grout.

Recommendation
Contact a qualified professional.

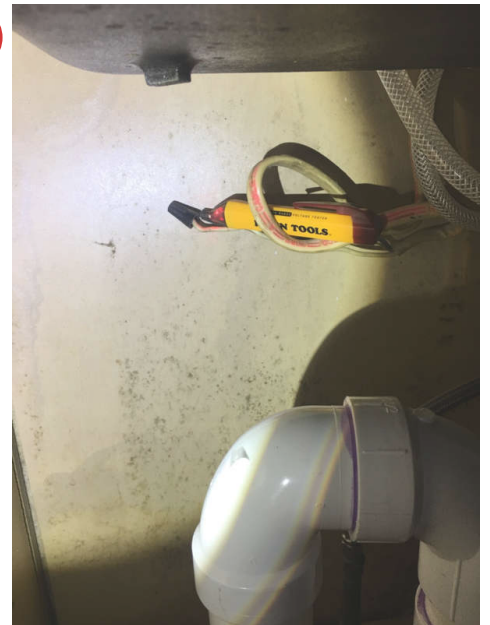
10.23.1 Electrical
NO JUNCTION BOX
KITCHEN

Wires were found underneath the kitchen sink that we're live and exposed.
Recommend having an electrician move to a junction box.

Recommendation
Contact a qualified electrical contractor.

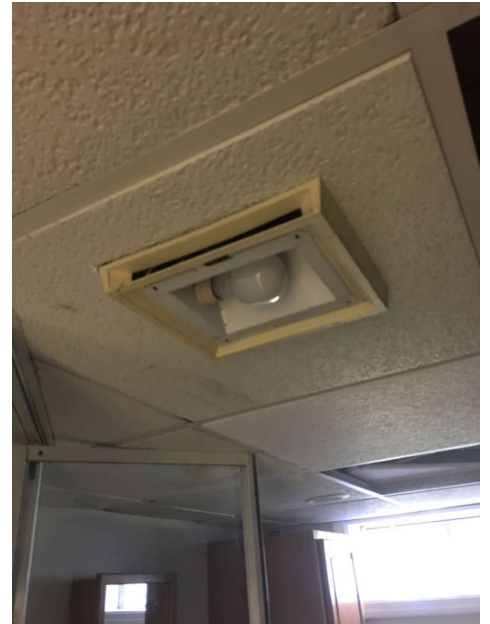
11.2.1 Exhaust Fans
NOT VENTED TO EXTERIOR
Recommendation
Contact a qualified general contractor.

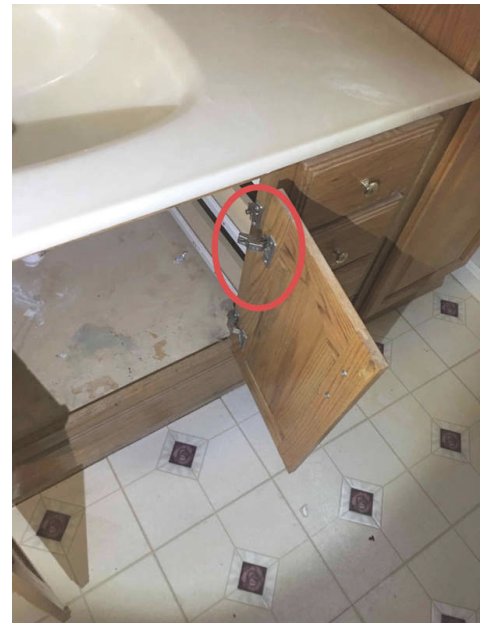
11.9.1 Cabinets

HARDWARE LOOSE AND/OR MISSING

Contact a qualified cabinet contractor.

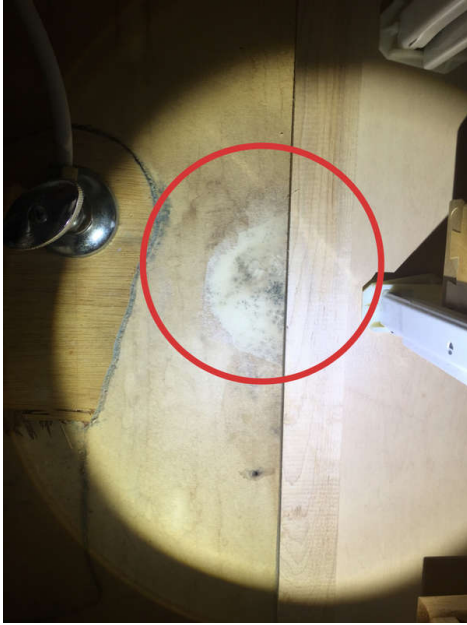
11.11.1 Environmental

MICROBIO GROWTH

Contact a qualified mold inspection professional.

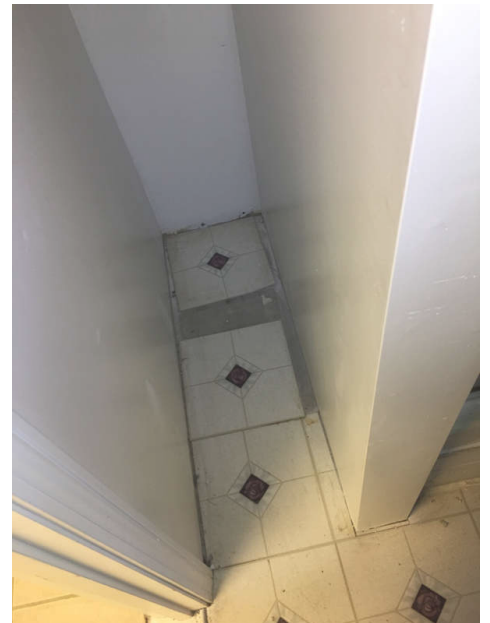
11.12.1 Floors

VINYL - DETERIORATED

Contact a qualified professional.
