RECOMMENDATIONS SUMMARY

1234 Main St. Vancouver WA 98685

Buyer Name
07/10/2017 9:00AM

Tim & Andrew Tewson
Licensed in Washington & Oregon
Slopeside Home Inspections
360-841-7103
tim@slopesideinspections.com

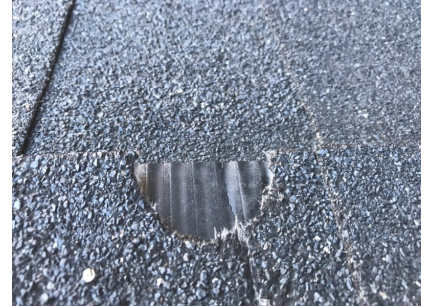
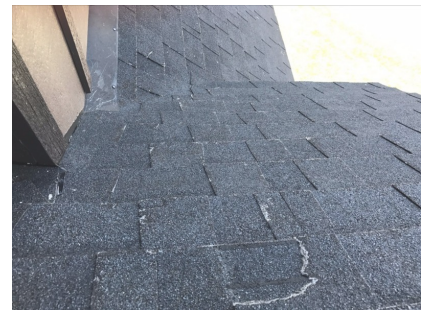
2.1.1 Coverings

DAMAGED (GENERAL)

SOUTH

Roof coverings showed moderate to severe damage at this area. Gutters may need to be installed to direct excess moisture away from this area of the roof surfaces. Recommend a qualified roofing professional evaluate and repair.

Contact a qualified roofing professional.

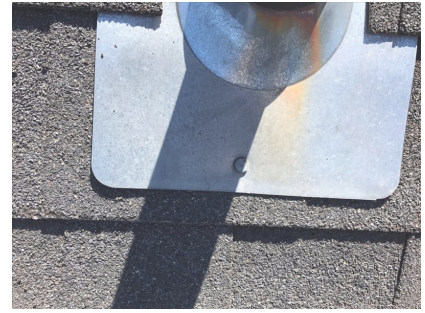
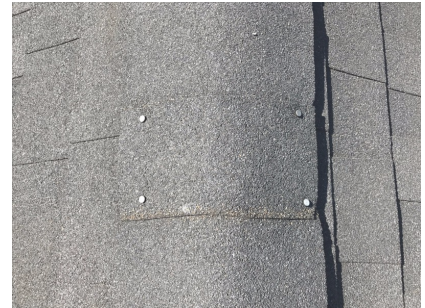
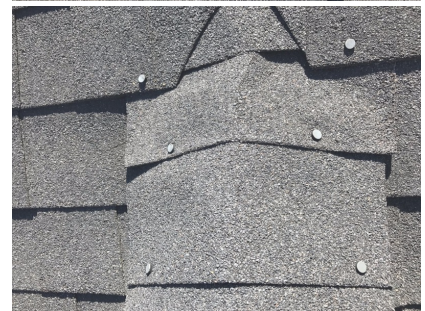
2.1.2 Coverings

EXPOSED FASTENERS/NAILS

Exposed fasteners observed at one or more locations. Exposed fasteners will corrode over time, and expansion and contraction may eventually expand the nail holes enough to allow leakage. Recommend correction or further evaluation by a qualified professional.

Contact a qualified roofing professional.

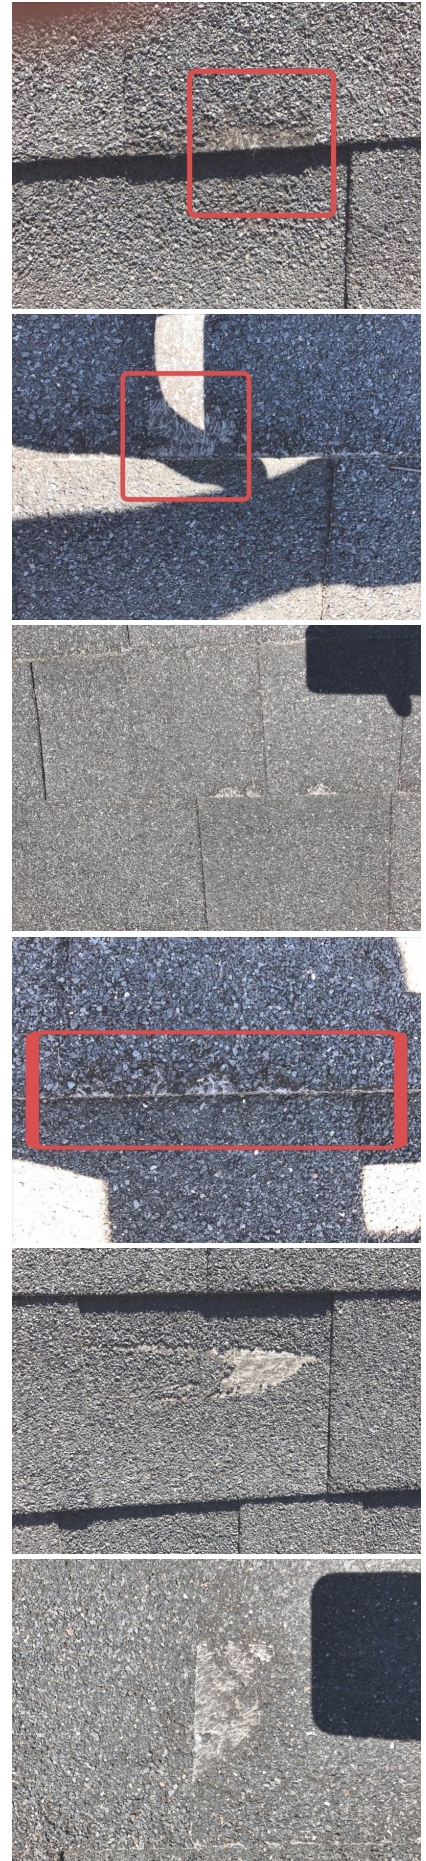
2.1.3 Coverings

GRANULE EROSION

There was visible erosion of the granular surface of the asphalt shingles, indicating its older age. The shingles may start to deteriorate quickly at this point. Replacement of the shingles in the near future is recommended. Recommend correction or further evaluation by a qualified roofing contractor.

Contact a qualified roofing professional.

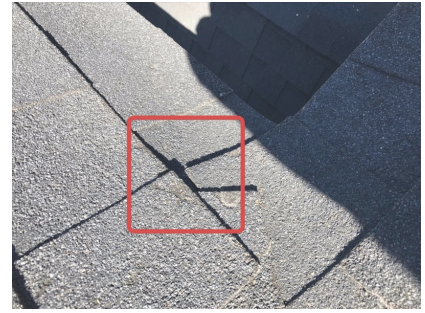
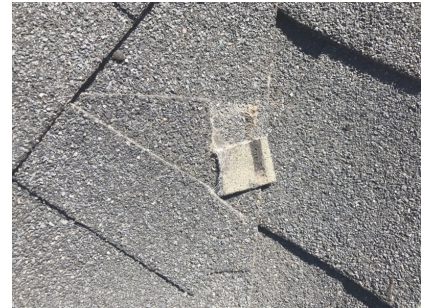
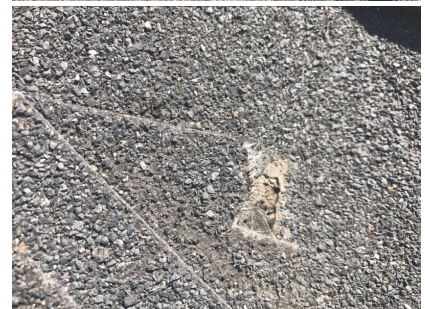
2.1.4 Coverings

DAMAGED SHINGLES ROOF VALLEY

Damaged shingles noted in roof valley. This area is prone to leaking. Recommend repair by a qualified roofing contractor.

Contact a qualified roofing professional.

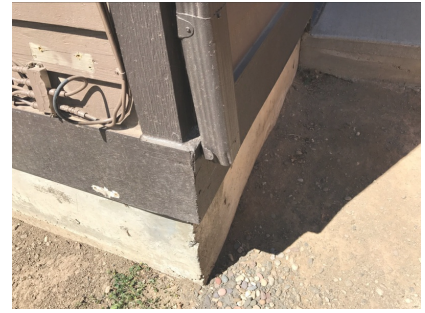
2.2.2 Roof Drainage Systems

DOWNSPOUTS DRAIN NEAR HOUSE

One or more downspouts drain too close to the home's foundation. This can result in excessive moisture in the soil at the foundation, which can lead to foundation/structural movement. Recommend a qualified contractor adjust downspout extensions to drain at least 6 feet from the foundation.

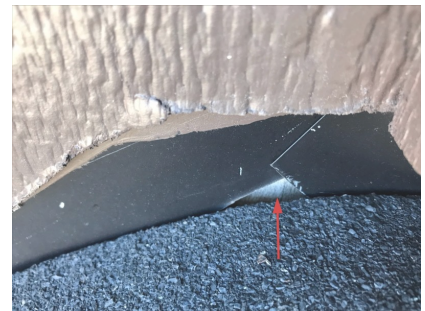
2.3.1 Flashings

GAP IN FLASHING

SMALL GABLED SECTION ABOVE ENTRY DOOR

There is a small gap in the flashing where the ridge meets the siding. This is a potential water entry point. Recommend correction or repair by qualified roofing contractor.

Contact a qualified roofing professional.

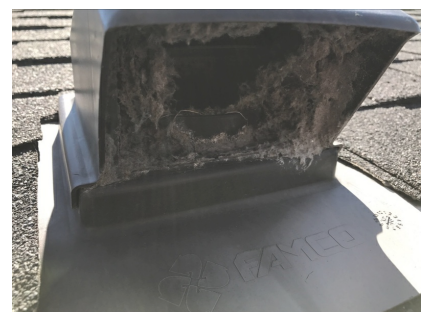
2.4.1 Skylights, Chimneys & Other Roof Penetrations

DRYER VENT DEBRIS

The dryer vent exhaust has excessive lint build-up. Recommend cleaning.

Contact a qualified professional.

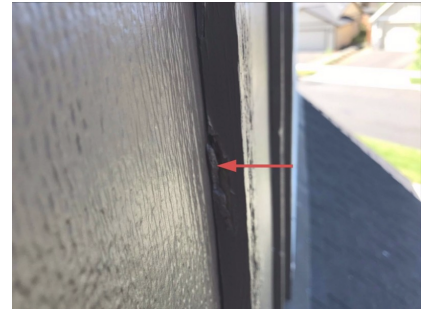
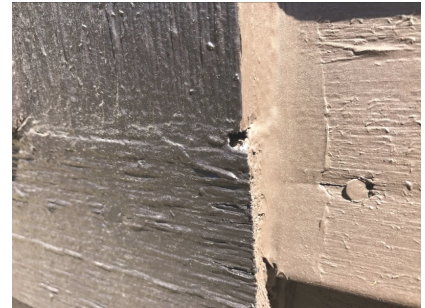
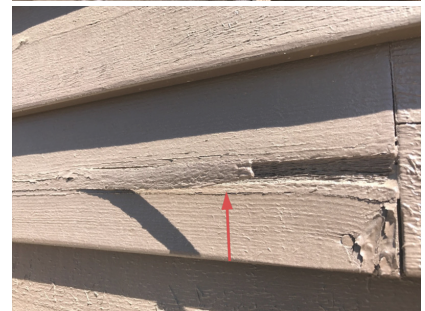
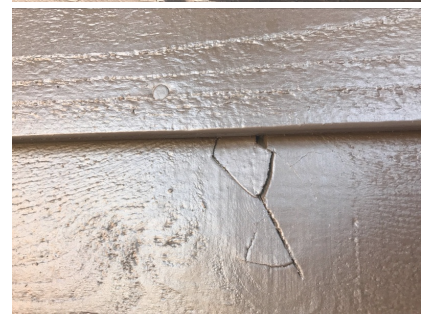
3.1.1 Siding, Flashing & Trim

CRACKING - MINOR

Siding and trim had cracking or minor damage in one or more areas. These areas are a potential water entry points. Recommend resealing and or repair.

Recommended DIY Project

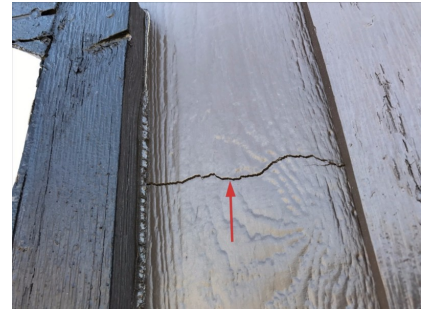
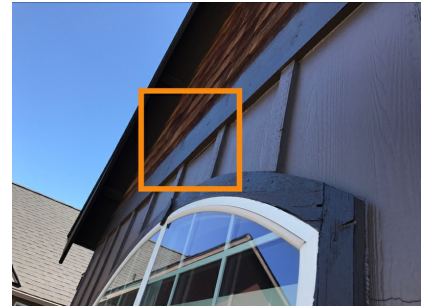
West Cracking

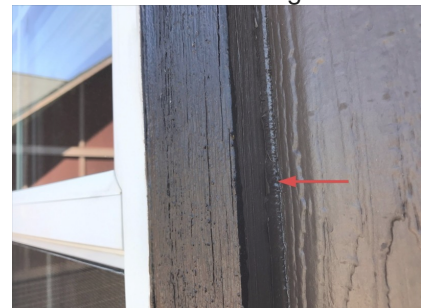
West - Needs resealing

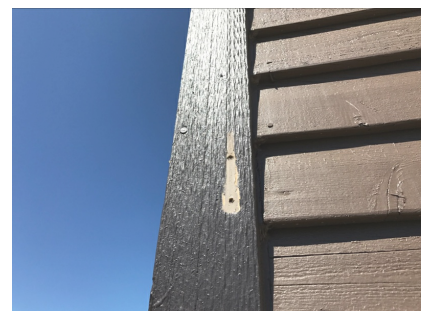
3.1.2 Siding, Flashing & Trim

PEELING PAINT, BARE WOOD

EAST - BACKSIDE OF HOME

Trim had peeling paint and bare wood exposed to weather. To avoid the need for replacement, repair and paint this trim soon.

Recommended DIY Project

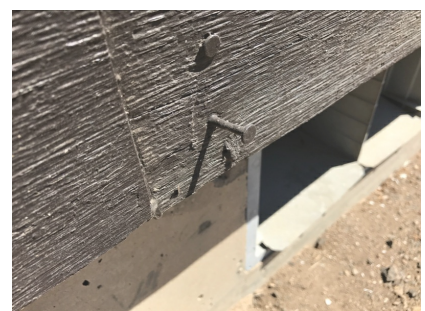
3.1.3 Siding, Flashing & Trim

UNDERDRIVEN NAILS

Underdriven nails were observed at one or more locations. This can be a safety issue do to cuts if contact is made with bare skin. In addition the siding rim board needs to be securely fastened to the wall. Recommend correction by a qualified professional.

Contact a qualified professional.

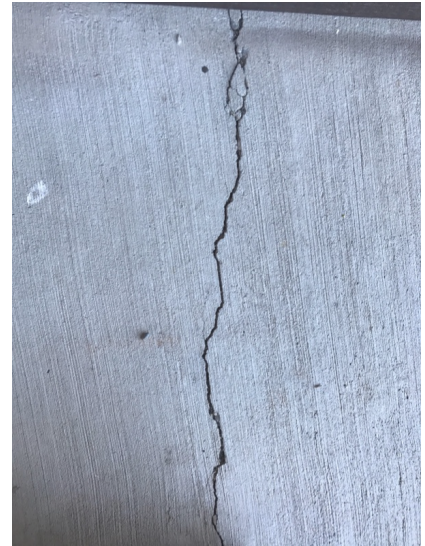
West Front Walkey

WALKWAY CRACKING - MINOR

A crack in the front patio was observed at the time of inspection. If not sealed, moisture can damage the concrete through freezing and expanding during seasonal temperature changes. Recommend sealing to prevent further damage. In addition, the sprinkler system was directing water towards the house in this area. Recommend adjusting.

Recommended DIY Project

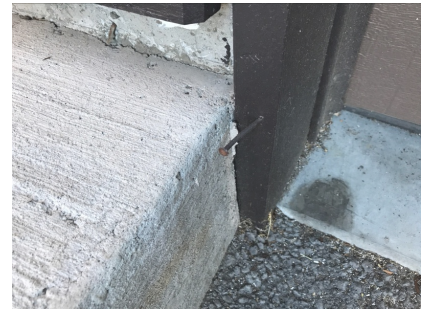
3.3.2 Walkways, Patios & Driveways

UNDERDRIVEN NAIL

An underdriven nail was observed on the trim of the garage. Recommend correction by a qualified professional.

Contact a qualified professional.

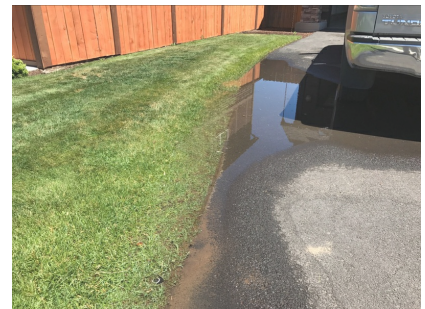
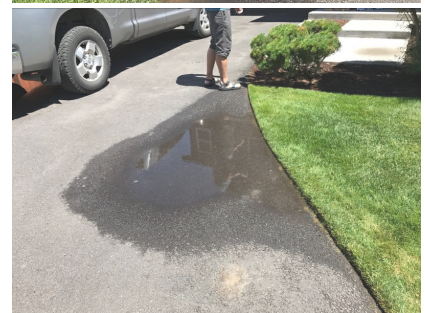
3.3.3 Walkways, Patios & Driveways

WATER POOLING

Water was pooling on the driveway. Excess water can shorten the lifespan of the asphalt material. Recommend directing sprinkler heads away from the driveway.

Contact a qualified professional.

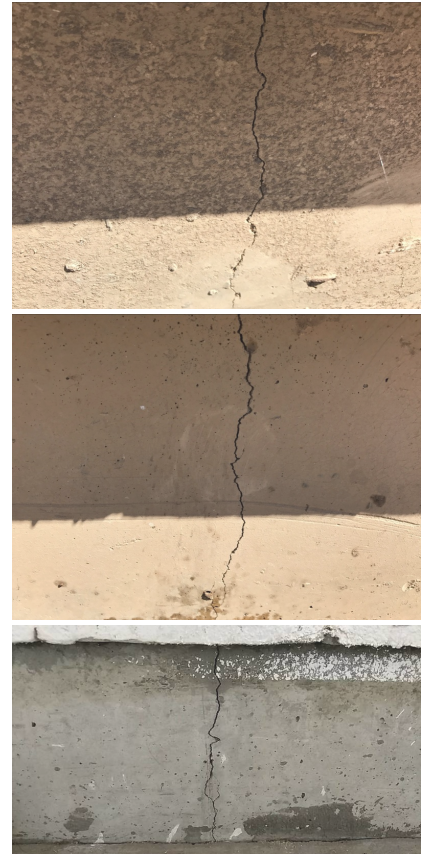
Garage South East

FOUNDATION CRACKS - MINOR

Minor cracking was noted at the foundation. This is common as concrete ages and shrinkage surface cracks are normal. Recommend monitoring for more serious shifting/displacement.

Contact a qualified structural engineer.

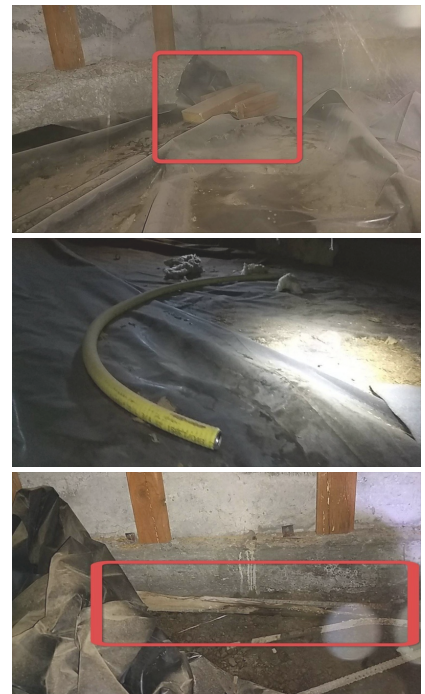
5.2.1 Basements & Crawlspaces

DEBRIS

Debris in crawlspace should be removed. Wood debris is a conducive condition for wood destroying organism. Recommend removing.

Contact a qualified professional.

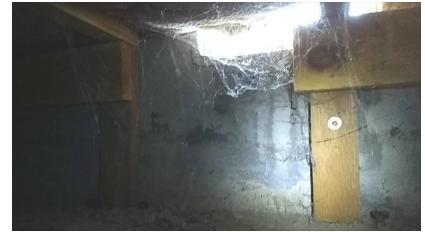
5.2.3 Basements & Crawlspace

CUT 2X6

EAST CRAWLSPACE

A portion of a 2x6 had been cut near one of the east vents. Recommend correction or further evaluation by a qualified contractor.

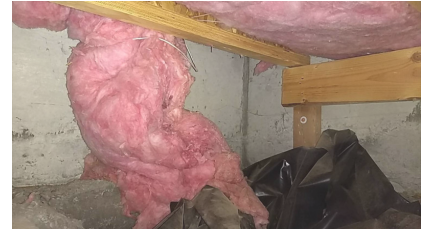
South West Corner

LOOSE INSULATION

Insulation has fallen loose. Recommend reinstalling.

Contact a qualified professional.

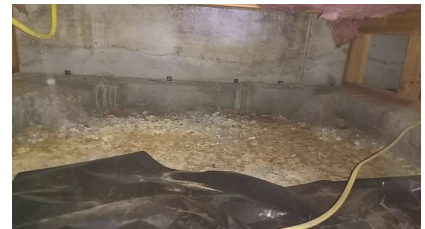
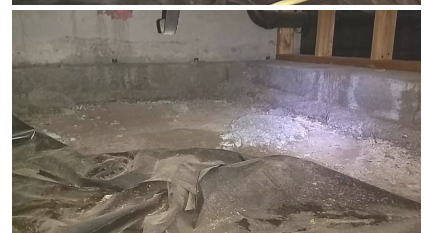
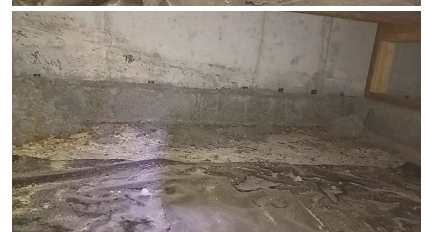
5.6.1 Vapor Retarders (Crawlspace or Basement)

EXPOSED SOIL

The vapor barrier was not adequately covering the soil or post footings at the time of the inspection. Soil covers help reduce humidity levels in crawlspaces by limiting moisture evaporation into the air from soil. Reducing humidity levels can help prevent conditions that encourage mold growth and wood decay. Recommend correction or further evaluation by a qualified professional.

Contact a qualified professional.

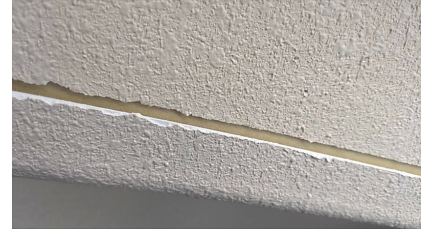
6.1.1 Ceilings

MINOR DAMAGE

SOUTH WEST BEDROOM - ABOVE WINDOW

Seam in the drywall above the window had pulled apart and left a sizable crack, most likely due to normal settling. No moisture damage was observed at the time of inspection. Recommend correction or further evaluation by a qualified professional.

Contact a qualified professional.

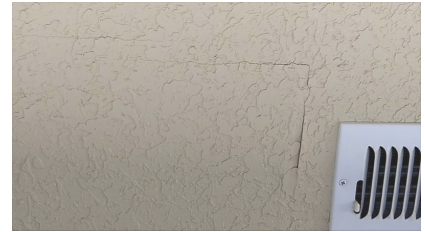
6.1.2 Ceilings

CRACKING

LIVING ROOM - LEFT SIDE OF CEILING REGISTER

Drywall cracking, appeared to be the result of normal settling. Recommend repair as needed.

Contact a qualified professional.

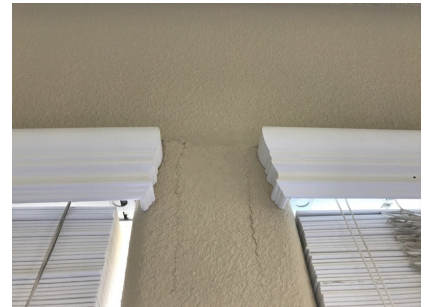
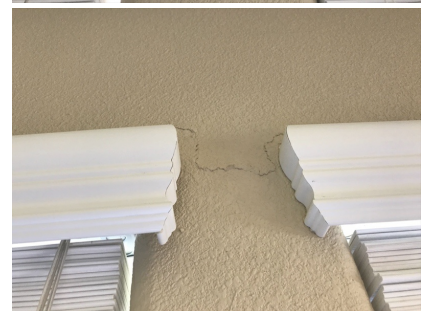
6.2.1 Walls

CRACKING

LIVING ROOM - EAST WINDOWS

Cracking in the drywall was visible at the time of inspection. Unable to determine the cause. Recommend asking seller about prior damage/moisture intrusion.

Contact a qualified professional.

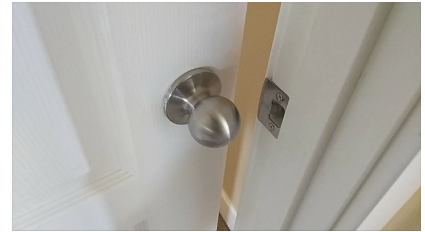
6.3.1 Doors

DOOR STICKS

NORTH WEST BEDROOM

Door sticks and is tough to open. Recommend sanding down offending sides.

Recommendation
Contact a quality handyman.

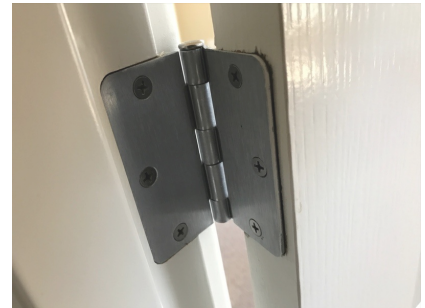
Master Bedroom

HINGES

Door hinges need tightening in one or more locations.

Recommendation
Contact a qualified professional.

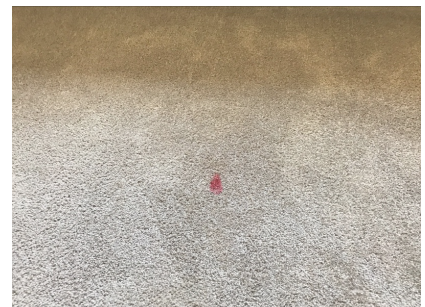
6.4.1 Floors

CARPET STAINS

Carpet had areas of staining or discoloration. Recommend a thorough steam clean by a qualified carpet cleaning company

Recommendation
Contact a qualified cleaning service.

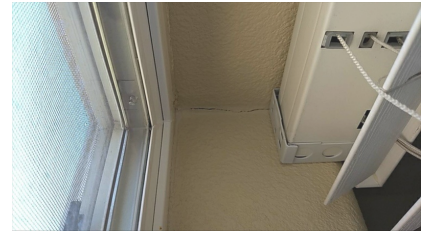
6.5.1 Windows

MINOR CORNER CRACKS

NORTH WEST BEDROOM - RIGHT SIDE

Minor cracks at the corners of doors and windows in walls. Appeared to be the result of long-term settling. Some settling is not unusual in a home of this age and these cracks are not a structural concern.

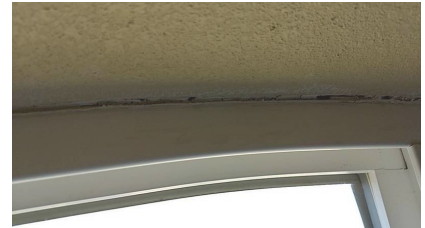
6.5.2 Windows

WINDOW SEAL DETERIORATING

WEST SIDE BEDROOMS

Window seal on one or more windows was deteriorating. Recommend resealing as needed.

Contact a qualified professional.

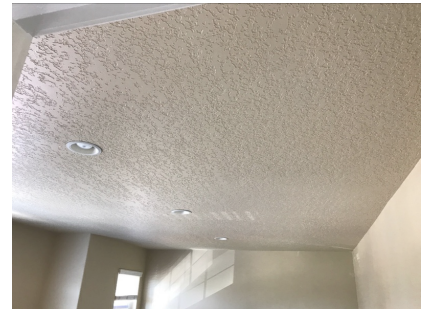
6.8.1 Smoke Detectors

MISSING SMOKE DETECTOR

WEST ROOM

No smoke detector was in the room above the garage. This is not considered a bedroom but we recommend a smoke detector on each floor and in each livable room of the house.

Contact a qualified professional.

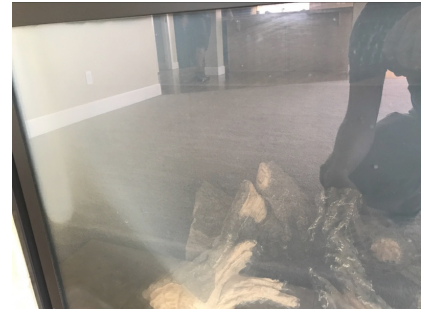
7.5.1 Fireplace, Woodstove

CLOUDY GLASS

Fireplace glass is cloudy. Recommend cleaning or replacing.

Contact a qualified professional.

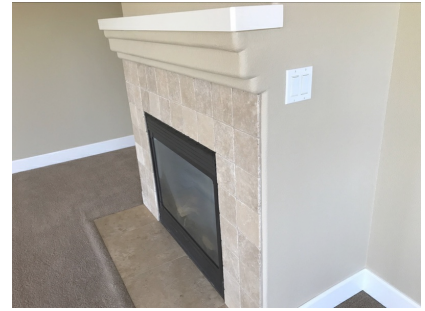
7.5.2 Fireplace, Woodstove

FAN

The fireplace fan did not appear to be either present or operable. Recommend asking seller about this condition or further evaluation by a professional.

Contact a qualified professional.

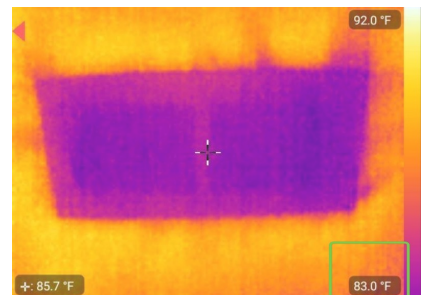
8.4.1 Presence of Installed Cooling Source in Each Room

COOLING AT REGISTER

The west facing bedroom had a register that was not cooling when the A/C was turned on. The air coming from the register remained at or near 83 degrees. Recommend correction or further evaluation by a licensed professional.

Contact a qualified HVAC professional.

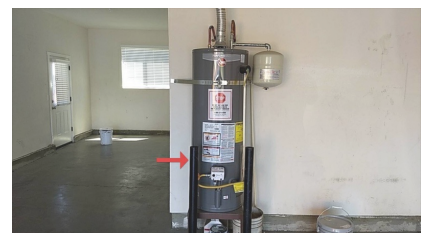
9.5.1 Hot Water Systems, Controls, Flues & Vents

MISSING SEISMIC STRAP

GARAGE

Missing seismic strap on lower third portion of water heater. Recommend installation by a qualified professional.

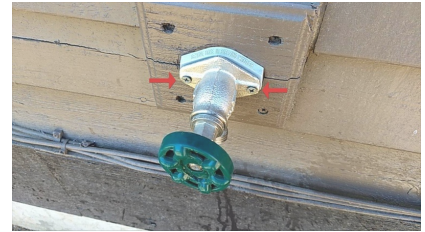
9.6.1 Exterior Hose Bib

LOOSE

EAST

Recommend tightening to properly secure hose bib.

Recommended DIY Project

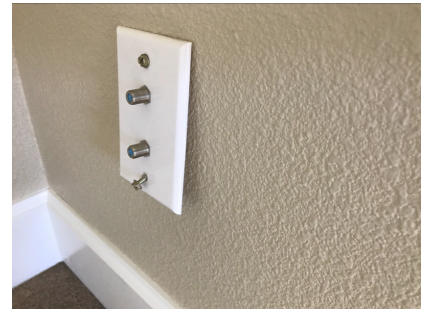
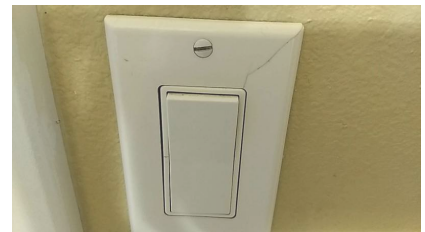
2nd Floor Bathroom

COVER PLATE DAMAGE

One or more receptacles have a damaged cover plate. Recommend replacement.

Contact a qualified electrician.

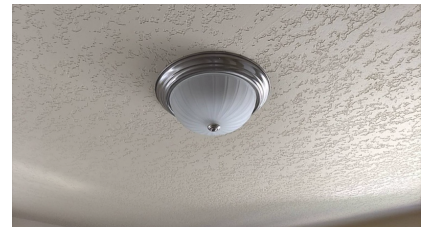
South West Bedroom

LIGHT INOPERABLE

One or more lights are not operating. New light bulb possibly needed.

Contact a qualified electrician.

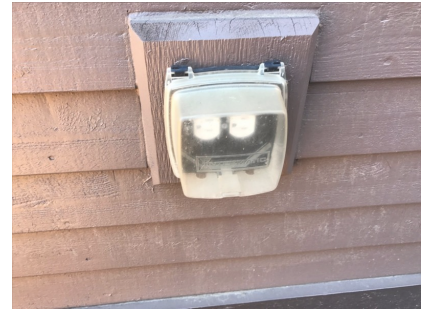
Exterior West

NO GFCI PROTECTION INSTALLED

No GFCI protection present at one or more locations in the home. Recommend licensed electrician upgrade by installing ground fault receptacles in all locations.

Contact a qualified electrician.

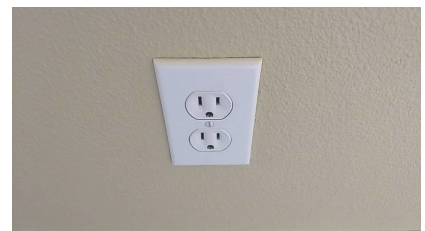
2nd Floor Hallway

COVER PLATE LOOSE

One or more cover plates were loose at the time of the inspection on the first floor.

Contact a qualified professional.

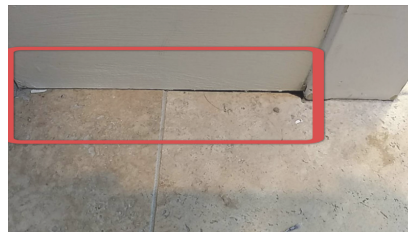
11.1.1 Floors, Walls and Ceilings

MISSING SEALANT

MASTER BATHROOM

Recommend sealant.

Recommended DIY Project

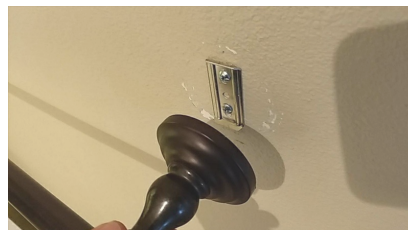
11.1.2 Floors, Walls and Ceilings

TOWEL RACK LOOSE

2ND FLOOR BATHROOM

Right side of towel rack is not secured properly. Recommend tightening to properly secure to the wall.

Recommended DIY Project

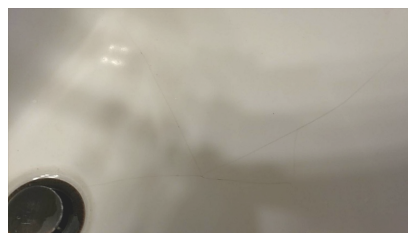
11.3.1 Toilets and Sinks

SINK CRACKS

2ND FLOOR BATHROOM

Right sink in second floor bathroom had a number of cracks. Recommend replacing sink.

Contact a qualified professional.

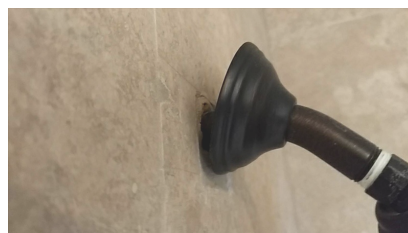
Master Bathroom

SHOWER HEAD PIPE LOOSE

Shower head pipes were loose in both upstairs bathrooms. Recommend correction by a qualified professional.

Contact a qualified professional.

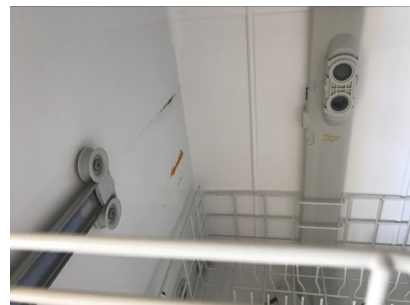
12.2.1 Dishwasher

RUST

Rust stains from objects placed inside the dishwasher can usually be lightened or removed with a citric acid treatment. To remove these stains, you can treat with citric acid crystals following the steps below:

Contact a qualified professional.

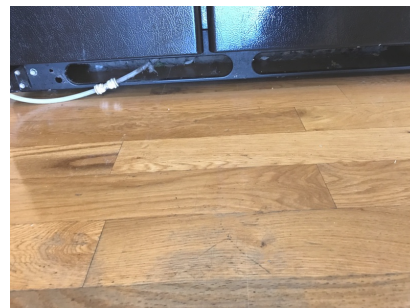
12.3.1 Refrigerator

COVER PLATE MISSING.

Contact a qualified professional.

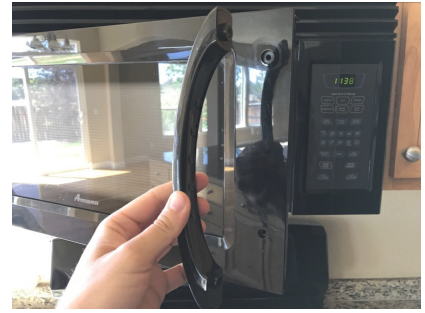
12.6.1 Built-in Microwave

BROKEN HANDLE. RECOMMEND REPAIR

Contact a qualified professional.

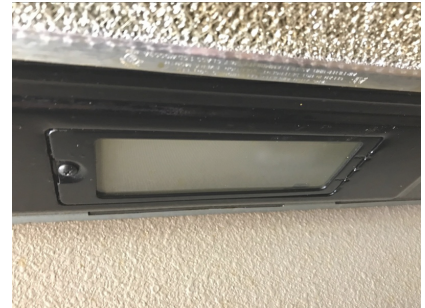
12.6.2 Built-in Microwave

LIGHTS NOT WORKING

The lights underneath the microwave that illuminate the stove top were not working at the time of inspection.

Contact a qualified professional.

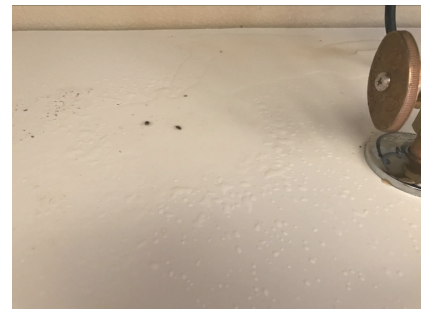
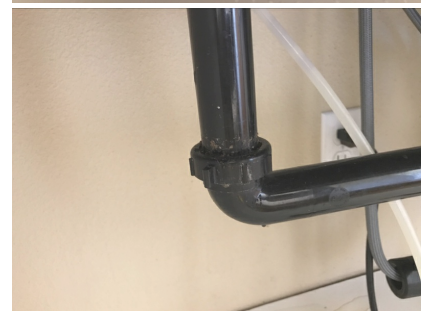
12.8.1 Sink (s) & Plumbing

LEAK

⚠ Safety Hazard and/or Requires Immediate Attention

There is an active water leak underneath the kitchen sink. The seal at the elbow appears to be broken. Recommend correction or further evaluation by a qualified professional.

Contact a qualified plumber.

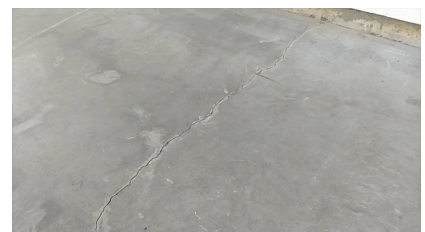
13.2.1 Floor

CRACKING

GARAGE

Crack was observed towards the back of the garage. Most likely due to concrete shrinkage and normal settling. Recommend monitor and/or have concrete contractor patch/seal.

Contact a qualified professional.

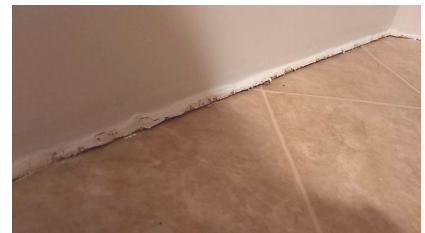
14.5.1 Trim

MOISTURE DAMAGE

Trim opposite the sink cabinet appeared to have moisture damage. Washing machine may have leaked at some point. Recommend asking sellers about this.

Contact a qualified professional.
