SUMMARY
1234 Main St. Charleston SC 29414
Buyer Name
05/09/2019 9:00AM

Adam Richardson
RBI49221, AHIT Cert, BPI BA, ...
PGR Home Inspections
8437890653
adam@pgrhomeinspections.com

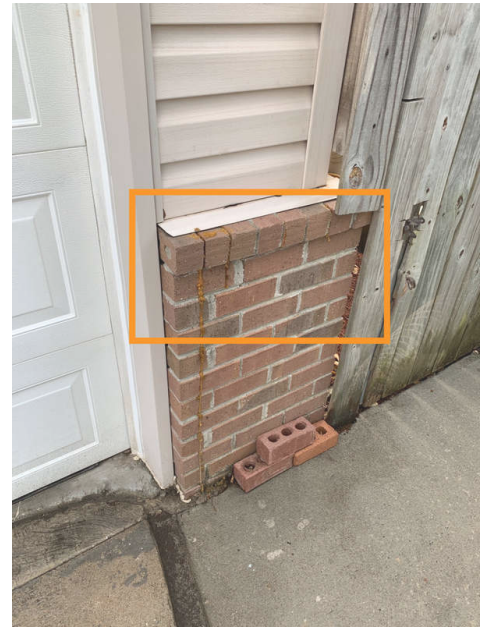
BRICK VENEER LOOSE

Moderate Deficiency

Brick veneer right of the garage door is loose. Recommend a qualified professional repair.

Recommendation
Contact a qualified professional.

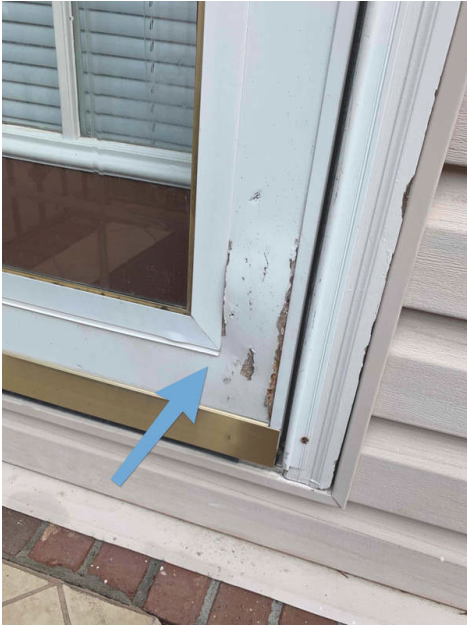
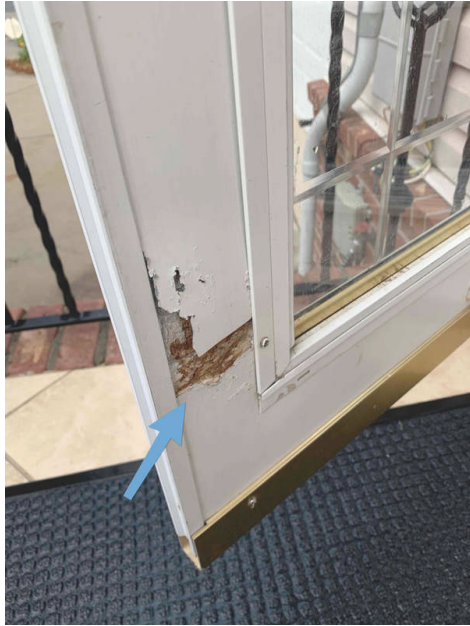
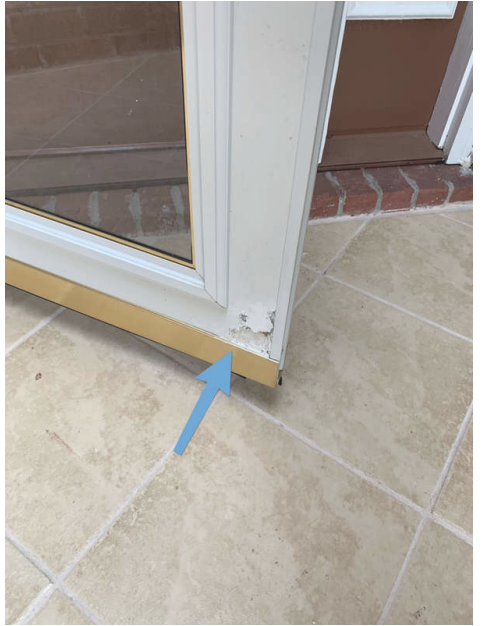
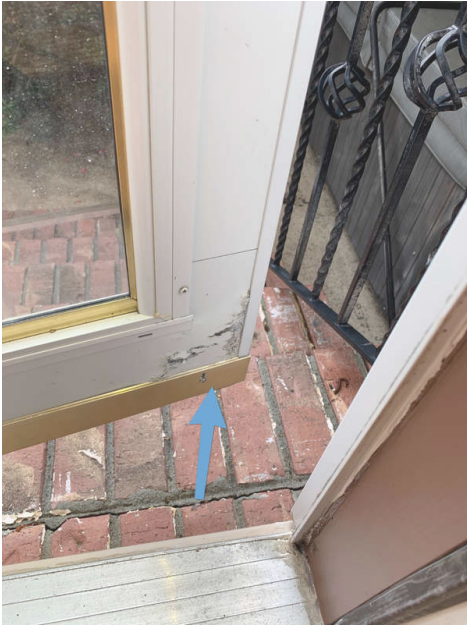
DAMAGED STORM DOOR

Visible damage to storm door. Damage is not affecting proper operation of the door. Recommend repair or replace as needed.

Recommendation

Contact a qualified door repair/installation contractor.

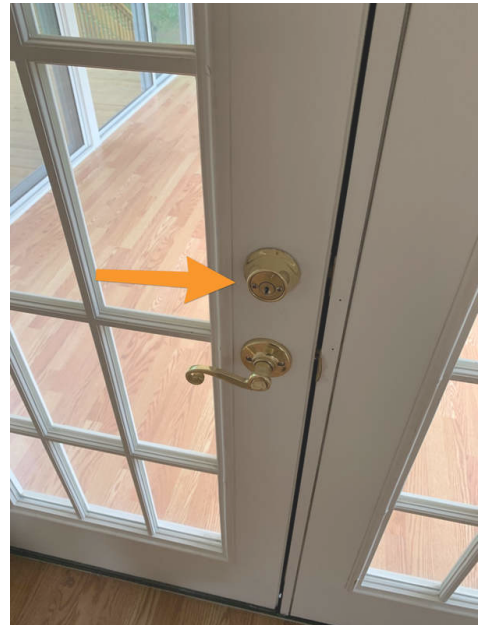
REPLACE LOCK

Highly recommend replacing the key lock with a deadbolt for safety reasons. In an emergency situation the key may not be readily available putting you at risk.

Recommendation

Contact a qualified professional.

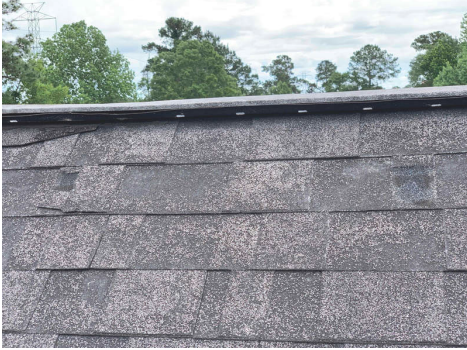
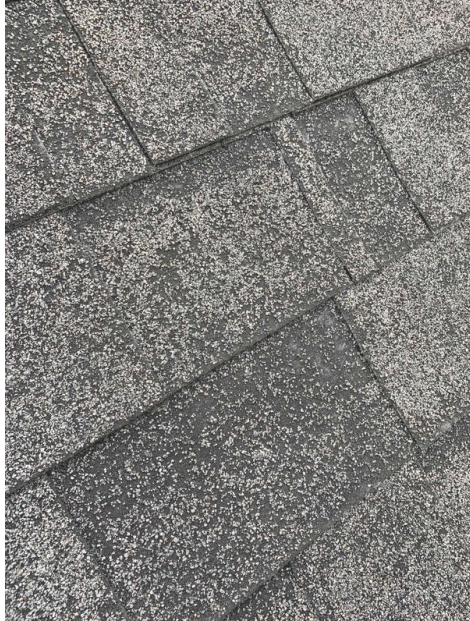
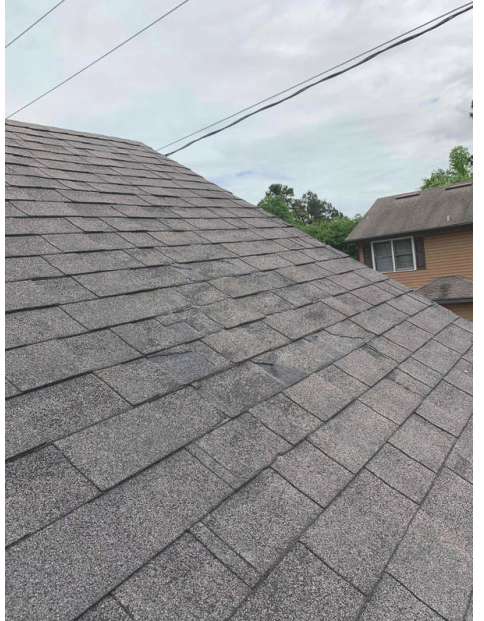
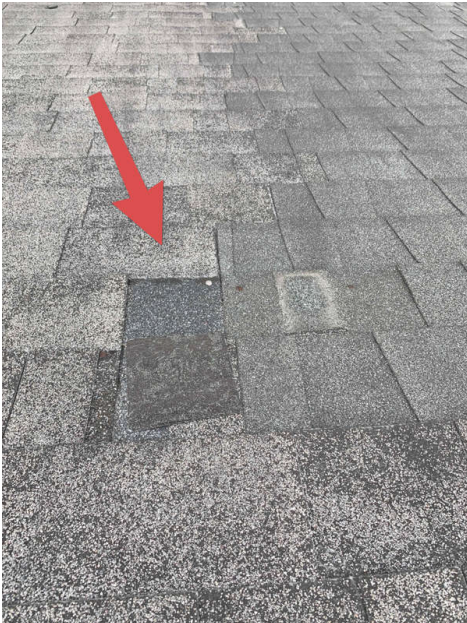
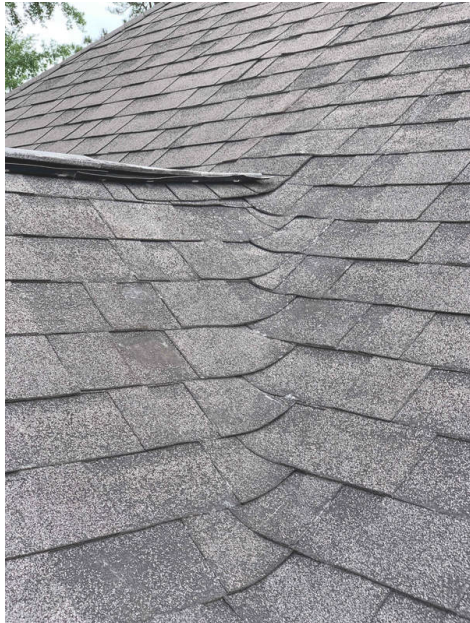
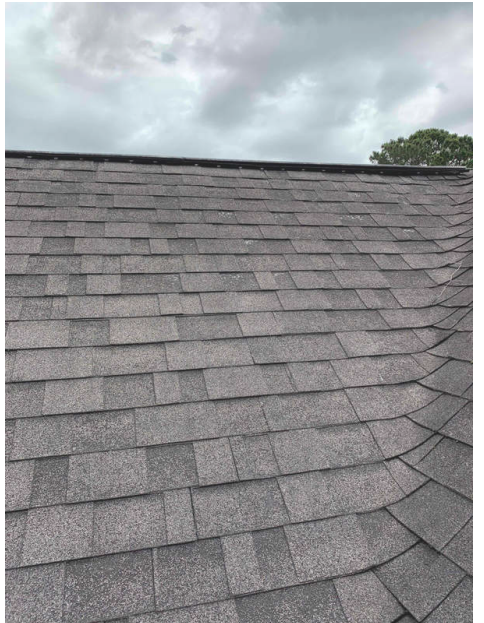
AGED ROOFING MATERIAL - DAMAGED SHINGLES

Significant Deficiency/ Safety Hazard

The roofing material showed signs of significant aging. Significant granule loss, exposed fiberglass in the shingles, moss growth are all signs of aging. One or more areas of damaged shingles were present as well. Recommend a qualified roofing contractor provide a more thorough evaluation, repair and damaged shingles and exposed nailhead on ridges/vents and budget for replacement in the near future.

Picture are a few samples showing the granule loss and exposed fiberglass.

Recommendation

Contact a qualified roofing professional.

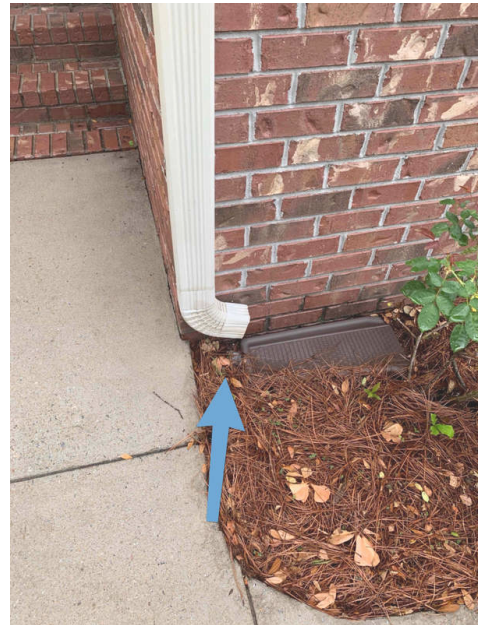
Front of the home

**RECOMMEND
DIVERTING
DOWNSPOUT**

Downspout terminates near foundation. Recommend diverting and/or extending the downspout to to ensure the water drains away from the foundation/ exterior wall.

Recommendation

Contact a handyman or DIY project

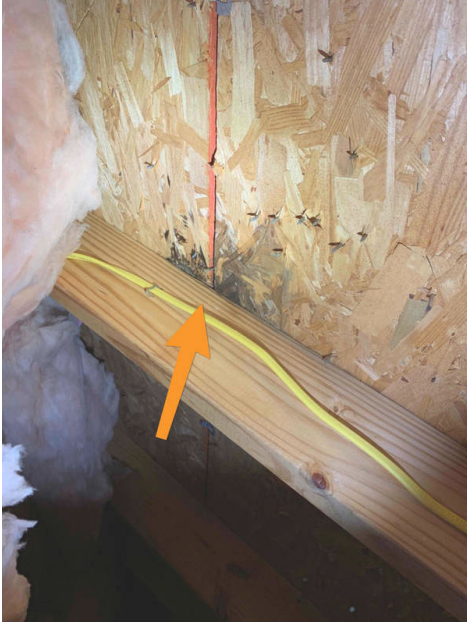
FROG RIGHT SIDE

EVIDENCE OF MOISTURE/ WATER INTRUSION

Evidence of water intrusion and possible current leak. No evidence of current leakage due to the dry weather conditions during time of inspection. Recommend a qualified roofing contractor further evaluate the condition, locate the point of intrusion and repair or replace as needed.

Recommendation

Contact a qualified roofing professional.

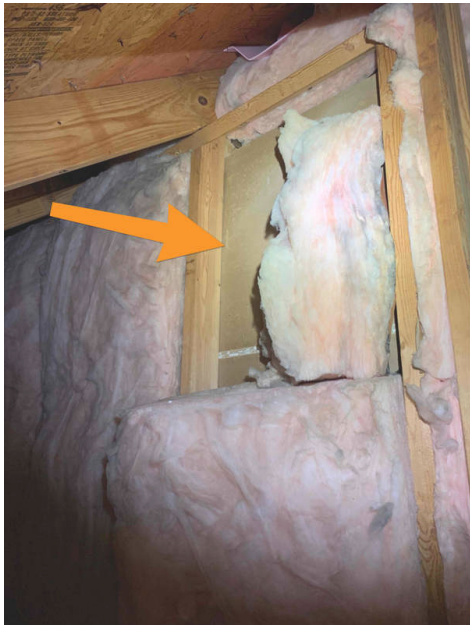
FROG

OUT OF PLACE INSULATION

Moderate Deficiency

Insulation was out of place resulting in reduced efficiency. Recommend a qualified professional repair the fallen insulation.

Recommendation
Contact a qualified professional.

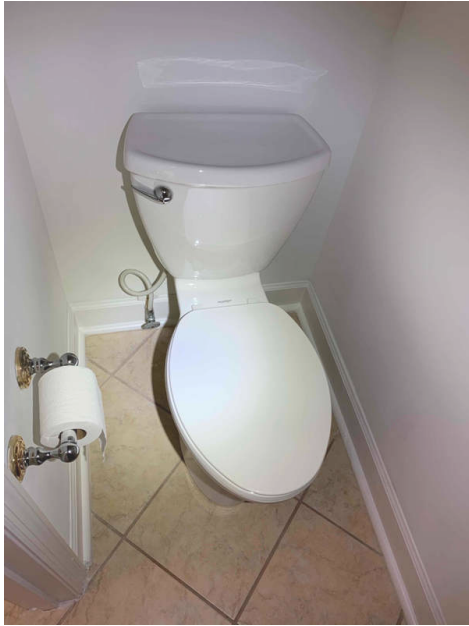
Powder Room

TOILET LOOSE

Toilet is loose at the base. Recommend a qualified plumbing professional evaluate and repair. It may just be loose at the anchor bolts or a possible issue with the flange.

Recommendation

Contact a qualified plumbing contractor.

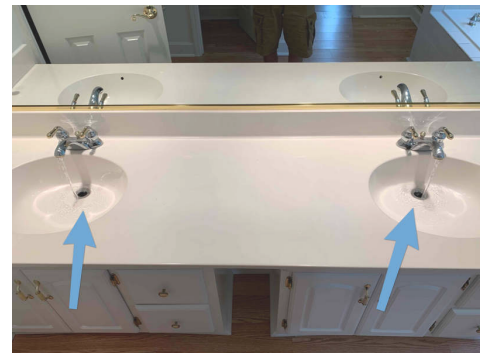
MISSING SINK STOPPER

Missing sink stoppers in master bathroom. Recommend replacing.

Recommendation

Contact a handyman or DIY project

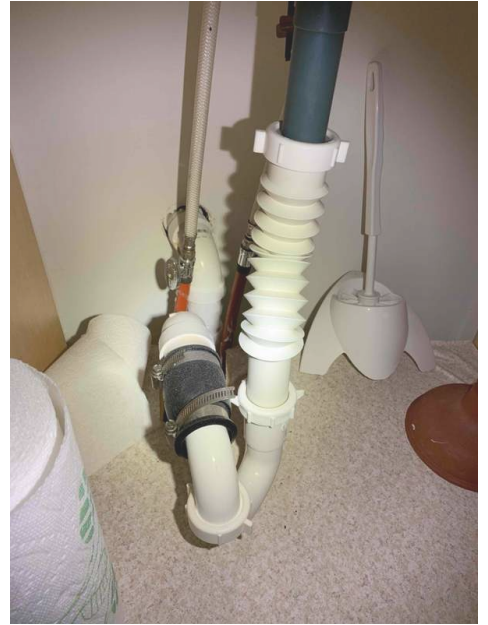
FROG Bathroom

Moderate Deficiency

IMPROPER TRAP SET UP

Bathroom trap setup is improper and closely resembles a P-trap which is not an approved trap method because it can allow for siphoning of the water in the trap. Recommend a qualified plumbing contractor evaluate and repair.

Recommendation

Contact a qualified plumbing contractor.

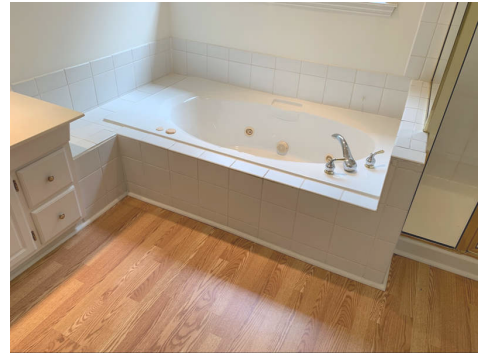
Moderate Deficiency

NO ACCESS PANEL

No access panel for the jetted tub for the motor and plumbing components. These are needed to perform maintenance on the components if needed. Unable to determine if any leaks are present and if there is GFCI protection in place. Recommend a qualified professional install an access panel and verify no issues are present and repair any issues prior to closing.

Recommendation

Contact a qualified professional.

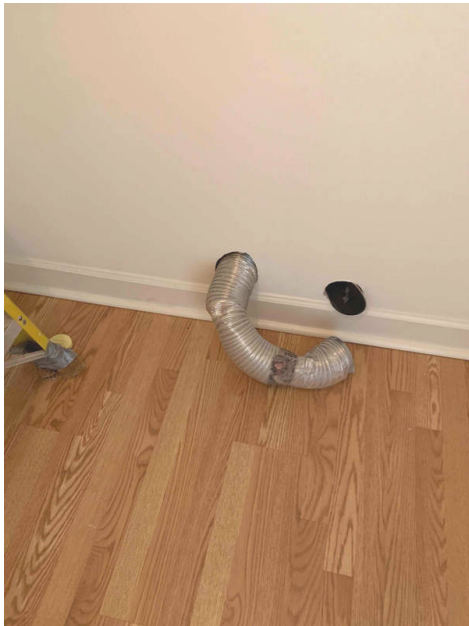
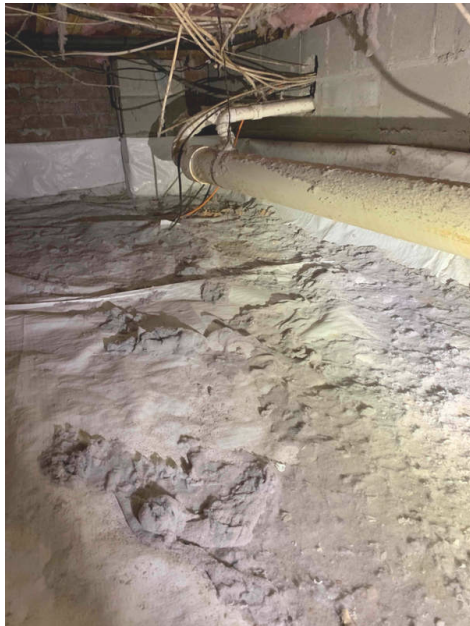
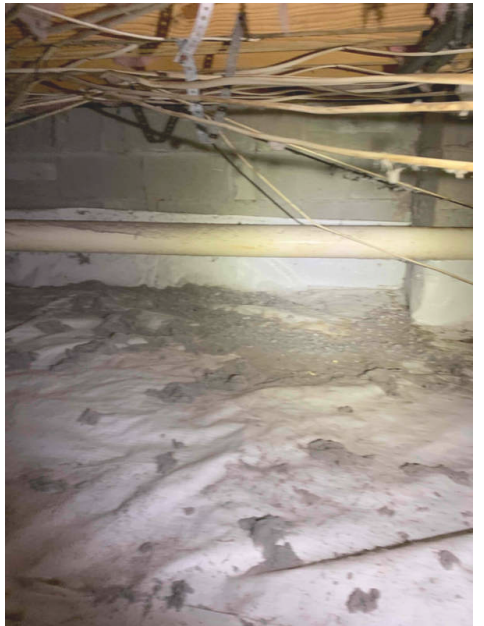
TERMINATE DRYER VENT TO EXTERIOR

The dryer vent terminates into the crawlspace. No exterior termination found. Which ultimately results in releasing a significant amount of humidity and moisture into the crawl. Recommend a qualified professional terminate the dryer vent extension to the exterior.

Dryer lint buildup

Recommendation
Contact a qualified professional.

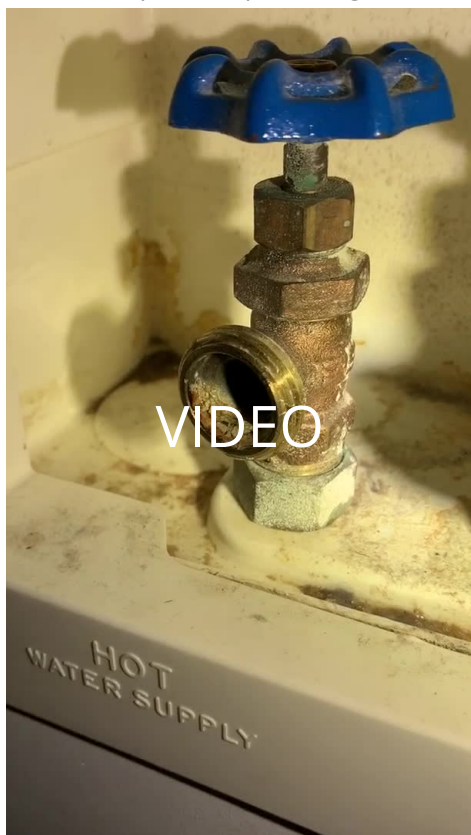
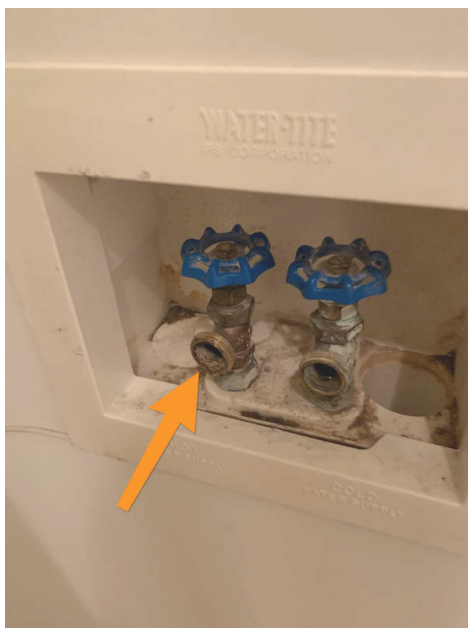
SLOW DRIP

Moderate Deficiency

Slow drip notice coming from the water valve. Recommend a licensed plumbing contractor evaluate and repair or replace.

Recommendation

Contact a qualified plumbing contractor.

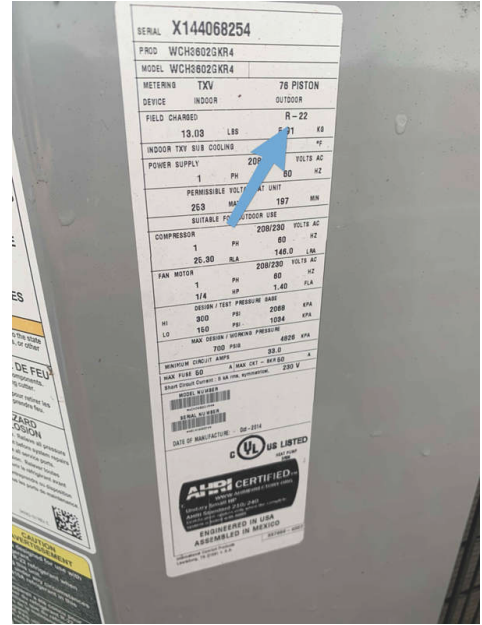
EXCEEDED LIFE EXPECTANCY

Moderate Deficiency

The air handler unit is 22 years old exceeding the typical life expectancy which is around 12-15 years. Recommend a licensed HVAC contractor service the unit and provide further evaluation on the remaining life of the unit and recommend budgeting for replacement in the near future.

CONTAINS R-22 REFRIGERANT (INFO ITEM)

The system contains R-22 refrigerant. This refrigerant is being phased out and will no longer be produced or imported in order to help protect the stratospheric ozone layer. Existing units can continue to use and be serviced with R-22 until inventory is depleted, but it may be expensive and/or difficult to obtain. This is just for your reference, so you are not blindsighted if additional refrigerant is required during servicing.

Recommendation

Contact a qualified HVAC professional.

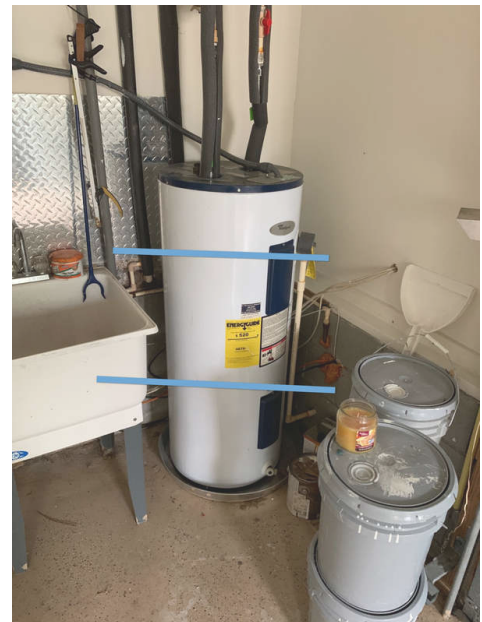
SEISMIC STRAPS MISSING

Water heater is missing seismic straps which are recommended for the area. Recommend a qualified professional install on the top and bottom third of the tank.

Recommendation
Contact a qualified professional.

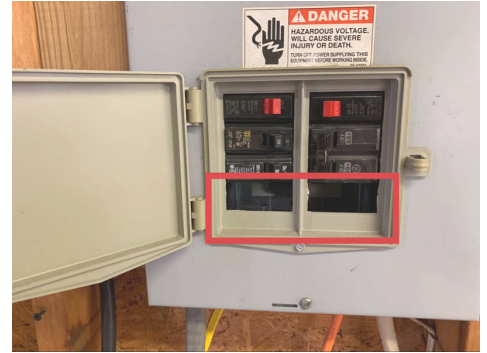
Garage subpanel

Significant Deficiency/ Safety Hazard

KNOCKOUTS MISSING

"Knockouts" are missing on the sub panel. This poses a safety hazard and it is recommended that a filler plate be installed by a licensed electrician.

Recommendation
Contact a qualified electrical contractor.

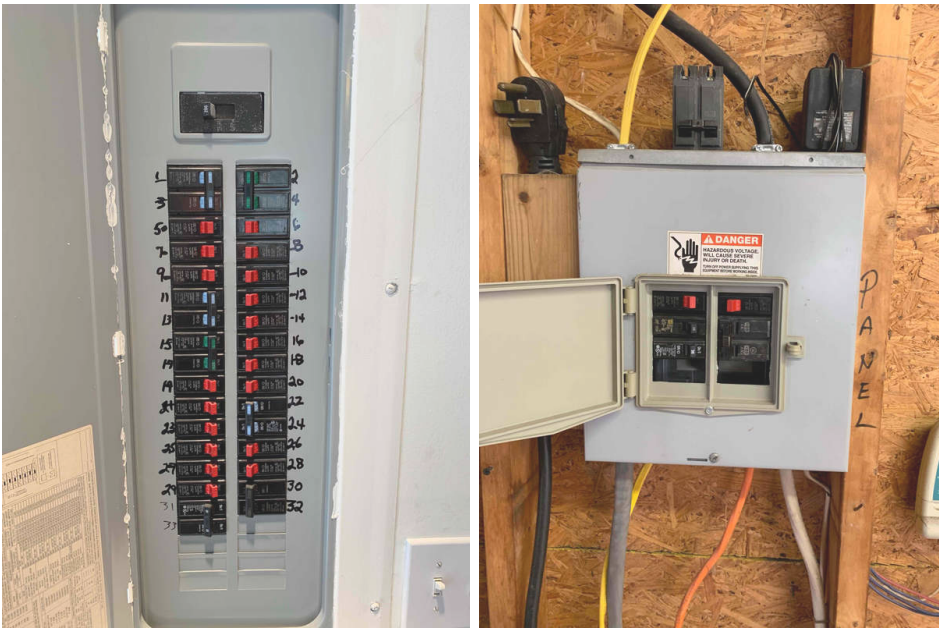
Maintenance/ Monitor/ Minor Items

MISSING LABELS ON PANEL

At the time of inspection, panel was missing labeling. Recommend mapping out the breaker locations.

Recommendation
Recommended DIY Project

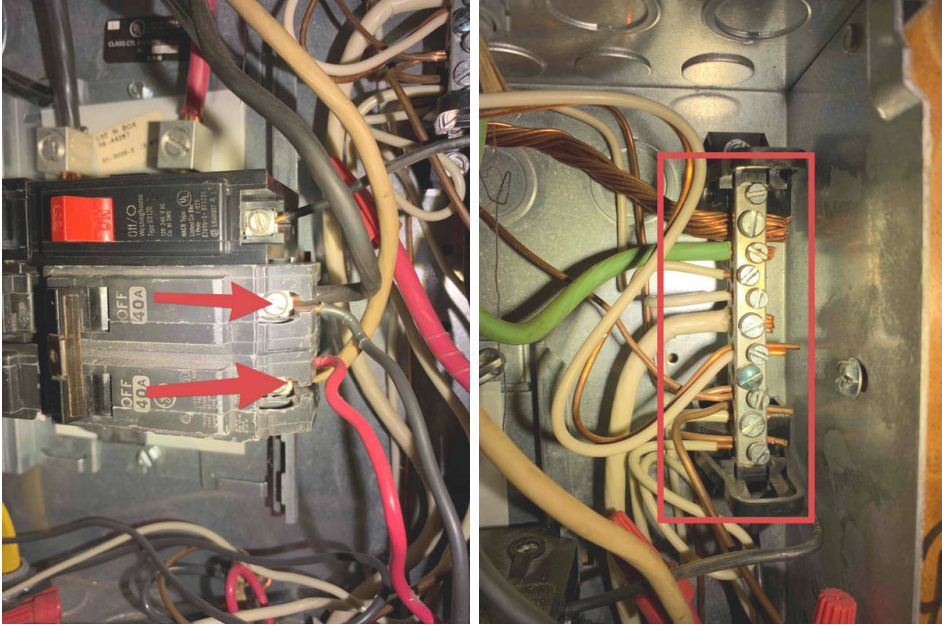
SUB PANEL: EVALUATE AND REPAIR

- Neutrals and grounds should be on separate bus bars with only the ground bus bar able to be bonded to the box.
- A double tapped breaker present. This breaker is not designed to hold two conductors per pole. Recommend a licensed electrician evaluate the panel for any other violations and repair as needed.

Recommendation
Contact a qualified electrical contractor.

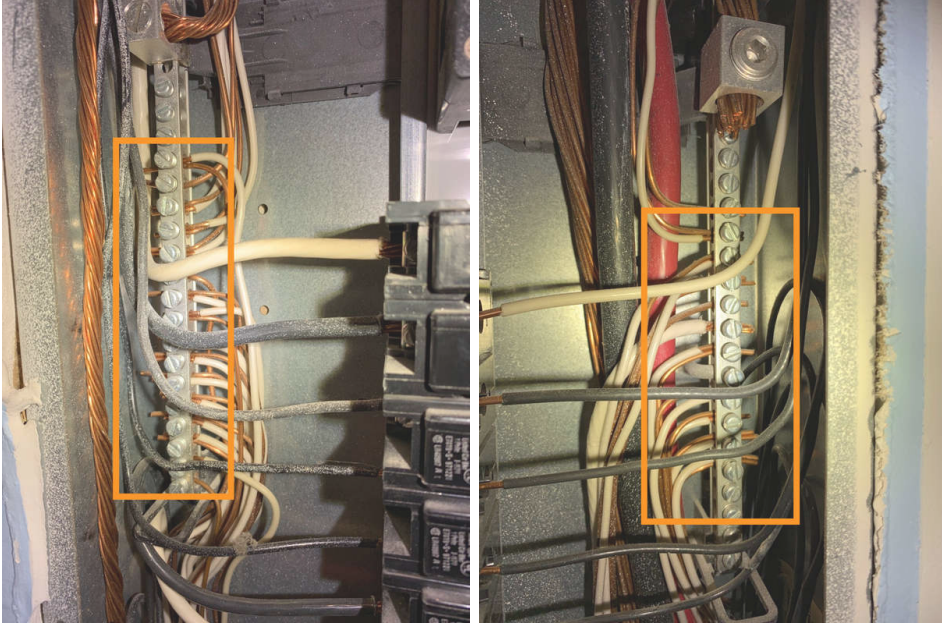
Moderate Deficiency

NEUTRALS AND GROUNDS SHARE SAME LUG ON BUS BAR

Neutrals and grounding conductors terminate under the same lug. An individual screw or lug should be provided for each neutral conductor. When the neutral is disconnected the objective is to still have the equipment ground connected. This cant be done when under the same lug. Also one conductor may be held in place better than the other and can loosen and possibly over heat. Recommend a licensed electrician repair.

Recommendation
Contact a qualified electrical contractor.

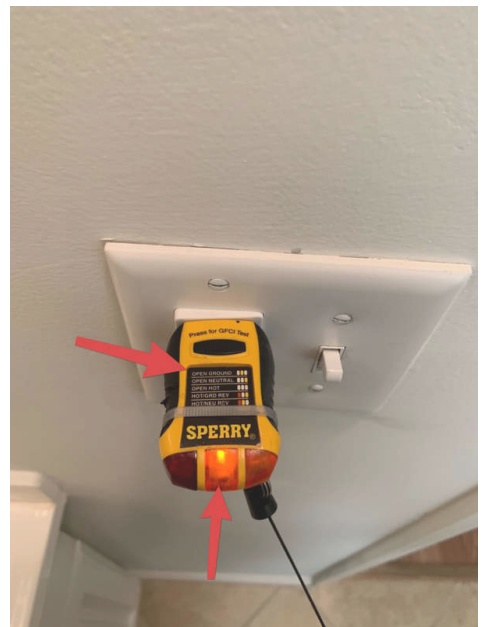
FROG bathroom

Significant Deficiency/ Safety Hazard

OPEN GROUND

One or more open grounds found on receptacles. It is possible the ground wire is loose or disconnected at the receptacle, on a receptacle upstream in the circuit or at the panel. Recommend a licensed electrician evaluate and repair as needed to prevent possible shock or injury, or damage to equipment.

Recommendation
Contact a qualified electrical contractor.

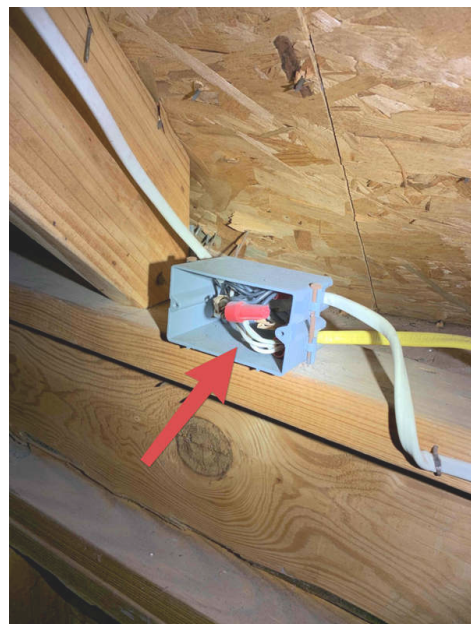
FROG attic space

EXPOSED WIRING

Exposed wiring in attic. Possible safety hazard due to the close proximity to the attic hatch opening. Recommend securing the wiring in an approved junction box.

Recommendation
Contact a qualified electrical contractor.

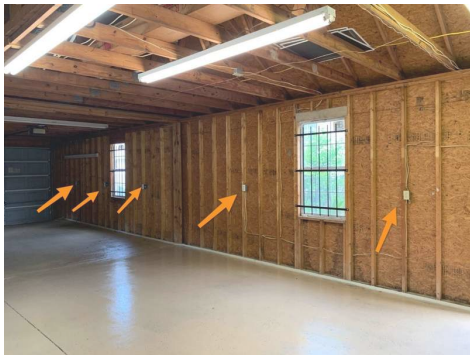
ALL receptacles in the detached garage

NO GFCI PROTECTION INSTALLED - NOT OPERATING PROPERLY

- No GFCI protection present in all locations where the receptacle could come in contact with water or other liquid. Potential safety hazard.

Recommend licensed electrician upgrade by installing ground fault receptacles or breakers for locations specified: **OUTSIDE, DETACHED GARAGE receptacles.**

Recommendation
Contact a qualified electrical contractor.

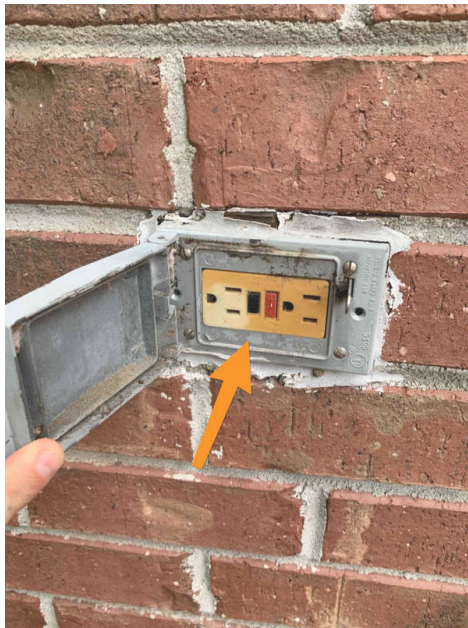
Front of the home, left of front steps

- The GFCI receptacle on the front of the house was not tripping properly indicating that it has likely failed. Recommend a licensed electrician evaluate and replace the receptacle as needed.

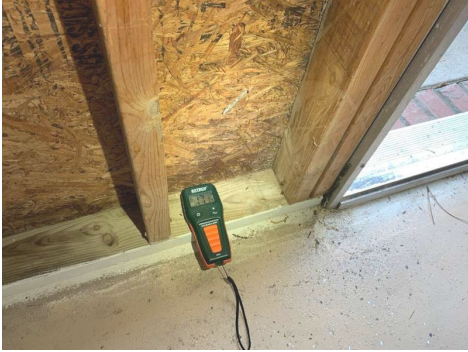
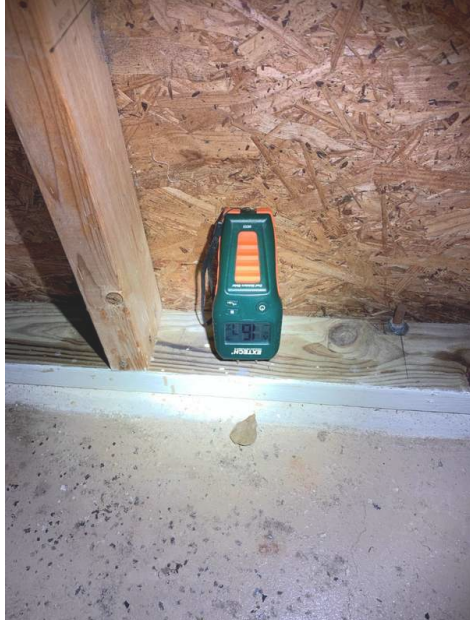
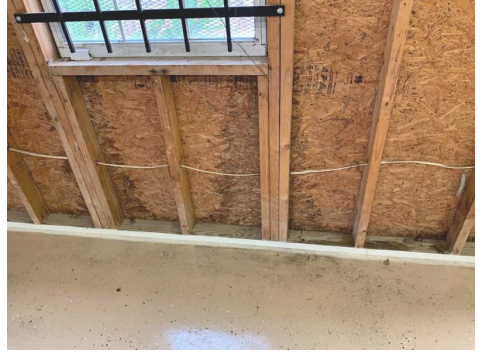
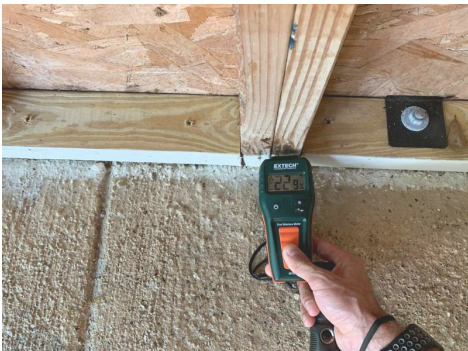
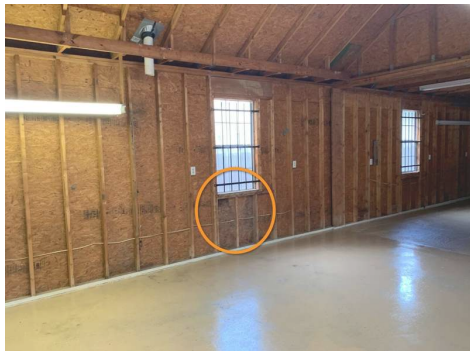
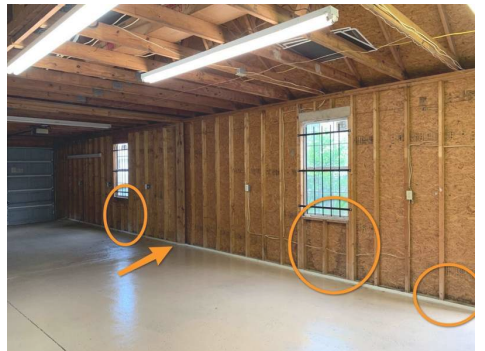
MOISTURE INTRUSION/ WOOD ROT

Several areas of moisture intrusion with high moisture present were found along the walls and framing of the detached garage. One or more of these areas had wood rot present. Recommend a qualified contractor evaluate the detached garage framing and locate the moisture intrusion point, evaluate the extent of the rot damage and repair.

Recommendation
Contact a qualified professional.

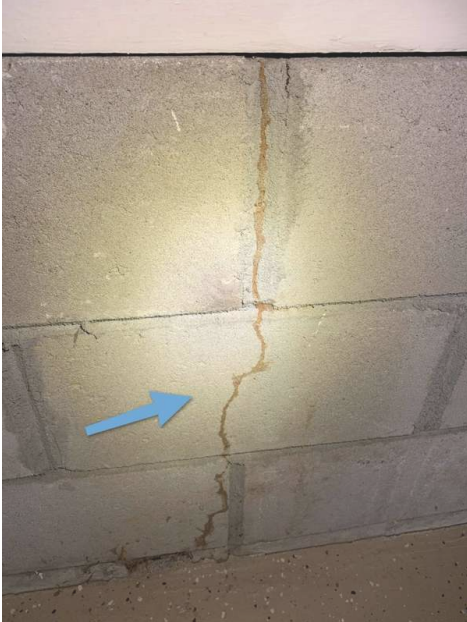
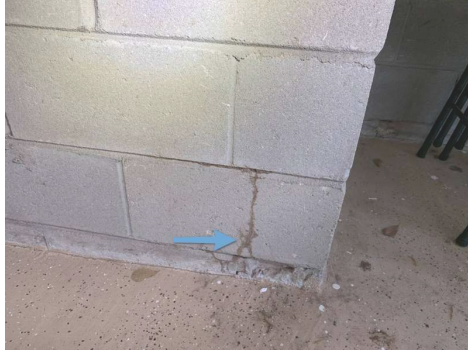
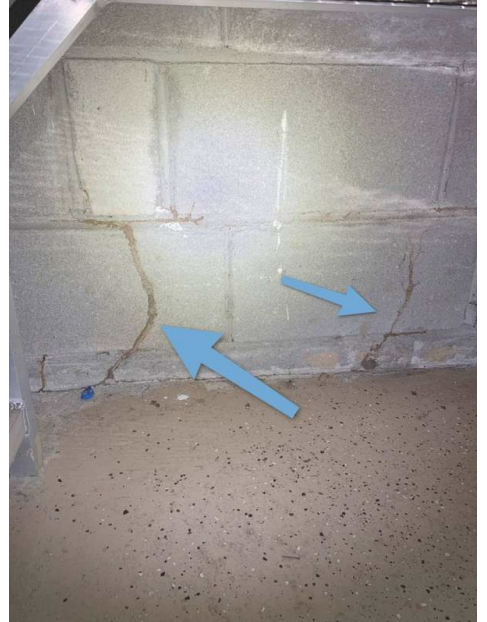
PREVIOUS TERMITE MUD TUNNELS

Observed one or more mud tunnels from previous termites. There were no signs of active termite colonies and no termites were found at time of inspection. Recommend maintaining consistent treatment on the home.

Recommendation

Contact a qualified pest control specialist.

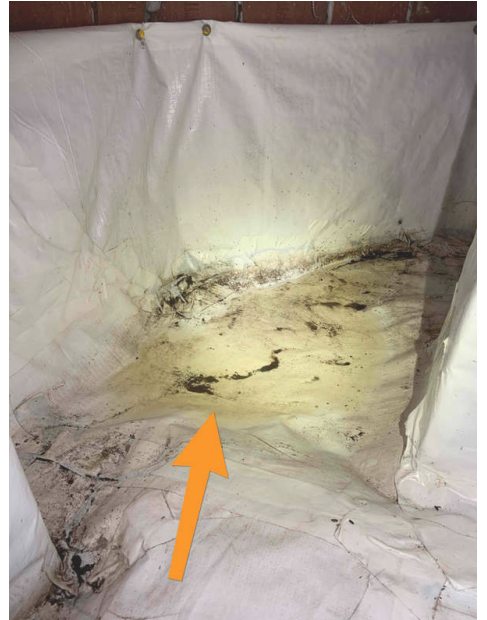
Left of crawlspace access panel

STANDING WATER

Observed signs that standing water may have been present on basement floor. Recommend a qualified professional evaluate and determine the water source and repair as needed. No signs of leaking at time of inspection.

Recommendation

Contact a qualified professional.

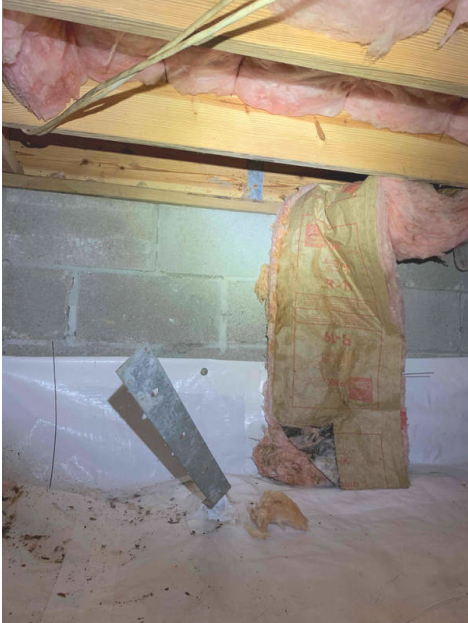
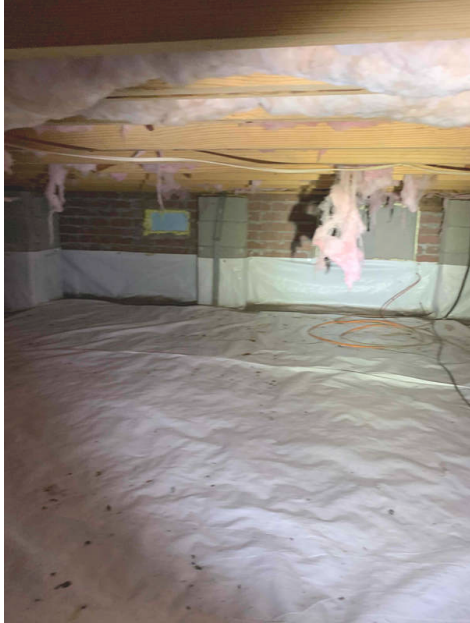
DAMAGED INSULATION

Moderate Deficiency

Insulation falling down in one or more areas. Recommend a qualified professional repair.

Recommendation

Contact a qualified professional.

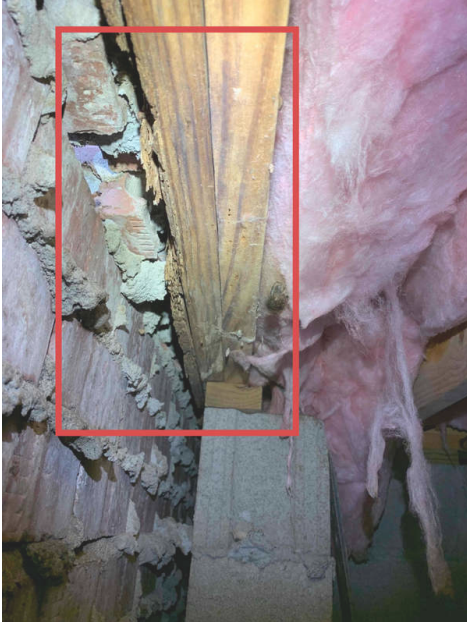
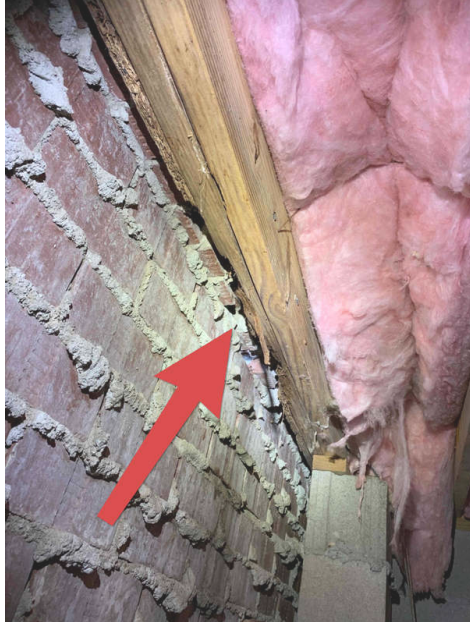
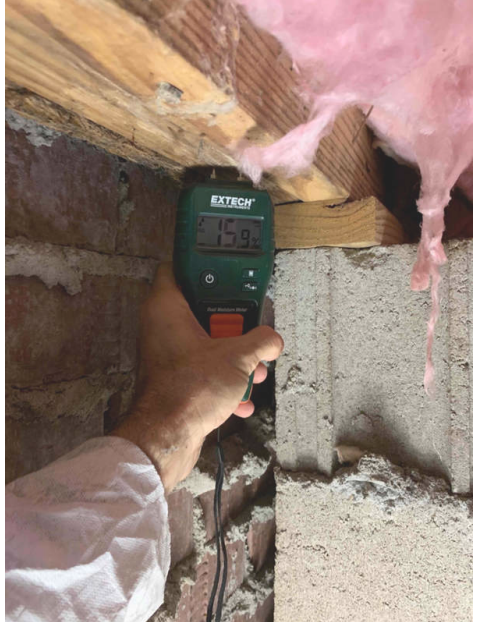
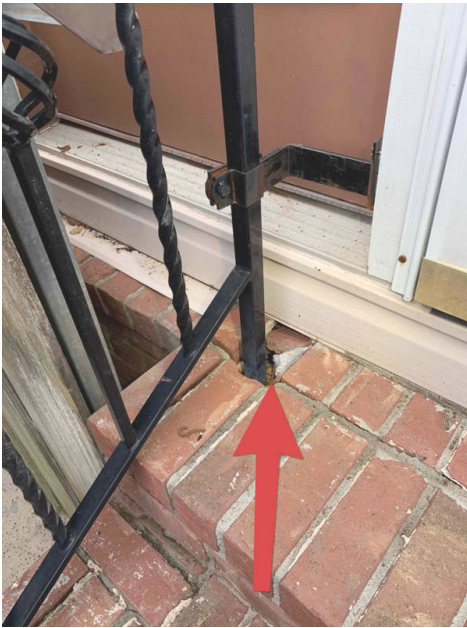
Back of the home

MOISTURE INTRUSION/ WOOD ROT

Significant Deficiency/ Safety Hazard

Observed one or more areas where there were signs of moisture intrusion and rotting on the band joist. Recommend a qualified contractor evaluate the extent of the rot, repair the moisture intrusion point and repair as needed.

Recommendation

Contact a qualified general contractor.
