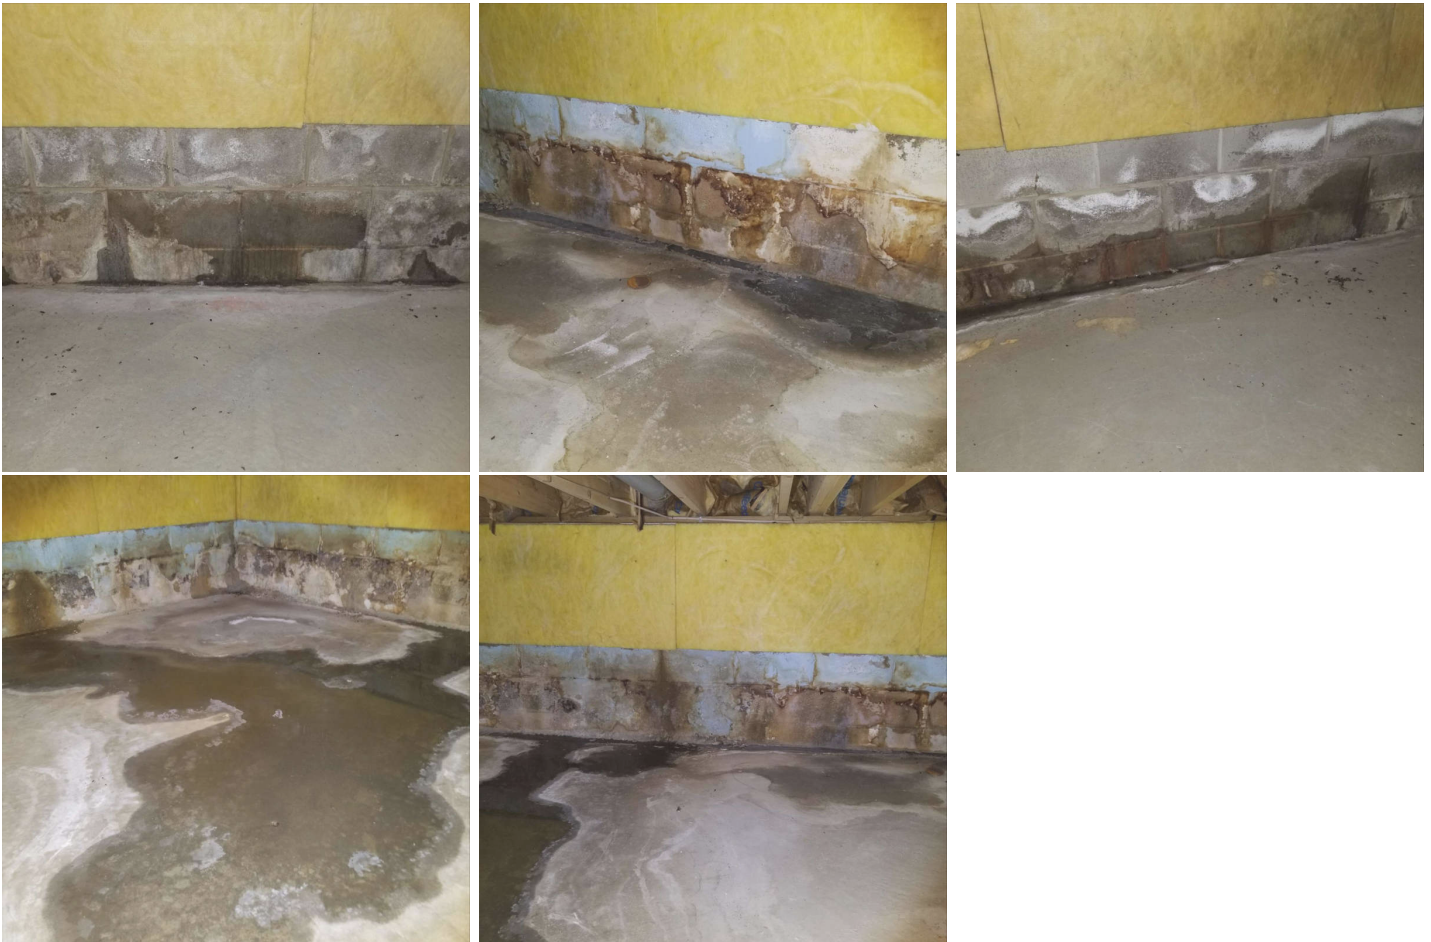
CRAWLSPACE

**FOUNDATION - MOISTURE INTRUSION**

The foundation wall had multiple areas of moisture staining and active moisture intrusion. Moisture on the walls can be common and is typically directed to the sump pit. However, some water was observed pooling on a portion of the crawlspace floor. Continued moisture intrusion may result in damage to the home. Recommend a qualified waterproofing contractor to evaluate and repair.

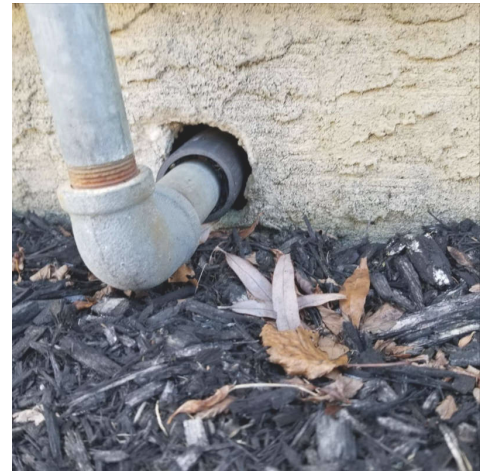
##### GAS METER PIPING

#### **SEALANT NEEDED**

A protrusion through the exterior wall was found to have damaged or missing sealant. Deteriorated or missing sealant could allow water intrusion causing damage to the exterior and interior components of home. Recommend sealing these gaps.

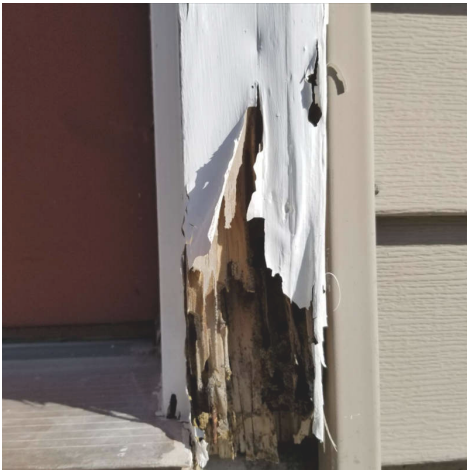
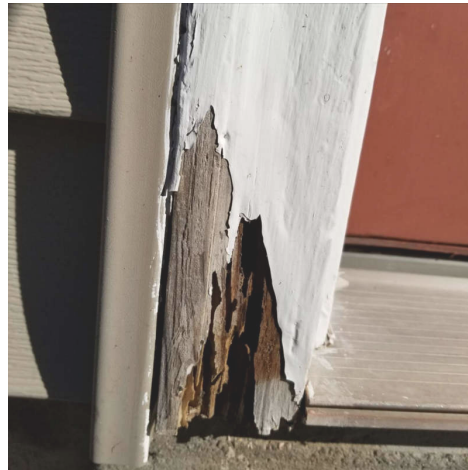
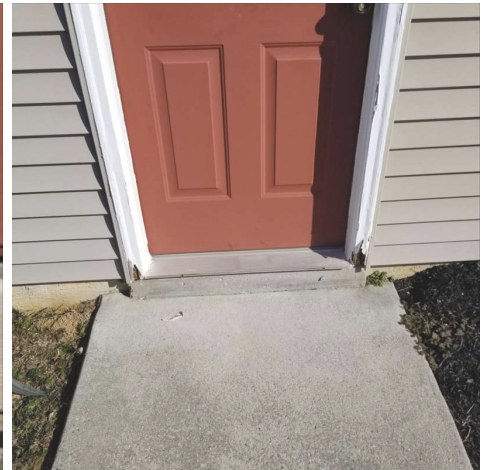
##### LEFT SIDE DOOR

#### **DOOR SILL/TRIM - DETERIORATION**

The door sill/trim has missing paint, termite damaged wood, and missing sealant. This could allow water intrusion into the home, further damage to the wood, and damage to the home. Recommend replacing the trim.

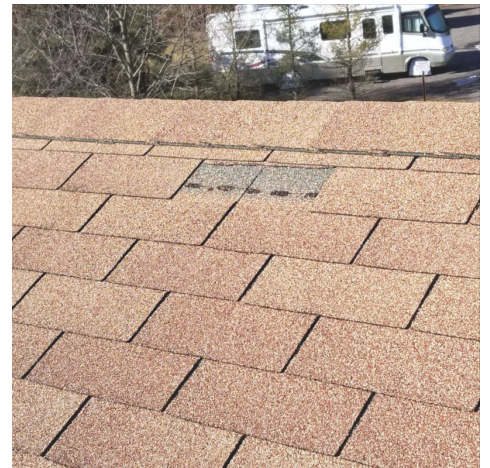
##### FRONT OF ROOF

#### **SHINGLES - BROKEN/CHIPPED**

One of the asphalt shingles on the roof of the home is broken or chipped. This could lead to water intrusion which may cause damage to the structure and interior components of the home. Recommend a licensed roofing contractor to repair.

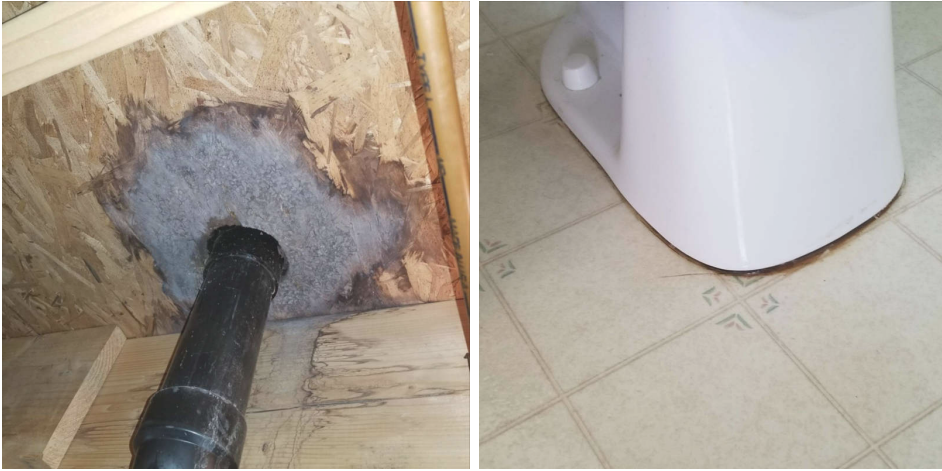
MASTER BATHROOM

**TOILET - LEAKING**

A toilet was observed that is leaking at the base. This could result in sewage entering the home and causing damage. Recommend a licensed plumber to repair or replace.

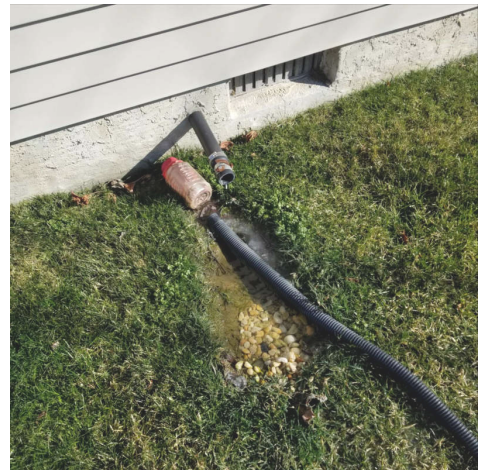
REAR LEFT CORNER

**SUMP PUMP - EXTENSION  
DISCONNECTED**

Due to the disconnected extension, the sump pump discharges directly next to the foundation. This could result in high levels of moisture in the soil surrounding the foundation which could lead to moisture intrusion into the basement. Recommend reconnecting the extension so the water discharges further from the foundation.

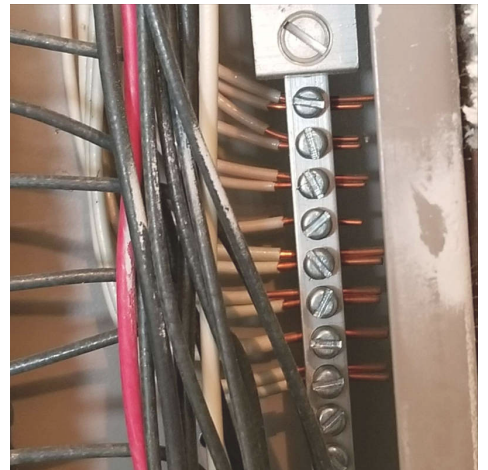
DISTRIBUTION PANEL

**MULTIPLE NEUTRAL CONDUCTORS  
UNDER BUS SCREW**

The electrical panel had more than one neutral conductor inserted under a single bus bar screw. The bus bar is designed to accept only one conductor per screw. This could lead to electrical system malfunction and creates a fire hazard. Recommend a licensed electrical contractor to repair.

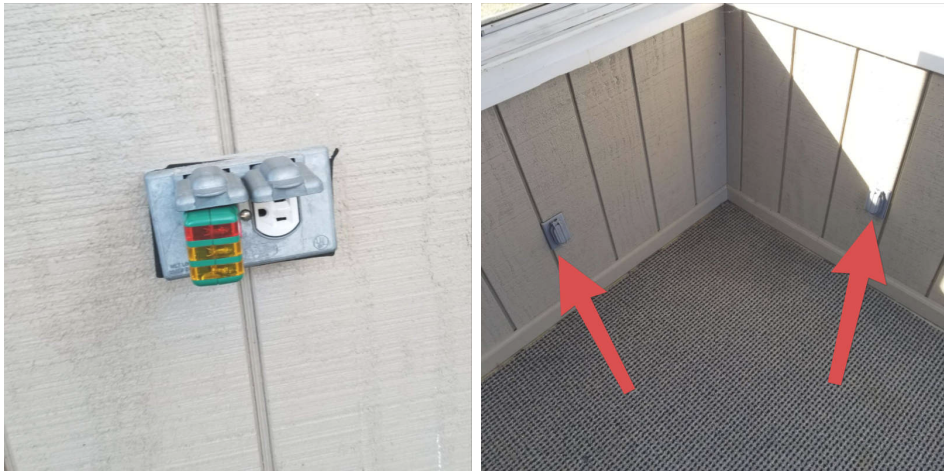
ALL SUN ROOM RECEPTACLES

**RECEPTACLE - INOPERABLE**

The electrical receptacle was not working at the time of inspection. Recommend a licensed electrical contractor to repair all broken or inoperable receptacles.

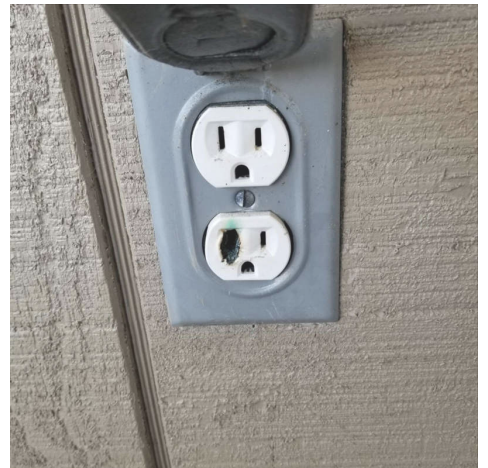
REAR SUN ROOM, RIGHT WALL

**RECEPTACLE - DAMAGED**

The electrical receptacle is damaged and broken. It appears to have had an electrical malfunction. This creates an electrical shock and fire hazard. Recommend a licensed electrical contractor to evaluate and replace.

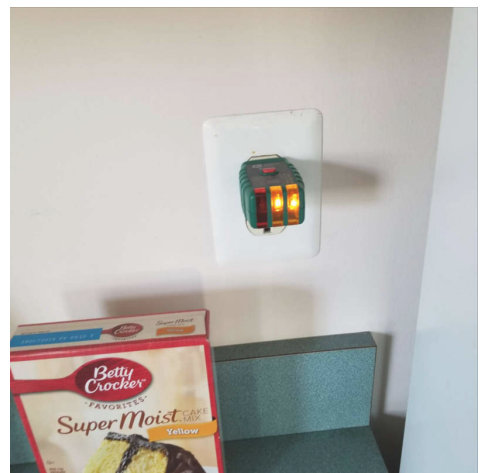
RIGHT SIDE OF STOVE

**NO GFCI PROTECTION INSTALLED**

An interior electrical outlet was observed without GFCI protection. This could lead to an electrical shock. Recommend a licensed electrical contractor to repair/replace.

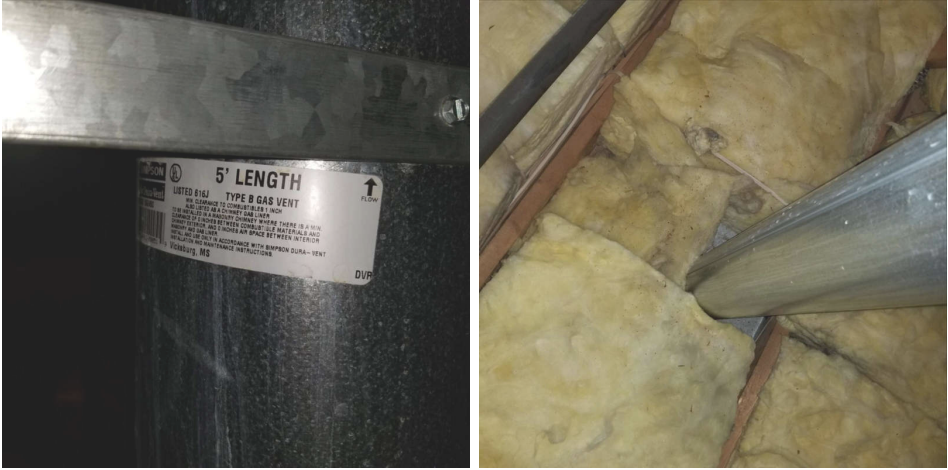
ATTIC

**INADEQUATE CLEARANCES**

Several pieces of fiberglass insulation are in contact with the metal B-vent. This is a fire hazard. The manufacturer of the B-vent recommends a 1 inch clearance for all combustible materials. Recommend removing all combustible materials from within 1 inch around the vent and secure all insulation and other combustible materials to prevent this problem from reoccurring.

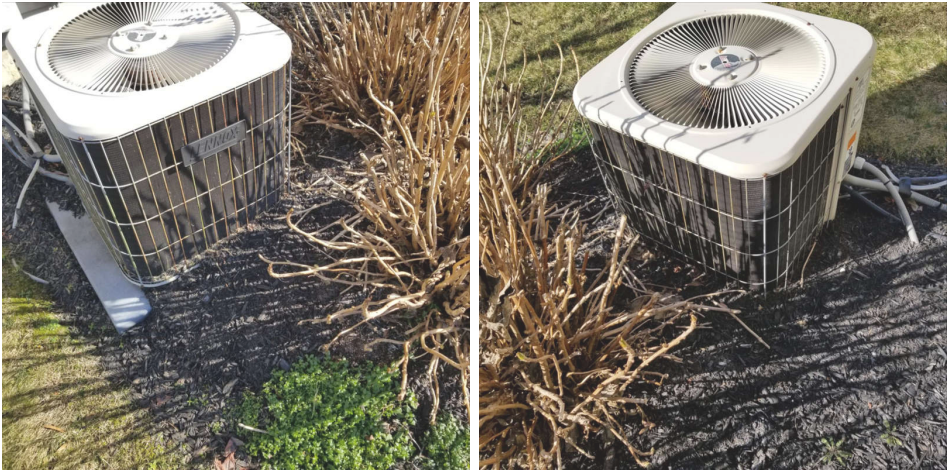
CONDENSER UNIT

**AIR CONDITIONER - COILS DAMAGED/DIRTY**

The air conditioning coils around the bottom of the condenser unit are dirty and have damaged fins. This could lead to a restricted airflow, decreased efficiency, and increased cooling costs. Recommend a licensed HVAC contractor to service, clean, and repair.

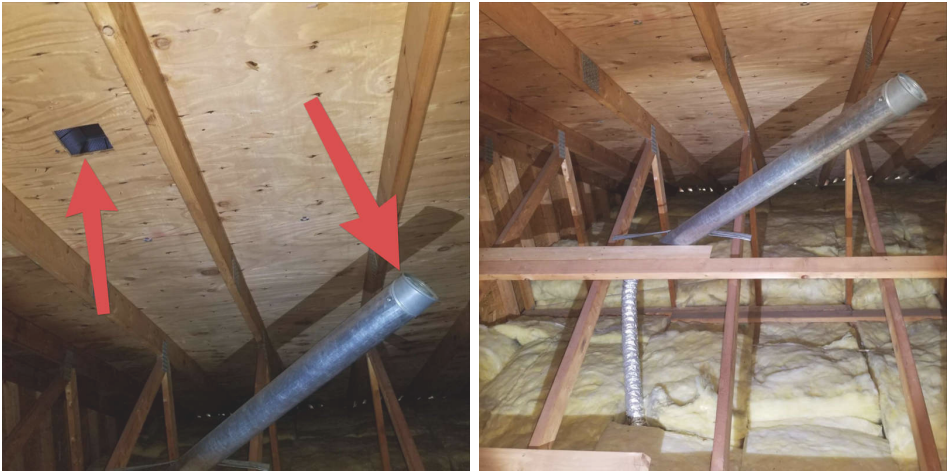
### BATHROOM EXHAUST FAN VENT - DISCONNECTED

ATTIC  
The bathroom exhaust fan vent is disconnected. This can cause moisture from the bathroom to vent into the attic resulting in damage to the wood, insulation and/or mold development. Recommend reconnecting this vent.

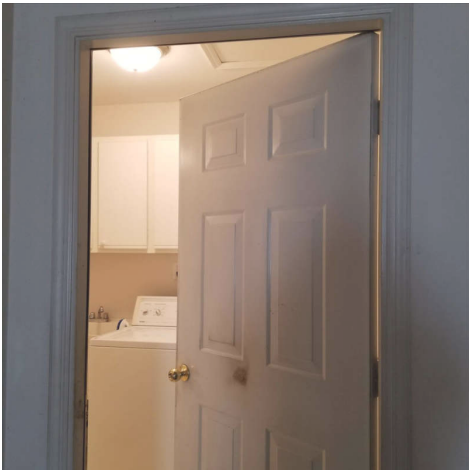
GARAGE

### DOOR - NOT SELF-CLOSING

The door from the garage to the interior of the home is missing a self-closing system. These hinges keep the door closed to help prevent the spread of fire and toxic gases to living space should they occur. Recommend a licensed contractor to install a self-closing system.
