**SUMMARY**  
1234 Main St. Dollard des Ormeaux QC  
H9A2K1  
Buyer Name  
11/14/2018 9:00AM

Jacek Stomal  
Bartek Inspections  
514 993-2883  
clientcare@bartekinspections.com

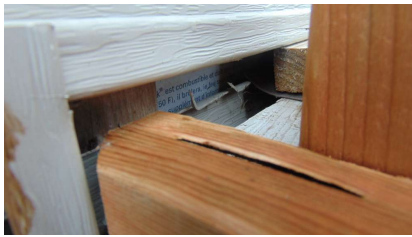
### DECK - WALL JUNCTION

Left side of the balcony had an exposed wall structure. possible water infiltration.

Recommendation  
Contact a qualified professional.

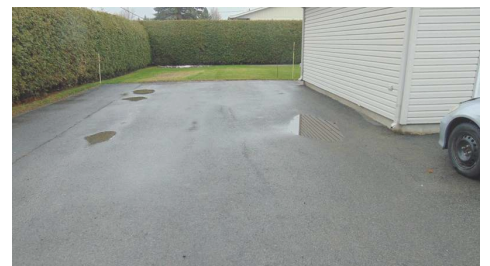
### DRIVEWAY DRAINING TOWARDS HOME

The driveway has a negative slope and drains towards the structure. Recommend a driveway contractor evaluate and repair.

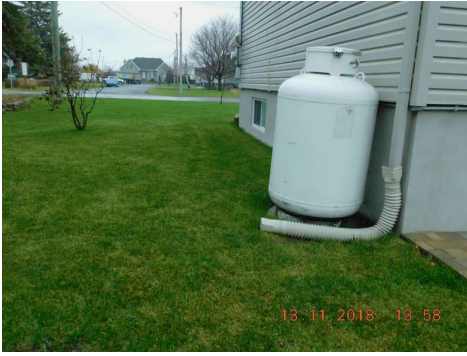
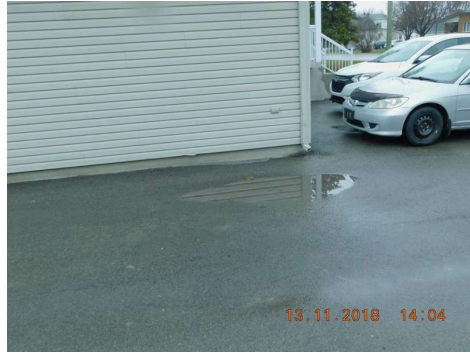
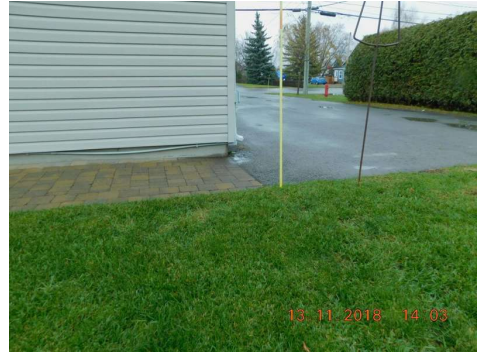
### NEGATIVE GRADING

Grading is sloping towards the home in some areas. This could lead to water intrusion and foundation issues. Recommend qualified landscaper or foundation contractor regrade so water flows away from home.

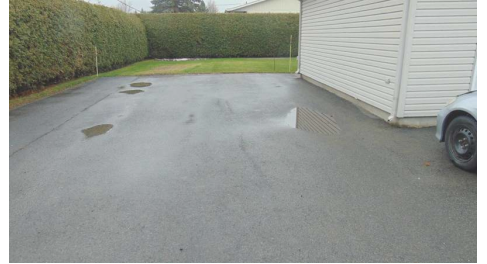
**STANDING WATER**

Standing water observed, which could indicate poor drainage and/or grading. Recommend monitor and/or have landscaper correct.

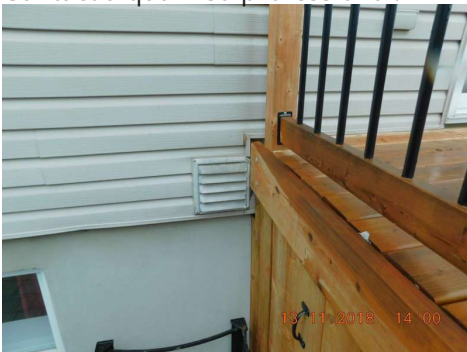
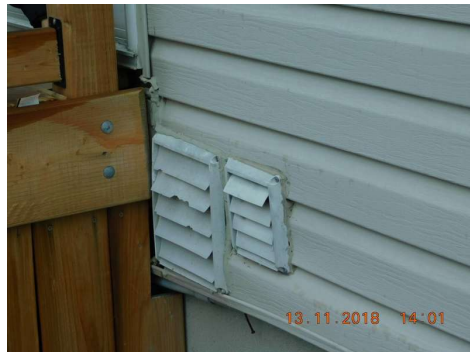
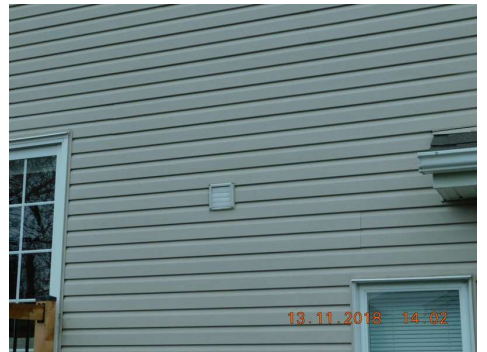
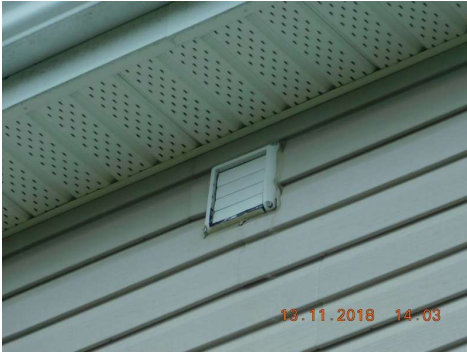
**PLASTIC VENT COVERS**

Deteriorated Plastic vent covers should be replaced with good quality metal ones.

Recommendation  
Contact a qualified professional.

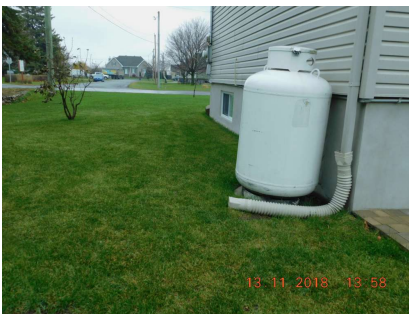
One or more downspouts drain too close to the home's foundation. This can result in excessive moisture in the soil at the foundation, which can lead to foundation/structural movement. Recommend a qualified contractor adjust downspout extensions to drain at least 6 feet from the foundation.

Gutter extension is sending water up hill.

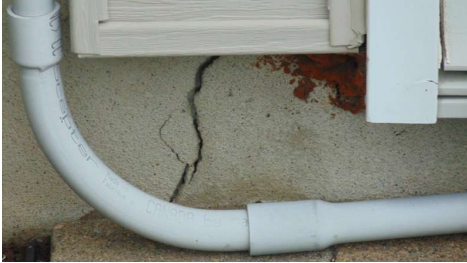
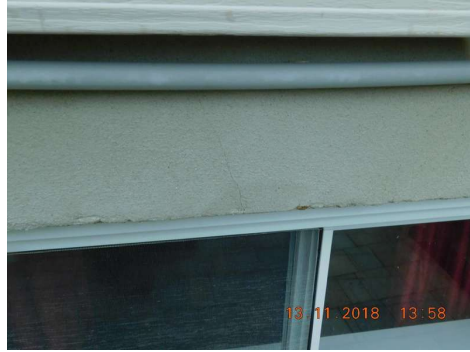
### FOUNDATION CRACKS - MINOR

Minor cracking was noted at the foundation. This is common as concrete ages and shrinkage surface cracks are normal. Recommend monitoring for more serious shifting/displacement.

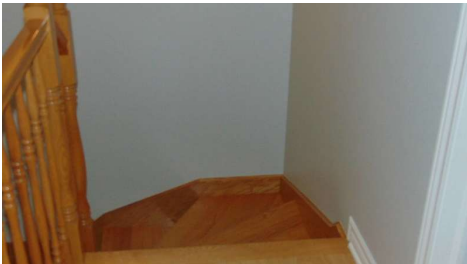
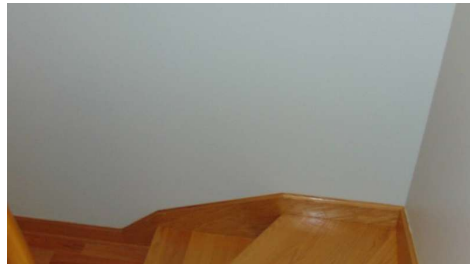
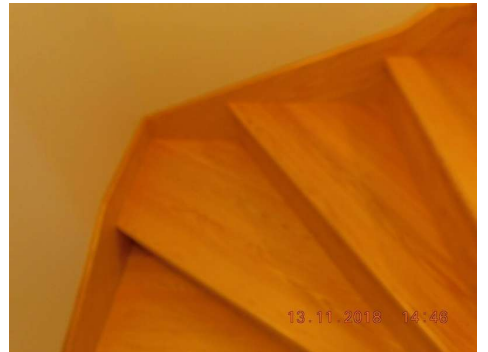
6.1.1 Steps, Stairways & Railings  
**NO HANDRAIL**

Staircase had no handrails, it is required that the rail is continuous along the entire staircase. This is a safety hazard. Recommend a qualified handyman install a handrail.

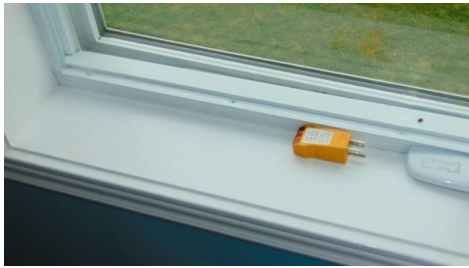
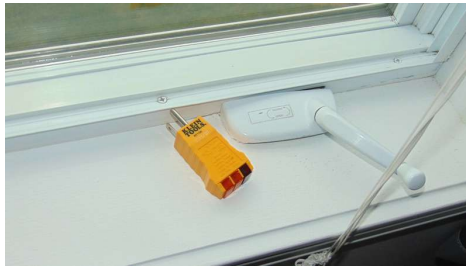
**DAMAGED**

One or more windows appears to have general damage, but are operational. Window did not close properly. The mechanism (crank) was loose. Recommend a window professional clean, lubricate & adjust as necessary.

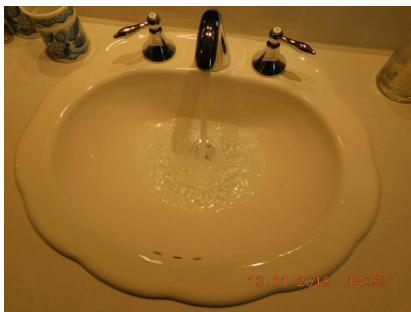
**SLOW DRAINING SINK**

Sinks was draining slowly; the drain will require cleaning.

Contact a qualified plumbing contractor.

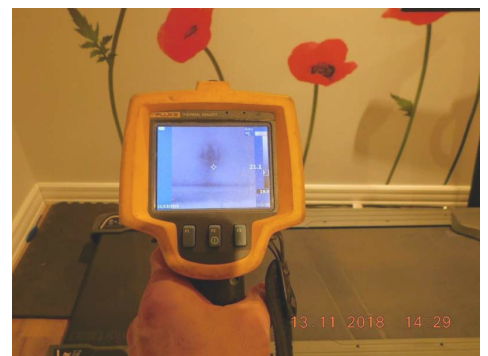
## LACK OF VAPOUR BARRIER

Due to lack of vapour barrier there is cold air infiltration through the plugs and switches.

Contact a qualified professional.

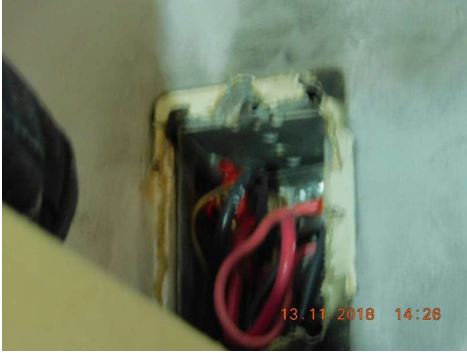
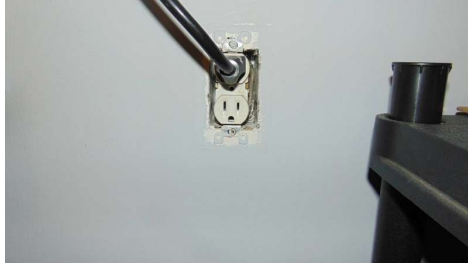
**COVER PLATES MISSING**

One or more receptacles are missing a cover plate. This causes short and shock risk. Recommend installation of plates.

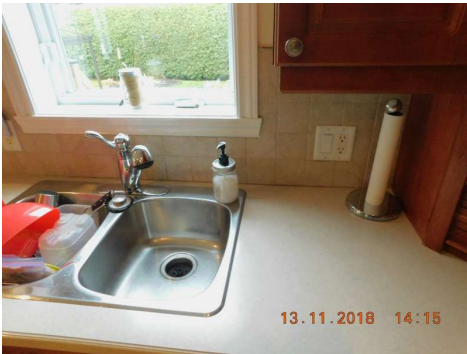
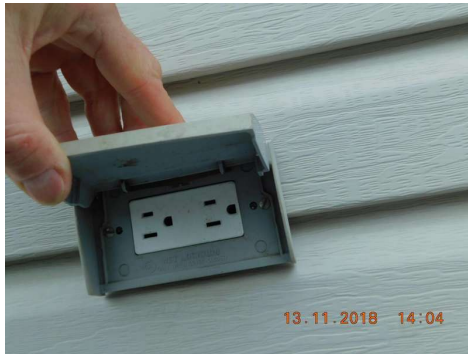
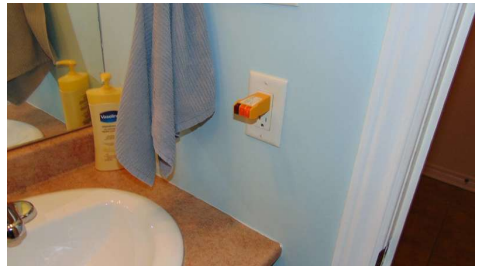
**NO GFCI PROTECTION INSTALLED**

No GFCI protection present in all locations. Recommend licensed electrician upgrade by installing ground fault receptacles in all locations.

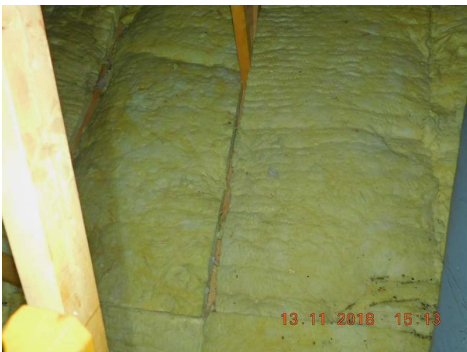
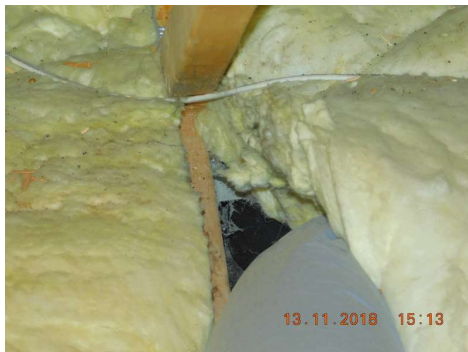
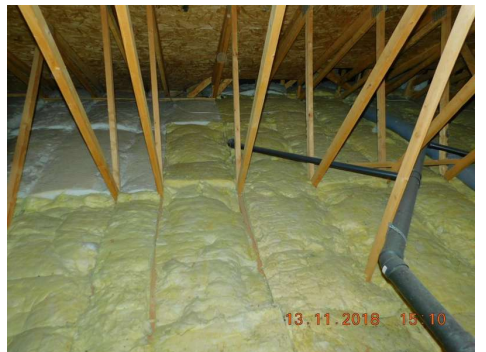
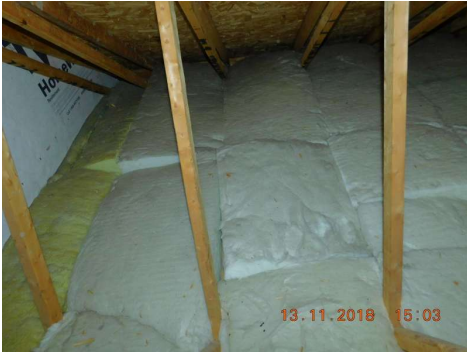
**INSUFFICIENT INSULATION**

Insulation depth was inadequate, space non insulated between the batting. Recommend a qualified attic insulation contractor install additional insulation.

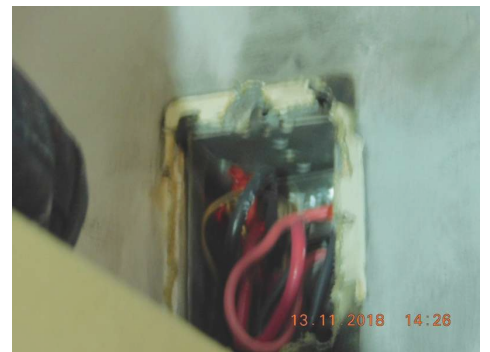
**BURNED WIRING**

Signs of burned wires on the wall in the garage. Recommended to verify by Master electrician

Contact a qualified professional.
