SUMMARY
1234 Main St. South Farmington NS
B0P1W0
Buyer Name
01/23/2018 9:00AM

Wayne Thurber
Certified Master Inspector
Kirwynd Real Estate Services
902-848-1033
kirwynd@gmail.com

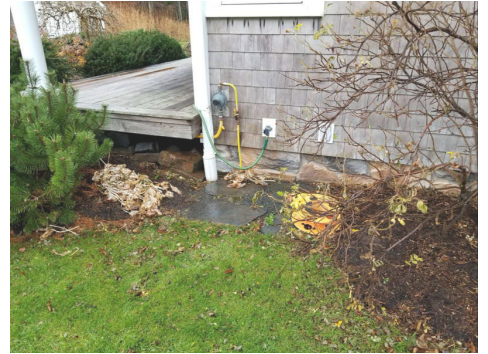
1.10.1 Grading & Surface Drainage **LOW AREA WITH BASEMENT**

There were low spots visible near the foundation wall which will collect water and can increase the potential for foundation seepage. Recommend filling or re-grading the affected areas as needed in order to create the proper slope away from the home while maintaining adequate clearances from the top of the foundation wall.

Recommendation
Contact a qualified landscaper or gardener.

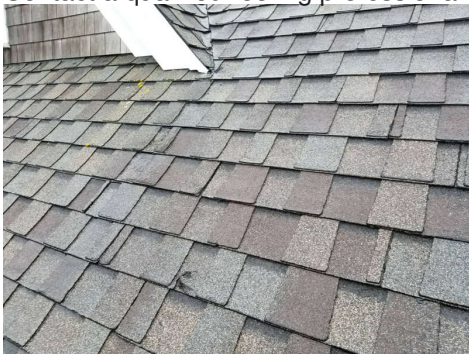
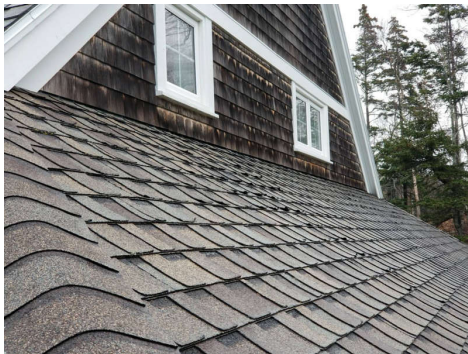
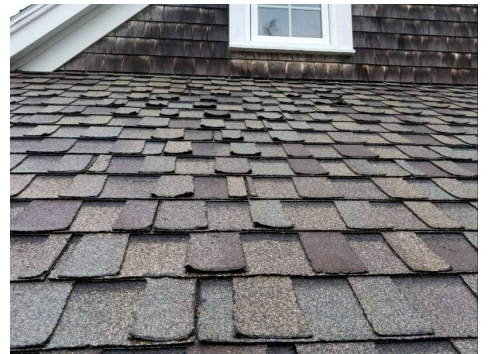
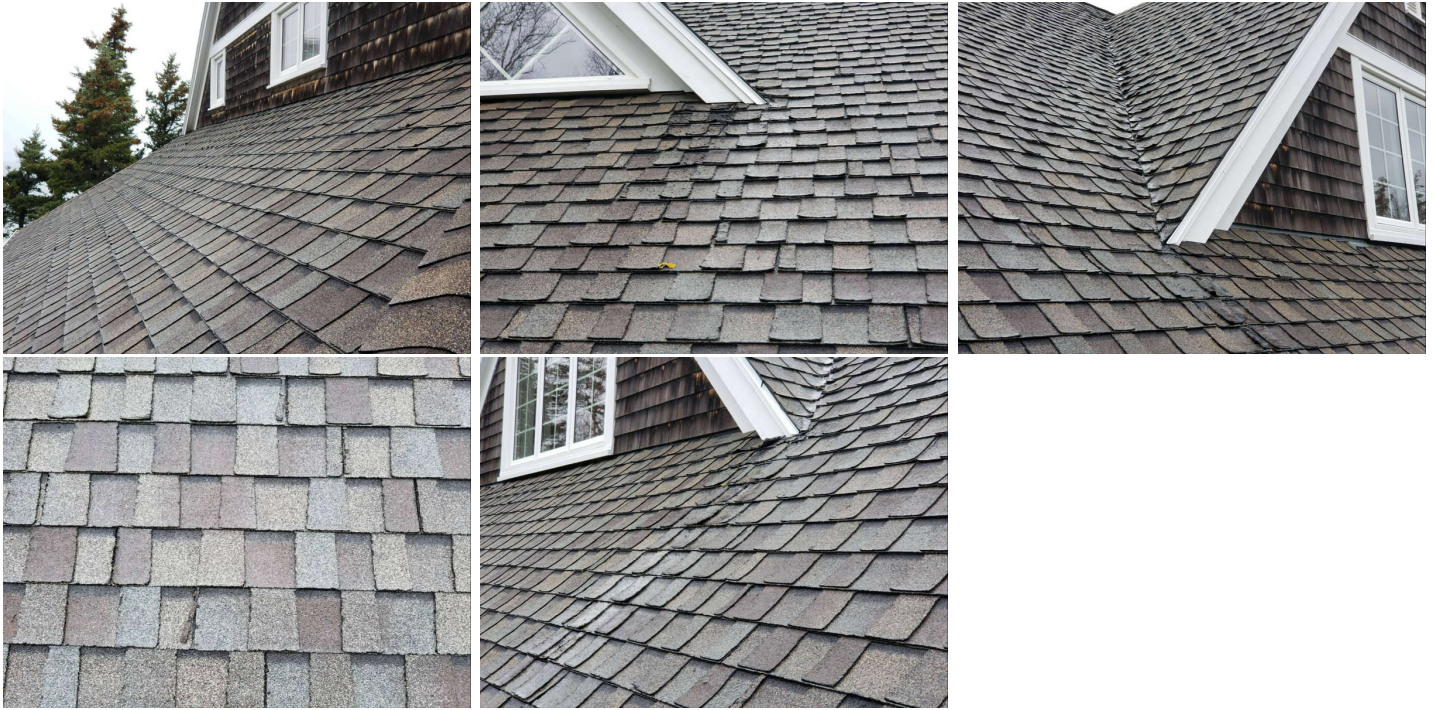
2.2.2 Roof Covering **DEFECTIVE SHINGLES**

Accelerated deterioration of the roof covering material appeared to be the result of a manufacturing defect. These shingles appeared to be approaching the end of their useful service life, and will require replacement long before their rated lifespan rating. Some areas appeared to be in need of replacement at this time (most notably below the south dormer valleys) in order to reduce the risk of damage to the home that may result from leaking. You are advised to have the roof covering reviewed by a qualified roofing contractor in order to determine whether a pro-rated manufacturer's warranty may be applicable and to provide a quote and estimated time line for replacement.

Recommendation
Contact a qualified roofing professional.

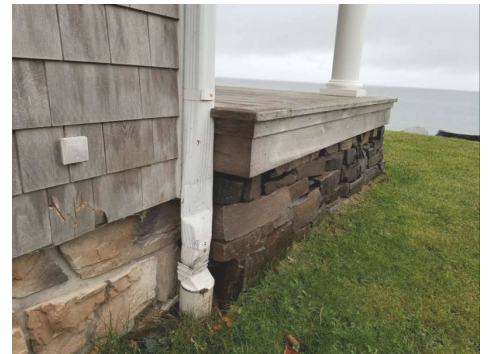
2.6.3 Roof Drainage System

A downspout designed to discharge roof drainage was damaged or in disrepair and may limit its ability to function as designed. Recommend repair to help protect the home structure.

Recommendation
Contact a qualified professional.

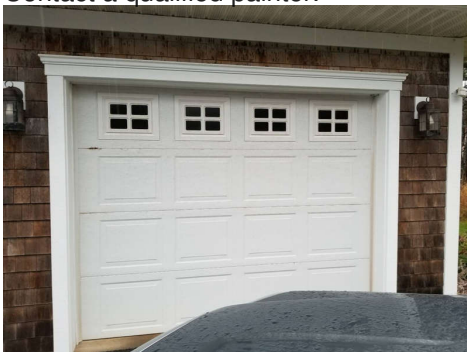
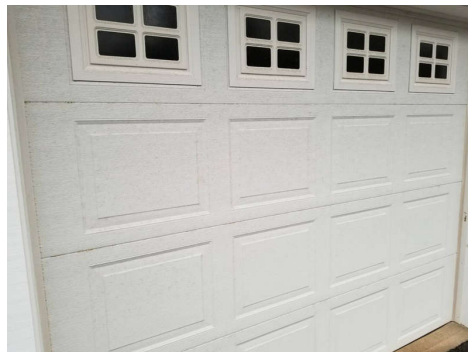
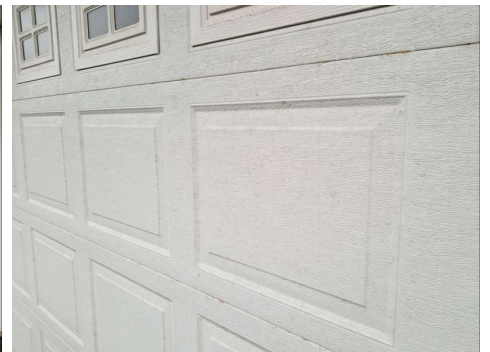
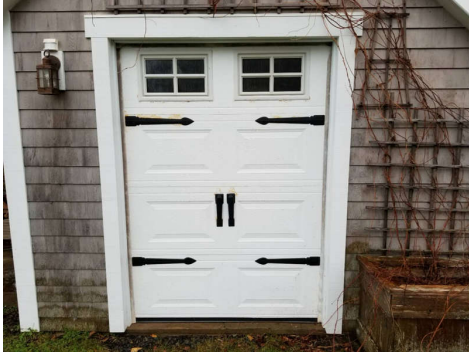
3.3.1 Garage Door(s)

Weathered/rusted garage door panels were observed. This is not uncommon for age and location. Recommend maintenance be performed to help protect the panels from further deterioration.

Recommendation
Contact a qualified painter.

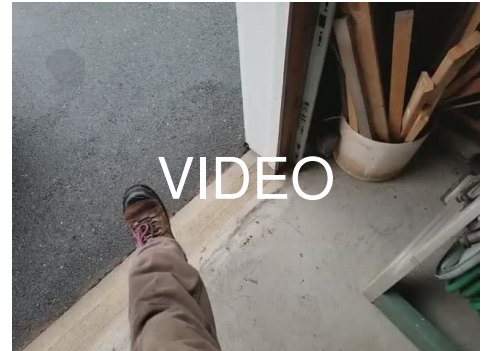
3.4.1 Garage Door Opener(s)

An automatic-reverse photoelectric sensor at an overhead garage door was inoperable. Photoelectric sensors are devices installed to prevent injury by raising the vehicle door if the sensor detects a person on a position in which they may be injured by the descending door. Installation of photo sensors in new homes has been required by building codes since 1993. Correction of this condition is advised.

Contact a qualified garage door contractor.

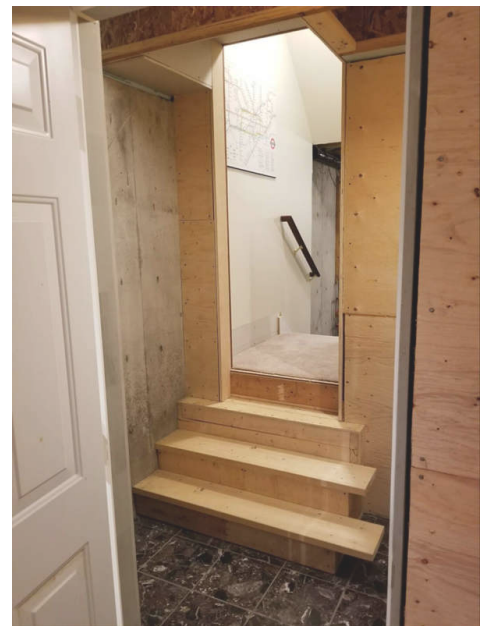
6.6.1 Stairways and Railings

Although a staircase had more than two risers, no handrail was installed. Recommend a handrail be installed to comply with modern safety standards.

Contact a qualified carpenter.

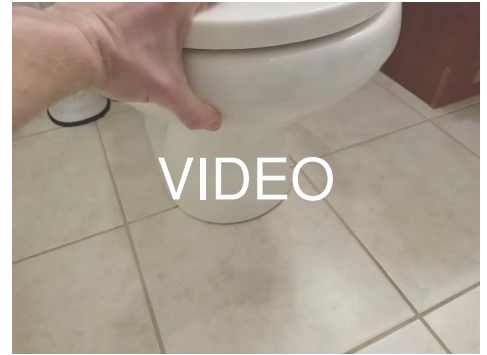
7.3.1 Toilet(s)

A loose toilet was observed. The wax ring seal inside the unit must have a snug, secure fit in order to keep from leaking. Properly resealing and re-securing this toilet is advised to prevent water leakage and damage to the sub-flooring beneath the fixture. Repairs may involve re-setting the toilet on a new wax seal.

Recommendation
Contact a qualified plumbing contractor.

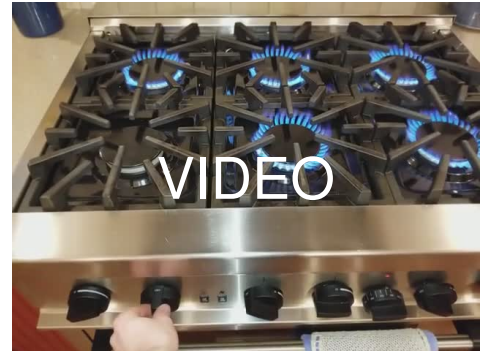
8.3.1 Ranges, Ovens, Cooktops

There were that burners did not operate properly when tested.
Recommend repair by a qualified appliance technician.

Recommendation
Contact a qualified appliance repair professional.

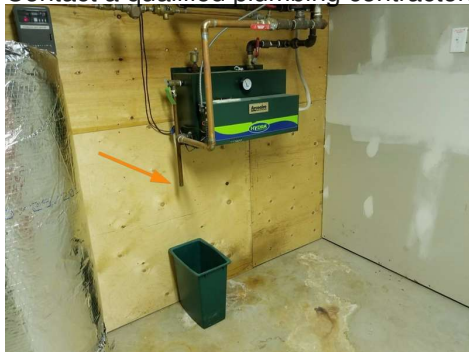
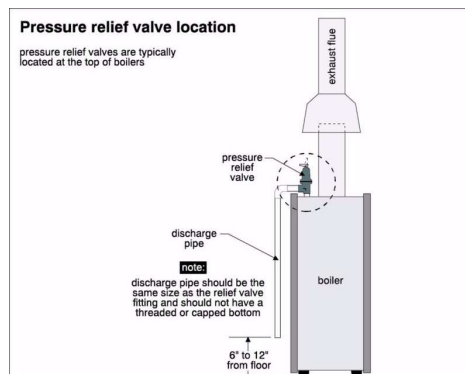
9.3.1 Heating System

The temperature pressure relief valve's discharge tube was too short. This safety valve releases water (and thus relieves pressure) if either the temp or pressure in the tank gets too high. The TPR valve discharge tube must terminate within 6" above the floor in order to ensure any potential blow-off is directed away from occupants. Recommend extending TPR discharge tube with 3/4" copper pipe to within 6" off the floor.

Recommendation
Contact a qualified plumbing contractor.

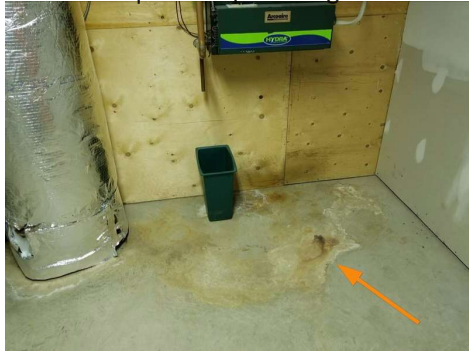
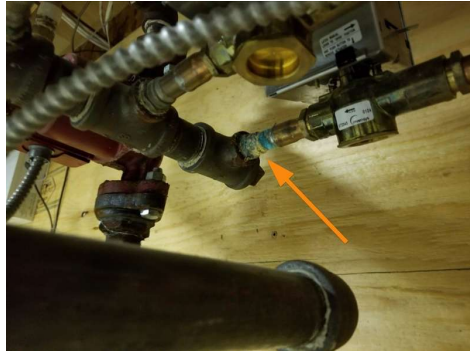
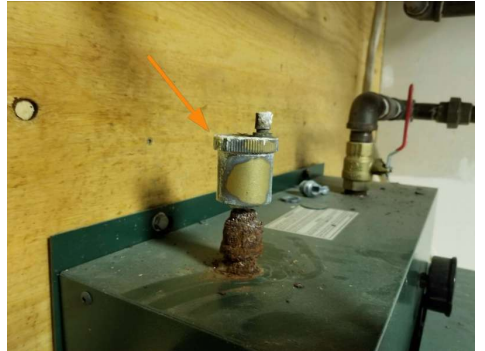
9.3.2 Heating System

Evidence of a past over temperature or pressure event was evident by staining on the basement floor below the TPRV discharge tube, while this may have occurred during the life of the previous boiler, a bucket below the tube indicates some leaking may still occur and may need to be addressed. Signs of past leaking and corrosion were also noted at the air vent and one fitting. It is advised that the boiler and associated components/fittings be reviewed, serviced and repaired as necessary as part of good maintenance practices to help prevent the potential for damage from leaking.

Contact a qualified plumbing contractor.

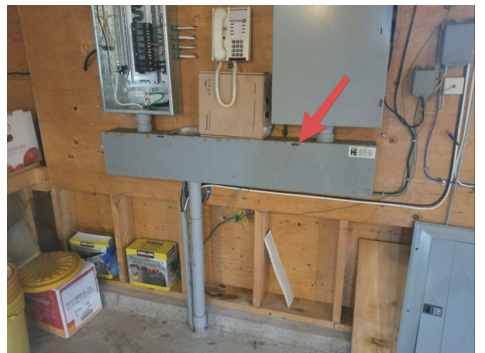
10.3.1 Sub Panel

Although not a requirement of the Canadian Electrical Code; using a zip tie to lock the access cover to the gutter containing the main panel and sub panel feeders is advised in order to reduce the potential for children to access to these high ampacity, exposed terminations.

Recommended DIY Project

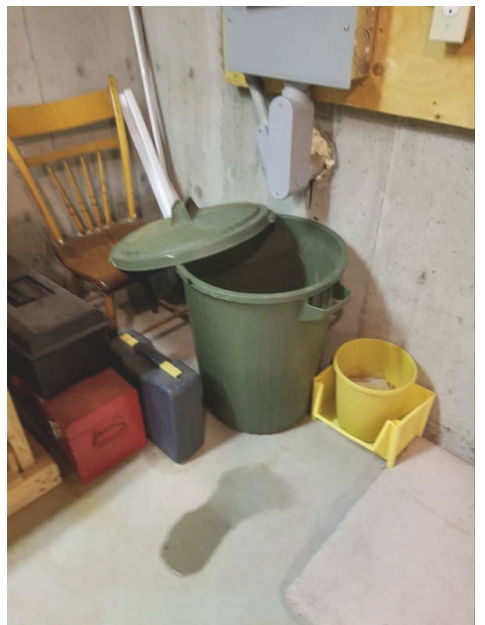
10.4.1 Branch Wiring

The conduit through which the feeders powering the electric service panel were housed, has filled with water and began leaking into the basement interior. Recommend repair as necessary to help prevent the potential for damage to the home or its contents which may arise from moisture intrusion.

Contact a qualified electrical contractor.

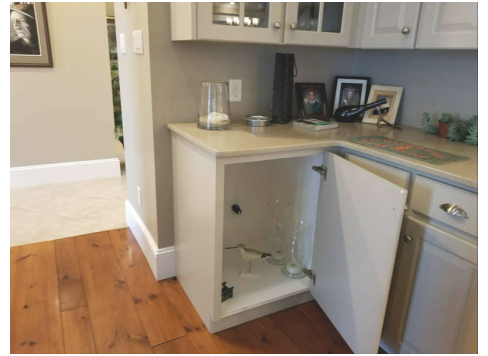
10.5.2 Lighting, Fixtures, Outlets & Switches

A receptacle was located within a cabinet. This is typically not an approved installation, unless it is intended to serve a specific appliance which is intended for such an application. You should consider properly terminating the receptacle if this is not the case.

Contact a qualified electrical contractor.

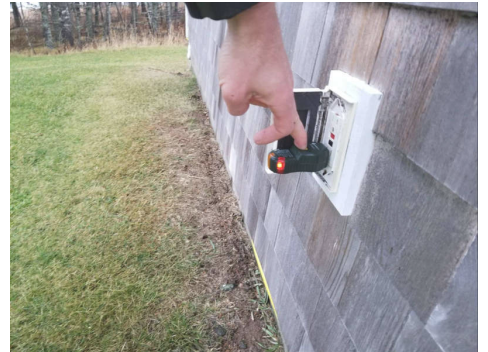
10.6.1 GFCI Protection

There were receptacles installed at wet locations that did not properly respond to trip testing. There is the potential for a shock hazard from unprotected receptacles at wet locations. Recommend correction by a licensed electrician.

Contact a qualified electrical contractor.

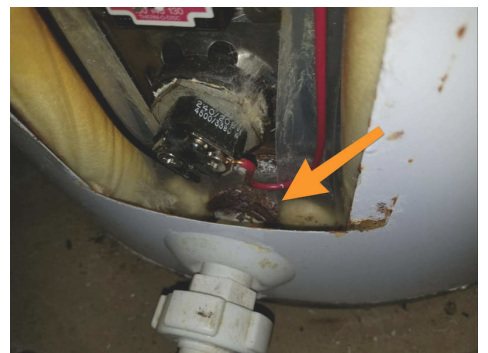
11.8.1 Water Heater

The water heater was past its typically expected life span. Some corrosion was observed within the unit near the element. As water heaters may fail at any time, and often without any warning, it is advised that the water heater be replaced at this time, prior to it's failure. The client should be aware that significant flooding can occur if the water heater fails. If replacement is put aside until a later time, it is recommended that a catch pan with drain, or a water alarm be installed by a qualified person to help prevent damage in the case of water leaks.

Contact a qualified plumbing contractor.

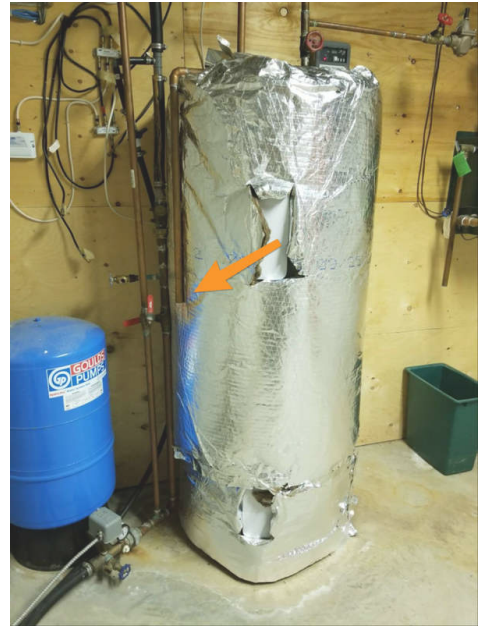
11.8.2 Water Heater

TPR TUBING TOO SHORT

Recommend extending TPR discharge tube with 3/4" copper pipe to within 6" off the floor.

Contact a qualified plumbing contractor.
