**SUMMARY**  
 1234 Main St. Boulder Colorado 80305  
 Buyer Name  
 12/13/2018 9:00AM

Eric Ernst  
 NACHI1707013  
 HERO Inspections & Environmental  
 (303) 500-3378  
 eric@heroinspect.com

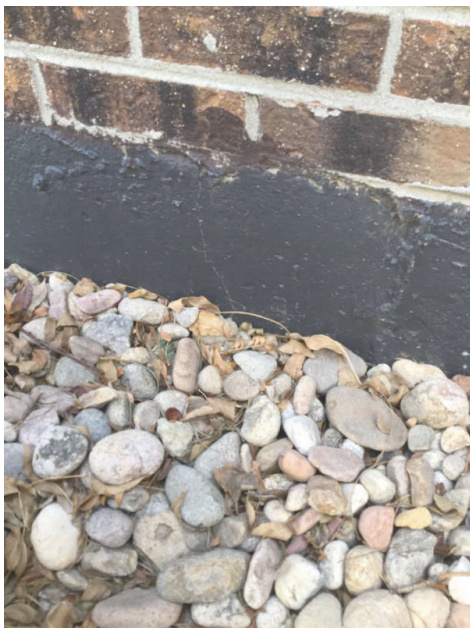
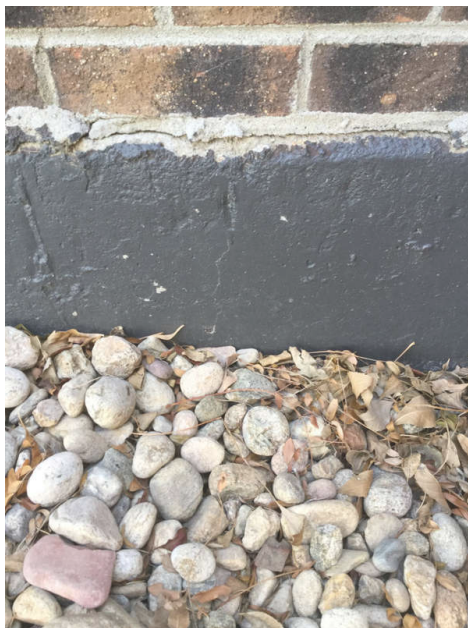
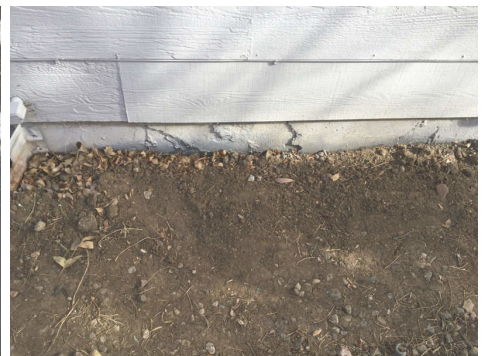
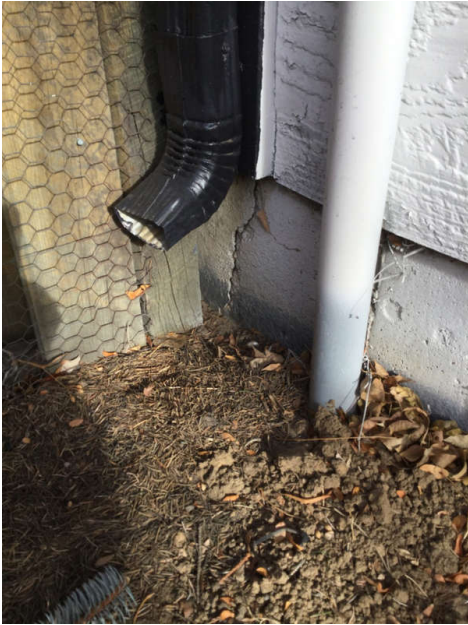
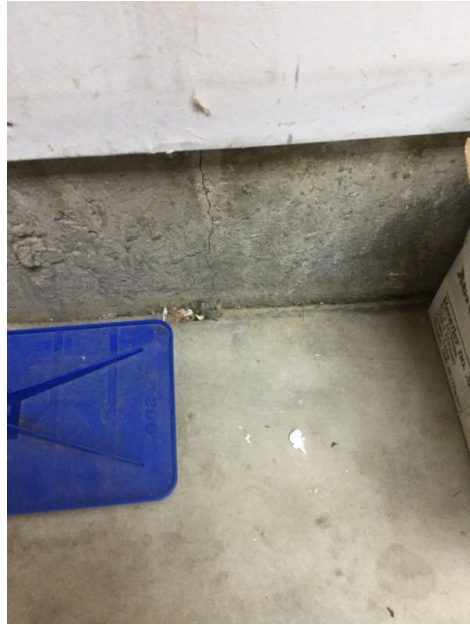
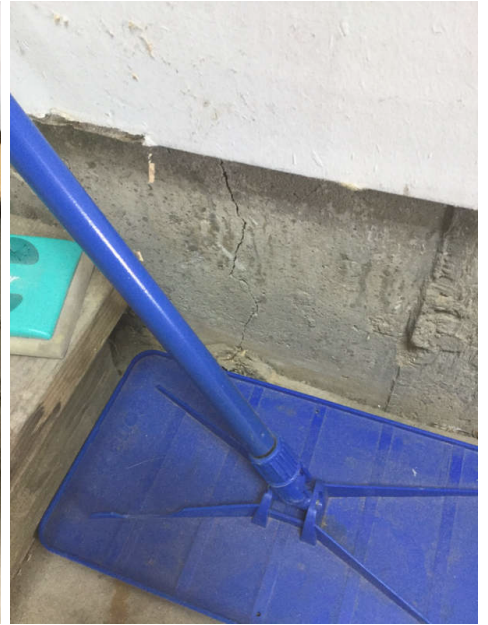
#### FOUNDATION - CRACKS - MINOR

There were minor cracks and/or cosmetic blemishes found in the foundation. These don't appear to be a structural concern, but recommend sealing them to prevent water infiltration and monitoring them in the future. Numerous products exist to seal such cracks including:

- Hydraulic cement. Requires chiseling a channel in the crack to apply.
- Resilient caulks (easy to apply).
- Epoxy sealants (both a waterproof and structural repair).

Recommendation  
 Contact a handyman or DIY project

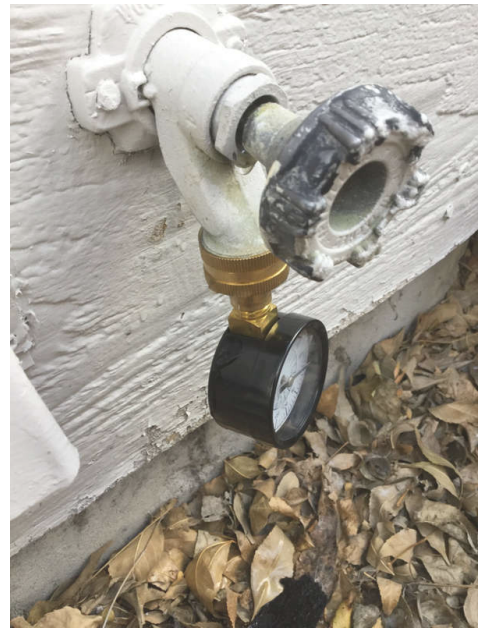
South Elevation

7.5.2 DRAINAGE/ PLUMBING/ GAS  
**FAUCET/ HOSE BIB - LEAKS**

The outside faucets leak. For example, from the valve stem when turned on or from the spigot when turned off. A qualified plumber should evaluate and repair as necessary.

Recommendation  
Contact a qualified plumbing contractor.

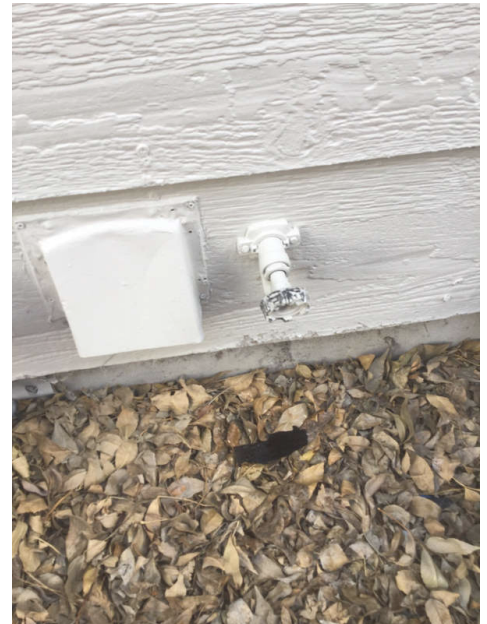
South Elevation

7.5.3 DRAINAGE/ PLUMBING/ GAS  
**FAUCET / HOSE BIB - NO ANTI-SIPHON**

Outside faucets are missing backflow prevention devices. These devices reduce the likelihood of polluted or contaminated water entering the potable water supply. This condition can occur when an outside faucet is left in the "on" position with a hose connected and the sprayer head turned off. When pressure in the system fluctuates, water can be drawn back into the water supply pipes from the house. If a chemical sprayer is being used with the hose, those chemicals can enter the water supply pipes.

Recommend installing backflow prevention devices on all exterior hose bibs where missing. They are available at most home improvement stores and are easily installed. For more information, visit:

Contact a qualified plumbing contractor.

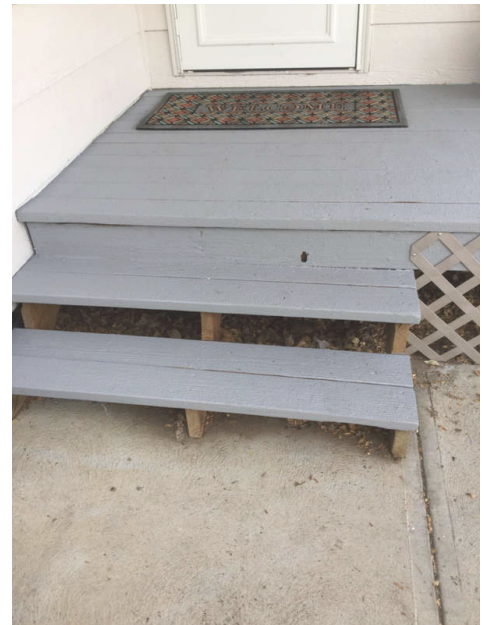
East Elevation

### HANDRAILS - MISSING

Flights of stairs with more than two risers have no handrail installed. This is a safety hazard. A qualified contractor should install graspable handrails that your hand can completely encircle at stairs where missing, and as per standard building practices.

Contact a handyman or DIY project

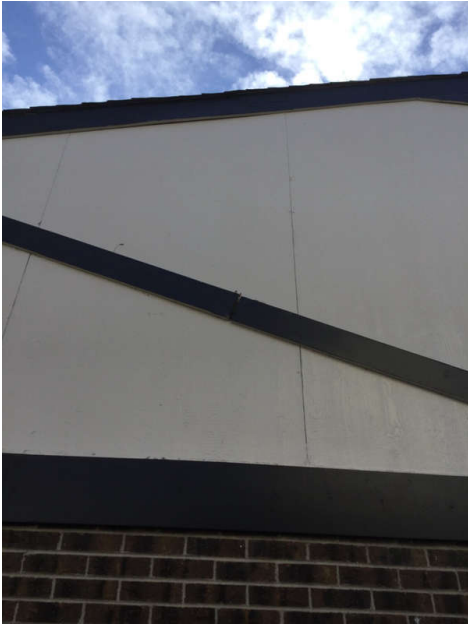
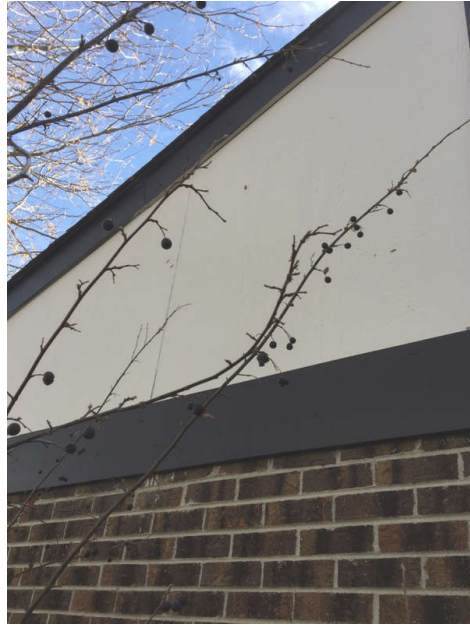
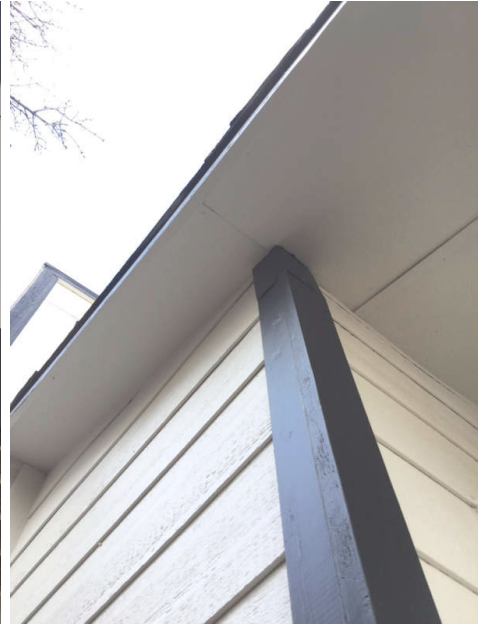
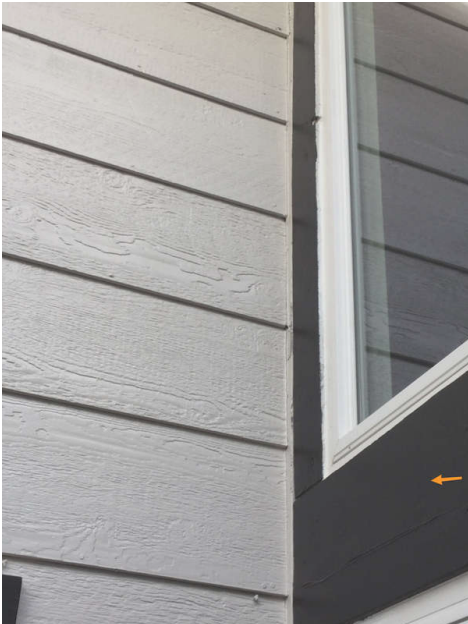
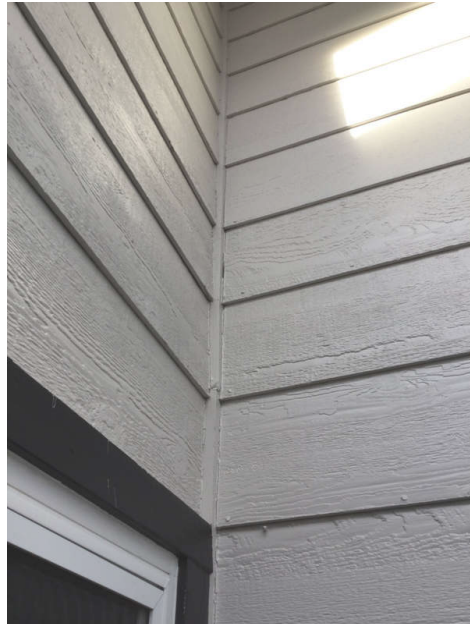
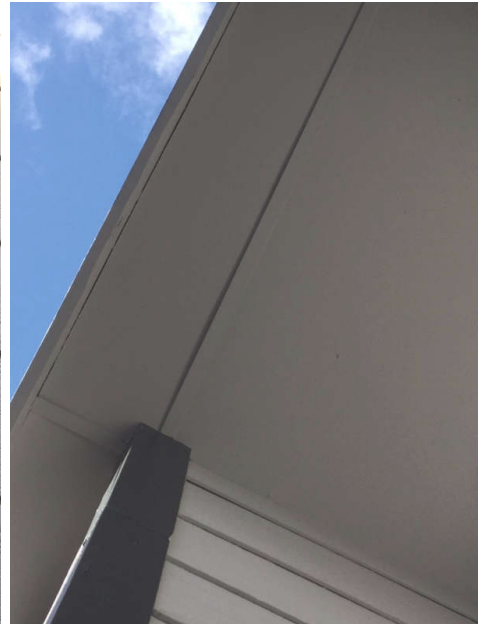
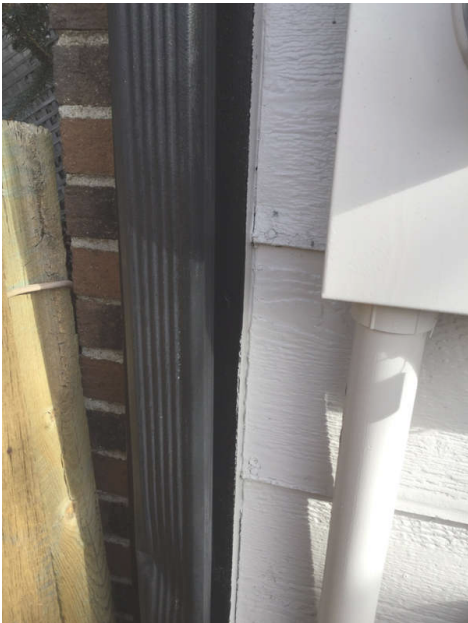
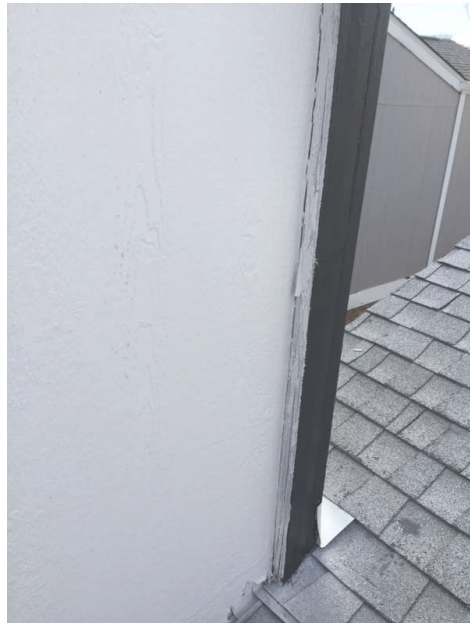
### CAULKING - GENERAL

Caulking/sealant is missing and/or deteriorated around the entire exterior where similar and dissimilar materials meet. This is a general maintenance situation which typically requires regular attention. A qualified contractor should evaluate and make repairs as necessary.

Contact a handyman or DIY project

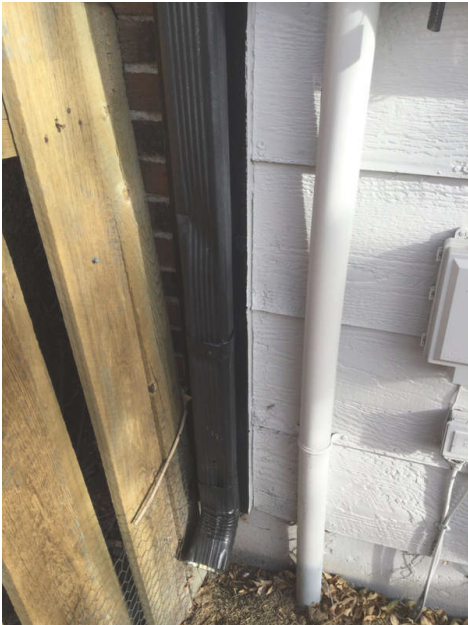
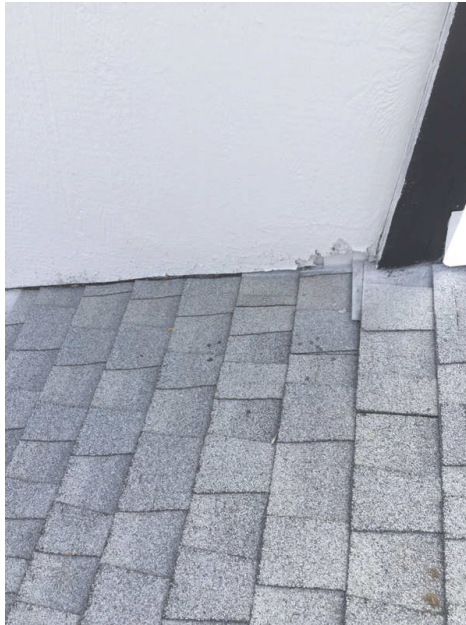
**SIDING - COMPOSITION SIDING - MINOR - MAINTAIN**

This property is clad with composition wood fiber siding. Many brands of this type of siding by different manufacturers are known to deteriorate and/or fail prematurely due to moisture penetration. Failure is typically visible in the form of swelling, cracking and delamination, especially at the bottom edges. Class action lawsuits have been filed or are being filed against most manufacturers of this material.

Some areas of siding on this structure show the symptoms described above, but it appears that the siding hasn't deteriorated to the point of needing replacement. Some manufacturers (Louisiana Pacific) recommend a repair process for this siding where affected areas are sealed with "Permanizer Plus", a flexible primer made by Pittsburgh Paint, followed by two coats of 100% acrylic latex paint. This sealant must be applied to the bottom edges using a brush. The face of the siding can be sprayed. The "Permanizer Plus" sealer isn't required for edges that aren't swollen, cracked or deteriorated, but the acrylic latex should still be brushed on these edges.

At a minimum, recommend having a qualified contractor seal and repaint as described above, or by other methods specified by the siding's manufacturer. The client(s) may wish to have a qualified contractor evaluate further to determine if some or all of the siding should be replaced.

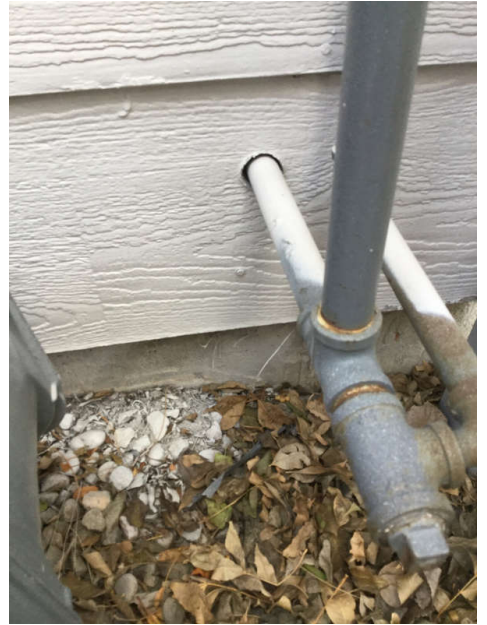
South Elevation

**SIDING - GAPS AT PENETRATIONS**

Gaps exist at openings around the exterior, such as those where outside faucets, refrigerant lines, and/or gas supply pipes penetrate the exterior. Gaps should be sealed as necessary to prevent moisture intrusion and entry by vermin.

Contact a handyman or DIY project

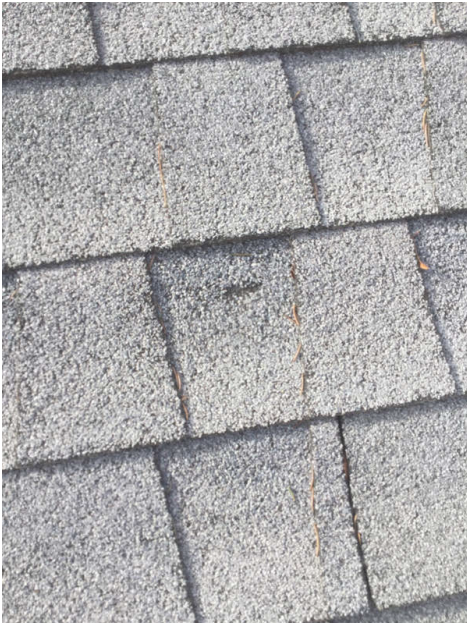
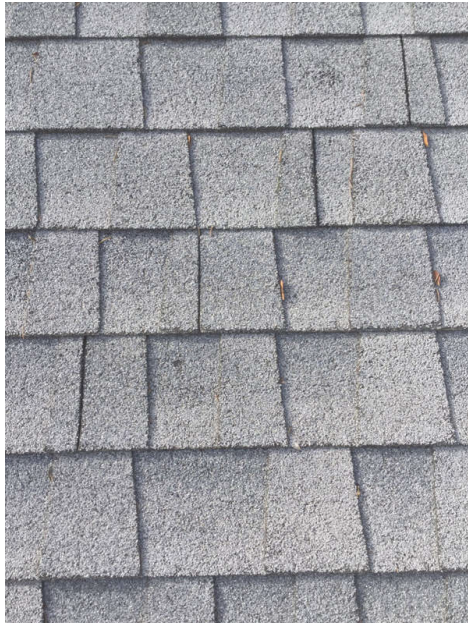
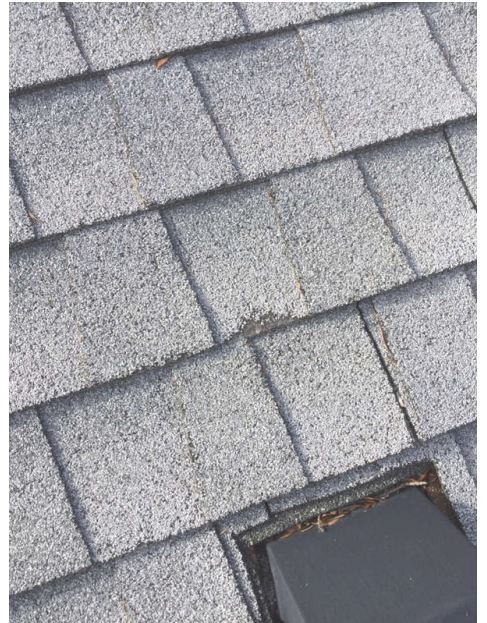
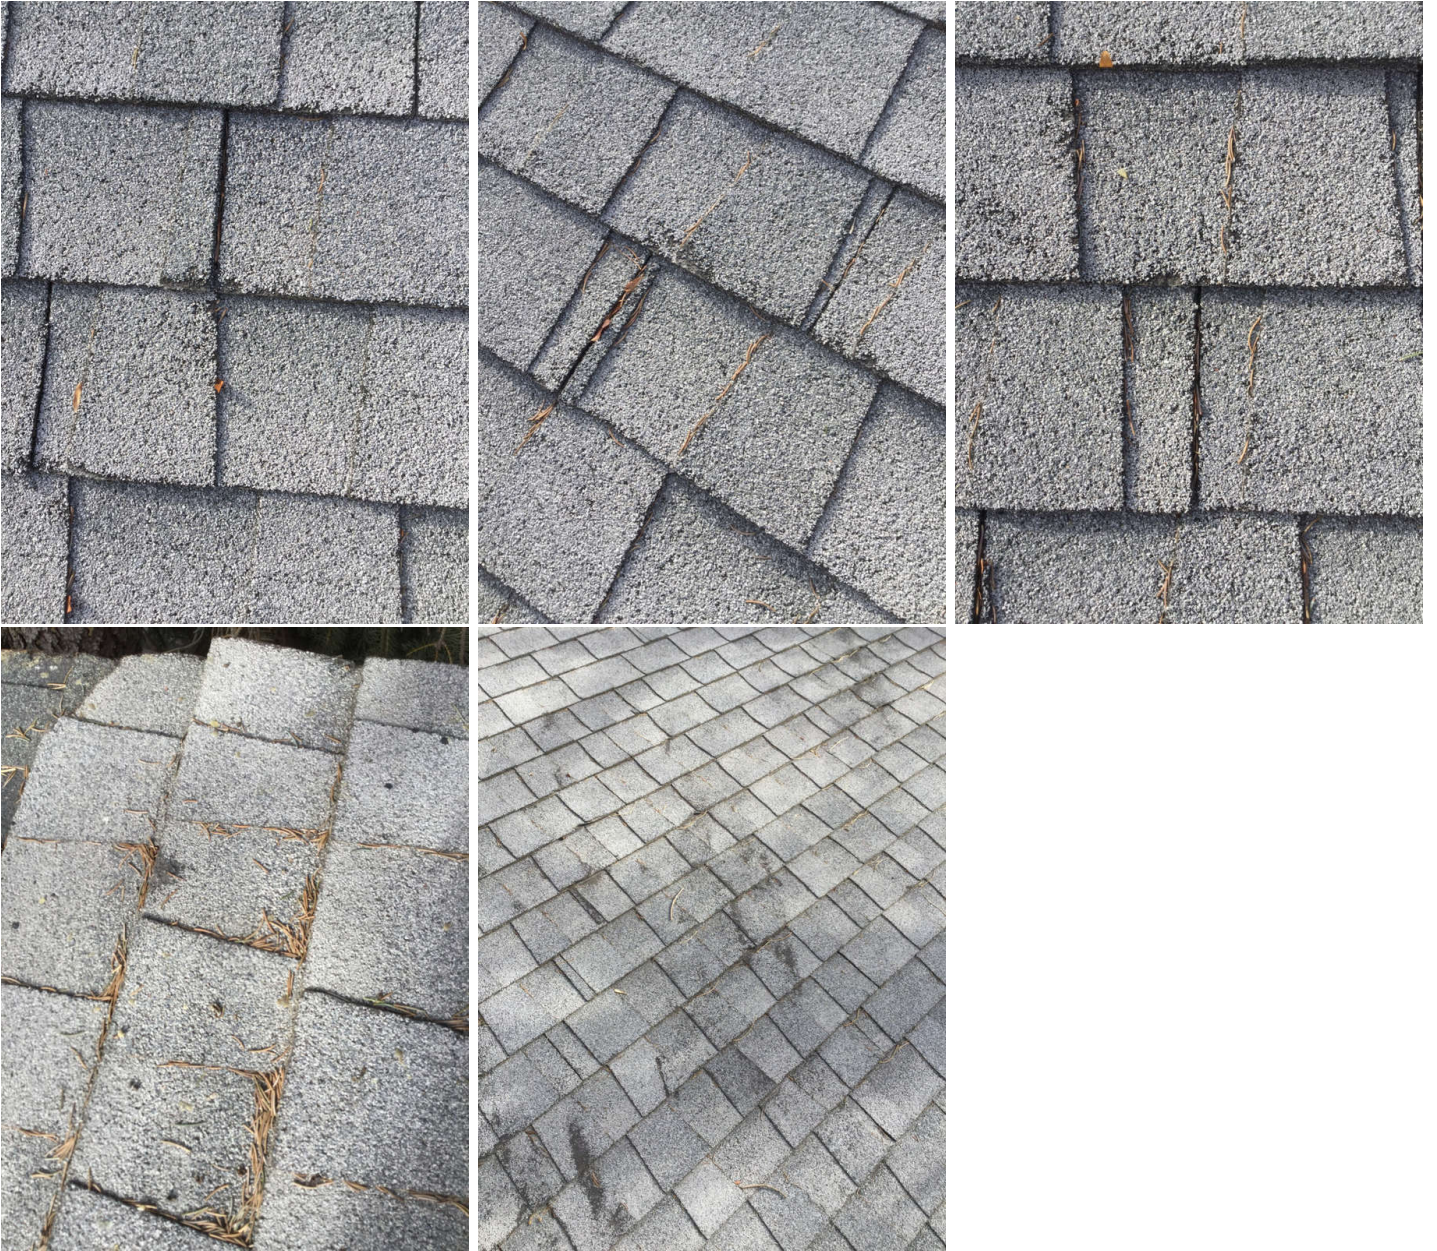
**DAMAGE - DETERIORATION - MINOR**

The roof has minor damage or deterioration. It is recommended to monitor the roofing system, however, the buyer may consider having it evaluated by a licensed roofer.

Recommendation  
Recommend monitoring.

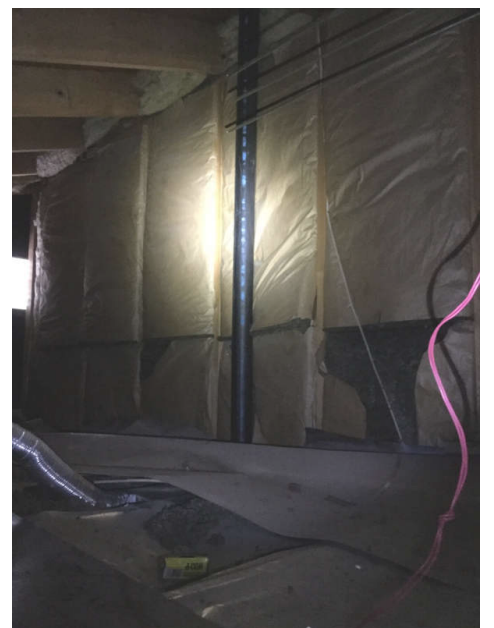
9.3.2 ATTIC  
**INSULATION - PAPER FACING  
ON BATTS EXPOSED**

Paper facing on batt insulation is oriented towards open spaces, rather than against interior space surfaces. This occurs when newer, fiberglass batt insulation with paper facing on one side is installed backwards or upside down, or when older batt insulation wrapped on both sides with paper is installed. The paper facing is flammable. Newer insulation usually has a warning label indicating this on the facing.

Also, the paper facing also acts as a vapor barrier, and if located away from the interior surfaces, can trap moisture from condensation in the cavity between the paper facing and the interior spaces. This is a conducive condition for wood destroying insects. The inspector was unable to evaluate the structure obscured by the insulation. When repairs are made, the exposed structure should be evaluated for damage by wood destroying insects and/or organisms, and repairs should be made if necessary.

For newer batt insulation with paper facing on one side only, the paper facing should be oriented towards interior spaces rather than exposed, open spaces. The existing insulation should be reinstalled or replaced.

For older batt insulation with paper facing on both sides, recommend that repairs be made as necessary to eliminate the exposed paper facing.

A qualified contractor should evaluate and make repairs as necessary, and as per standard building practices and the insulation manufacturer's recommendations to eliminate the fire hazard.

Recommendation  
Contact a qualified insulation contractor.

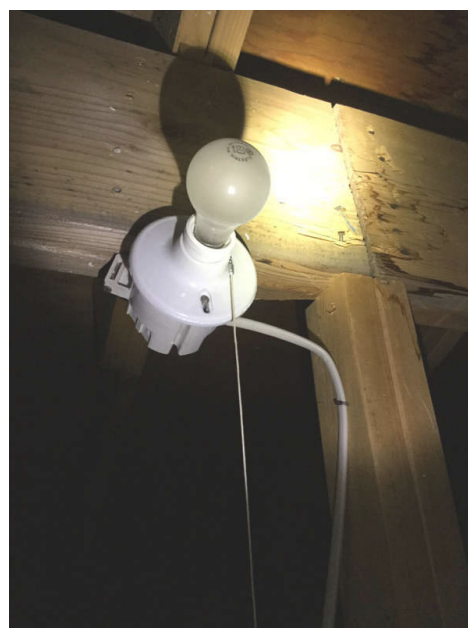
#### 9.4.1 ELECTRICAL **LIGHT FIXTURE - INOPERABLE**

The light fixtures appear to be fully or partially inoperable. Recommend further evaluation by replacing bulb(s) and/or consulting with the property owner(s). Repairs or replacement of the light fixture by a qualified electrician may be necessary.

Recommendation  
Contact a handyman or DIY project

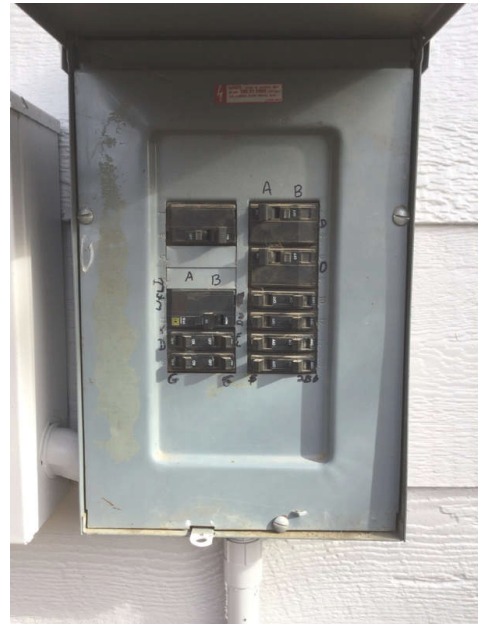
### SAFETY - MINOR - MISSING OR INADEQUATE LEGEND

The legend for overcurrent protection devices (breakers or fuses) in the main service panel is missing, unreadable or incomplete. Recommend installing, updating or correcting the legend as necessary so it's accurate. Evaluation by a qualified electrician may be necessary.

Contact a qualified electrical contractor.

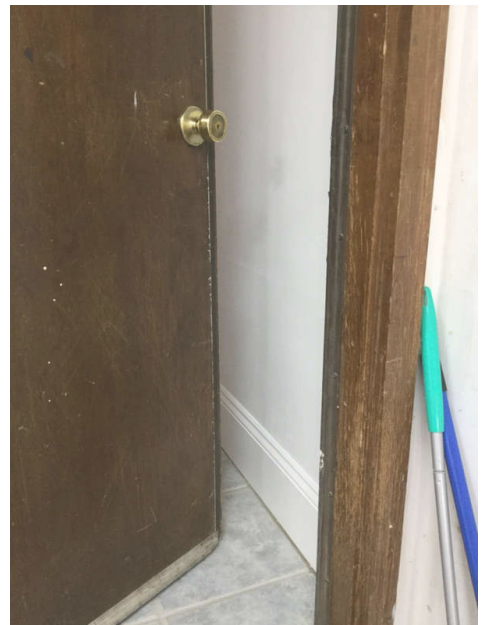
### GARAGE/ HOUSE DOOR - AUTO CLOSE - NOT INSTALLED

The garage-house door isn't equipped with an automatic closing device such as sprung hinges. This door should close and latch automatically to prevent vehicle fumes from entering living spaces and/or to slow the spread of fire from the garage to living spaces. A qualified contractor should install automatic closing device(s) as necessary, and as per standard building practices, so this door closes and latches automatically.

Contact a handyman or DIY project

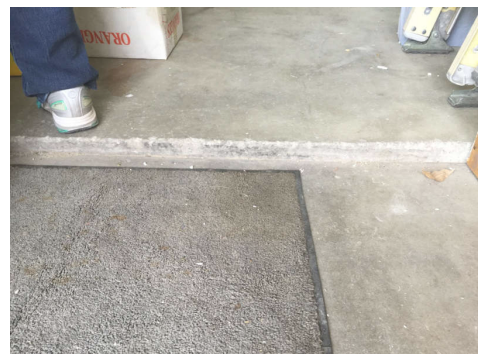
### FLOORS - CRACKS - TRIP HAZARD

Trip hazards were found in the garage floor due to cracks, settlement and/or heaving. Recommend having a qualified contractor evaluate and repair or replace sections as necessary to eliminate trip hazards.

Contact a qualified concrete contractor.

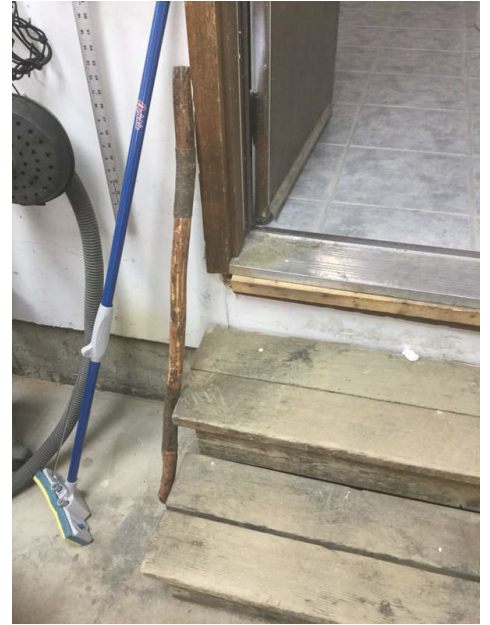
## HANDRAILS - MISSING

Flights of stairs with more than two risers have no handrail installed. This is a safety hazard. A qualified contractor should install graspable handrails that your hand can completely encircle at stairs where missing, and as per standard building practices.

Contact a handyman or DIY project

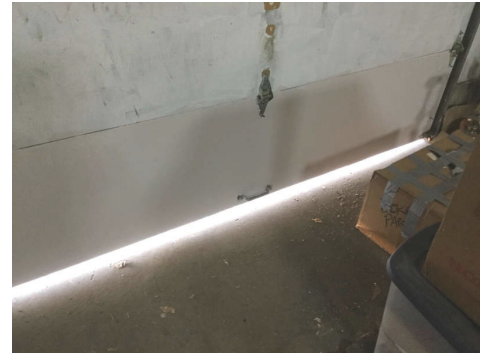
## VEHICLE DOOR - WEATHERSTRIP MISSING

Weatherstrip at the sides and/or bottom of the vehicle door is missing. It should be installed where missing to prevent water and vermin intrusion.

Contact a handyman or DIY project

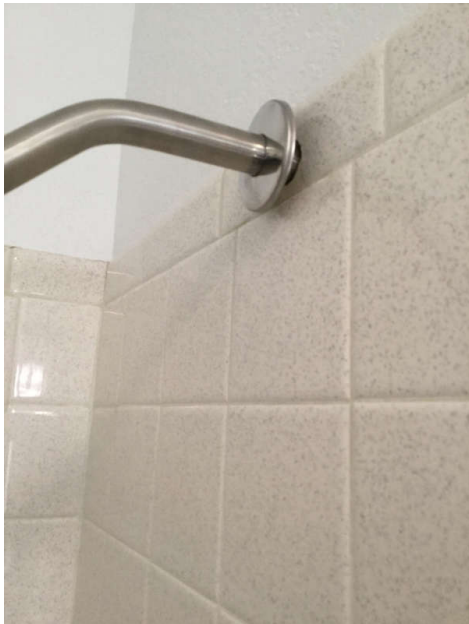
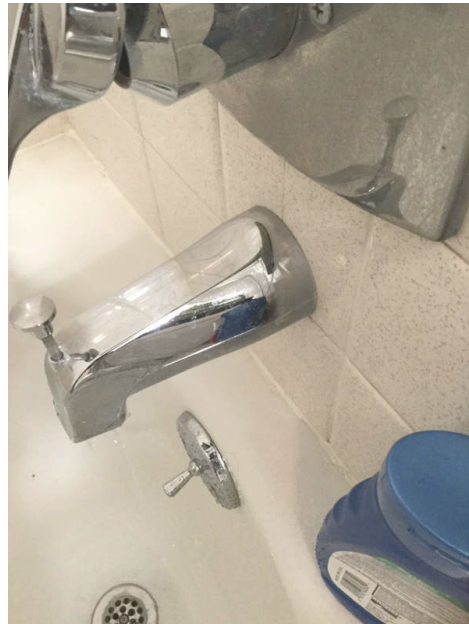
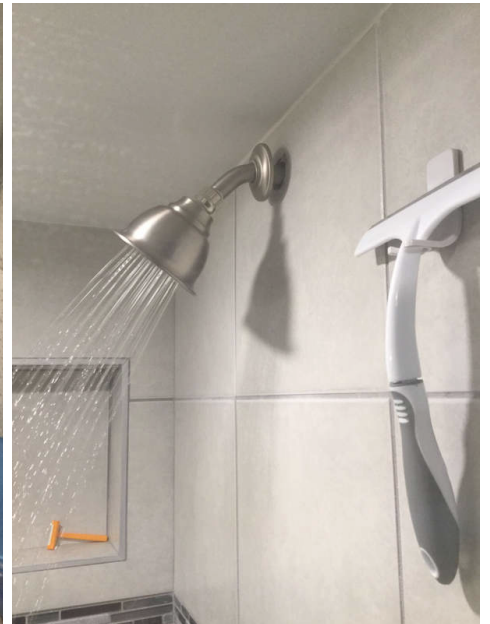
## CAULK - MISSING AT FIXTURES

Caulk is missing or deteriorated around fixtures such as the base of shower/bathtub spouts and/or at the base of the control valves and/or at the base of the shower head back plate. Caulk should be replaced where deteriorated and/or applied where missing to prevent water intrusion and damage to wall structures.

Contact a handyman or DIY project

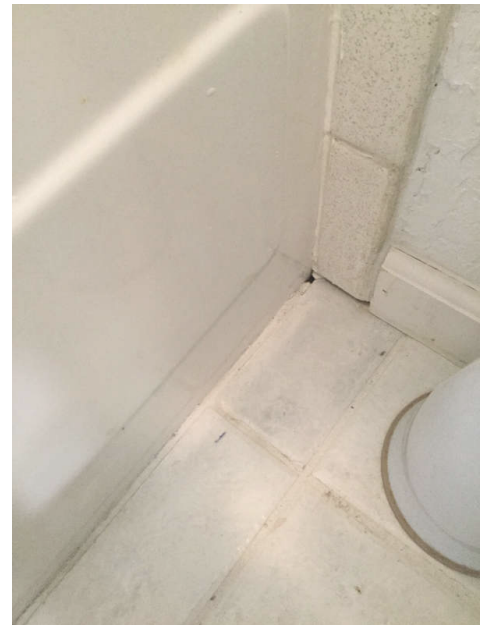
1st Floor Bathroom

### CAULK - MISSING AT FLOOR

Caulk is missing or deteriorated along the base of the shower/bathtub, where flooring meets the shower/bathtub. It should be replaced where deteriorated and/or applied where missing to prevent water intrusion and damage to the floor structure.

Contact a handyman or DIY project

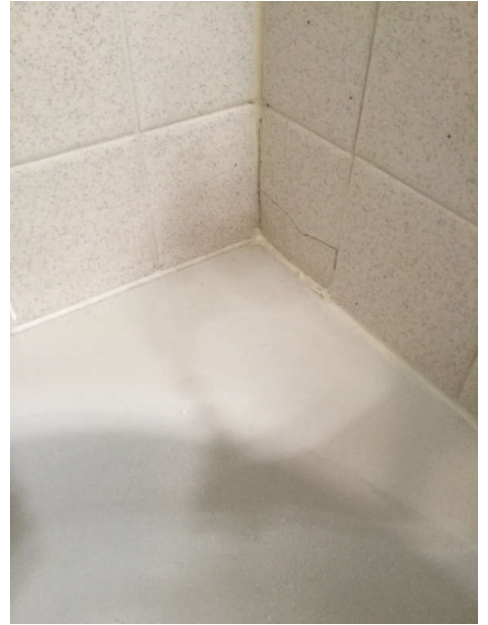
1st Floor Bathroom

### SHOWER/TUB - TILE OR GROUT DETERIORATED

Tile and/or grout around the bathtub/shower is damaged or deteriorated. For example, deteriorated/missing grout, and/or cracked, missing or loose tiles, etc. A qualified contractor should evaluate and repair tile and/or grout as necessary.

Contact a qualified tile contractor

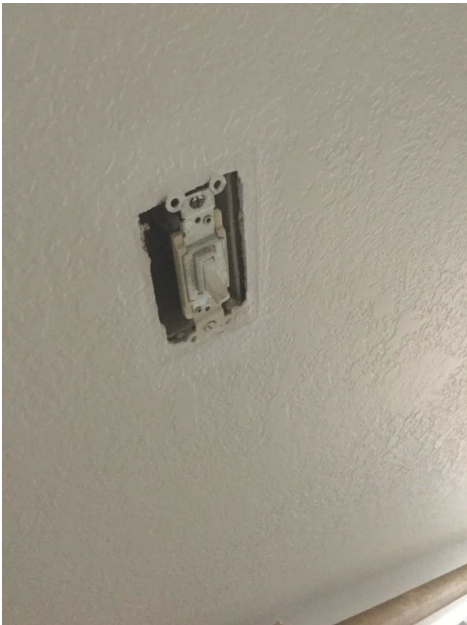
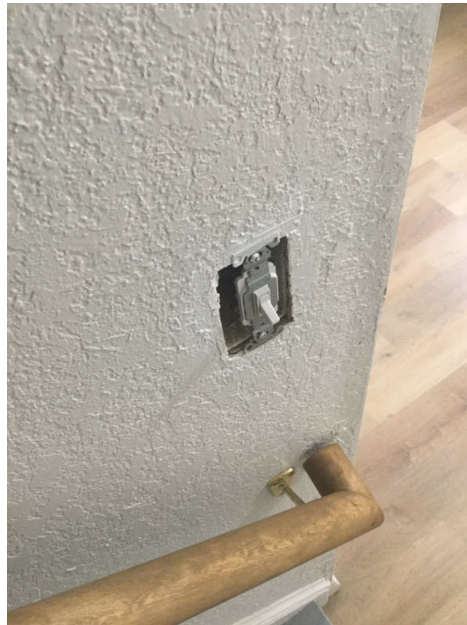
### 16.3.1 ELECTRICAL **COVER PLATES - MISSING**

Cover plate(s) are missing from electric boxes, such as for receptacles, switches and/or junction boxes. They are intended to contain fire and prevent electric shock from exposed wires. This is a safety hazard due to the risk of fire and shock. Cover plates should be installed where missing.

Recommendation  
Contact a handyman or DIY project

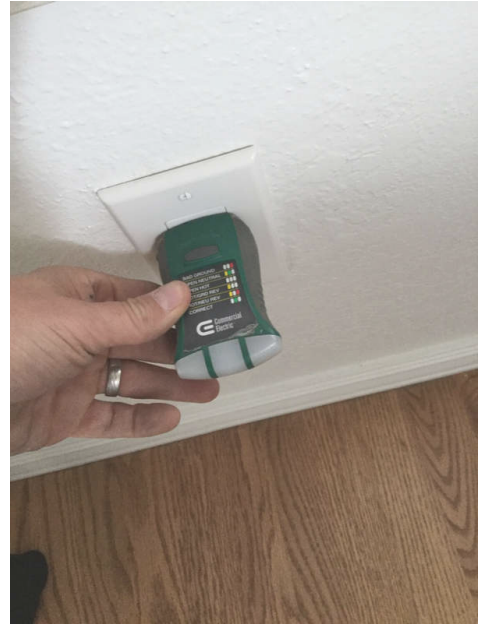
Family Room East Wall

### 16.3.3 ELECTRICAL **RECEPTACLES - LOOSE**

Electric receptacles and/or the boxes they are installed in are loose and/or not securely anchored. Wire conductors may be damaged due to repeated movement and/or tension on wires, or insulation may be damaged. This is a safety hazard due to the risk of shock and fire. A qualified electrician should evaluate and repair as necessary.

Contact a qualified electrical contractor.

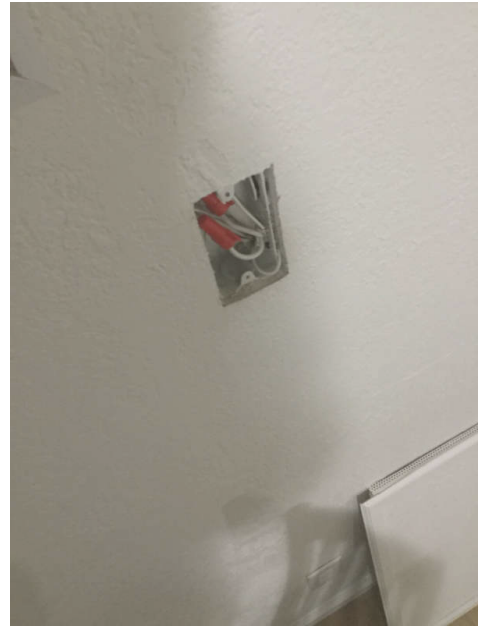
Basement East

### WIRING - SPLICES EXPOSED

Wire splices are exposed due to not being contained in a covered junction box. This is a safety hazard due to the risk of shock and fire. A qualified electrician should evaluate and make repairs as necessary. For example, install securely mounted junction boxes with cover plates where needed to contain wiring splices.

Contact a qualified electrical contractor.

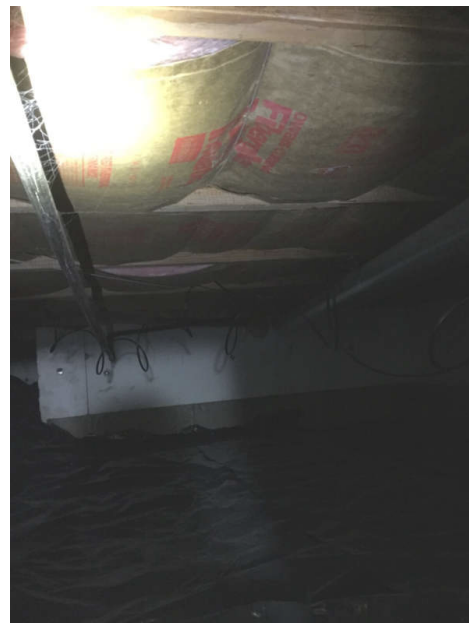
### INSULATION - A PAPER FACING ON BATTS EXPOSED

Paper facing on batt insulation is oriented towards open spaces, rather than against interior space surfaces. This occurs when newer, fiberglass batt insulation with paper facing on one side is installed backwards or upside down, or when older batt insulation wrapped on both sides with paper is installed. The paper facing is flammable. Newer insulation usually has a warning label indicating this on the facing.

Also, the paper facing also acts as a vapor barrier, and if located away from the interior surfaces, can trap moisture from condensation in the cavity between the paper facing and the interior spaces. This is a conducive condition for wood destroying insects. The inspector was unable to evaluate the structure obscured by the insulation. When repairs are made, the exposed structure should be evaluated for damage by wood destroying insects and/or organisms, and repairs should be made if necessary.

For newer batt insulation with paper facing on one side only, the paper facing should be oriented towards interior spaces rather than exposed, open spaces. The existing insulation should be reinstalled or replaced.

For older batt insulation with paper facing on both sides, recommend that repairs be made as necessary to eliminate the exposed paper facing.

A qualified contractor should evaluate and make repairs as necessary, and as per standard building practices and the insulation manufacturer's recommendations to eliminate the fire hazard.

Contact a handyman or DIY project
