SUMMARY
1234 Main St. Raeford NC 28376
Buyer Name
11/26/2018 9:00AM

James Saunders
NC License # 3728
Certified Inspectors of North Carolina
LLC
910-578-4943
james.cinlcl@gmail.com

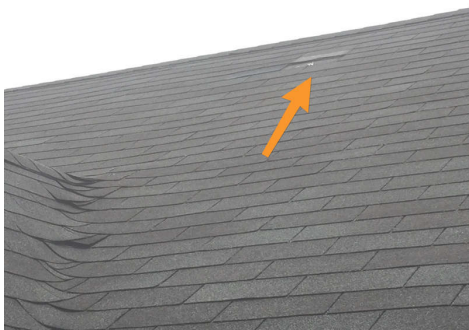
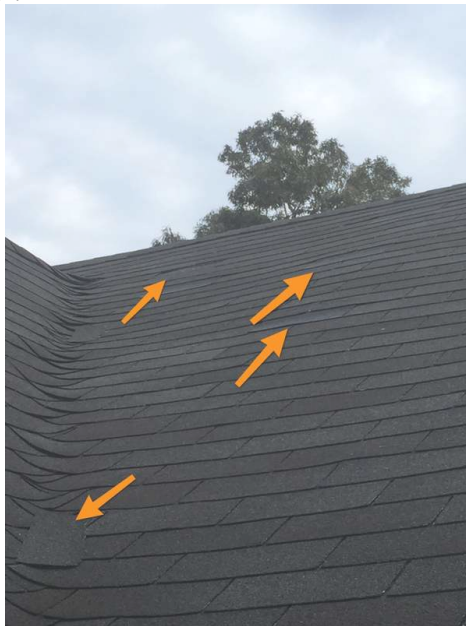
2.1.1 Coverings

SHINGLES MISSING

Observed areas that appeared to be missing sufficient coverings. These areas are subject to water penetration to the wood roof sheathing as the roof covering material should overlap the previous course. Recommend qualified roofing contractor evaluate & repair.

Contact a qualified roofing professional.

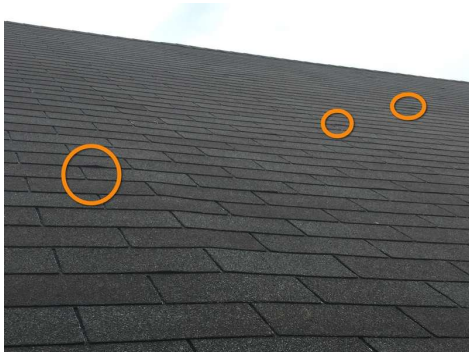
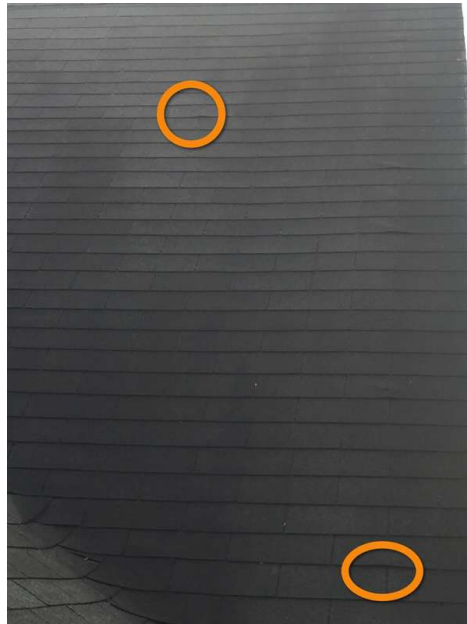
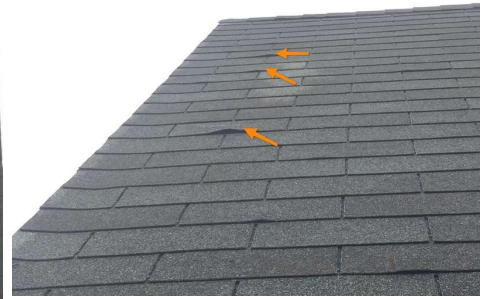
2.1.2 Coverings

NAIL POPS-ROOF

Roof surface shows evidence of nail pops in several areas around the roof plane. Nails that are lifting and eventually popping through the shingle roof covering can cause small leaks in several different areas and lead to rotted roof sheathing and even damaged roof framing overtime if they are not repaired. Recommend a licensed roofing contractor do a full evaluation of the roof system and covering and make repair recommendations.

Contact a qualified roofing professional.

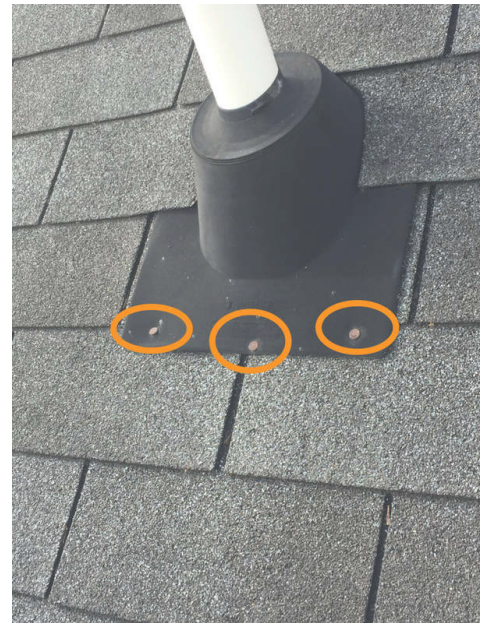
2.3.1 Flashings

BOOT FLASHING / NAIL SEALANT

The nails at the bottom of the plumbing boot flashing and vents are not sealed. Nail/screw heads should be sealed to prevent water intrusion to the roof structure from around the nail head. Recommend a qualified contractor seal the nail heads with silicone roof sealant.

Contact a qualified roofing professional.

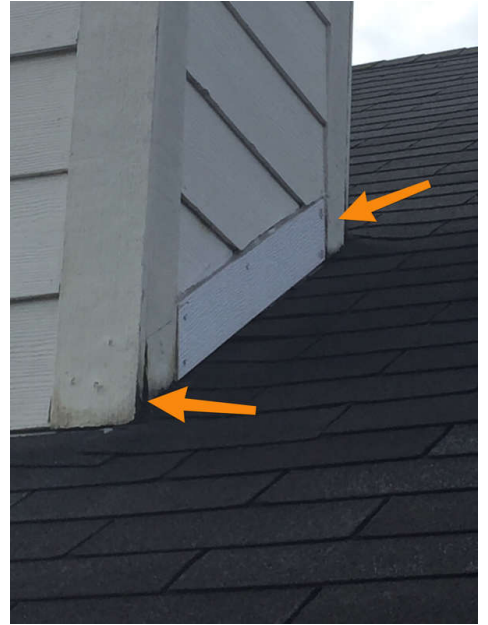
3.1.1 Siding, Flashing & Trim

CHIMNEY SIDING/TRIM-WATER DAMAGE

Siding and trim In several areas have observed indications of water damage around the chimney. Recommend replacement by a licensed contractor.

Contact a qualified siding specialist.

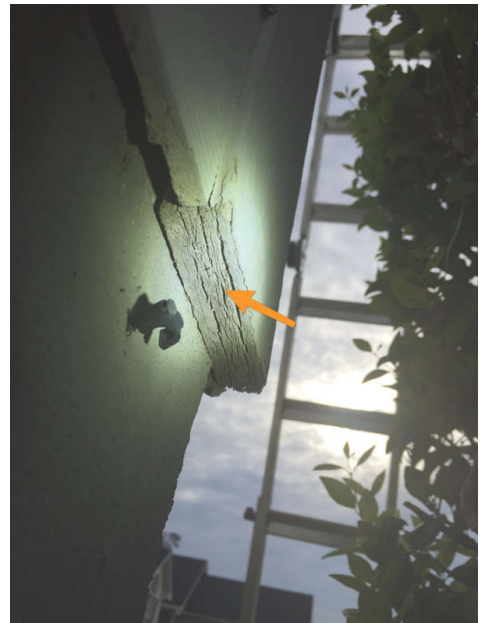
3.1.2 Siding, Flashing & Trim

WOOD TRIM-ROTTED

CORNERS OF BUILDING

The wood trim in several areas around the home have observed indications of wood rot. If this condition is not corrected water damage may spread to adjacent materials and cause further damage. Inspector recommends a full evaluation of all wood trim and siding materials and repair as needed. All work should be done by a licensed general contractor.

Engineered wood coming apart at ends

Contact a qualified siding specialist.

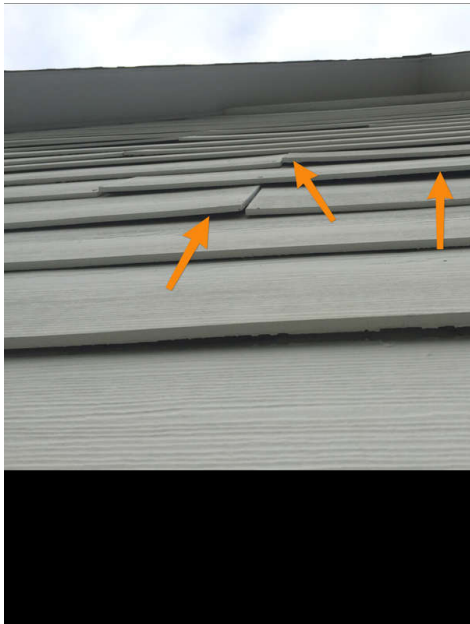
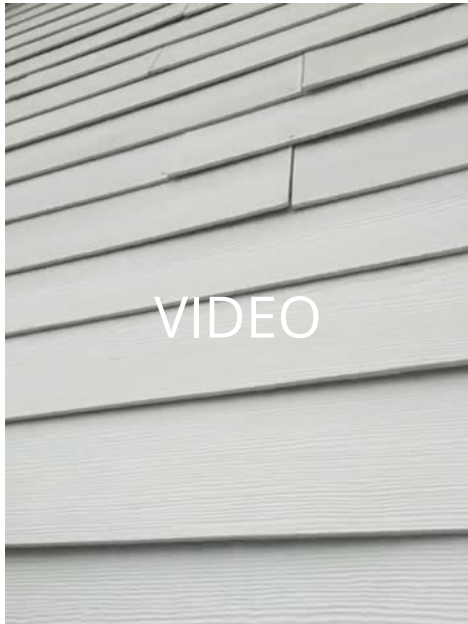
3.1.3 Siding, Flashing & Trim

SIDING LOOSE

The siding is loose on areas of the structure. This condition may allow a blow off of the siding from strong winds and subjects the exterior wall to the elements. Recommend further evaluation for damage and verify proper installation per manufacturer instructions and correct as needed by a licensed contractor.

Contact a qualified siding specialist.

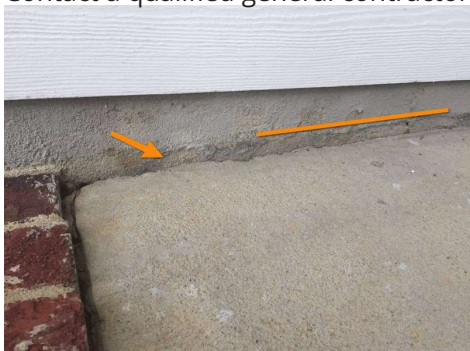
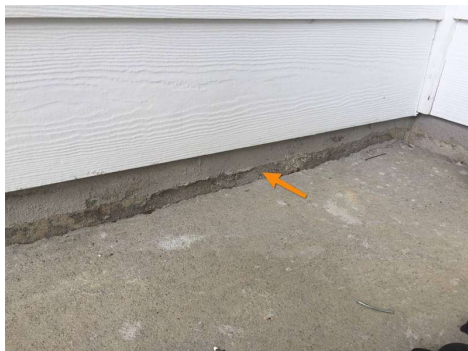
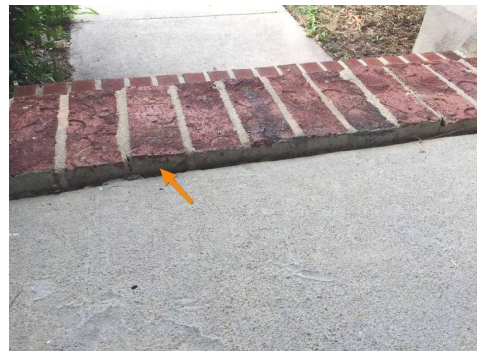
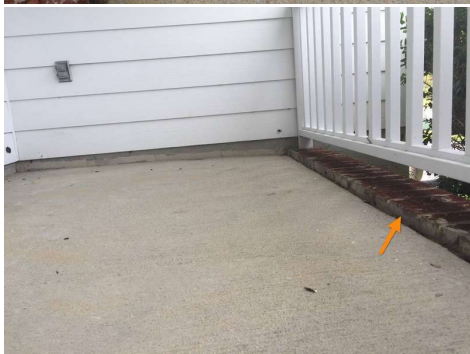
3.4.1 Decks, Balconies, Porches & Steps

FRONT PORCH SLAB MOVEMENT

FRONT PORCH

The front porch slab has sunken several inches from the surrounding brick. In the majority of cases this is due to poor water drainage, but it can also be the result of ground movement, subsidence or poor construction. These problems can be repaired. Recommend a full evaluation by a licensed contractor to determine the cause and make recommendations for correction.

Contact a qualified general contractor.

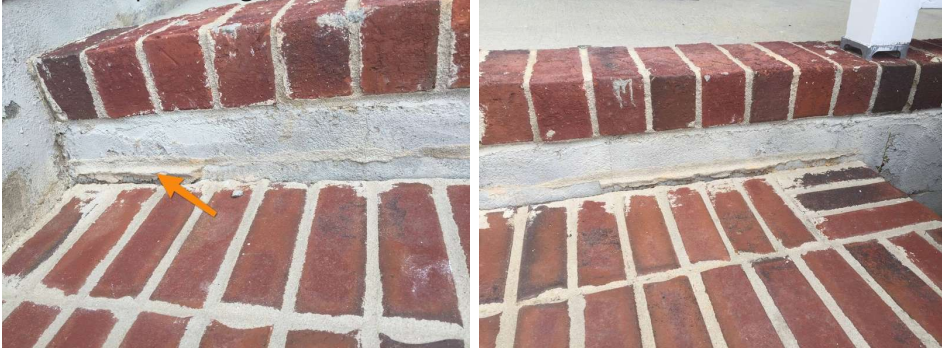
3.4.2 Decks, Balconies, Porches & Steps

STAIRS DIFFERENTIAL MOVEMENT

FRONT PORCH

The stairs had observed indications of movement. This could be caused by excessive water intrusion, soil instability or un-compacted soils, or other external factors. This condition may worsen if not corrected. A licensed general contractor should be consulted to determine the cause and take necessary corrective action.

Contact a qualified general contractor.

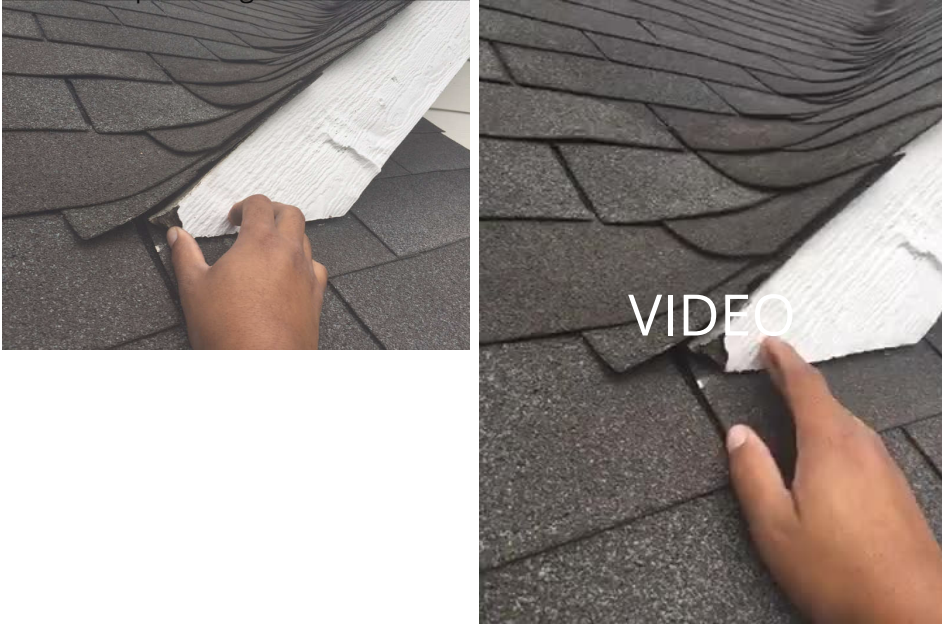
3.5.1 Eaves, Soffits & Fascia

RAKE TRIM ROTTED

WEST SIDE OF HOME. ROOF

The wood rake board is rotted and touching the roof surface. Wood will wick moisture from roof run off and rot, exposing adjacent materials to moisture damage. Recommend replacement of the roof rake trim board allowing a minimum of 1/2inch from roof surface. Repairs should be made by a qualified contractor.

Contact a qualified general contractor.

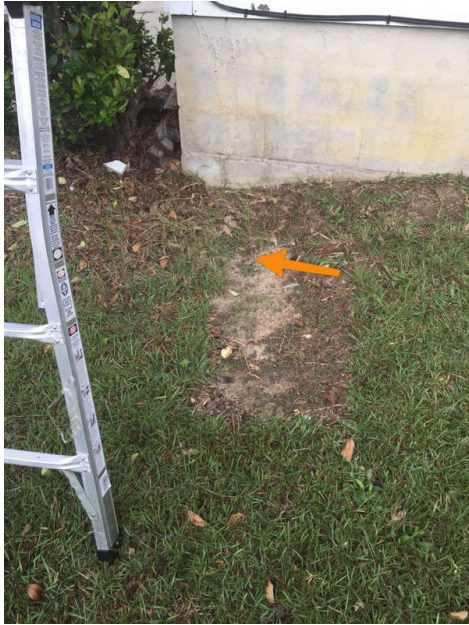
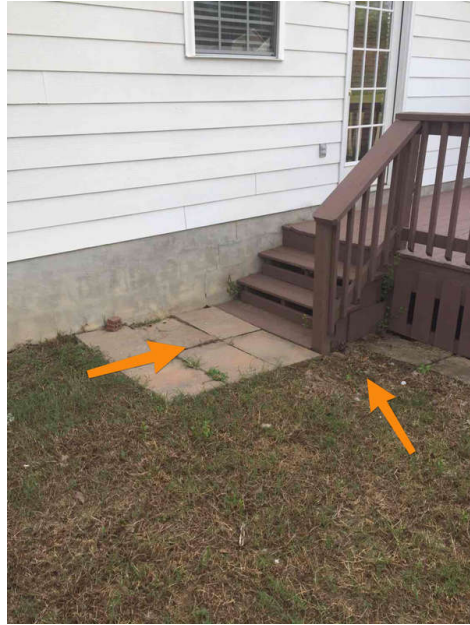
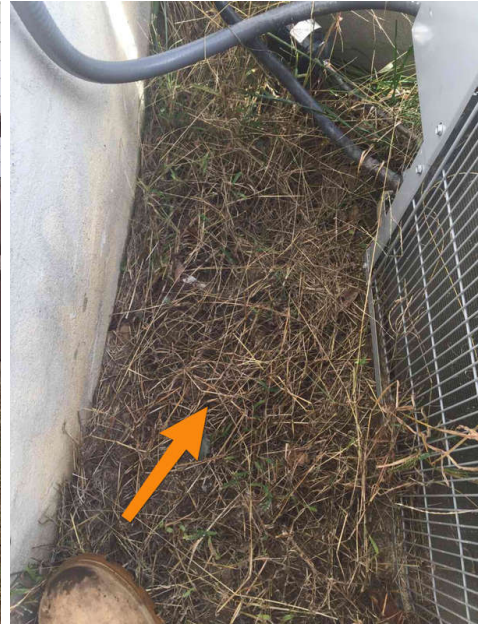
3.6.1 Vegetation, Grading, Drainage & Retaining Walls

NEGATIVE GRADING

WEST AND EAST SIDE OF HOME, REAR OF A/C UNIT

Grading is sloping towards the home in some areas. This could lead to water intrusion and foundation issues. Recommend qualified landscaper or grading company regrade so water flows away from home. Some areas may easily be filled with fill dirt and sloped.

Rear of a/c unit

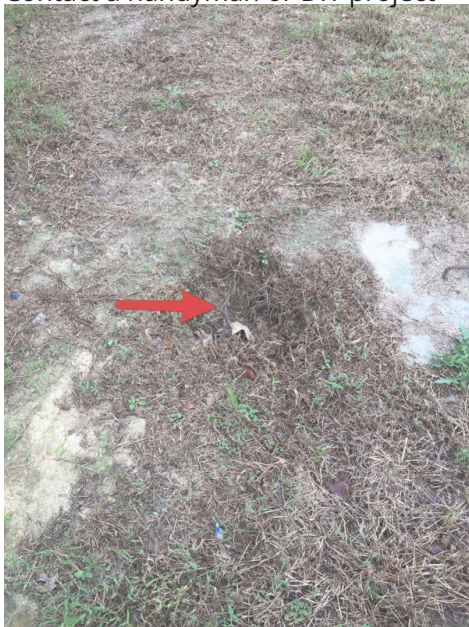
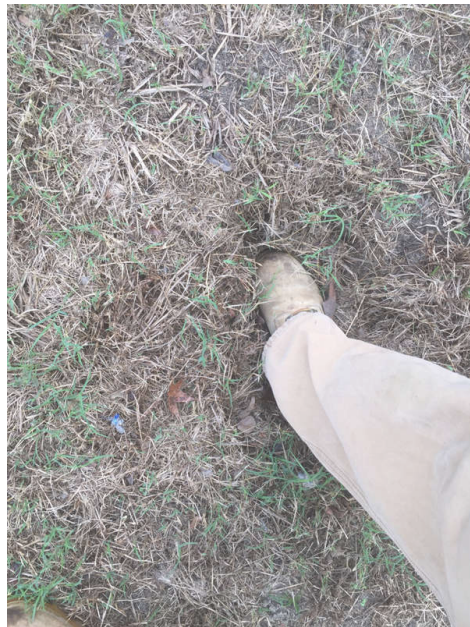
3.6.2 Vegetation, Grading, Drainage & Retaining Walls

YARD-LARGE VOID/HOLE

SOUTH EAST OF BACK YARD

There is a large hole in the walking surface of the yard. This condition may allow someone to step into the hole and cause personal injury and/or fall. This condition may be remedied by filling the hole with fill dirt, then compacting.

Contact a handyman or DIY project

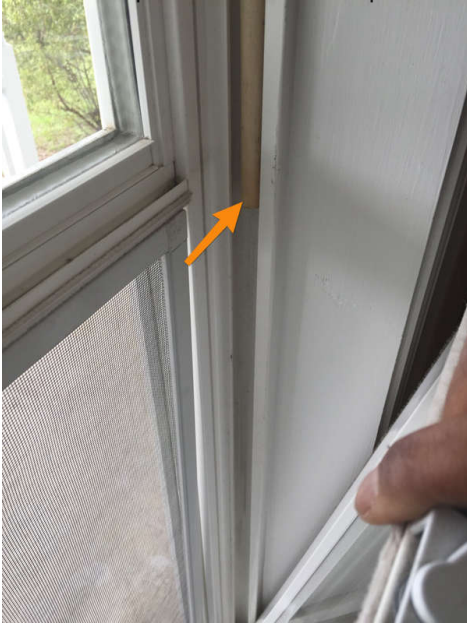
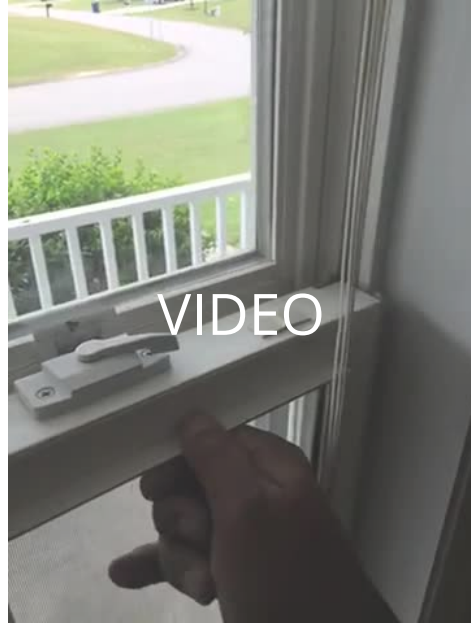
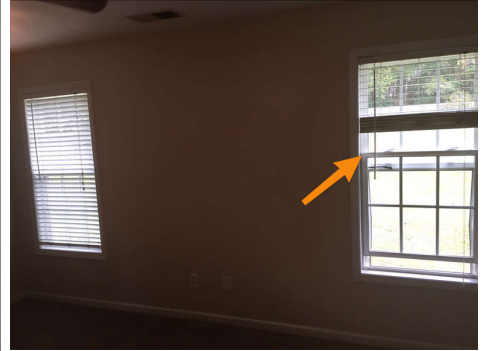
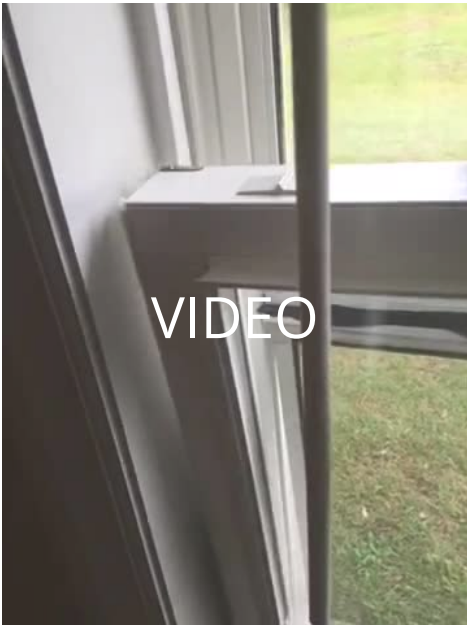
4.2.2 Windows

WINDOW-BROKEN BALAST

LIVING ROOM, MASTER BEDROOM

The window ballast was not properly adjusted or broken. A window ballast helps to support the weight of the sash. Windows may fall in their tracks if not working properly. Recommend a window installation company for repair.

Recommendation
Contact a qualified window repair/installation contractor.

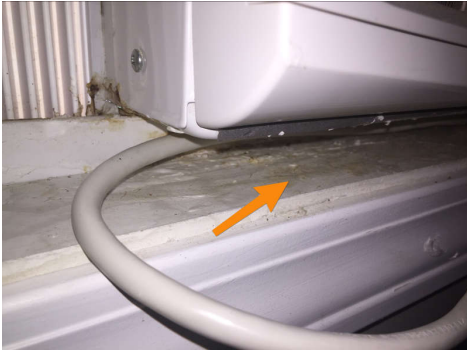
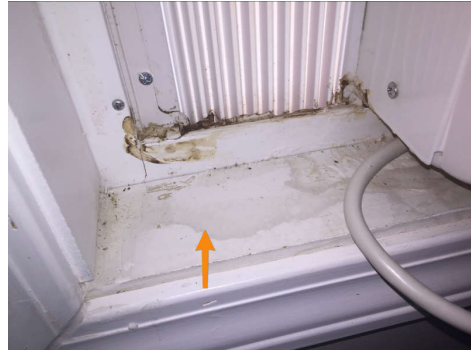
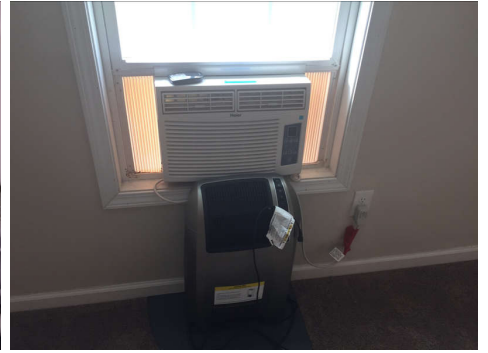
4.2.3 Windows

WINDOW SILL MOISTURE DAMAGE

BONUS ROOM

The window seal on the interior of the window has indications of moisture damage. This is an indication of water intrusion and should be corrected by a licensed general contractor soon as possible. If correction is not made water may enter the wall assembly.

Recommendation
Contact a qualified general contractor.

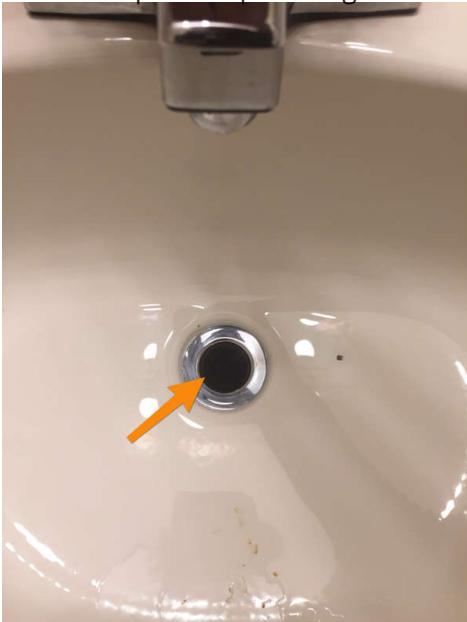
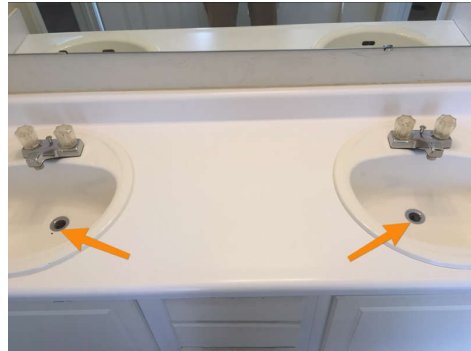
5.3.1 Water Supply, Distribution Systems & Fixtures

DRAIN STOP-MISSING

HALLWAY BATHROOM, MASTER BEDROOM

Drain stop is missing from the drain. A drain stop is a method to restrict or protect the waste outlet from an object or objects from entering and stopping up the drainage system (fixture arm, branch, drain, etc.) Recommend a licensed plumber repair or replace per standard building practices.

Contact a qualified plumbing contractor.

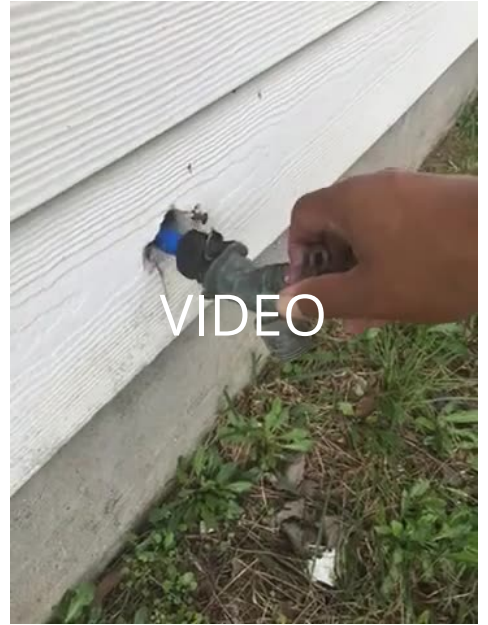
5.3.2 Water Supply, Distribution Systems & Fixtures

HOSE BIB- LOOSE ATTACHMENT

REAR

The hose bib is not securely attached to the home. This condition may cause undue stress on the piping material and brackets. Recommend a licensed plumbing contractor secure the exterior Fossett to the building using standard building practices.

Contact a qualified plumbing contractor.

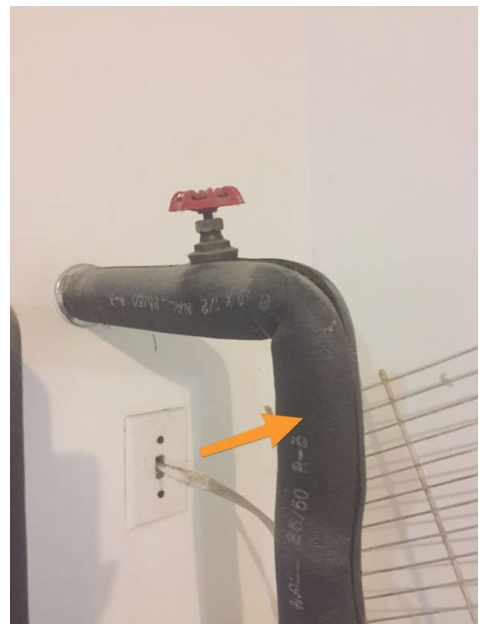
5.4.2 Hot Water Systems, Controls, Flues & Vents

NO EXPANSION TANK

No expansion tank was present. Expansion tanks allow for the thermal expansion of water in the pipes. These are required in certain areas for new installs. Recommend a qualified plumber evaluate and install.

Contact a qualified plumbing contractor.

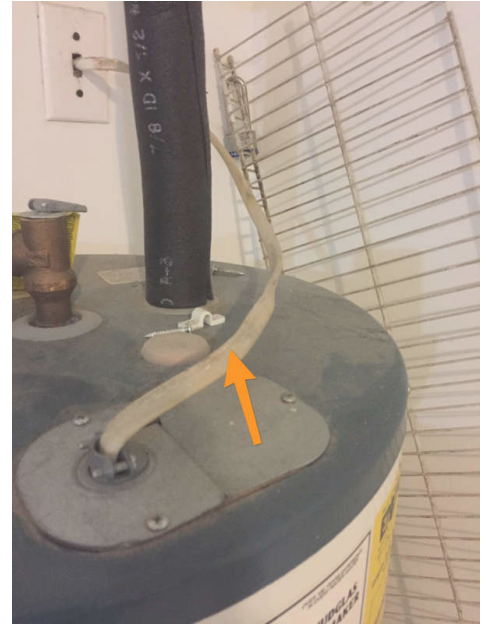
5.4.3 Hot Water Systems, Controls, Flues & Vents

WATER HEATER ELECTRICAL-UNPROTECTED

The power cable to the water heater is not protected. Water heater power cables are not required to be in conduit, however, it is important that the power cable be protected primarily when in an area of the home where the cable may be subject to damage. Recommend a licensed plumber or electrical contractor make repairs as recommended.

Contact a qualified plumbing contractor.

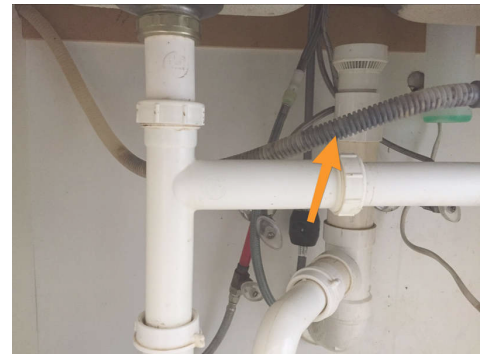
6.1.1 Dishwasher

EXCESSIVE DEBRIS IN DRAIN PIPE

There are observed indications of excessive debris or build up in the dishwasher drain hose. This may stop or slow down the flow of drain water to the waste pipe. It is recommended that the dishwasher drain be cleaned or replaced as needed by a licensed plumbing contractor

Contact a qualified plumbing contractor.

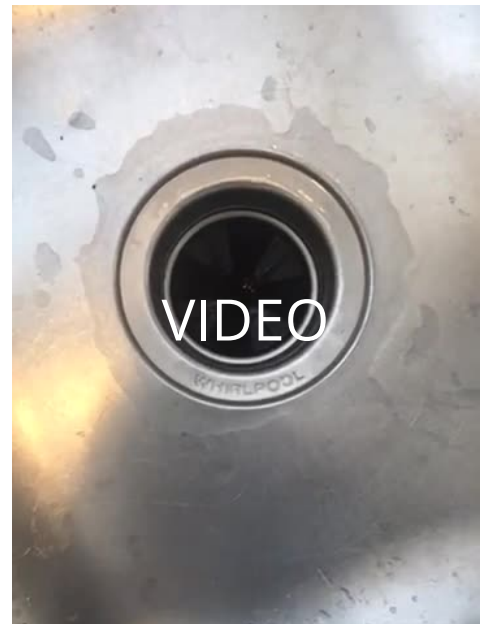
6.4.1 Garbage Disposal

DISPOSAL-INOPERATIVE

The garbage disposal in the kitchen does not turn on when operated by the wall switch. This may be an inconvenience for the homeowner as it cannot be used when needed. If this is of concern to the client, the inspector recommends further evaluation and repair or replacement of the garbage disposal.

Contact a qualified plumbing contractor.

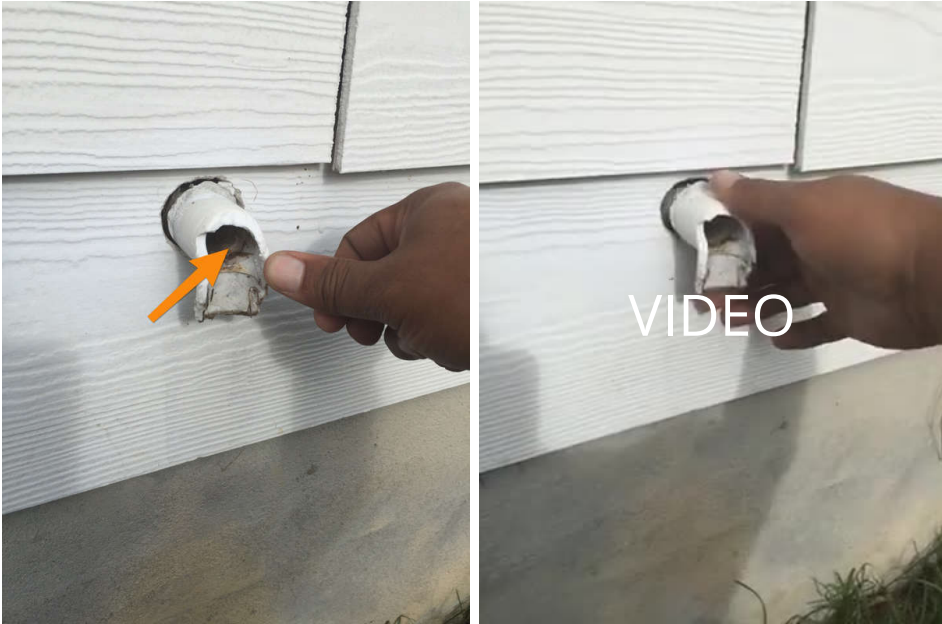
7.1.1 Cooling Equipment

CONDENSATE TUBE DAMAGED

Condensate tube was damaged, which limits safe discharge of condensation produced by evaporator coils. The discharge water may also run to unwanted places. Recommend a qualified HVAC technician repair.

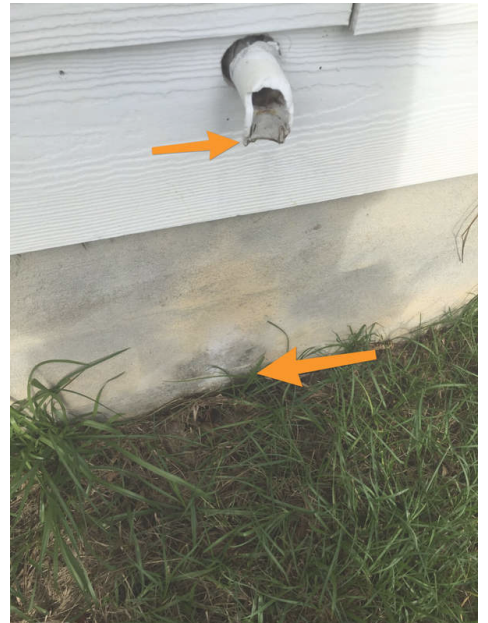
7.1.2 Cooling Equipment

CONDENSATE DRAIN-TOO CLOSE

A/C condensate drain line is too close to the foundation. The A/C drain water is usually routed just an inch or two from the edge of your foundation. Water pools there and seeps under your foundation. The hotter the weather, the harder the A/C unit works, the more condensation is created. An A/C unit can generate between 5 and 20 gallons of water per day. It is recommended that the condensate drain line be no less than 12 inches away from the foundation. Recommend that a Licensed HVAC Contractor make any necessary repairs.

Recommendation
Contact a qualified heating and cooling contractor

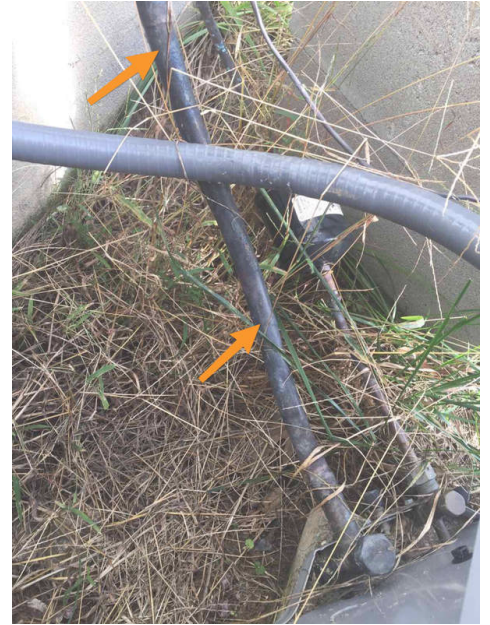
7.1.3 Cooling Equipment

HVAC SUCTION LINE NOT FULLY INSULATED

The AC suction line is not fully insulated. This line is normally cold while the unit is in operation. When the line comes into contact with warm air, the line will condensate and leak water, possibly damaging nearby building components depending on the location. Inspector recommends that this line be fully insulated from the air handler to the condenser unit. This repair should be made by a licensed HVAC contractor.

Recommendation
Contact a qualified HVAC professional.

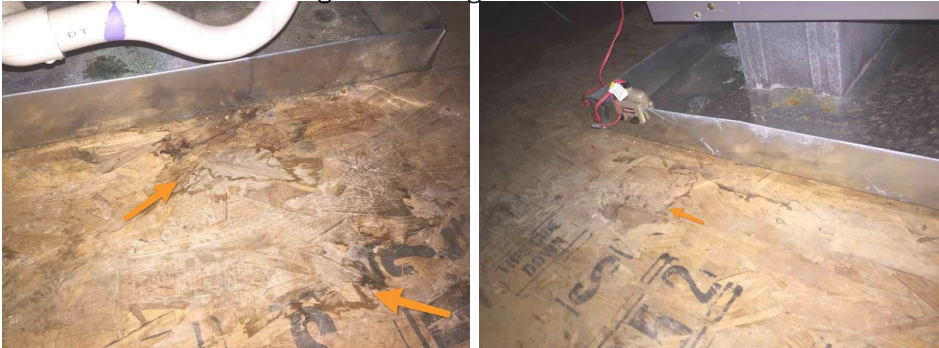
7.1.4 Cooling Equipment

CONDENSATE DRAIN LEAKING AT AIR HANDLER

ATTIC

The condensate drain at the trap of the air handler was leaking water onto the attic flooring. This will cause water damage and rotting of the attic floor space over time. Water may also damage adjacent components. Recommend further evaluation by a licensed hvac contractor and correct the condition as necessary.

Recommendation
Contact a qualified heating and cooling contractor

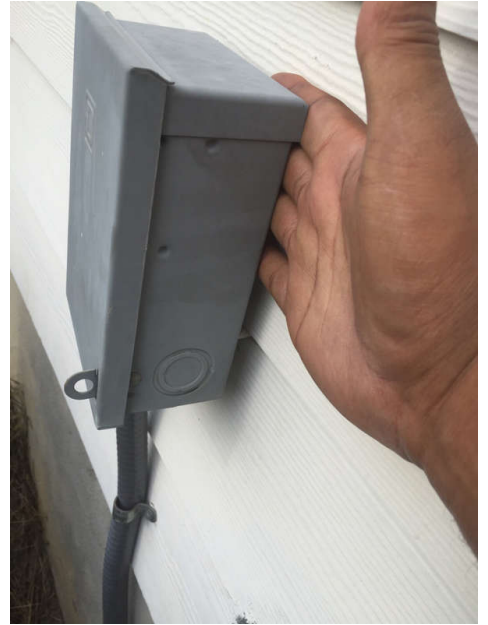
9.3.1 Branch Wiring Circuits, Breakers & Fuses

HVAC DISCONNECT-LOOSE

The electrical disconnect for the AC condensing unit is not securely attached to the home. The attachment is only going through the siding and not through to the sheathing. All electrical connections and boxes should be secure to prevent damage from wiring, conduit, or related components. Inspector recommends correction by a licensed HVAC contractor.

Recommendation
Contact a qualified heating and cooling contractor

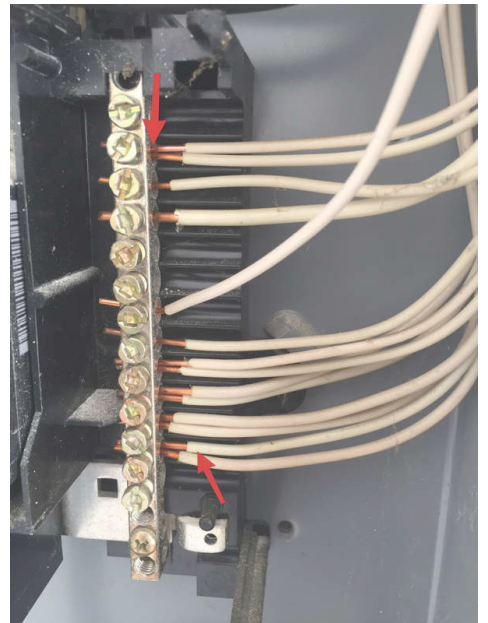
9.3.2 Branch Wiring Circuits, Breakers & Fuses

DOUBLE TAPPED NEUTRALS

The electrical panel board has several double tap neutral wires. A panel with double tap wires have circuits that should not be worked on because the circuits are not isolated. Also, too neutral wires underneath one lug can come loose overtime due to current vibrations. Circuit ground may be double tapped but neutrals should not. Correction should be made by a licensed electrical contractor.

Contact a qualified electrical contractor.

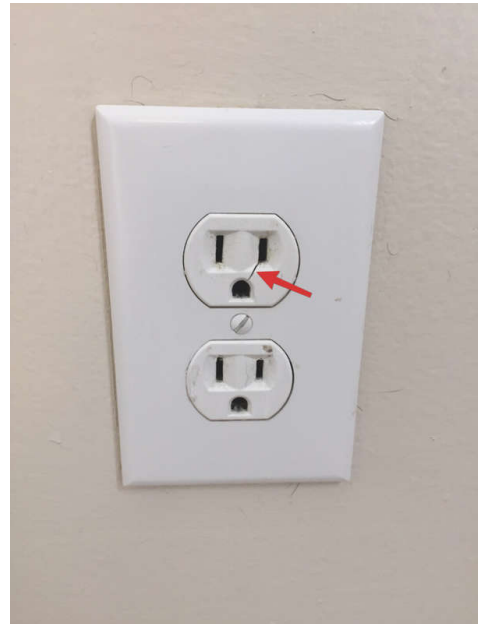
9.4.1 Lighting Fixtures, Switches & Receptacles

OUTLET-DAMAGED

DINETTE

Body of the electrical outlet is damaged. A damaged outlet may not be safe to use by the occupant risking electrical shock or arcing. Inspector recommends replacement of the outlet by a licensed electrical contractor.

Crack may get worse with use

Contact a qualified electrical contractor.

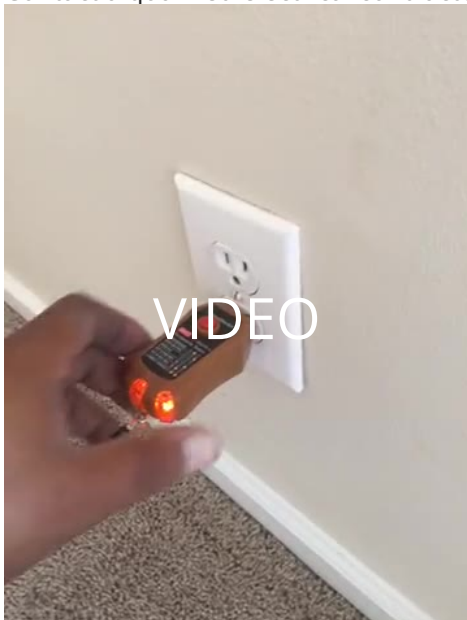
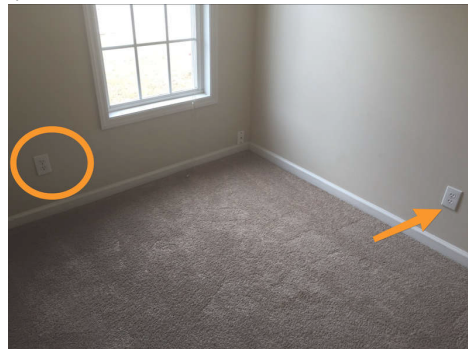
9.4.2 Lighting Fixtures, Switches & Receptacles

INTERIOR OUTLET LOOSE

FIRST BEDROOM

The interior outlet is loose and needs to be secured properly. Wires can move around and come loose from the terminals causing them to overheat and potentially catch fire. Loose outlets can also cause damage to the outlets and face plates while in use. Recommend a licensed electrical contractor for evaluate all outlets and make any necessary repairs.

Contact a qualified electrical contractor.

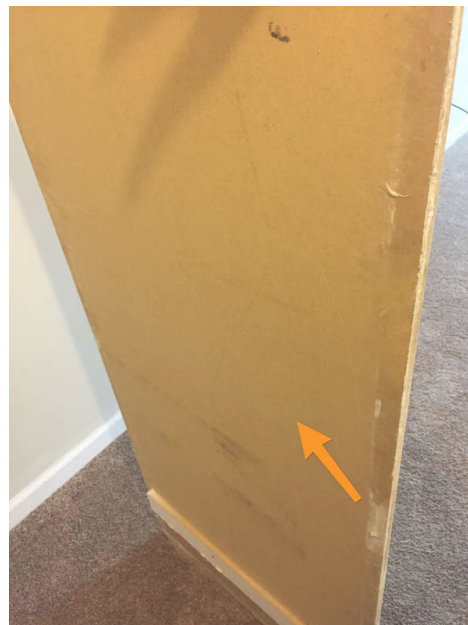
10.4.1 Attic Entry

ACCESS DOOR NOT INSULATED

BONUS ROOM

The attic access door is not insulated. Conditioned air from the living space will be lost into the attic. Attic access doors in living spaces should be insulated and sealed to prevent energy loss. Recommend a qualified general contractor or maintenance company insulate and seal the door.

Contact a qualified insulation contractor.

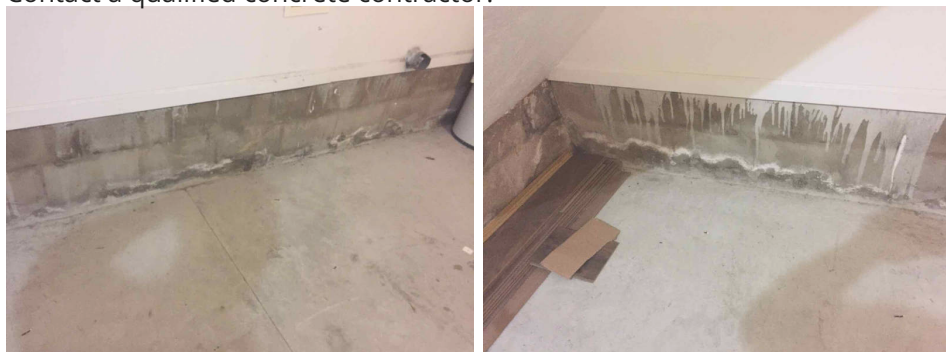
12.1.2 Foundation

EFFLORESCENCE ON FOUNDATION WALL

GARAGE

Efflorescence found on the foundation wall inside of the garage. Efflorescence happens when water or moisture is absorbed through masonry because masonry is a porous material, and that moisture carry's salt deposits from the masonry and can be seen on the surface. Efflorescence itself is not harmful but can be an indication of current or past moisture intrusion from heavy rains etc. Recommend further evaluation to determine the cause and make any corrections if needed.

Contact a qualified concrete contractor.
