The following is our report **summary** and describes each of the home's systems and also details any recommendations we have for improvements. We've also included potential and obvious limitations that could have restricted our inspection as well.

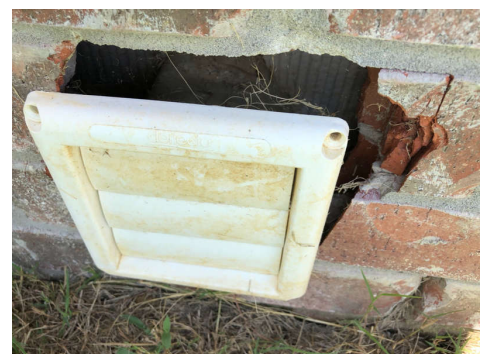
3.8.1 Dryer Vent Cap

SEAL TOP OF VENT CAP

The brick is damaged at the dryer termination point. Repairs are needed. Water can easily enter your house through your dryer hose. Seal the top of the vent cap after the brick is repaired.

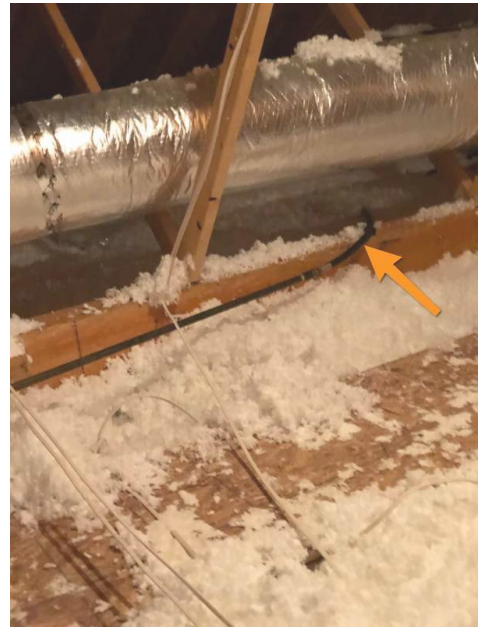
6.1.1 Gas Meter

CSST GAS PIPE NOT BONDED

Gas pipes were not bonded. I recommend a qualified plumber and electrician evaluate and address this condition.

Corrugated stainless steel tubing or CSST is a flexible thin wall pipe used to carry gas to appliances. Its prone to damage if exposed to stray voltage from lightening strikes. It's **IMPORTANT! that this condition be corrected.**

In the attic near the furnace.

Contact a qualified plumbing contractor.

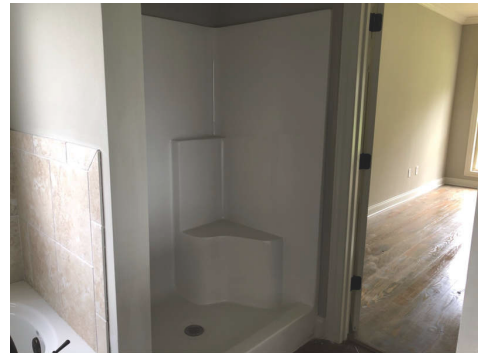
6.4.1 Interior Fixtures/Faucets

MISSING SHOWER DOOR

MASTER BATH

Missing shower door - install as needed.

Contact a qualified professional.

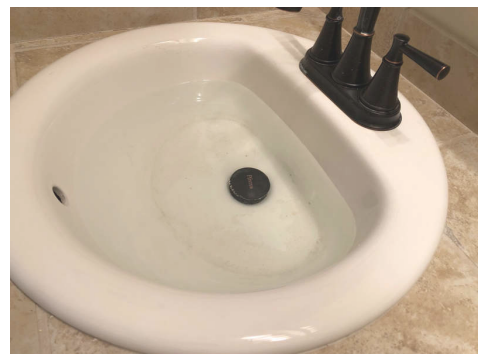
6.5.1 Drain/Vent Systems

DRAIN REPAIRS

At the time of the inspection the vanities were draining slow. At one point water stood in the bowl...see picture of water mark in the bowl.

While testing the dishwasher the kitchen sink was also backing up. We ran the disposal and noted a noise and believe it to be debris in the unit. Have a plumber clean the system and tested for function.

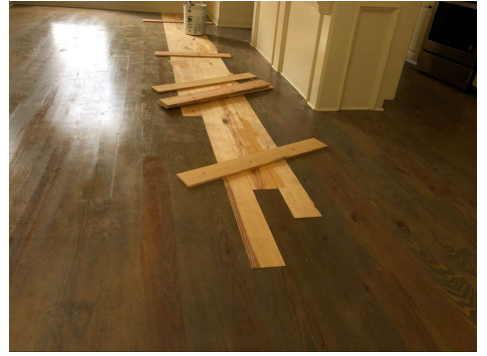
10.3.1 Floors

FINISH REPAIR

Finish repairing the family room flooring.

Contact a qualified professional.

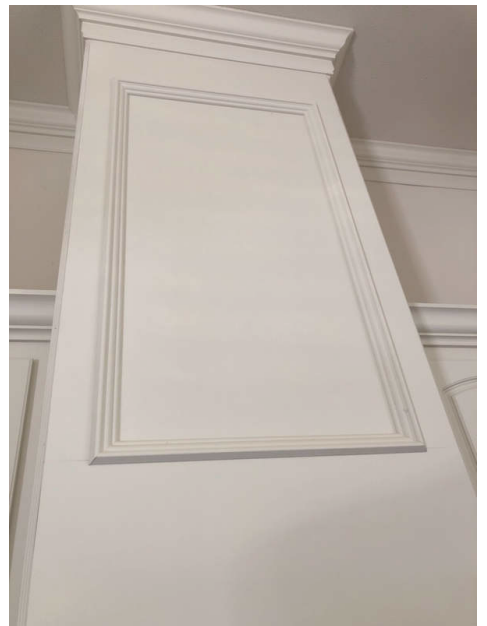
11.11.1 Exhaust Vent

MISSING VENT PIPE

IN THE ATTIC

The vent hood pipe designed to carry cooking smoke and moisture is missing in the attic. When installing the pipe make sure to seal the pipe to the drywall (at the attic penetration) to prevent a fire draft. The pipe should extend to the roof decking and terminate in a roof mounted vent equipped with a bug screen.

Contact a qualified professional.
