SUMMARY

1234 Main St. Truckee CA 96161

Buyer Name 05/29/2019 9:00AM

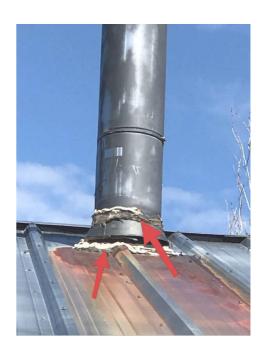
2.3.1 Chimney & Roof Penetrations

CHIMNEY IN POOR CONDITION

Sealant used to seal flashing around chimney vent. Bent vent stack above roof. Contact roofing contractor to repair flashing

Recommendation Contact a qualified roofing professional.

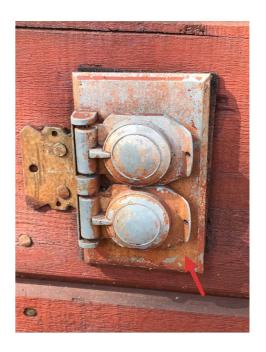
4.5.1 Electrical

OUTLET(S) NOT GFCI PROTECTED

Recommendation

Contact a qualified electrical contractor.

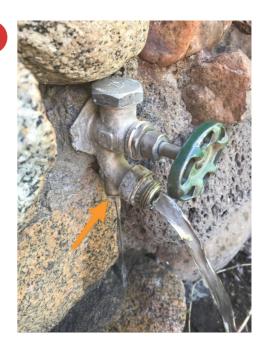
RIGHT OF ENTRY

4.6.1 Plumbing

HOSE BIB LEAKING

Recommend replacing to prevent further leaking of hose bib.

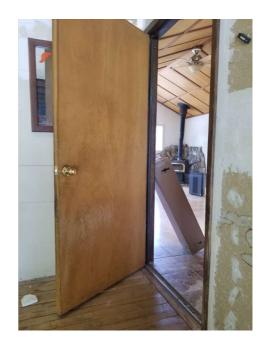
12.7.1 Fire Door

THE SELF-CLOSING DEVICE ON FIRE DOOR ISN'T SET

The self-closing device on the door from the house leading to the garage does not function properly. This is a fire hazard. Recommend adjusting or replacing the hinges to allow for proper closure of the door.
