SUMMARY

1234 Main St. North Augusta SC 29841

Jeff Young
SC License: RBL 49162 /...
Premier Home Inspections of the CSRA
706 836 4488
jeff@premiercsra.com

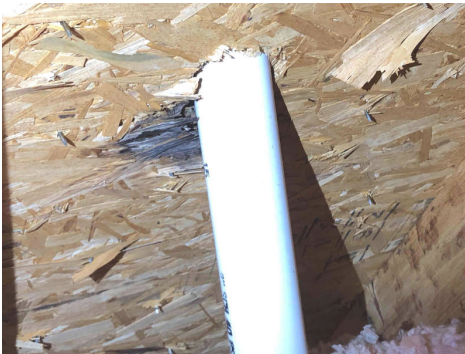
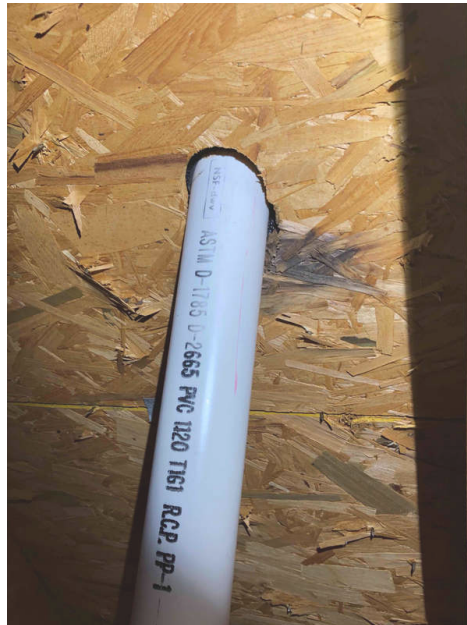
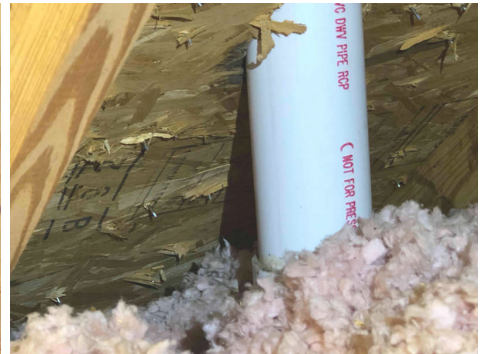
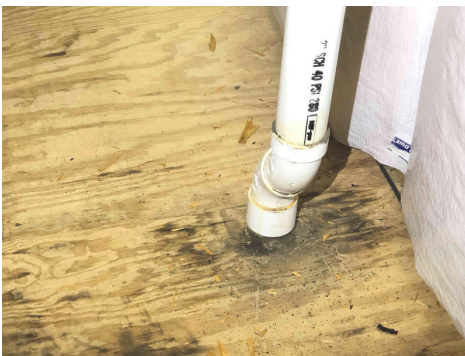
VENT STACKS ON BACK RIGHT SIDE OF ATTIC

STAINING OBSERVED

Staining on the roof decking was observed at the time of the inspection. There was no active or abnormal moisture readings observed at the time of the inspection. Monitor

*Staining was observed below the vent stacks on the right side of the attic space. Given the high temps with no previous rain. The areas should be monitored to ensure no active staining is present.

Recommend monitoring.

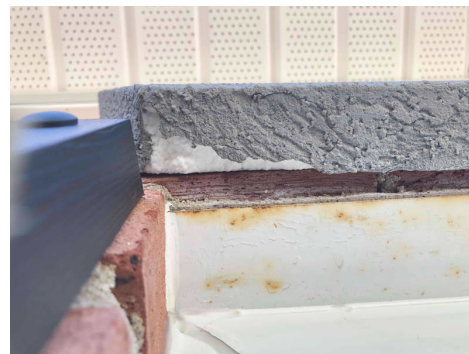
LOWER PORTION OF STUCCO TRIM (FRONT FAR RIGHT GARAGE WINDOW)

STUCCO DAMAGED

The stucco trim over the far right front garage window exhibited minor damages. No subsequent damages were observed however repairs should be made to prevent moisture related or insect related damages.

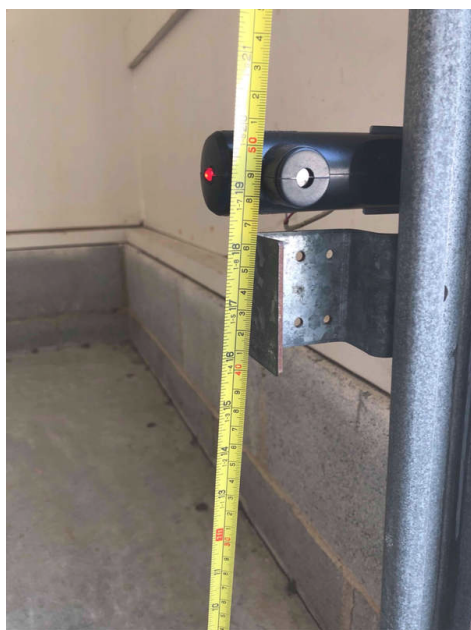
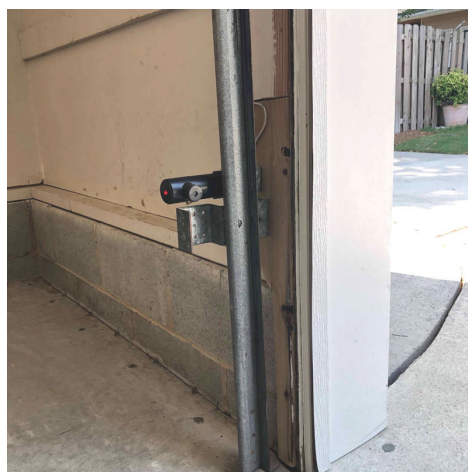
GARAGE DOOR SENSORS TOO HIGH

The garage door safety sensors were mounted too high up.

**As a general rule, garage door sensors should be mounted not more than six inches above the floor. That's because they might not trigger properly otherwise, and people or animals could get trapped under the door as it closes. The object under the door needs to break the sensor's infrared beam in order for the sensor to work. If the sensors are too high up, a person or small animal in that spot won't break the beam — so the door will continue to close.*

The sensors were mounted at a height of approximately 19 inches.

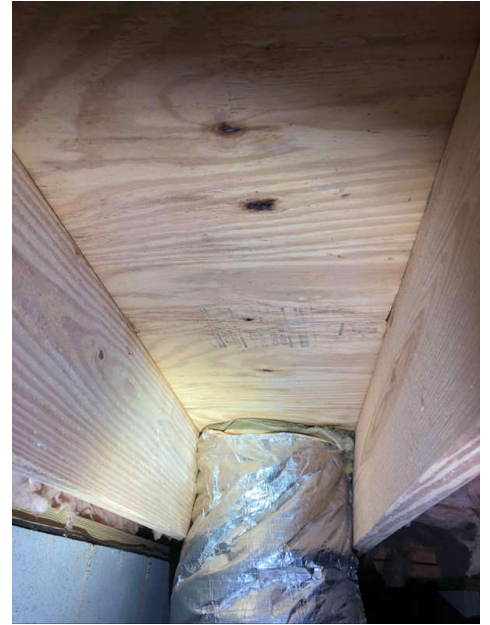
MIDDLE OF CRAWLSPACE (BESIDE HVAC RETURN)

MISSING INSULATION

Insulation should be installed where missing in the crawlspace.

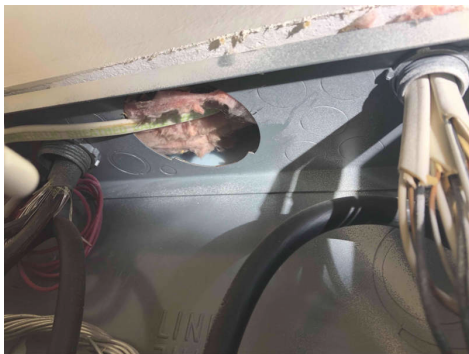
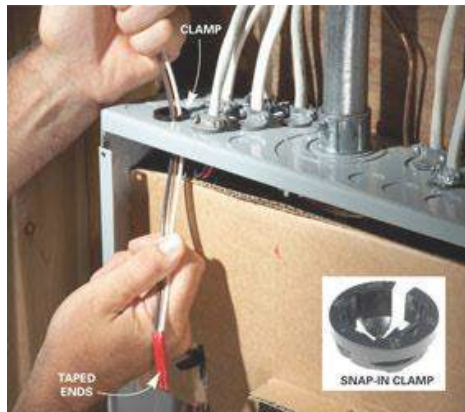
TOP OF PANEL

MISSING SECURE CLAMP (NM CONNECTOR)

Secure Clamps (NM Connectors) should be installed where missing. The Secure Clamps are designed to prevent damages to the wire sheathing in the event the wiring rubs against the distribution panel edges. In addition, by protecting the wire sheathing from damages, shock hazards in the electric panel are also diminished.

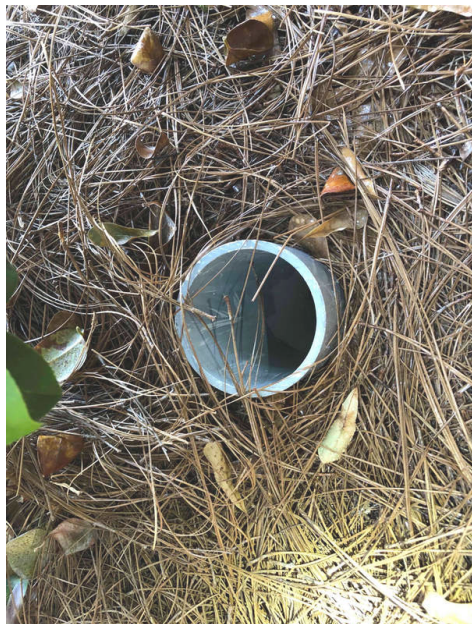
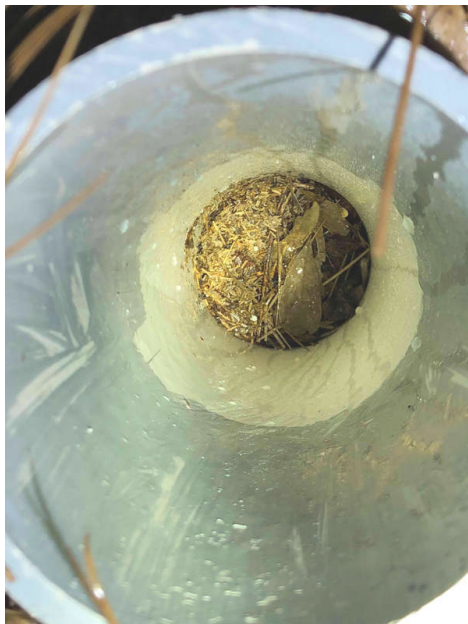
FRONT LEFT SIDE OF HOME

CLEAN OUT MISSING CAP

The plumbing clean out located on the front left side of the home was missing a cap. Debris was observed in the drain line. Debris should be cleaned out and a cap installed.

Contact a qualified plumbing contractor.

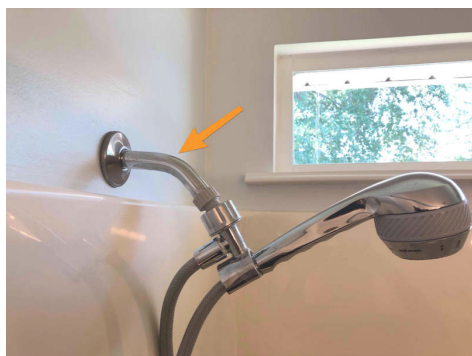
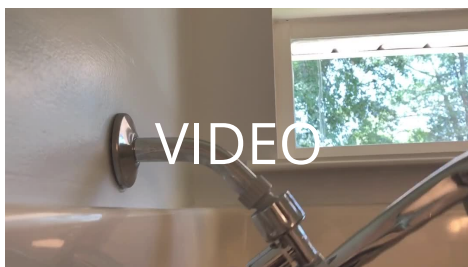
UPSTAIRS HALL BATHROOM

LOOSE SHOWER HEAD PLUMBING

The plumbing to the shower head was loose at the time of the inspection. Secure the plumbing line to prevent potential damages.

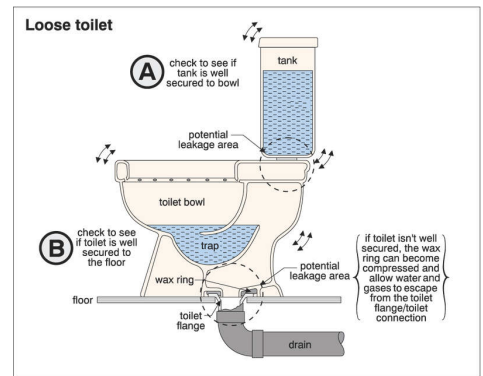
DOWNSTAIRS HALF BATH,

TOILET BOWL LOOSE

A loose toilet causes the wax ring gasket to lose its seal. This can cause leaking. Continued use of a loose toilet can also cause damage to the drain flange. Replace the wax ring and evaluate the flange for damage.

Recommendation
Contact a handyman or DIY project
