SUMMARY
1234 Main St.Saranac Lake NY 12983
Buyer Name
03/15/2018 9:00AM

Charlie Smith
lic. 16000089134
Saranac Lake Inspection Services
5185697970
charlie@slinspectionsservices.com

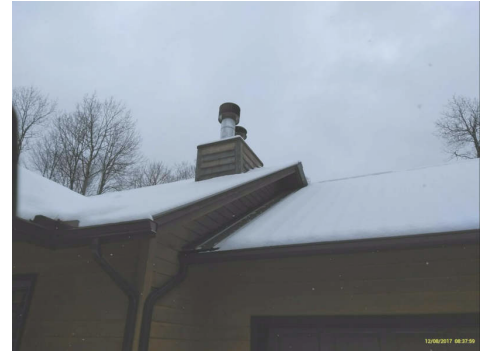
2.2.1 Roof Penetrations

UNFINISHED WOOD AROUND CHIMNEY

The chase around the chimneys appeared to be covered in unfinished wood. Wood on the exterior of a house should be finished in order to extend the life of the wood and help protect from moisture intrusion. Recommend a qualified contractor to repair as needed.

Recommendation
Contact a qualified painter.

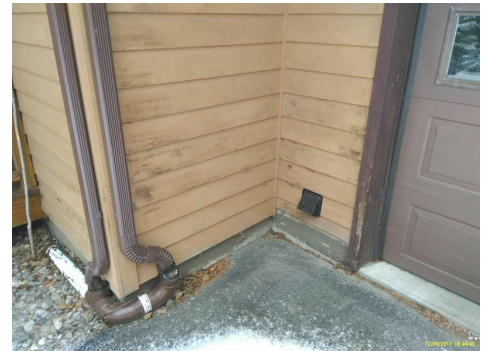
3.1.1 Siding, Flashing & Trim

CHIPPING AND PEELING PAINT

There were various areas of chipping and peeling paint around the house on the siding and exterior trim. Paint prevents exterior wood from the elements and increases the lifespan of the wood. Recommend scraping and repainting as needed, or contacting a qualified contractor to repair as needed.

Recommendation
Contact a qualified painter.

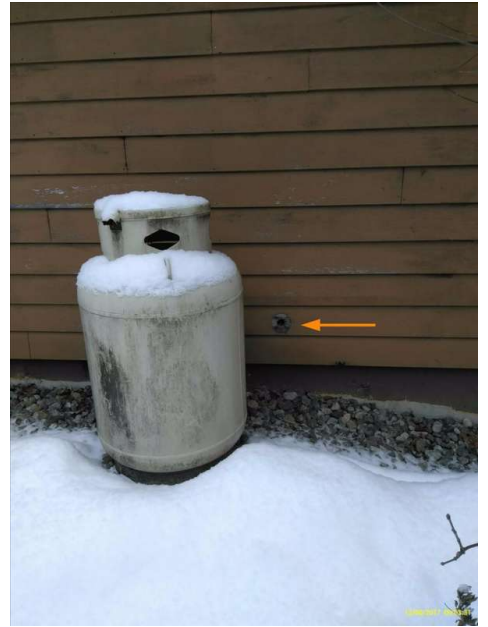
3.1.2 Siding, Flashing & Trim

HOLE IN SIDING

There was a hole in the siding along the back wall of the attached garage. It appears as though there used to be a propane line entering the wall at this point, but there was not one at the time of the inspection. Any holes in the exterior of the house should be sealed to prevent moisture or pests from entering. Recommend a qualified contractor to repair as needed.

Recommendation
Contact a qualified siding specialist.

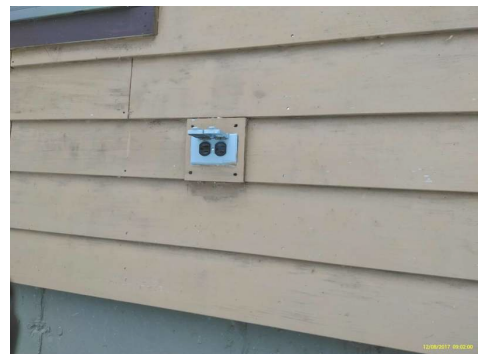
3.1.4 Siding, Flashing & Trim

NON GFCI OUTLETS

The exterior outlets were not GFCI (ground fault circuit interrupter) protected. GFCI outlets are recommended any location where there may be water present to reduce the risk of electric shock, such as the exterior of a house, the garage, or near any plumbing fixtures. Recommend a qualified contractor to repair as needed.

Contact a qualified electrical contractor.

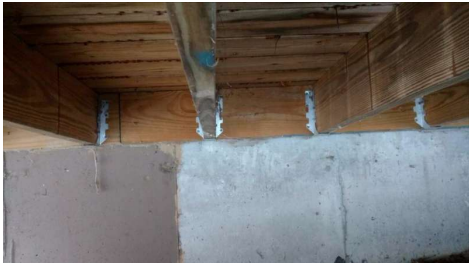
3.3.1 Decks, Balconies, Porches & Steps

IMPROPER DECK SUPPORT

The deck ledger boards for both the front and back porches did not have adequate fasteners. Proper fasteners have the strength to prevent a deck from pulling away or dropping. Recommend a qualified contractor to repair as needed.

Underneath the front porch.

Contact a qualified deck contractor.

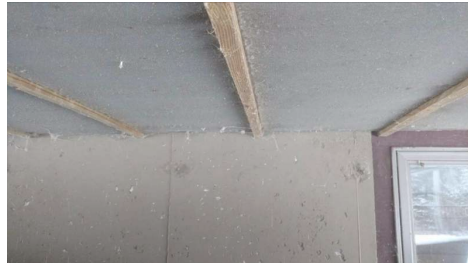
Underneath the back porch, when viewed with a flashlight the ledger was visible, but not able to be photographed.

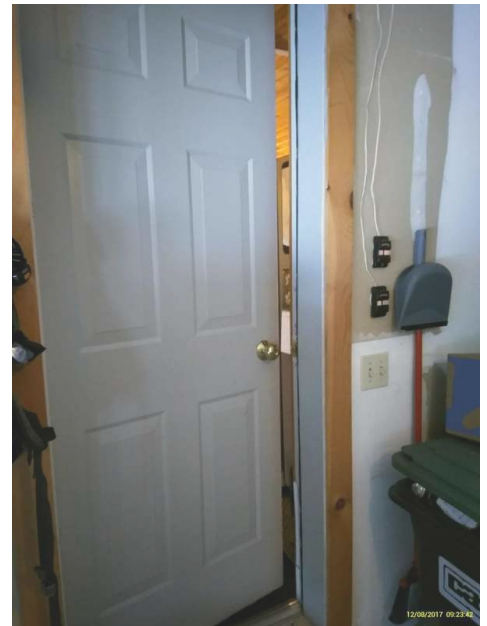
5.5.1 Occupant Door (From garage to inside of home)

SELF CLOSING MECHANISM NOT STRONG ENOUGH

The entrance door to the house did not fully self close at the time of the inspection. While equipped with proper hinges, they did not provide adequate force to fully close the door. A self closing door is important in slowing the spread of fire from the garage to the rest of the house, and preventing carbon monoxide from running vehicles from entering the house. Recommend a qualified contractor to repair as needed.

Contact a qualified professional.

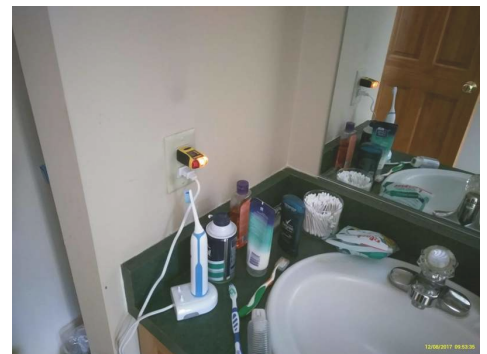
7.3.1 Outlets

GFCI INOPERABLE

When tested, the GFCI (ground fault circuit interrupter) outlet did not trip. GFCI outlets help prevent electric shock in the event of an electric device coming in contact with water. Recommend a qualified contractor to repair as needed.

Contact a qualified electrical contractor.

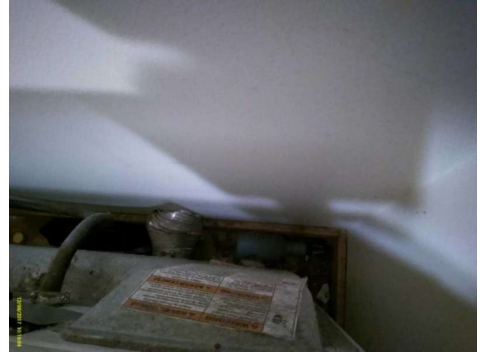
11.2.1 Dryer

CRUSHED DRYER VENT

The vent pipe for the dryer was crushed. Restricting the air flow exiting a dryer can cause lint to accumulate, increasing the chance of fire. Recommend a qualified contractor to repair as needed.

Contact a qualified professional.

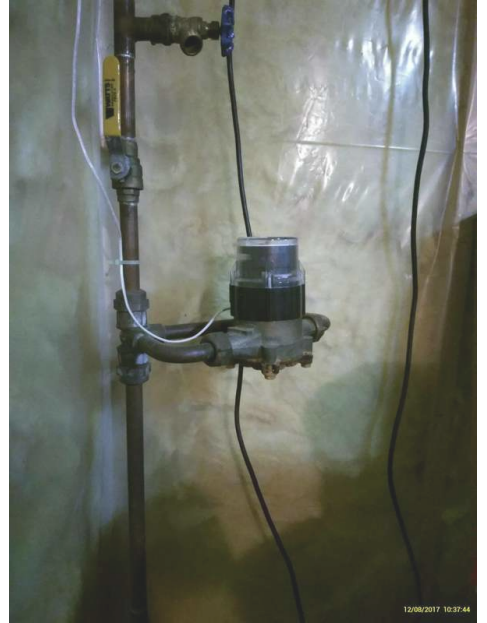
14.3.1 Water Supply, Distribution Systems & Fixtures

WATER SUPPLY NOT BONDED

The water supply system did not appear to be bonded to the electrical system. Proper bonding of the water to the electrical system helps prevent possible electric shock in the event of electric appliances negatively interacting with the plumbing system. Recommend a qualified contractor to repair as needed.

Contact a qualified electrical contractor.

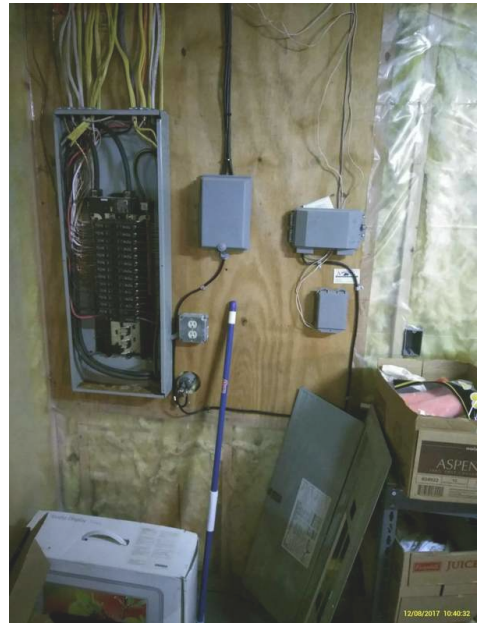
15.1.1 Main & Subpanels, Service & Grounding, Main Overcurrent Device

COVER REMOVED

The electrical panel cover was not in place at the time of the inspection. It is not recommended that the face of the panel be removed for long periods of time to reduce the risk of electric shock. Recommend a qualified contractor to repair as needed.

Contact a qualified electrical contractor.
