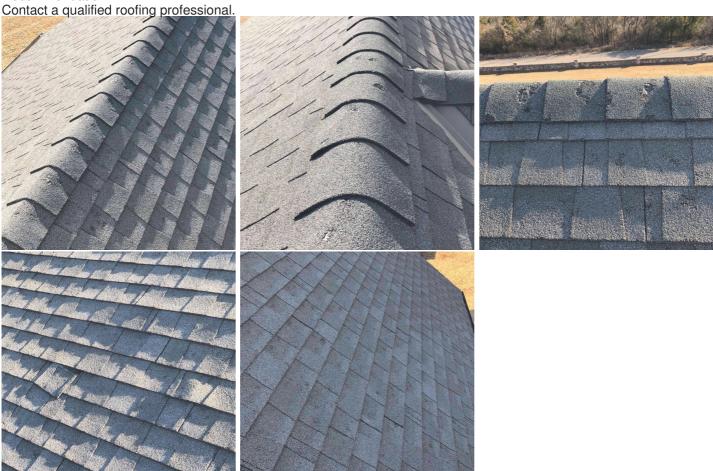
WIDESPREAD FUNCTIONAL HAIL DAMAGE

At the time of the inspection, the asphalt composition shingle roof had widespread damage visible that appeared to be the result of hail strikes. This damage appeared to meet the definition of what insurance companies call "functional damage." Functional damage is damage that;

- 1. Reduces the ability of the roof to shed water; or
- 2. Significantly shorten the shingle's long term service life. Offering estimates of the remaining long-term expected service life of asphalt shingles exceeds the scope of the General Home Inspection.

The Inspector recommends replacement of all damaged shingles by a qualified contractor.
