SUMMARY
1234 Main St. LOLO MT 59847
Buyer Name
05/22/2019 9:00AM

Tim Netzley
NACHI09081108
Inspect Montana | T&B House and
Property, LLC
(406) 241-9464
tim@inspectmt.com

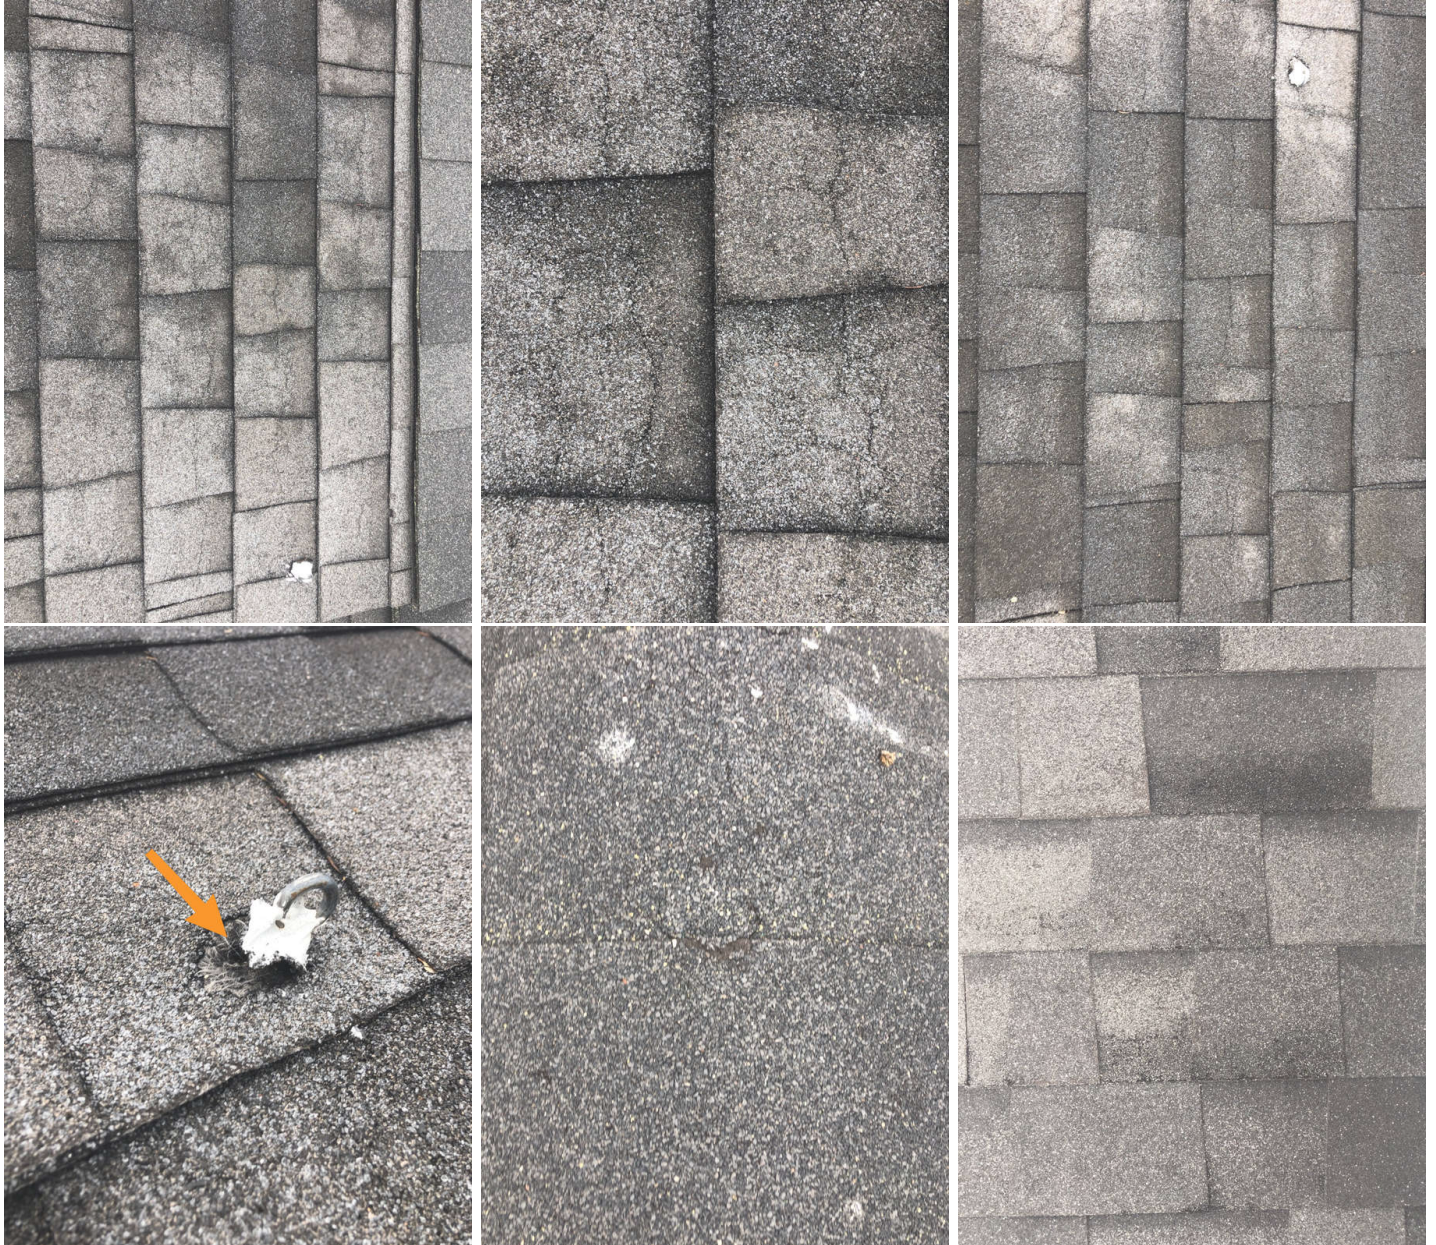
2.3.1 Coverings

DAMAGED (GENERAL)

EAST

Roof coverings showed damage. Recommend a qualified roofing professional evaluate and repair.

Contact a qualified roofing professional.

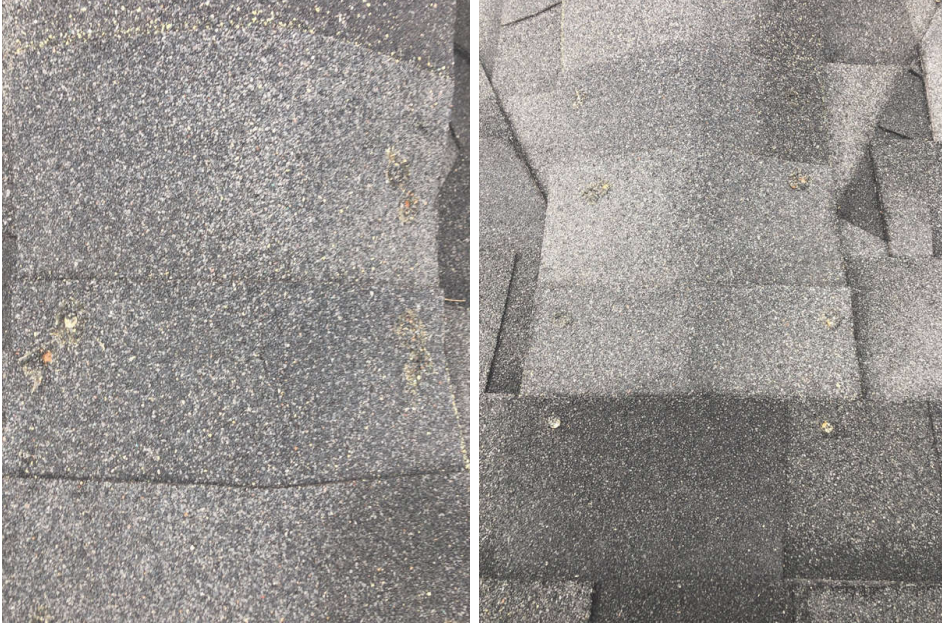
2.3.2 Coverings

EXPOSED FASTENERS

Several exposed fasteners without proper sealing were found.

Contact a qualified roofing professional.

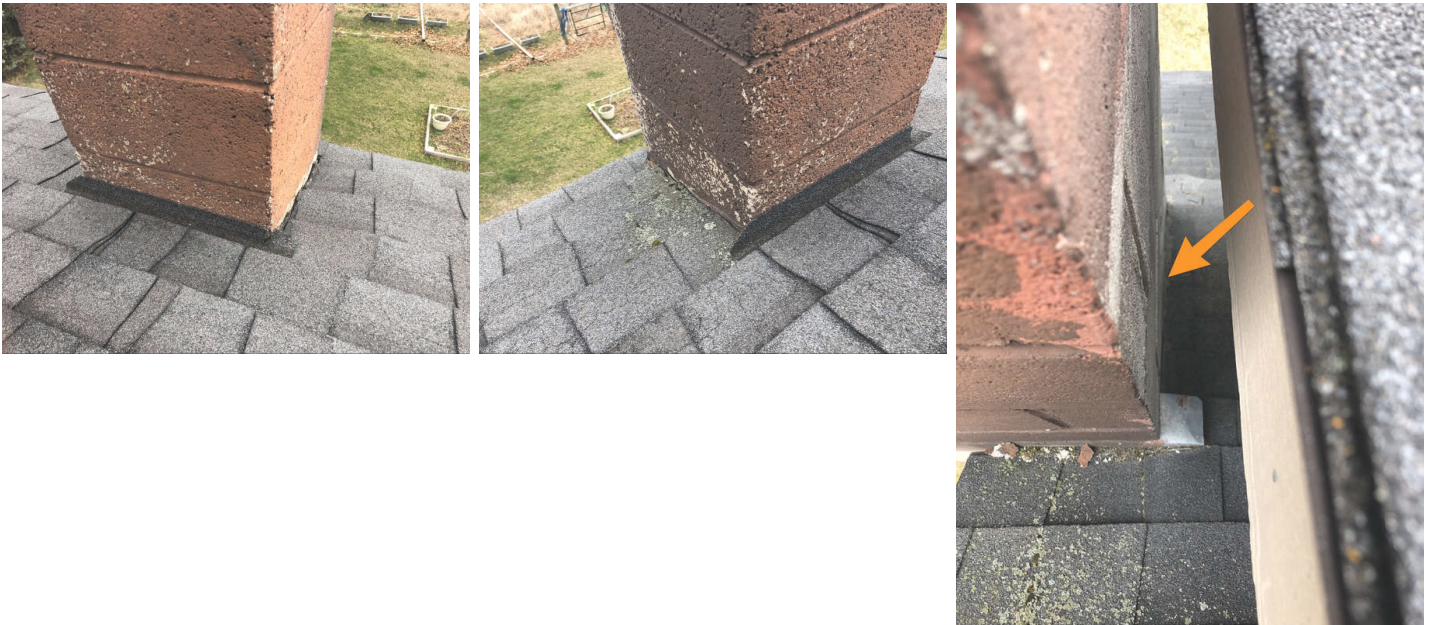
2.5.1 Flashings

MISSING

Proper flashings at chimneys were missing at time of inspection. Flashings provide protection against moisture intrusion. Recommend a qualified roofing contractor evaluate and remedy.

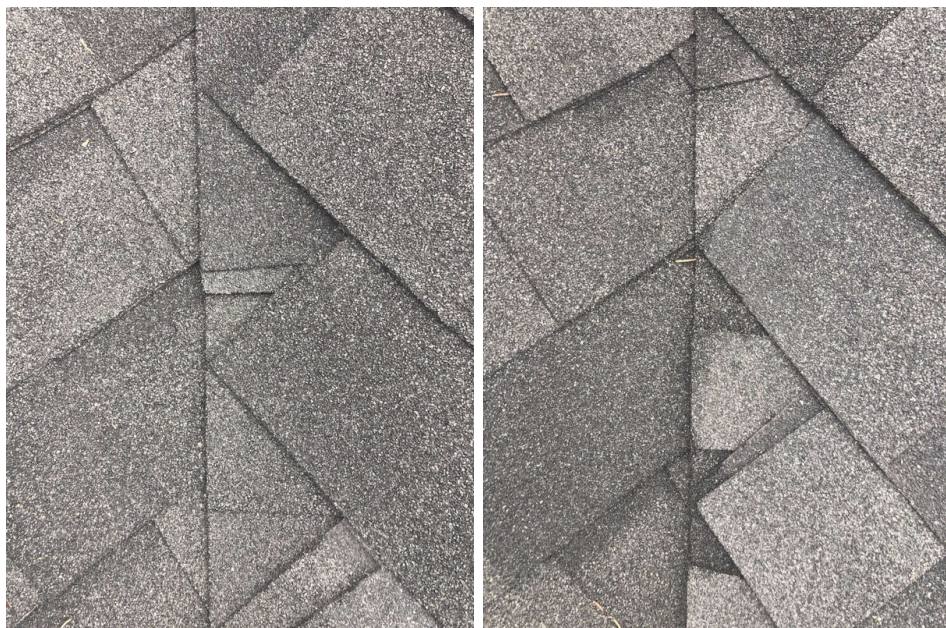
2.6.1 Valleys

IMPROPERLY CUT

Valley is improperly cut and may lead to moisture problems. See video explaining proper valley installation [here](#). Refer to a qualified contractor for evaluation.

Contact a qualified roofing professional.

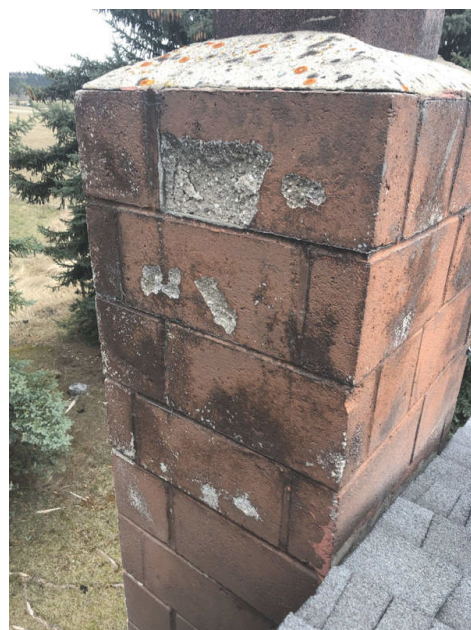
2.8.1 Chimneys

DETERIORATION

Portions of block were damaged and/or deteriorated. The crown was also deteriorated. Refer to qualified mason for correction.

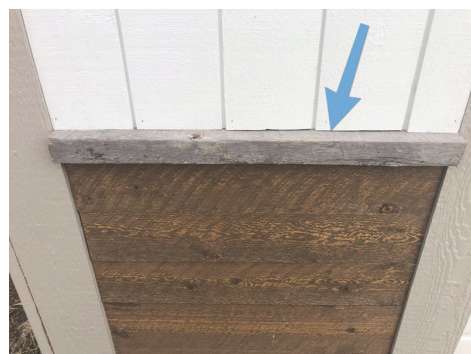
3.3.1 Siding

FLASHING/TRIM IMPROPERLY INSTALLED

Flashing was missing at transition points, which could result in moisture intrusion and damaging leaks if sealing and caulking are not installed and maintained regularly thereafter.

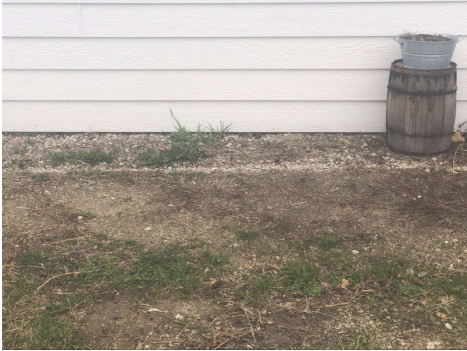
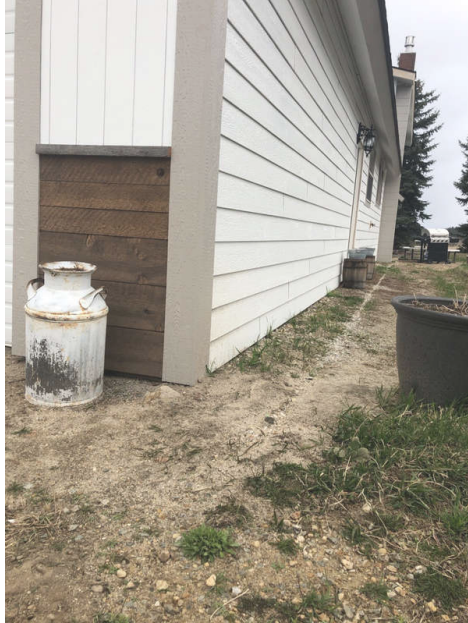
3.3.2 Siding

GROUND CLEARANCE

Inadequate clearance between the siding and ground. Recommend a minimum ground clearance between bottom of siding and ground of 6". Siding in contact with the ground or soil is a serious concern because that condition can provide direct access for water to susceptible materials.

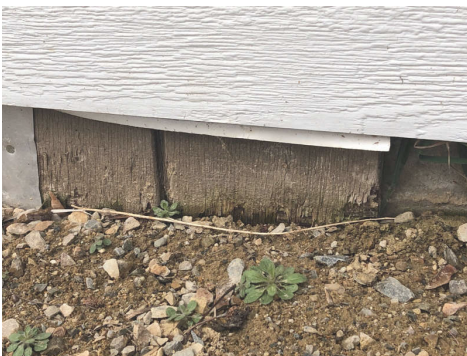
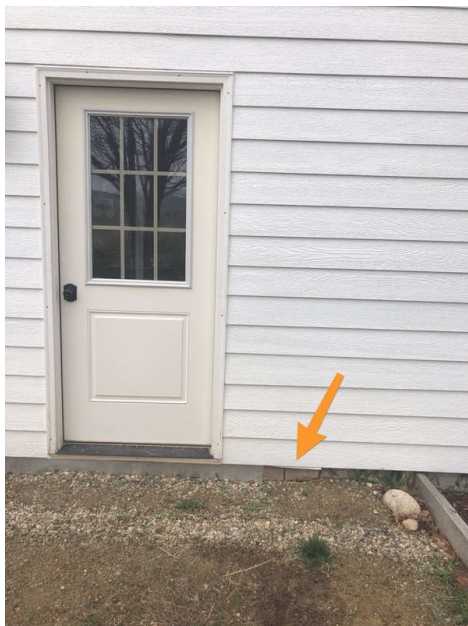
3.3.3 Siding

WOOD IN CONTACT WITH SOIL

Wood was found to be in contact with soil. I would will run out as well as potential he create a van for moisture intrusion. We recommend reparations be done.

Contact a qualified professional.

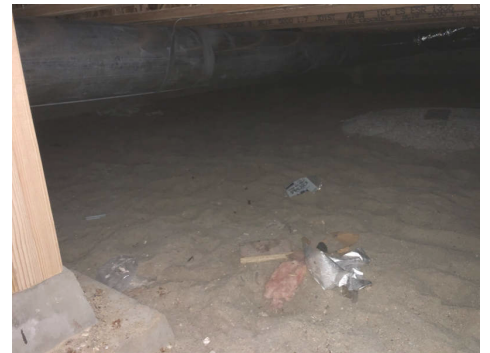
5.2.1 Floor

NO VAPOR BARRIER

No Vapor Barrier observed. A minimum of 6mil. Plastic covering should be installed on floor surface to minimize moisture intrusion and potential mold growth. Refer to a qualified contractor for correction.

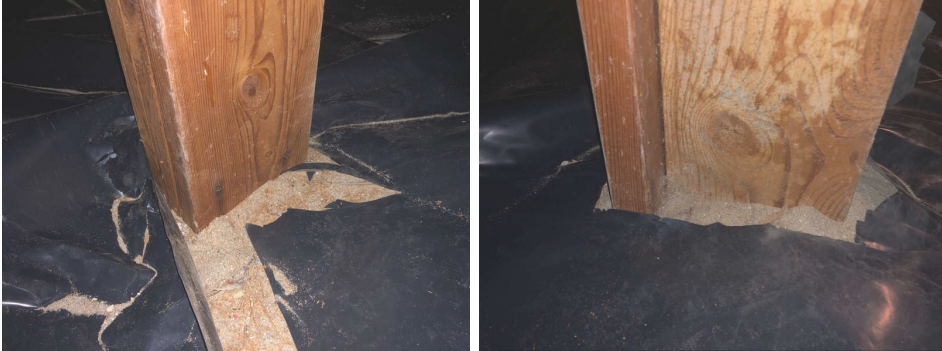
5.4.1 Piers

WOOD NEAR OR IN CONTACT WITH SOIL

Proper ground clearance between soil and wood structure was not present at some locations.

We recommend review by a structural specialist.

Contact a qualified structural engineer.

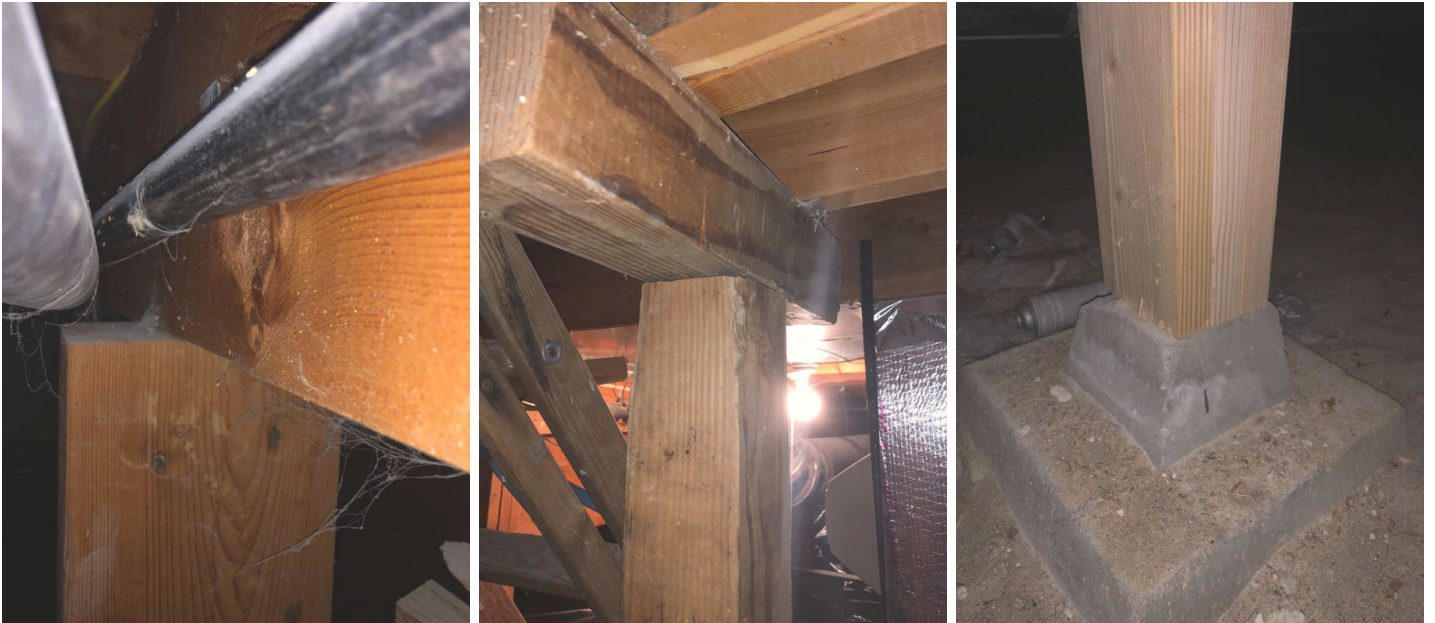
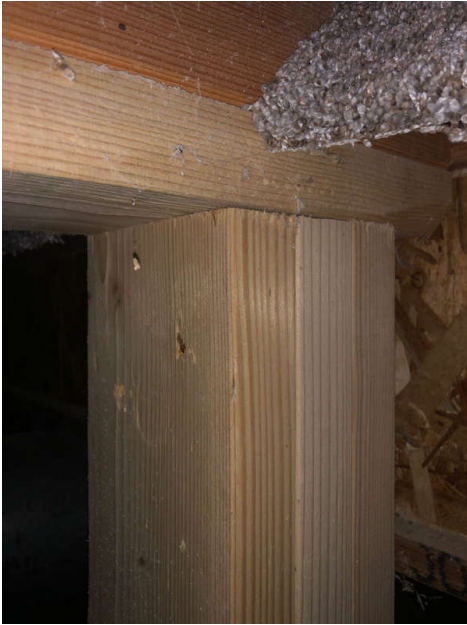
5.4.2 Piers

MISSING OR IMPROPER ANCHORING

Missing or improper anchoring was observed at several places throughout the crawlspace.

Contact a qualified professional.

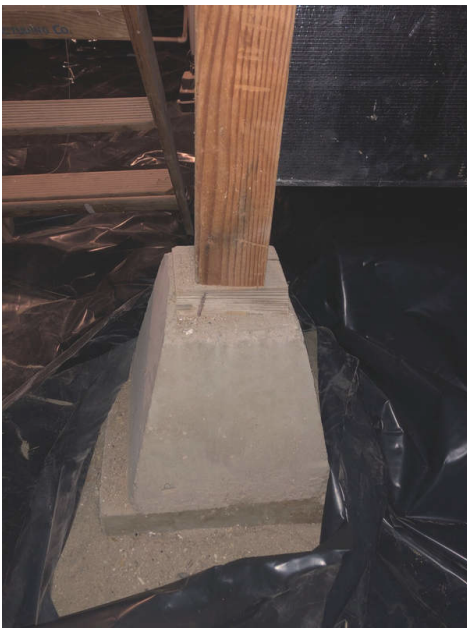
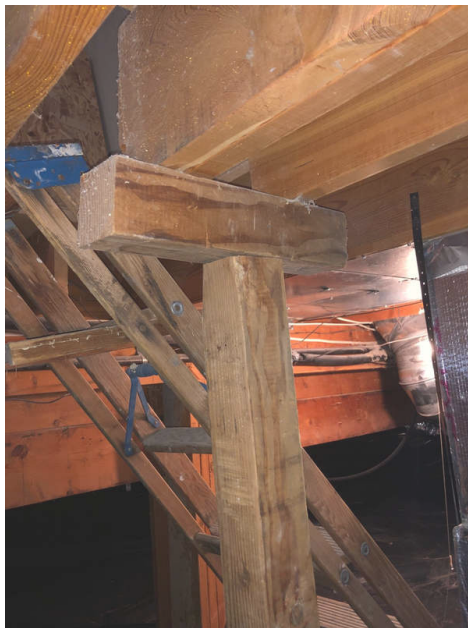
5.4.3 Piers

IMPROPER INSTALLATION

Improper installation of a pier holding up floor joists for the cut in crawlspace access hatch was noted.

Contact a qualified professional.

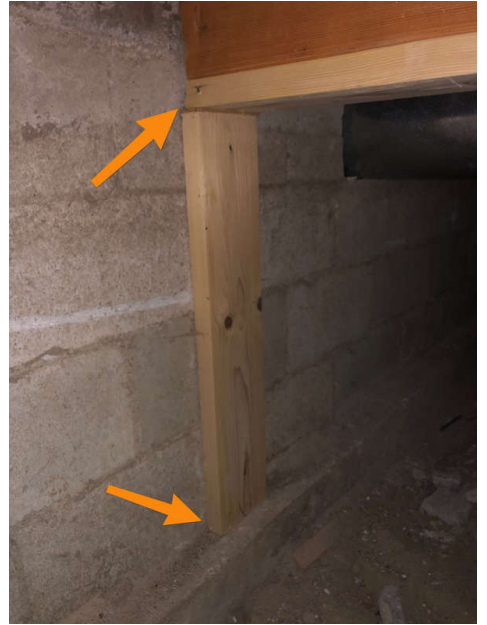
5.5.1 Beams

IMPROPER SUPPORT

A support under a short beam in the addition was inadequately supported and anchored according to standards.

Contact a qualified structural engineer.

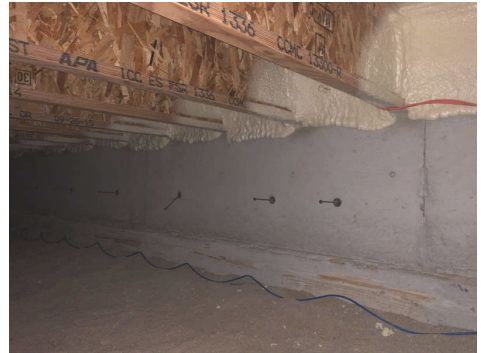
5.8.1 Insulation

INSULATION MISSING

Insulation was missing or inadequate.

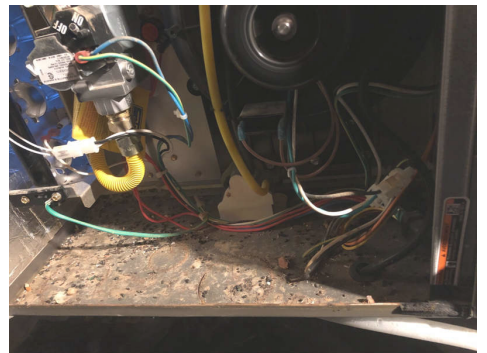
7.1.1 Equipment

NEEDS SERVICING / CLEANING

Furnace should be cleaned and serviced annually. We recommend a qualified HVAC contractor clean, service, and certify furnace.

Contact a qualified HVAC professional.

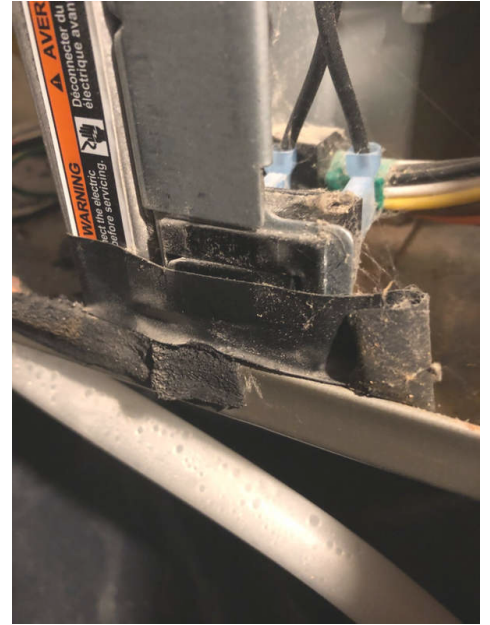
7.6.1 Blower Door Switch

MADE INOPERABLE

The safety switch was made inoperable by tape.

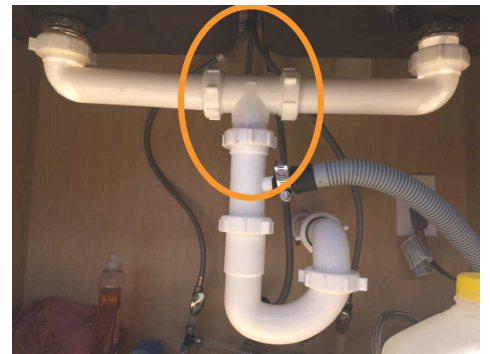
9.2.1 Drain, Waste, & Vent Systems

KITCHEN SINK DRAIN PIPING

While this tee style drain set up under a two or more basin sink fixture is fairly commonly available in hardware stores, there is the potential for drain water and debris to back up from one basin to the next due to the proper installation of a proper Santee missing.

Contact a qualified professional.

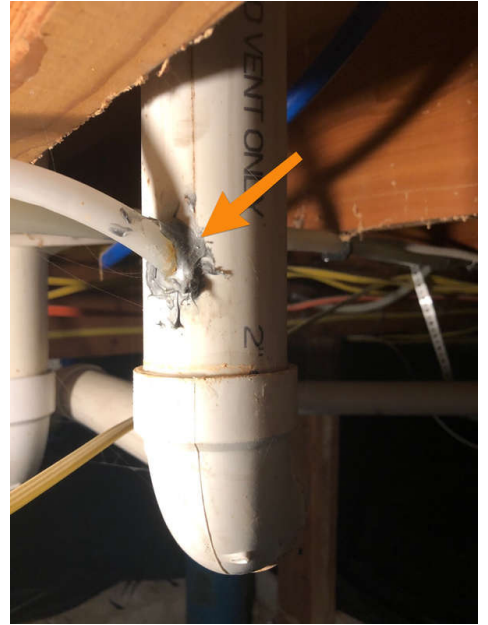
9.2.2 Drain, Waste, & Vent Systems

DAMAGE FROM IMPROPER PRACTICES

A vent pipe was cut into to accommodate the condensate drain line from the furnace. We recommend reparations and proper disposal of condensate.

Contact a qualified plumbing contractor.

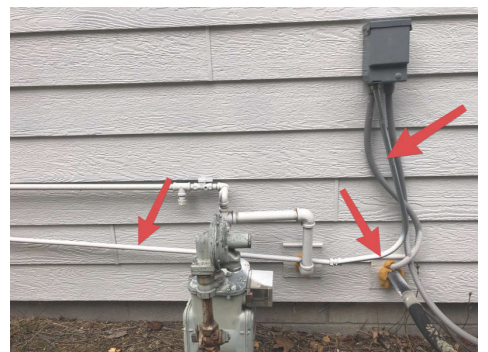
10.5.1 Branch Wiring, Circuits

DAMAGED CONDUIT

The conduit to the AC unit wiring was damaged and unsupported. We recommend reparations to prevent damages to wiring within, creating potential hazards.

Contact a qualified professional.

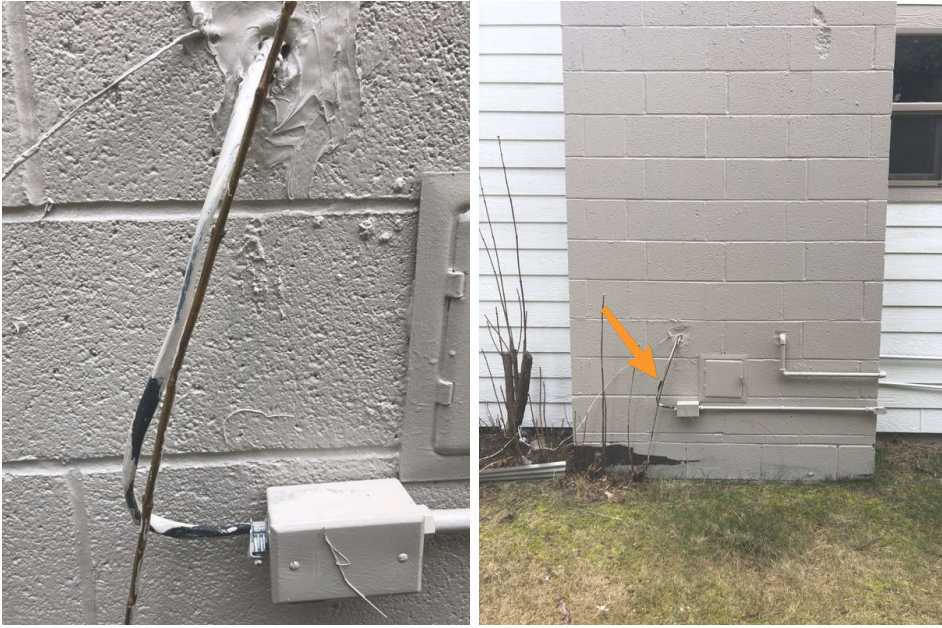
10.5.3 Branch Wiring, Circuits
EXPOSED WIRING

Cabling that appeared not to be designed for sunlight or moisture exposure was exposed outside.

Contact a qualified electrical contractor.

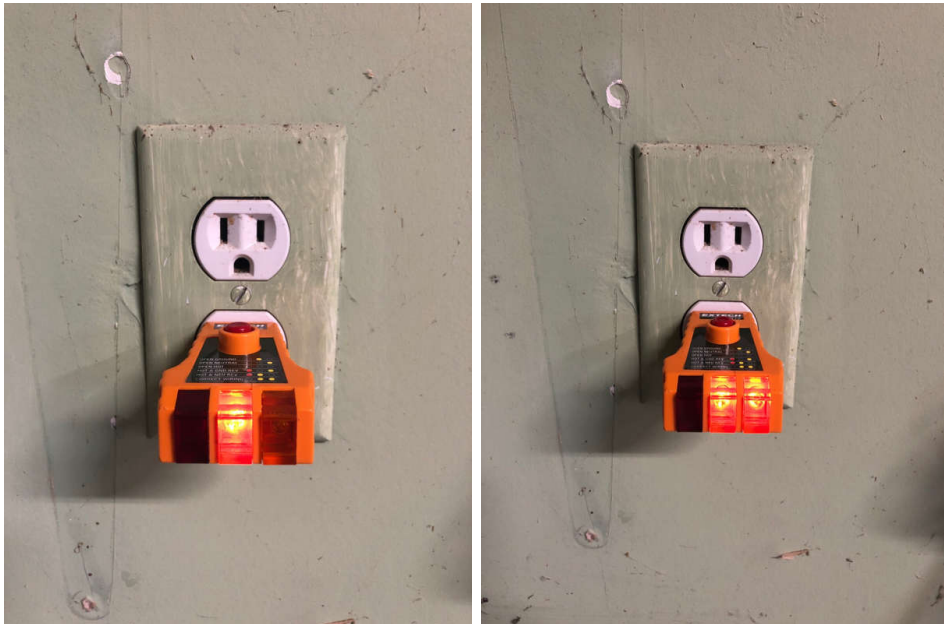
10.6.1 Receptacles
FAULTY DEVICE

A receptacle in the garage had inconsistent readings and appeared to be shorting at the device.

Contact a qualified electrical contractor.

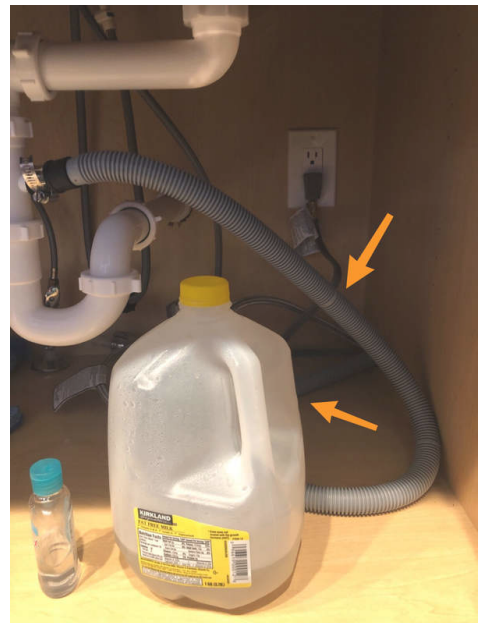
12.8.1 Dishwasher

IMPROPERLY INSTALLED DRAIN PIPE

The dishwasher drain hose did not terminate through an air gap, or run in a high loop above the unit, either of which is typically required by manufacturers for proper operation.

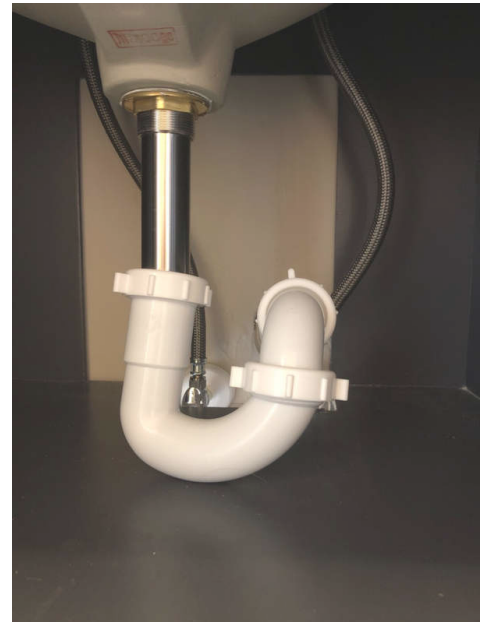
15.8.1 Drains & Fixtures

IMPROPER CONNECTION

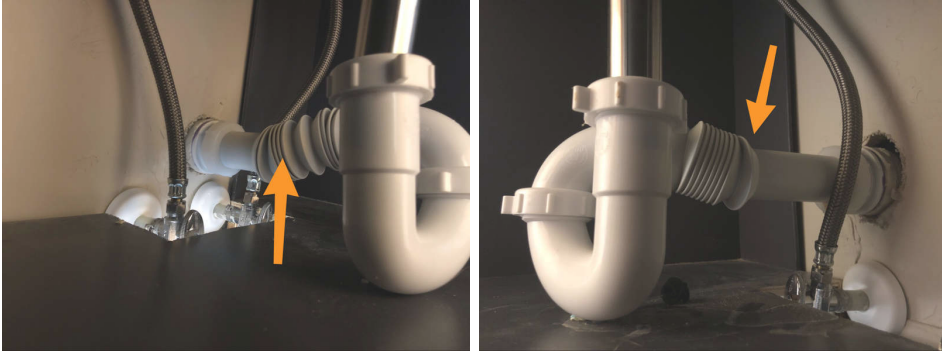
15.8.2 Drains & Fixtures

CORRUGATED DRAIN LINES

Though sold regularly at hardware stores these corrugated drain lines are never recommended by professionals due to the high probability of blockages from accumulated debris.

Contact a qualified plumbing contractor.

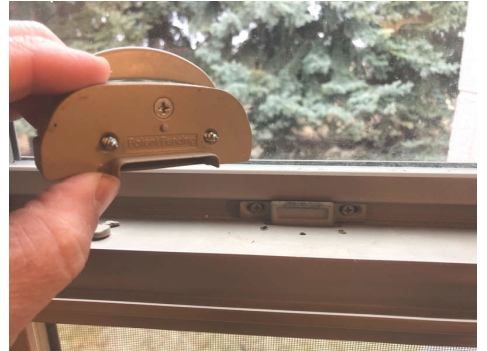
17.2.1 Windows

MISSING / DAMAGED HARDWARE

The hardware for one or more windows to properly lock / open / close is missing or damaged. We recommend that all windows in the home be properly tested and in proper working function prior to closing.

Contact a handyman or DIY project

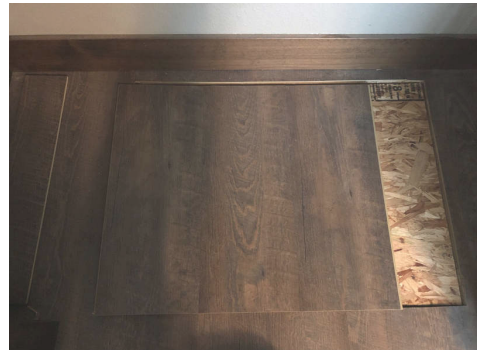
17.3.1 Floors

NOT ADHERED

Flooring was not properly adhered to crawlspace access hatches.

Contact a qualified professional.

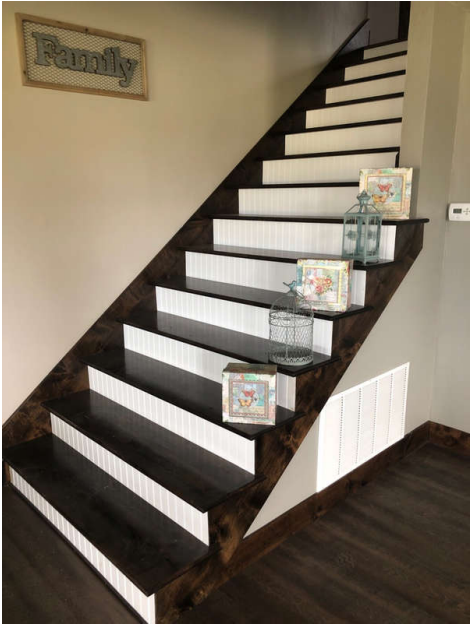
17.6.1 Steps

OPEN SIDE

For added safety add a handrail to open side of stairs.
