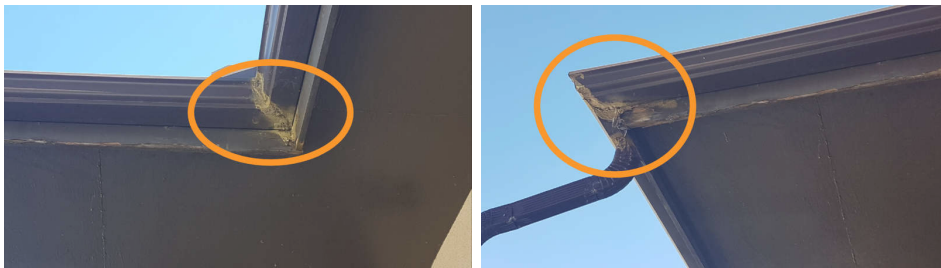
2.2.1 Roof Drainage Systems

GUTTERS REQUIRE MAINTENANCE

Gutter corners appear to have been patched from what I assume is water leaks. Because of the cold weather I cannot say if they are currently leaking however, I do recommend that a roofing professional assess the gutter system for repair and/or replacement.

Contact a qualified roofing professional.

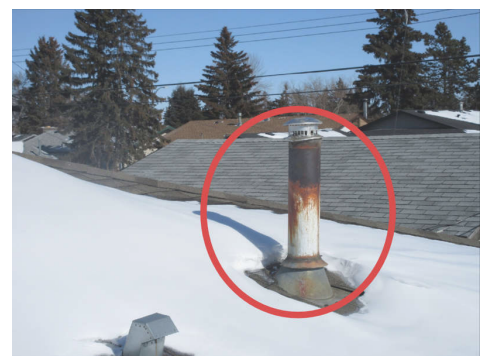
2.4.1 Skylights, Chimneys & Other Roof Penetrations

METAL CHIMNEY RUST

The metal chimney shows evidence of rust and/or rusting. Recommend monitoring the chimney which may have to be replaced at some point.

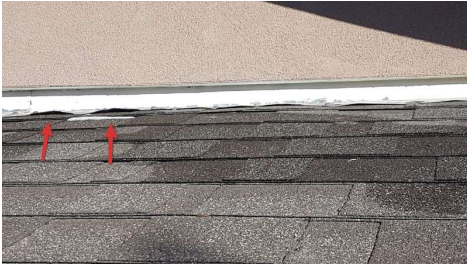
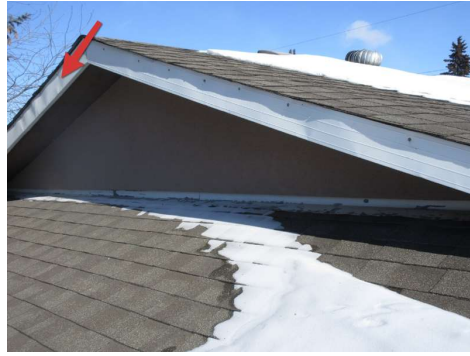
3.1.1 Siding, Flashing & Trim

FLASHING/TRIM IMPROPERLY INSTALLED

FRONT OF HOUSE

Flashing & trim pieces were improperly installed, which could result in moisture intrusion and damaging leaks. Recommend a qualified siding contractor evaluate and repair.

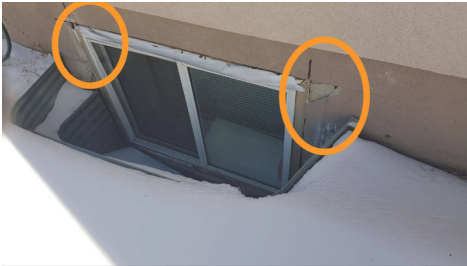
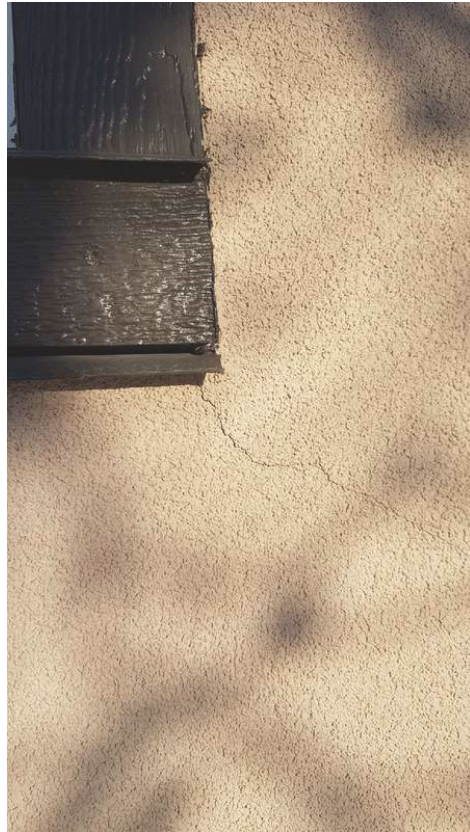
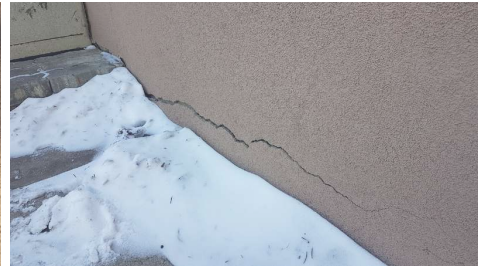
3.1.2 Siding, Flashing & Trim

STUCCO NEEDS REPAIR

Stucco at several points of the exterior shows that it is in need of repair. Recommend stucco professional to remedy in order to prevent possible water intrusion

Contact a stucco repair contractor

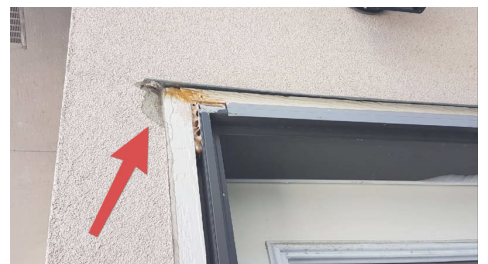
3.2.1 Exterior Doors

DOOR SILL/TRIM

Door sill and/or trim is loose, deteriorated or worn and repair or replacement should be considered.

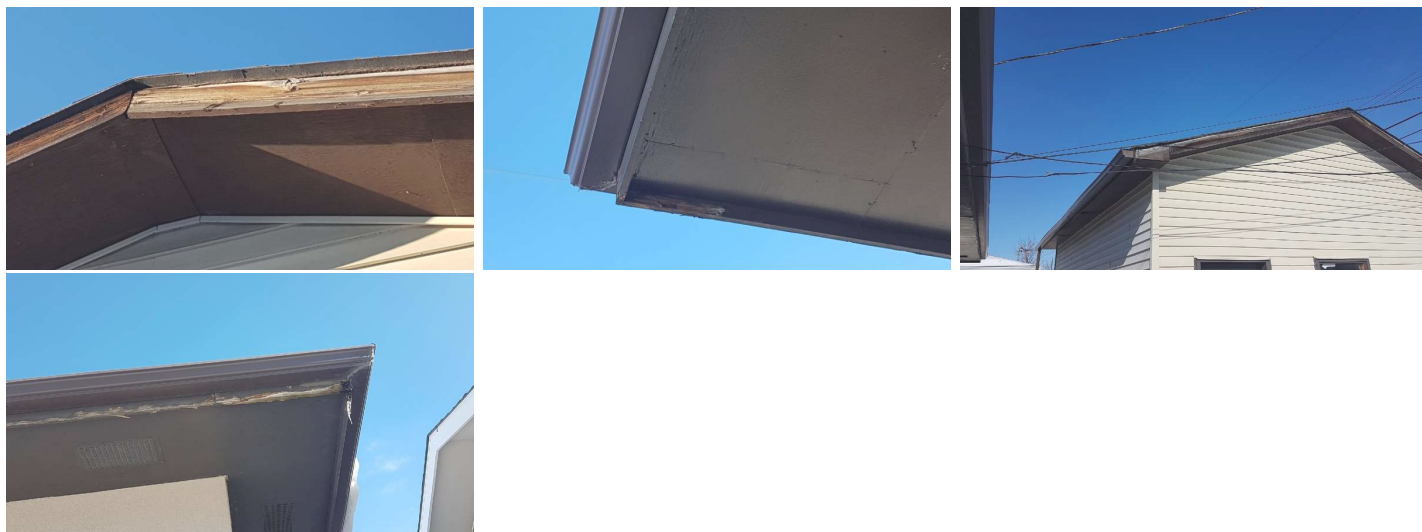
3.4.1 Eaves, Soffits & Fascia

FASCIA - ROTTED

One or more sections of the fascia are rotted, decayed and/or require paint. Recommend qualified roofer evaluate & repair.

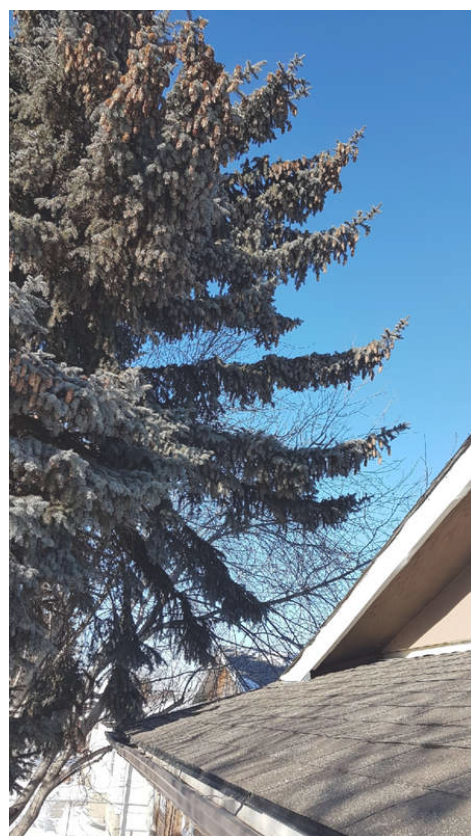
3.5.1 Vegetation, Grading, Drainage & Retaining Walls

TREE OVERHANG

Trees observed overhanging the roof. This can cause damage to the roof and prevent proper drainage. Recommend a qualified tree service trim to allow for proper drainage.

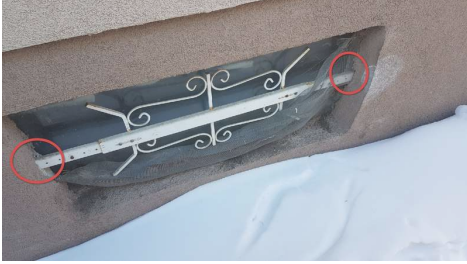
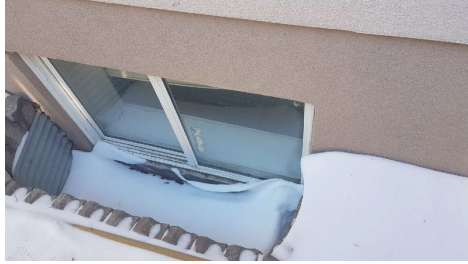
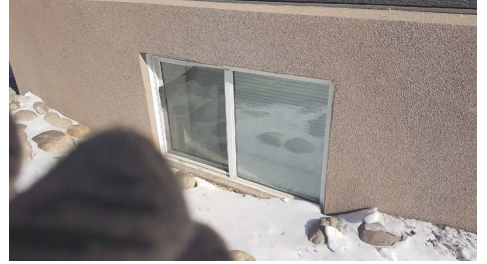
3.6.1 Windows

INADEQUATE FLASHING

Basement window flashings do not extend full width of windows which may lead to water penetration over time.

Also, covering window bars with stucco does make for a lasting water tight system.

Recommend professional to replace with appropriate flashings.

Contact a qualified window repair/installation contractor.

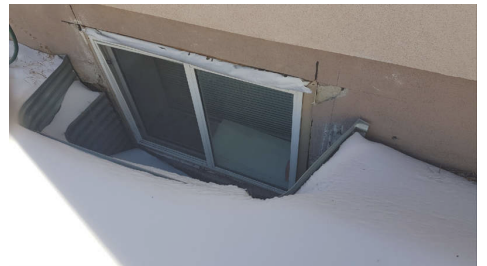
3.6.2 Windows

UNFINISHED WINDOW TRIM/FLASHING

Basement window appears to be in an unfinished state, leaving untreated wood exposed to the elements which will lead to wood decay/rot. This may also allow water intrusion. I recommend contacting a qualified window installer to evaluate and remedy.

Contact a qualified window repair/installation contractor.

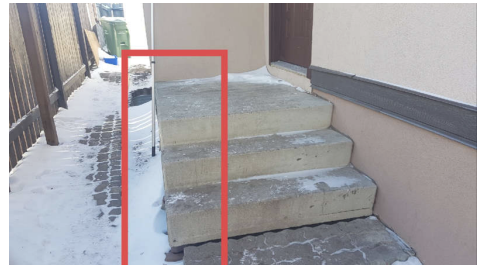
3.8.1 Guard Rails & Hand Rails

MISSING

Guard rails were missing during time of inspection. Steps with 4 or more risers require a handrail.

Recommend installation of handrail and guard at front steps to prevent falls.

Contact a qualified professional.

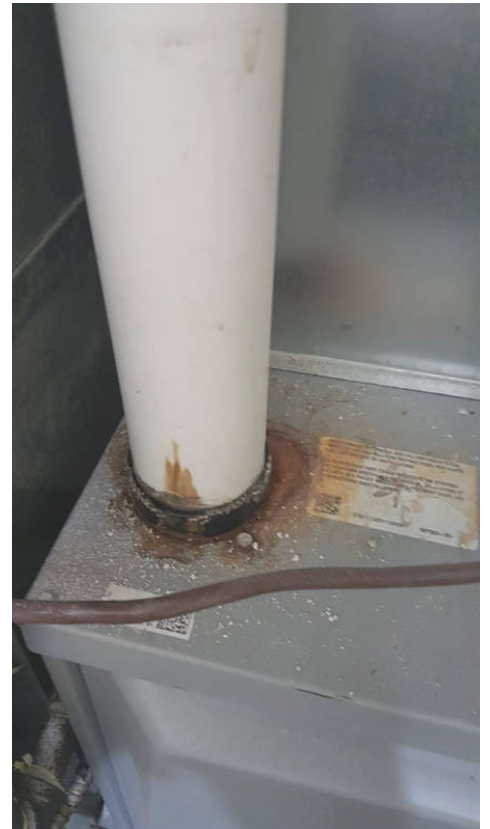
7.1.1 Equipment

CORROSION

Furnace was corroded in one or more areas. This could be the result of improper venting, which the source would need to be identified. Recommend a HVAC contractor evaluate and repair.

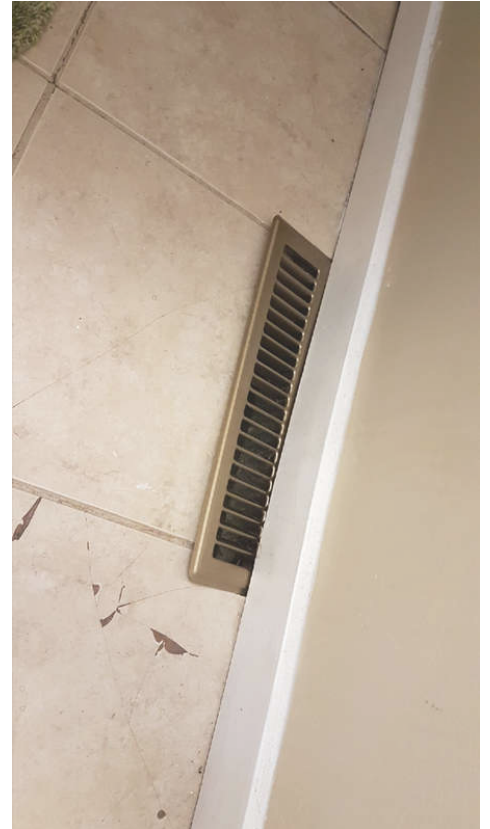
7.3.2 Distribution Systems

SUSPICIOUS VENT PLACEMENT

Several heat vents were installed partially under walls which is not best practice.

Recommend a qualified HVAC specialist to evaluate and make recommendations.

Contact a qualified HVAC professional.

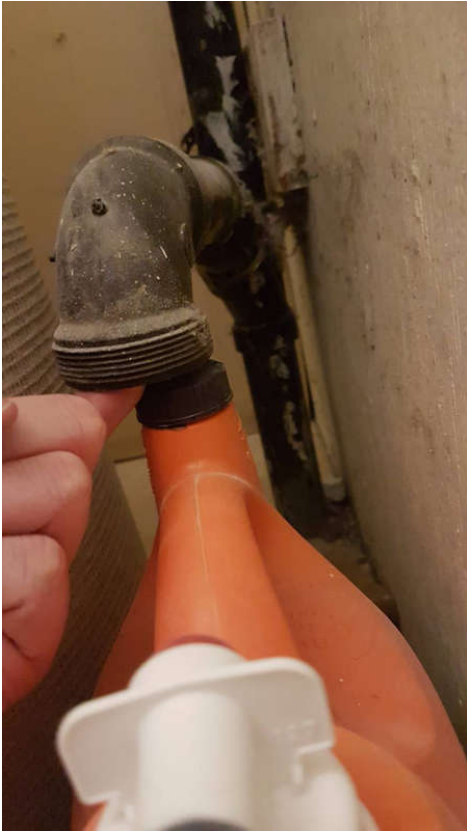
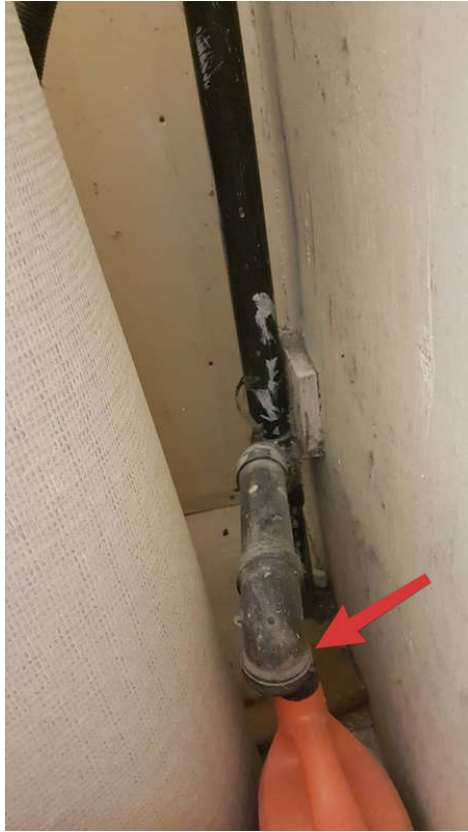
8.2.1 Drain, Waste, & Vent Systems

CAP MISSING OR IMPROPER INSTALLATION

BASEMENT LAUNDRY ROOM

Basement waste pipe was missing cap which may allow sewer gases in to the house. Recommend sealing off this pipe to prevent this.

Contact a qualified plumbing contractor.

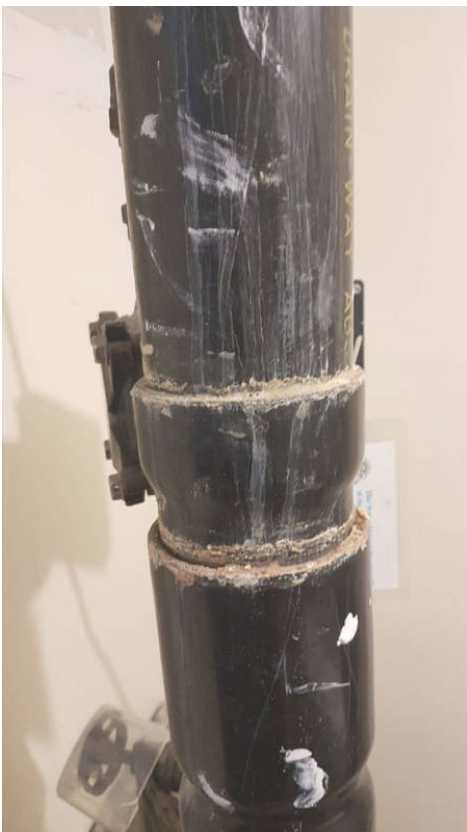
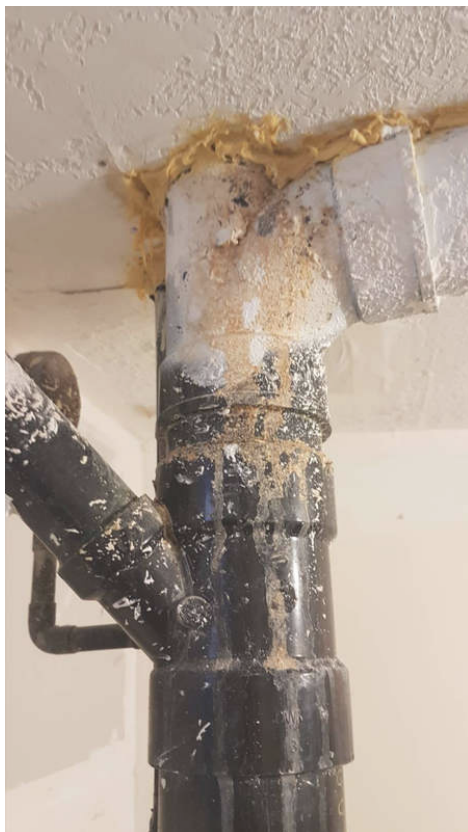
8.2.2 Drain, Waste, & Vent Systems **EVIDENCE OF PRIOR LEAKS**

Although there appeared to be signs of previous waste pipe leaks, none were observed on the day of the inspection.

Recommend monitoring for signs of future leaks.

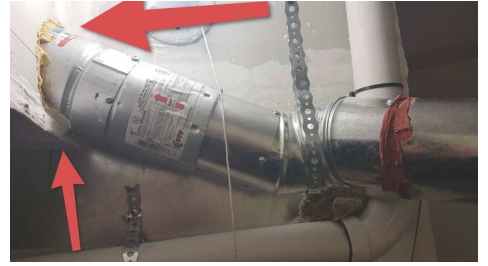
8.4.1 Hot Water Heater, Controls, Flues & Vents

IMPROPER INSTALLATION

Safety Hazard

Water heater is improperly installed or in a dangerous location.
"Type B" gas vent is running through drywall which is not allowed.
Type B gas vents require a **MINIMUM 1" CLEARANCE** from combustibles as these vents heat up which can pose a fire hazard.
Recommend qualified plumber evaluate & repair/relocate.

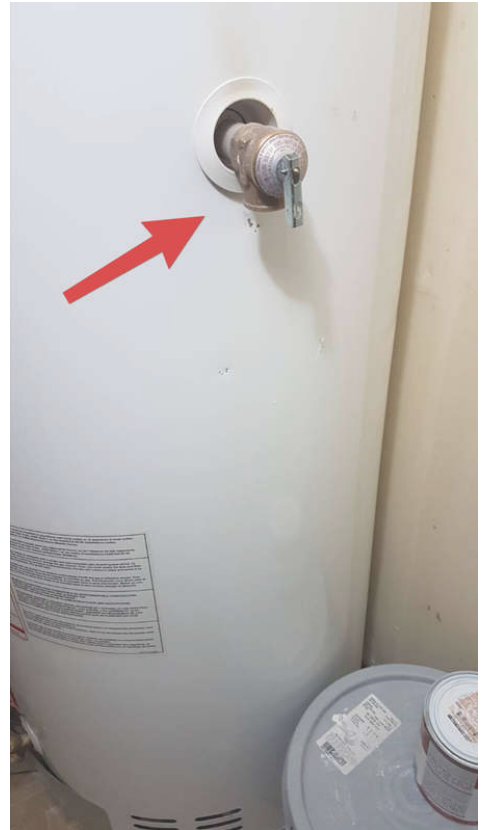
8.4.2 Hot Water Heater, Controls, Flues & Vents

TPR VALVE MISSING/NEED REPAIR

Safety Hazard

TPR valve and extension were located and appear to be properly installed. If missing or improperly installed this can lead to severe burns if the TPR valve is exercised.

Recommendation
Contact a qualified professional.

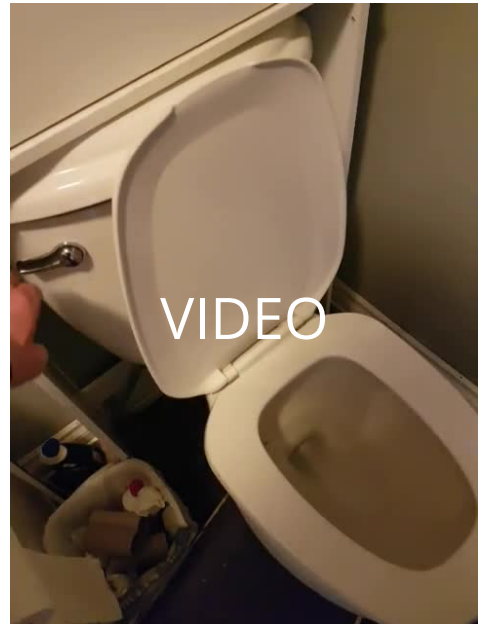
8.7.1 Toilets

TOILET NOT FLUSHING PROPERLY

Recommendation
Contact a qualified professional.

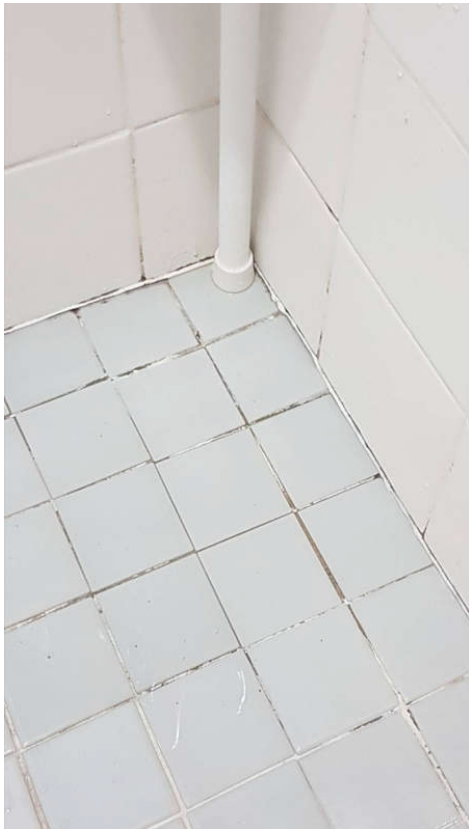
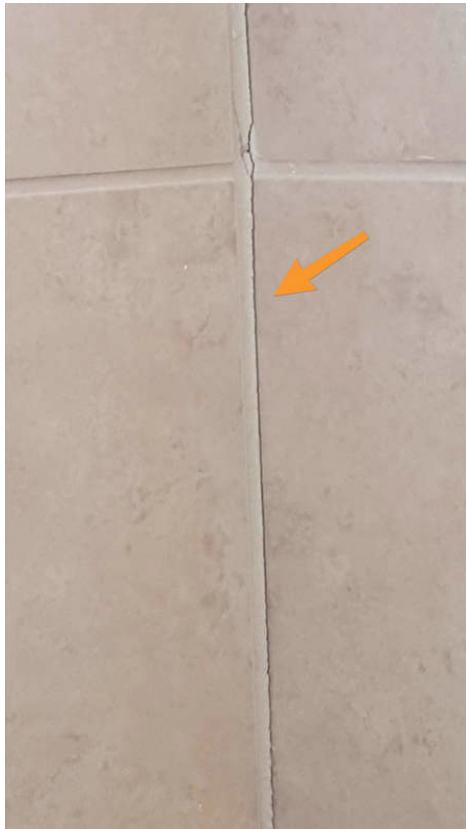
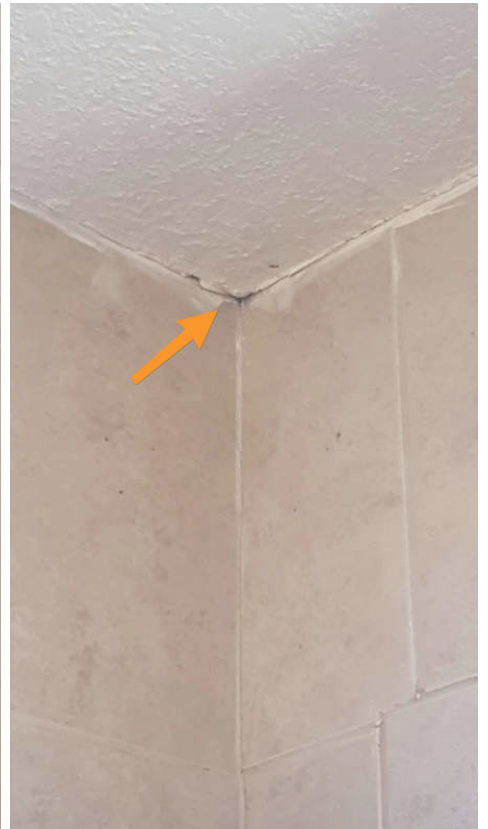
8.8.1 Bathtubs(s) and shower enclosures

CAULKING/SEALANT

UPSTAIRS SHOWER, BASEMENT SHOWER

Caulking/sealant in need of repair to prevent water from penetrating floor/wall areas surrounding tub/shower enclosure.

Contact a qualified professional.

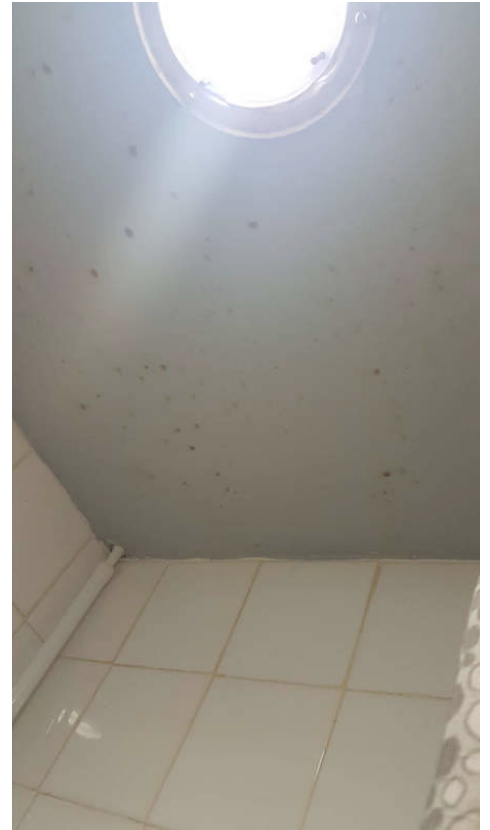
8.8.3 Bathtubs(s) and shower enclosures

STAINS ON SHOWER CEILING

Staining noted on basement shower ceiling. This could be due to the bathroom fan not being operated during and after showers which is needed to exhaust moist air outside.

Recommend monitoring.

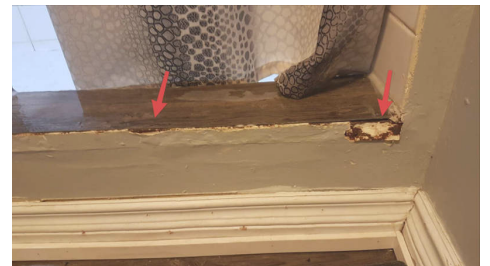
8.8.4 Bathtubs(s) and shower enclosures

WOOD ROT

Wood rot noted around entry to basement shower enclosure

Recommend replacing to maintain water tightness

Contact a qualified professional.

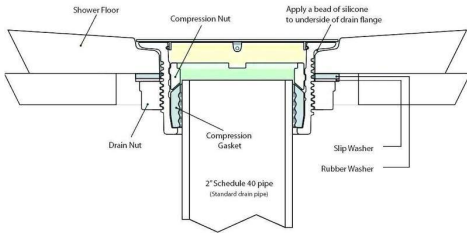
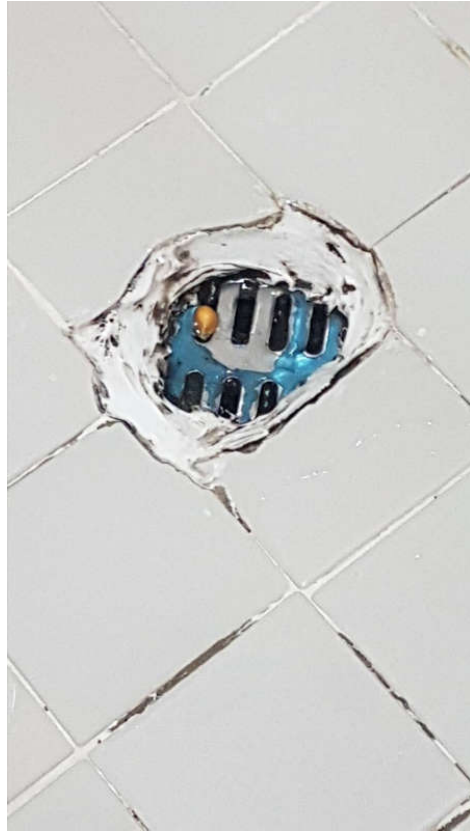
8.8.5 Bathtubs(s) and shower enclosures

IMPROPER DRAIN ASSEMBLY

BASEMENT

Due to the excess caulking observed, the drain assembly is suspect as to whether it was finished properly.

At buyer's discretion, I recommend replacing replacing tile immediately adjacent to drain and ensuring a proper assembly which can only be confirmed by opening up a small part of the shower floor.

Contact a qualified professional.

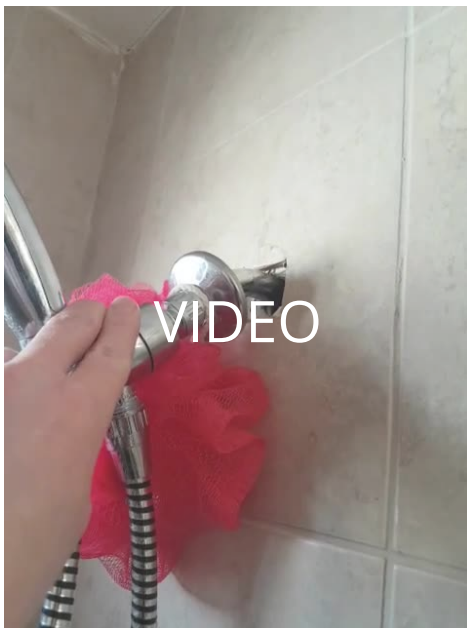
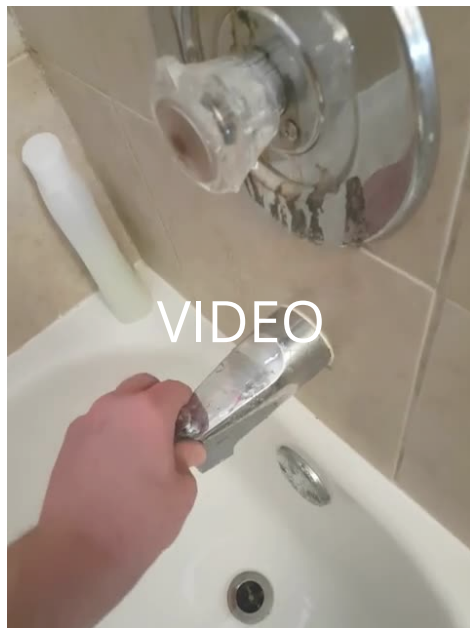
8.8.6 Bathtubs(s) and shower enclosures

LOOSE CONNECTIONS

Main floor shower faucets seem to be too loose for a proper install. This could lead to plumbing leaks. Recommend a licensed plumber evaluate.

Contact a qualified professional.

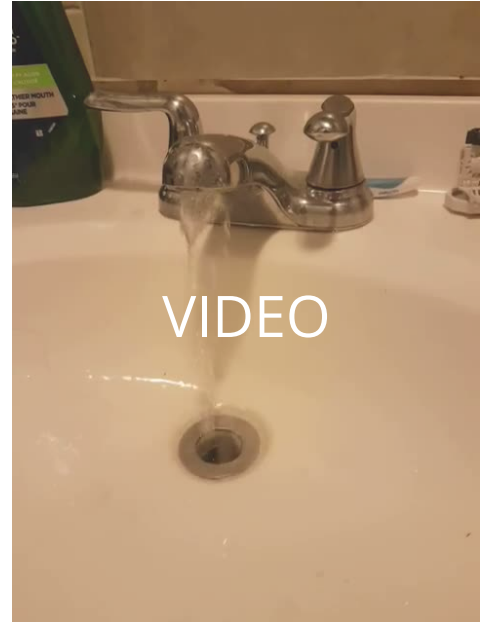
8.9.1 Faucets

VERY LOW COLD WATER FLOW

Basement bathroom

Contact a qualified plumbing contractor.

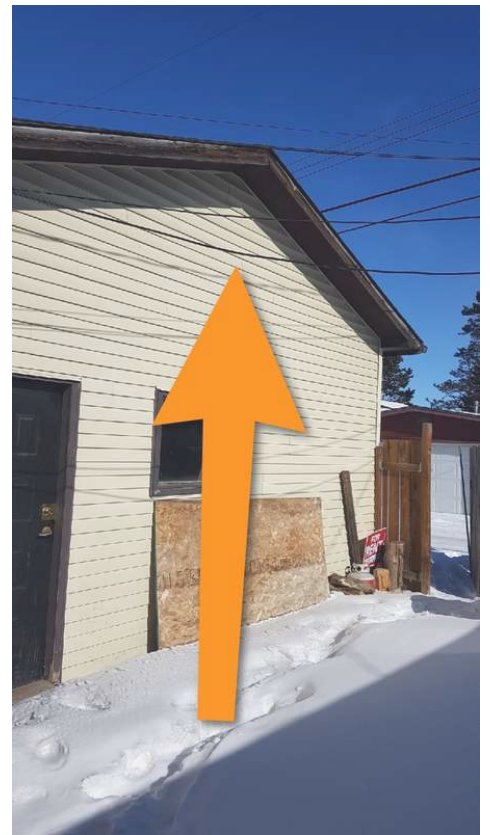
9.1.1 Service Entrance Conductors

NOT ENOUGH CLEARANCE

Service drop overhead wires are too low, not giving enough clearance above grade. Recommend contacting your local electric utility company or qualified electrician to see if they can correct.

According to ENMAX, overhead conductors need to have a clearance area from finished grade of at least:

- 5 m across the ground, accessible to pedestrians only
- 4 m across residential driveways
- 5 m across commercial and industrial driveways
- 5 m across alleys, streets and highways

Contact your local utility company

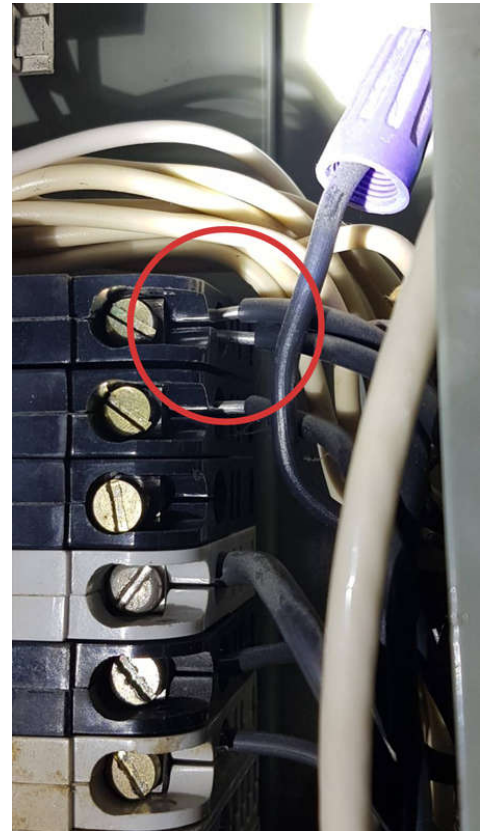
9.2.1 Main & Subpanels, Service & Grounding, Main Overcurrent Device

DOUBLE TAPPED BREAKER

Two conductors were found to be attached to a breaker rated for single conductors. This is an immediate safety concern due to the possibility of overheating. A licensed electrician is recommended to evaluate and remedy as soon as possible.

Contact a qualified electrical contractor.

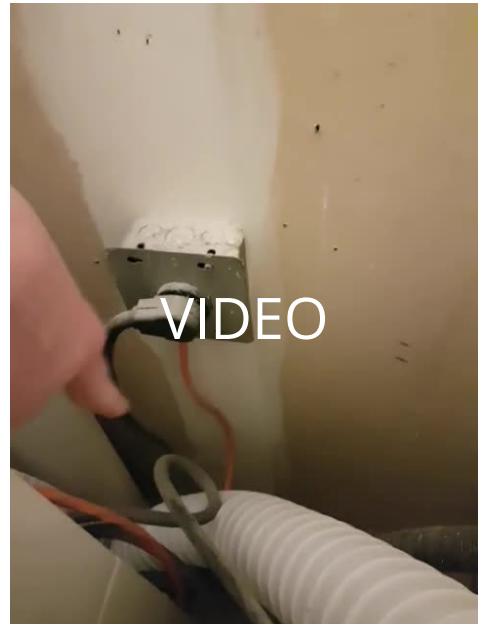
9.3.2 Branch Wiring Circuits, Breakers & Fuses

IMPROPER ELECTRICAL PRACTICES

Electric dryer source appears to have been improperly tapped in to for additional power requirements and does not appear to have been done by a licensed electrician. Recommend a licensed electrician evaluate and remedy.

Contact a qualified electrical contractor.

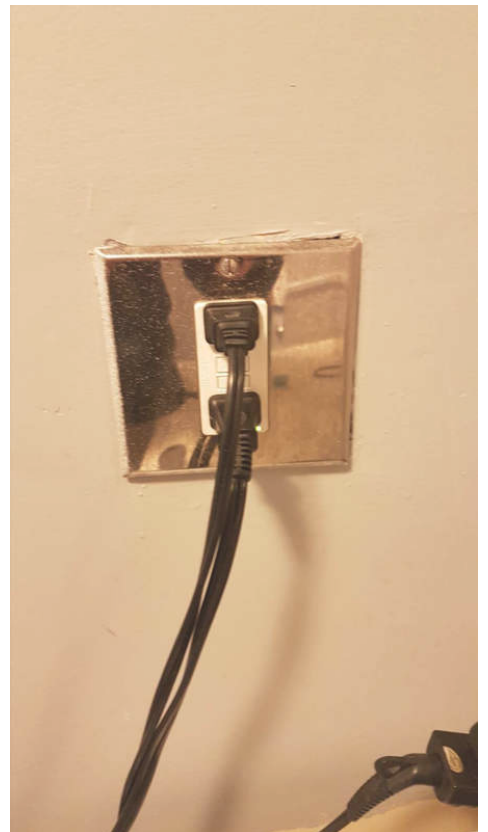
9.4.1 Lighting Fixtures, Switches & Receptacles

LOOSE COVER PLATE

BASEMENT BATHROOM

More than 1 receptacle plates were observed to be loose and require tightening to reduce electrical shock hazard

Contact a qualified electrical contractor.

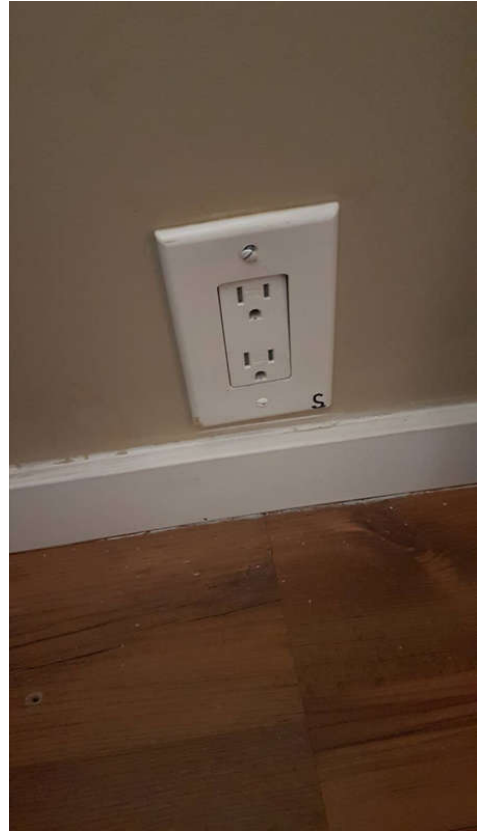
9.4.2 Lighting Fixtures, Switches & Receptacles

LOOSE RECEPTACLE

1ST FLOOR LIVING ROOM

Receptacle was loose in kitchen. Recommend licensed electrician to remedy

Contact a qualified professional.

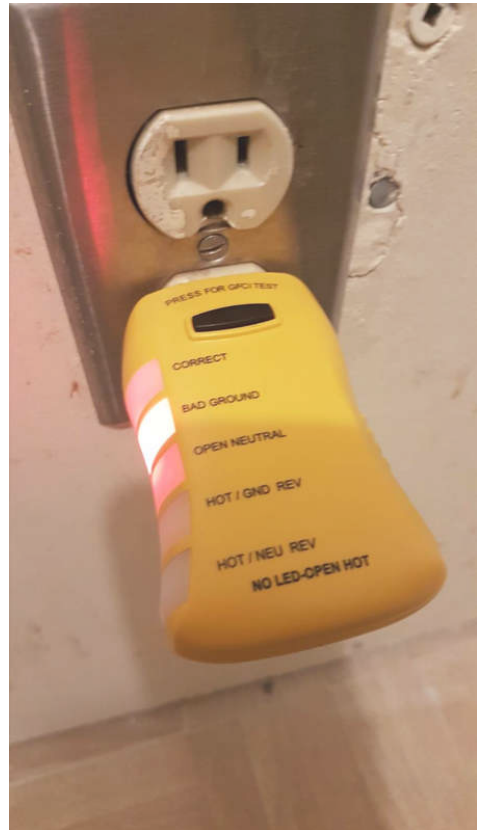
9.4.3 Lighting Fixtures, Switches & Receptacles

BAD GROUND OBSERVED

BASEMENT UNDER STAIRS

Bad ground observed in basement receptacle. This is a possible safety hazard as it increase the risk of electrical shock. Recommend a licensed electrical contractor evaluate and repair.

Contact a qualified electrical contractor.

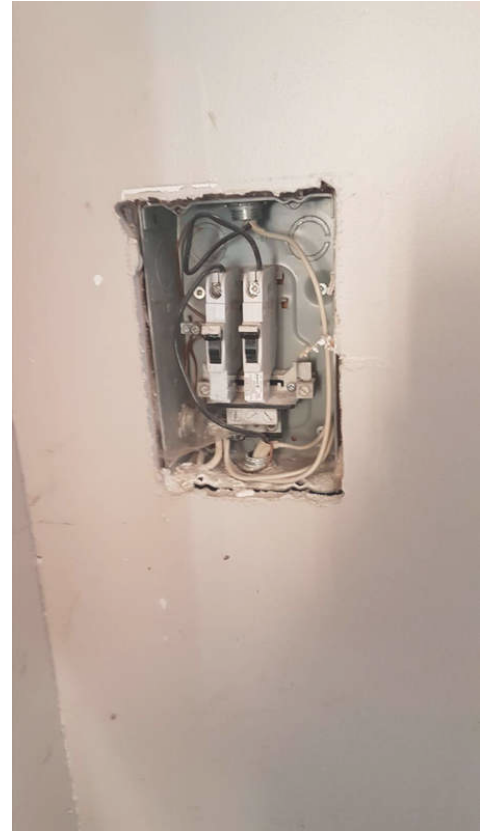
9.4.4 Lighting Fixtures, Switches & Receptacles

UNSAFE ELECTRICAL IN GARAGE

Exposed breakers noted in garage. This is a safety hazard and should be finished with proper coverings to reduce the risk of electrical shock or electrocution.

Contact a qualified electrical contractor.

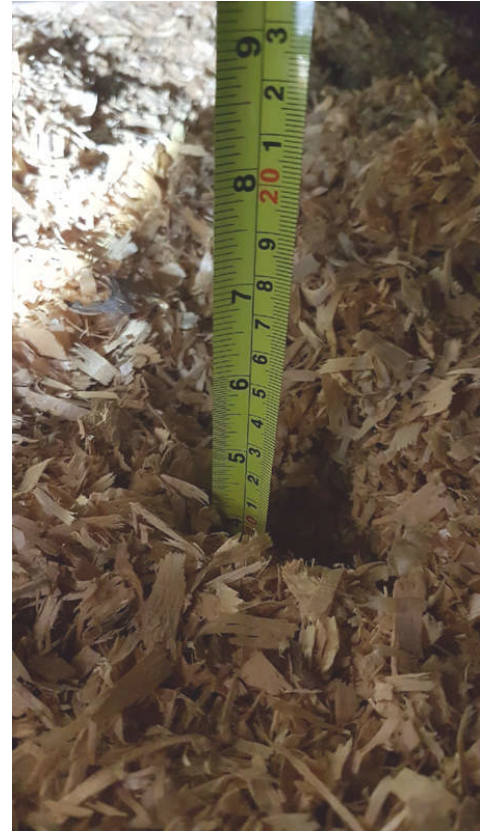
10.1.1 Attic Insulation, Venting & Vapour Barriers

INSUFFICIENT INSULATION

Insulation depth was inadequate. Recommend a qualified attic insulation contractor install additional insulation.

Wood shaving insulation is rated at R2.4 per inch. Approximate R-value in this home is R-12 which is well below current standards of R-49.

Contact a qualified insulation contractor.

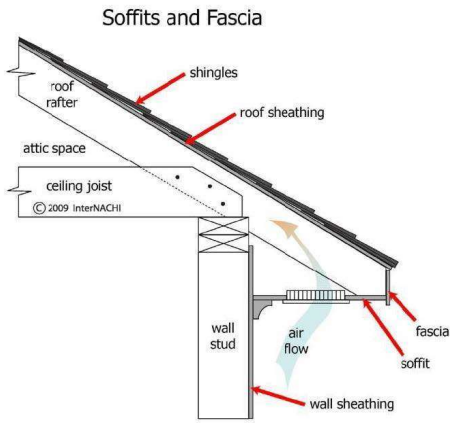
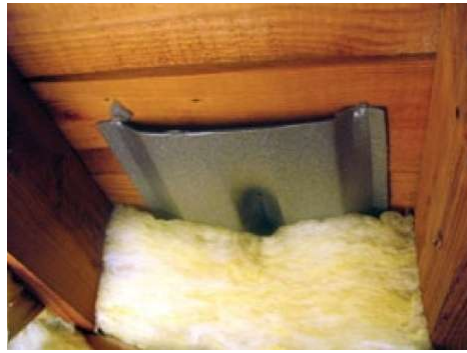
10.1.3 Attic Insulation, Venting & Vapour Barriers

SOFFIT VENTS BLOCKED

Soffit vents need to be unobstructed in order to complete the attic ventilation system. In a passive venting system such as this home, both upper and lower venting are needed for proper air flow to remove any moist air in the attic. Soffit vents are the lower vents in this situation, and are blocked by insulation. Over time, mold may develop in the right conditions, if moist air is impeded from ventilating.

Recommend a qualified professional install insulation baffles.

Contact a qualified insulation contractor.

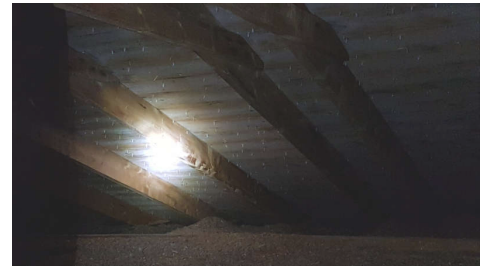
10.1.4 Attic Insulation, Venting & Vapour Barriers

FROST IN ATTIC

Frost was observed in the attic on the roof decking.

This could be due to excessive moisture seeping into the attic and/or an indication of poor attic ventilation as noted by the blocked soffit vents.

Over time moisture can lead to the development of mold.

Recommend sealing attic hatch with weather stripping and unblocking soffit vents.

Contact a qualified professional.

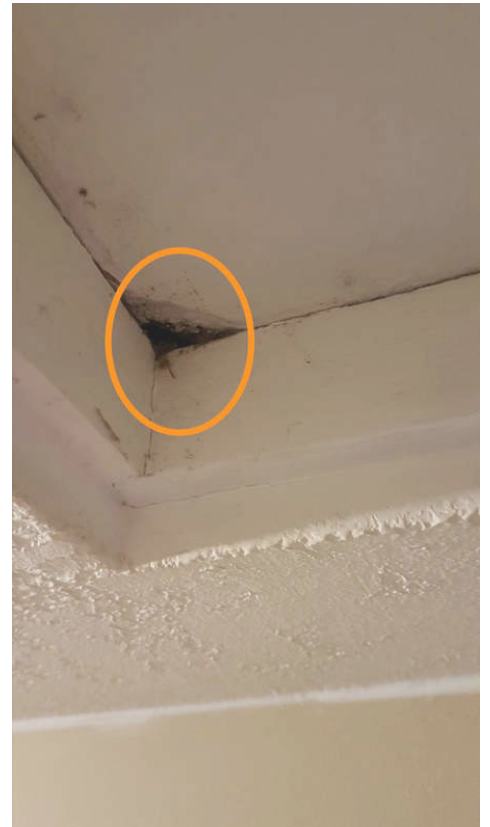
10.1.5 Attic Insulation, Venting & Vapour Barriers

HOLE IN ATTIC HATCH

Recommend replacing attic hatch as it has a hole in it which will allow moist air up to attic space. Over time this may lead to mold growth.

Contact a qualified professional.

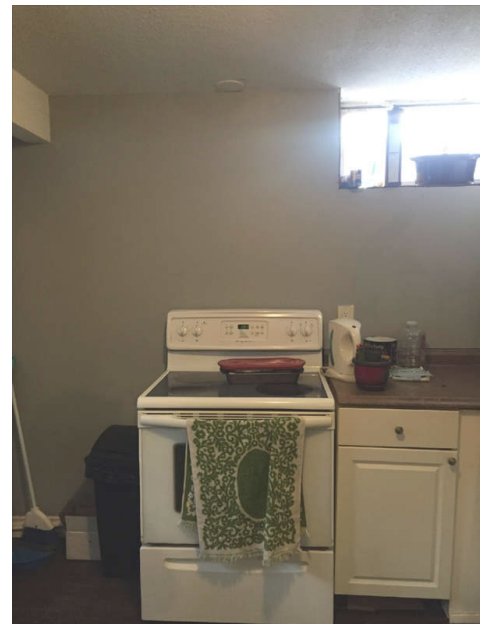
KITCHEN MISSING EXHAUST FAN

Kitchen in basement suite has no fan above range. Recommend checking with local codes for possible updates.

Kitchen fans remove localized moist air and odours from living space

Recommendation
Contact a qualified professional.

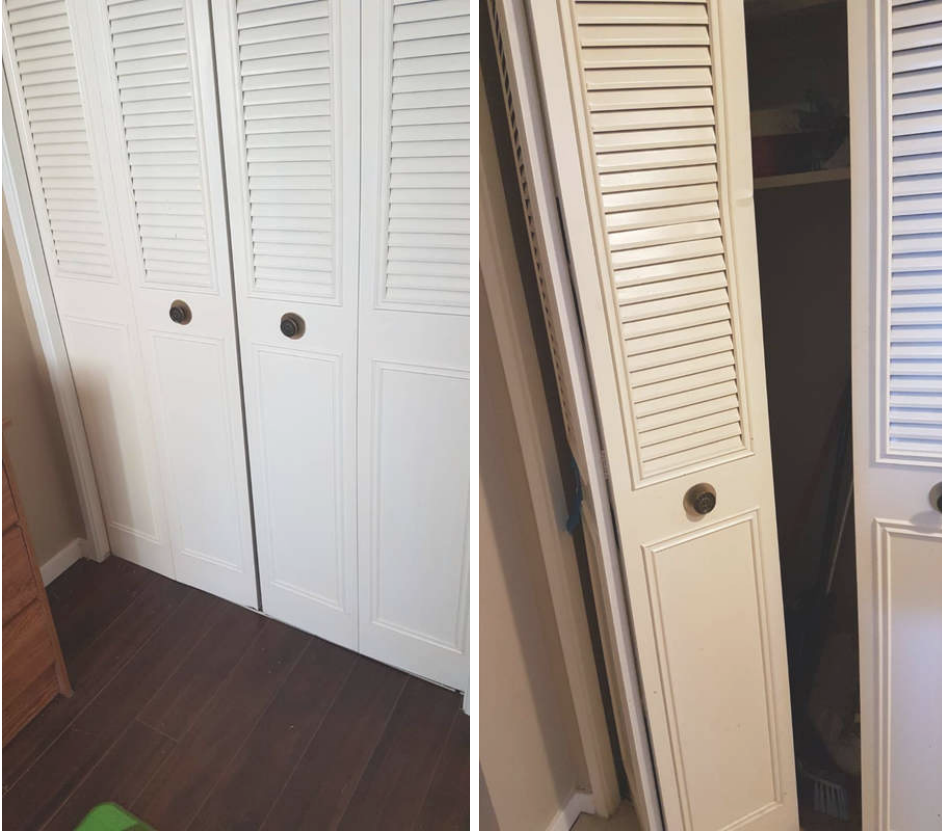
CLOSET DOOR STICKS

UPSTAIRS BEDROOM AND HALLWAY

Door sticks and is tough to open. Recommend sanding down offending sides.

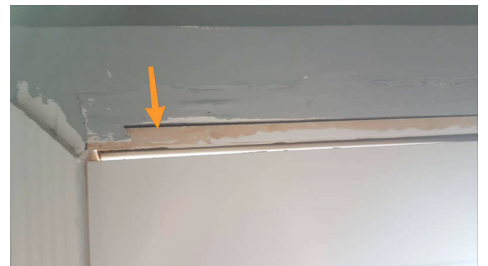
11.1.3 Doors

NOTICEABLE GAP

SOUTH ENTRY DOOR

One or more gaps could result in energy loss. Recommend handyman or door contractor evaluate.

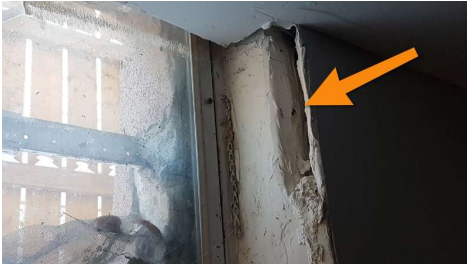
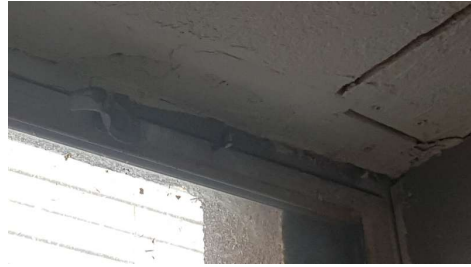
11.2.1 Windows

BASEMENT WINDOWS NOT FINISHED

Basement windows, specifically window at bottom of stairs does not appear to be completely finished. Although this is more of a cosmetic issue, I recommend that a qualified window installer evaluate and remedy so as to ensure proper insulating properties and means of egress.

Contact a qualified professional.

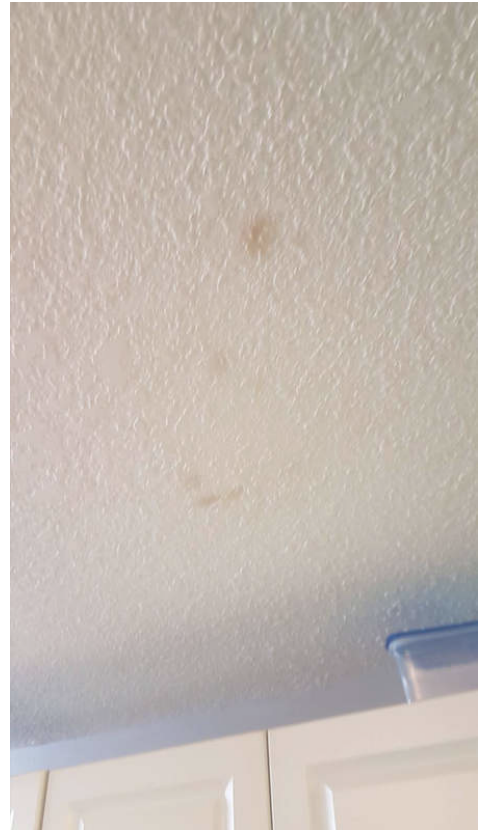
11.5.1 Ceilings

STAIN(S) ON CEILING

BASEMENT KITCHEN

There is a stain on ceiling/wall that requires repair and paint. Source of staining should be determined.

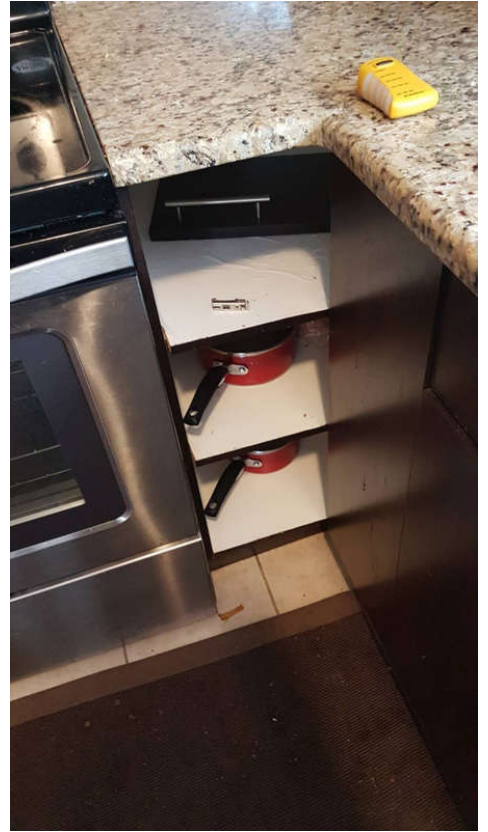
11.7.1 Countertops & Cabinets

CABINET DOOR MISSING

One or more cabinet doors were missing.

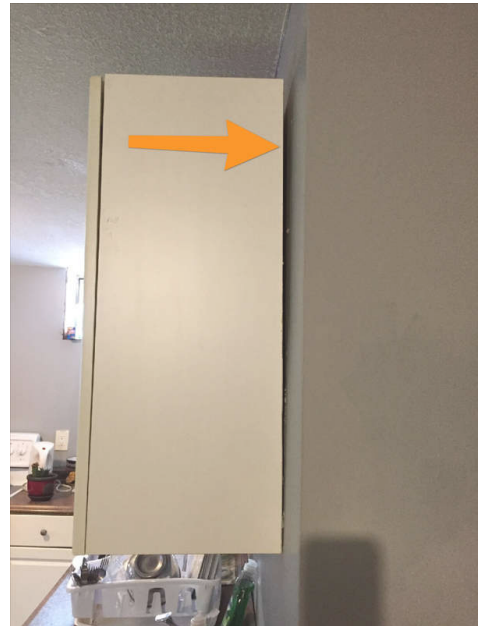
11.7.2 Countertops & Cabinets

CABINET SEPARATING FROM WALL

Cabinets are separating from wall. Recommend a qualified cabinet contractor re-fasten cabinets securely.

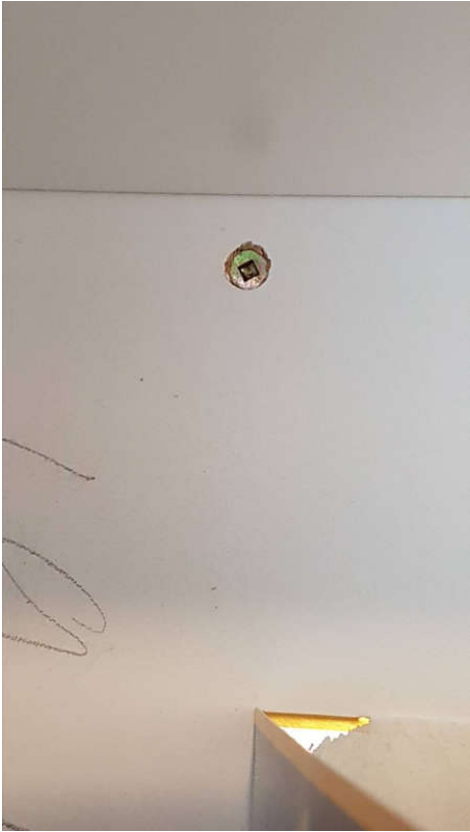
11.7.3 Countertops & Cabinets

IMPROPER FASTENERS

Screws to attach upper cabinets should be a "washer head cabinet screw". This appears to be a decking screw which does not have the same shear strength as proper cabinet screws. Recommend replacing with appropriate fasteners.

Contact a qualified professional.
