SUMMARY

1234 Main St. Big Bear City CA 92314

Buyer Name
05/29/2019 9:00AM

Loch Bell
InterNACHI Certified...
Highlander Inspections
909-963-0756
nspctrloch@gmail.com

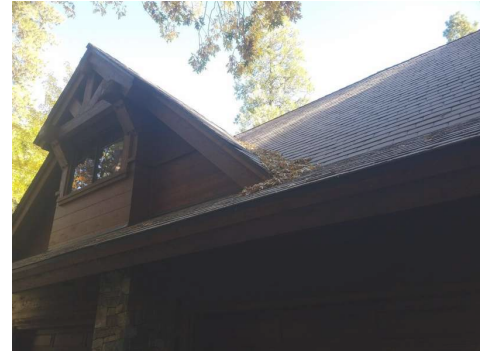
VALLEYS AND CHIMNEYS

DEBRIS

Debris was observed on roof surface. Tree droppings will trap water and moisture long enough for it to eventually find a path beneath the roofing and into the structure. I recommend removal of the debris.

Contact a qualified roofing professional.

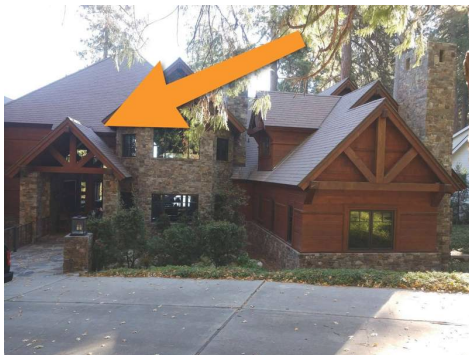
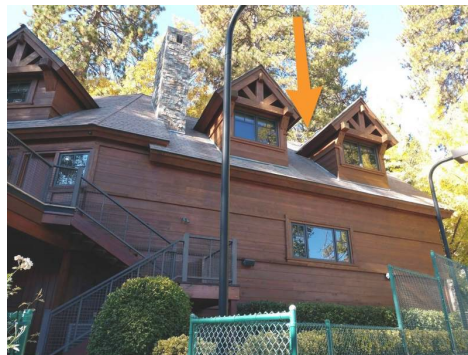
MAIN ENTRY, NORTHEAST DORMER

TILES CRACKED/BROKEN

Roof had cracked/broken tiles. I recommend consulting a qualified professional to replace to prevent moisture intrusion and damage.

Contact a qualified roofing professional.

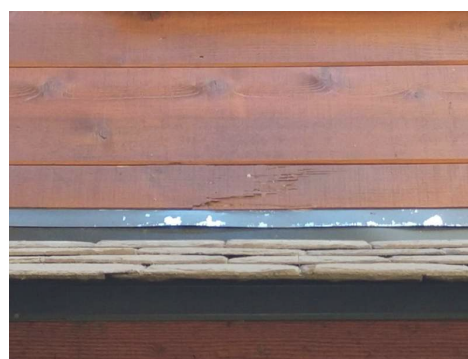
WEST FACE TO THE RIGHT OF THE ENTRY

DAMAGED SIDING

Observed damaged siding in one or more location.

Contact a qualified siding specialist.

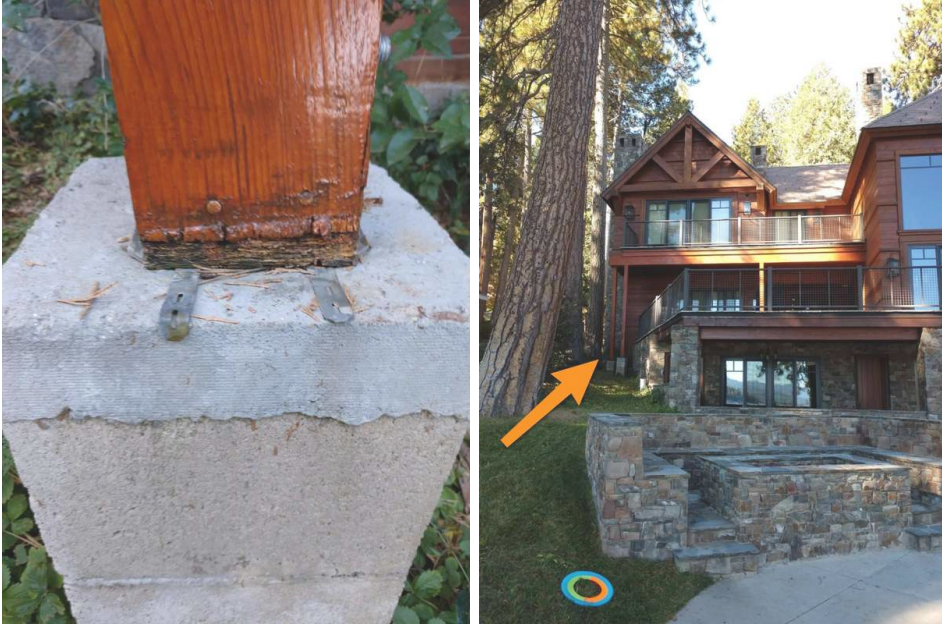
SOUTHEAST CORNER

IMPROPER MATERIALS

Observed use of improper material application. Use of OSB as a shim below an exposed exterior framing member will retain moisture and degrade at an accelerated rate. I recommend replacement by a qualified professional.

Contact a qualified deck contractor.

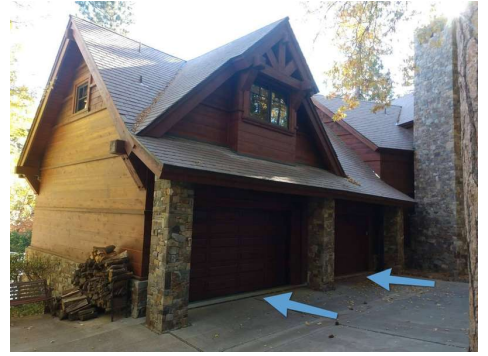
TRENCH DRAIN AT GARAGE

OBSTRUCTED DRAIN

I observed drain lines nearly filled with material preventing the collection of water. I recommend clearing away material to allow the flow of water away from the building.

Contact a qualified professional.

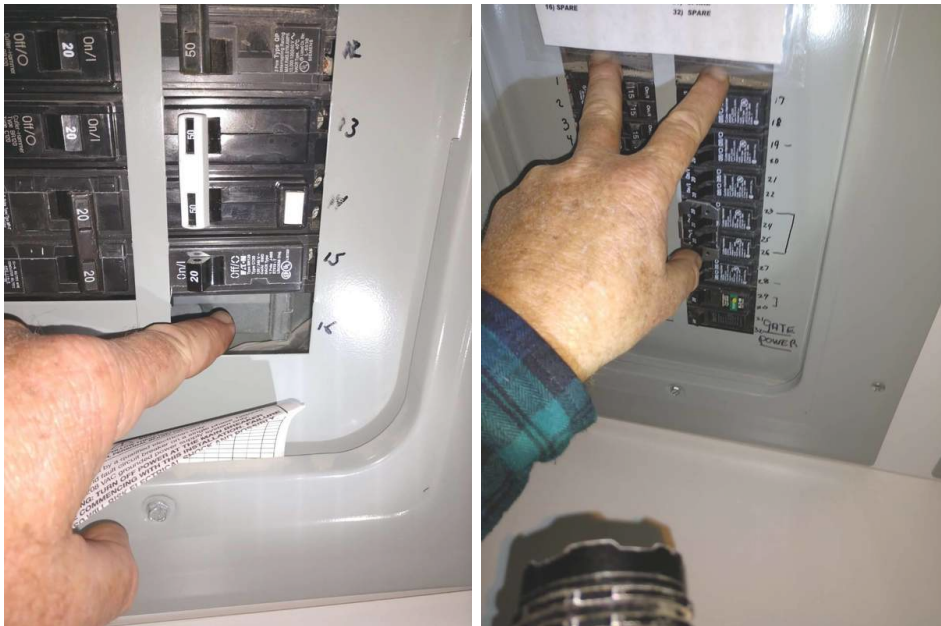
LAUNDRY ROOM PANELS

KNOCKOUTS MISSING

Observed one or more "knockouts" were missing in the electric panel. This poses a safety hazard and it is recommended that the opening in the panel caused by the missing knockout(s) be properly replaced by a qualified professional.

Contact a qualified electrical contractor.

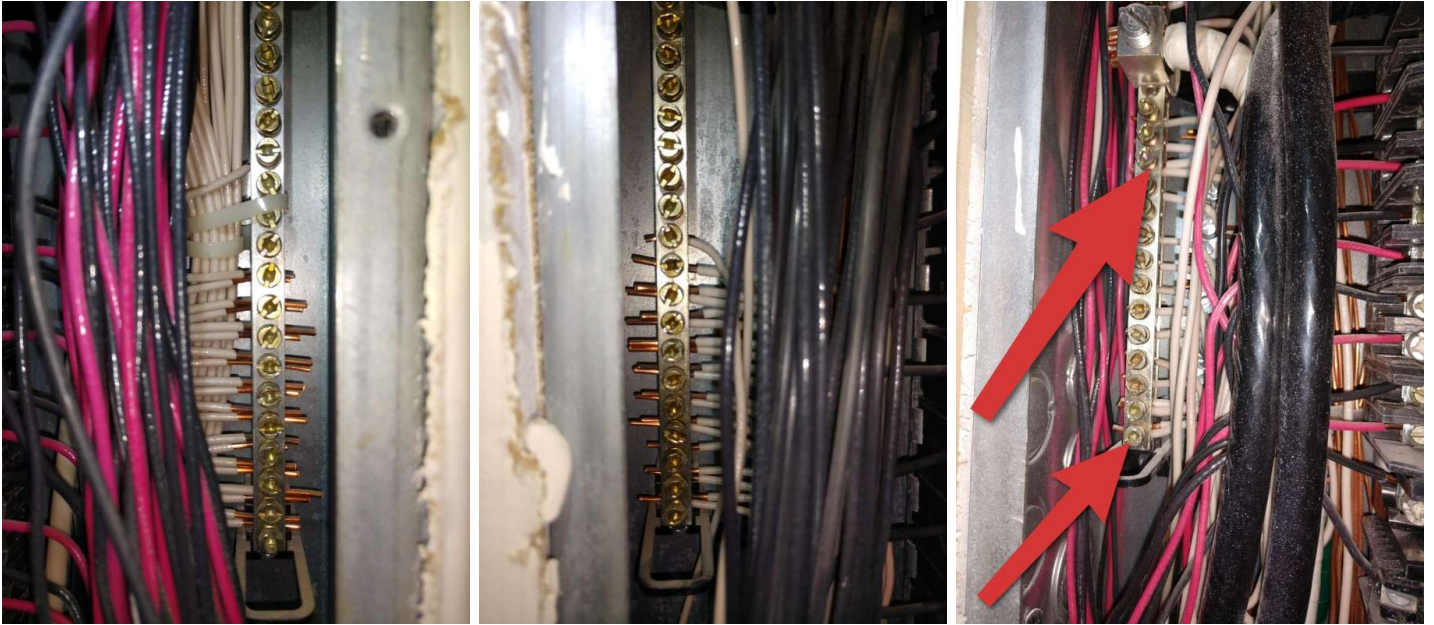
ALL 4 SUB PANELS

DOUBLE TAP - NEUTRAL

Observed one or more lugs on neutral bus bar with more than one wire. This prevents isolation of the circuit if it needs to be worked on, and wires may slip out of lugs that are not designed for multiple conductors, creating a fire hazard. I recommend consulting a qualified professional to evaluate and correct.

Contact a qualified electrical contractor.

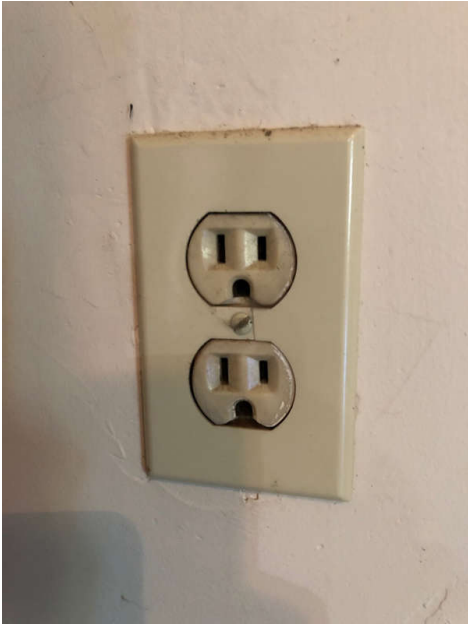
Garage

COVER PLATE DAMAGED

One or more switch or receptacle have a damaged cover plate. I recommend replacement.

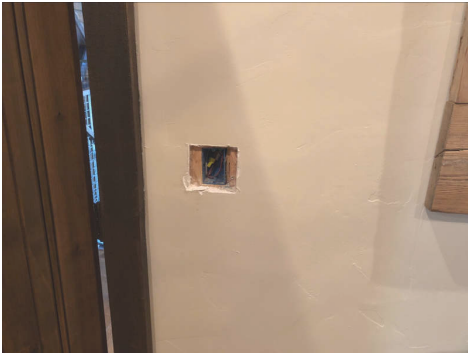
2nd Floor South Bedroom

COVER PLATE MISSING

Observed one or more outlets (junction box, receptacle, switch) were missing a cover plate. This creates a short and shock risk. I recommend installation.

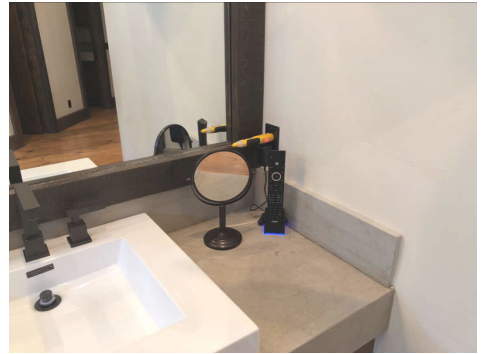
2nd Floor South Bathroom

4.4.3 Lighting Fixtures, Switches & Receptacles **REVERSED POLARITY**

Observed one or more receptacles have been wired in reverse polarity (hot and neutral reversed). This can create a shock hazard. I recommend correction by a qualified professional.

Contact a qualified electrical contractor.

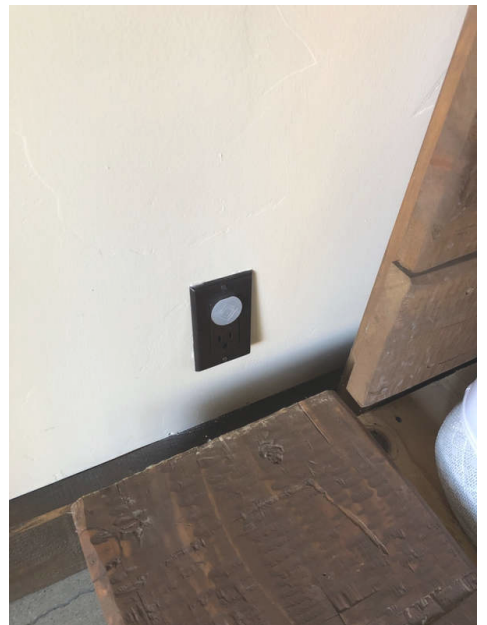
Basement Southeast Bedroom

4.4.4 Lighting Fixtures, Switches & Receptacles **DAMAGED / LOOSE RECEPTACLE**

I observed one or more damaged / loose receptacle(s). Receptacles having damage (cracks, missing insulation, etc.) or that are loose (moves around when inserting or removing plug) cause a potential electrical short or electrocution hazard. I recommend having a qualified professional evaluate and correct.

Contact a qualified electrical contractor.

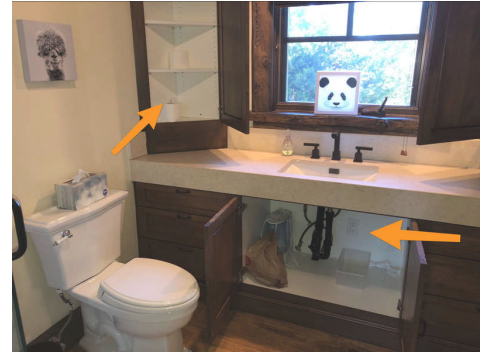
2nd Floor Northeast Bathroom

NO POWER

I observed no power to one or more electrical outlet. I recommend consulting a qualified professional for evaluation and correction.

Contact a qualified electrical contractor.

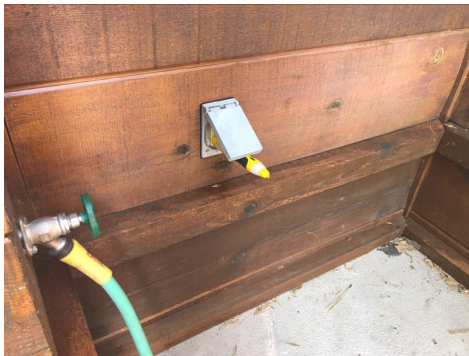
2nd Floor Master Patio

NO POWER

Observed no power to outlet outside

Contact a qualified professional.

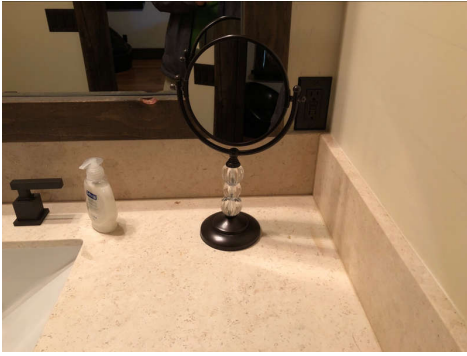
2nd Floor Northwest Bathroom

DEFECTIVE GFCI

When tested the gfcı outlet will not reset.

Contact a qualified professional.

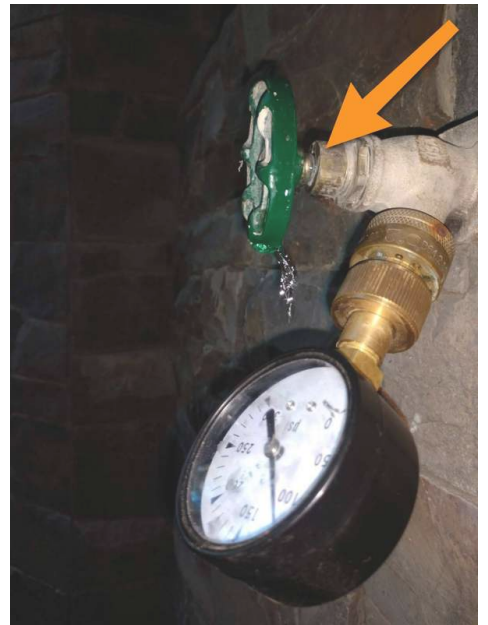
WEST SIDE TO THE RIGHT OF THE ENTRY

LEAKING VALVE

Observed leaking water supply valve. Recommend correction by a qualified professional.

Contact a qualified plumbing contractor.

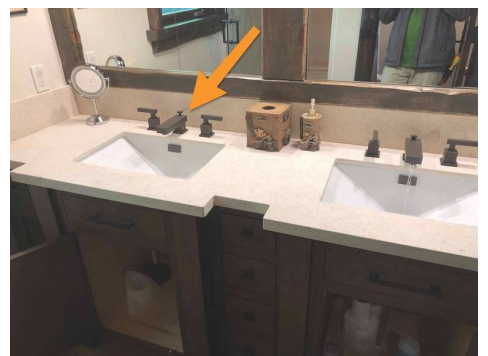
2ND FLOOR LEFT BATHROOM

STOPPER INOPERABLE

Stopper was inoperable.

Contact a qualified professional.

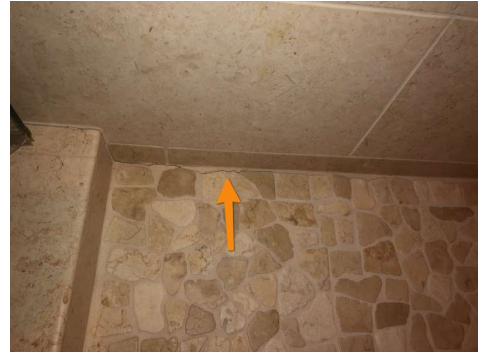
DAMAGED / CRACKED SHOWER ENCLOSURE

Damaged grout line in shower enclosure.

2nd Floor Northwest Bathroom, floor to wall intersection.

Contact a qualified professional.

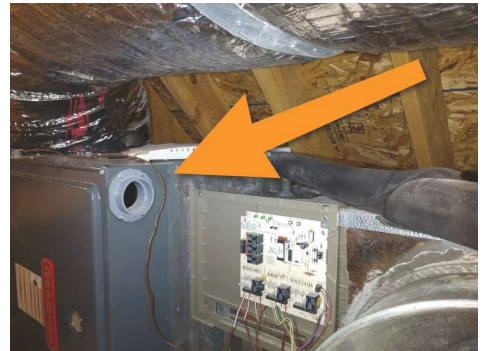
INTAKE / EXHAUST VENT CONNECTION MISSING

Observed missing intake / exhaust vent connector. I recommend consulting a qualified professional for evaluation and correction.

Contact a qualified heating and cooling contractor

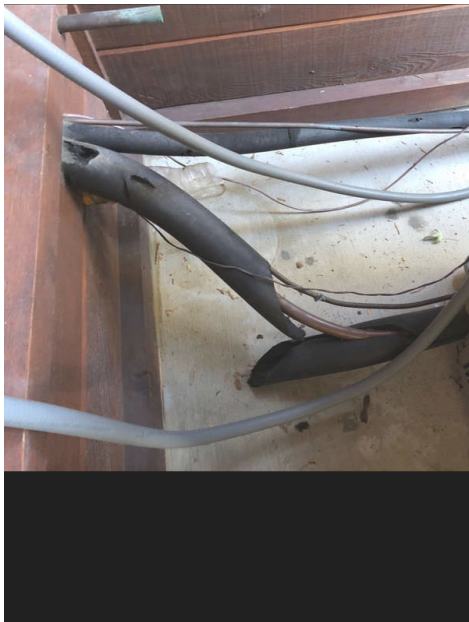
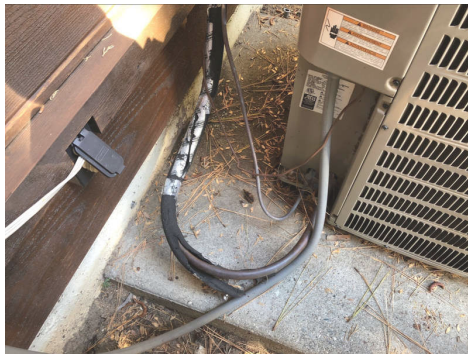
INSULATION MISSING OR DAMAGED

Missing or damaged insulation on refrigerant line can cause energy loss and condensation.

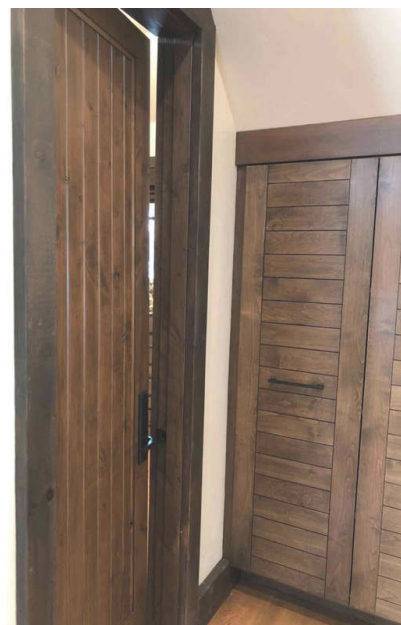
2nd Floor South Master Closet

WARPED DOOR DOESN'T LATCH

I observed one or more door that doesn't latch properly due to being warped. I recommend evaluation and correction by a qualified professional

Contact a qualified door repair/installation contractor.

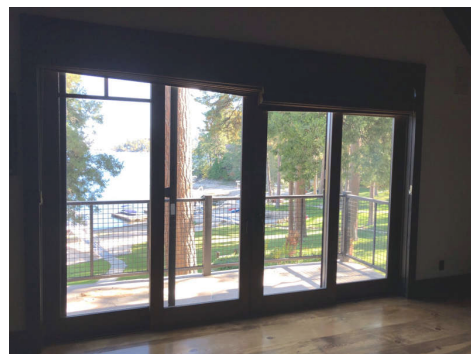
2nd Floor Southeast Master Bedroom

DOOR LATCH ALIGNMENT

Door latch and/or strike plate is out of alignment. I recommend correction by a qualified professional.

Contact a qualified door repair/installation contractor.

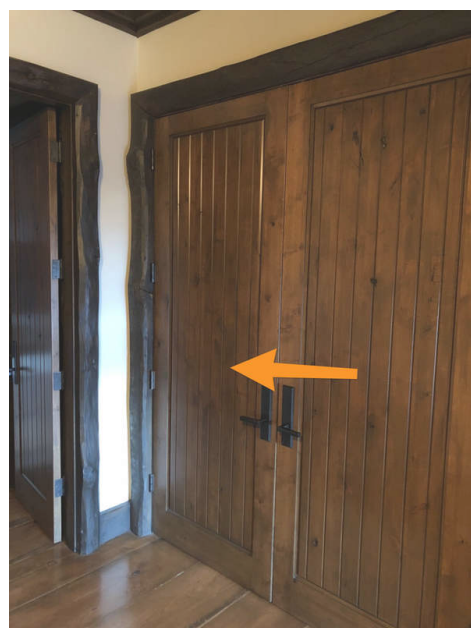
1st Floor Southeast Bedroom Closet

DOOR STICKS

Door sticks and won't open. Recommend evaluation and correction by licensed contractor

Contact a qualified door repair/installation contractor.

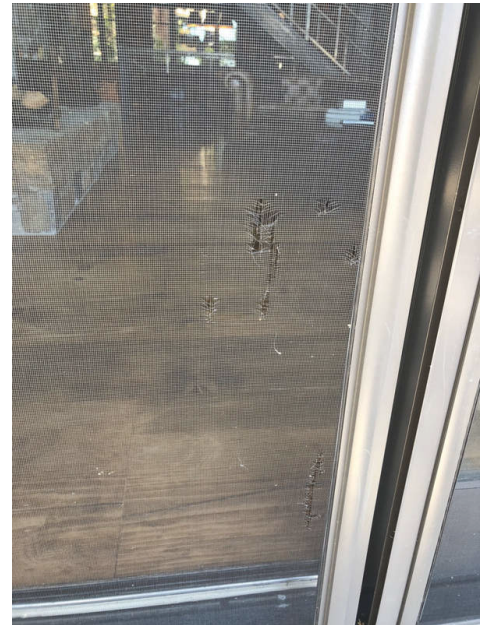
1st Floor

SCREENS DAMAGED

Observed one or more damaged window or door screen.
Recommend repair/replacement by qualified professional.

Recommendation
Contact a qualified professional.

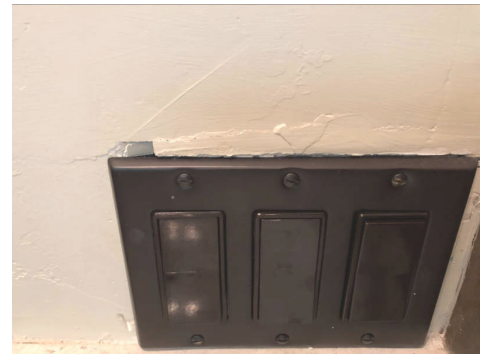
1st Floor Southwest Bathroom

CRACKS

Observed cracks at the intersections and surfaces of walls in one or more location. I recommend monitoring for change, consult a qualified professional as needed for correction.

Recommendation
Recommend monitoring.

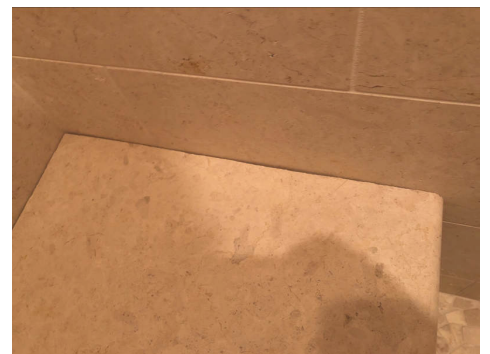
1st Floor Southeast Bathroom

SEALANT DECADENCE

Observed sealant in tub/shower enclosure degrading and becoming ineffective in one or more location. I recommend removing, cleaning and replacing as a DIY project, or consult a qualified professional for correction.

Recommendation
Contact a qualified painting contractor.

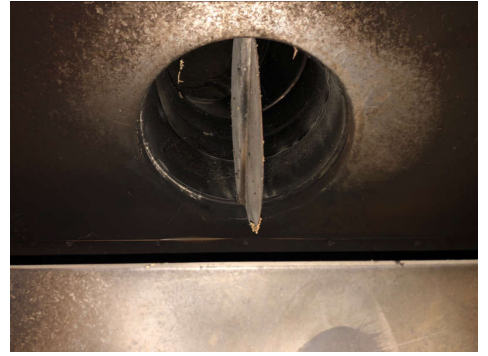
MISSING DAMPER CLAMP

2nd floor left fire place missing damper clamp.

Recommendation
Contact a qualified professional.

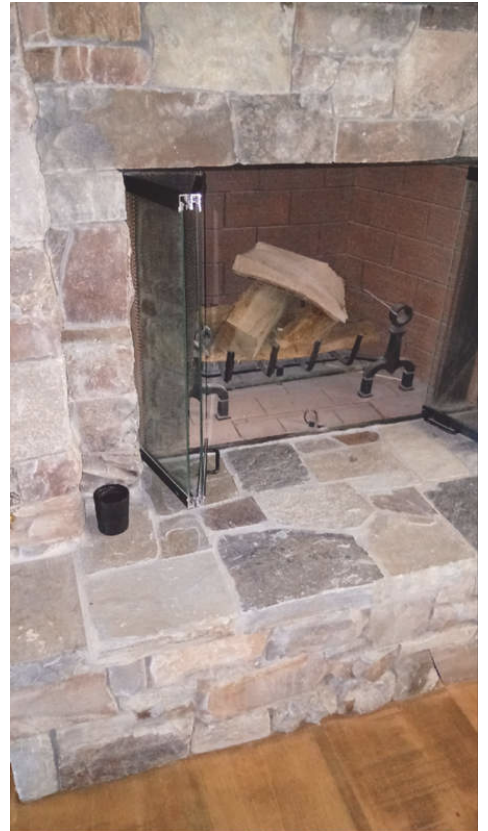
WEST LOFT SITTING ROOM FIREPLACE

FIREPLACE GAS CONTROL VALVE

The natural gas control valve inset behind the masonry stones is non-operational

Recommendation
Contact a qualified professional.

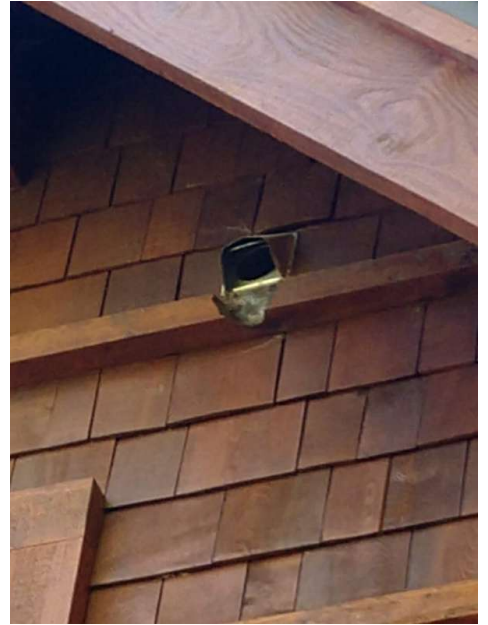
NORTH WALL

EXHAUST DAMPER MISSING

Observed missing damper in exhaust duct. I recommend replacement (wildlife may find it an inviting nesting place).

Recommendation
Contact a qualified professional.

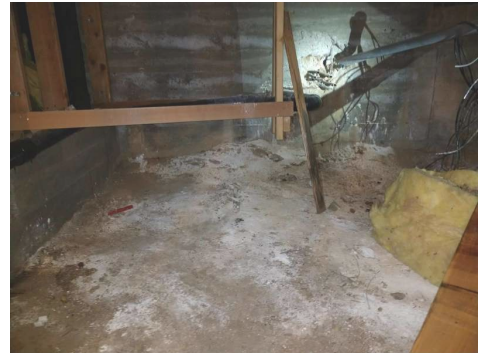
EFFLORESCENCE

Efflorescence is present on the crawlspace surface (bare earth). This is a white, powdery deposit that is consistent with moisture intrusion. This can compromise the soil's ability to support the home structure and/or lead to mold growth. I recommend a qualified professional identify the source of moisture and correct.

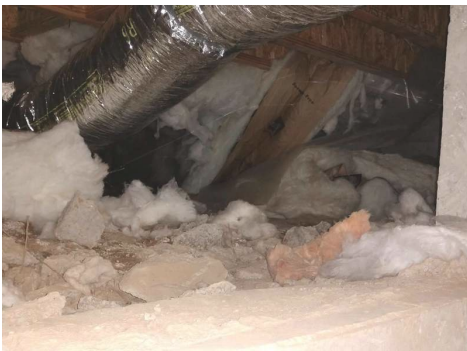
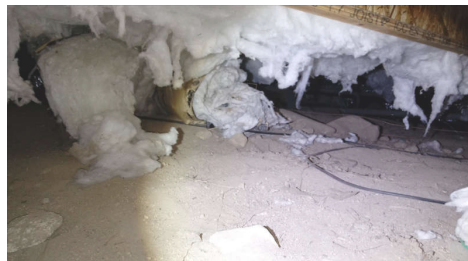
INSULATION MISSING, DAMAGED OR FALLEN

I observed in one or more locations missing, damaged or fallen insulation from the floor or wall structure. I recommend reinstalling the insulation to improve climate control in the conditioned space above as a DIY project or by a qualified professional.

Contact a qualified insulation contractor.

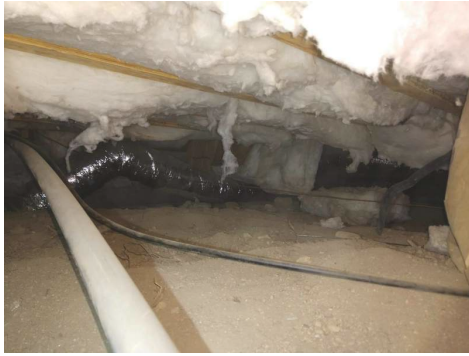
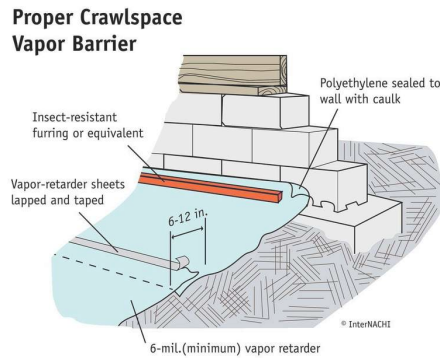
NO MOISTURE BARRIER

I observed the absence of a moisture barrier on the floor (exposed dirt) of the crawlspace. This is not a requirement of any kind, but it will reduce the amount of ground moisture introduced into the area below the conditioned space (living area). I recommend considering installation of a moisture barrier.

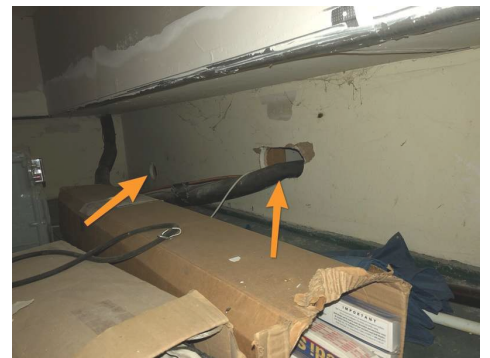
SOUTH SIDE BEHIND STORAGE DOORS

COMPROMISED FIREWALL

Observed damaged drywall or unsealed penetration or transition. I recommend correction by a qualified professional.

Contact a qualified drywall contractor.

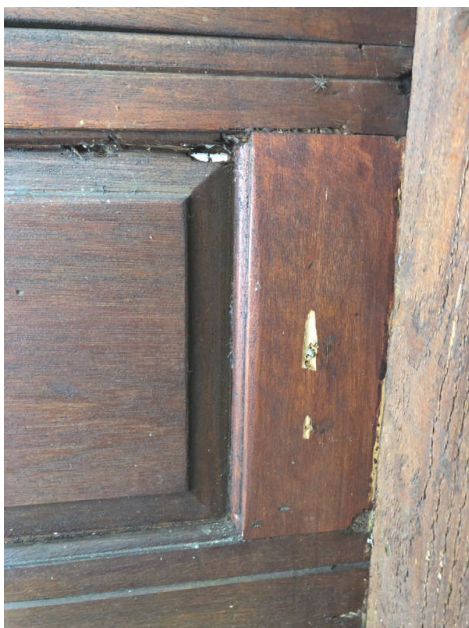
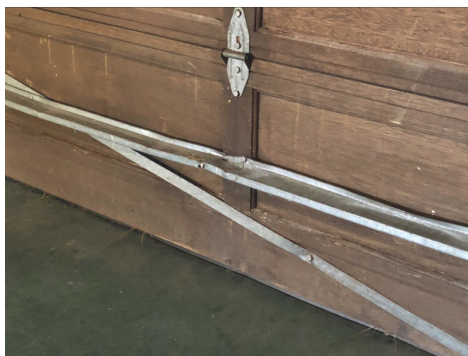
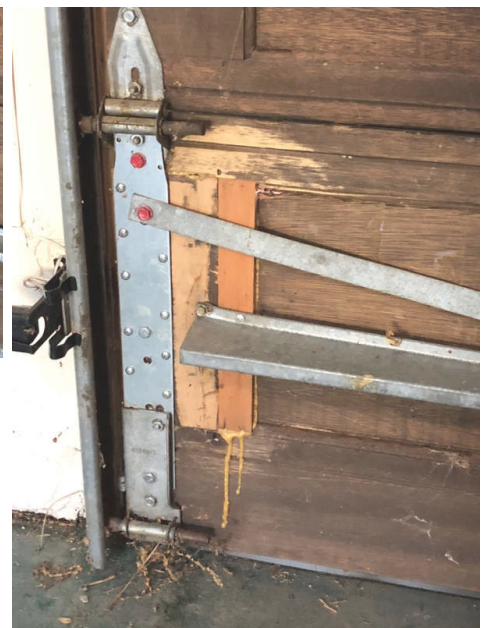
Left door

PANEL DAMAGE

Garage door panel is damaged and may need repair/replacement. Recommend a qualified garage door contractor evaluate.

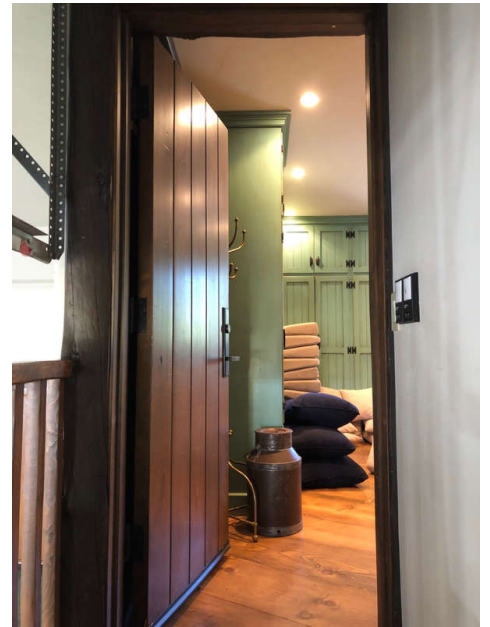
NOT SELF-CLOSING

Door separating garage from home should have self-closing hinges or a door closer to help prevent spread of a fire to living space. I recommend installation self-closing hinges or a door closer.
