SUMMARY
1234 Main St. Boyne City MI 49712
Buyer Name
08/31/2018 9:00AM

Bill Ulvund
InterNACHI Certified Professional
Inspector, InterNACHI Certified
Specialties: Deck Inspector, Crawlspace
Inspector, Roof Inspector, Chimney
Inspector, Residential Fire Extinguisher
Inspector, Safe Workplace Inspector
MI House Detective, LLC
2318816700
bill@mihousedetective.com

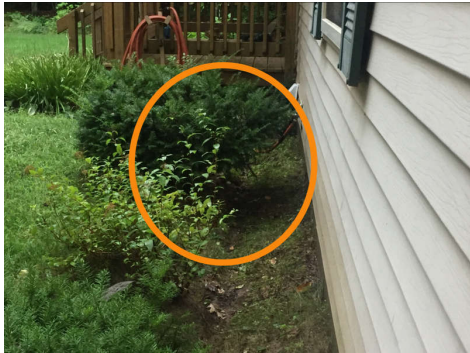
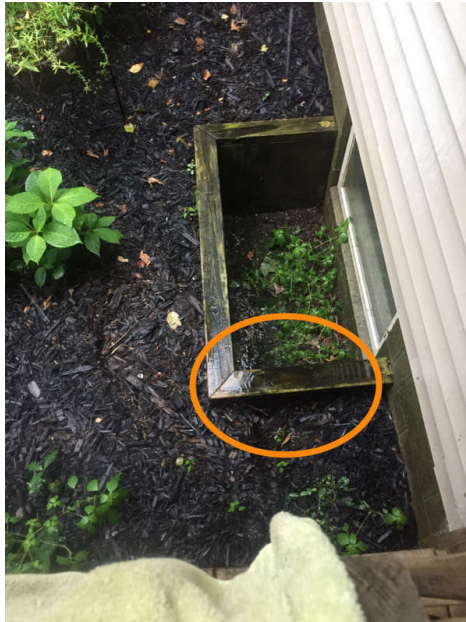
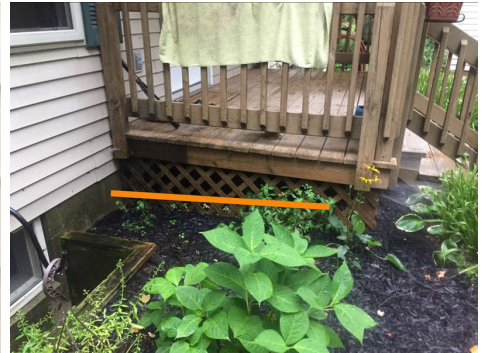
2.2.1 Vegetation, Grading, Drainage & Retaining Walls

NEGATIVE GRADING

Grading is sloping towards the home in some areas. This could lead to water intrusion and foundation issues. Recommend qualified landscaper or foundation contractor regrade so water flows away from home.

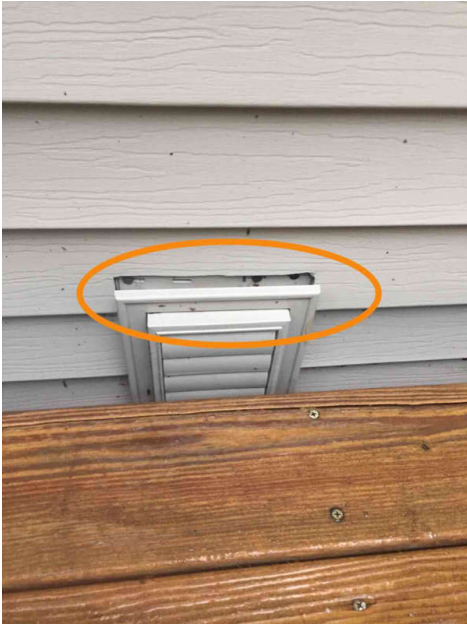
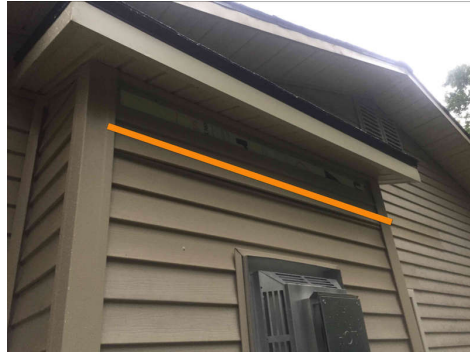
2.3.1 Siding, Flashing & Trim

CRACKING - MAJOR

Moderate to major cracking was observed at one or more points on the exterior. This can be the result of poor original compaction of soil at the time of construction or excess moisture in the underlying soil. Recommend consulting with a structural engineer and/or soil expert.

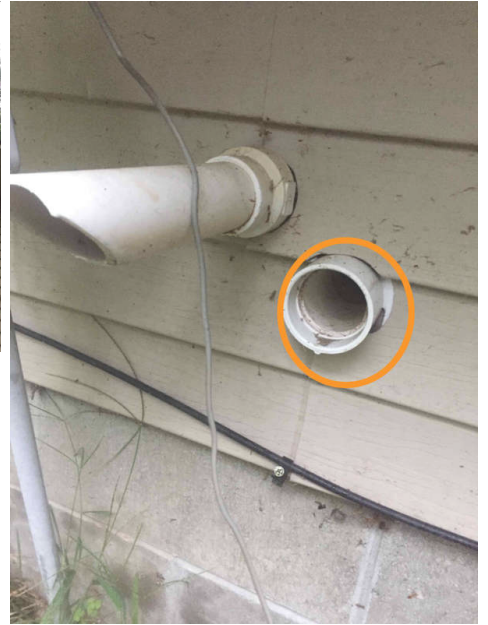
Above fireplace. Siding detached

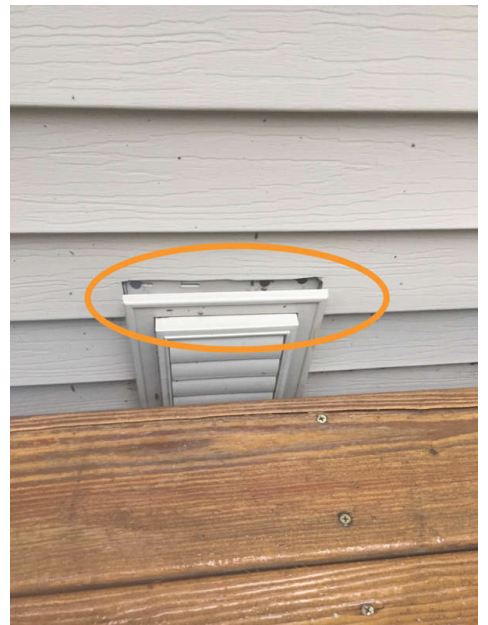
2.3.2 Siding, Flashing & Trim

FLASHING/TRIM IMPROPERLY INSTALLED

Flashing & trim pieces were improperly installed, which could result in moisture intrusion and damaging leaks. Recommend a qualified siding contractor evaluate and repair.

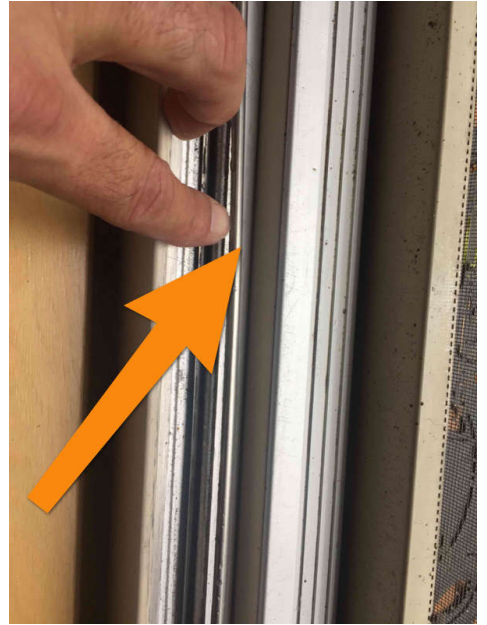
2.4.1 Exterior Doors

HARDWARE DAMAGED

One or more pieces of door hardware are damaged. Recommend repair or replace.

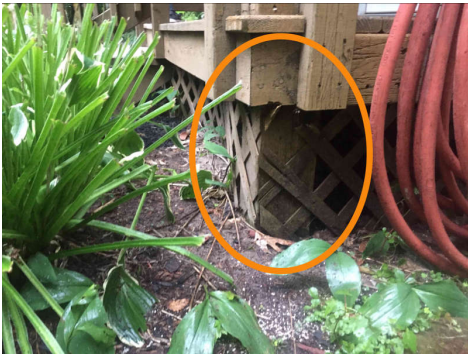
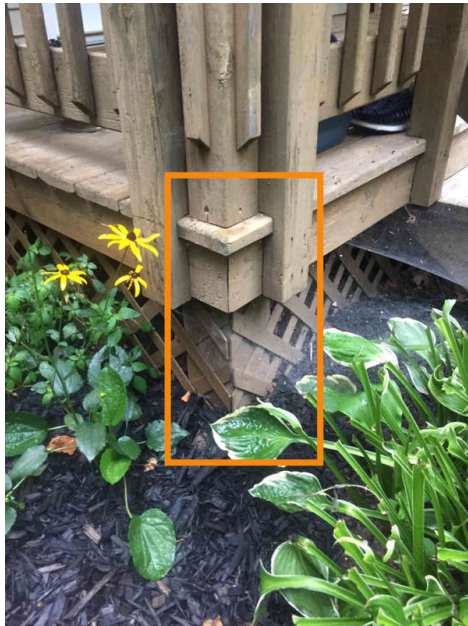
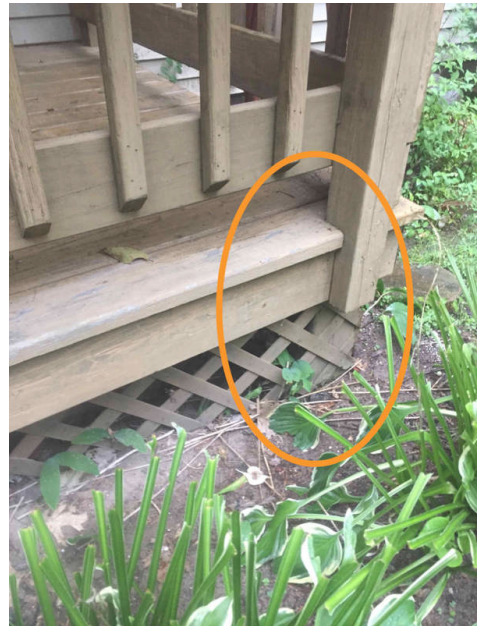
2.6.1 Decks, Balconies, Porches & Steps

IMPROPER DECK CONSTRUCTION PRACTICES

Deck was observed to have general poor construction. Recommend qualified deck contractor evaluate.

Due to height and weight load of roof over front porch this should be a 6 x 6 post in direct line with the post going in the ground

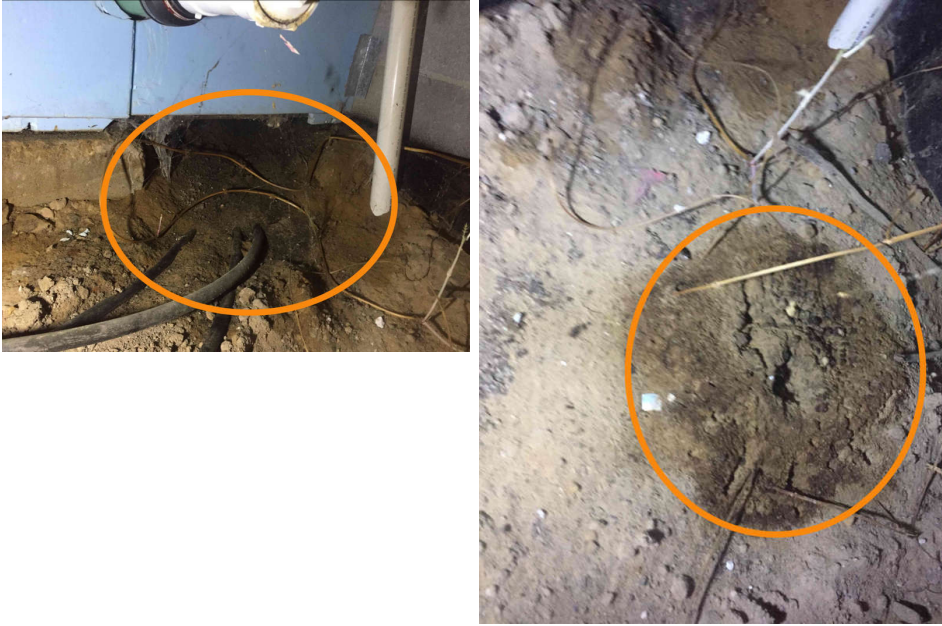
4.1.1 Foundation

WATER INTRUSION

Water intrusion was evident on the surface of the floor slab or in the basement/crawlspace. This can compromise the soil's ability to stabilize the structure and could cause damage. Recommend a qualified contractor identify the source of moisture and remedy.

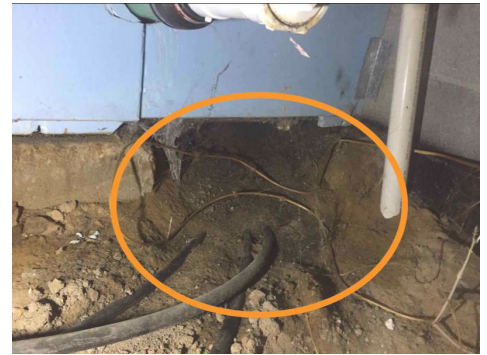
4.2.3 Basements & Crawlspaces

UNDERMINING

- **Undermining (found. damage visible)**

Gaps visible beneath foundation walls in the crawlspace indicate undermining has occurred. Undermining occurs when flowing water erodes soil from beneath a foundation. This is a structural problem because foundations are designed to transfer the weight of the structure above to the soil. Without the support of soil, the foundation is exposed to structural loads for which it was not designed and can fail. The Inspector recommends identifying the source of the moisture and correcting it.

Moisture intrusion can also encourage the growth of microbes such as mold fungi. Cracking in the foundation in this area was consistent with damage typically caused by inadequate foundation support. You should consult with a qualified foundation repair contractor before the expiration of your Inspection Objection Deadline to gain an understanding of options and costs for correction.

- **Damage beneath slider (recent)**

Wood framing visible in the crawlspace beneath the sliding glass door had evidence of moisture intrusion. The moisture meter indicated elevated levels of moisture indicating recent leakage.

The Inspector recommends correction of any neutral or negative grade around the home to prevent future damage. The grade should slope away from the home for a minimum distance of 6 feet from the foundation.

Recommendation

Contact a qualified structural engineer.

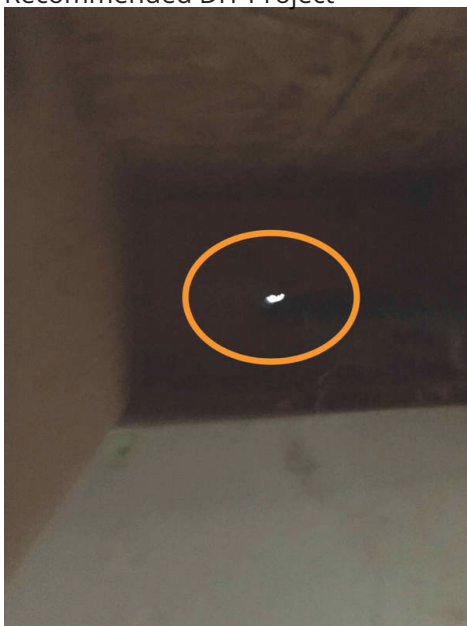
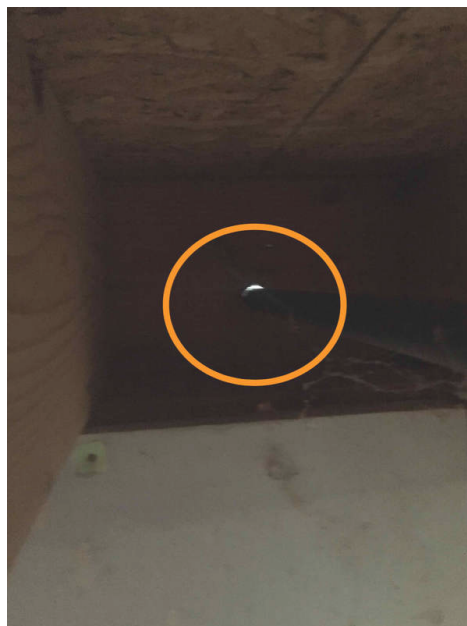
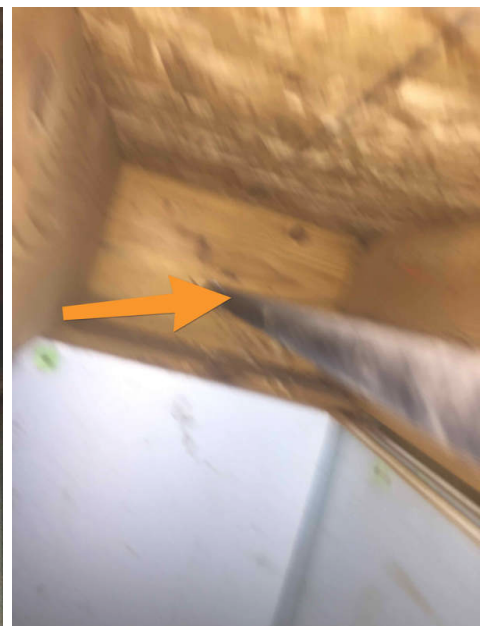
4.4.1 Wall Structure

OPENS SPACE AROUND PENETRATION

Seal air space to reduce air transmission

Recommendation

Recommended DIY Project

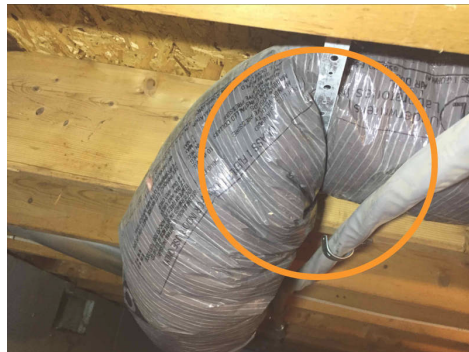
5.3.1 Distribution Systems

DUCT DAMAGED

Air supply duct was damaged. Recommend a qualified HVAC contractor repair.

Restriction to airflow. Crawlspace

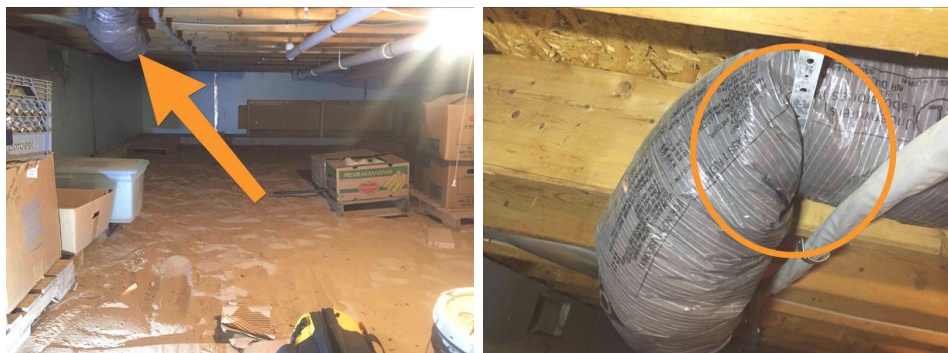
5.3.2 Distribution Systems

DUCTS IN CRAWLSPACE

Air supply ducts were not properly sealed. Recommend a qualified HVAC contractor seal supply and return ducts for maximum efficiency.

Unsealed/uninsulated ducts in unheated space may lose 25% to 40% of their energy.

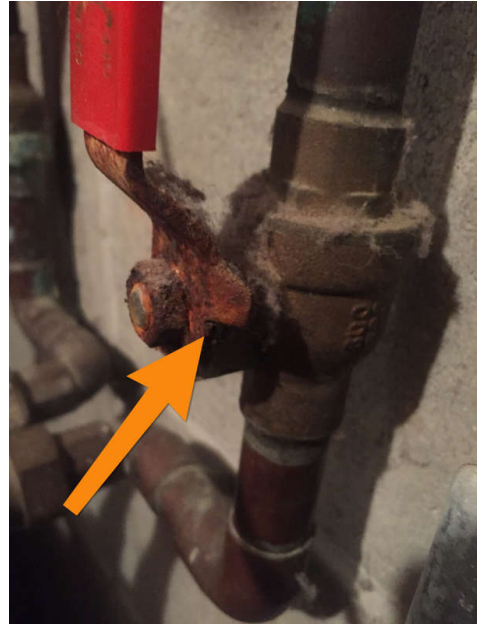
7.1.1 Main Water Shut-off Device

CORROSION

Water main shut-off shows signs of corrosion. Recommend a qualified plumber evaluate.

Moves smoothly

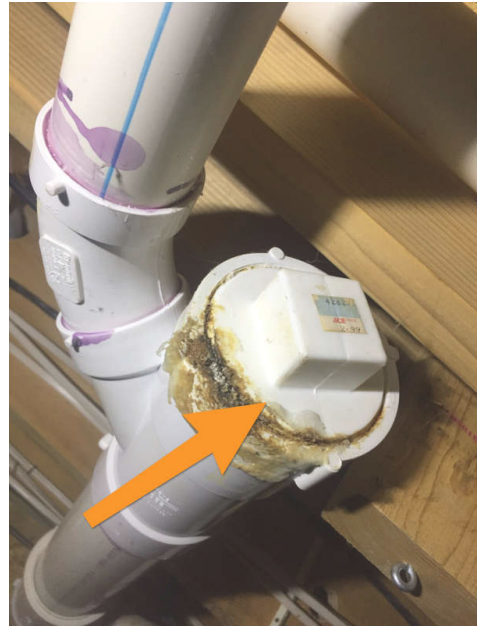
7.2.1 Drain, Waste, & Vent Systems

LEAKING PIPE

A drain, waste and/or vent pipe showed signs of a leak. Recommend a qualified plumber evaluate and repair.

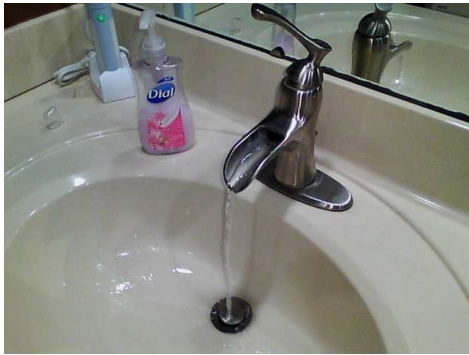
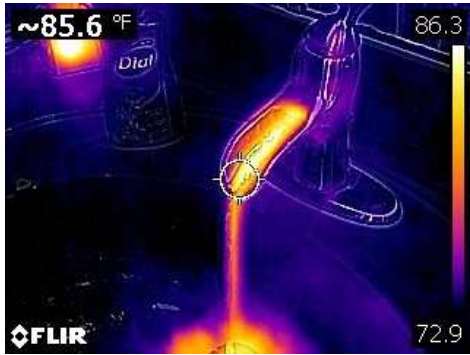
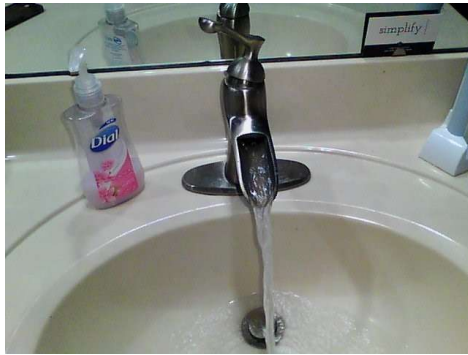
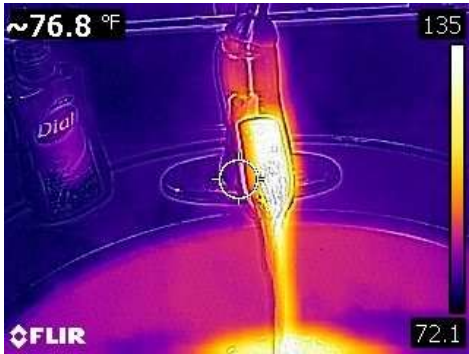
7.3.1 Water Supply, Distribution Systems & Fixtures

LOWER WATER-FLOW AND TEMPERATURE IN LEFT HAND SINK

BATHROOM

Recommendation

Contact a qualified professional.

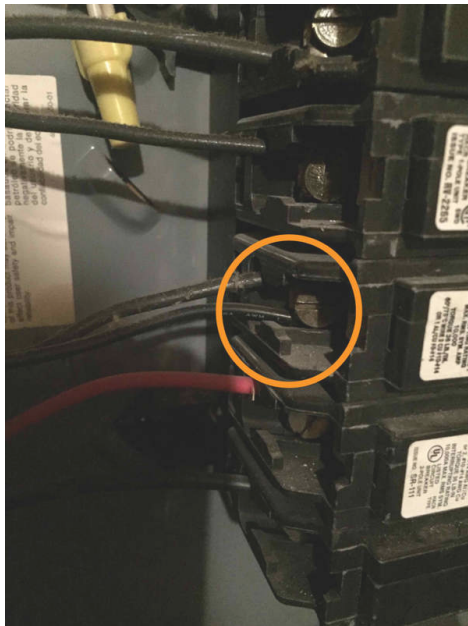
8.2.1 Main & Subpanels, Service & Grounding, Main Overcurrent Device

BREAKER INCORRECTLY WIRED

Circuit breaker was incorrectly wired / installed. This indicates that work was probably not performed by a licensed electrician and poses a safety hazard. Recommend that a licensed electrician check the entire panel and repair and replace as need.

Safety Hazard

Double tapped breaker

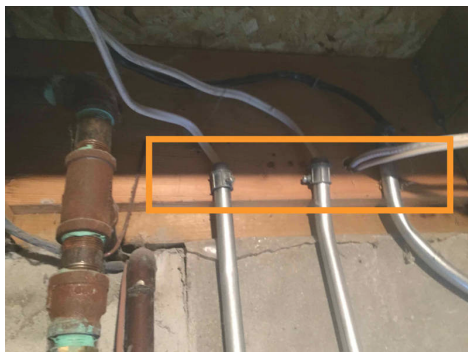
8.4.1 Lighting Fixtures, Switches & Receptacles

RETAINERS ABSENT

Wires that run through conduit must have a retainer at the end of the conduit to secure the wires

Recommendation
Contact a qualified professional.

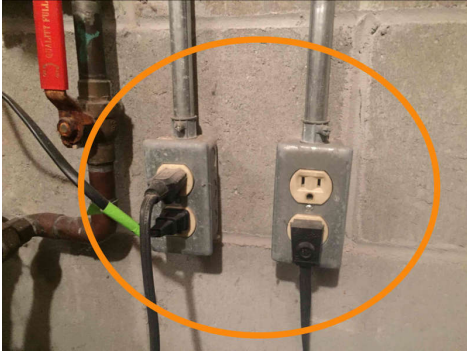
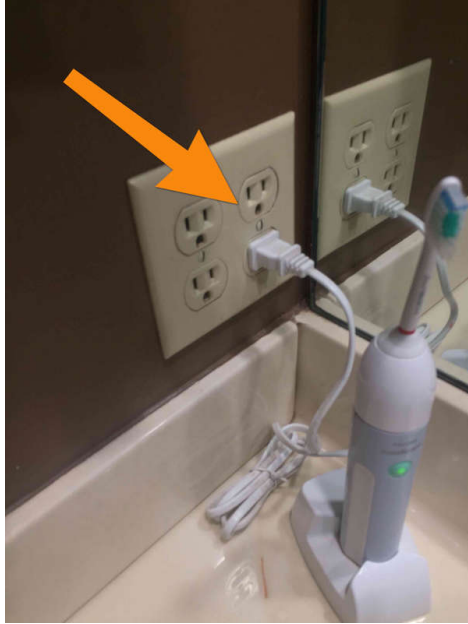
8.5.1 GFCI & AFCI

NO GFCI PROTECTION INSTALLED

MASTER BATHROOM, BASEMENT LAUNDRY AREA AND SUMP PUMP LOCATION

No GFCI protection present in all locations. Recommend licensed electrician upgrade by installing ground fault receptacles in all locations.

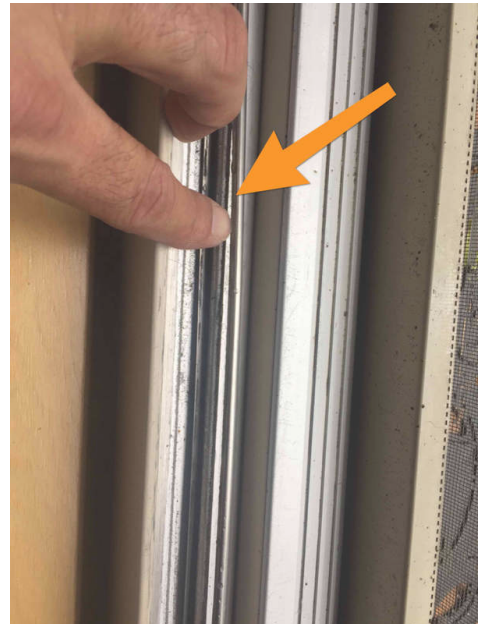
11.1.1 Doors

DOOR STICKS

Door sticks and is tough to open. Recommend sanding down offending sides.
