## SUMMARY

1234 Main St. Louisville CO 80027

Brett Duryea  
InterNACHI Certified, InterNACHI  
Certified Radon Tester, AHIT Certified  
Boulder Home Inspector  
303-676-8006  
[brett@boulderhomeinspector.com](mailto:brett@boulderhomeinspector.com)

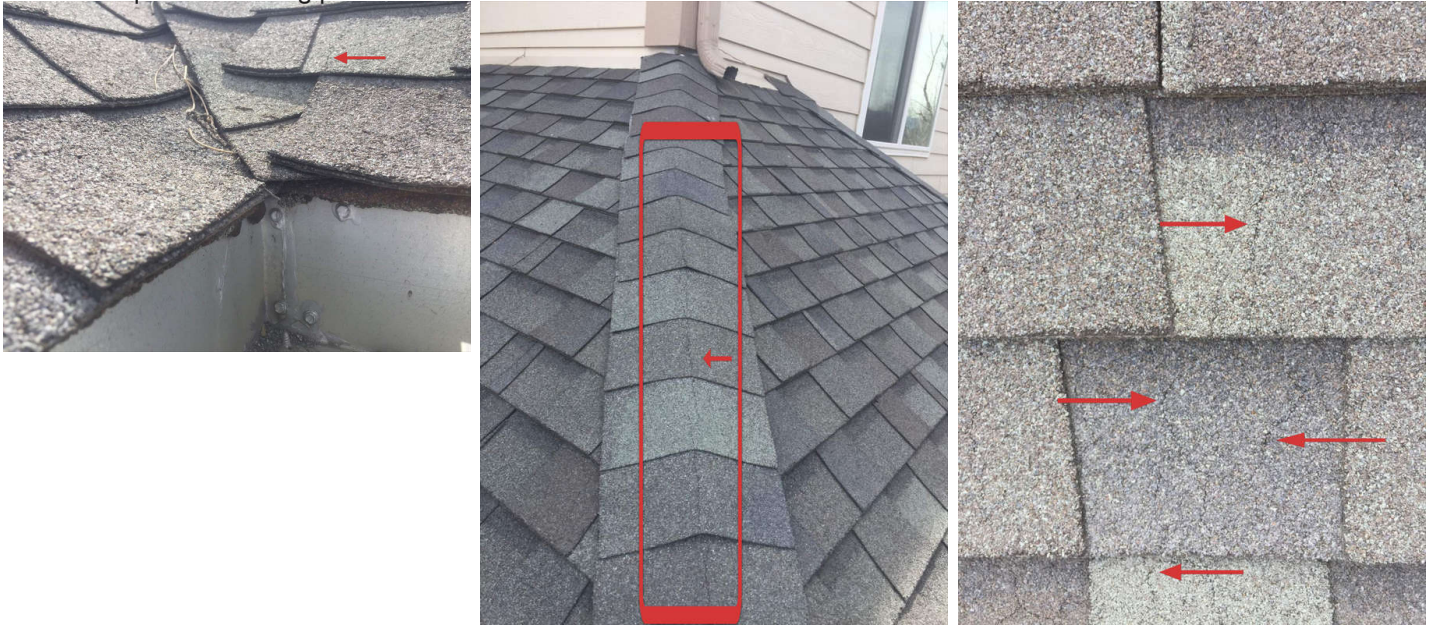
#### **TILES CRACKED/BROKEN**

*Stairstep split pattern (no fasteners or underlayment exposed)*

Cracking of shingle tabs in a stairstep pattern across portions of the roof at areas where shingles bridge joints in underlying shingles may be caused by thermal contraction of the shingles. This condition may eventually result in exposure of fasteners or underlayment, either of which would be a defect needing correction. Neither fasteners nor underlayment appeared to be exposed at the time of the inspection.

*Splitting over underlying joints*

Splitting of shingle tabs on portions of the roof at areas where shingles bridge joints of underlying shingles may be caused by thermal contraction of both the shingles and roof sheathing. The inspector recommends replacement of damaged shingles to prevent damage to home materials from moisture intrusion.

Roof had cracked/broken tiles. Recommend a qualified roof contractor repair or replace to prevent moisture intrusion and/or mold.

Recommendation  
Contact a qualified roofing professional.

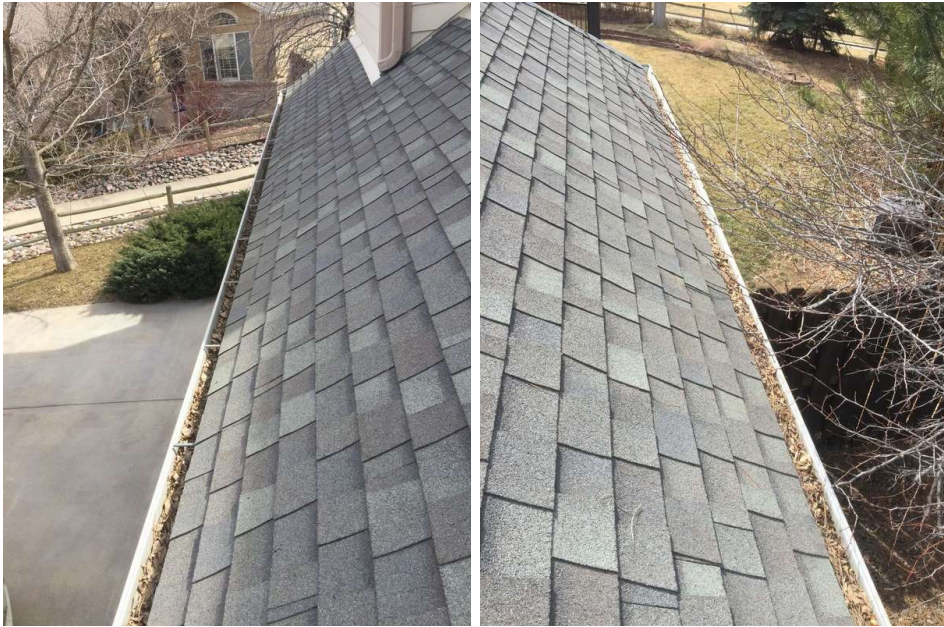
NORTH ROOF

**ORIGINAL ROOF - END OF LIFE**

The roof is the original 1997 Asphalt composition shingles and appeared to be at or near the end of their long-term service life. The Inspector recommends that before the expiration of your Inspection Objection Deadline, you consult with a qualified roofing contractor to discuss options and costs for repair or replacement.

Average roof life expectancy for asphalt shingles is 20 years.

Recommendation  
Contact a qualified roofing professional.

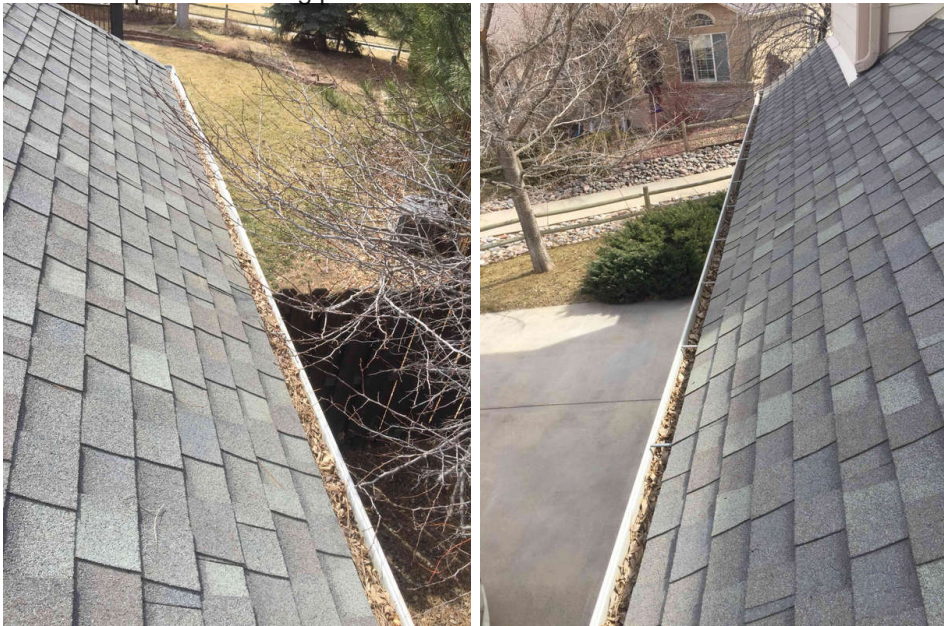
#### **DEBRIS**

Debris has accumulated in the gutters. Recommend cleaning to facilitate water flow.

Contact a qualified roofing professional.

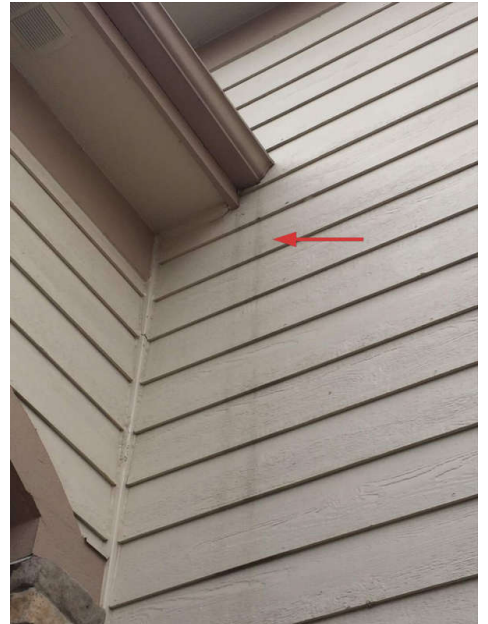
NORTH ENTRYWAY

#### **GUTTER LEAKAGE**

Gutter water stains were observed on the north side of the house by entry way. Recommend a qualified contractor evaluate and repair gutters to proper functionality.

Water stains are present from water overflowing from the gutter. I would recommend further investigation from a roof/gutter professional.

Contact a qualified roofing professional.

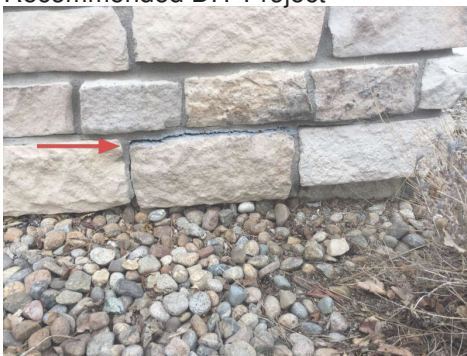
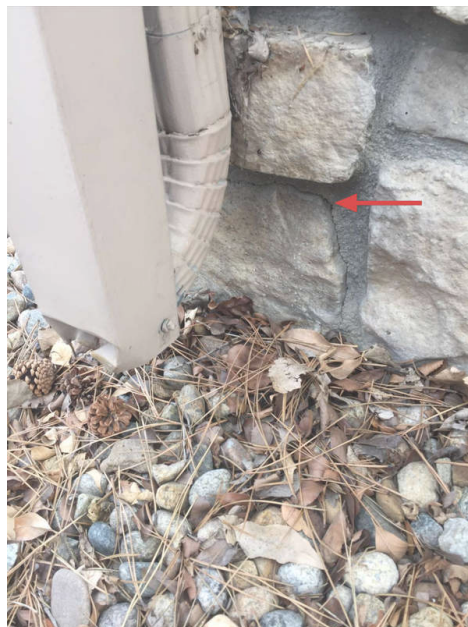
#### **CRACKING - MINOR**

Siding showed cracking in one or more places. This is a result of temperature changes, and typical as homes with stucco age. Recommend monitoring.

Recommendation  
Recommended DIY Project

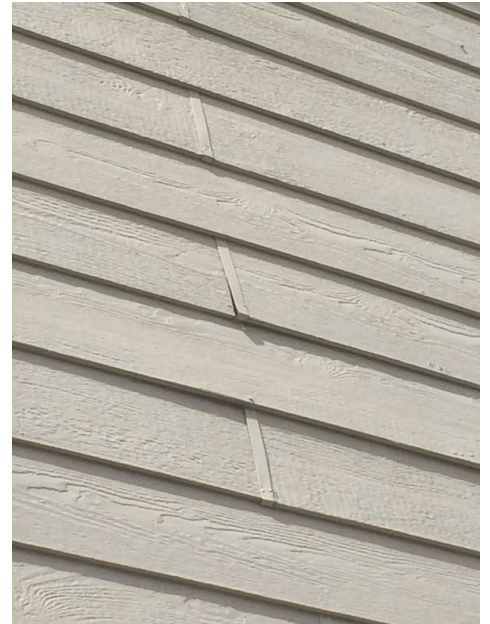
#### **SIDING - MINOR ISSUE**

Siding or Siding Attachment is showing minor wear and tear. I would recommend repairing this item so moisture, insects do not enter the home.

Recommendation  
Contact a handyman or DIY project

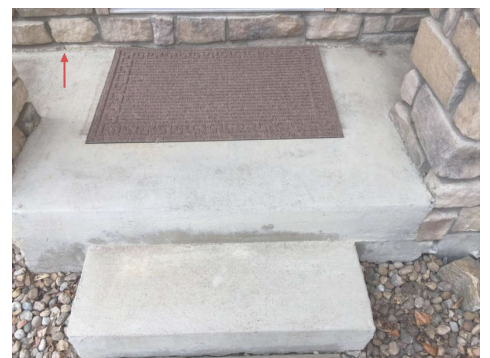
#### **WALKWAY CRACKING - MINOR**

Minor cosmetic cracks observed. Recommend monitor and/or patch/seal.

Recommend filling with grout so that moisture does not enter through the cracks.

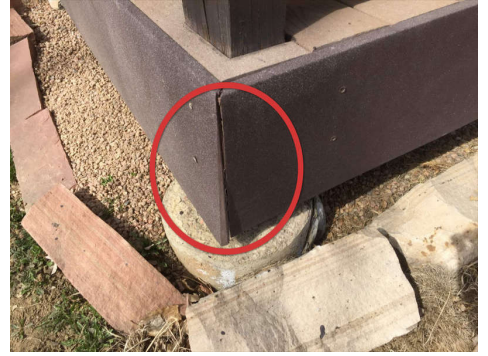
#### **DECK MINOR REPAIR ITEM**

Deck needs a minor repair. I would recommend a Deck professional to evaluate and repair the issue.

Recommendation  
Contact a qualified deck contractor.

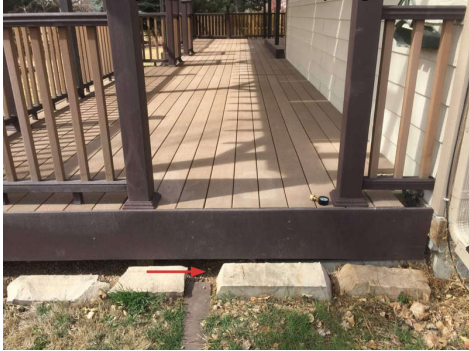
A riser is too high. Risers shouldn't be more than 7 inches high. Correction and further evaluation is recommended. The minimum tread depth is 10 inches. Correction and further evaluation is recommended. Deck steps to backyard on south and south east side of deck exceed the step limit. I would recommend adding a step so that there are two steps to walk into the backyard.

This deck step is very low and with two unequal heights or missing surface it could pose a tripping hazard. I would recommend adding a step that is one level plane and goes across the deck entrance.

Contact a qualified landscaping contractor

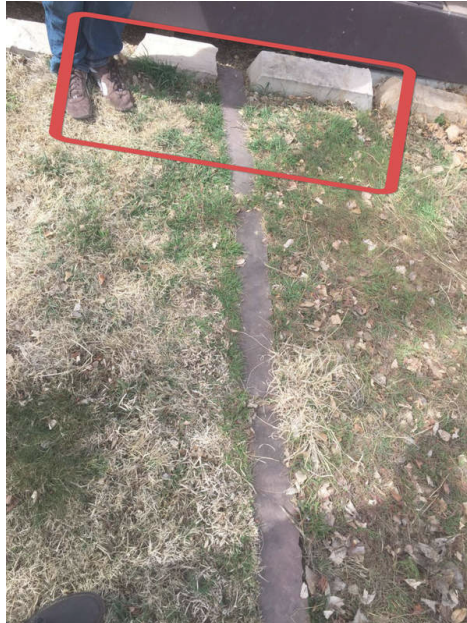
The minimum tread depth is 10 inches.

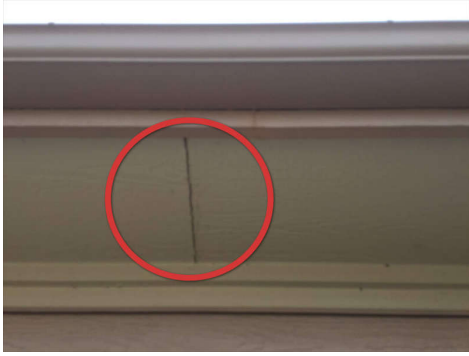
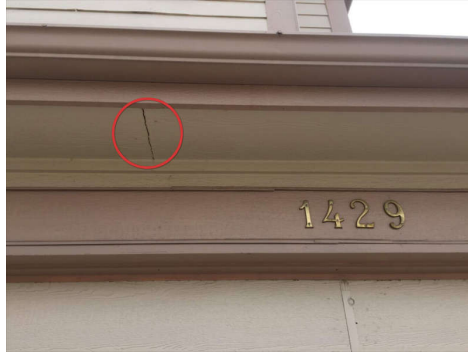
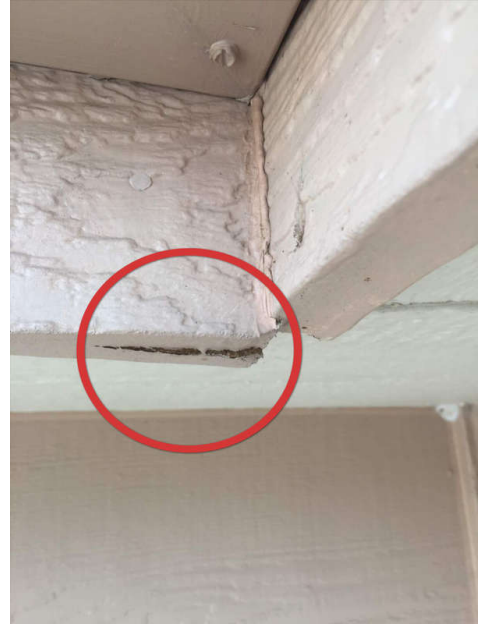
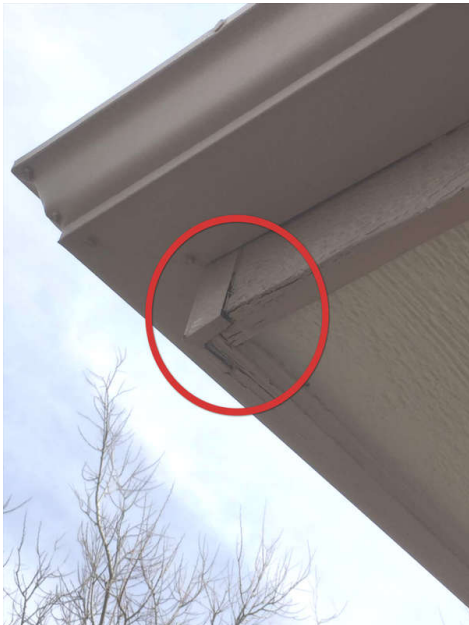
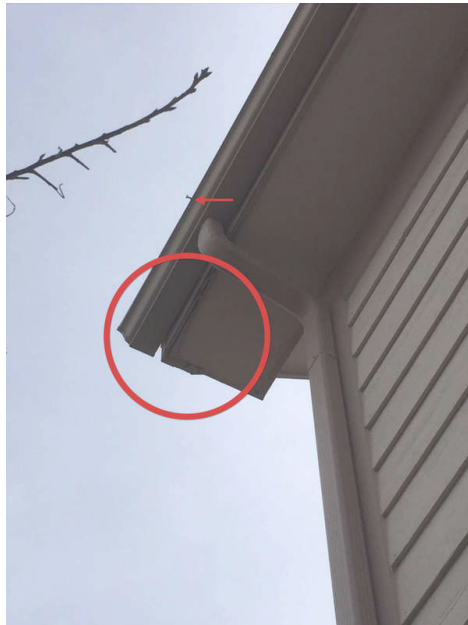
#### GAP

There is opening, gap or hole in fascia / soffit which should be repaired. This can allow water intrusion and rodent infestation as well as deterioration of the surrounding material.

Minor cracking on upper level fascia on the north east corner of the roof.

Contact a qualified roofing professional.

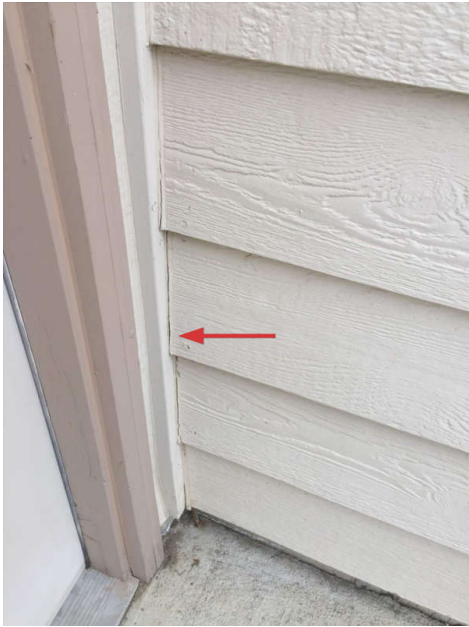
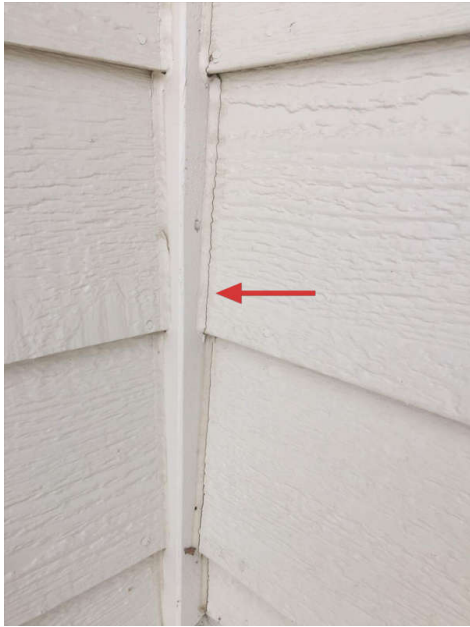
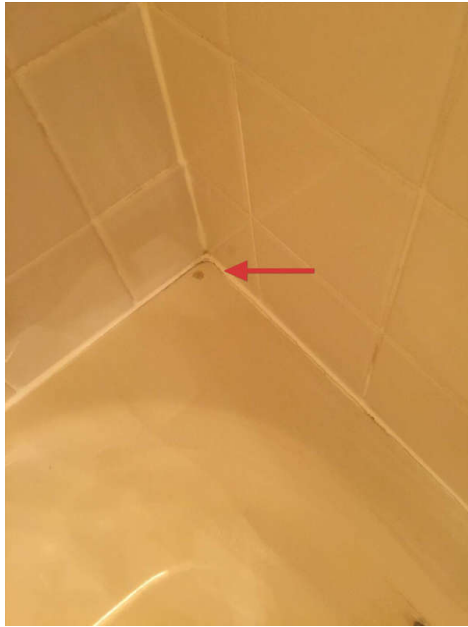
#### **CAULKING**

Caulking around windows, doors, fascia, eaves and soffits is cracking, missing or in need of repair. I would recommend adding/replacing caulk asap so that water and insect intrusion is reduced.

Contact a handyman or DIY project

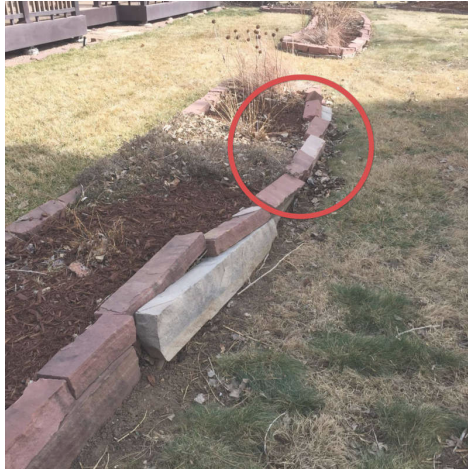
**LANDSCAPE COSMETICS**

There were landscape items that were deteriorating or in need of minor repair. I would recommend a landscape professional or DIY to repair these minor issues so that further deterioration does not take place and it does not become a hazard.

Recommendation  
Contact a handyman or DIY project

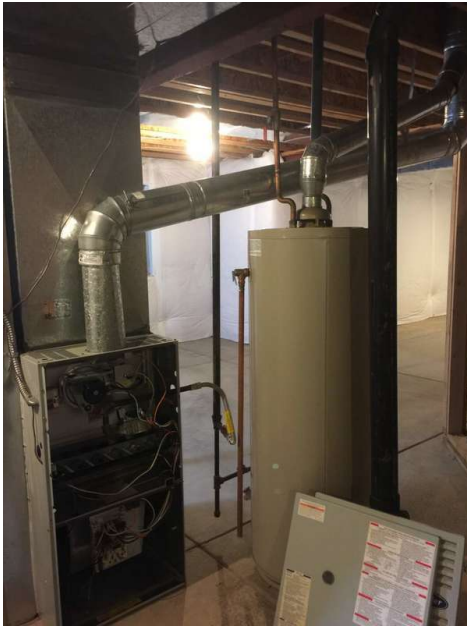
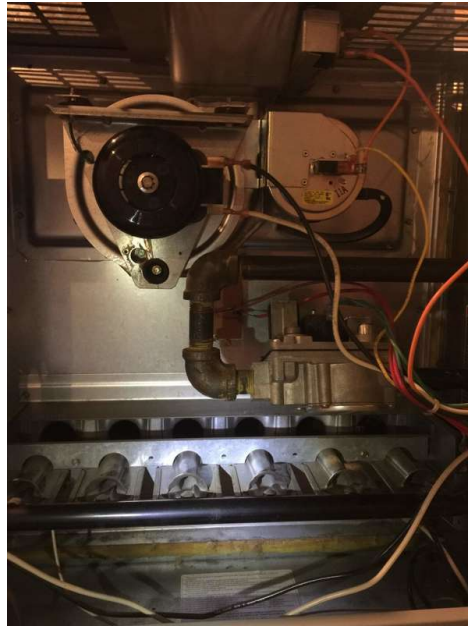
BASEMENT

6.1.1 Equipment  
**NEAR END OF LIFE**

The normal life expectancy is 15-25 years. While the unit may continue to operate for years to come, it is very close to a normal life expectancy and may fail tomorrow. I would recommend a professional to evaluate the Furnace as soon as possible.

Recommendation  
Contact a qualified HVAC professional.

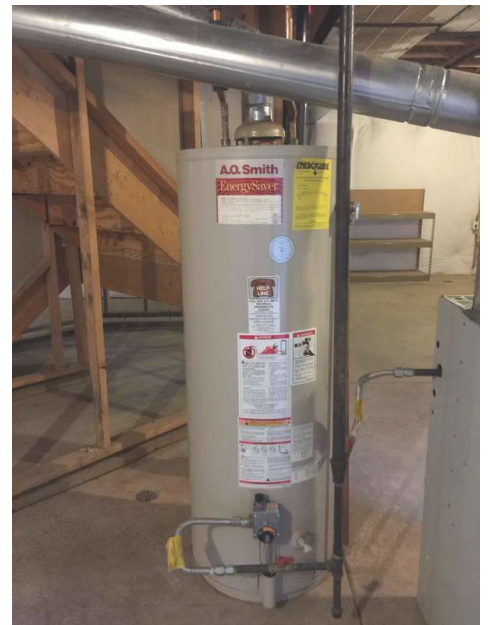
BASEMENT

**NEAR END OF LIFE**

The water heater normal life expectancy is 6-12 years. While the unit may continue to operate for years to come, it is very close to a normal life expectancy and may fail tomorrow. I would recommend a professional to evaluate the water heater as soon as possible.

Contact a qualified plumbing contractor.

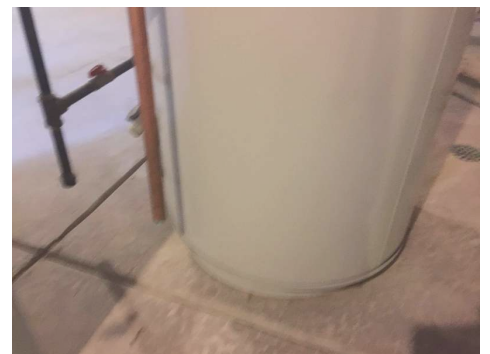
**NO DRIP PAN**

No drip pan was present. Recommend installation by a qualified plumber.

Contact a qualified plumbing contractor.

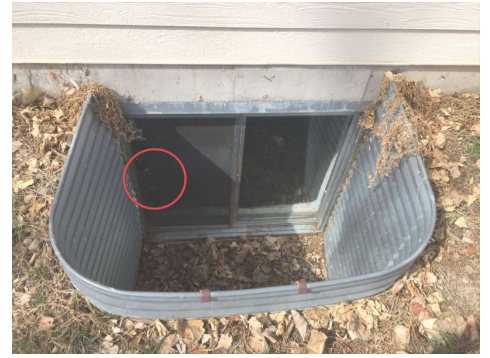
EAST SIDE YARD

**SCREEN MISSING OR TORN**

The screen is missing or torn. I would recommend repairing or replacing the screen.

Contact a handyman or DIY project
