SUMMARY
1234 Main St. Spokane Washington
99224
Buyer Name
03/02/2019 9:00AM

Andy Ballard
Home Inspector License # 2313
WAYPOINT PROFESSIONALS
(509) 413-6443
andy@waypointpro.com

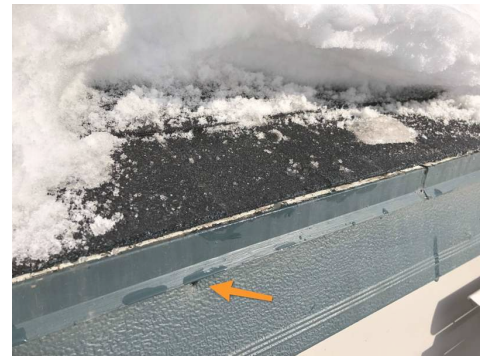
There are no gutters present on the structure. Given the observed hole pattern throughout the aluminum fascia covering, there may have been gutters present on the house in the past. Gutters are recommended because they collect rain water from the roof and direct it away from the building.

There is a series of holes just at and/or beneath the drip edge that suggests there may have been gutters on the house previously.

Recommendation
Contact a qualified gutter contractor

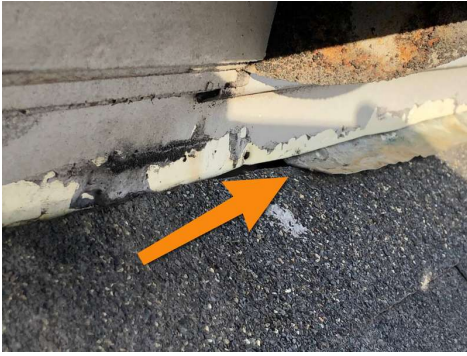
Although I could not observe all roof locations, flashings were missing at one or more locations at the time of inspection. Flashings provide protection against moisture intrusion. Recommend continued monitoring and definitely get a closer look when the snow melts. Should there be flashing missing in multiple locations, contact a qualified roofing contractor evaluate and remedy. Most good roofing contractors can come out and assess the situation free of cost. I use Roman at [Performance Roofing](#), he has always treated my clients well and does exceptional work.

Flashing from sidewall over side entry roof stops short, it should be continuous across roof.

Recommendation
Contact a qualified roofing professional.

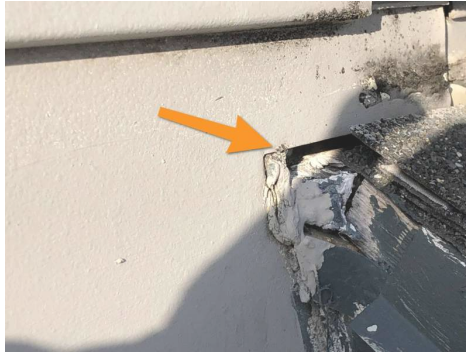
Kickout flashing missing here, with evidence of previous moisture exposure.

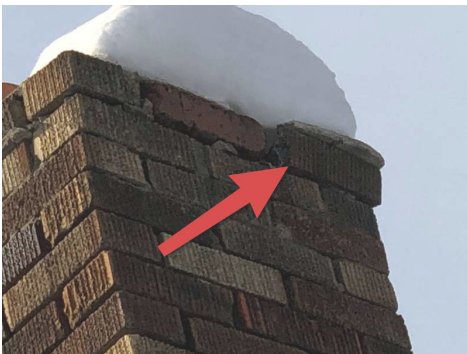
Joints in the masonry have deteriorated and should be repointed. (Repointing is the restoration of the mortar joints in the masonry). I counted 13 courses of brick down from the top that had deteriorated mortar. It is likely that the masonry chimney cap is deteriorated as well. At least one loose brick was observed, so I have highlighted this as a safety concern. I recommend contacting a licensed chimney repair contractor. I have had success with [Dobson Chimney](#), they are affordable and trustworthy folks.

This brick is loose and will fall eventually unless repairs are made.

Contact a qualified chimney contractor.

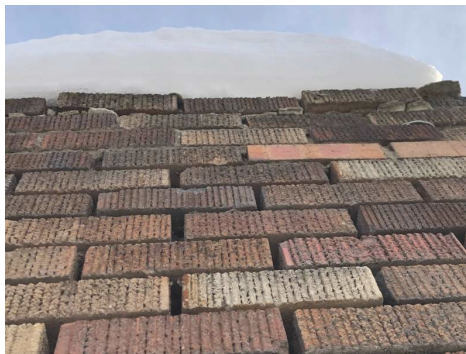
From the top down there are at least 13 courses of brick that need mortar repointed.

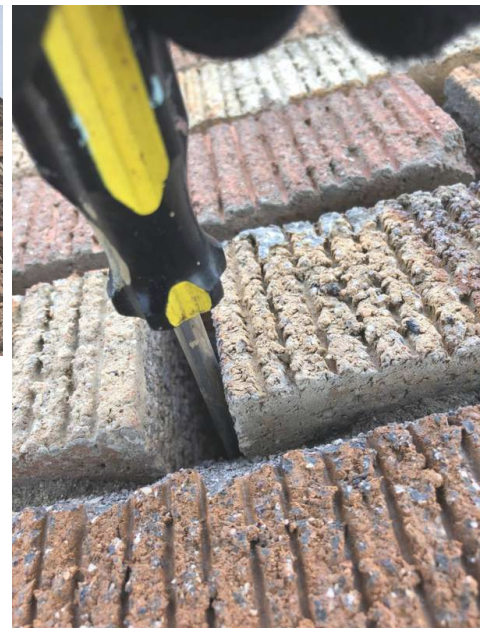
This screwdriver is 6 inches long, you should not be able to do this.

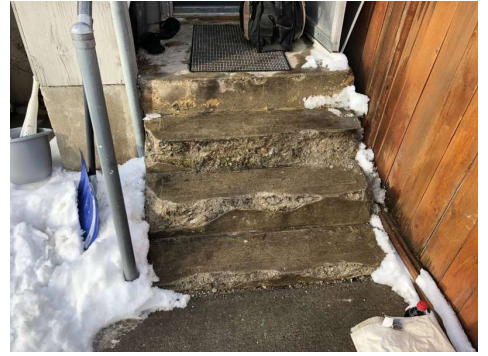
SIDE ENTRY

One or more sections of the exterior stairs are deteriorated. Also the rise and run ratio of the steps is not correct, which can pose a tripping hazard. Recommend qualified concrete contractor evaluate & repair. I have used [Allwright Concrete](#) in the past.

These concrete steps are shot.

Contact a qualified concrete contractor.

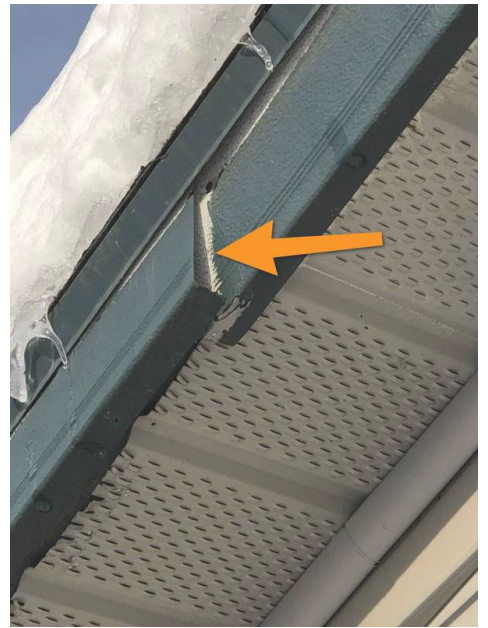
One or more sections of the fascia are loose. Recommend qualified individual evaluate & repair.

Loose fascia.

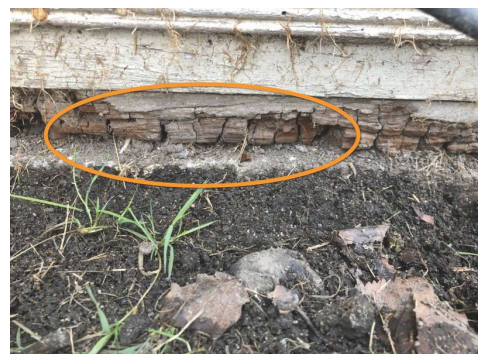
Grading is sloping towards the home in some areas, specifically on the north side of house near chimney. This could lead to water intrusion and left unchecked, eventually foundation issues. At least one window showed evidence of prior moisture exposure and wood rot due to close proximity to earth and negative grading. There were numerous sprinkler heads located in close proximity to the exterior foundation, so vigilant monitoring is recommended to keep the spray pattern away from the house. Recommend replacement of rotted wood and addition of window wells as needed. More importantly, recommend DIY project, or a qualified landscaper regrade so water flows away from home.

This is classic wood rot that needs replacement with pressure treated wood and the underlying moisture needs to be resolved with better grading and or addition of a window well.

Contact a handyman or DIY project

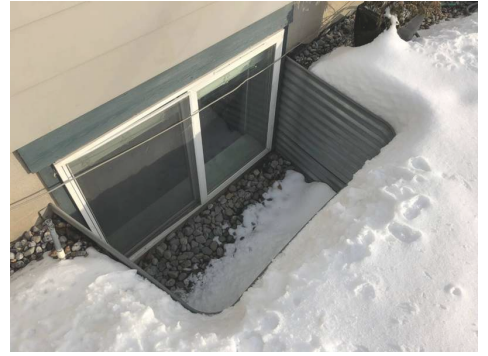
Egress window well observed to be open (no cover). In areas that are easily accessible, such as this one, it is recommended that a cover be provided to eliminate a fall hazard, and this also helps keep moisture out.

Open egress well

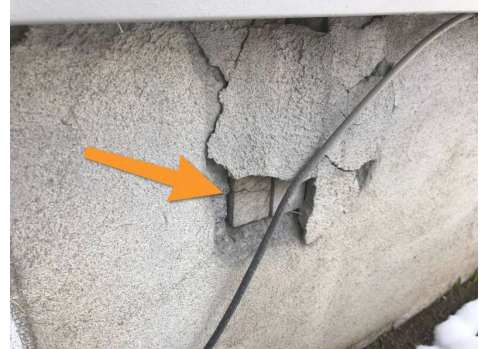
One or more areas of the foundation veneer (cosmetic covering) showed evidence of disrepair. In this case the parge coat of the exterior foundation was deteriorated. Recommend repair as necessary to prevent moisture intrusion. Here is a link to learn more about this kind of [repair products](#), as well as a useful [video](#).

Foundation parge coat is failing. Structural members can be seen. this needs to be sealed up to prevent moisture intrusion.

Contact a qualified professional.

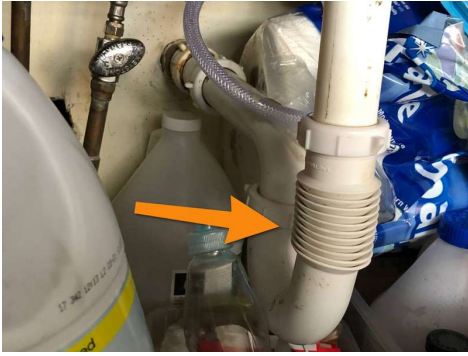
Improper connections were observed. There are flexible drain trap/discharge tube extensions installed for trap assemblies under the kitchen sink and main floor bathroom vanity. The kitchen sink drain was clogged/slowly draining, and the bathroom vanity drain leaked upon filling the basin and allowing to drain. Although the flexible, accordion-shaped pipe shown in the photo and video is sold in home improvement stores, it is not approved for installation by plumbing codes, which require that any waste pipe fitting have a smooth interior surface that allows the free flow of drain water and prevents waste buildup clogs. A professional plumber can adjust the tailpipe and trap assembly to use all rigid pipe. Recommend a qualified plumber evaluate and repair as necessary. As highlighted in other areas, there is evidence of unprofessional plumbing work done throughout the house, so a more thorough inspection by a plumber for all plumbing is warranted. Justin at [Vertical](#) is my go to plumber.

Flexible trap.

Contact a qualified plumbing contractor.

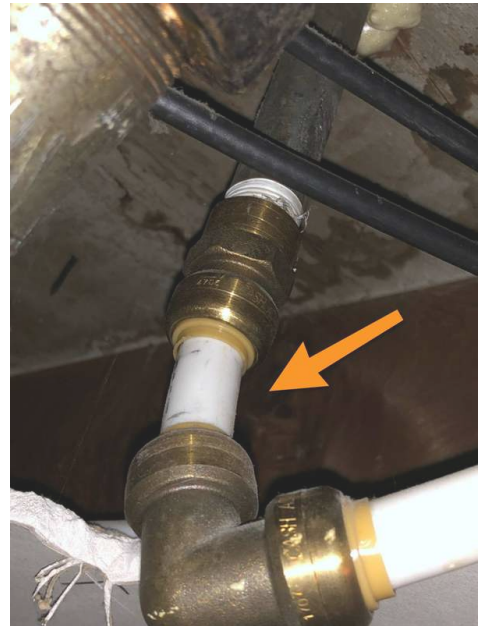
Distribution pipes were installed in a sub-standard way. at least one connection appeared to be under strain. Recommend a qualified plumber evaluate and properly fit and install pipes.

This connection should be made more in-line so that the connection is not under stress.

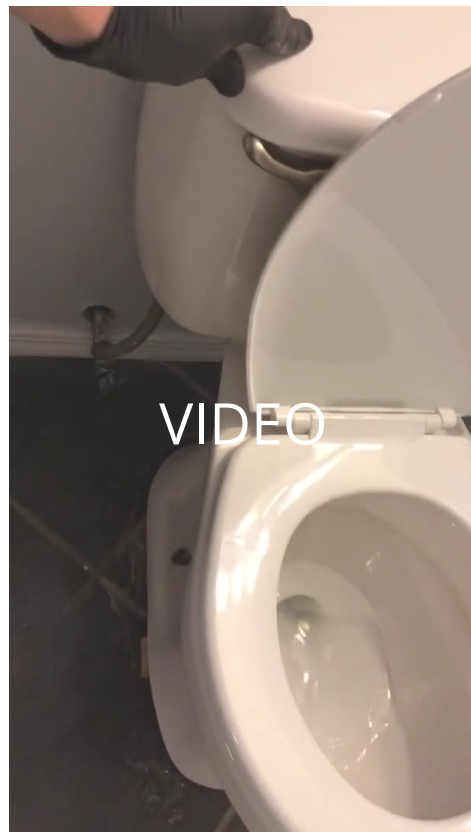
Toilet is loose at the base. Recommend a qualified plumber evaluate and repair as necessary. Although not leaking currently, it is only a matter of time that the wax seal would be compromised, potentially allowing sewer gas entry into the home as well as leaks.

Contact a qualified plumbing contractor.

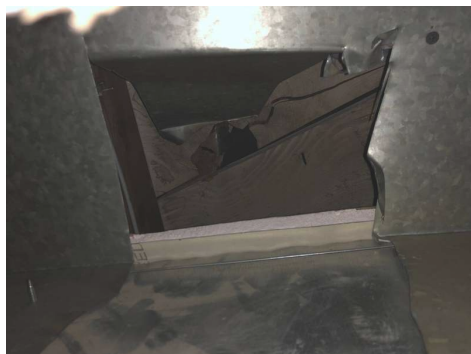
Supply duct was observed to be leaking air through a cut open flange in the duct. This may have been done to heat the floor space above, or to allow conditioned air to enter a floor joist bay in order to reach a register. In either case this is an inefficiency. Recommend a qualified HVAC technician evaluate and repair as necessary.

This HVAC trunk line has been cut open.

Contact a qualified HVAC professional.

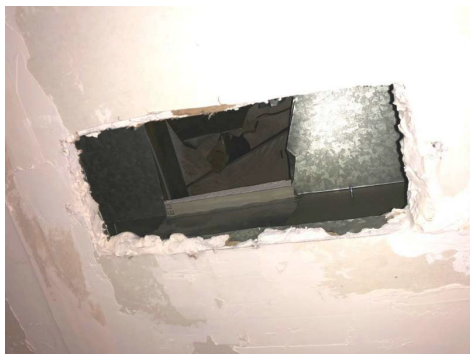
Open ducting above ceiling register.

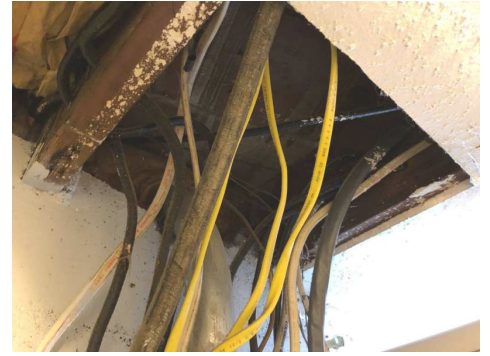
Electrical cables below 8-feet above the floor (in other words, within reach) are required to be protected either inside a wall, floor/ceiling bay, or running in conduit. Recommend electrician evaluate and repair as necessary.

Unprotected wires.

Contact a qualified electrical contractor.

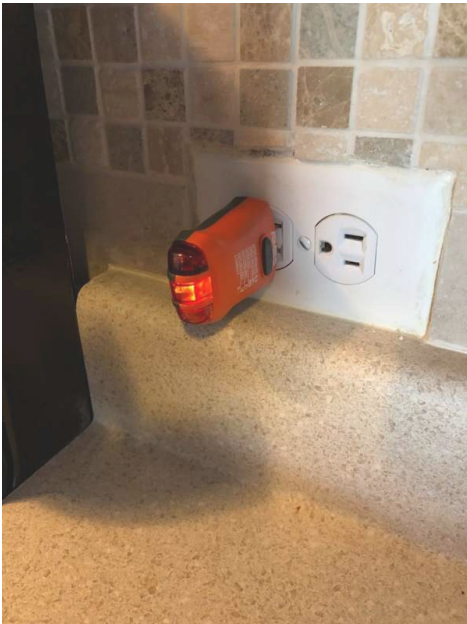
Open grounds were observed in several locations. Ground Fault Circuit Interruptors (GFCI) protection was not present in all required locations. Open grounds in three prong receptacles are a common issue found in older homes. This is an unsafe condition and should be corrected. The repair is fairly simple and does not require rewiring the home as some mistakenly believe. Only those circuits with the ungrounded receptacles are required to be addressed. Recommend licensed electrician upgrade by installing ground fault receptacles in all required locations.

Open Ground/No GFCI.

Contact a qualified electrical contractor.

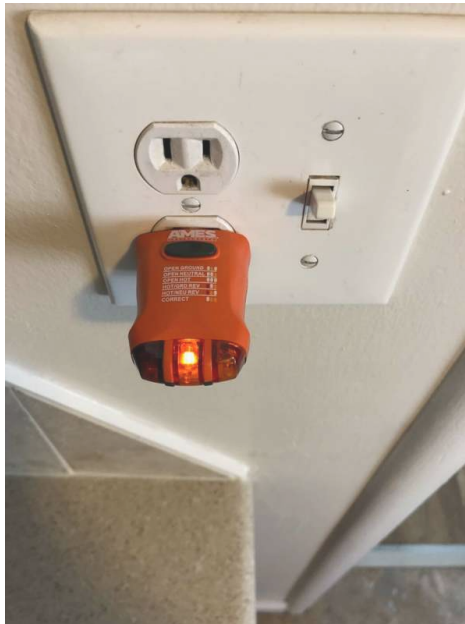
Open Ground.

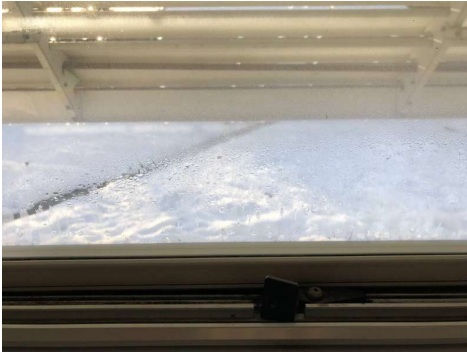
Observed condensation between the window panes of some windows, which indicates a failed seal. Recommend qualified window contractor evaluate & replace as necessary.

Condensation between window panes.

Contact a qualified window repair/installation contractor.

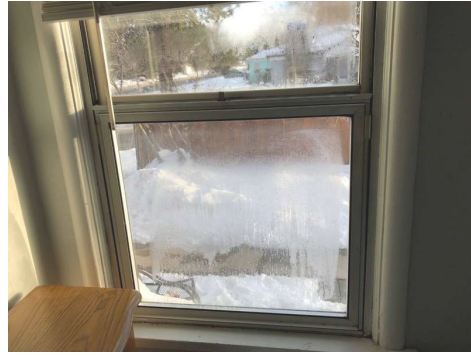
Seals blown between panes.

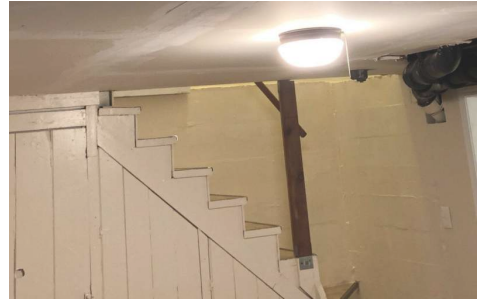
The overall construction of handrail and/or baluster spacing is not up to modern safety standards. The space between balusters should not allow passage of a 4 inch sphere for child safety. Recommend a qualified handyman or contractor repair and bring up to code.

Stairs have no balusters.

Contact a qualified professional.
