SUMMARY 1234 Main St.Richardson TX 75080 Buyer Name 04/28/2019 9:00AM

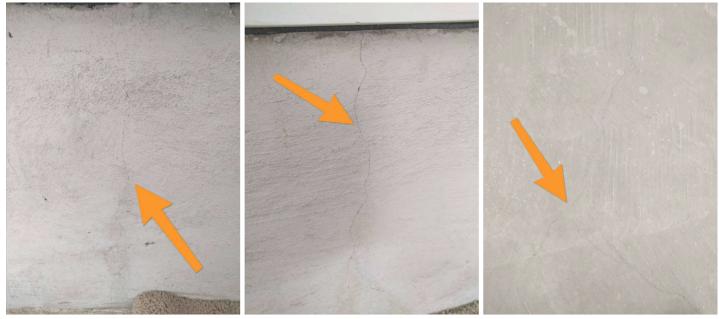
2.1.1 A. Foundations FOUNDATION CRACKS - MINOR

Minor cracking was noted at the foundation. This is common as concrete ages and shrinkage surface cracks are normal. Recommend monitoring for more serious shifting/displacement.

Contact a qualified structural engineer.

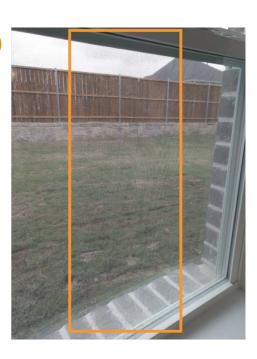
MASTER BEDROOM

2.8.1 H. Windows **DAMAGED**

One or more windows appears to have general damage, but are operational. Recommend a window professional clean, lubricate & adjust as necessary.

Recommendation Contact a qualified window repair/installation contractor.

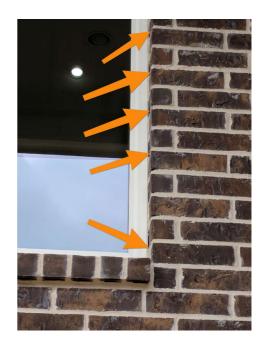
2ND FLOOR PORCH WINDOWS

2.8.2 H. Windows IMPROPER INSTALLATION

Windows appear to not be operating properly due to substandard installation. Recommend window specialist evaluate.

Recommendation Contact a qualified window repair/installation contractor.

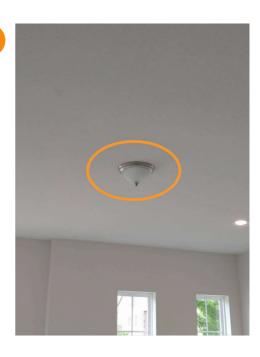
3.2.1 B. Branch Circuits, Connected Devices, and Fixtures LIGHT INOPERABLE GAME ROOM

One or more lights are not operating. New light bulb possibly needed. Recommendation

Contact a qualified electrical contractor.
