SUMMARY
1234 Main St. Waterford Works New
Jersey 08089
Buyer Name
01/13/2019 9:00AM

Todd Vazquez
NJ Home Inspector License #...
Smart Inspections LLC
(609) 805-0641
todd@smart-inspections.com

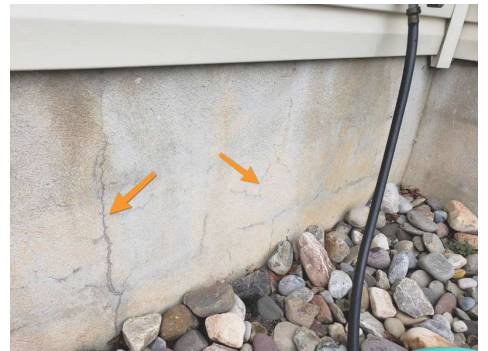
2.1.1 Foundation Walls

EXTERIOR FOUNDATION - SHRINKAGE CRACKS

The foundation wall exhibited signs of shrinkage cracking. Shrinkage cracks appear as part of the natural concrete curing process and are not a structural concern. The inspector recommends monitoring the cracks for future displacement or shifting by a qualified professional.

Contact a foundation contractor.

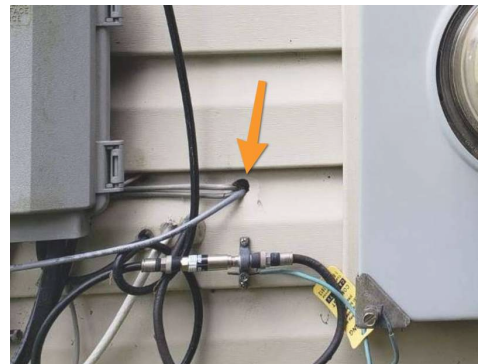
2.2.2 Exterior Cladding

SIDING PENETRATION

The siding had one or more wall penetrations that were not sealed properly. This condition may allow moisture intrusion, which may cause damage to surrounding components. The inspector recommends that all wall penetrations be properly sealed by a qualified professional.

Contact a qualified siding specialist.

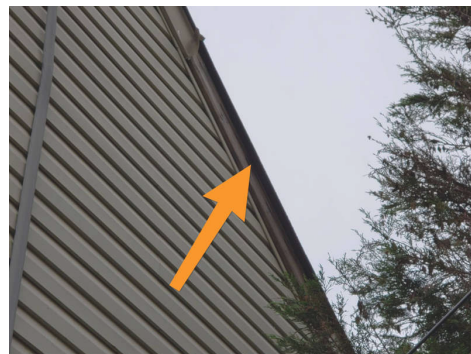
2.4.1 Trim and Flashing

TRIM - MISSING

A section of the rack board trim is missing. This condition may allow moisture intrusion to damage surrounding components. The inspector recommends further evaluation and repair of the trim by a qualified professional.

Contact a qualified siding specialist.

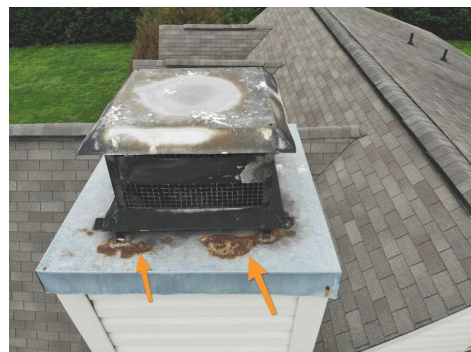
2.8.1 Chimney Exterior

CHIMNEY CROWN - MINOR CORROSION

The chimney crown exhibited signs of corrosion. This condition may allow moisture intrusion, which may cause damage to surrounding components. The inspector recommends further evaluation and repair of the chimney crown by a qualified professional.

Contact a qualified chimney contractor.

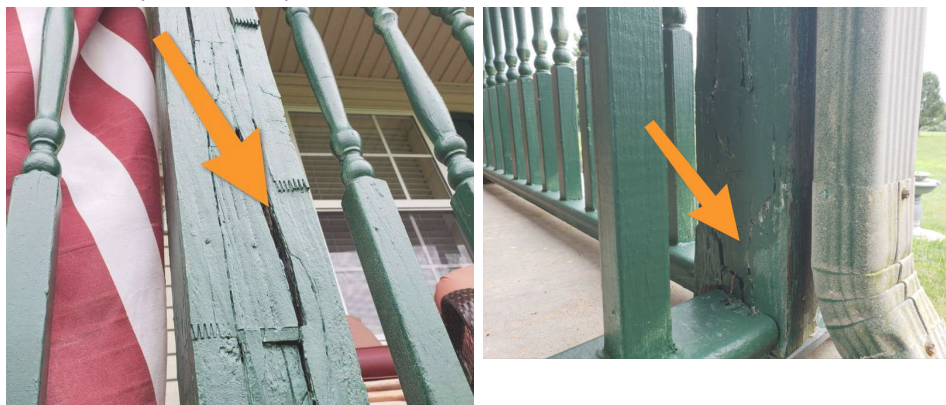
2.9.1 Decks, Patios and Porches

PORCH - ROOF SUPPORT POST

One or more porch roof support posts exhibited signs of wood rot. This condition is likely caused by moisture intrusion and will only worsen over time. The inspector recommends further evaluation and repair of the damaged posts by a qualified professional.

Contact a qualified carpenter.

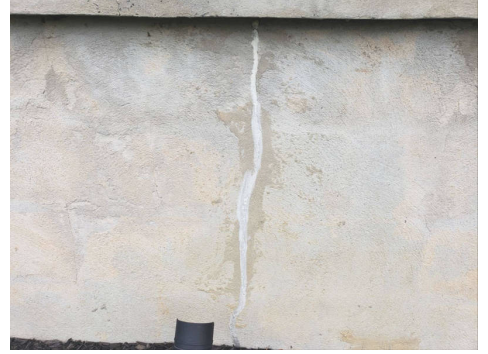
2.9.2 Decks, Patios and Porches

PORCH - EVIDENCE OF PAST REPAIR

The front porch exhibited signs of past repair, likely from settlement. Additional settlement may cause the mortar joints to deteriorate. The inspector recommends the affected areas be monitored for further settlement or separation of mortar joints by a qualified professional.

Recommendation
Contact a qualified concrete contractor.

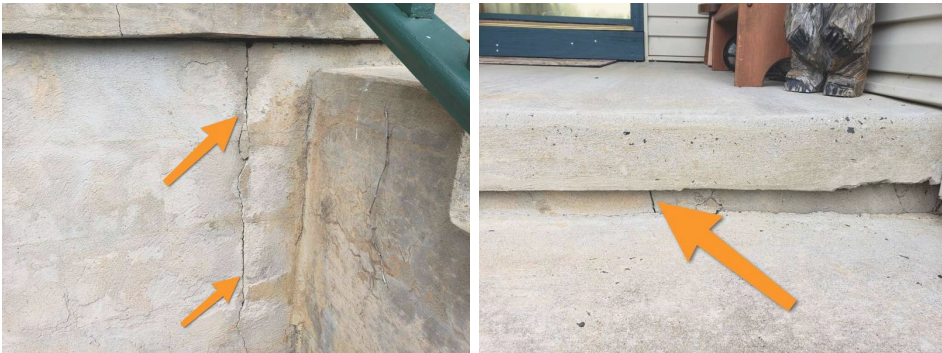
2.9.3 Decks, Patios and Porches

PORCH - MINOR CRACK

The porch had one or more minor cracks. This condition may allow moisture intrusion and cause additional damage to the concrete porch. The inspector recommends the cracks be further evaluated and repaired by a qualified professional.

Recommendation
Contact a qualified concrete contractor.

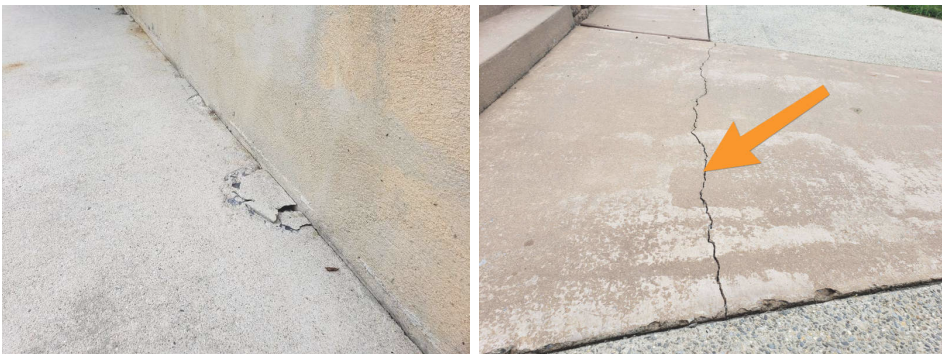
2.10.1 Walkways, Steps and Railings

WALKWAY - CRACKING

One or more sections of the concrete walkway were cracked. This condition may allow moisture intrusion, which could cause upheaval. The inspector recommends further evaluation and repair by a qualified professional.

Recommendation
Contact a qualified concrete contractor.

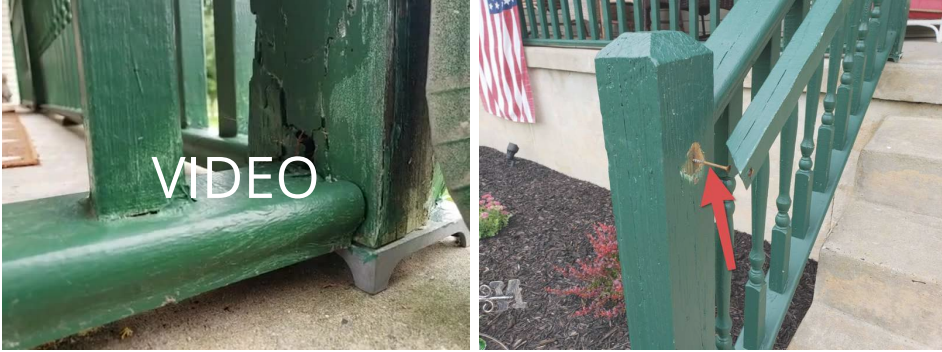
2.10.2 Walkways, Steps and Railings

RAILING - NOT ATTACHED

The front stairway railing was not attached to its support post. This condition may cause a safety hazard for anyone who may use the railing for support. The inspector recommends further evaluation and repair by a qualified professional.

Recommendation
Contact a qualified carpenter.

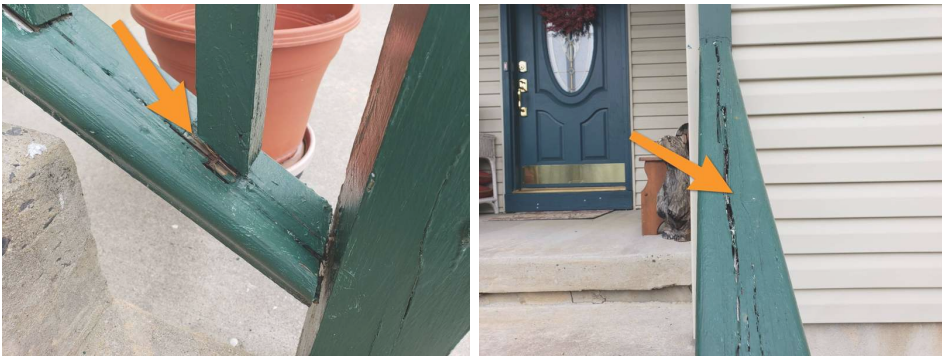
2.10.3 Walkways, Steps and Railings

RAILING - WOOD ROT

The front railing exhibited signs of wood rot in one or more locations. This condition may cause structural failure of the railings. The inspector recommends further evaluation and repair by a qualified professional.

Recommendation
Contact a qualified carpenter.

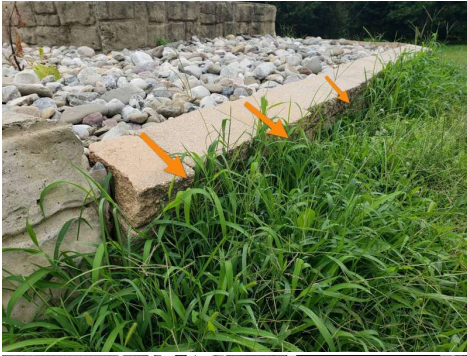
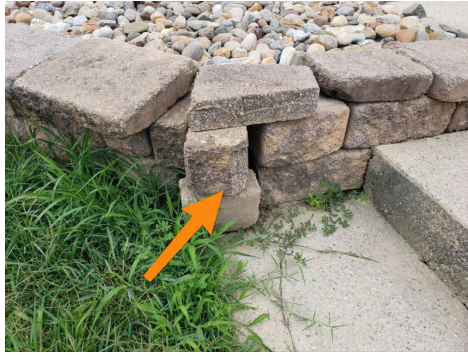
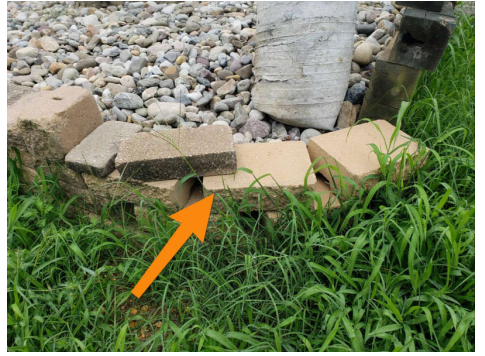
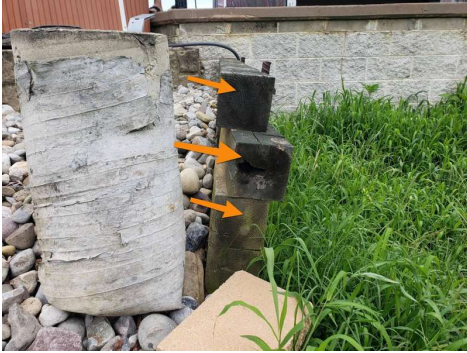
2.12.1 Landscaping and Retaining Walls

RETAINING WALL - DETERIORATION

One or more retaining walls are exhibiting signs of deterioration. This condition may cause the retaining walls to fail when under additional loads. The inspector recommends further evaluation and repair of the retaining walls by a qualified professional.

Recommendation
Contact a qualified professional.

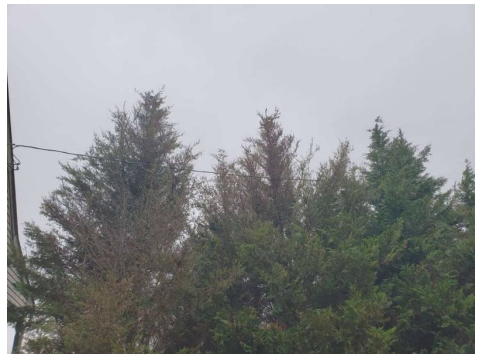
2.12.2 Landscaping and Retaining Walls

VEGETATION NEXT TO STRUCTURE

Decorative vegetation is either too close or touching the siding or foundation. Vegetation too close to the structure can lead to excess moisture around the soil and foundation. The inspector recommends that all vegetation be cut back or removed by a qualified handyman or contractor. There should be a minimum of a two foot buffer between the structure and vegetation.

Recommendation
Contact a qualified professional.

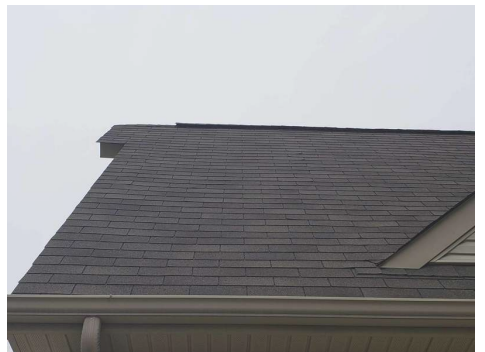
3.1.1 Roof Surface

AGING ASPHALT SHINGLES

Although functional, standard three tab roof shingles had widening gaps between tabs and missing granules, which indicate they are near the end of their functional life expectancy. The shingles are likely original to the structure, approx. 17 years old. The life expectancy of three tab shingles is about 20 years. Continued use of the shingles without replacement may lead to moisture penetration into the interior space. The inspector recommends further evaluation of the asphalt shingles by a qualified professional.

Recommendation
Contact a qualified roofing professional.

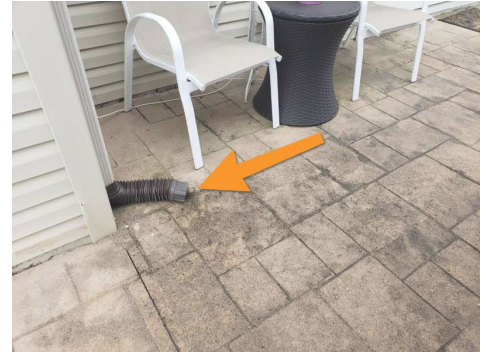
3.2.1 Roof Drainage Systems

DOWNSPOUT DRAIN NEAR DWELLING

One or more downspouts drain too close to the home's foundation. This can result in excessive moisture in the soil at the foundation, which can lead to foundation/structural movement. The inspector recommends a qualified contractor adjust downspout extensions to drain at least 6 feet from the foundation.

Recommendation
Contact a qualified gutter contractor

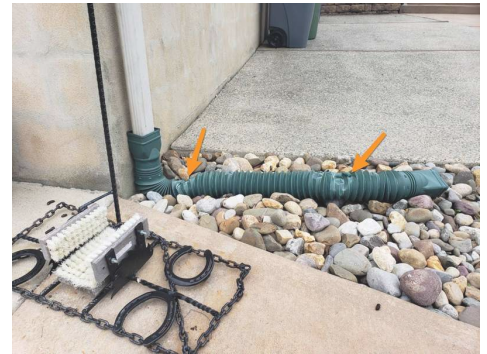
3.2.2 Roof Drainage Systems

DOWNSPOUT EXTENSION - CRUSHED

One or more downspout extension pipes were crushed. This condition may cause water to back up, causing the roof drainage system to fail. The inspector recommends further evaluation and repair of the entire roof drainage system by a qualified professional.

Recommendation
Contact a qualified gutter contractor

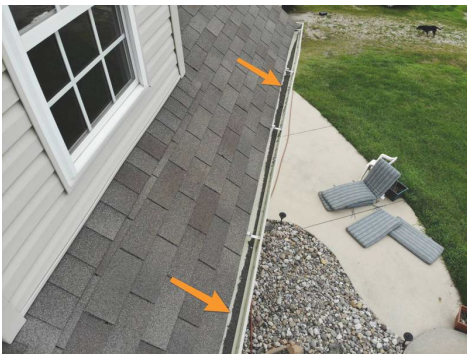
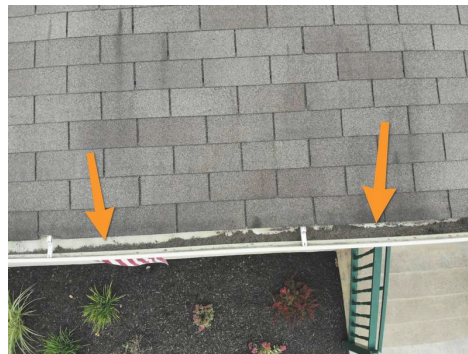
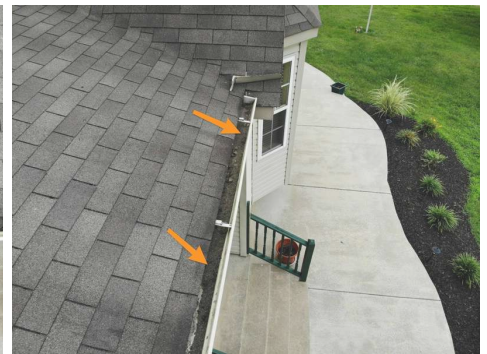
3.2.3 Roof Drainage Systems

GUTTER - LOOSE GRANULES

One or more gutters exhibited signs of containing loose shingle granules. This condition is characteristic of an aging roof. The granules should be cleaned from the gutters so they don't impede the flow of water runoff. The inspector recommends further evaluation and repair by a qualified professional.

Recommendation
Contact a qualified roofing professional.

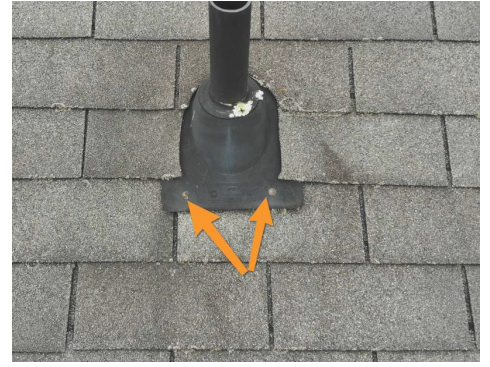
3.3.1 Roof Flashings

ROOF PENETRATION - EXPOSED FLASHING FASTENERS

One or more vent flashing fasteners were exposed to environmental elements. This condition may cause fastener corrosion, which could cause moisture intrusion. The inspector recommends evaluation and repair of all of the roof penetration flashings by a qualified professional.

Recommendation
Contact a qualified roofing professional.

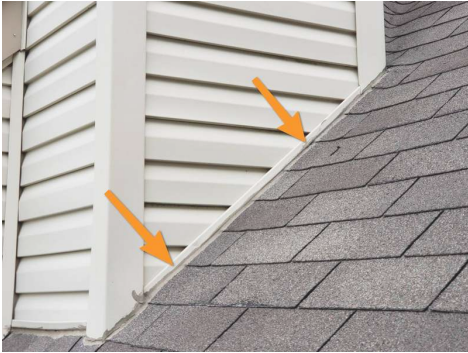
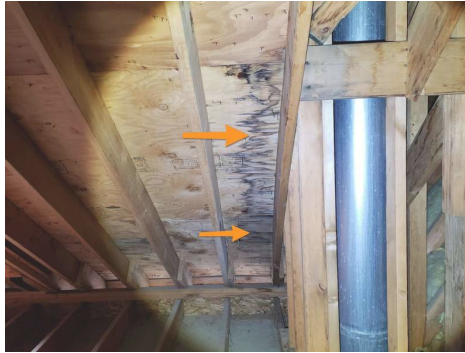
3.3.2 Roof Flashings

CHIMNEY FLASHING - SILICON/COUNTER FLASHING

The joint around the chimney is sealed with silicon. Silicon is not the preferred method for sealing the connection between the siding and chimney. This condition is likely an attempt to stop moisture intrusion that has caused damage to the roof structure over the garage. The inspector recommends further evaluation and repair of the affected areas by a qualified professional.

Recommendation
Contact a qualified roofing professional.

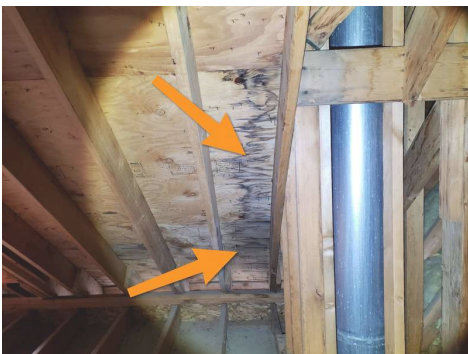
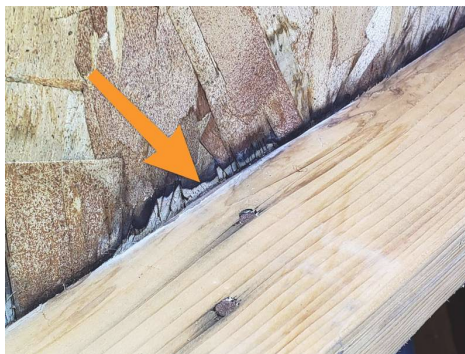
4.1.1 Roof Structure

ROOF SHEATHING - MOISTURE INTRUSION

At the time of the inspection, one or more sections of the roof sheathing exhibited signs of moisture intrusion. This condition, if it has not already been repaired, may lead to the growth of mold and/or water damage to surrounding components. The inspector recommends further evaluation of the roof sheathing by a qualified professional.

Recommendation
Contact a qualified roofing professional.

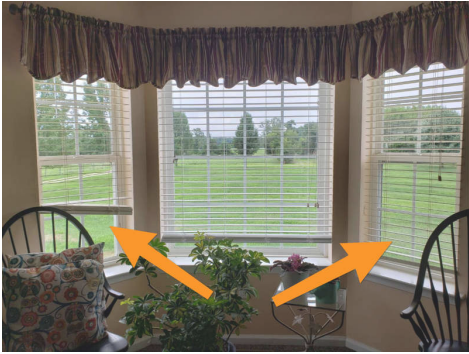
5.1.1 Windows

INOPERABLE WINDOW

One or more of the windows at the time of the inspection were not operational. Inoperable windows may prevent egress during emergency situations. The inspector recommends that all of the windows be evaluated and repaired by a qualified professional.

Contact a qualified window repair/installation contractor.

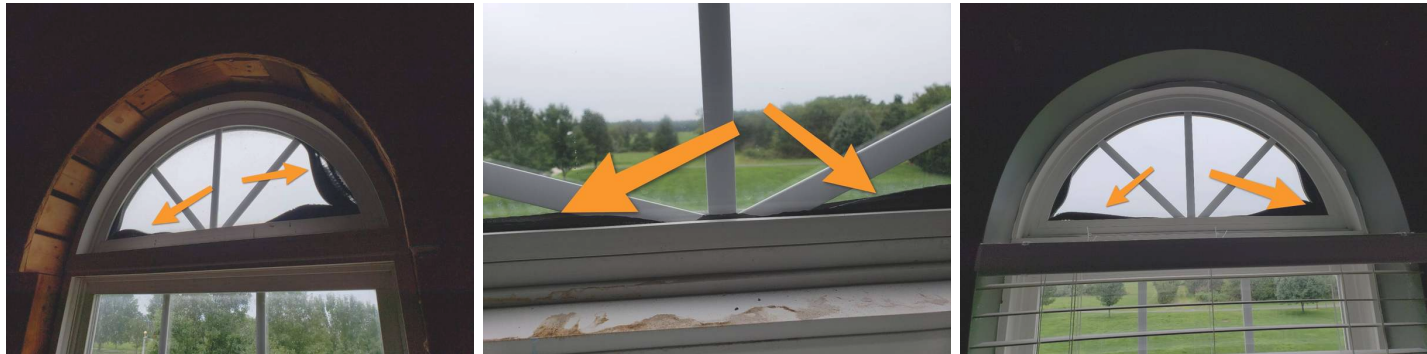
5.1.2 Windows

WINDOW - DAMAGED SEALANT

One or more windows exhibited signs of damaged sealant. This condition may compromise the thermal efficiency of the windows. The inspector recommends further evaluation and repair by a qualified professional.

Contact a qualified window repair/installation contractor.

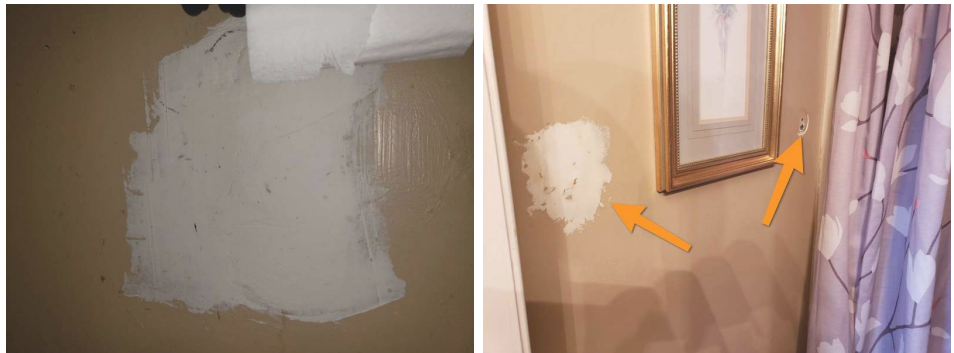
5.5.1 Walls

DRYWALL - POOR PATCHING

One or more sections of dry patching was sub-standard. This condition is an indication of poor workmanship, likely not done by a qualified professional. The inspector recommends the drywall be re-patched using proper techniques by a qualified professional.

Contact a qualified drywall contractor.

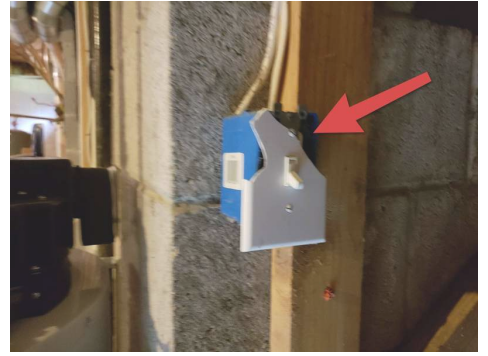
6.6.1 Lighting Fixtures, Switches & Receptacles

RECEPTACLE - COVER PLATES DAMAGED

One or more switch plate covers are damaged. This condition may cause a shock hazard. The inspector recommends further evaluation and repair by a qualified professional.

Contact a qualified electrical contractor.

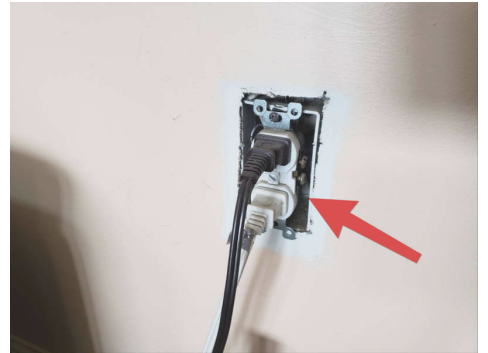
6.6.2 Lighting Fixtures, Switches & Receptacles

RECEPTACLE - MISSING COVER PLATE

One or more receptacle cover plates were missing. This condition may cause an electrical short or shock hazard. The inspector recommends evaluation and repair of all cover plates by a qualified professional.

Contact a qualified electrical contractor.

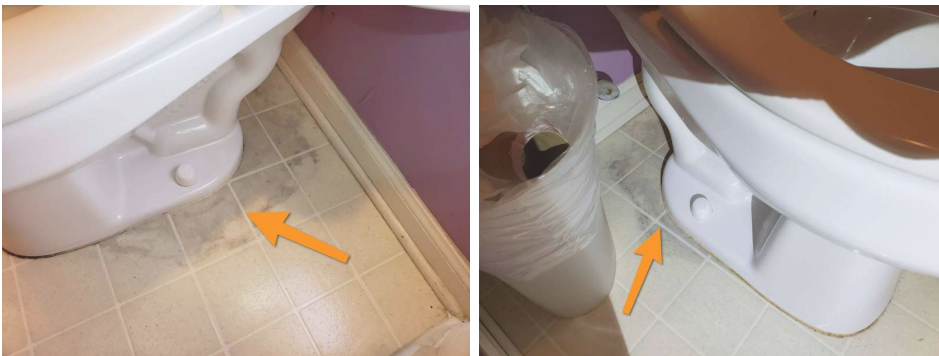
7.4.1 Fixtures and Faucets

TOILET - FAILING WAX SEAL

The wax seal on one or more toilets is failing. This condition may allow moisture intrusion which may cause damage to surrounding components. The inspector recommends further evaluation and repair by a qualified professional.

Contact a qualified plumbing contractor.

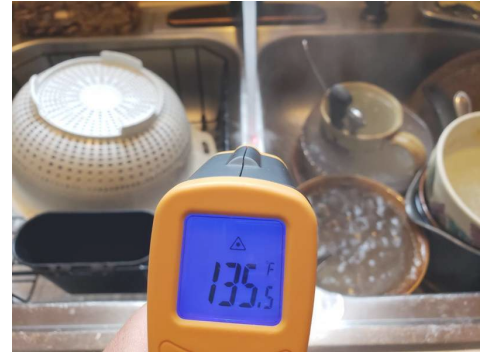
7.5.1 Water Heater

WATER HEATER - EXCESSIVE TEMPERATURE

At the time of the inspection the temperature of the water in the kitchen was 135 Degrees F. This condition may be a scalding hazard. The inspector recommends further evaluation and repair by a qualified professional.

Recommendation
Contact a qualified plumbing contractor.

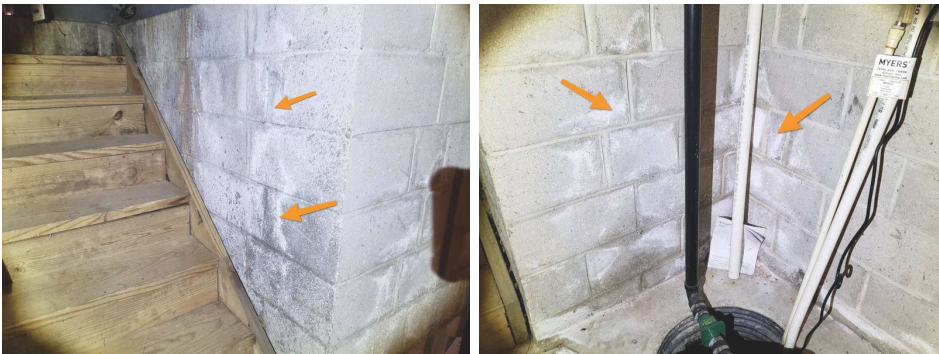
8.1.1 Foundation Walls

EFFLORESCENCE

One or more foundation walls showed signs of efflorescence. Efflorescence is a white, powdery deposit that is consistent with moisture intrusion. This can compromise the soil's ability to support the home structure and/or lead to mold growth. The inspector recommends the affected walls be evaluated by a qualified contractor to identify the source of moisture and repair.

Recommendation
Contact a foundation contractor.

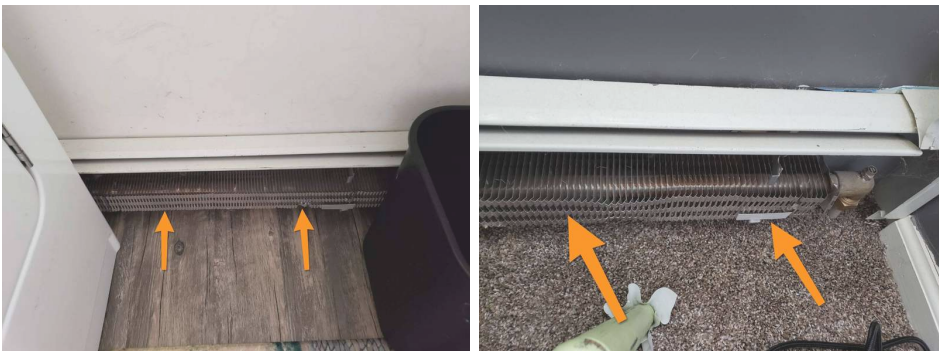
9.4.1 Distribution Systems

BASEBOARD - NO COVER

One or more sections of baseboard heating elements were not covered. This condition is a burn hazard especially to small children. The elements are also susceptible to damage if not covered. The inspector recommends further evaluation and repair of all of the baseboard heating elements by a qualified professional.

Recommendation
Contact a qualified heating and cooling contractor

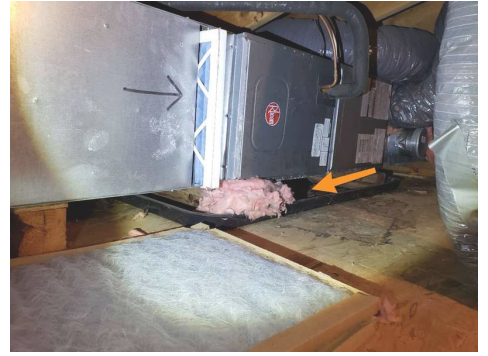
10.2.1 Condensate Tube

CONDENSATE - OVERFLOW PAN (NO ALARM)

The air handler does not have an high water alarm on the condensation overflow pan. This condition may allow condensation to overflow the pan without being noticed until damage is done to surrounding components. The inspector recommends further evaluation and repair by a qualified professional.

Recommendation
Contact a qualified heating and cooling contractor

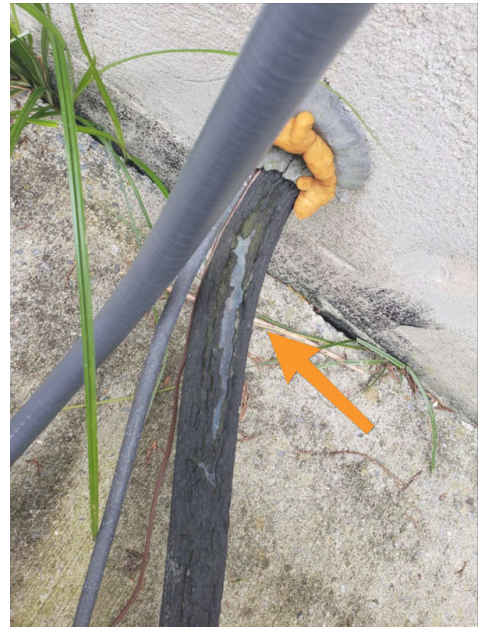
10.3.1 Refrigerant Lines

MISSING SUCTION LINE INSULATION

The suction line insulation is not adequate and is in poor condition. This condition may cause the condensing coil to operate less efficiently. The inspector recommends complete insulation of the refrigerant line by a qualified handyman or contractor.

Recommendation
Contact a handyman or DIY project

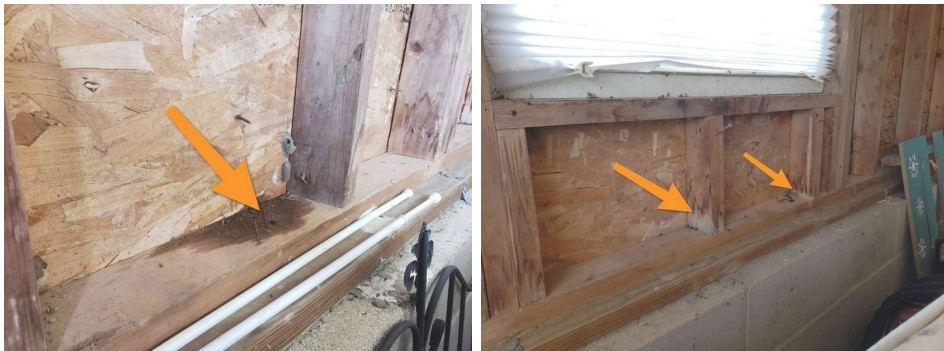
12.3.1 Walls & Firewalls

GARAGE WALL - MOISTURE INTRUSION

One or more sections of the garage wall exhibited signs of moisture intrusion. This condition will only worsen over time if not corrected. Which may cause damage to surrounding components. The inspector recommends further evaluation and repair by a qualified professional.

Recommendation
Contact a qualified carpenter.

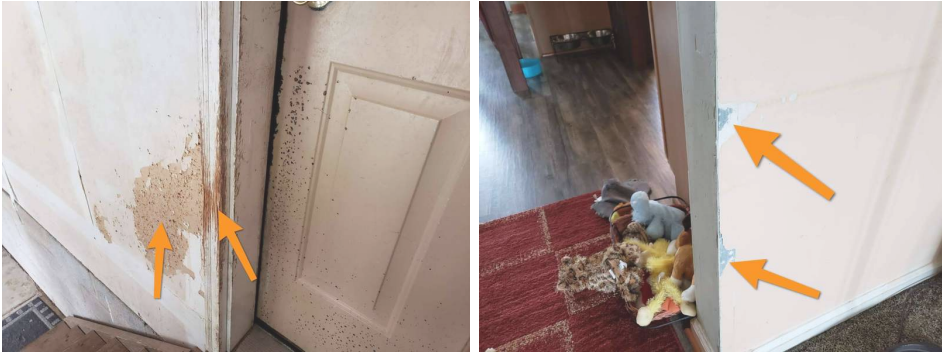
INTERIOR WALL - PET DAMAGE

One or more interior walls exhibited signs of pet damage. This is a cosmetic defect to door trim and drywall. The inspector recommends further evaluation and repair by a qualified professional.

Recommendation
Contact a qualified carpenter.

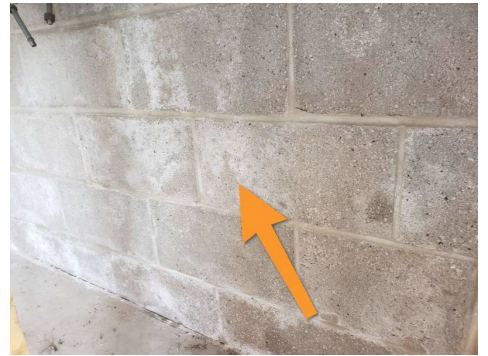
WALL - EFFLORESCENCE

Recommendation
Contact a foundation contractor.
