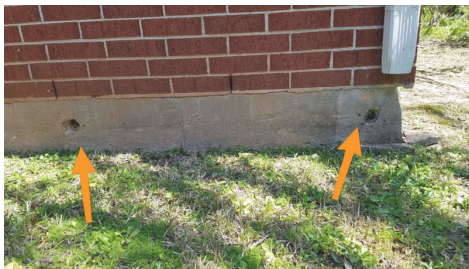
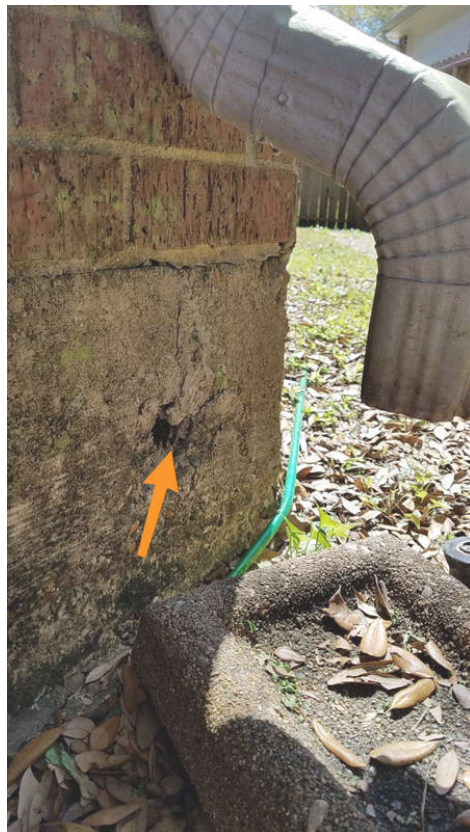
Rear Left

POST TENSION CABLE ENDS

One or more of the post tension cable ends are exposed and need to be properly sealed.

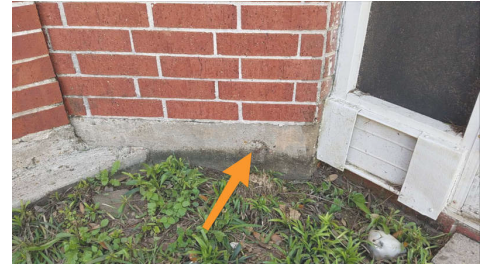
Rear

VISIBLE REBAR

The foundation re bar is visible on the edge of the foundation beam and needs to be properly covered.

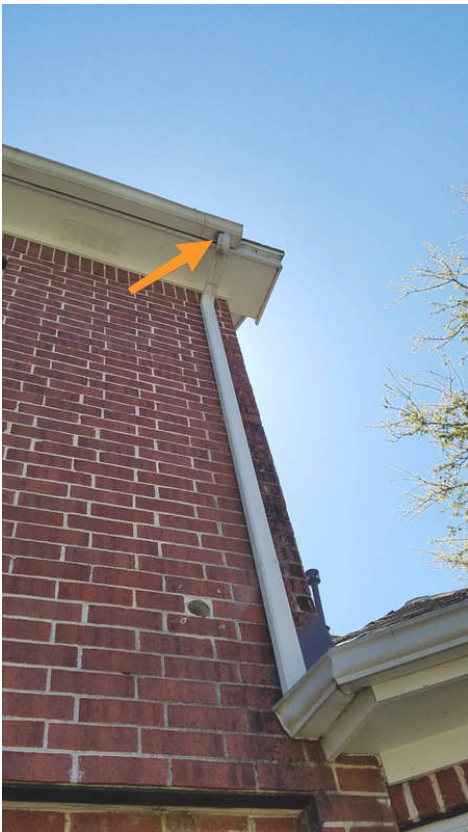
Rear

DOWNSPOUT SEPERATED

The downspout is separated.

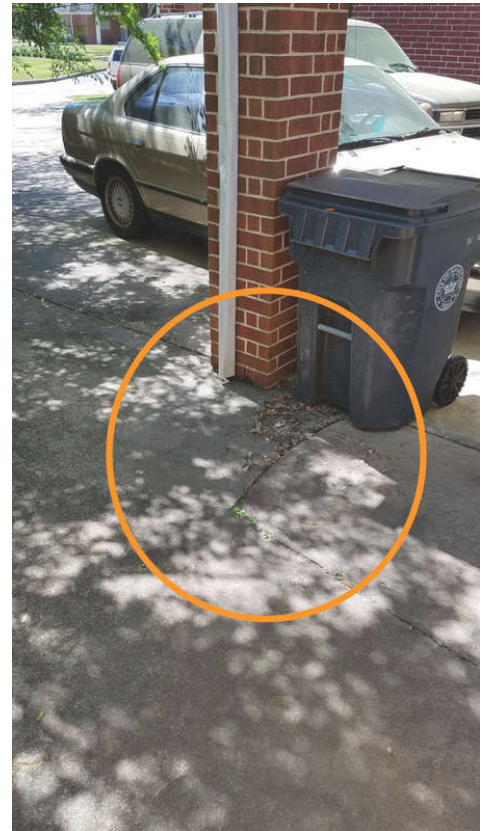
STANDING WATER

Standing water observed, which could indicate poor drainage and/or grading. Recommend monitor and/or have landscaper correct.

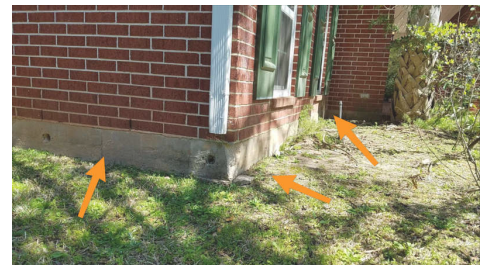
LOW SOIL

The soil line is low. Under current building standards there should be 4-inches of foundation visible below masonry veneer and 6-inches of foundation visible below wood type veneer. It is recommended that fill dirt be added around the structure in the noted areas.

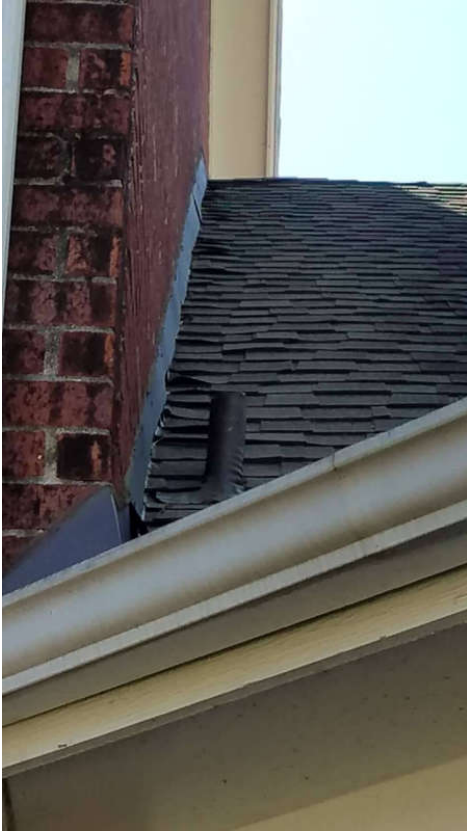
LIFTED SHINGLES

The roofing material observed to have loose and/or lifting shingles in various locations. The damage may have been caused by a previous wind storm and should be further evaluated.

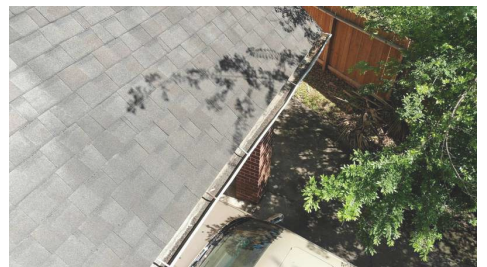
GRANULAR LOSS

The composition roofing material has experienced granular loss in various locations and should be further evaluated by a qualified roof contractor and repaired as necessary.

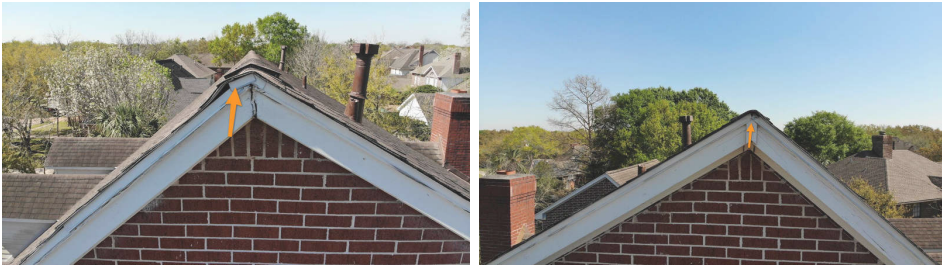
FLASHING INDEQUATE

The flashing appears to be inadequate in one or more locations.

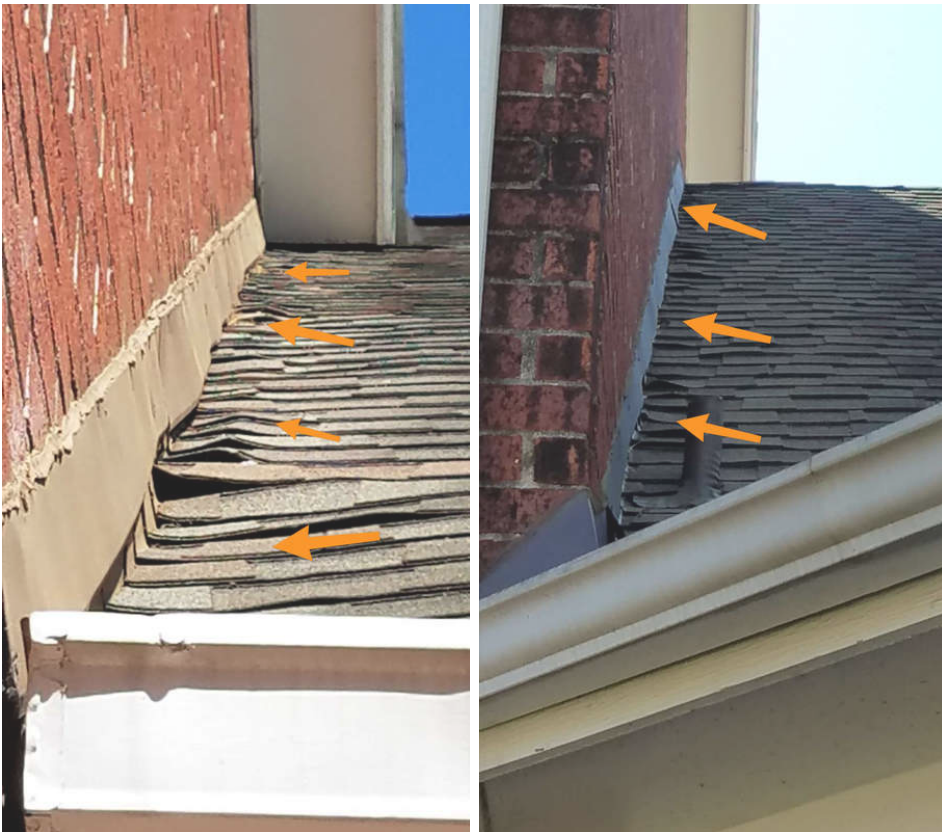
FLASHING LIFTED

The flashing is lifting and/or pulling loose and should be re-secured.

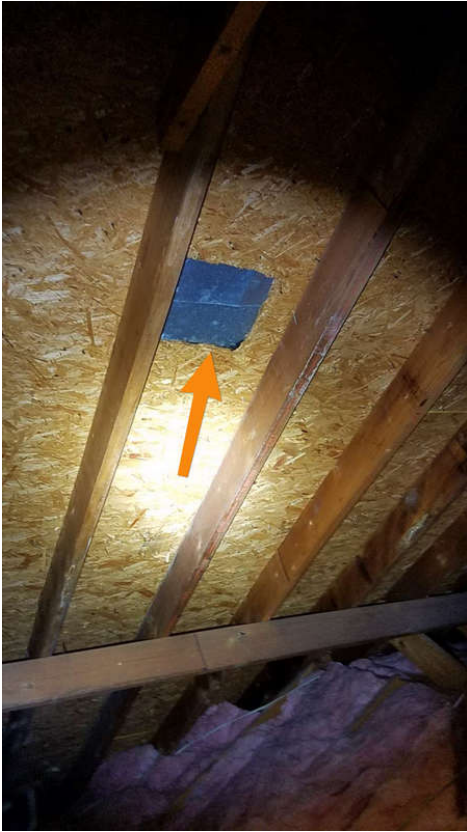
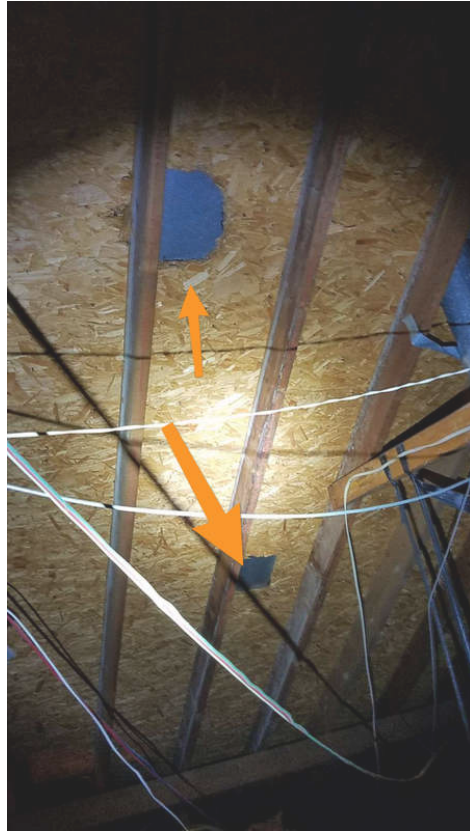
Attic

DECKING DAMAGED

Some roof sheathing (decking) deterioration and/or damage was observed in one or more locations. This condition should be further evaluated by a qualified roofer and repaired as necessary

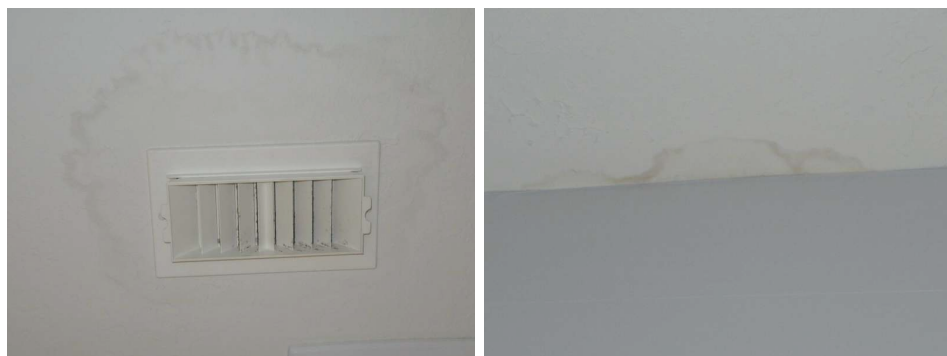
WATER STAIN

Water stains were observed on the ceiling finish. The cause and remedy should be further evaluated and corrected as necessary.

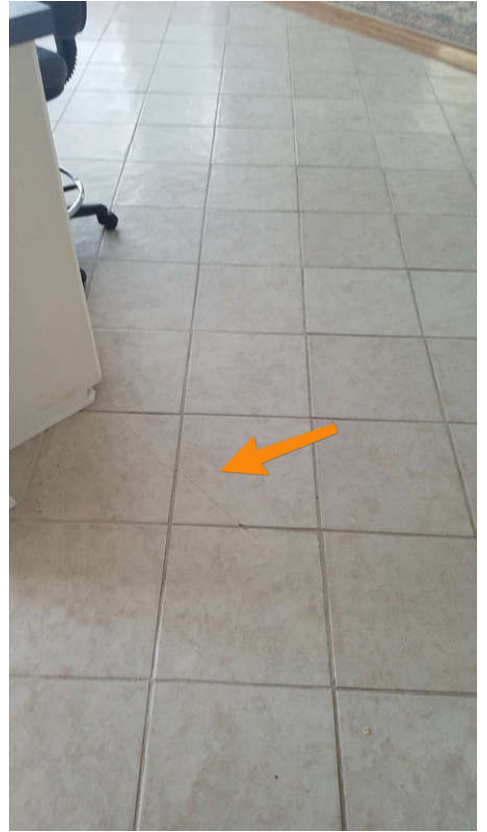
Upstairs gameroom

LOOSE OR DAMAGED TILE

The floor tile(s) were observed to be cracked and/or damaged.

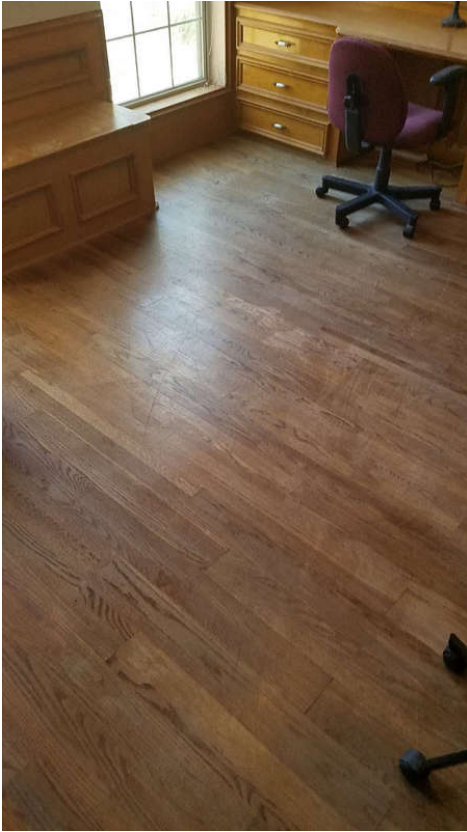
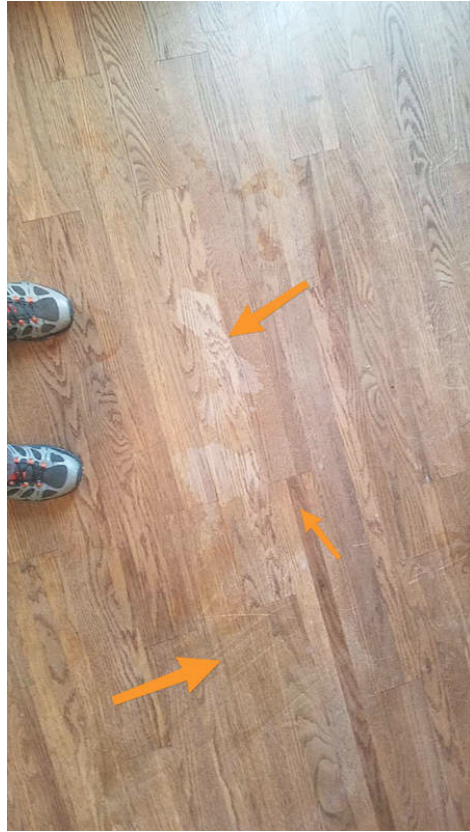
Study/office

WORN FLOOR COVERING

The floor covering is noticeably worn and/or damaged in one or more locations of the home.

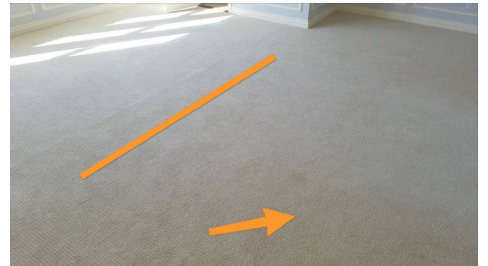
MINOR CARPET WEAR - GENERAL

The home had general minor carpet wear on major paths of travel.

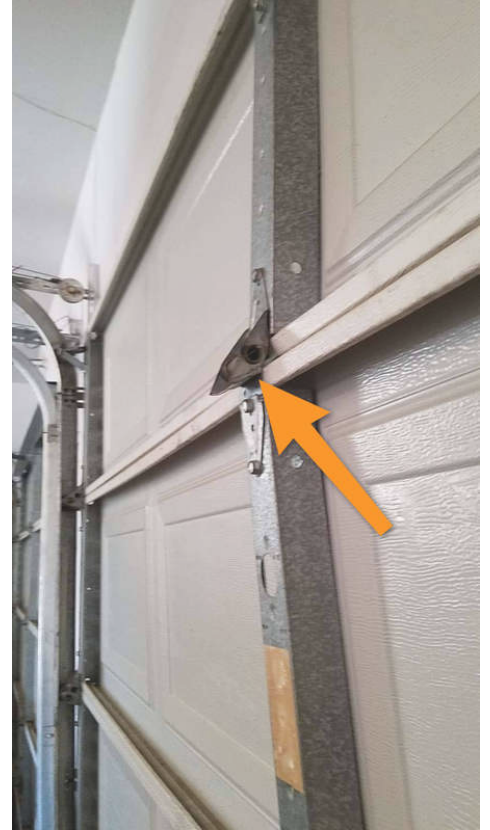
GARAGE DOOR HINGE LOOSE

Some of the overhead garage door hinges were observed to be loose and should be re-secured.

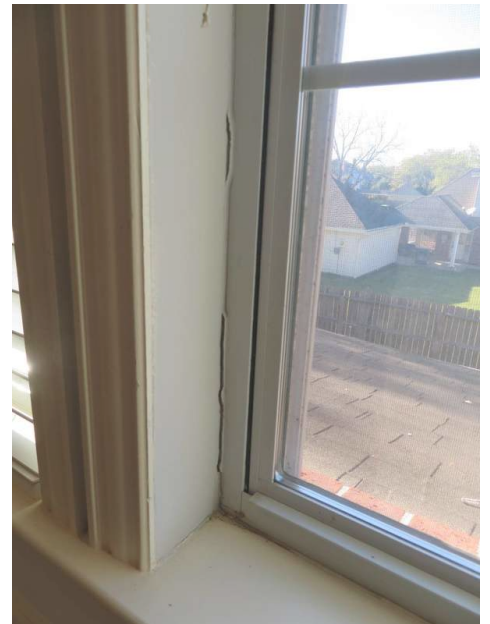
SILL DAMAGE INTERIOR

The interior window sill(s) have some deteriorated and/or damaged.

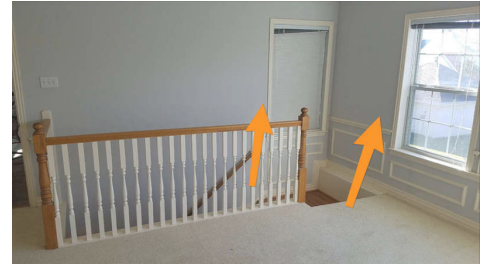
Right stairs

POOR LIGHT SWITCH LOCATION

The light switch for the stairway is poorly located. Under current electrical standards, the activation switch should be accessible at the top and bottom of the stairway without traversing any step of the stairs.

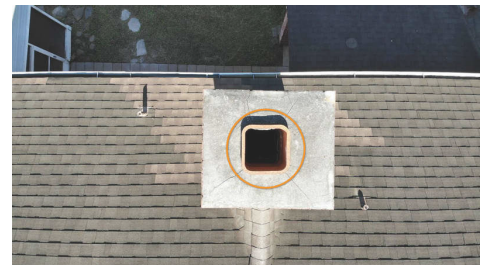
NO CHIMNEY CAP / SCREEN

There is no chimney rain cap or screen in place at this time.

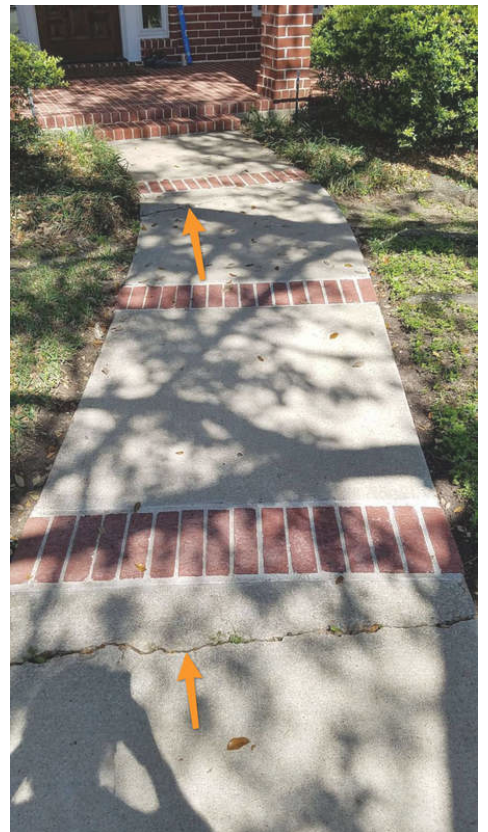
Front

SIDEWALK SETTLED

The sidewalk has settled somewhat. If this condition persists or if the sidewalk becomes a trip hazard, improvements should be undertaken.

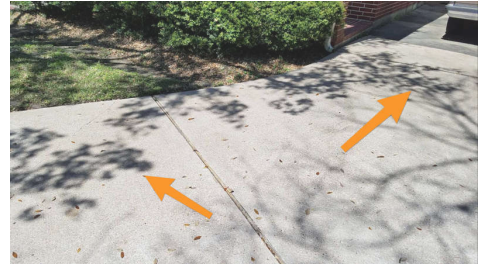
MINOR DRIVEWAY CRACKS

Minor cracks and/or deficiencies were observed in the driveway.

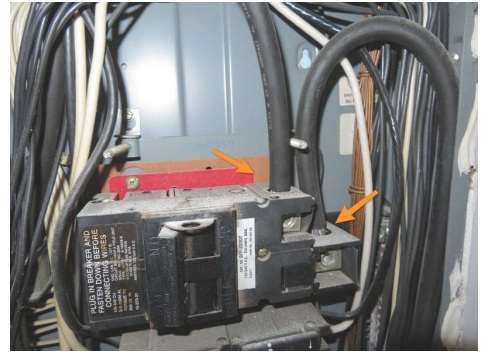
NO ANTI-OXIDANT ALUMINUM

There was no anti-oxidant gel observed on the exposed aluminum conductor terminations.

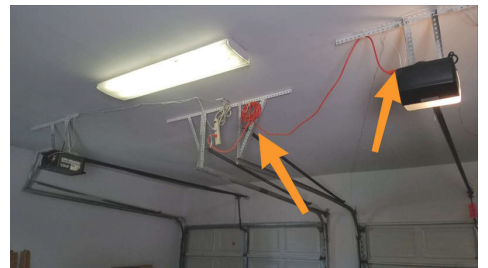
EXTENSION CORD PERMANENT

Electrical flex extension cords should not be used for permanent wiring or pass through walls or ceilings.

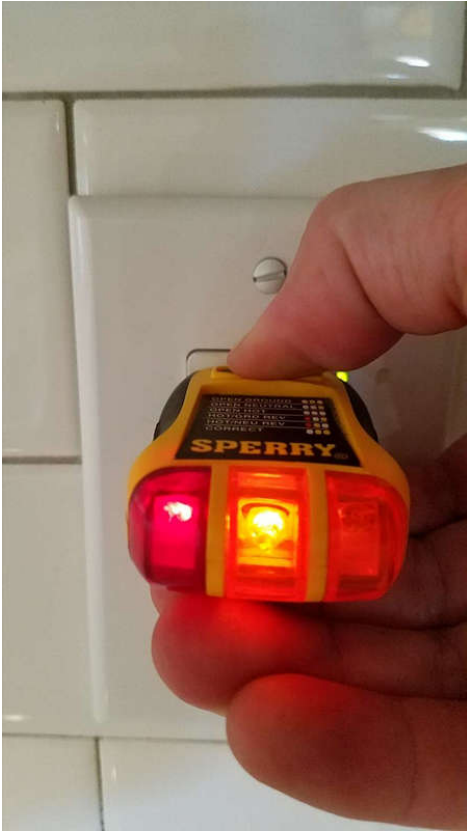
GFCI DOES NOT FUNCTION PROPER

One or more of the ground fault circuit interrupter (GFCI) devices does not appear to be functioning properly at the time of this inspection. Recommend further evaluation by a licensed electrician and repair as needed.

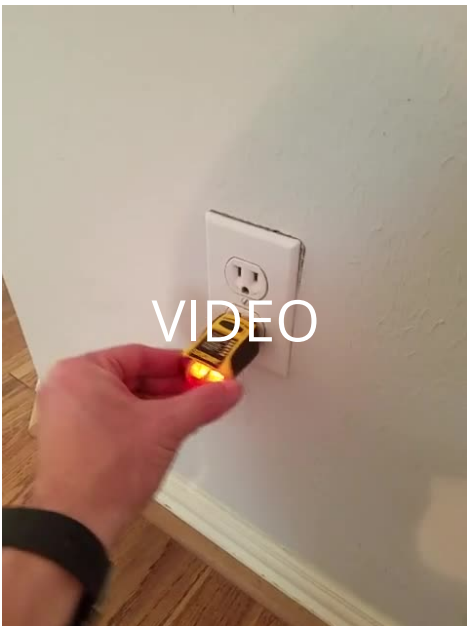
LOOSE PLUG

One or more of the receptacles were observed to be loose at the wall mount. Recommend a licensed electrician evaluate and repair or replace as necessary.

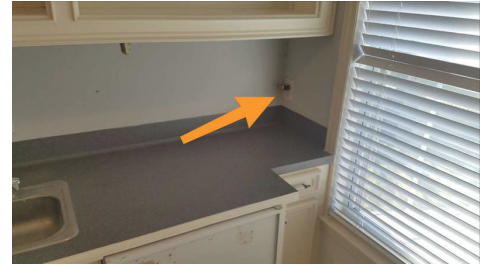
INOP PLUG

One or more of the receptacles appears to be inoperative. This receptacle(s) and circuit should be investigated and corrected as necessary.

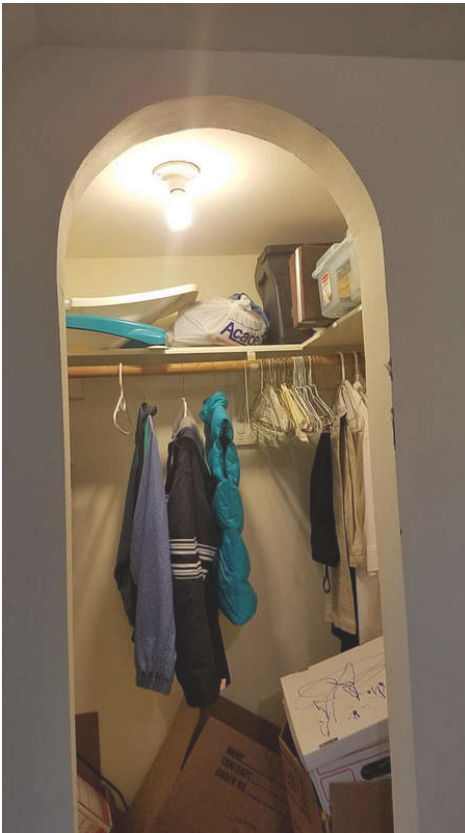
Upstairs Bedroom Closet

CLOSET LIGHT NO COVER

One or more of the closet light fixtures appear to be installed without globes and/or covers. Safety precautions should be taken around these light fixtures. This is an as built condition however we are required by TREC to note this as a deficiency.

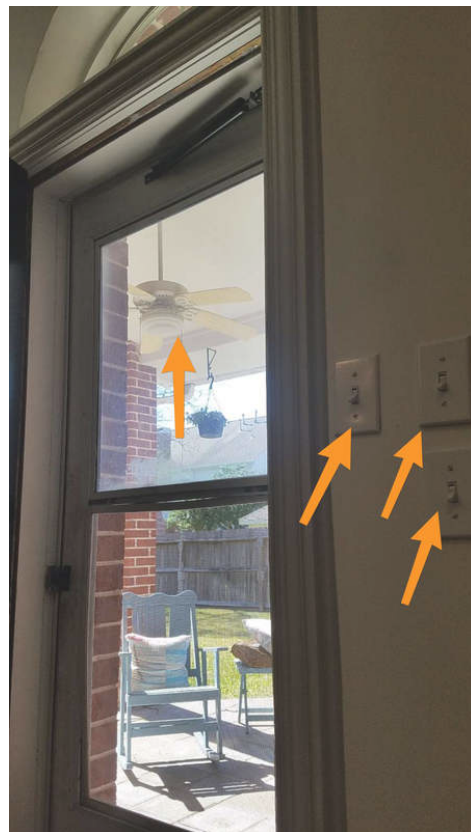
Rear

EXTERIOR LIGHT INOP

Some light fixtures mounted on the exterior walls of the residence were inoperable at the time of the inspection. This condition can be caused by burned out bulbs, the light may be connected to a timer or light-sensitive switch or a problem may exist with the light fixture, wiring or the switch. You should re-test any inoperable light fixtures after replacing the bulbs.

If after bulb replacement the lights still fail to respond to the switch, consider evaluation by a qualified electrical contractor. This condition may be a potential fire hazard.

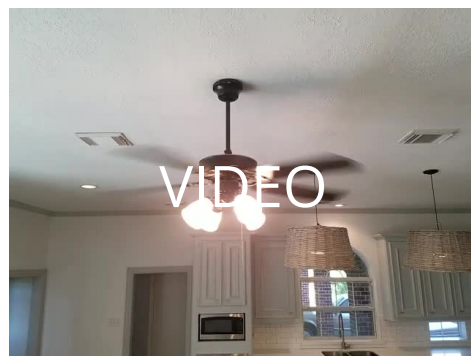
FAN OUT OF BALANCE

The ceiling fan is not balanced properly and wobbles when operated.

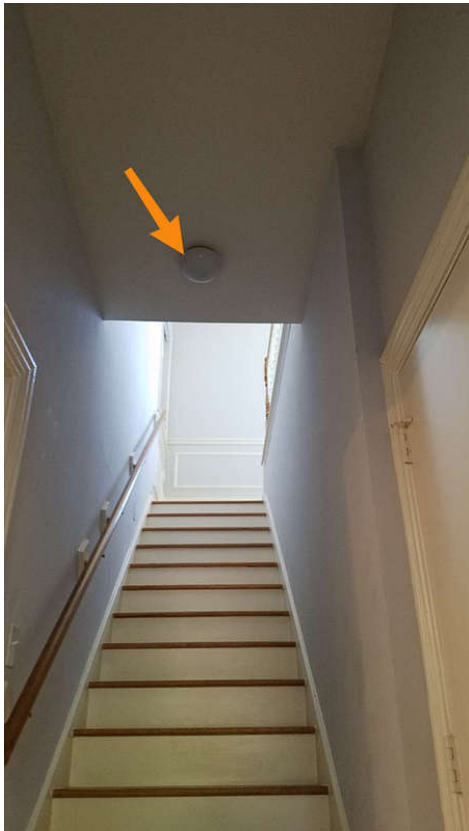
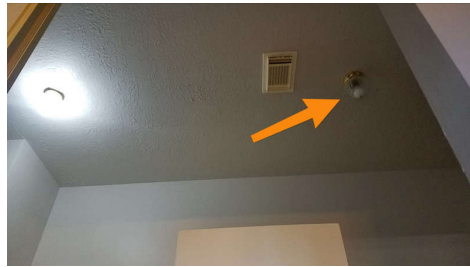
BULB?

One or more of the light fixtures appear to be inoperative. This may be due to a bad bulb or some other unknown condition. This condition should be further evaluated and corrected as necessary.

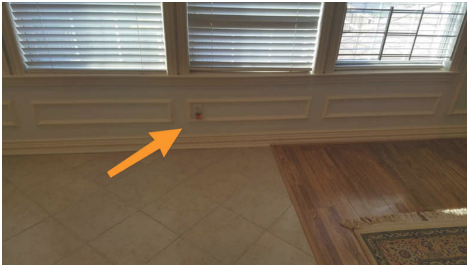
Upstairs gameroom

PLUG GROUND & HOT REVERSED

One or more plugs has improper wiring, and the "hot" and ground are reversed. Recommend a licensed electric repair or replace.

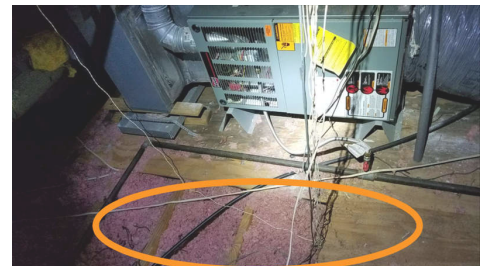
NO SERVICE PLATFORM

The attic equipment service platform is inadequate or missing. There should be at least a 30 X 30 inch floored service space in front of the service side of the equipment.

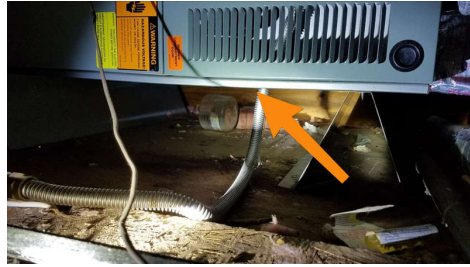
FLEX INTO CABINET

The gas supply flex connector was observed to be passing through the heating unit cabinet. Under current mechanical installation standards, this is no longer an accepted practice. Only rigid black gas pipe is allowed to pass through the heating unit cabinet. This may be an as-built condition but Per TREC standards of practice we are required to report this condition as a deficiency.

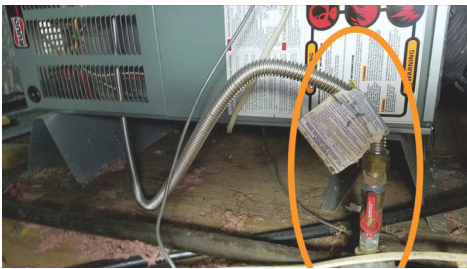
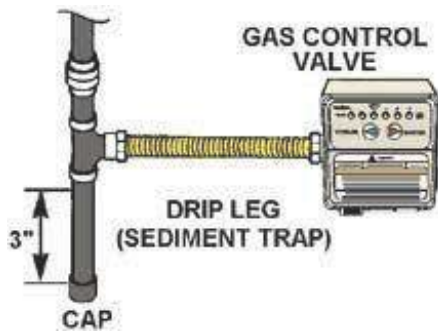
4.1.3 A. Heating Equipment
NO SEDIMENT TRAP

The heater gas supply line is not equipped with a sediment trap just before the gas appliance connector. This condition does not meet current installation requirements and should be corrected.

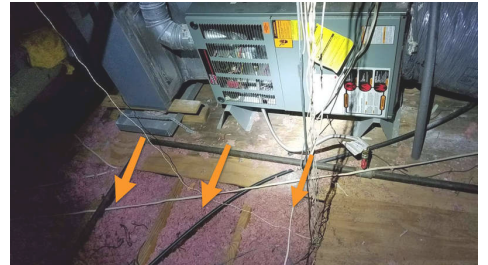
4.2.1 B. Cooling Equipment
30X30
ATTIC

The attic equipment service platform is inadequate or missing. There should be at least a 30 X 30 inch floored service space in front of the service side of the equipment.

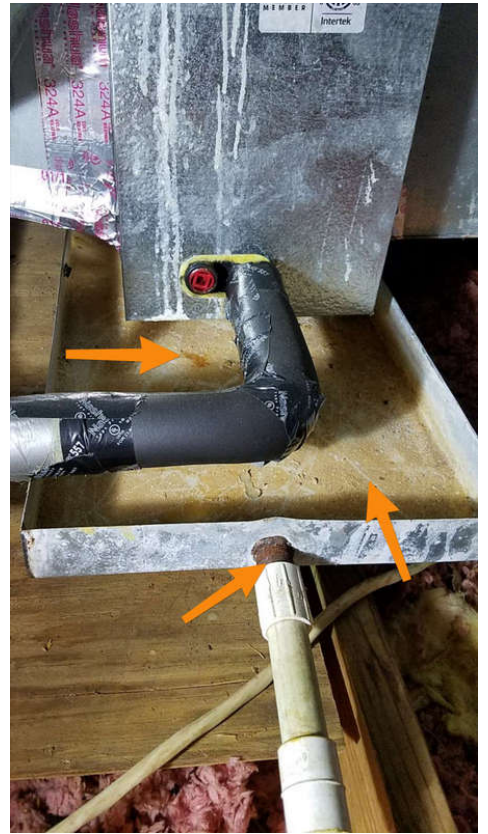
Upstairs unit

4.2.2 B. Cooling Equipment
RUST IN PAN
ATTIC

The auxiliary/secondary drain pan under the coil housing has some water staining and/or a rust build-up. This would indicate that the pan has held water in the past and should be closely monitored.

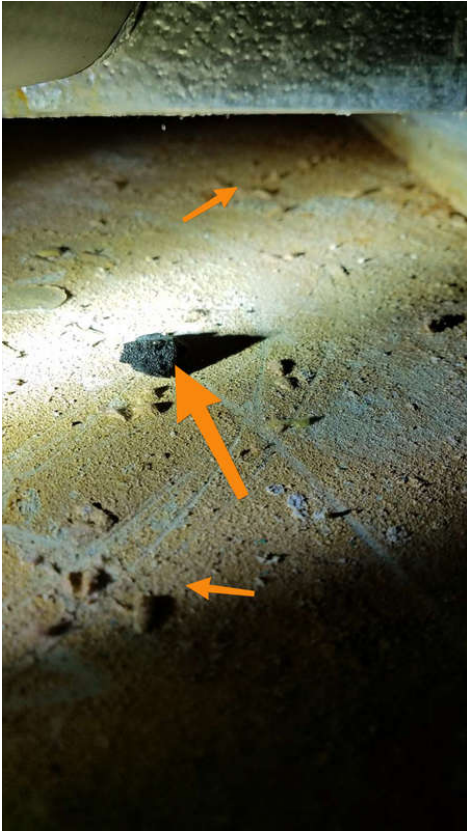
DEBRIS IN PAN

The auxiliary/secondary drain pan under the coil housing should be free of all debris. The debris in the pan could clog the drain line and cause water to leak to the interior of the house.

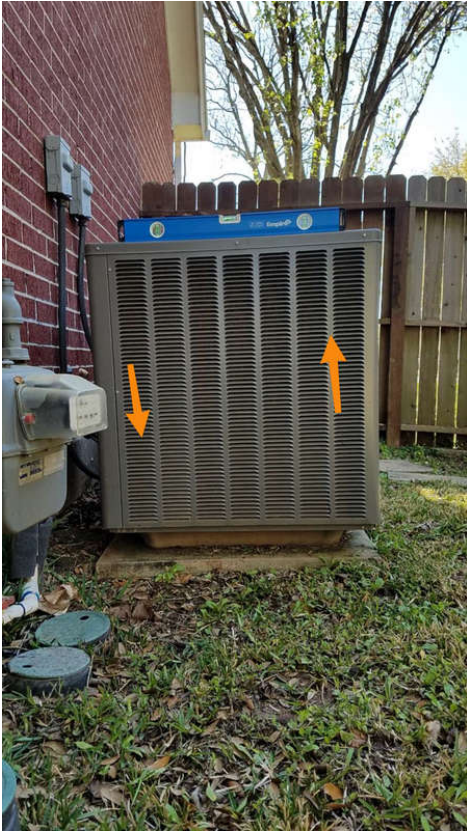
LEVEL OUTSIDE UNIT

The outdoor unit of the air conditioning system is out of level. It is recommended that the outside condenser/coils be within 1-inch of level.

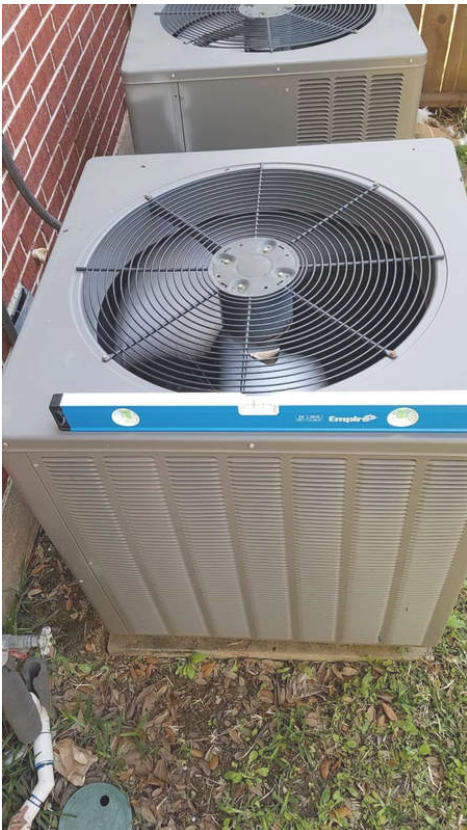
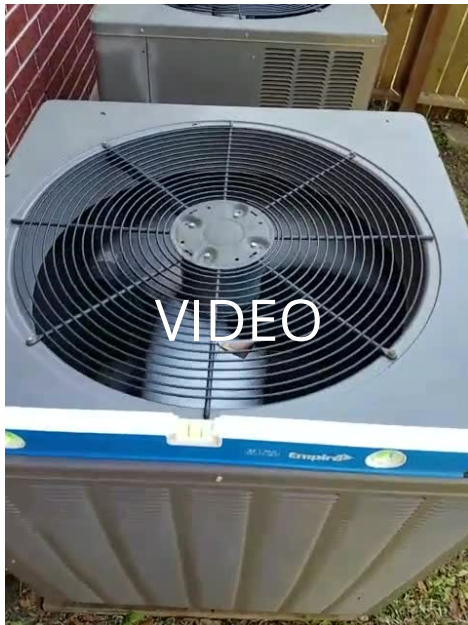
4.2.6 B. Cooling Equipment
FAN MOTOR BALANCE

The outside condenser/coil fan motor is out of balance and causes the unit to vibrate more the normal.

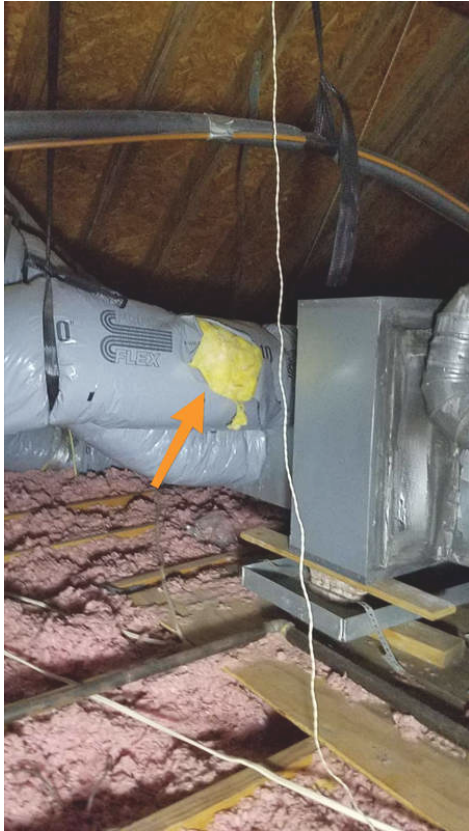
Attic

DAMAGED INSULATE

Ductwork insulated covering was observed to be damaged and/or pulling loose.

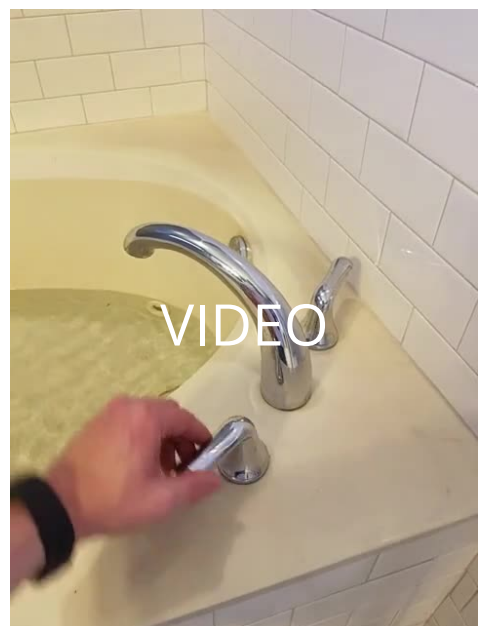
"WATER HAMMERING"

Water hammering is a term used to describe noise produced by a destructive force known as hydraulic shock. Water hammering develops in a piping system when an instantaneous change in the velocity of flowing water occurs, or when water flowing at a given velocity is stopped abruptly. A quick closure of a valve, for example, creates some form of shock. The shock wave is accompanied by a pressure surge that can expand the wall of the pipe. Recommend further evaluation by a licensed plumber and repair or replace as necessary.

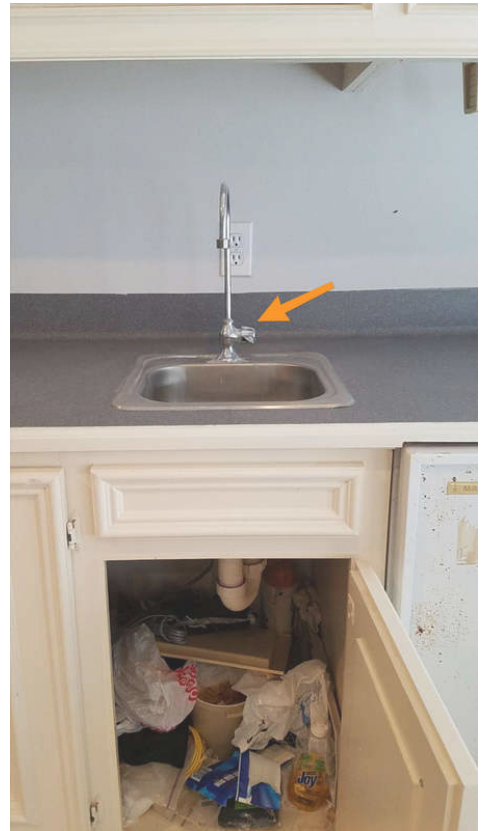
Upstairs Gameroom

FAUCET NOT FUNCTION PROPER

The faucet is not functioning properly at this time.

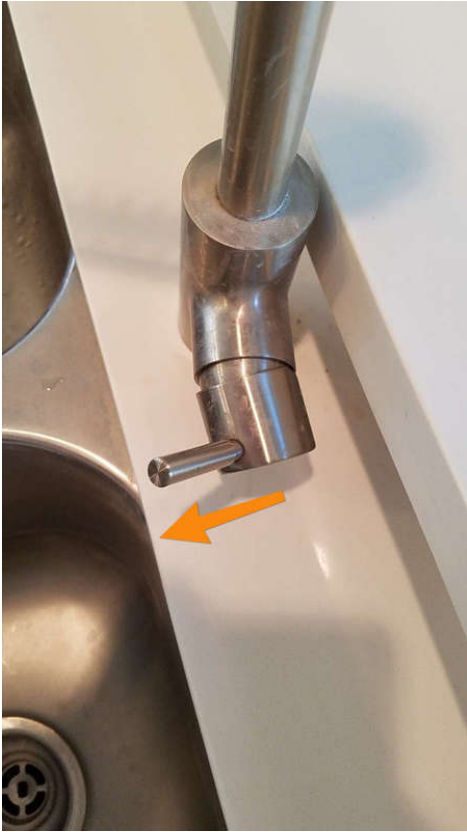
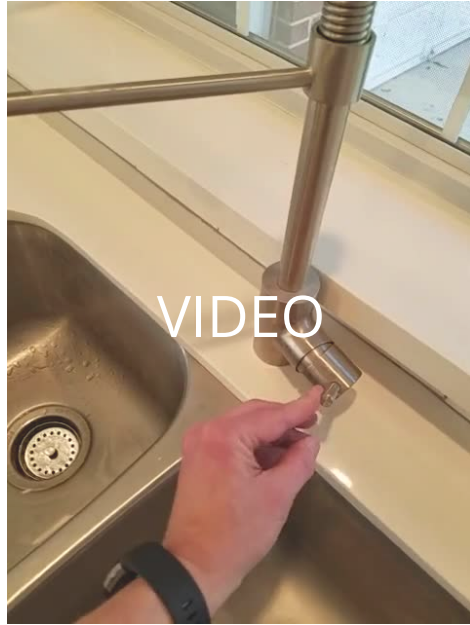
Kitchen

INOPERABLE

The faucet cold water supply is inoperative. The cause and remedy should be further evaluated.

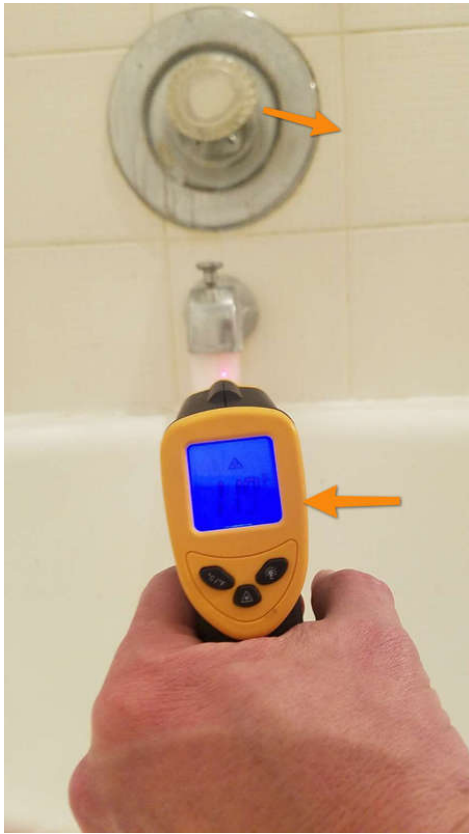
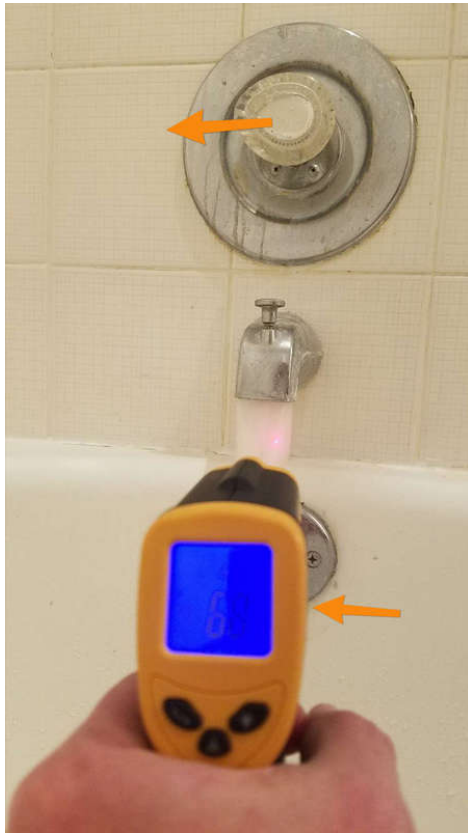
HOT COLD REVERSED

The faucets hot/cold water orientation is reversed.

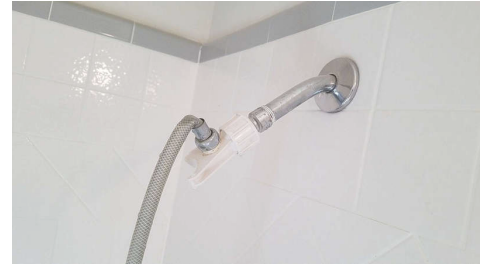
Upstairs Garage apartment

LEAK AT NECK CONNECTION

The shower spout is leaking at the neck connection. This condition could result in water intrusion into the wall cavity.

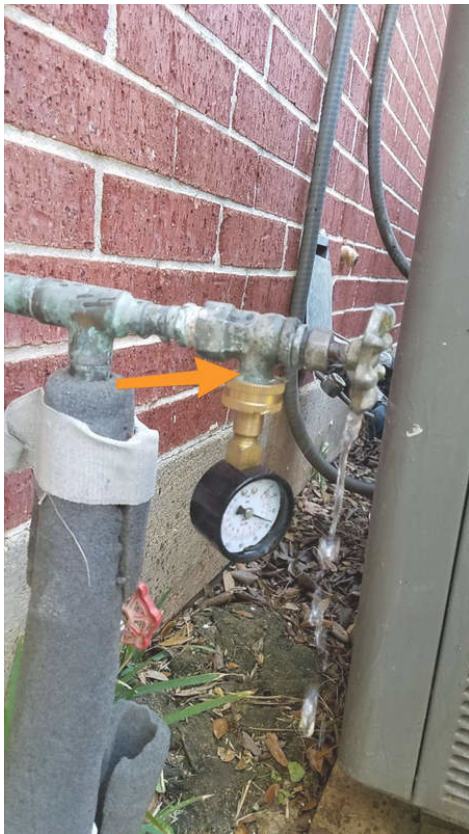
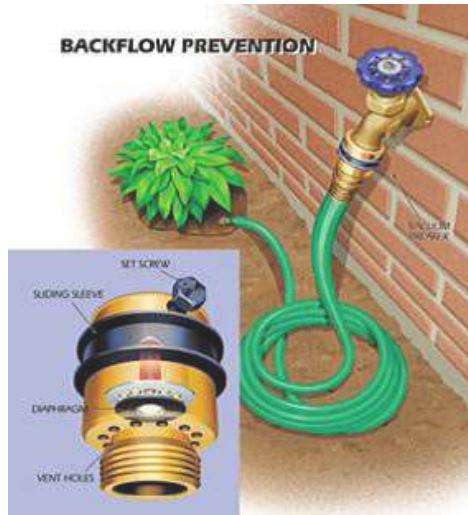
BACKFLOW MISSING

One or more of the exterior water hose bibbs (faucet) do not have a back-flow or anti-siphon device (Vacuum Breakers) in place. Note: This is not uncommon to observe with a home of this age.

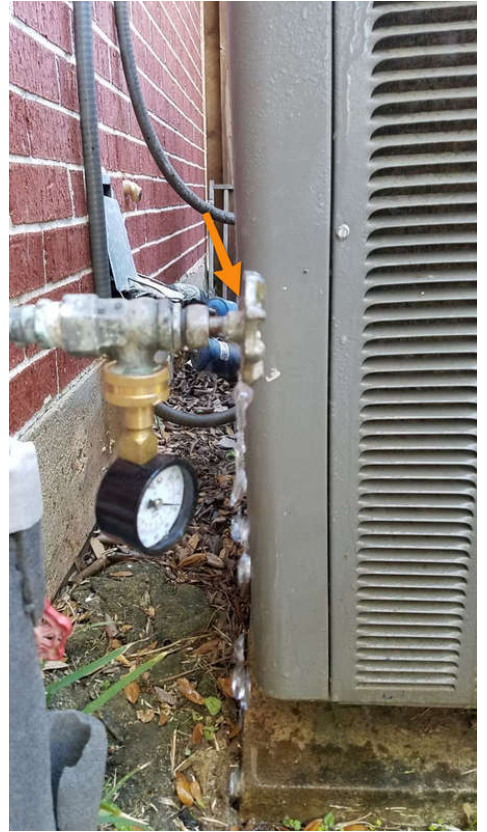
Left

LEAKS AT HANDLE

The exterior water hose bib (faucet) is leaking at the handle when operated.

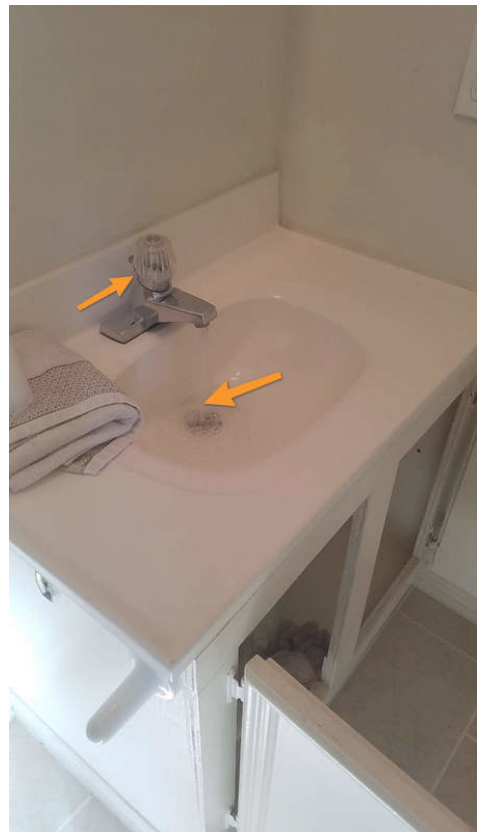
Upstairs Garage Apt.

The sink hardware was installed incorrectly. It did not properly hold water as a result.

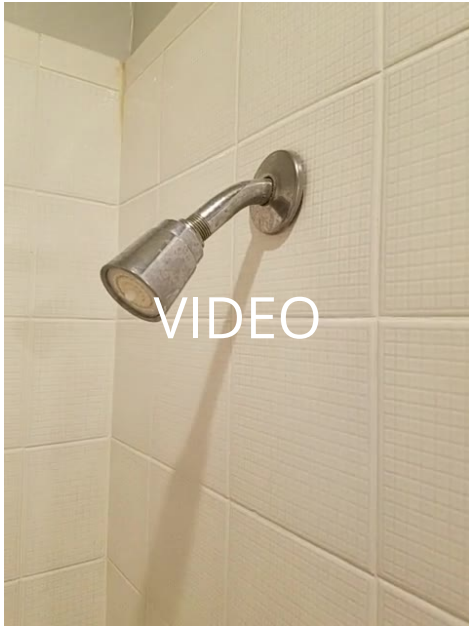
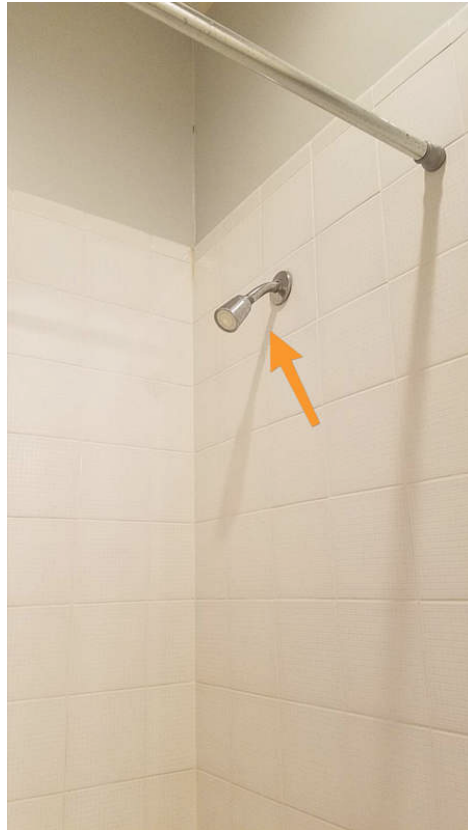
SHOWER SPOUT LOOSE

Shower spout is loose. Recommend a licensed plumber repair or replace as recommended.

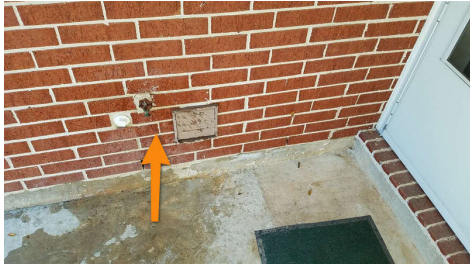
Rear

HOSE BIB PIPEING LOOSE

The hose bib is loose at the connection and does not have support for the piping inside the wall. Recommend repair by licensed plumber.

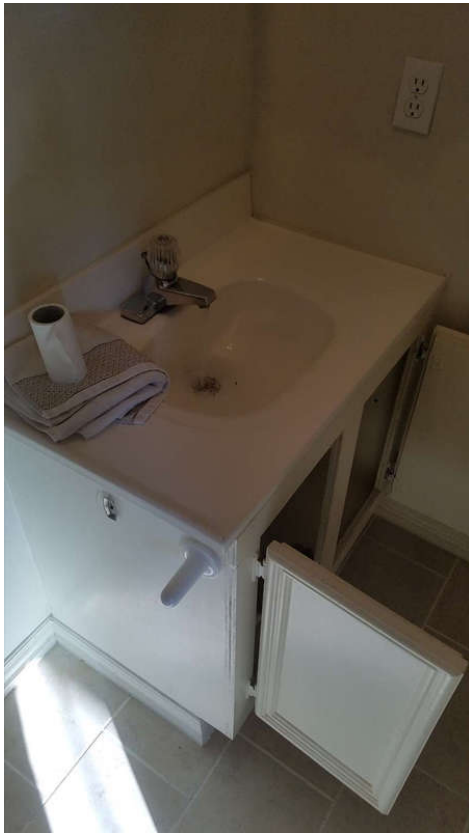
Upstairs Garage apt

The sink was observed to drain slowly, suggesting that an obstruction may exist.

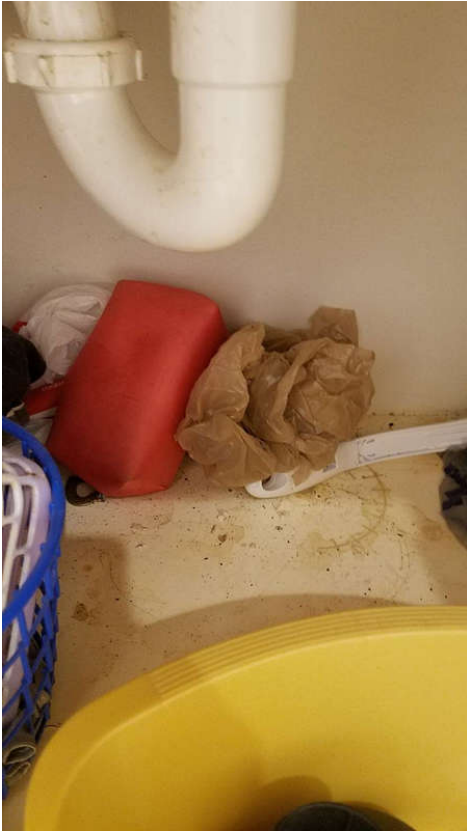
Upstairs Bathroom Left

PRIOR LEAK

Previous water leaks were observed at and/or around the drain connections under the sink. This would indicate previous problems and should be closely monitored and corrected when necessary.

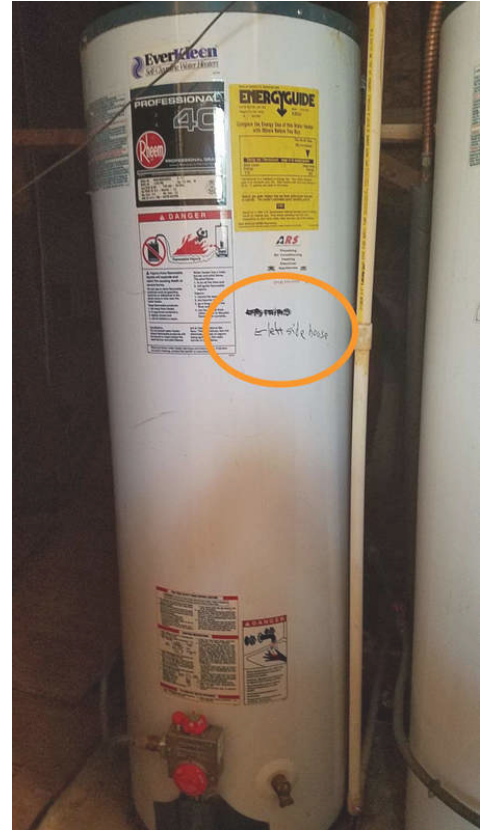
The water heater is making a rumbling noise when operated. This is a good indicator that there is a lot of sediment in the bottom of the water heater tank. Cleaning and servicing is recommended.

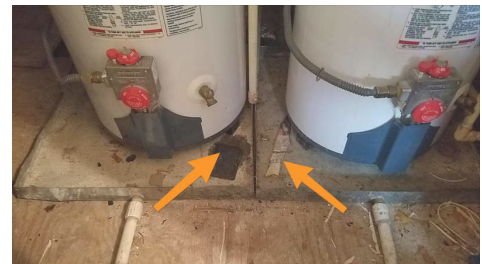
Attic

The debris in the water heater pan should be cleaned out to help prevent the pan drain line from being clogged.

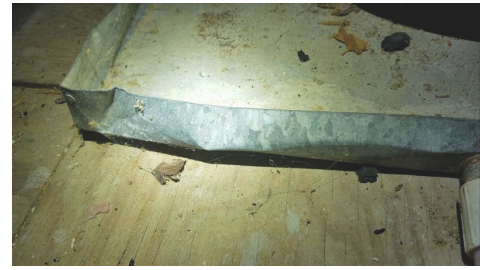
Attic

PAN DAMAGED

The pan under the water heater was observed to be damaged and repairs are recommended.

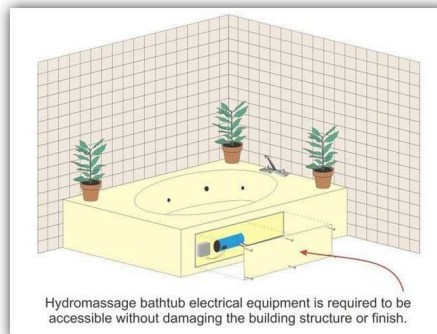
The access to the hydro-massage therapy equipment motor is not readily accessible and inspection of the equipment lines and motor could not be performed. This does not meet current installation standards.

Hydromassage bathtub electrical equipment is required to be accessible without damaging the building structure or finish.

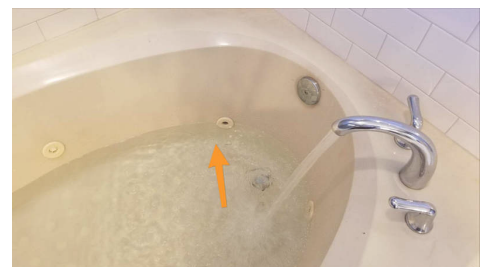
DAMAGED COMPONENT

One or more of the hydro-massage therapy jets or covers has damaged and/or missing components.

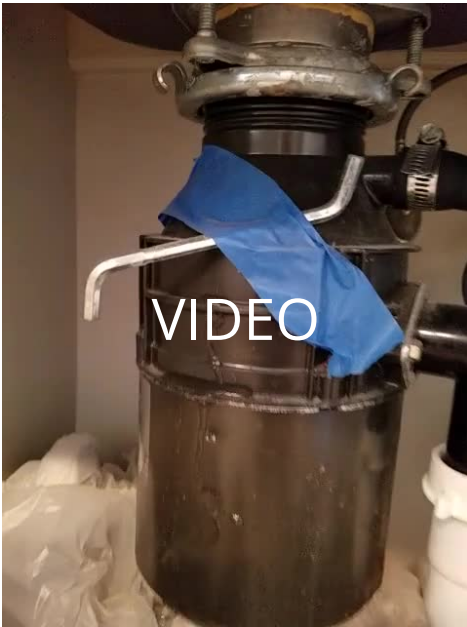
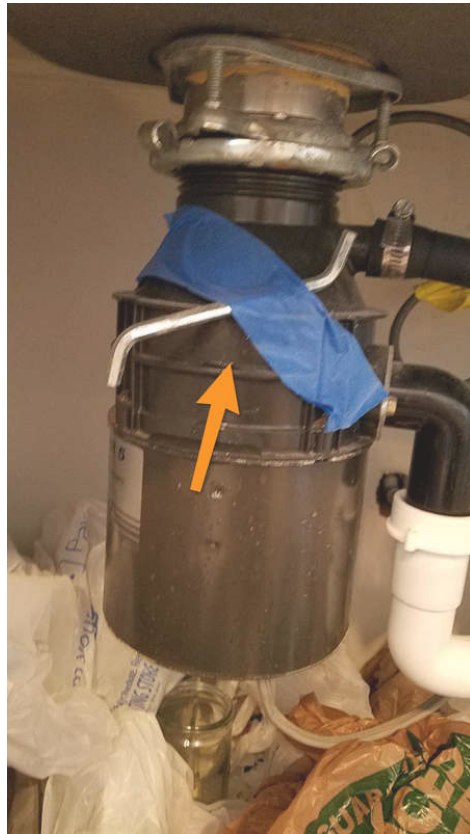
Kitchen

LEAKS

The food waste disposer is leaking water into the cabinet area. This condition should be further evaluated and corrected as necessary.
